# *Home Inspection Services By Jove inc*

## Property Inspection Report

**132 Pinnacle Point, Macon, GA 31216**

**Date of Inspection: 8/11/2025 Time: 9:00**

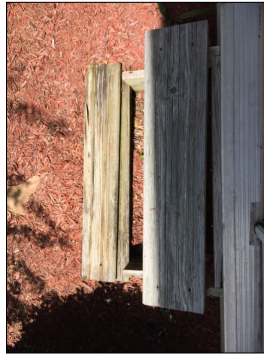
Replace the deteriorated stairway at the rear left basement exterior door.

- 1.1. Replace the deteriorated stairway at the rear left basement exterior door.

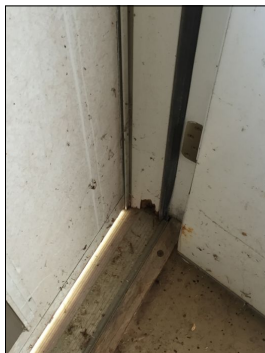
Repair the area of rotted door jamb at the bottom of the right side exterior door unit.

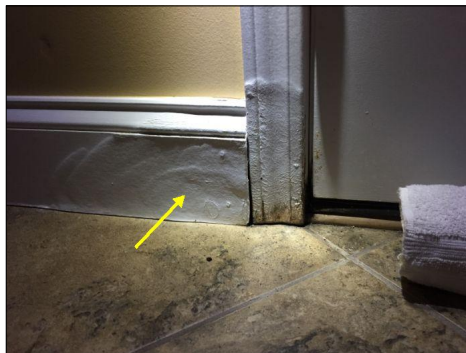
Replace the rotted baseboards, door jamb and doors at the rear left basement exterior door unit, and consider installing a roof brow over or awning over the door unit.

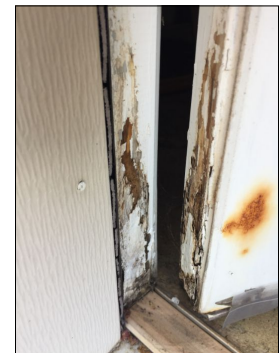
The wood core is rotted in the rear left basement exterior doors, replace.

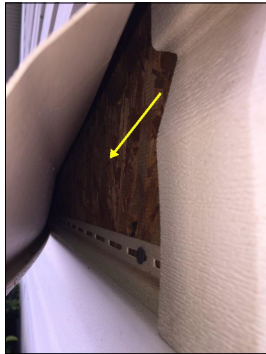
Be advised no moisture barrier was installed behind the vinyl siding as required on the exterior wall sheathing

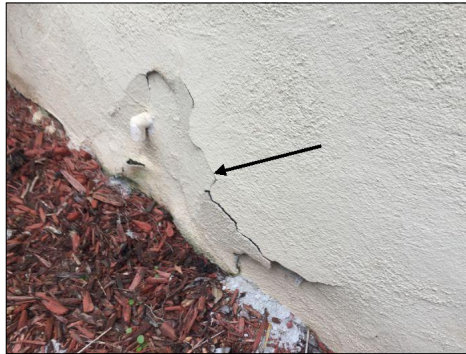
Call for further evaluation of the deteriorated stucco coating on the right side foundation wall for estimate to repair as necessary.

3.3. Call for further evaluation of the deteriorated stucco coating on the right side foundation wall for estimate to repair as necessary.

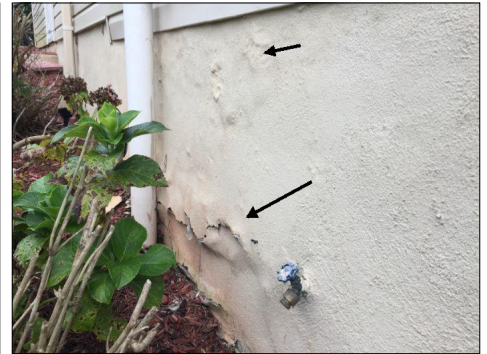
Replace all deteriorated stucco mix on the foundation walls as necessary.

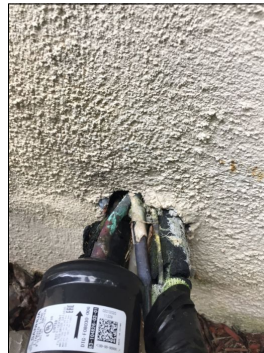
Seal the hole in the right side exterior wall, at the refrigerant pipe entry point behind the condensing units.

3.4. Seal the hole in the right side exterior wall, at the refrigerant pipe entry point behind the condensing units.

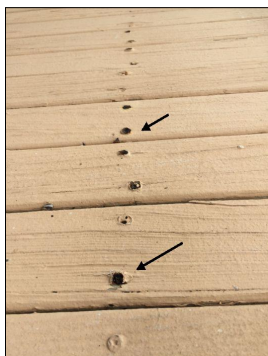
The rust damaged rear deck flooring screws should be replaced as necessary, using coated deck screws or stainless steel screws.

4.1. The rust damaged rear deck flooring screws should be replaced as necessary, using coated deck screws or stainless steel screws.

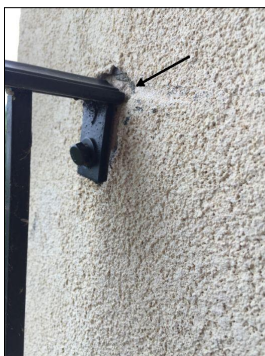
Several deck railing screws were loose.

4.2. Several deck railing screws/lag bolts were loose, have a qualified carpenter, ensure there is no water damage to the areas where the deck railings are lag bolted to the porch columns and thoroughly secure all loose lag bolts as necessary.

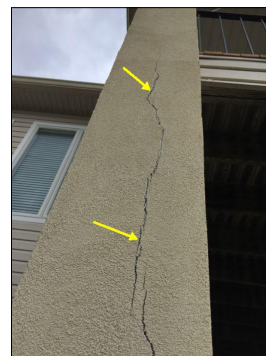
There were signs of water intrusion behind the stucco wrapped around the rear porch / deck area support columns where the hand rails are fastened, cracks were noted in the stucco

4.3. There were signs of water intrusion behind the stucco wrapped around the rear porch / deck area support columns where the hand rails are fastened, as well as where the band joist is fastened to the columns / posts, cracks were noted in the stucco, call for further evaluation by a stucco contractor, to ensure no water damage has occurred to the columns behind the stucco.

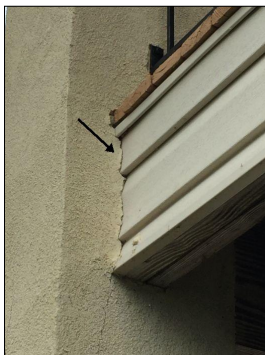
Signs of water intrusion behind the stucco where the deck bands are fastened to the posts.

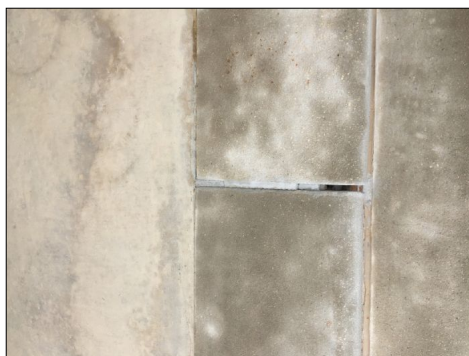
Point tuck the missing mortar on the front porch steps.

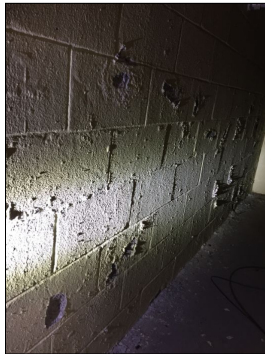
1.1. Spalling noted in the concrete block foundation wall across the front basement foundation wall which appears to be the result of ground water pressure against the exterior side of the block wall, resulting in heavy efflorescence or possibly Alkali - Silica reaction if the hollow block cells were filled with cement during construction, spalling weakens the structural integrity of the concrete block wall and increases the likelihood of water intrusion through porous areas of the wall, contact a moisture control specialist for options to seal / reinforce the wall, such as carbon fiber reinforcement etc. and the foundation wall may require water proofing on the exterior side of the basement.

Spalling noted in the concrete block foundation wall across the front basement foundation wall which appears to be the result of ground water pressure against the exterior side of the block wall.

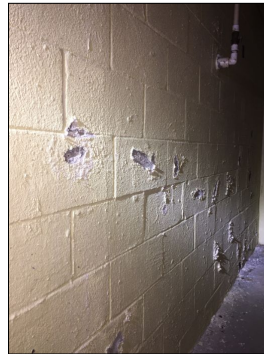
Spalling concrete block foundation wall across the front of the basement

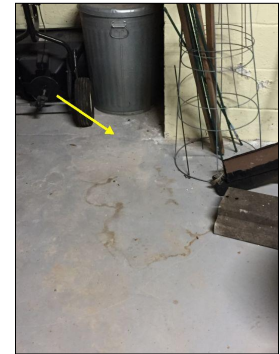
Various water stains were noted on the basement floor across the base of the front foundation wall, from apparent periodic water seepage.

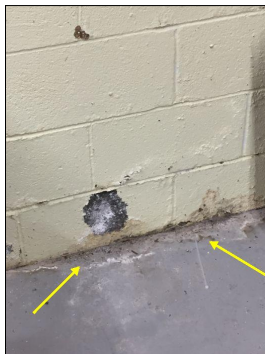
Signs of periodic water intrusion at the front, right and left side basement foundation walls.

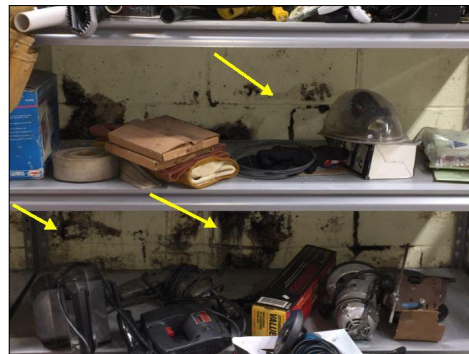
Water stains and mildew / mold growth noted on the right side basement wall from water seepage through the concrete block wall, call for further evaluation for remediation, by a basement moisture mitigation contractor.

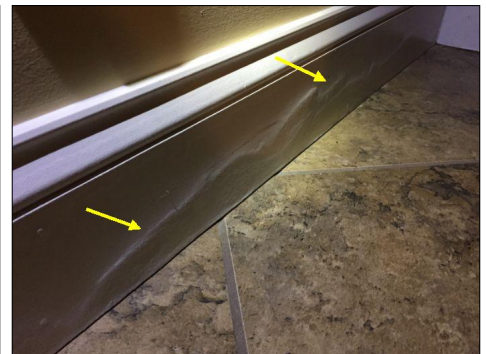
Minor water damage noted to the baseboards in the front left basement bedroom wall base, from apparent periodic water intrusion, call for evaluation of the left basement wall for remediation.

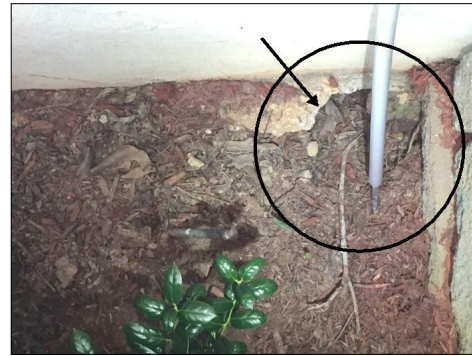
There were signs of a hole in the left side basement foundation wall, seal the hole in the wall and back fill the recessed area of soil at the front left corner below the retaining wall.

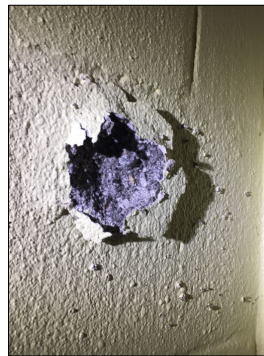
Concrete block deterioration noted across the front foundation wall

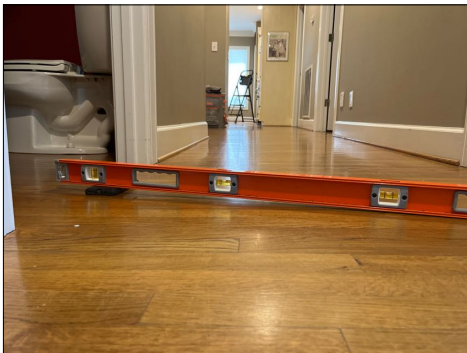
Deflection noted in the floor below the 1/2 bath / dining room wall area

3.1. The cut, improperly reinforced floor joist as well as the single strength TGI floor joists under the powder room / .5 bath area, should be reinforced by adding several additional full length 2x12" floor joists bearing on both ends or vertical support, where deflection was noted in the floor below the 1/2 bath area walls, which are carrying some level of roof load.

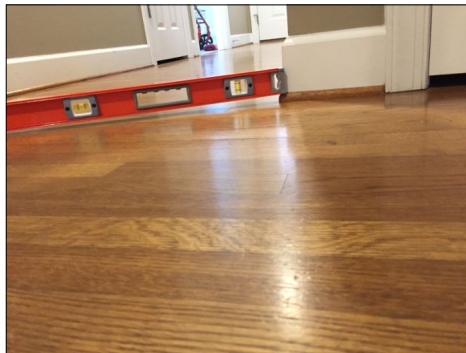
Deflection noted in the floor which slopes downward from the basement stairway landing to the hall closet/half bath wall area.

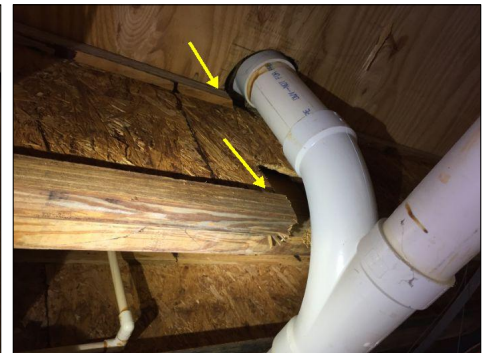
The top and bottom cords of the TGI floor joist were cut under the 1/2 bath, which has been inadequately reinforced.

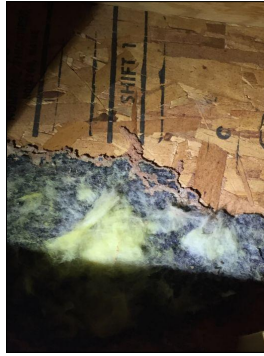
Signs of Termite activity were noted on the Band or Rim joist at the front right basement area under the dining room exterior wall, call for further evaluation by a pest control company.

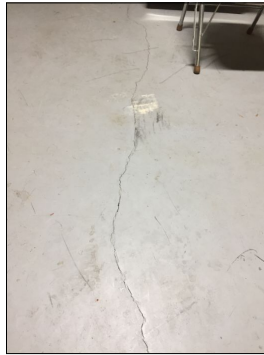
Several minor shrinkage cracks were noted in the basement slab.

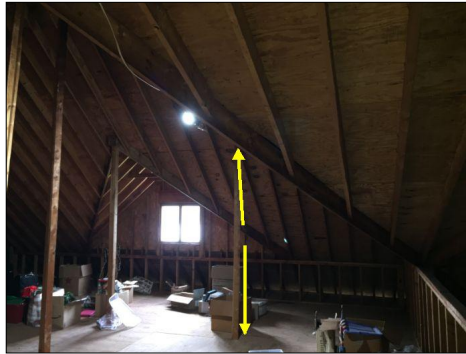
Install a support post under the rear right valley rafter, post should bear on a wall

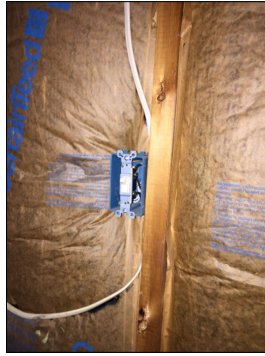
Cover the open electric switch box in the attic

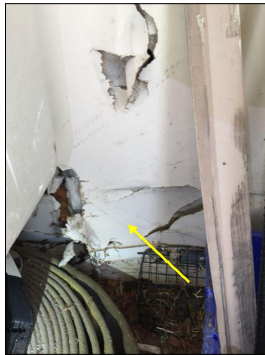
Impact damage noted to the sheet rock at the front garage wall.

2.1. Call for all of the damaged sheet rock to be replaced on the front garage exterior wall, have the wall evaluated by a pest control company where Termite damaged sheet rock and missing base board was noted.

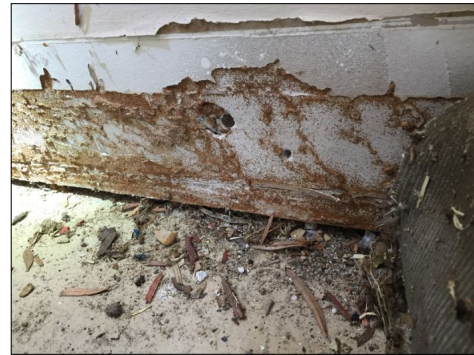
The sheet rock at the front garage wall base is Termite damaged and the base board is missing

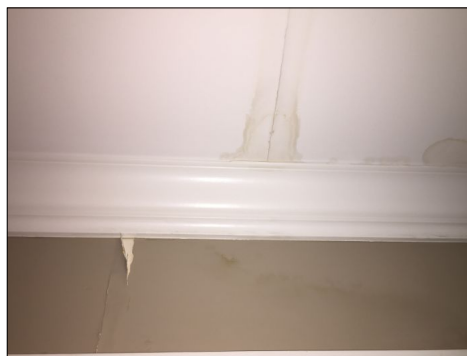
Water stains noted on the basement ceiling below the ice maker area, from an apparent past leak, repair the damage and monitor.

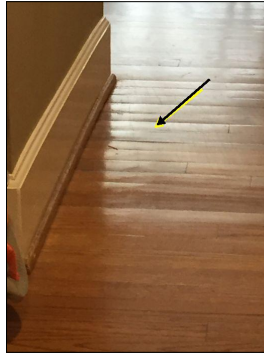
small area of cupping noted in the hardwood flooring to the right of the refrigerator area from an apparent past leak.

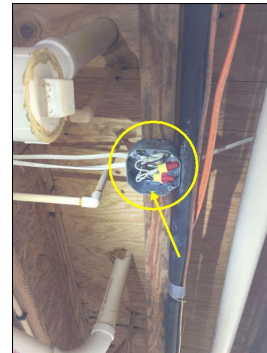
Cover all/any open electric junction boxes in the unfinished area of the basement.

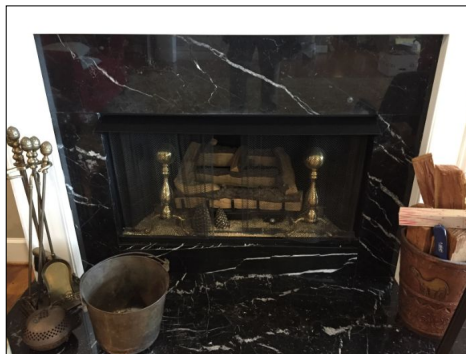
The gas logs would not light there seemed to be no gas pressure, call for further evaluation by the gas company.

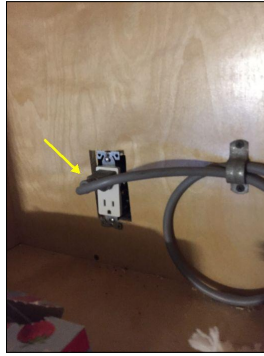
Replace the missing electric outlet cover above the basement kitchen microwave.

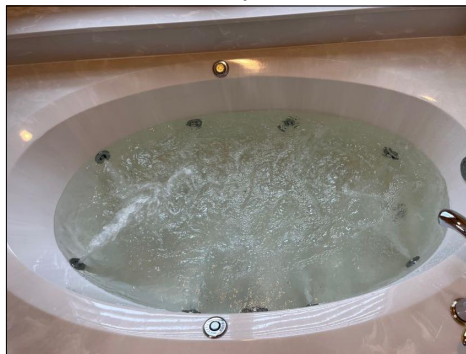
There was no access to the jetted tub motor area as required.

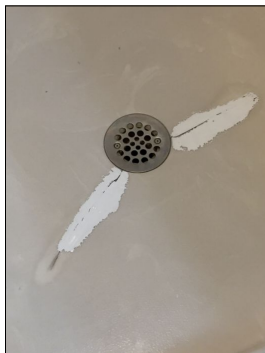
The cultured marble floor in the master shower is cracked in 2 areas.

- 5.1. The cultured marble floor is cracked in the master shower and should be replaced

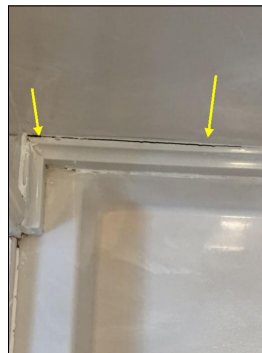
Thoroughly seal / caulk all gaps & joints in the master shower cultured marble.

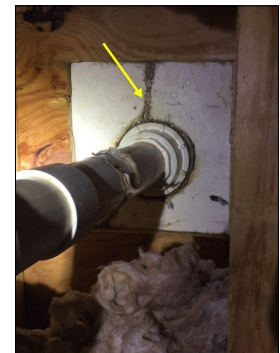
The master shower floor cultured marble is cracked all the way through the marble sheet and should be replaced.

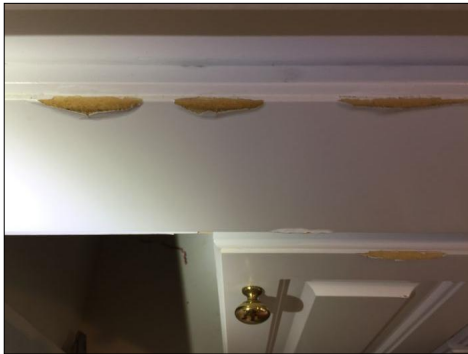
Replace the water damaged vanity doors & drawers in the master bathroom.

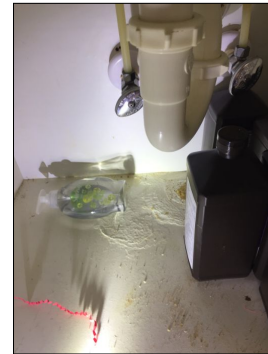
Repair the water damaged bottom shelf in the left vanity of the master bathroom from an apparent past leak.

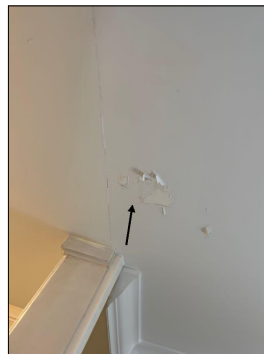
Minor water damage unit to the master bath ceiling

10.2. Minor water damage unit to the master bath ceiling, have the roof above checked for possible leaks.

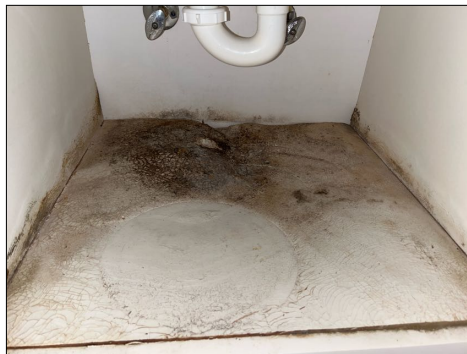
Water, damaged vanity shelf, rear right bathroom

- 3.2. [Repair/replaced the water damaged bottom shelf in the right rear bathroom vanity](#)

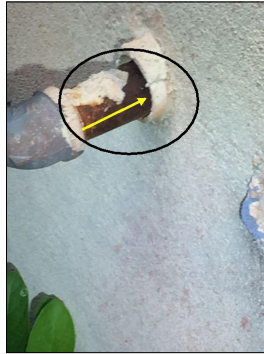
Have the gas company evaluate the rust damaged main gas entrance pipe behind the gas meter for the need of replacement.

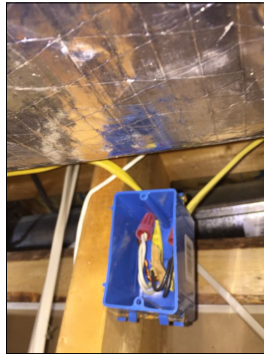
Cover any open electric junction boxes in the unfinished area of the basement
