January 3, 2024

Re: **Hazardous Materials Inspection Report**  
*Former Commercial / Commercial Retail Facility*  
1850 Church Street; Appomattox, Virginia 24522  
**Hurt & Proffitt Project Number: 20232156**

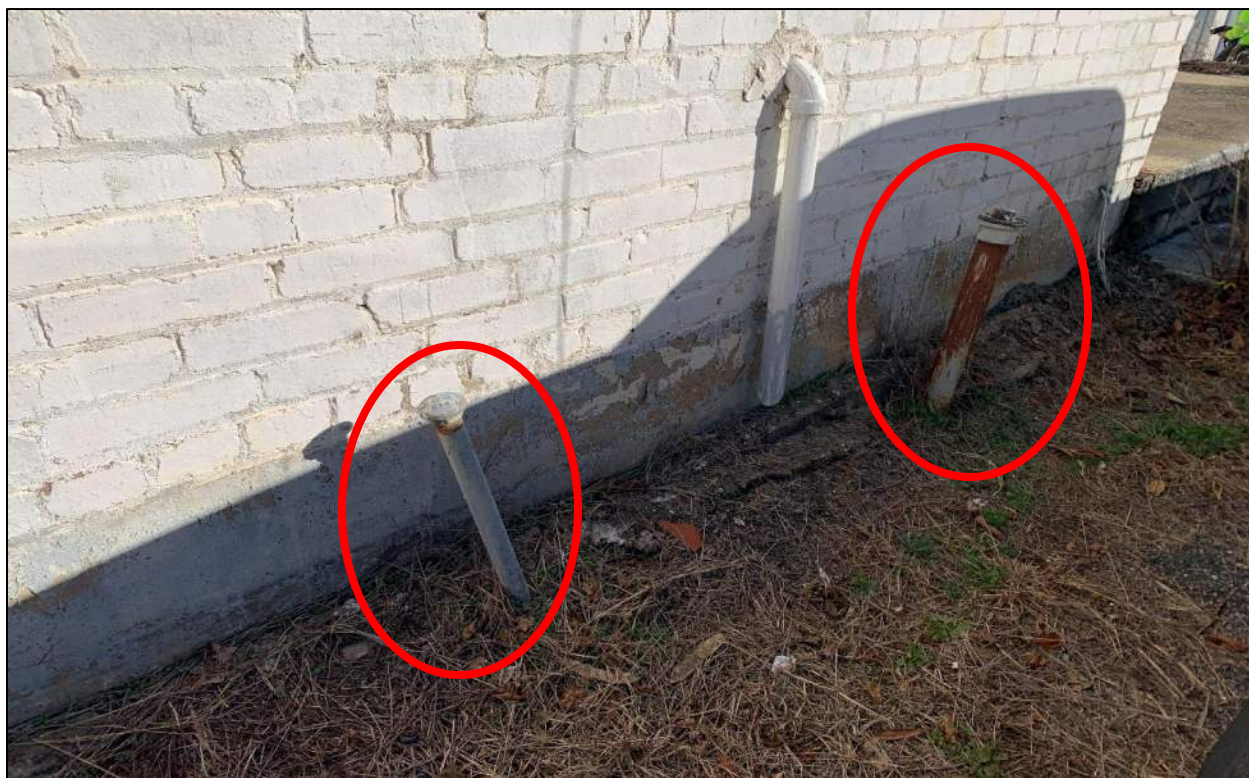
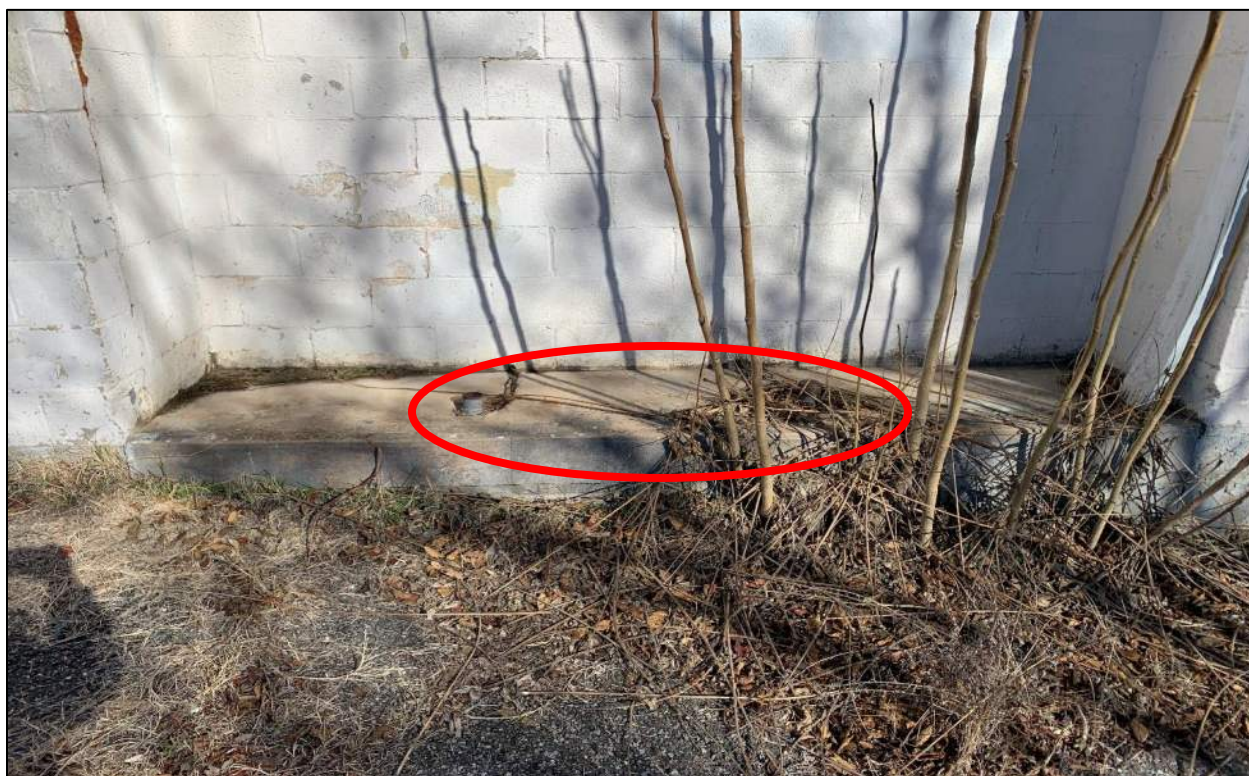
Hurt & Proffitt personnel observed a single, five hundred (500) gallon capacity steel aboveground storage tank (AST) system, presumably containing Fuel Oil, along the northern exterior wall of the *Former Gallery*. During site reconnaissance activities, neither visual nor olfactory evidence of incidental petroleum-based product release(s) were observed in association with the aboveground storage tank (AST) system.

In addition, along the exterior wall of the garage area, Hurt & Proffitt personnel observed evidence, i.e.: fill pipe, vent piping, presumably associated with two (2) underground storage tank (UST) systems. Photographs, which illustrate the underground storage tank (UST) system appurtenances, are located upon the following page:

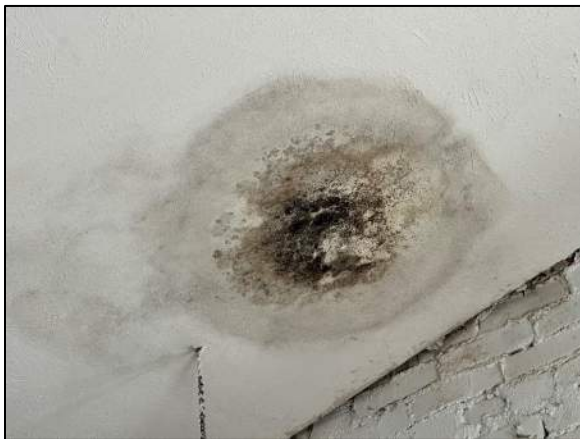
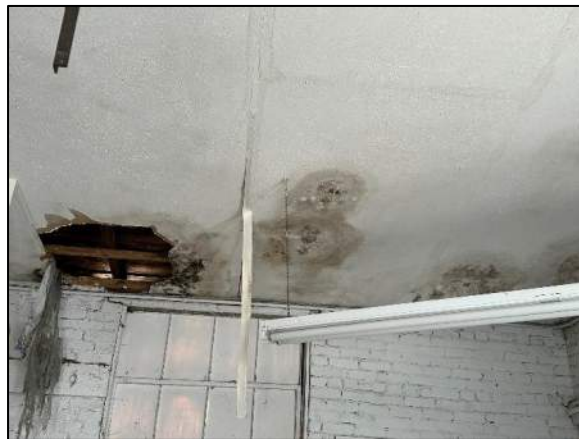
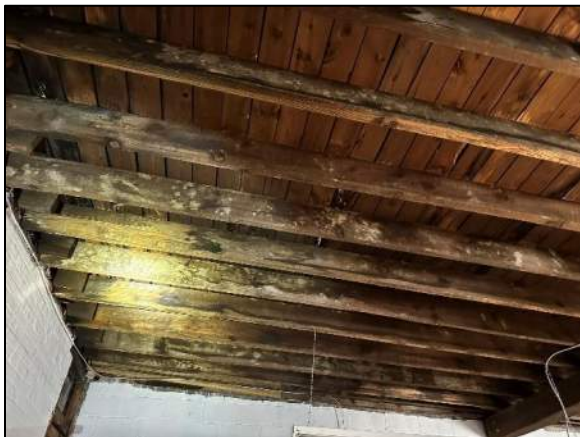
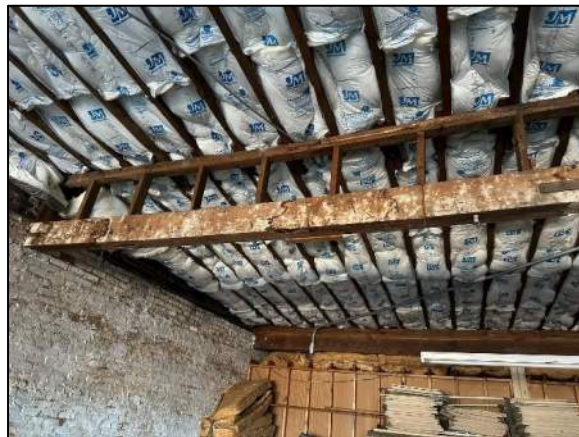
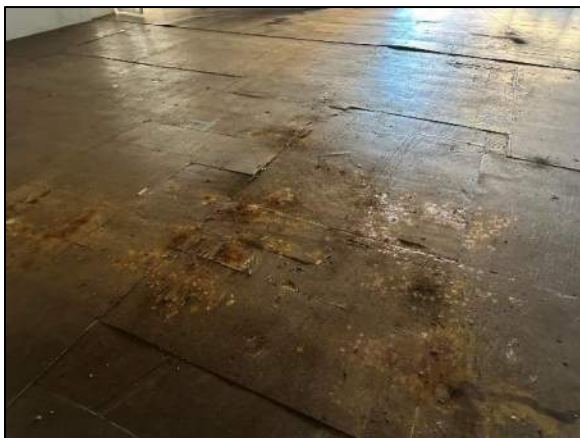
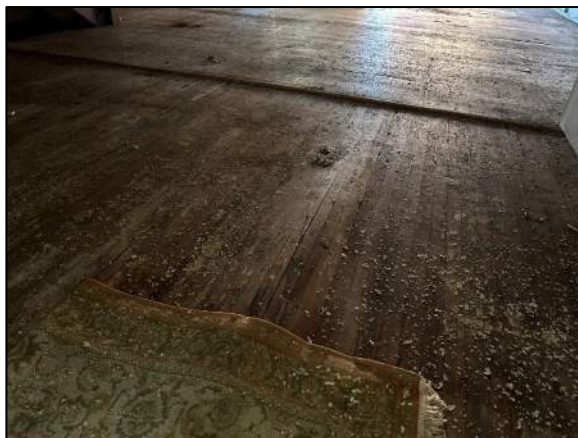
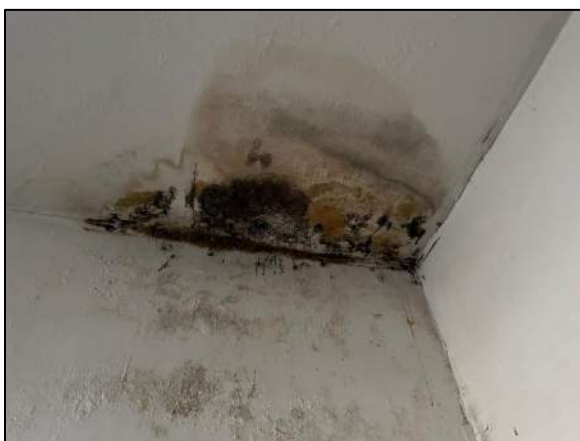
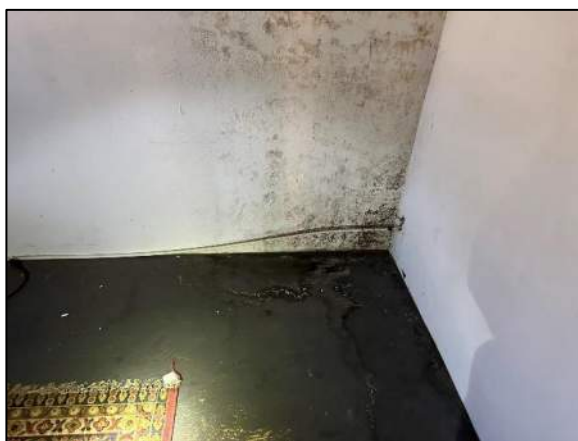
Throughout the interior of the *Former Commercial / Commercial Retail Facility*, Hurt & Proffitt personnel observed water stained/damaged building components, buckled wooden flooring systems, and visual water intrusion. Based upon observations made during the completion of visual assessment activities, it is Hurt & Proffitt's professional opinion that the above referenced damage, etc. is the result of water intrusion, moisture wicking from the earthen crawlspace, high indoor humidity, and the structure being unconditioned.

Based upon the findings of the visual mold / water intrusion assessment, Hurt & Proffitt recommends a comprehensive full facility mold and moisture assessment be conducted prior to proposed renovation activities OR human occupancy.

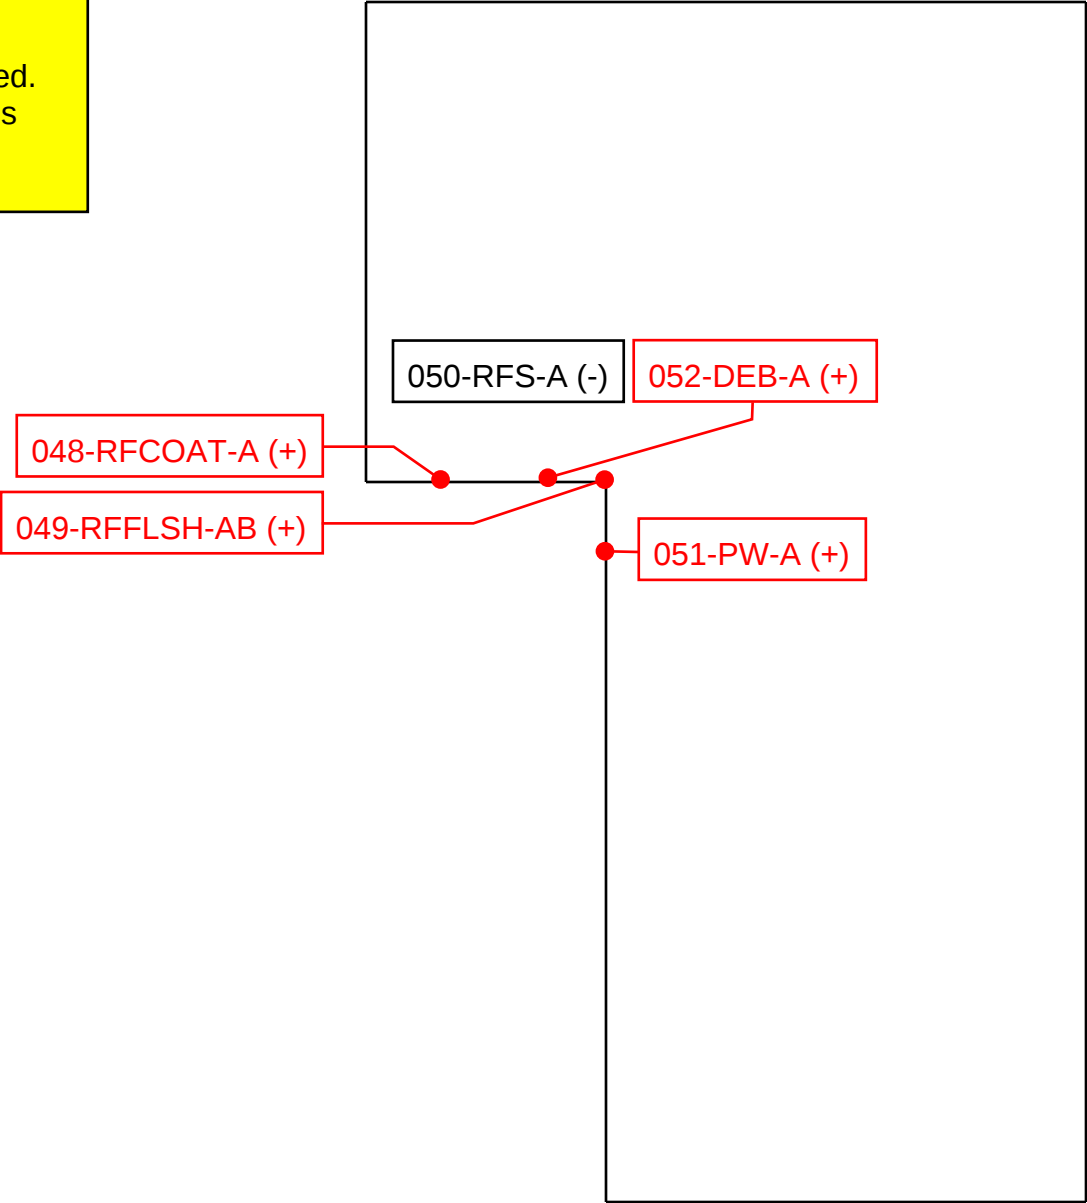
Garage, Roofing System

**Note:**  
Due to structural deficiencies, the entirety of the garage roofing system could not be safely assessed. Therefore, additional asbestos-containing materials may exist, either undetected or inaccessible, upon other areas of the roofing system.

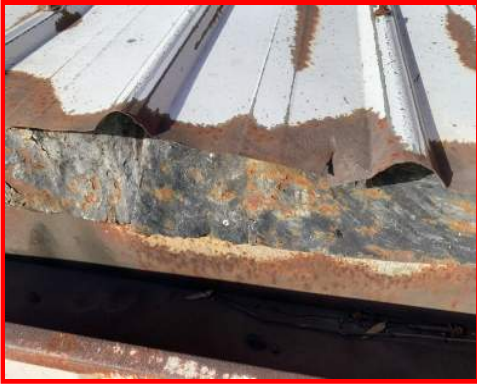
| Sample No | Material Description | Location | Estimated Quantity | Lab Results (% Asbestos) | Condition/ Friable Y/N |
|---|---|---|---|---|---|
| 048-RFCOAT-A | BLACK ROOF COATING | GARAGE, ROOFING SYSTEM, UNDERLYING NEWER METAL ROOFING SYSTEM | +/- 3,300 SF | 6% CHRYSOTILE | FAIR / N |

048-RFCOAT-A (+)  
Asbestos-Containing Black  
Roof Coating (Underlying  
Newer Metal Roofing System)

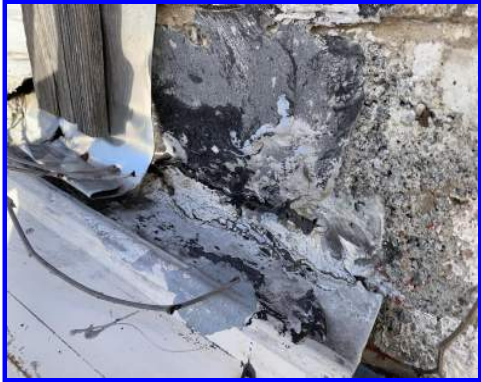
| Sample No | Material Description | Location | Estimated Quantity | Lab Results (% Asbestos) | Condition/ Friable Y/N |
|---|---|---|---|---|---|
| 049-RFFLSH-AB | BLACK ROOF FLASHING | GARAGE, ROOFING SYSTEM | +/- 10 SF | 10% CHRYSOTILE | FAIR / N |

049-RFFLSH-AB (+)  
Asbestos-Containing  
Black Roof Flashing

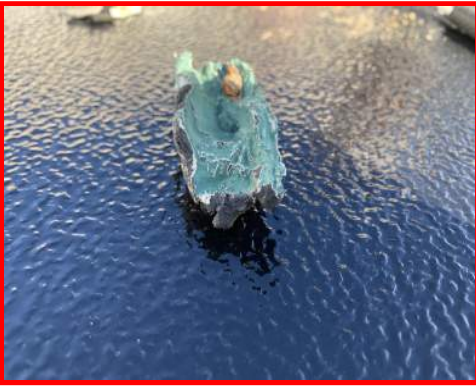
| Sample No | Material Description | Location | Estimated Quantity | Lab Results (% Asbestos) | Condition/ Friable Y/N |
|---|---|---|---|---|---|
| 052-DEB-A | BLACK ROOFING SYSTEM DEBRIS | GARAGE, ROOFING SYSTEM | +/- 15 SF <sup>1</sup> | 3% CHRYSOTILE | FAIR / N |

052-DEB-A (+)  
Asbestos-Containing Black  
Roofing System Debris

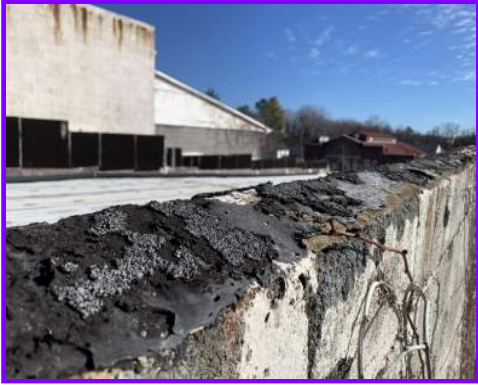
| Sample No | Material Description | Location | Estimated Quantity | Lab Results (% Asbestos) | Condition/ Friable Y/N |
|---|---|---|---|---|---|
| 051-PW-A | BLACK PARAPET WALL SEALANT | GARAGE, PARAPET WALL | +/- 100 SF | 5% CHRYSOTILE | FAIR / N |

051-PW-A (+)  
Asbestos-Containing Black  
Parapet Wall Sealant
