Reference Property: Lot 248, 1909 E. Beech Road.

Spring Grove Farm HOA Architectural Compliance Review

Date: 6 April 2017

Spring Grove Farm Lot Number:	248	Street Address:	1909 E. Beech Road
-------------------------------	-----	-----------------	--------------------

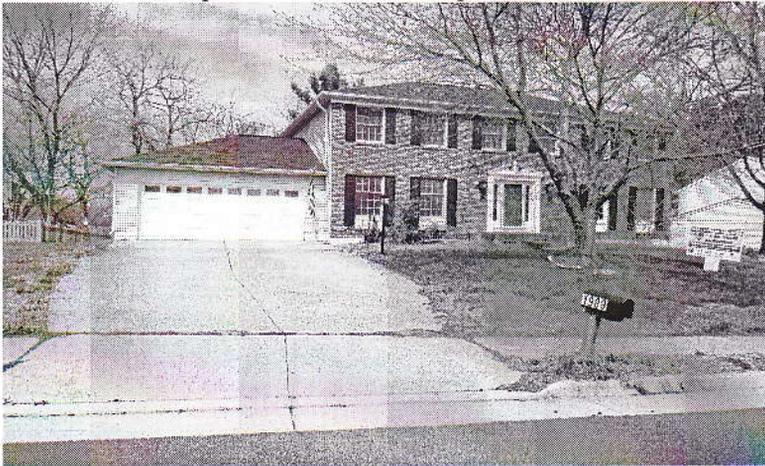
Photo: P4056041

Roof: Unsatisfactory. The roof has light gray, charcoal color asphalt shingles, and except for one noticeable missing shingle on the front of the garage, appears to be in otherwise acceptable condition. (Photos: P4056041, P4056050, P4056074, P4056094, P4056095, P4066115).

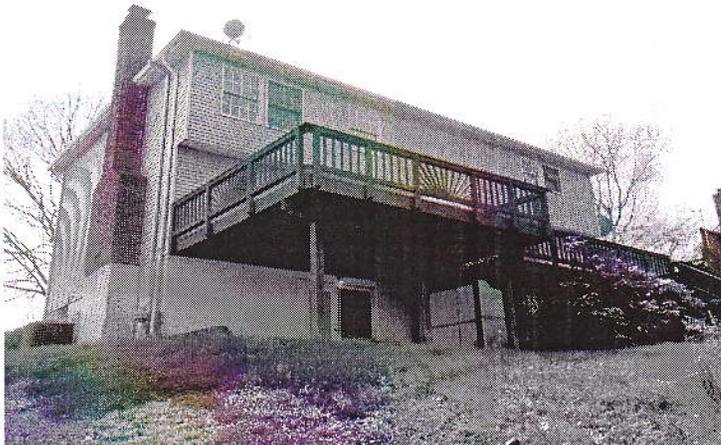
P4056059

Rear Walkout Basement – Unsatisfactory. – There is a ground level basement egress to the back yard via a walkout French style door leading to a concrete patio under the deck on the right side of the residence. The concrete patio is in need of pressure washing to remove staining and mold. (Photos: P4056059, P4056061, P4056102).

The deck surface is overall in need of surface refinishing and painting or restaining, as well as removal of trash and debris. The hot tub is also piled with debris and trash. (Photos: P4056059, P4056061, P4056062, P4056063, P4056064, P4056066, P4056068, P4056069, P4056073, P4056080, P4056081, P4056082, P4056083).

12. **Deck Repair.** Recommend removal of debris, pressure washing, and re-staining of deck surfaces, as well as repair or removal of debris laden hot tub. (Photos: P4056059, P4056061, P4056062, P4056063, P4056064, P4056066, P4056068, P4056069, P4056073, P4056080, P4056081, P4056082, P4056083).

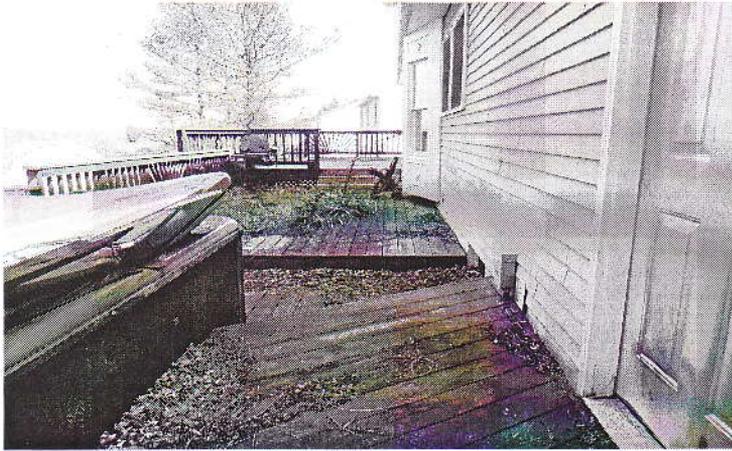
P4056081

Exterior siding: Unsatisfactory. Light crème in color. The siding on this residence appears to be the original aluminum siding, and while it does not appear to have any significant damage or missing panels, it does have multiple instances of mold in need of removal by power washing. (Photos: P4056074, P4056076, P4056078, P4056081, P4056082, P4056083, P4056098).

3. **Exterior Siding Mold Removal.** Recommend removal of mold growth from the multiple locations on the exterior siding. (Photos: P4056074, P4056076, P4056078, P4056081, P4056082, P4056083, P4056098).

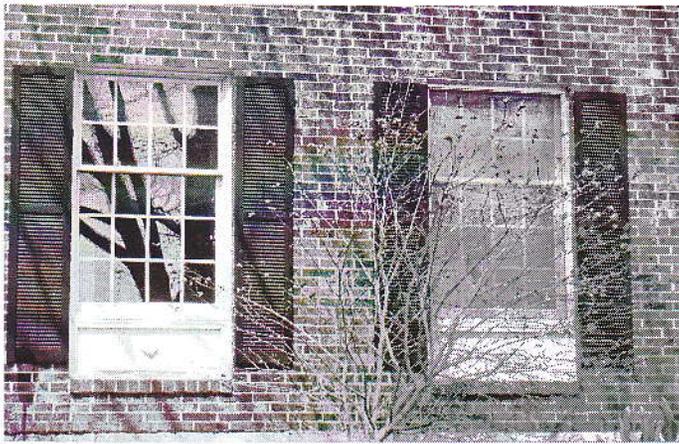
P4056046

Windows: Unsatisfactory. The windows are equipped with lattice panels, and may have been replaced at some juncture. The front of the residence has one missing screen and one severely damaged screen on the right side from the entrance door. (Photos: P4056043, P4056045, P4056046). The rear of the residence has multiple missing screens. (Photos: P4056049, P4056068, P4056069, P4056073).

Trim: Unsatisfactory. The trim is white throughout but has visible multiple instances of rotting wood, and peeling paint that is in need of repair/replacement. (Photos: P4056045, P4056046, P4056068, P4056104, P4056105).

2. **Missing & torn window screens.** Recommend installation of missing window screens on the front and rear of the residence, and the repair of a front torn

window screen (RF lower). (Photos: P4056043, P4056045, P4056046, P4056049, P4056068, P4056069, P4056073).

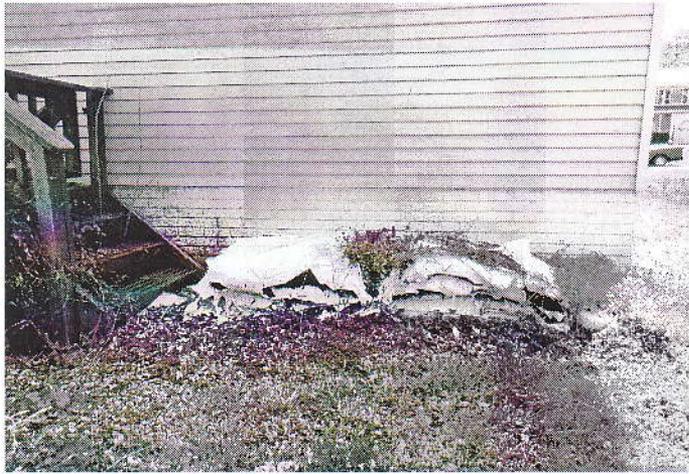
P4056077

Visible Foundation to finished siding surface: Unsatisfactory. The perimeter of the visible foundation to siding areas are in need of weed and vine removal, mold removal, and repainting to rectify ground settling and unsatisfactorily maintained painted visible above ground concrete foundation areas. (Photos: P4056045, P4056047, P4056048, P4056050, P4056052, P4056055, P4056056, P4056061, P4056063, P4056073, P4056077, P4056079).

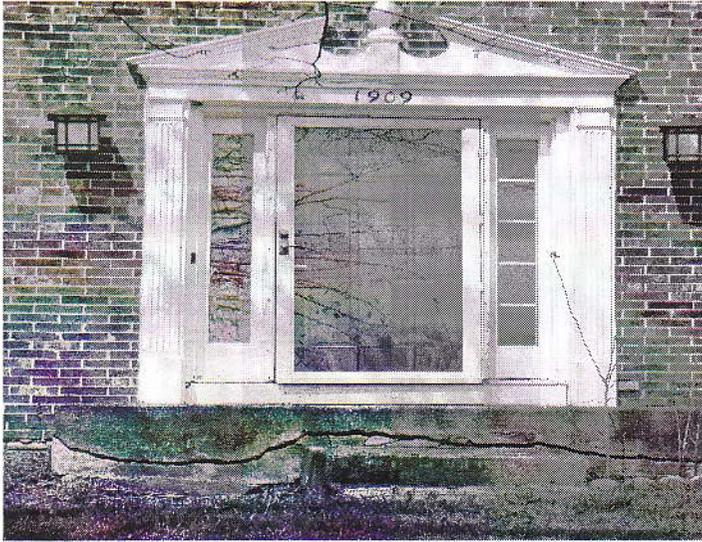
P4056044

Porch/Railing: Front – Unsatisfactory. The front porch is a concrete entry pad with one step and without railings. The concrete base of the porch pad and step shows evidence of significant ground settling, and a prior repair. The concrete porch and step will either need to be replaced or again repaired. (Photos: P4056044, P4056047, P4056090.)

4. **Front Porch & Railing.** Recommend repair of broken concrete steps/porch, due to ground settlement. The front porch and step show visible settling damage that has damaged the front concrete steps and porch. (Photos: P4056044, P4056047, P4056090.)

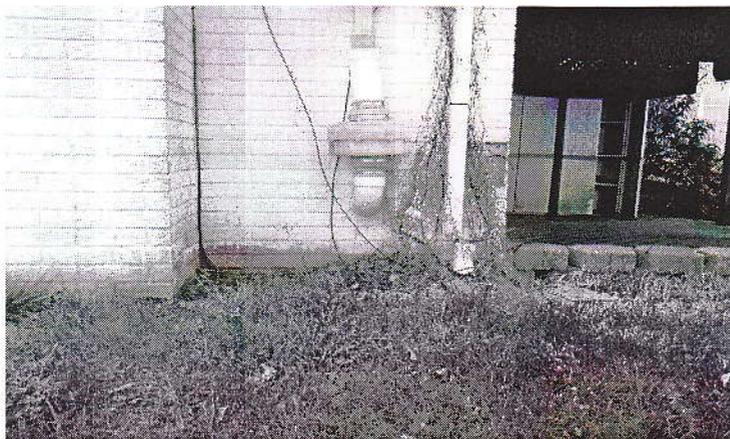
P4056056

Rainspouts/Downspouts: Unsatisfactory. The gutters and downspouts have missing or separated downspout pieces and are in need of repair. The horizontal gutters are heavily covered in mold and in need of power washing. (Photos: P4056041, P4056042, P4056052, P4056053, P4056055, P4056056, P4056079, P4056091, P4056097).

6. **Gutters.** Recommend repair of missing and damaged gutter and downspout sections, removal of vine infiltration, and mold removal from gutters. (Photos:

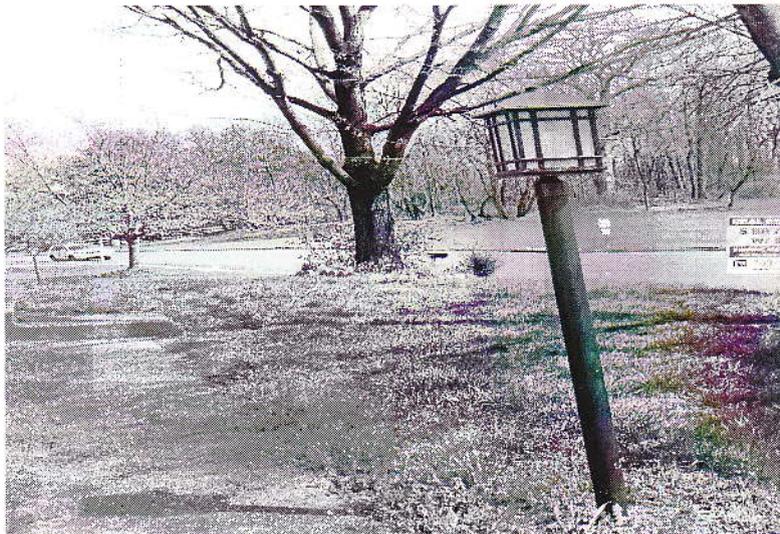
P4056089

Sidewalk: Satisfactory. The entry sidewalk is of concrete construction and given the age of the concrete sidewalk, is in useable condition. (Photo: P4056089, P4056090). There is evidence of lack of weed removal from the walkway pad joints and edges that is in need of correction (see comments in landscaping below).

9. **Landscaping.** Recommend correction of landscaping deficiencies:

- Lawn condition deficiencies, Tree concrete edging blocks repair/replacement/removal, weed removal, debris removal, edging of lawn and driveway surfaces including weed removal from concrete pad seams, repair or removal of wooden flower boxes, removal of rotting yard care supplies. (Photos: P4056040, P4056041, P4056043, P4056045, P4056047, P4056048, P4056049, P4056051, P4056052, P4056057, P4056058, P4056059, P4056060, P4056064, P4056068, P4056070, P4056071, P4056072, P4056073, P4056074, P4056077, P4056079, P4056092, 4056098, P4056099, P4056101).

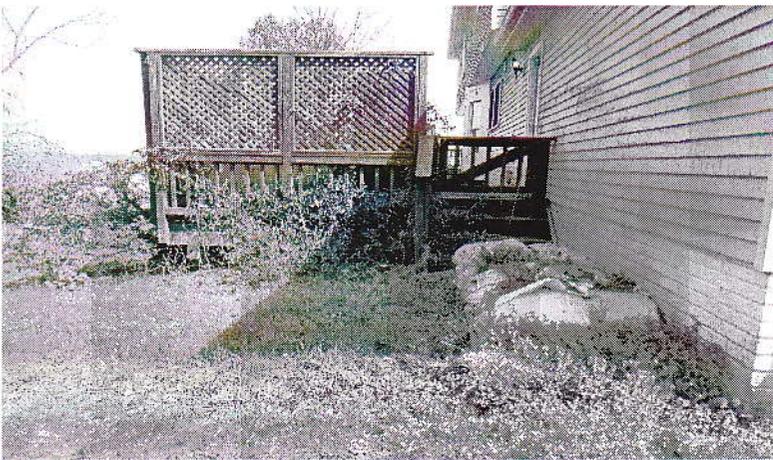
P4056098

The landscaping in the backyard area of the residence is also unsatisfactorily maintained, with little actual grass, overgrown weeds, debris in flower beds, un-maintained flower or garden boxes with debris and weeds, and bagged bulk yard supplies stored in open view. (Photos: P4056057, P4056058, P4056059, P4056060, P4056064, P4056068, P4056070, P4056071, P4056072, P4056073, P4056074, P4056077, P4056079, P4056098, P4056099, P4056101).

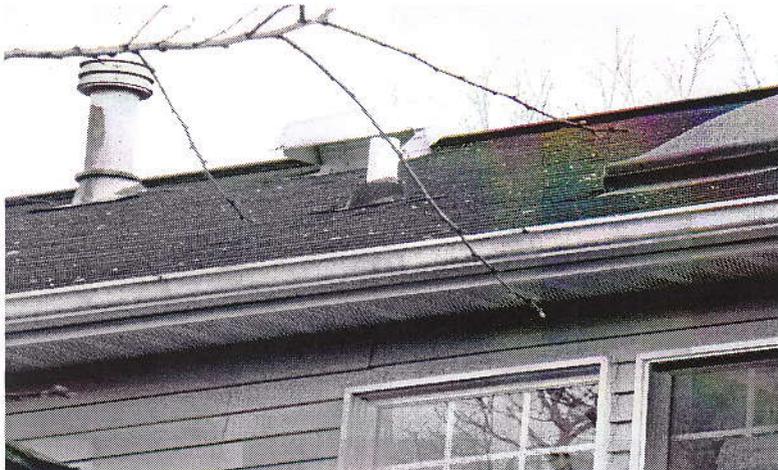
P4066117

Roof Metal Vent Stack: Unsatisfactory. The vent stack shows visible rusting on the back yard side of the pipe. Re-painting with high temperature paint is needed to arrest the exterior pipe rust. (Photos: P4066115, P4066117).

10. **Vent Stack Rust Removal.** Recommend repainting of metal roof furnace vent stack to remove visible rust with high temperature resistant paint.

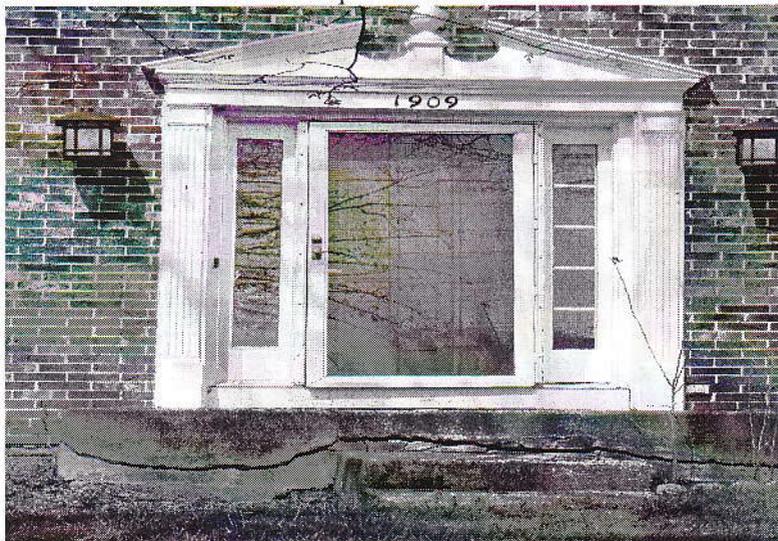
P4056044

Exterior Porch Lamps: Unsatisfactory. The porch lamps were replaced in 2014 with non-compliant fixtures, and for which two violation letters are on file. The fixtures on the pole lamp and front porch will need to be replaced with compliant fixtures. (Photos: P4056042, P4056043, P4056047).

11. **Front Porch & Pole Lamp Fixtures.** Recommend replacement with compliant fixtures. The existing fixtures were installed circa 2014 and there are two violation letters on file instructing the owner to replace them with compliant fixtures. (Photos: P4056044, P4056089).

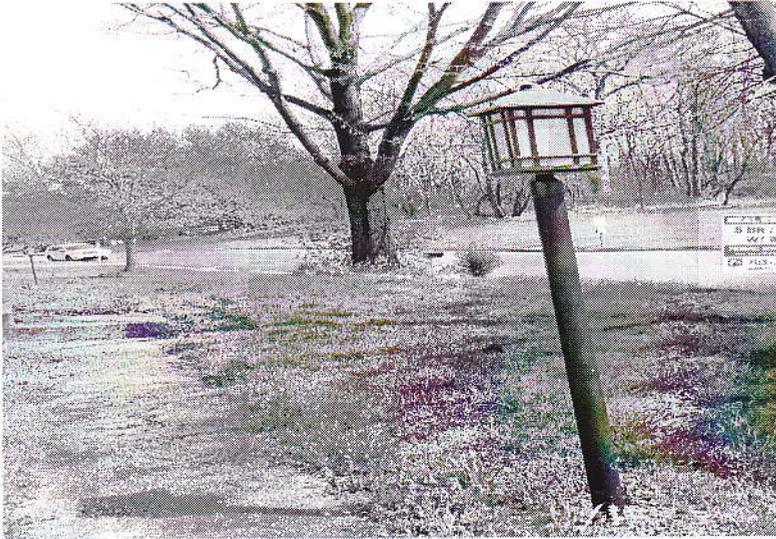
P4056089

Pole Lamp: Unsatisfactory. The porch lamps were replaced in 2014 with non-compliant fixtures, and for which two violation letters are on file. The fixtures on the pole lamp and front porch will need to be replaced with compliant fixtures. (Photos: P4056042, P4056043, P4056047).

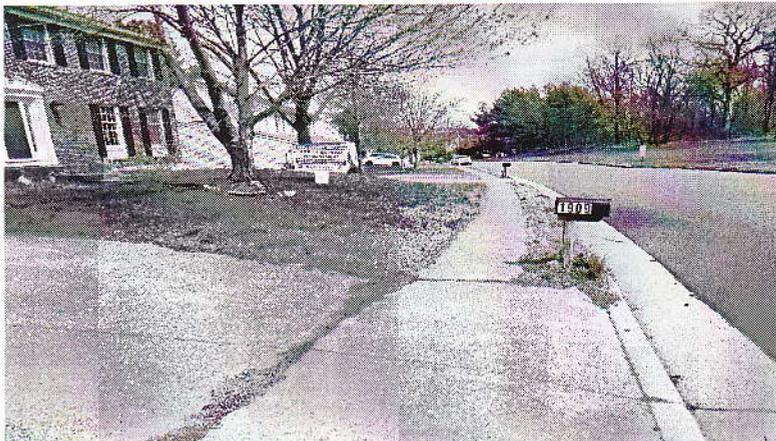
P4056040

Mailbox: Unsatisfactory. The mailbox is a black metal box mounted on a wooden support pole. The pole has been shortened and is not USPS compliant, and in need of replacement. (Photo: P4056040).

12. **Mailbox Replacement.** Recommend replacement of mailbox with minimum of 36 inch above ground wooden pole and metal box.
