**I Spy Inspections**  
7550 Don Bruce Ct  
Christiana TN 37037  
615-828-2617  
ispyinspections@mail.com

**Inspection reference: 2427**

# **Confidential Inspection Report**

**4021 Old Nashville Hwy**  
**Murfreesboro TN 37129**

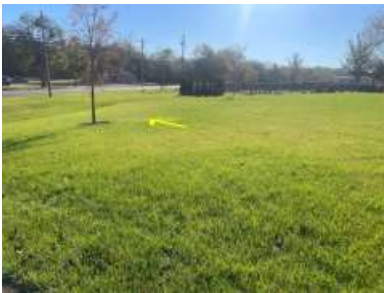
**Site Drainage:**

Functional - The lot appears to have adequate drainage to prevent water from ponding.

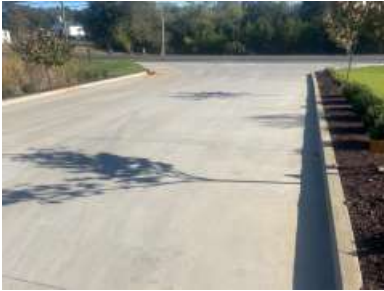
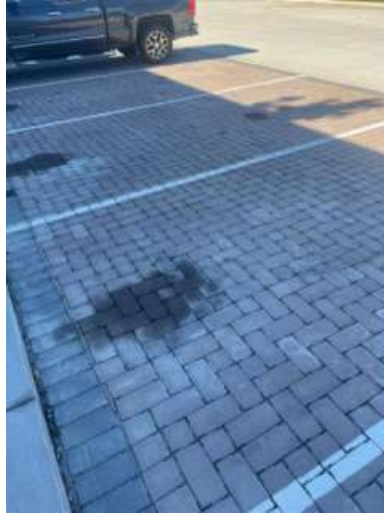
**Driveway Condition:**

The driveway surface material is in functional condition with only normal deterioration noted.

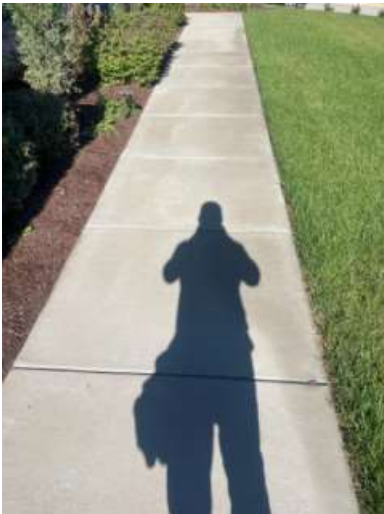
**Walkway Condition:**  
The walkway surface material is in functional condition with only normal deterioration noted.

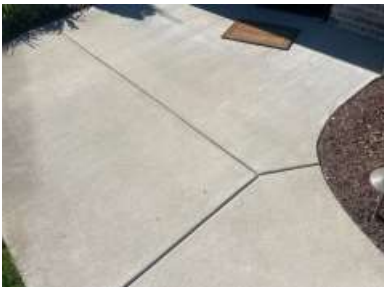
**Entryway Stoop:**  
The entryway stoop is in functional condition.

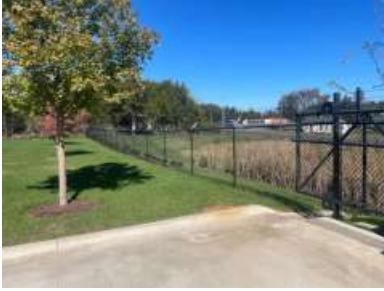
**Fence Materials Condition:**

Good - The materials used in the fencing are in as good or better condition than expected.

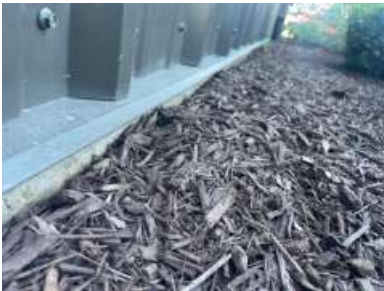
**Visible Portions of Exterior Foundation Walls:**

The exposed portions of the perimeter foundation walls appear to be adequate.

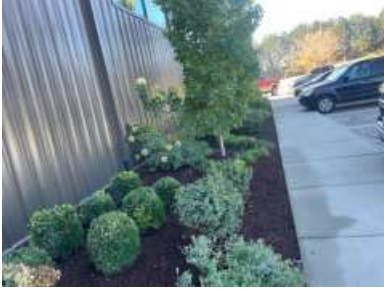
**Perimeter Foundation Drainage Surface:**

The drainage around the perimeter of the foundation appears to have adequate ground slope to remove run-off water from the immediate area.

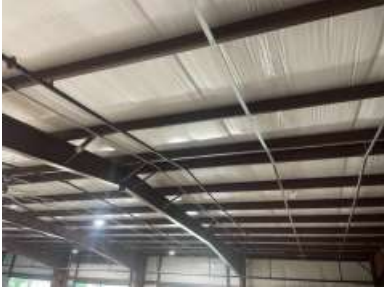
**Roof Framing:**

The rafters and steel beam system appears to be in functional condition.

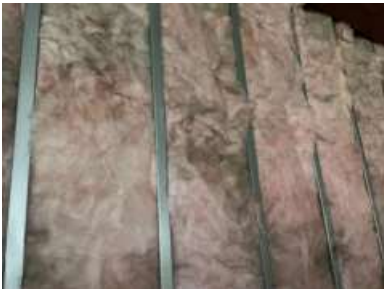
**Insulation Noted:**

The attic insulation appears to be adequate and properly installed.

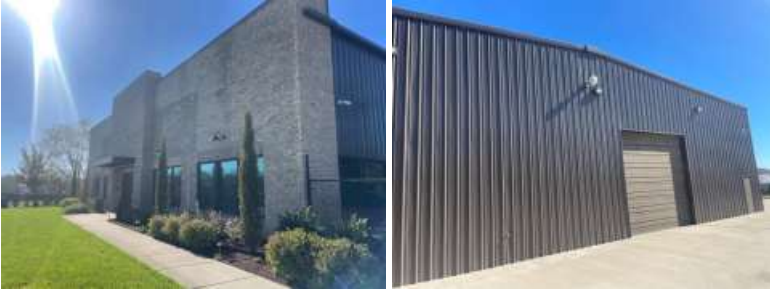
**Siding Condition:**

The siding is in serviceable condition.

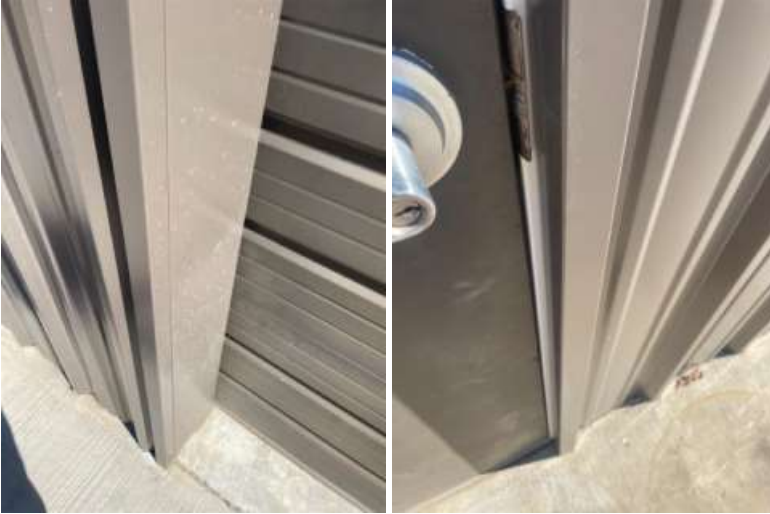
**Trim Condition:**

The trim is intact and functional.

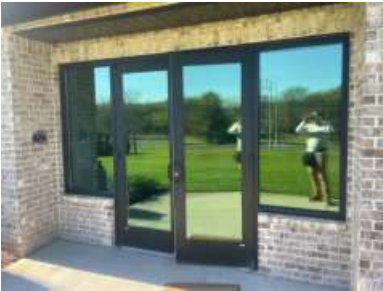
**Outside Entry Doors:**

The outside entry door(s) is functional as noted from the exterior.

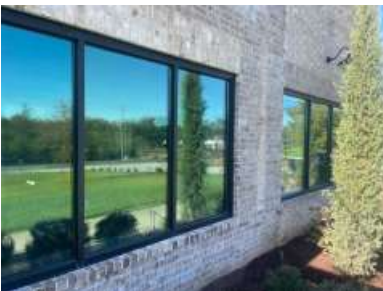
**Window Condition:**

The window framing and glass are functional.

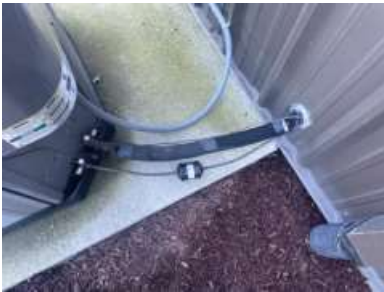
**Insulation Wrap on the Suction Line:**

Insulation wrap is functional, without significant damage.

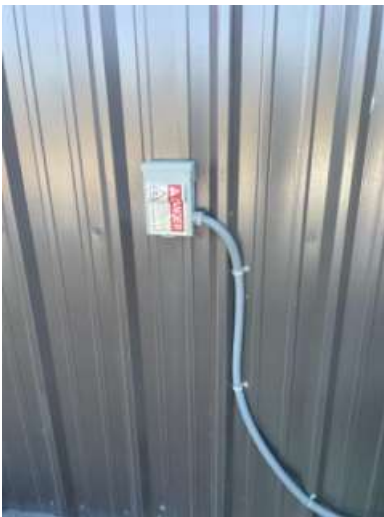
**Service Disconnect:**

The installed service disconnect is located within sight of the condensing coil cabinet and not more than 50 feet from the unit.

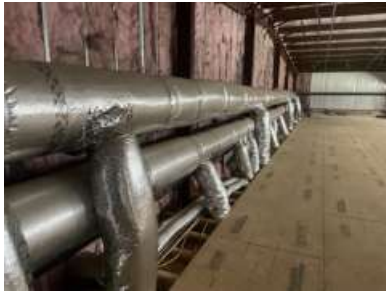
**Ducts Condition:**

The ductwork appears to be properly installed and supported.

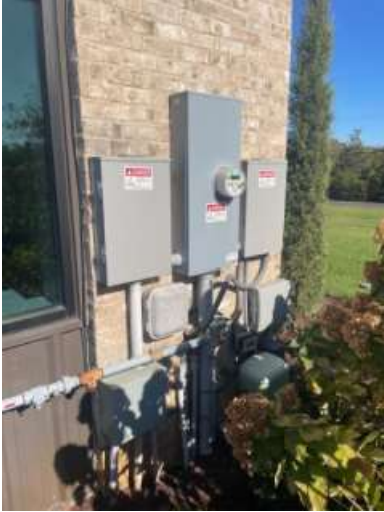
**Type & Condition:**

Underground, 120/240 Volt, Circuit breakers, Appears serviceable.

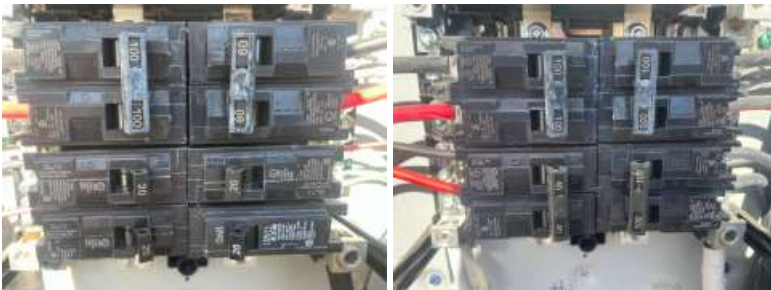
**Breaker/Fuse to Wire Compatibility:**

The breakers/fuses in the main power panel appear to be appropriately matched to the circuit wire gauge.

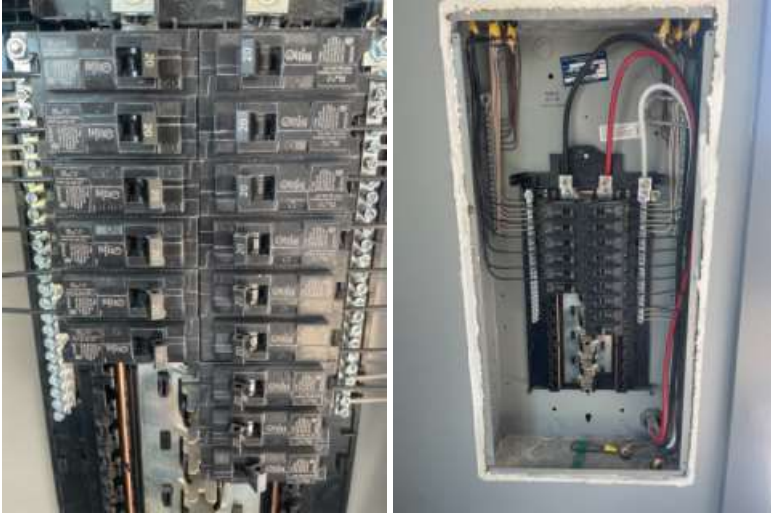
**Subpanels- Office:**

This subpanel is wired correctly and functional. The electrical panel cover is correctly installed protecting the wiring.

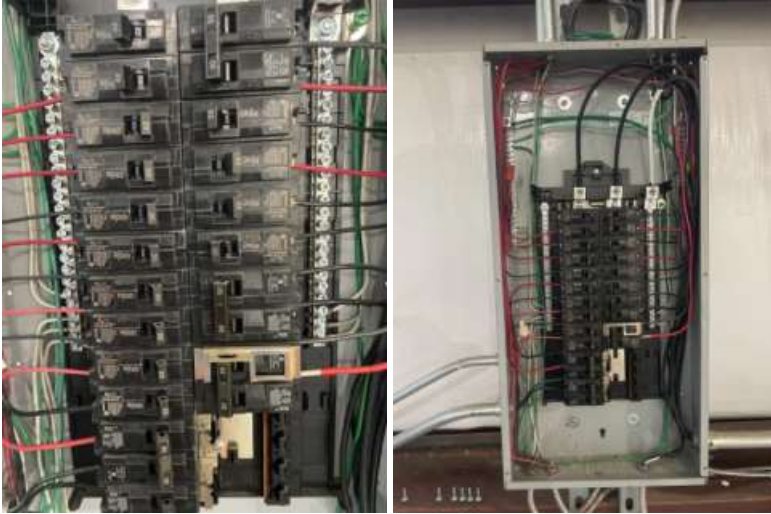
**Subpanels- Garage 2:**

This subpanel is wired correctly and functional. The electrical panel cover is correctly installed protecting the wiring.

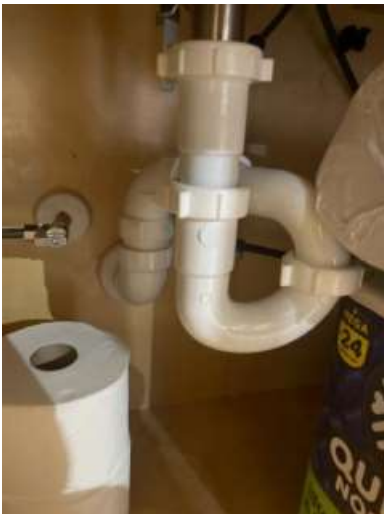
**Waste Piping Condition:**

The visible plumbing waste piping appears functional.

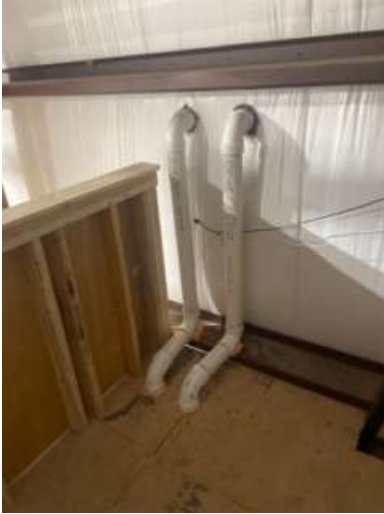
**Vent Piping Condition:**

The visible plumbing vent piping appears functional.

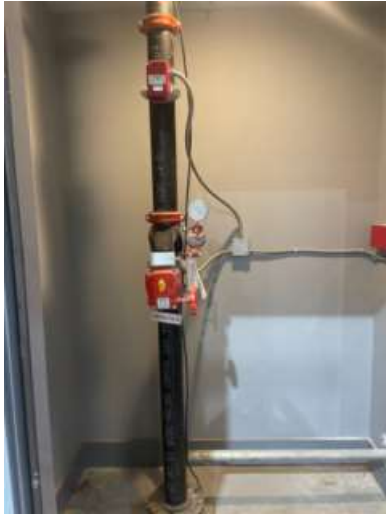
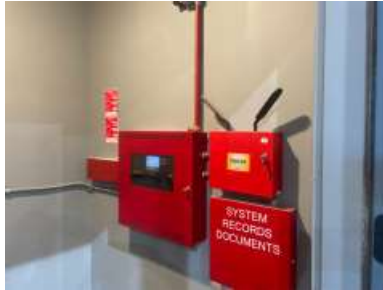
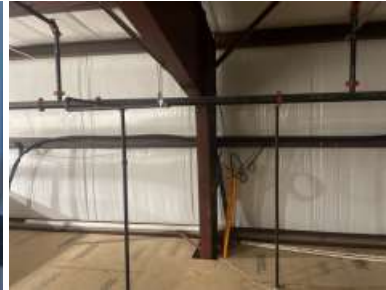
**Fire Sprinkler Installed:**

Yes - There is a fire sprinkler system installed. It is recommended that it be checked by a professional with appropriate experience. The type system installed is referred to as a Wet Pipe System.

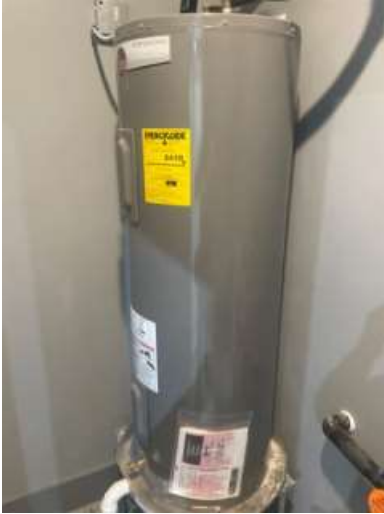
**Exposed Water Heater Condition:**

Good - Rust free and clean. Should provide years of service.

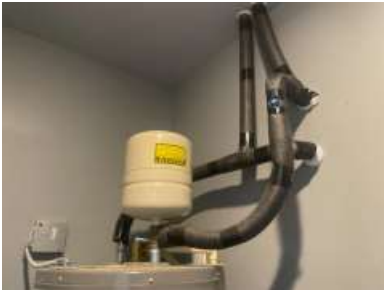
**Water Piping Condition:**

The incoming and output piping is installed correctly.

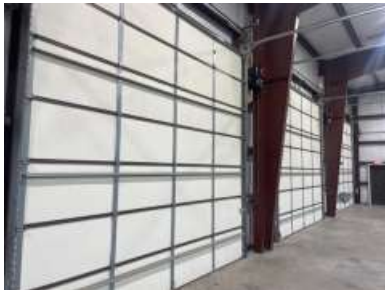
**Overhead Door and Hardware Condition:**

The overhead doors are in satisfactory condition, and it is functional.

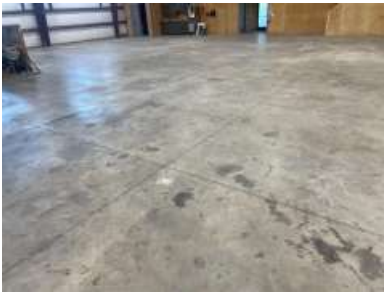
**Floor Condition:**

The garage floor is functional and has a satisfactory appearance.

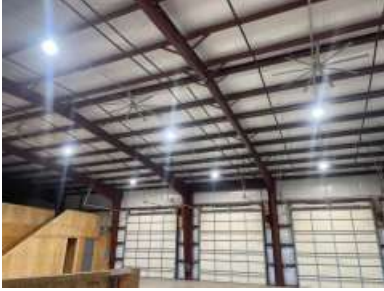
**Garage Walls Condition:**

The wall covering and framing appears to be without significant issues.
