Home Inspection

**20494 W. Daniel Place
Buckeye, Arizona 85396**

Prepared for: Ricky Wilson

**Prepared by: Commercial and Residential Inspections LLC
16435 N. 47th. Place
Phoenix,, Arizona, 85032**

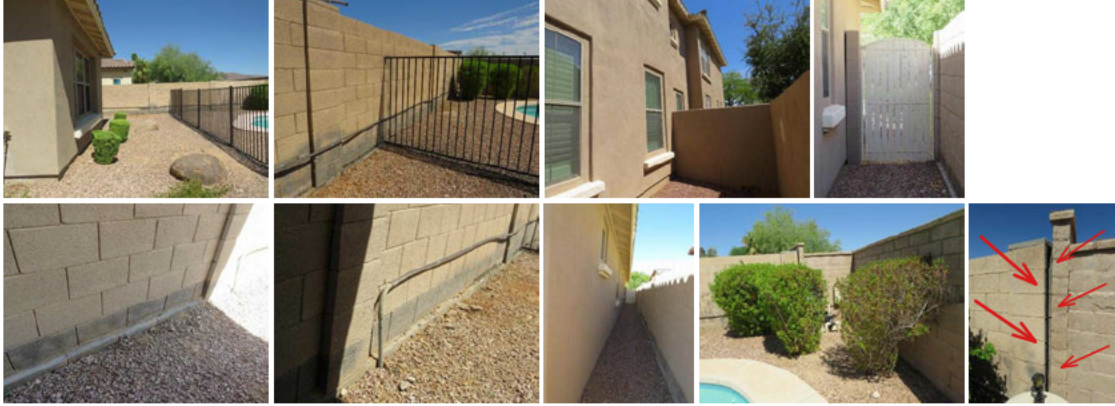
10. Fences: Block - Separation by pool equipment..

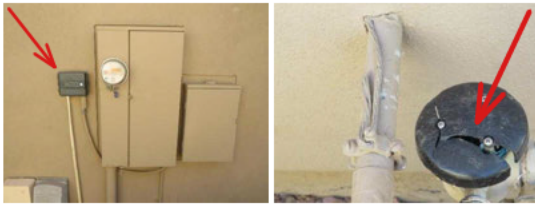
11. Lawn Sprinklers: Front and back yard Drip System - Cap on sprinkler valve broken. Needs replacing.

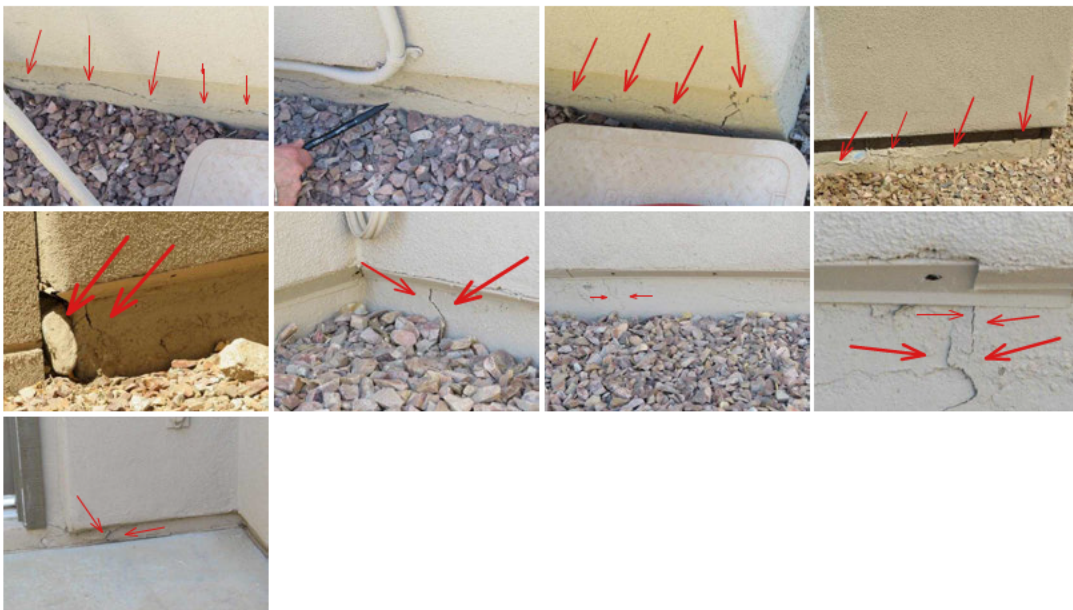
5. Sill Plate: Concrete - Cracks at west side of garage. and rear of home. Pictures around all of home. Patch and monitor.

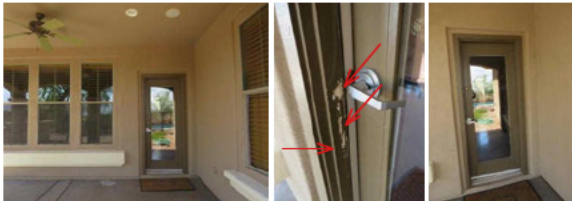
8. Patio Door: Wood with glass. Wood trim needs painting.

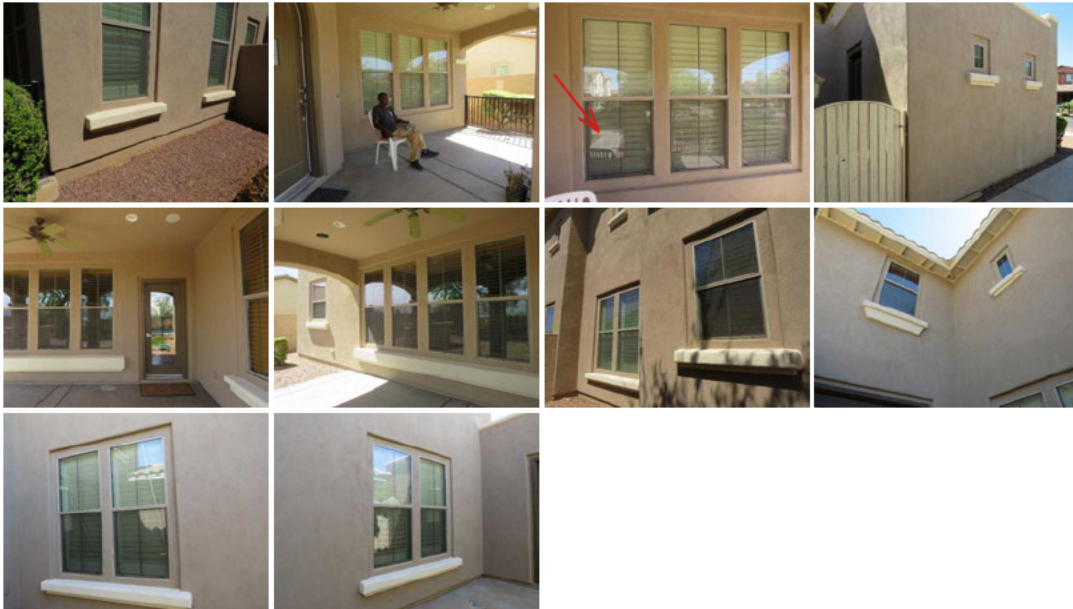
9. Windows: Aluminum double hung - 1st window, argon leak. Replace. Living room window west (cement courtyard) Argon leak. Replace

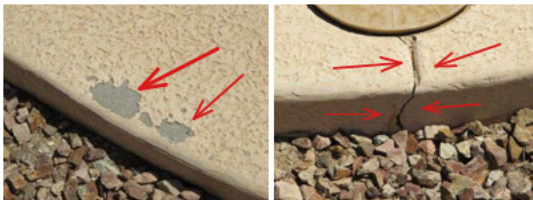
4. Deck: Concrete - Two spots where cool decking has peeled off. Recoat.

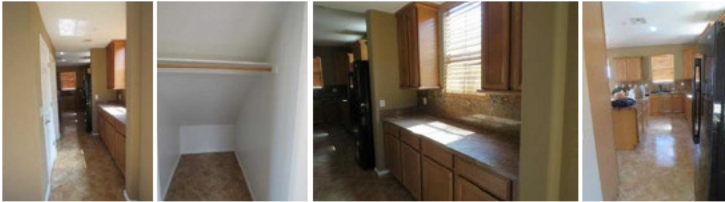
- 10. Plumbing/Fixtures: ABS
- 11. Counter Tops: Marble
- 12. Cabinets: Wood
- 13. Pantry: Walk In - Missing light cover.

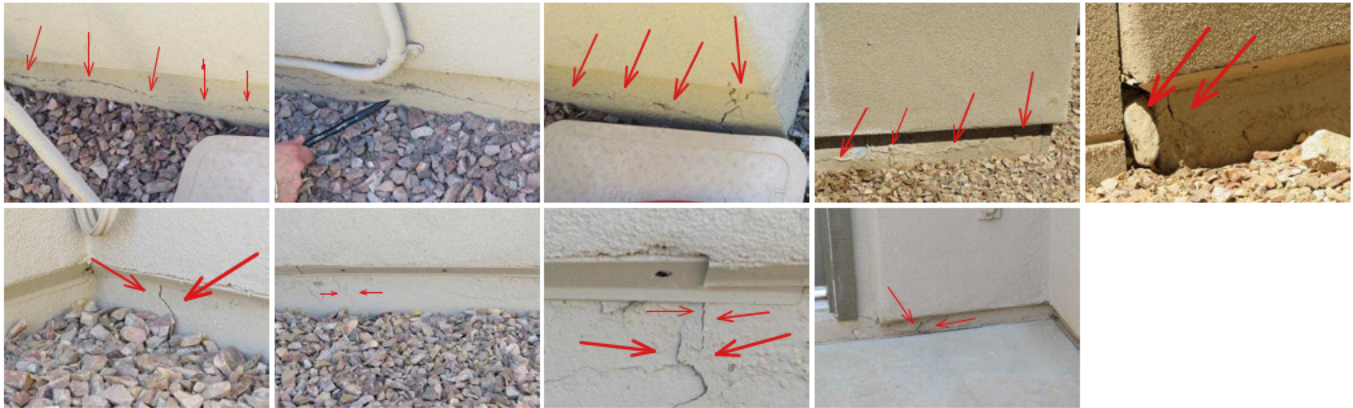
1. Sill Plate: Concrete - Cracks at west side of garage. and rear of home. Pictures around all of home. Patch and monitor.

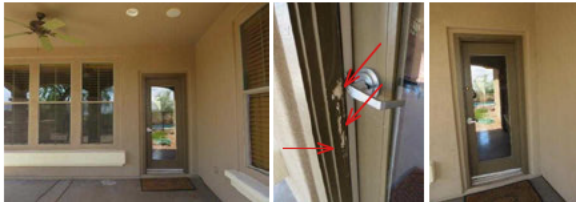
2. Patio Door: Wood with glass. Wood trim needs painting.

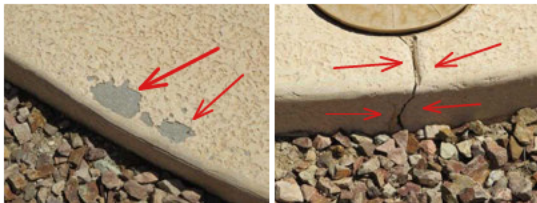
3. Behind home Swimming Pool Deck: Concrete - Two spots where cool decking has peeled off. Recoat.

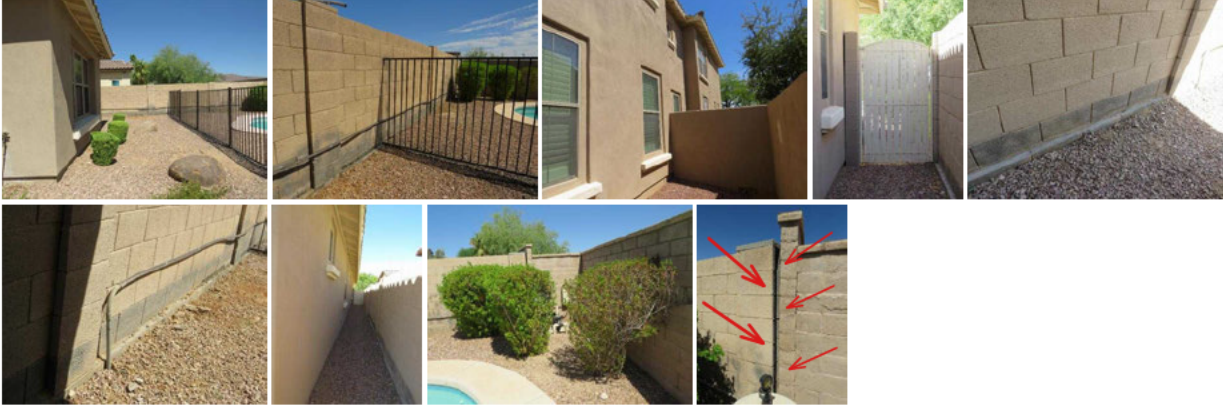
1. Fences: Block - Separation by pool equipment..

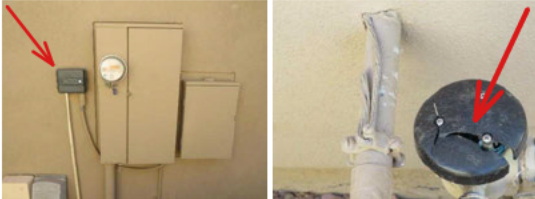
2. Lawn Sprinklers: Front and back yard Drip System - Cap on sprinkler valve broken. Needs replacing.

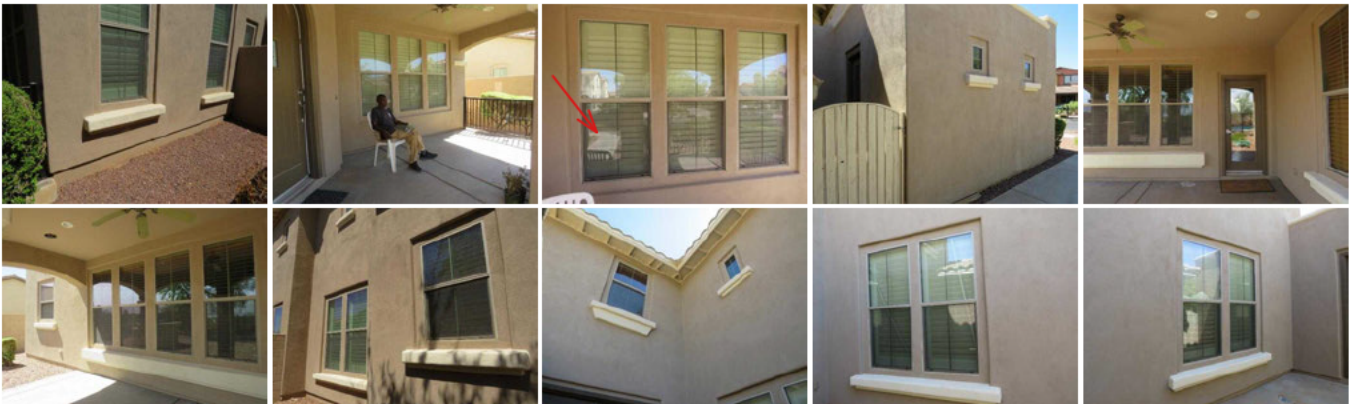
3. Windows: Aluminum double hung - 1st window, argon leak. Replace. Living room window west (cement courtyard) Argon leak. Replace
