Don Meyler Inspections

Inspection  
1545368

## Windstorm Mitigation Inspection

**Nicole Munn  
850 Gulf Shore Dr  
Carrabelle, FL 32322  
August 16, 2022**

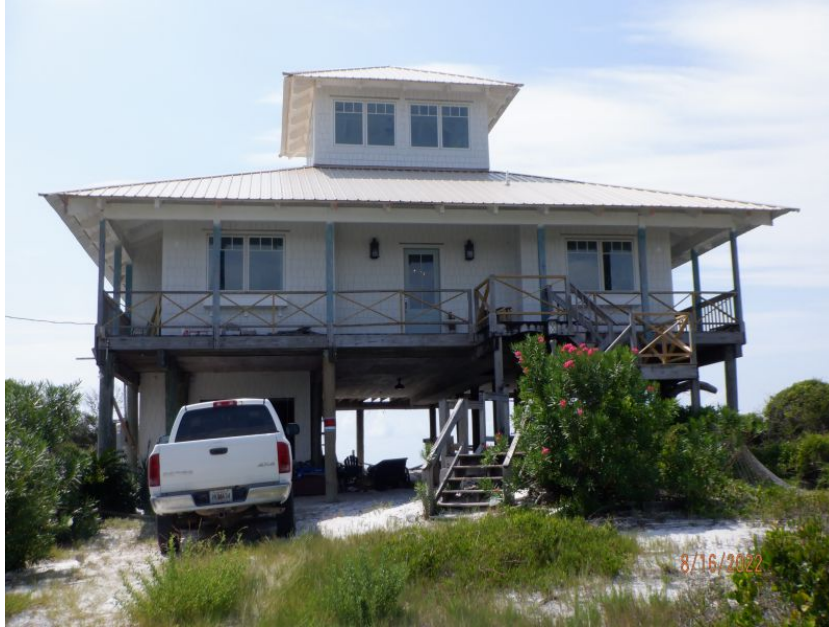
Front Elevation

**Front Elevation:** 1 entry door, and 8 windows

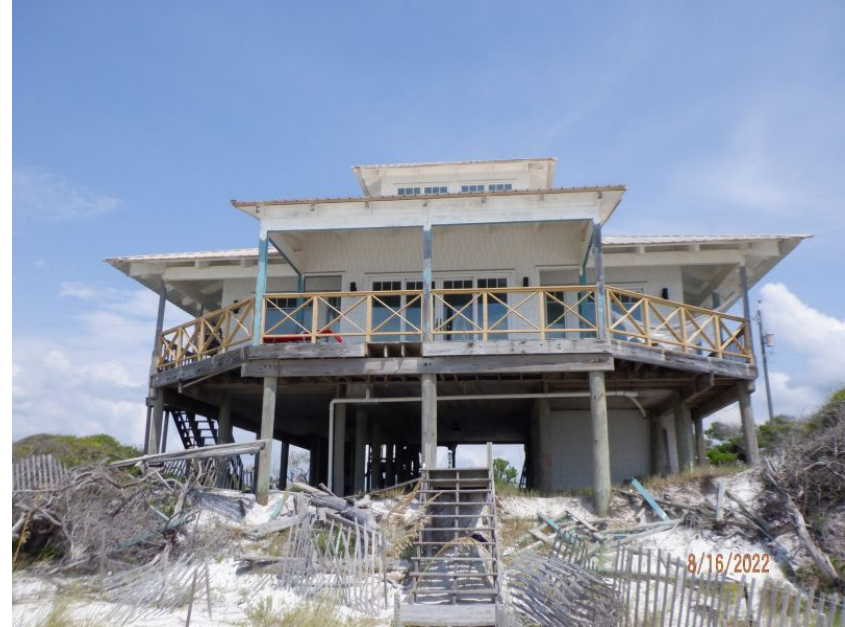
Back Elevation

**Back Elevation:** 2 entry doors, and 8 windows

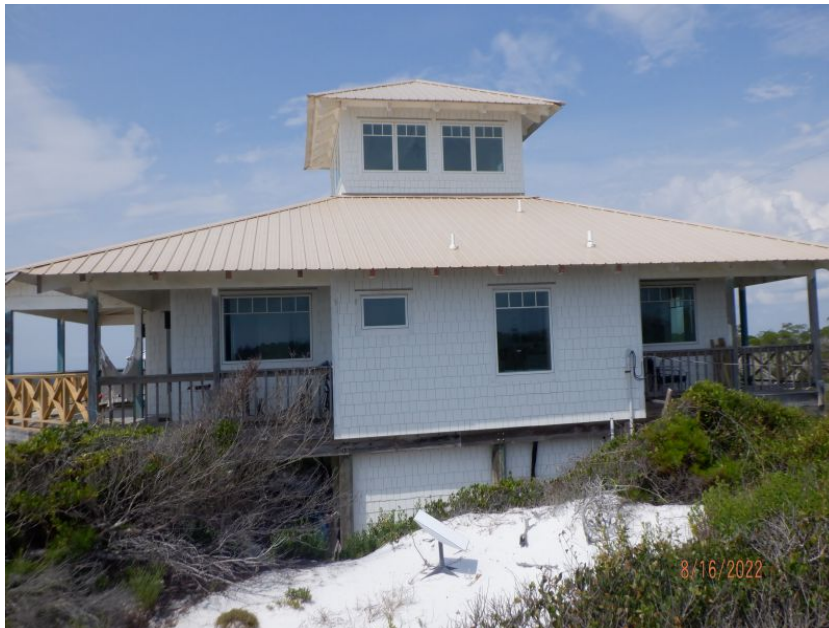
Left Elevation

**Left Elevation:** 8 windows

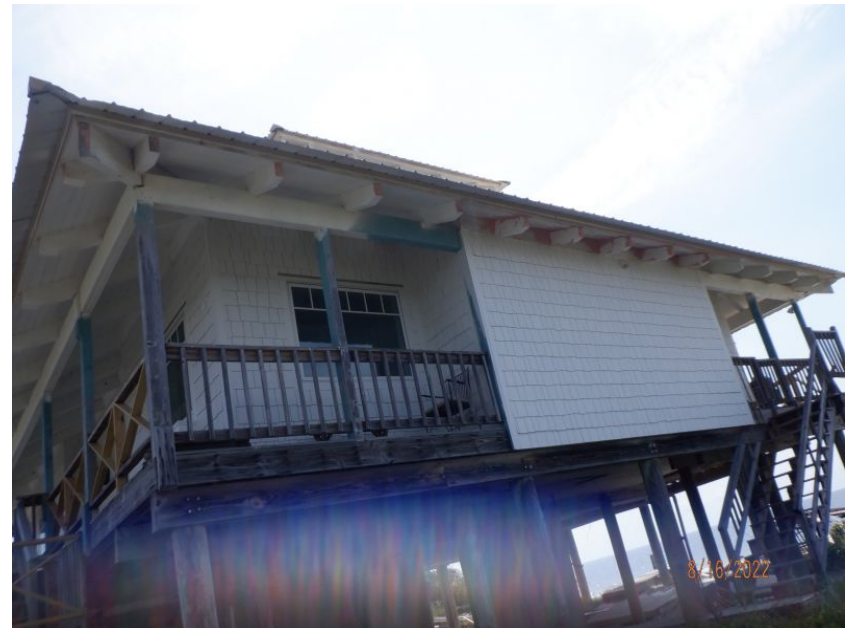
Right Elevation

**Right Elevation:** 6 windows

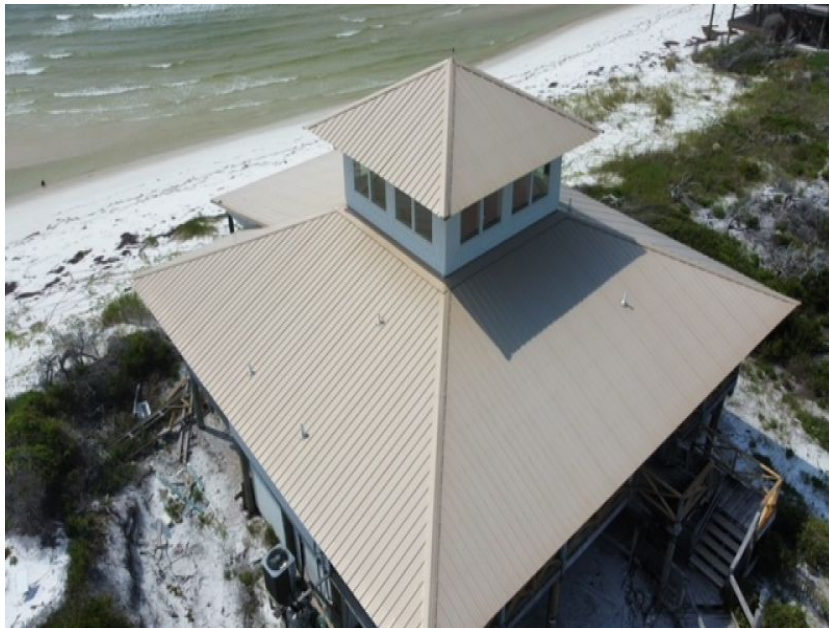
Metal Roof Covering

**Roof Covering Replacement.** Our report shows that at least a portion of your roof was permitted prior to the adoption of the latest building codes. As a result, the next time your roof is replaced, it will receive credit for having a roof covering and installation that meets the very latest Florida Building Code requirements.

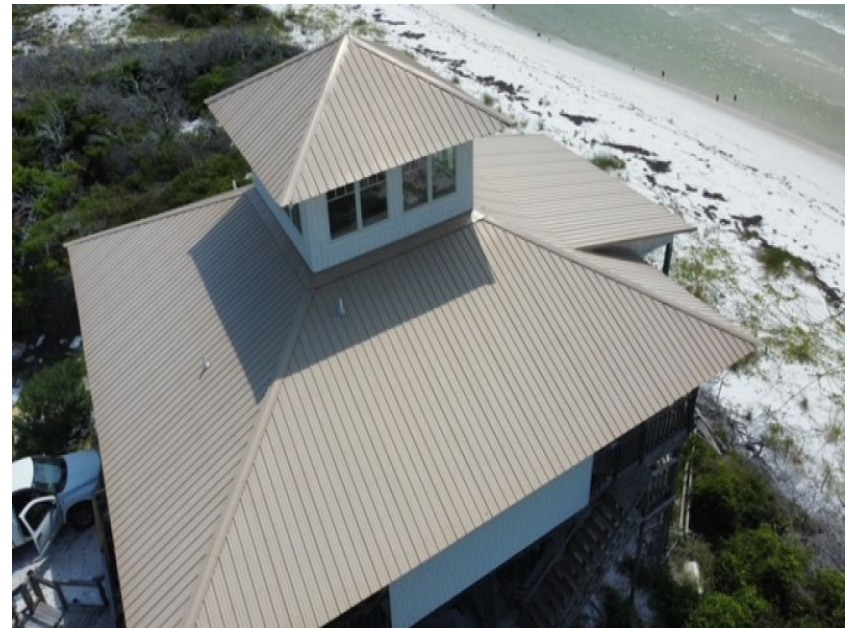
Metal Roof Covering

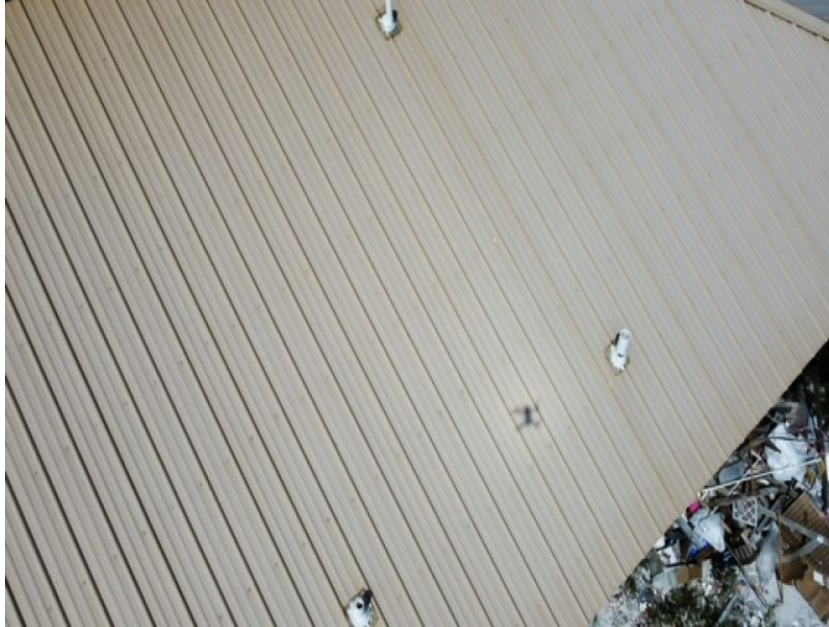
Metal Roof Covering

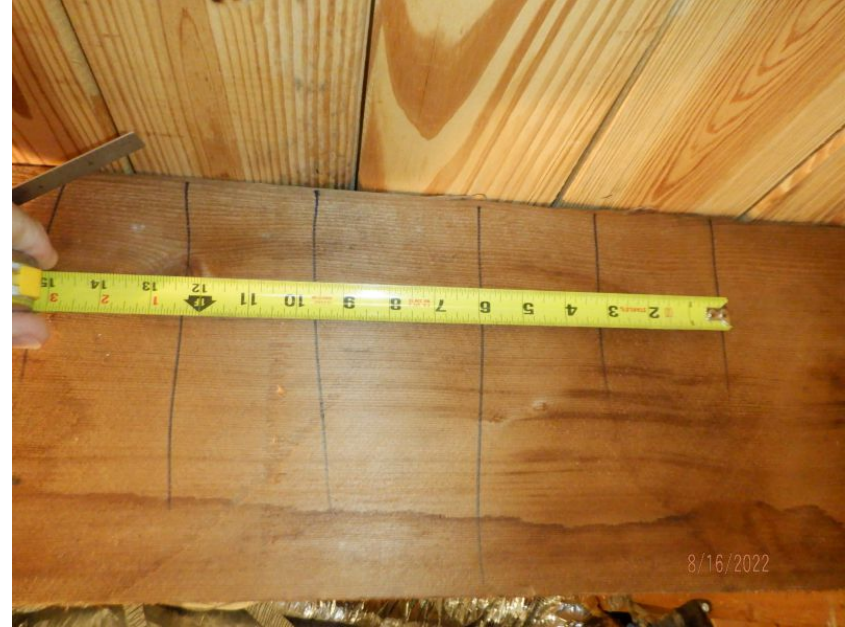
Dimensional Lumber/Tongue & Groove-2 nails per board

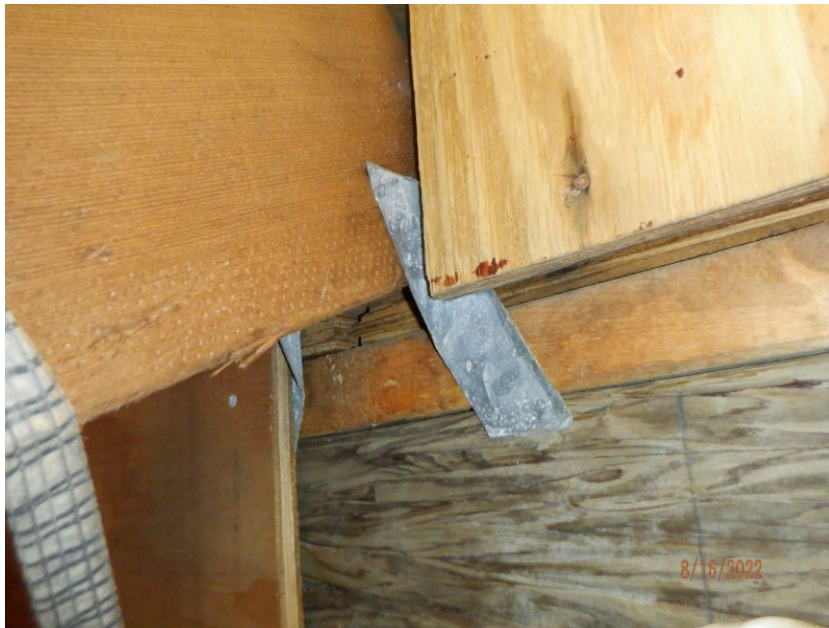
Clip with 3 Nails

**Roof-to-Wall Attachment** Our report indicates that the existing roof-to-wall attachment(s) do not meet the requirements on the Uniform Mitigation Verification Inspection form for Single Wrap Straps. This definition requires at least two nails on the front side and at least one on the other of every strap in the attic, on every truss or rafter. As it is often difficult to access every truss or rafter, the ideal time to upgrade this feature is when the roof deck is being replaced. In some circumstances, this work can be done on its own; consult a professional for details. Retrofits to existing roof to wall connections should be permitted with the local building department, and installations should follow the manufacturer's guidelines.

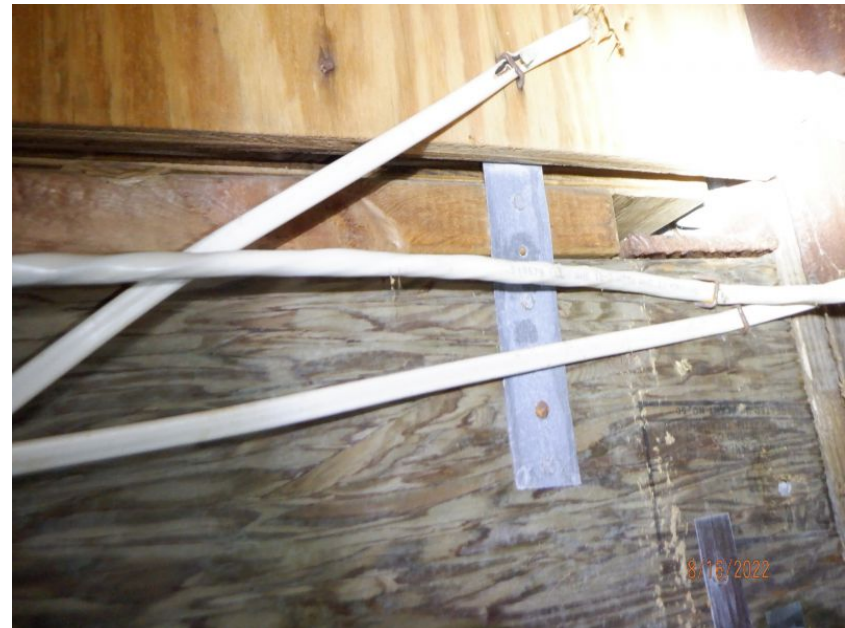
Opposing side of Truss

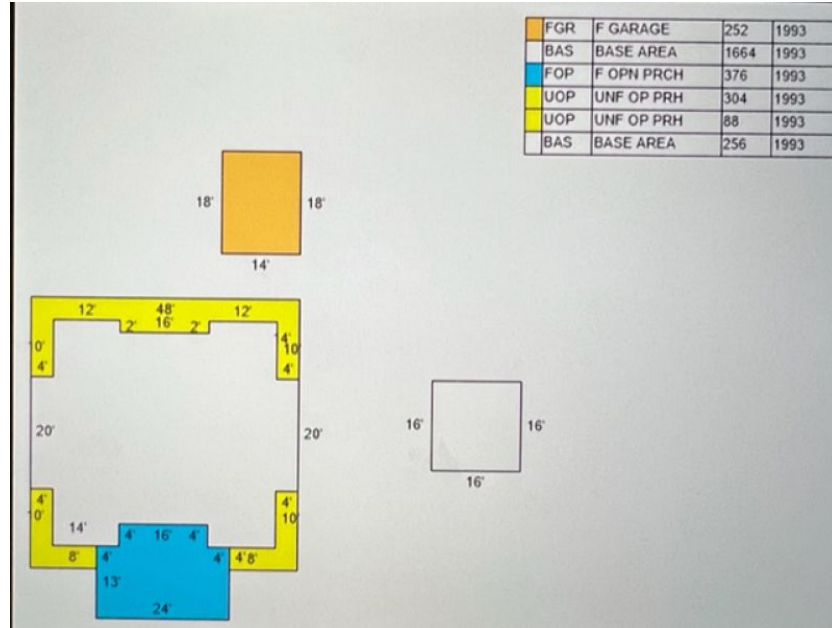
Roof perimeters

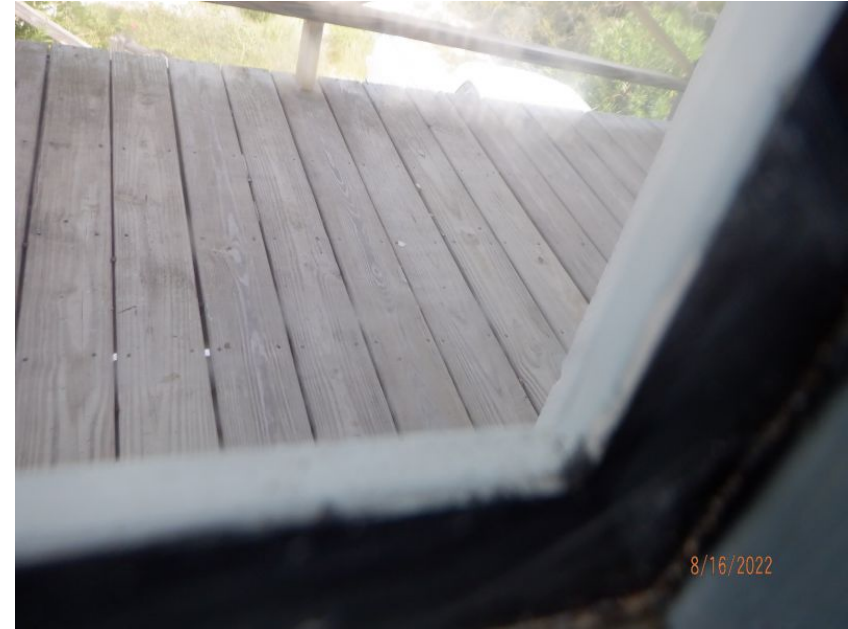
Unprotected Window

In order to obtain a valid A-A.3 rating, the following opening(s) would need to be protected or replaced using a qualifying impact-rated ("A") device:

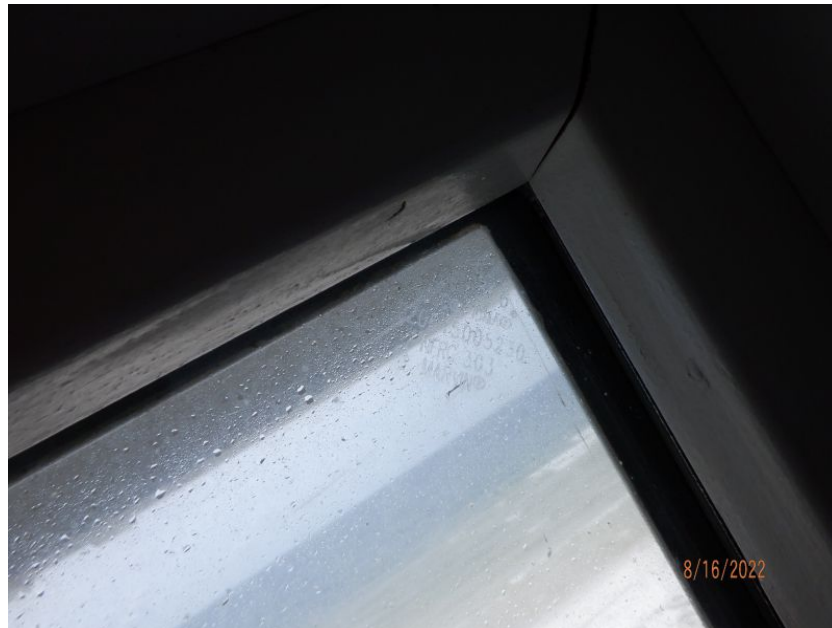
Unprotected Glazed Entry Door

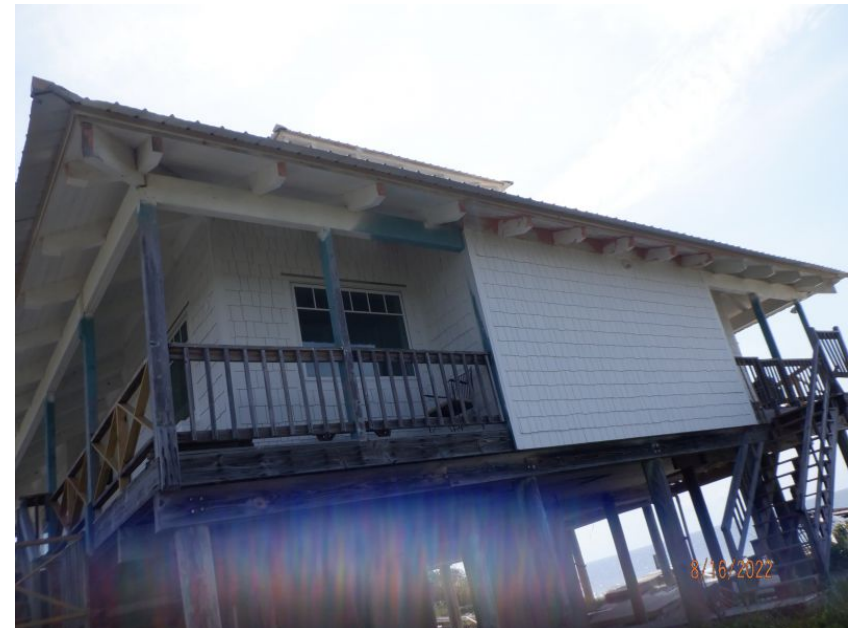
Unprotected Window

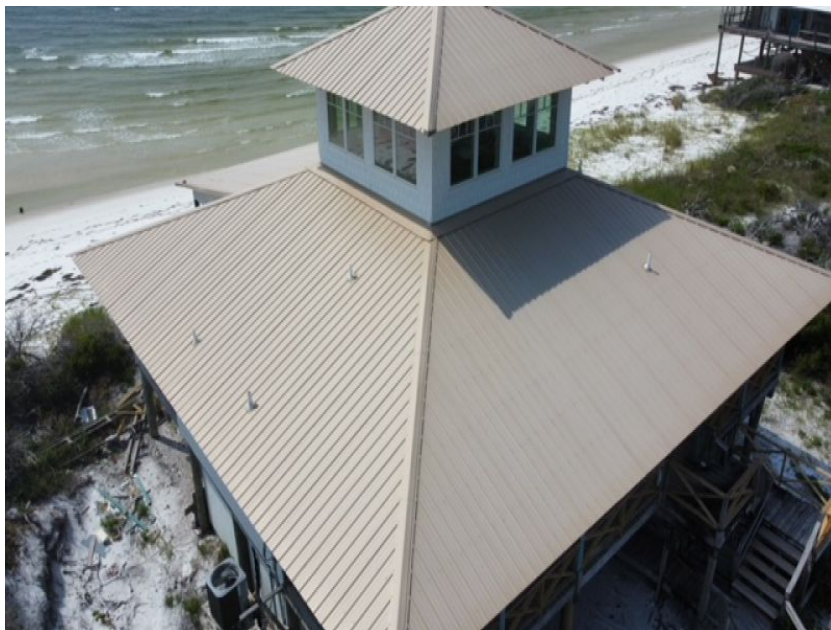
Unprotected Window

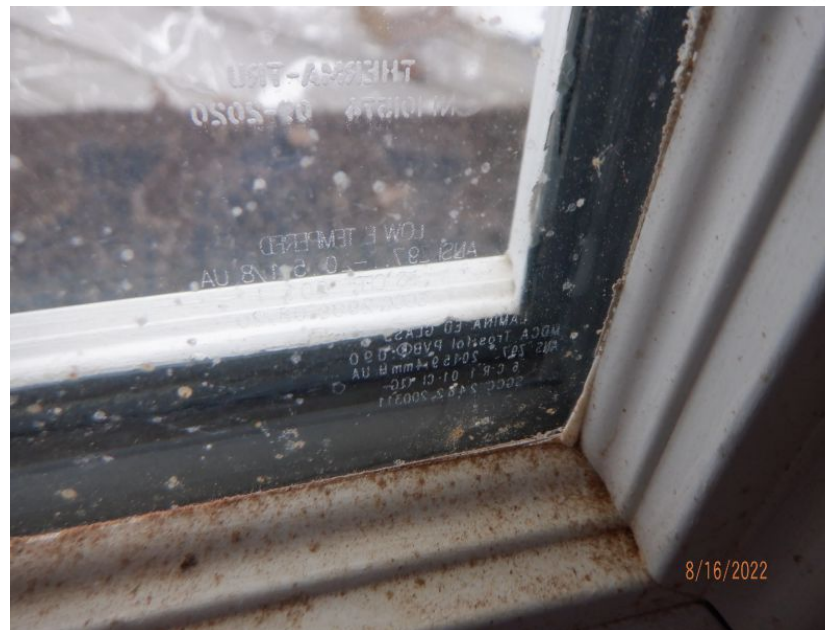
Impact Rated Glazed Door Etching/Engraving
