# Sam Agnew Home Inspections

Client(s): **Jean Smith Estate**  
Property address: **1119 Farmington Rd.**  
**Mocksville, NC**  
Inspection date: **Wednesday, March 28, 2018**

## Property Inspection Report

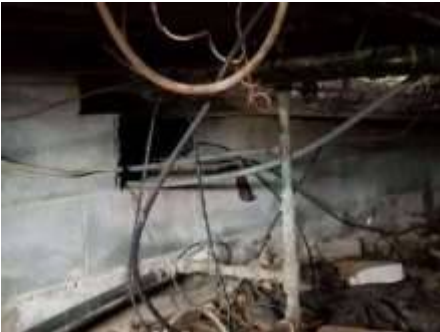
Photo 7-1

7 🛠️ 🔍 ⓘ - I could not find any access to the crawl space area under an apparent addition other than a small hole through the original area to the newer area. Its main purpose is to feed mechanicals into the smaller, newer space. Consider installing a larger access between the two areas.

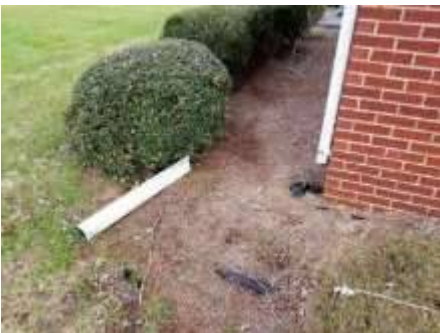
Photo 10-1

10 🛠️ - Extensions such as splash blocks or drain pipes for one or more downspouts were damaged. Water can accumulate around the building foundation or inside crawl spaces or basements as a result. Recommend that a qualified person install, replace or repair extensions as necessary so rainwater drains away from the structure.

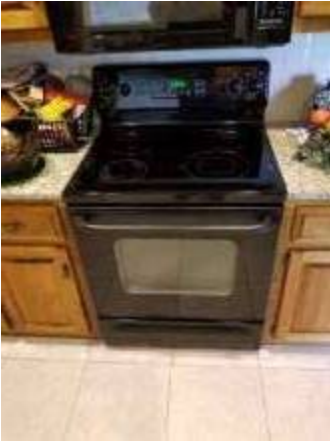
Photo 20-1

- The range could tip forward. An anti-tip bracket may not be installed. This is a potential safety hazard since the range can tip forward when weight is applied to the open door, such as when a small child climbs on it or if heavy objects are dropped on it. Anti-tip brackets have been sold with all free-standing ranges since 1985. Recommend installing an anti-tip bracket to eliminate this safety hazard. For more information, visit:

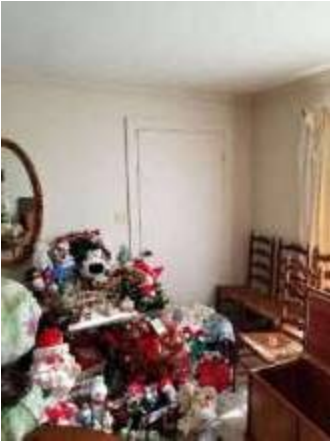
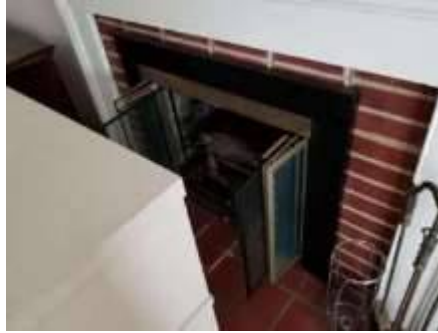
Some areas and items at this property were obscured by furniture. This often includes but is not limited to walls, floors, windows, inside and under cabinets, under sinks, on counter tops, in closets, behind window coverings, under rugs or carpets, and under or behind furniture. Areas around the exterior, under the structure, in the garage and in the attic may also be obscured by stored items. The inspector in general does not move personal belongings, furnishings, carpets or appliances. When furnishings, stored items or debris are present, all areas or items that are obscured, concealed or not readily accessible are excluded from the inspection. The client should be aware that when furnishings, stored items or debris are eventually moved, damage or problems that were not noted during the inspection may be found.

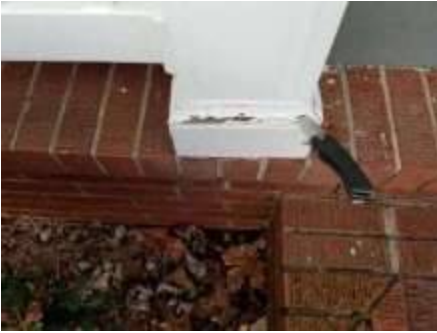
Photo 2-1

Fungal rot was found in support posts at one or more decks or porches. Conducive conditions for this such as wood-soil contact should be corrected. Recommend that a qualified contractor evaluate and repair as necessary. All rotten wood should be replaced.

The base of one front porch column is rotted.

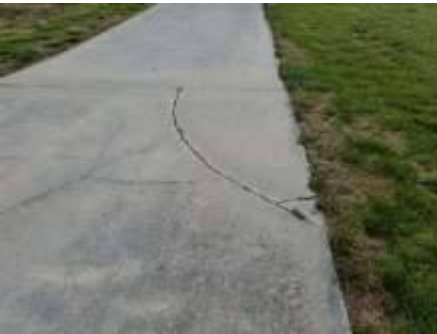
Photo 3-1

Minor deterioration (e.g. cracks, holes, settlement, heaving) was found in the driveway, but no trip hazards were found. The client may wish to have repairs made for cosmetic reasons.

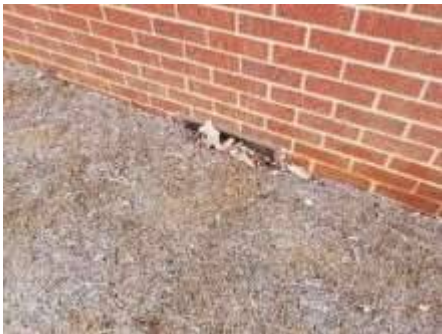
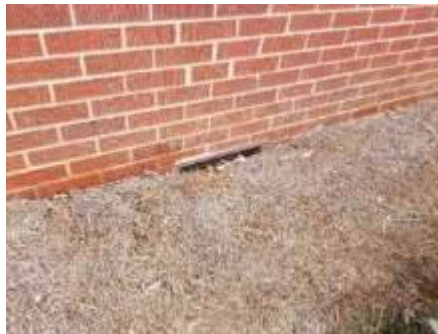
One or more crawl space vents were blocked by soil. This restricts ventilation in the crawl space and can result in increased levels of moisture inside. This is a conducive condition for wood-destroying organisms. Materials or items blocking vents should be removed as necessary.

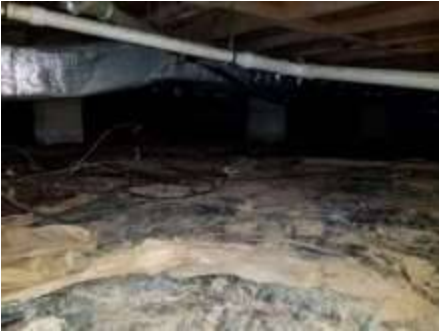
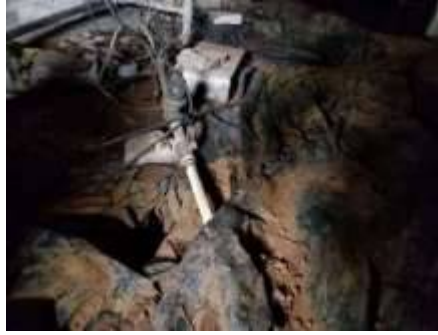
The vapor barrier in many areas of the crawl space was deteriorated, damaged, missing and/or substandard. Soil was exposed as a result and will allow water from the soil to evaporate up into the structure. This is a conducive condition for wood-destroying organisms. A 6 mil black plastic sheet should be placed over all exposed soil with seams overlapped to 24 inches, and not in contact with any wood structural components. The sheeting should be held in place with bricks or stones, not wood. Recommend that a qualified person replace or repair the vapor barrier where necessary and per standard building practices.

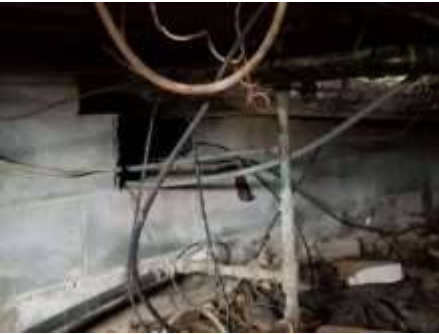
Photo 7-1

I could not find any access to the crawl space area under an apparent addition other than a small hole through the original area to the newer area. Its main purpose is to feed mechanicals into the smaller, newer space. Consider installing a larger access between the two areas.

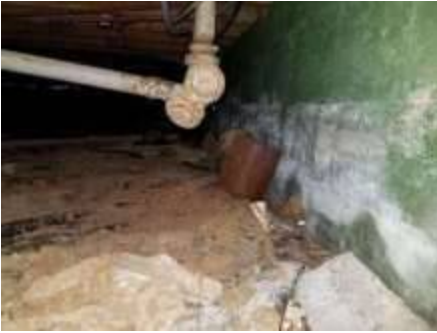
Photo 8-1

Evidence of prior water intrusion or accumulation was found in one or more sections of the crawl space. For example, sediment stains on the vapor barrier or foundation, and/or efflorescence on the foundation. Accumulated water is a conducive condition for wood-destroying organisms and should not be present in the crawl space. Recommend that the client review any disclosure statements available and ask the property owner about past accumulation of water in the crawl space. The crawl space should be monitored in the future for accumulated water, especially after heavy and/or prolonged periods of rain. If water is found to accumulate, then recommend that a qualified contractor who specializes in drainage issues evaluate and repair as necessary. Typical repairs for preventing water from accumulating in crawl spaces include:

- Repairing, installing or improving rain run-off systems (gutters, downspouts and extensions or drain lines)
- Improving perimeter grading
- Repairing, installing or improving underground footing and/or curtain drains

Ideally, water should not enter crawl spaces, but if water must be controlled after it enters the crawl space, then typical repairs include installing trenches, gravity drains and/or sump pump(s) in the crawl space.

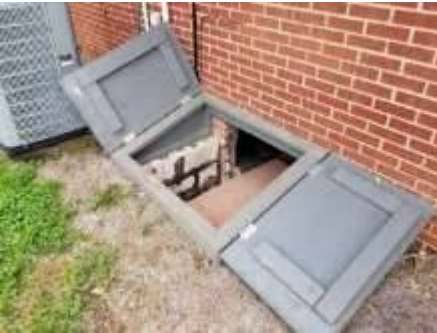
Photo 9-1

Crawl space access at the rear of the house.

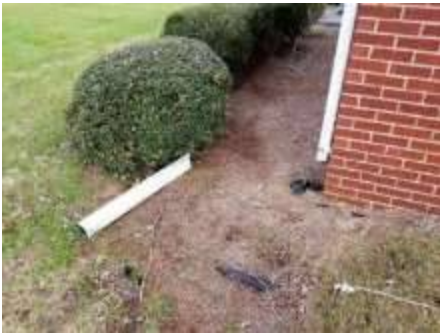
Photo 10-1

Extensions such as splash blocks or drain pipes for one or more downspouts were damaged. Water can accumulate around the building foundation or inside crawl spaces or basements as a result. Recommend that a qualified person install, replace or repair extensions as necessary so rainwater drains away from the structure.

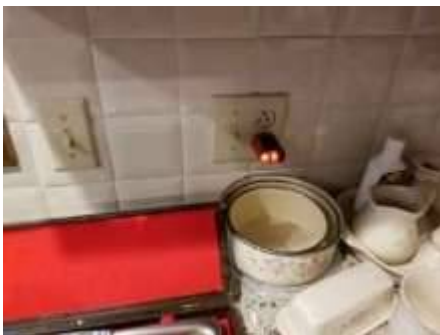
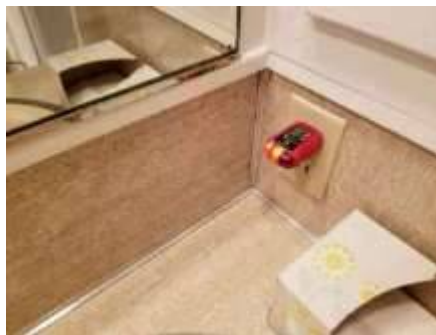
One or more electric receptacles (outlets) at the kitchen and/or bathroom(s) had no visible ground fault circuit interrupter (GFCI) protection, or the inspector was unable to determine if GFCI protection was present. If not GFCI-protected, receptacles in wet areas pose a shock hazard. Recommend that a qualified electrician evaluate and install GFCI protection if necessary and per standard building practices. General guidelines for GFCI-protected receptacles include the following locations:

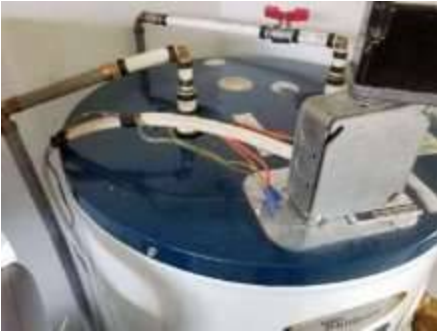
**Photo 13-1**

Wire splices were exposed and were not contained in a covered junction box. This is a potential shock or fire hazard. Recommend that a qualified electrician repair per standard building practices. For example, by installing permanently mounted junction boxes with cover plates where needed to contain wiring splices.

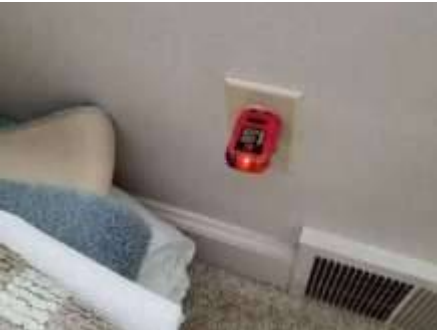
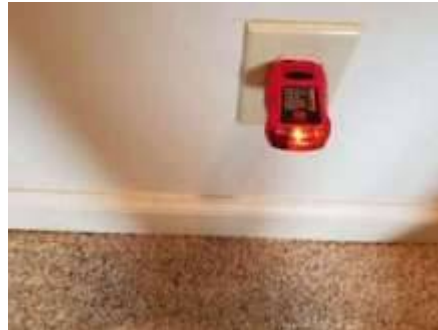
One or more modern, 3-slot electric receptacles (outlets) were found with an open ground. Three-slot receptacles should have a hot, a neutral and a ground wire connected. Homeowners often install new 3-slot receptacles on older, 2-wire circuits that only have hot and neutral wires. This is a shock hazard when appliances that require a ground are used with these receptacles. Examples of such appliances include computers and related hardware, refrigerators, freezers, portable air conditioners, clothes washers, aquarium pumps, and electrically operated gardening tools. Where the electric system was installed prior to when grounded circuits were required (1960s), it is permissible to replace 3-slot receptacles with 2-slot receptacles to prevent appliances that require a ground from being plugged in to an ungrounded circuit. However, the client should be aware of this limitation when planning use for various rooms, such as an office. For newer electric systems, circuits should be repaired so grounded, 3-wire cables provide power to 3-slot receptacles. Recommend that a qualified electrician repair per standard building practices. These outlets are in the bedrooms and bedroom hallway.

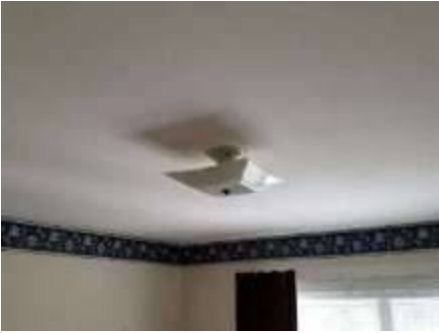
Photo 16-1

Bulbs in one or more light fixtures were missing or broken. These light fixtures couldn't be fully evaluated. If replacement bulbs are inoperable, then recommend that a qualified electrician evaluate and repair or replace light fixtures as necessary.

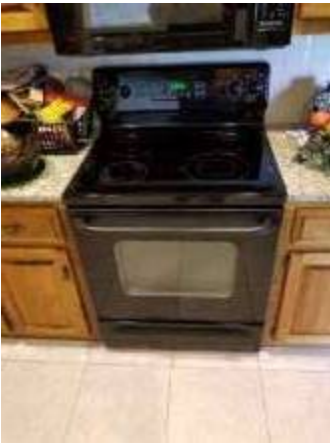
Photo 20-1

The range could tip forward. An anti-tip bracket may not be installed. This is a potential safety hazard since the range can tip forward when weight is applied to the open door, such as when a small child climbs on it or if heavy objects are dropped on it. Anti-tip brackets have been sold with all free-standing ranges since 1985. Recommend installing an anti-tip bracket to eliminate this safety hazard. For more information, visit:

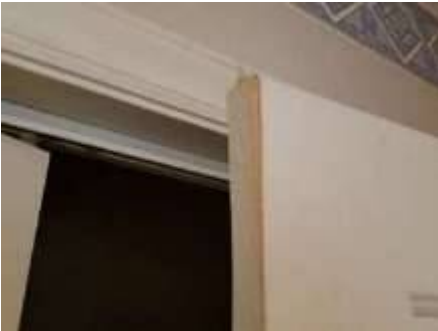
**Photo 22-1**

22) 🛠️ One or more interior doors were damaged. Recommend that a qualified person replace or repair doors as necessary.

One of the master bathroom bi-fold doors is damaged under the pin the keeps the door on its upper track.

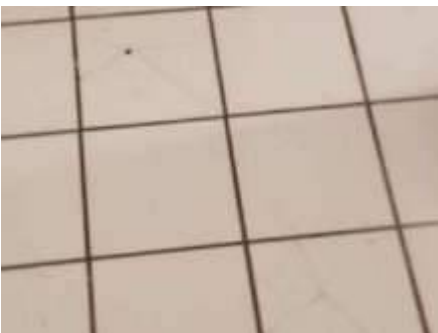
**Photo 23-1**

23) 🖐️ Small cracks in master bathroom tiles.
