# Sam Agnew Home Inspections

Client(s): **Jean Smith Estate**

Property address: **1119 Farmington Rd.  
Mocksville, NC**

Inspection date: **Wednesday, March 28, 2018**

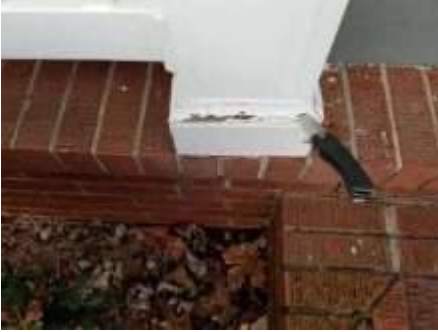
Photo 2-1

- Fungal rot was found in support posts at one or more decks or porches. Conducive conditions for this such as wood-soil contact should be corrected. Recommend that a qualified contractor evaluate and repair as necessary. All rotten wood should be replaced.

The base of one front porch column is rotted.

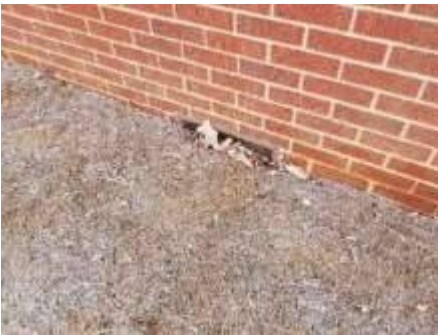
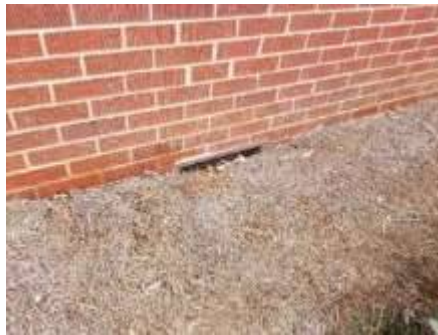
- One or more crawl space vents were blocked by soil. This restricts ventilation in the crawl space and can result in increased levels of moisture inside. This is a conducive condition for wood-destroying organisms. Materials or items blocking vents should be removed as necessary.

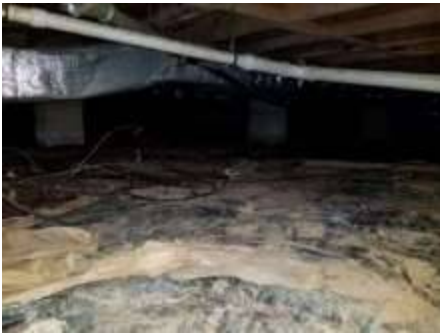
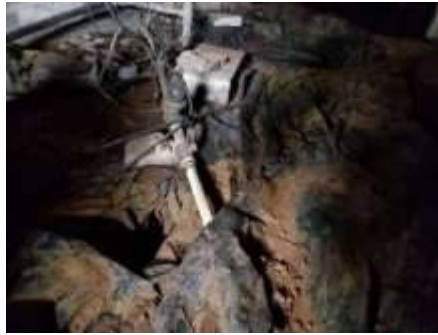
- The vapor barrier in many areas of the crawl space was deteriorated, damaged, missing and/or substandard. Soil was exposed as a result and will allow water from the soil to evaporate up into the structure. This is a conducive condition for wood-destroying organisms. A 6 mil black plastic sheet should be placed over all exposed soil with seams overlapped to 24 inches, and not in contact with any wood structural components. The sheeting should be held in place with bricks or stones, not wood. Recommend that a qualified person replace or repair the vapor barrier where necessary and per standard building practices.

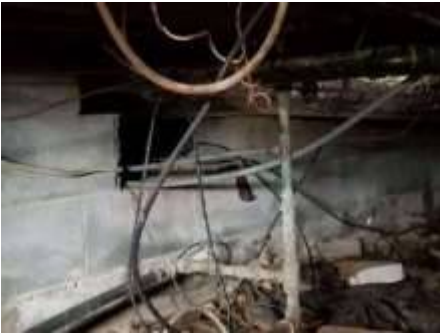
Photo 7-1

7 🛠️ 🔍 ⓘ - I could not find any access to the crawl space area under an apparent addition other than a small hole through the original area to the newer area. Its main purpose is to feed mechanicals into the smaller, newer space. Consider installing a larger access between the two areas.

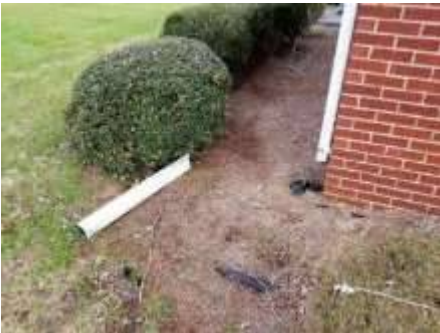
Photo 10-1

10 🛠️ - Extensions such as splash blocks or drain pipes for one or more downspouts were damaged. Water can accumulate around the building foundation or inside crawl spaces or basements as a result. Recommend that a qualified person install, replace or repair extensions as necessary so rainwater drains away from the structure.

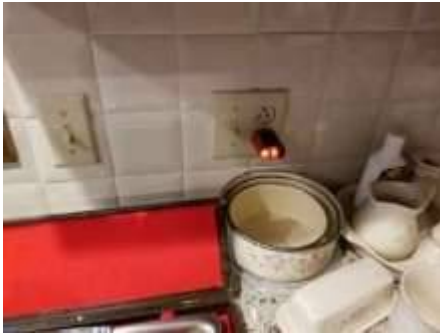
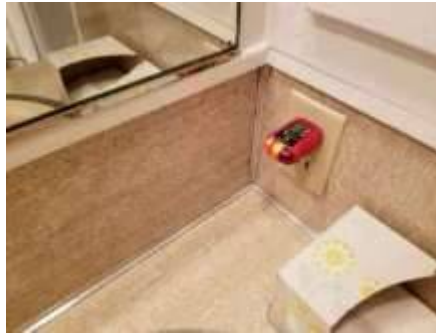
- One or more electric receptacles (outlets) at the kitchen and/or bathroom(s) had no visible ground fault circuit interrupter (GFCI) protection, or the inspector was unable to determine if GFCI protection was present. If not GFCI-protected, receptacles in wet areas pose a shock hazard. Recommend that a qualified electrician evaluate and install GFCI protection if necessary and per standard building practices. General guidelines for GFCI-protected receptacles include the following locations:

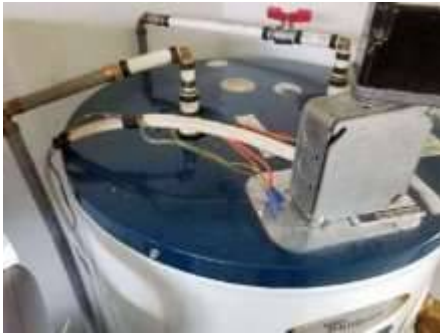
Photo 13-1

- Wire splices were exposed and were not contained in a covered junction box. This is a potential shock or fire hazard. Recommend that a qualified electrician repair per standard building practices. For example, by installing permanently mounted junction boxes with cover plates where needed to contain wiring splices.

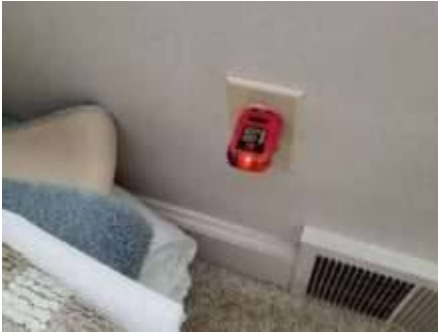
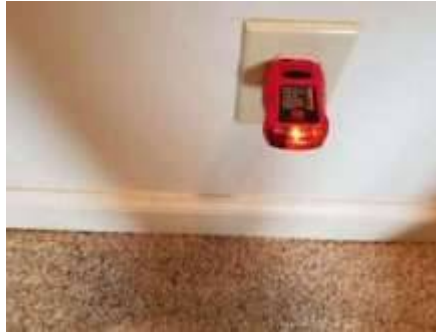
- One or more modern, 3-slot electric receptacles (outlets) were found with an open ground. Three-slot receptacles should have a hot, a neutral and a ground wire connected. Homeowners often install new 3-slot receptacles on older, 2-wire circuits that only have hot and neutral wires. This is a shock hazard when appliances that require a ground

are used with these receptacles. Examples of such appliances include computers and related hardware, refrigerators, freezers, portable air conditioners, clothes washers, aquarium pumps, and electrically operated gardening tools. Where the electric system was installed prior to when grounded circuits were required (1960s), it is permissible to replace 3-slot receptacles with 2-slot receptacles to prevent appliances that require a ground from being plugged in to an ungrounded circuit. However, the client should be aware of this limitation when planning use for various rooms, such as an office. For newer electric systems, circuits should be repaired so grounded, 3-wire cables provide power to 3-slot receptacles. Recommend that a qualified electrician repair per standard building practices. These outlets are in the bedrooms and bedroom hallway.

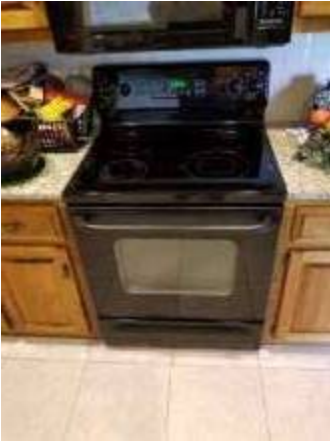
Photo 20-1

- The range could tip forward. An anti-tip bracket may not be installed. This is a potential safety hazard since the range can tip forward when weight is applied to the open door, such as when a small child climbs on it or if heavy objects are dropped on it. Anti-tip brackets have been sold with all free-standing ranges since 1985. Recommend installing an anti-tip bracket to eliminate this safety hazard. For more information, visit:

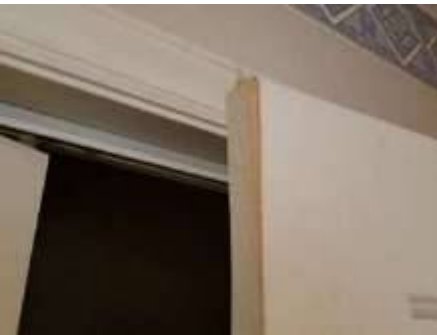
Photo 22-1

- One or more interior doors were damaged. Recommend that a qualified person replace or repair doors as necessary.

One of the master bathroom bi-fold doors is damaged under the pin the keeps the door on its upper track.

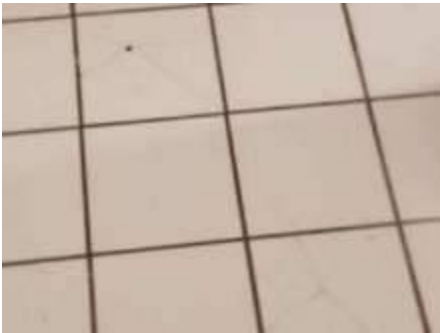
Photo 23-1

- Small cracks in master bathroom tiles.
