# Home Inspection Report

629 McGregor Rd. Winston-Salem, NC

06/24/2020

Guy's Home Inspection Services  
1005 Elk Place  
High Point, NC 27262

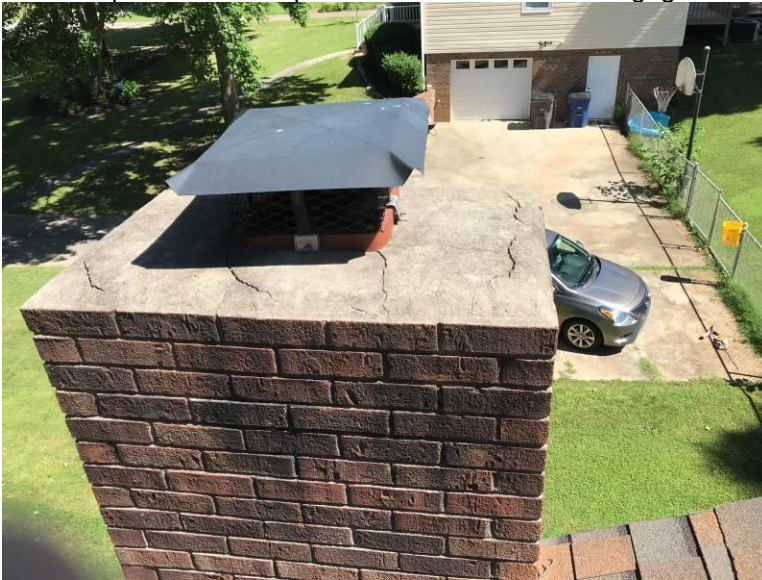
- **Repair:** The concrete chimney cap on the masonry chimney is cracked and should be repaired to prevent moisture penetration. A qualified mason should be engaged to repair this.

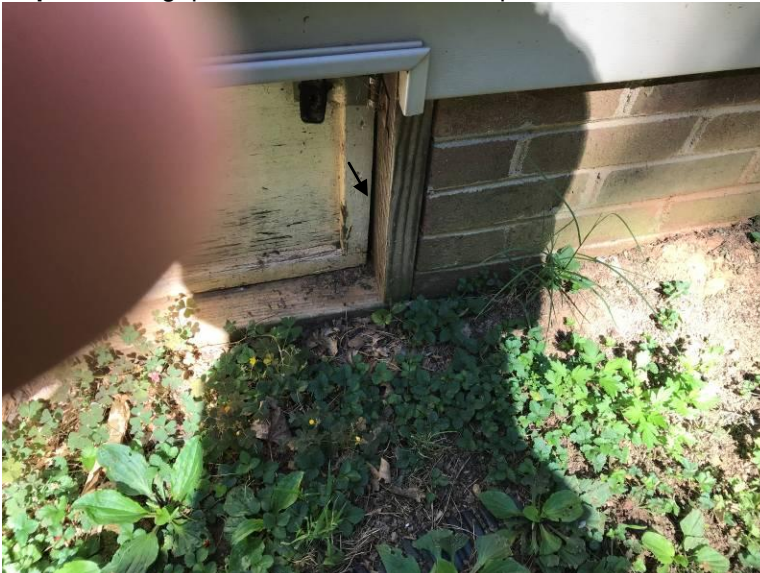
- **Repair:** The gaps around the rear crawl space door should be sealed to prevent vermin entry.

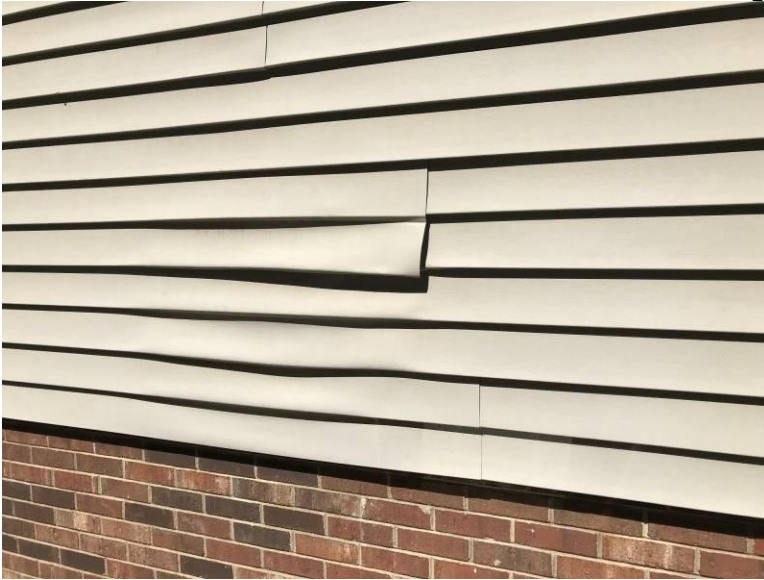
- **Repair:** The loose or damaged siding at the rear exterior should be re-secured to avoid more wind-damage and possible moisture penetration. A qualified vinyl siding contractor should be engaged to repair this

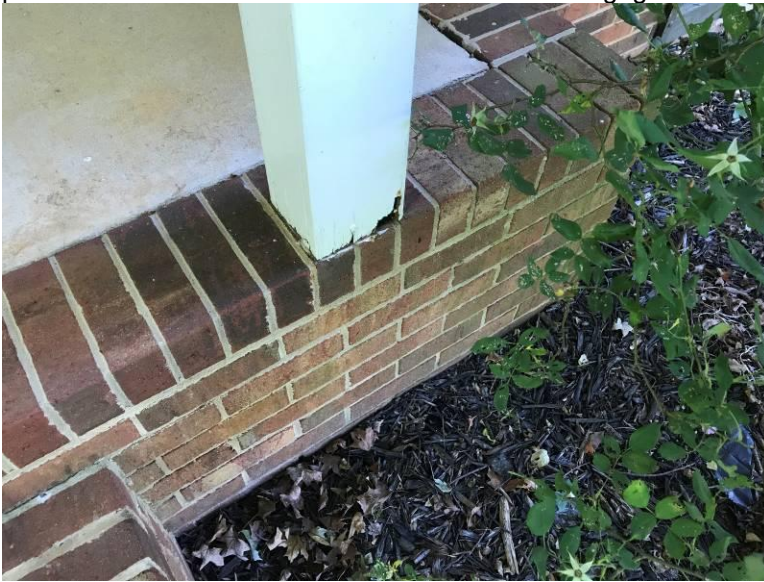
- 
- **Repair:** The handrail at the deck steps is loose and should be repaired for improved safety.
- **Repair:** The porch posts are rotten at the base and should be repaired or replaced to prevent sagging of the porch structure. A licensed contractor should be engaged to remedy this.

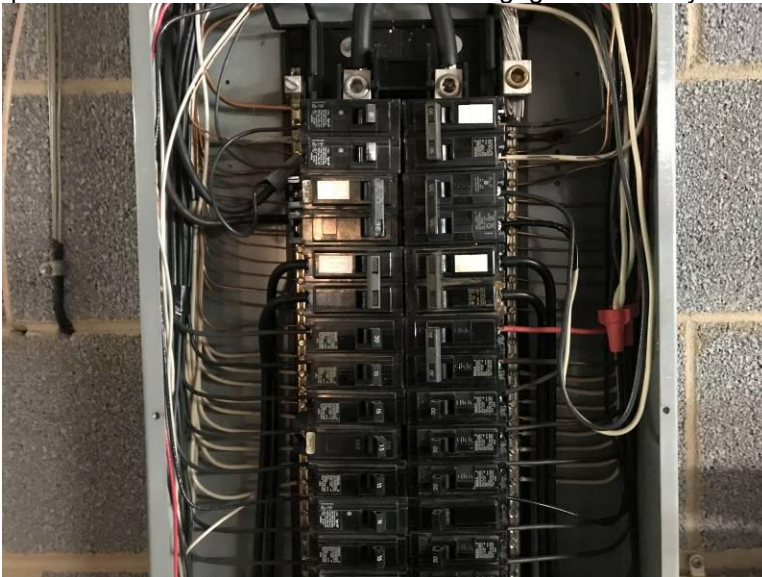
- **Repair:** A maximum of 6 disconnects are allowed to disconnect power at the main electrical panel. A qualified electrical contractor should be engaged to remedy this and may involve significant expense.

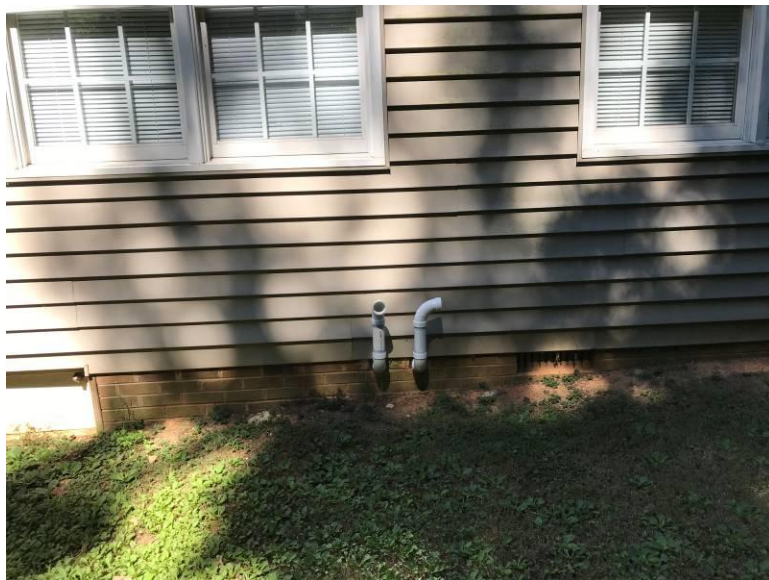
- **Repair:** The dirty air filters should be replaced for improved energy efficiency and to prolong the life of the unit. A qualified HVAC technician should be engaged to repair this.
- **Repair:** The basement unvented heater did not respond to normal operating controls. A licensed HVAC technician should be engaged to investigate this and to repair as necessary.
- **Repair, Safety Issue:** The crawlspace furnace exhaust terminates below a window and/or below a foundation vent. It should be a minimum of 4 ft. below, 4 ft. horizontal or 1ft. above any building opening. This should be repaired to prevent the possibility that carbon monoxide could enter the home. A qualified HVAC technician should be engaged to repair this.

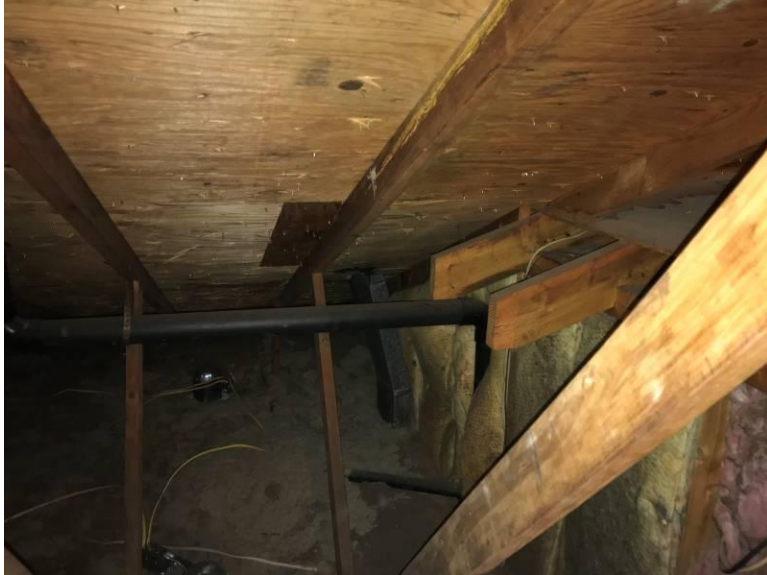
Evidence suggests the “can” lights at the attic are not rated for insulation contact and correctly have clearances to insulation as required. It would be wise to replace the can lights with air tight can lights that allow insulation contact for improved energy efficiency. An alternative is the Tenmat *FF130E* ([www.tenmatusa.com](http://www.tenmatusa.com)) insulation protection cover is made from a fire-resistant material and is designed to keep insulation away from recessed light fixtures. When installed with a foam sealant, it also stops air leakage through the fixture (the DOE estimates that recessed lights account for 50% of total thermal losses through ceilings). The covers are not meant for use in one- or two-hour fire-rated ceiling assemblies.

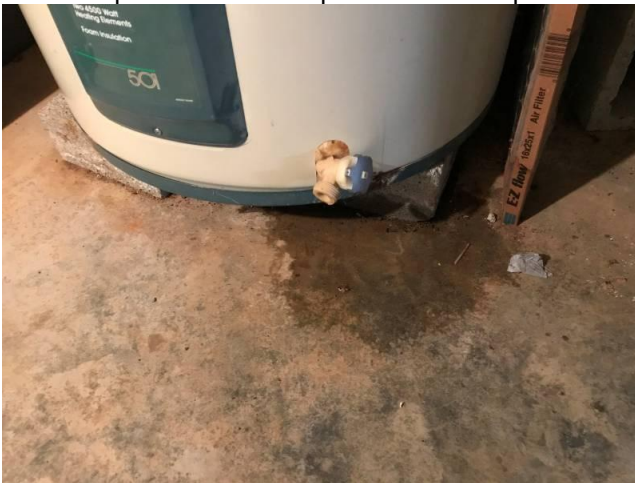
- **Repair:** The water heater is rusty and leaking. A licensed plumber should be engaged to replace the water heater to prevent moisture penetration and possible damage.

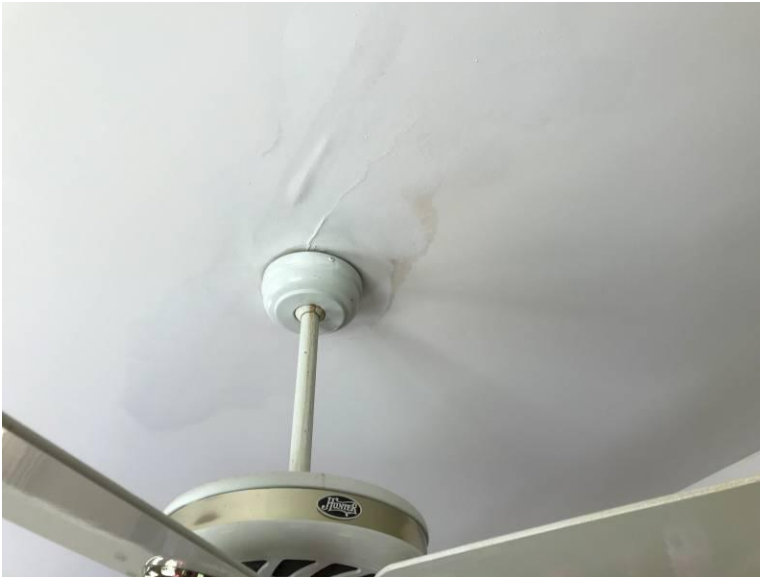
- **Repair:** Water staining was noted in multiple locations. The stains were not active at the time of the inspection but some damage (“popcorn” ceiling @ right front bedroom) was noted and should be repaired as desired.

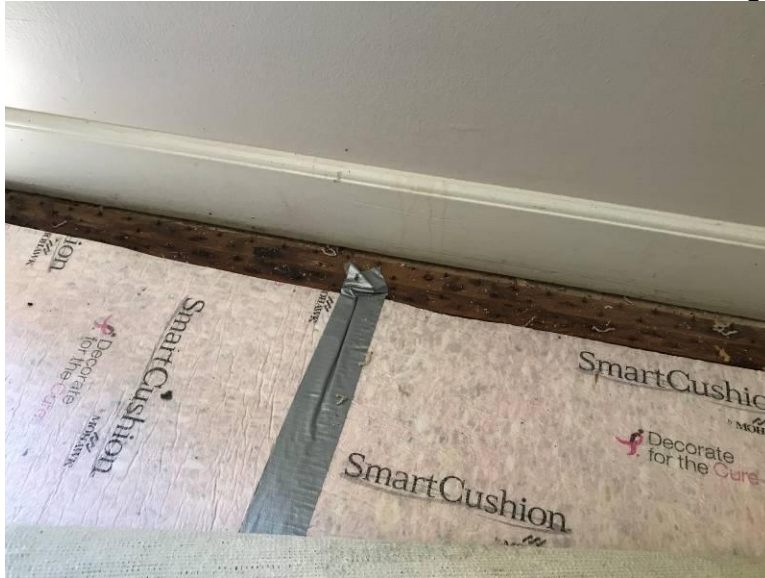
- - **Repair:** Water staining and wet carpet was noted at the right side basement wall. This should be investigated and repaired as necessary by a qualified waterproofing contractor.
-
