HOME INSPECTION REPORT

Zach Johnson
2227 Gideon Grove Church Rd
Stokesdale, NC 27357

On 5/14/2025, HomeTeam Inspection Service made a visual inspection of the property referenced above. Enclosed please find a written, narrative report of our findings in accordance with the terms of our Home Inspection Agreement. Although maintenance items may have been addressed verbally at the time of the inspection, they may not be included in the enclosed report.

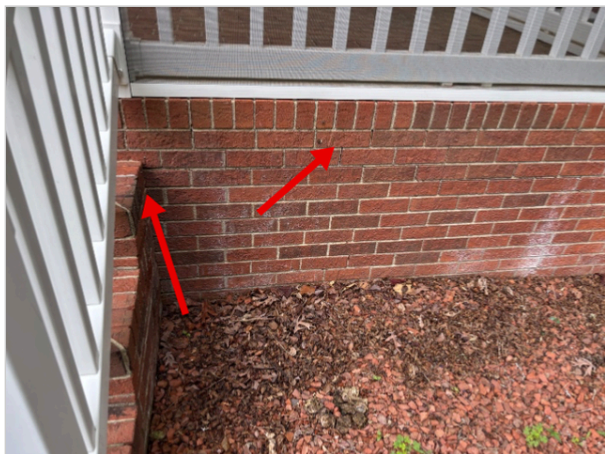
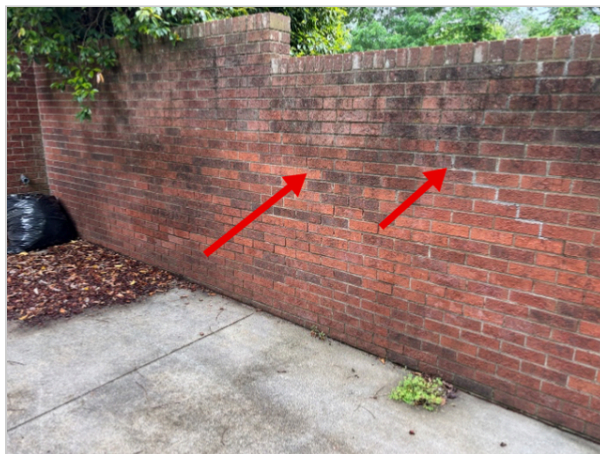
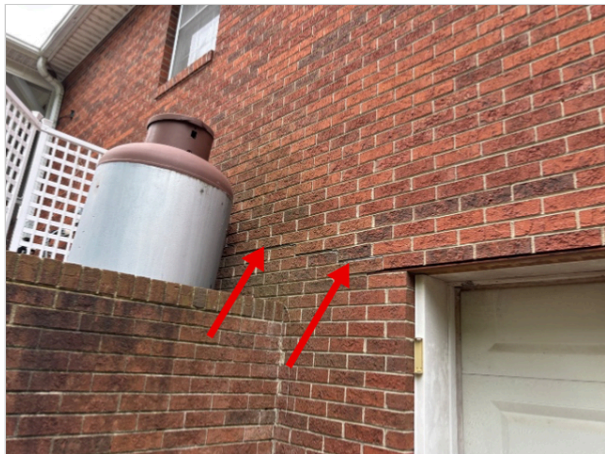
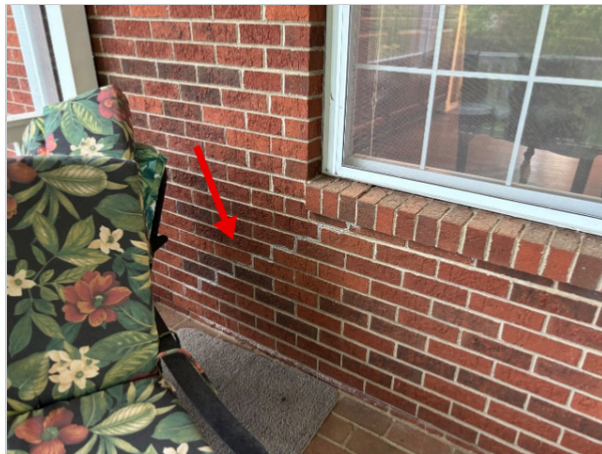
Wall cracking/open gaps observed at The rear. This is a settlement/water penetration concern. Recommend repairs by a qualified contractor.

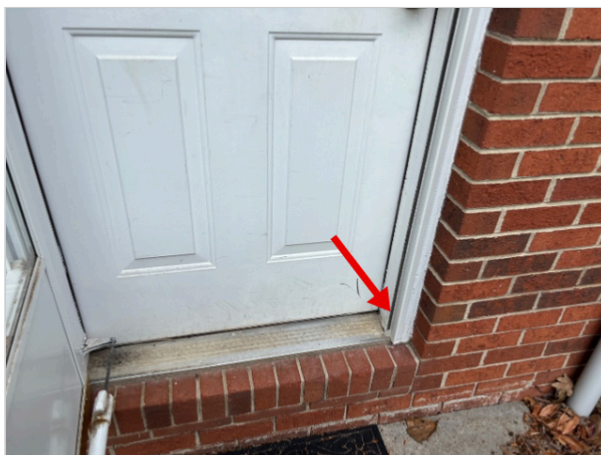
Wood rot/damage was observed on the exterior door(s) at the rear of the house. This is a water penetration/damage concern. Recommend repairs by a qualified contractor.

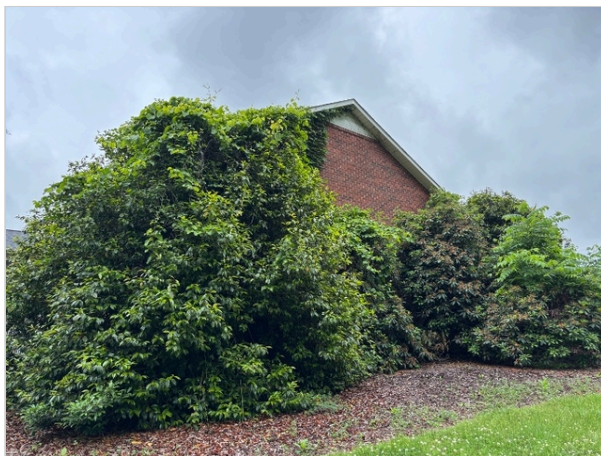
Vegetation was touching areas of the house. Clearances are recommended between vegetation and the siding to minimize water penetration and pest concerns. Recommend repairs by a qualified person.

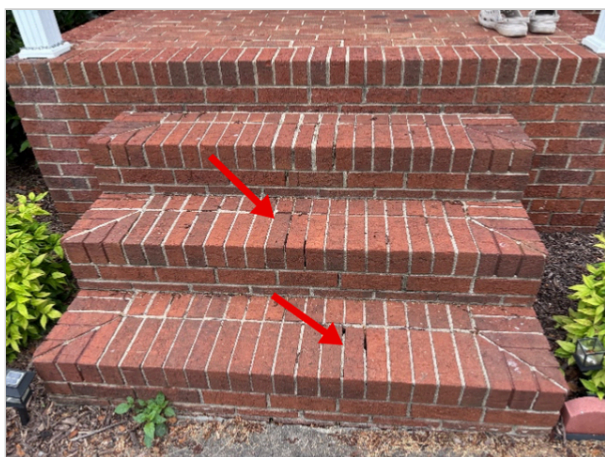
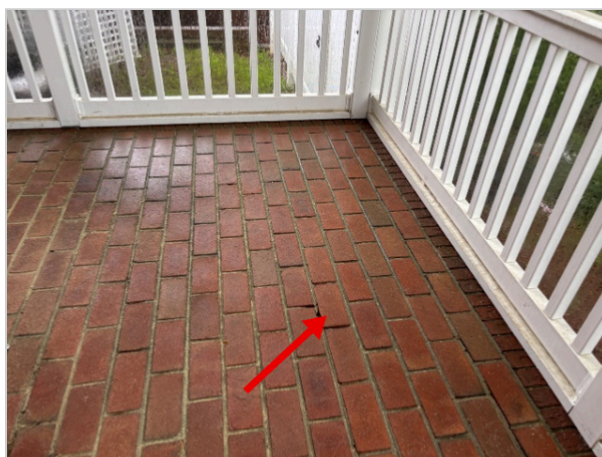
Open mortar joints/cracking was observed at the front and rear porch. This is a water penetration/settlement concern. Recommend repairs by a qualified person.

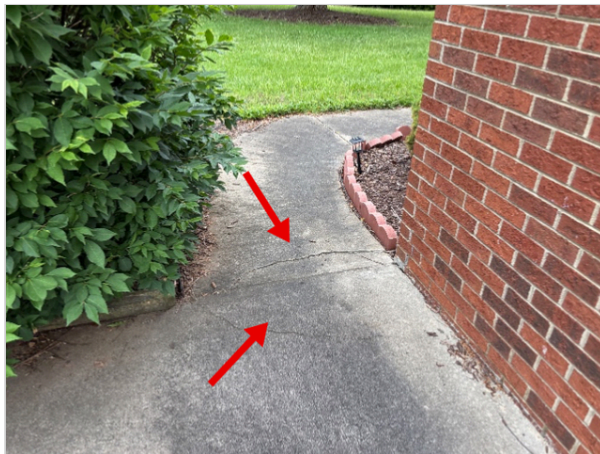
Cracking observed on the walkeay,driveway and patio. This is a damage/fall concern. Recommend repairs by a qualified person.

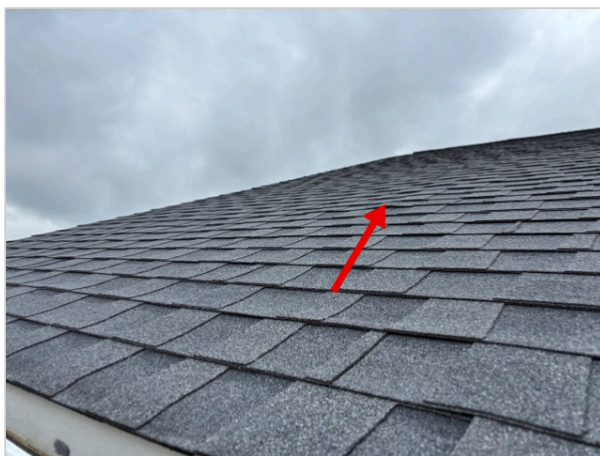
Raised shingles were observed at the rear of the roof. This is a water penetration/wind lift concern. Recommend repairs by qualified person.

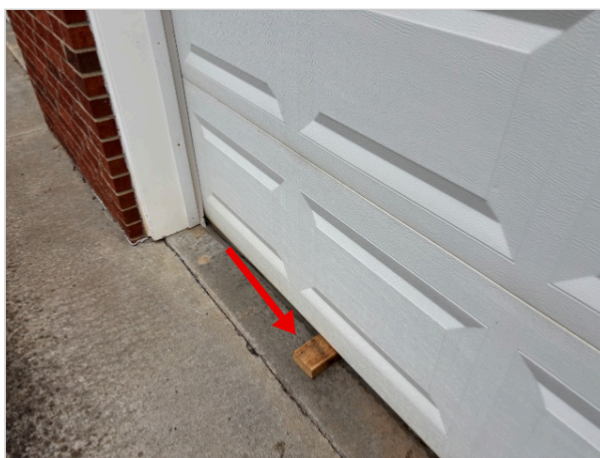
The garage door did not reverse when met with reasonable resistance. This is a safety concern. Recommend repairs/adjustments by qualified person and verifying proper operation prior to closing.

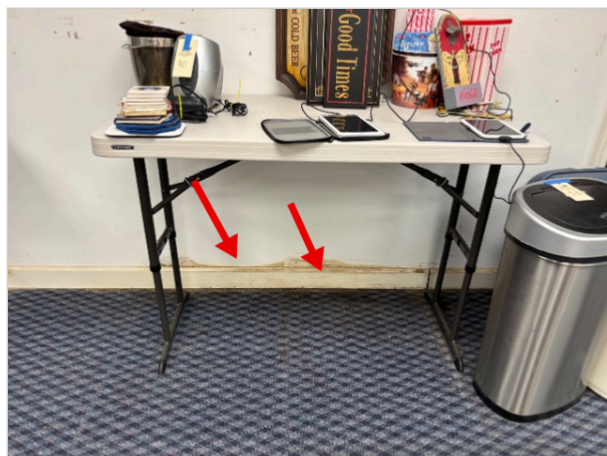
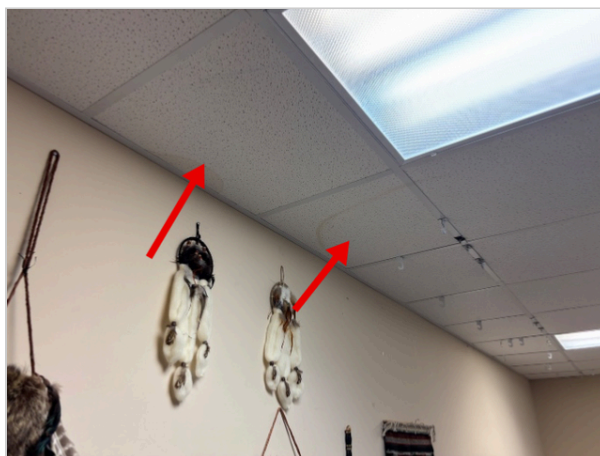
Staining was observed on the ceiling and wall at The center basement. Moisture levels were within typical range at time of inspection however future conditions cannot be confirmed. Stains pose a potential leakage concern until repaired/monitored. Recommend verifying conditions and/or having further review by a qualified contractor.

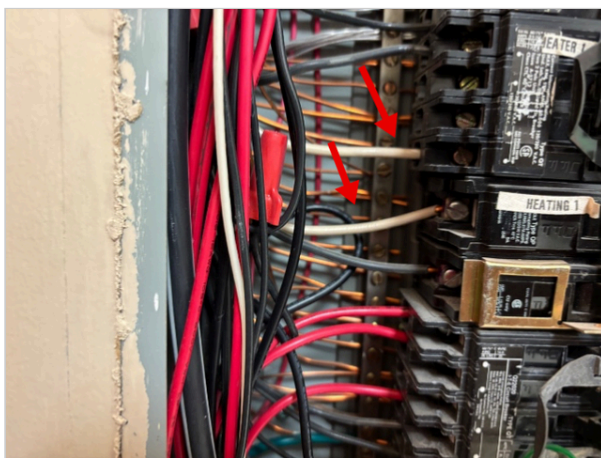
White wires typically used for the common, are being used for power in the main electric panel. Although using white or "common" wires for power is allowed, they should be marked accordingly with black markings or tape. This is a safety concern. Recommend repairs by qualified person.

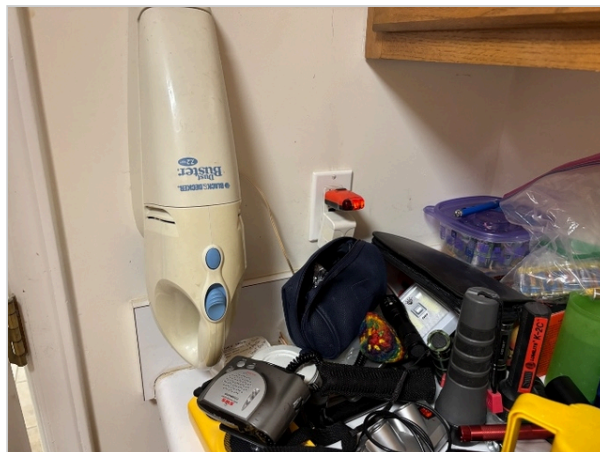
The GFI outlet at The laundry room did not trip when tested. This is a function/safety concern. Recommend repairs by a qualified contractor.

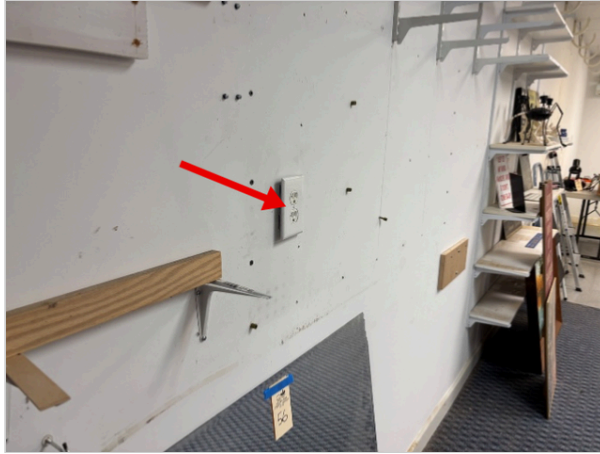
Loose outlet observed at The basement. This is a damage/safety concern. Recommend repairs by a qualified person.

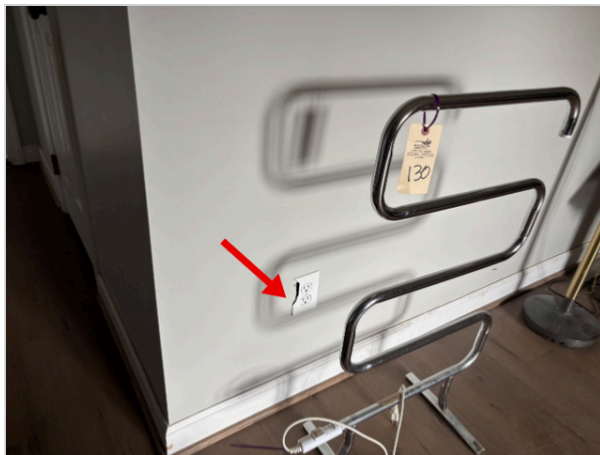
A broken electrical outlet was observed at The master bedroom. This is a safety and damage concern. Recommend repairs by a qualified contractor.

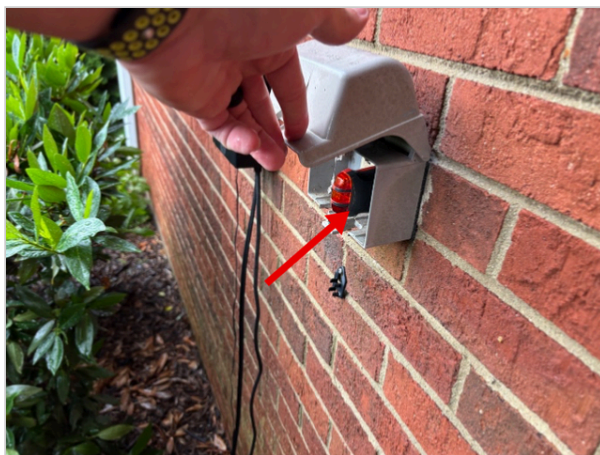
No power was tested at the electrical outlet at The exterior. This is a wiring/function concern. Recommend review and repairs as directed by qualified contractor.

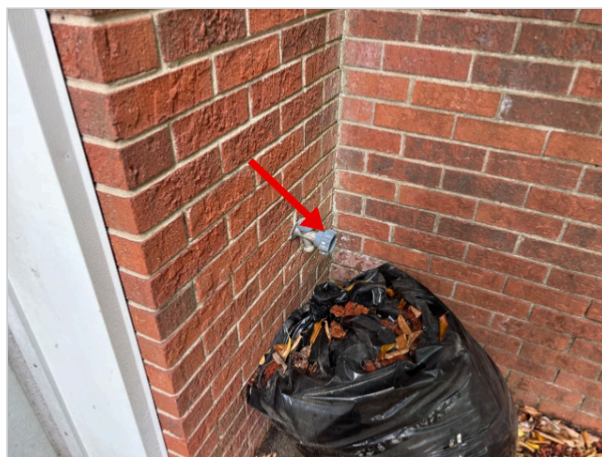
The plumbing fixture did not operate at The rear exterior. This is a function concern. Recommend repairs by a qualified contractor.

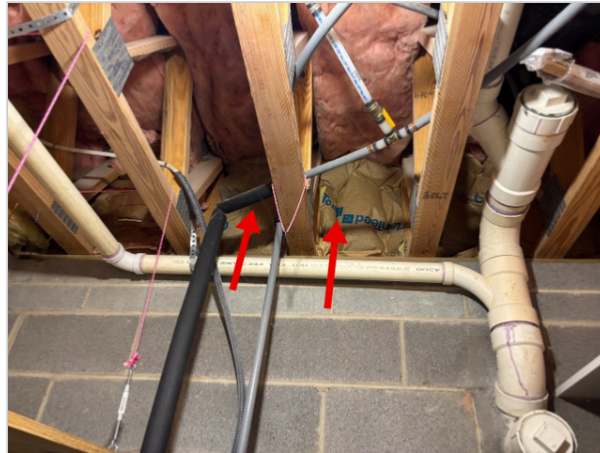
The insulation was installed in areas of the basement with the paper backing exposed. This is an installation/function concern as the paper backing is typically installed towards the conditioned side of the house. Recommend repairs by qualified contractor.

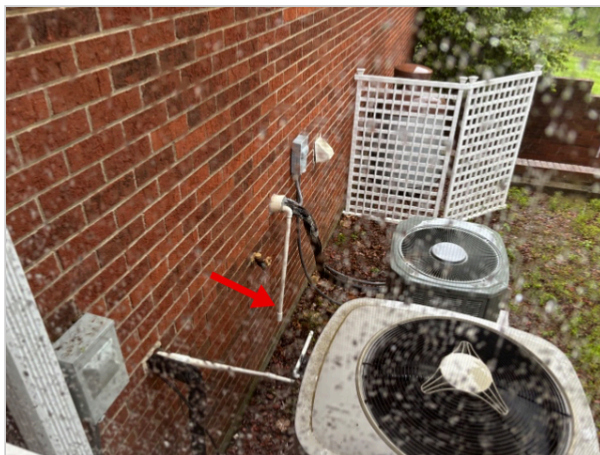
The AC condensate drain line was not properly sloped at The rear exterior. This is a drainage concern. Recommend repairs by a qualified contractor.
