Structural Engineering Investigation
For
Joe Gribbins
Estate of Dr. Robert Sexton, Jr.
10410 Forest Garden Lane
Louisville, KY 40223
Job No. 2022-534

By
Nathan Grimes, P.E., P.L.S., C.F.E.I., C.F.I.I., R.H.I.

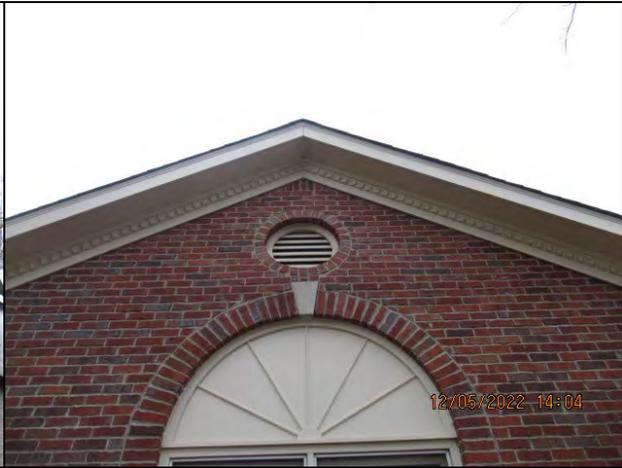
9. There are brick veneer masonry joint cracks on front facade, right side facade, and rear facade in several locations. These cracks vary in width from hairline to 2.5mm and none were offset. There is evidence that brick veneer masonry joints have been repaired in other locations previously.

Brick Veneer Masonry Joint Cracks Front Facade

- 23. All interior drywall cracks should be repaired with fiberglass mesh tape.
- 24. All brick veneer masonry joint cracks should be tuckpointed with mortar that matches the existing to keep stormwater infiltration from entering wall assembly and causing further damage.

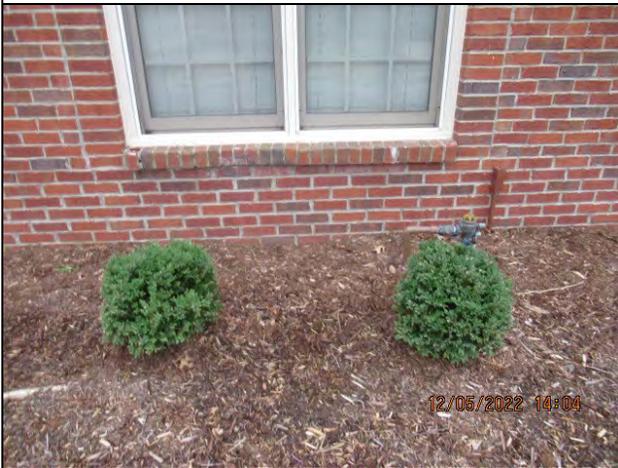
Brick Veneer Masonry Joint Cracks Front Facade

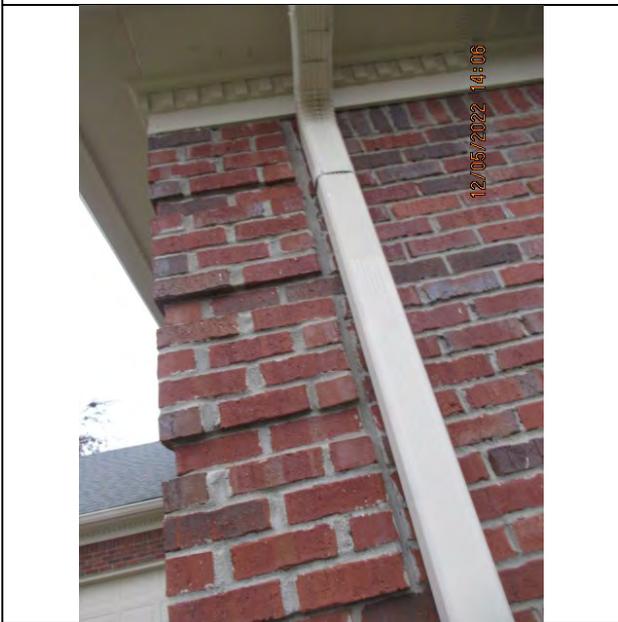
Brick Veneer Masonry Joint Crack Right Side Facade

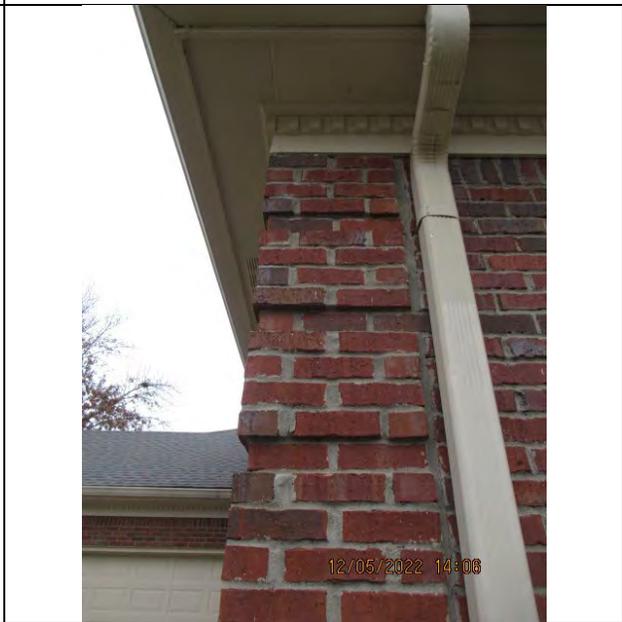
Brick Veneer Masonry Joint Crack Right Side Facade

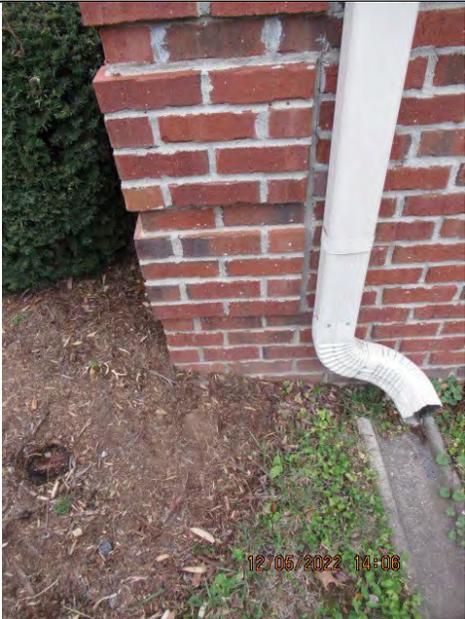
Brick Veneer Masonry Joint Crack Right Side Facade

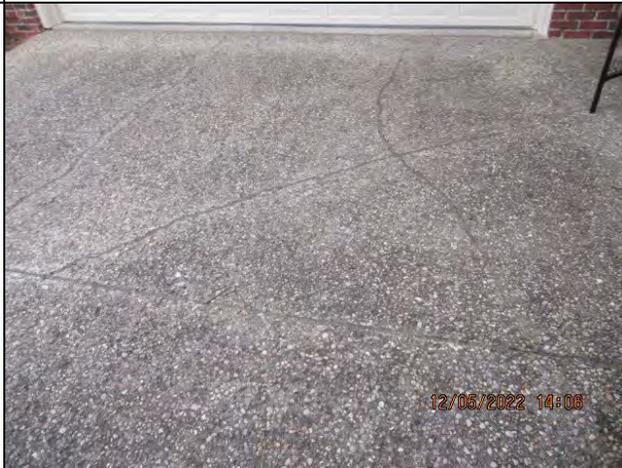
13. There are repaired cracks in concrete driveway slab that were up to ¾” in width.
14. The interior garage window trims have separated on front wall of house.

Repaired Concrete Driveway Slab Cracks

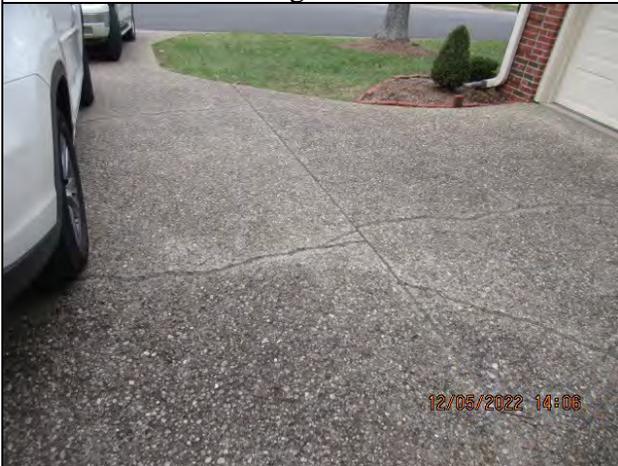
Repaired Concrete Driveway Slab Cracks

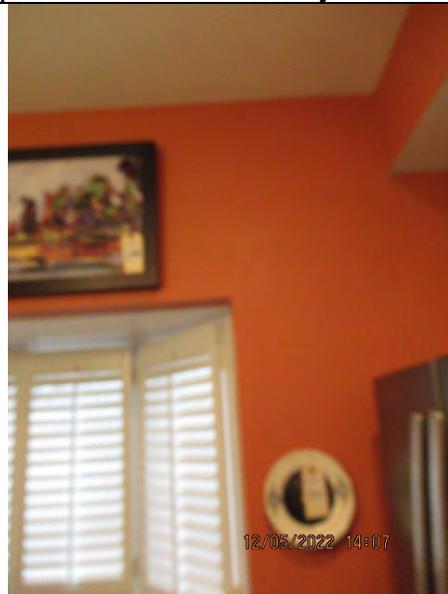
10. On the right side there is an opening between concrete foundation wall and brick veneer of 5.5mm in one location at base of exterior wall.
11. There are drywall cracks in garage front wall, kitchen right side wall, and front office right side wall. These cracks vary in width from hairline to 1.00mm and none of them are offset.

Drywall Crack in Kitchen Right Wall

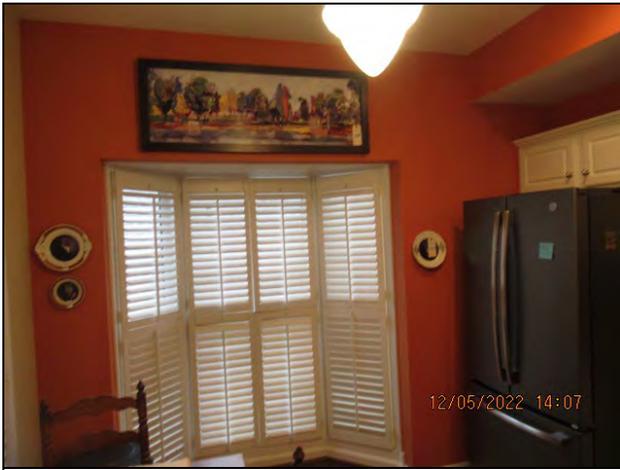
Drywall Crack in Kitchen Right Side Wall

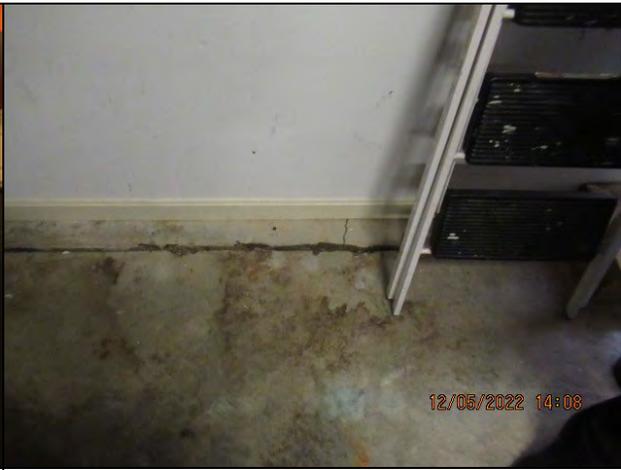
19. There is an offset in joint in garage floor slab near rear wall of garage. This offset is ½” height at the joint in the concrete floor slab.
20. Most of the reinforced basement and foundation walls are not visible on exterior of the house due to the finished grade of the soil.
21. The visible garage and basement concrete slab floors were not cracked except as listed above.

Offset Joint in Garage Floor

- 25. Garage floor slab joint crack and rear patio slab crack should be sealed with concrete crack sealer.
- 26. Basement wall cracks should be sealed with injected concrete crack sealer.

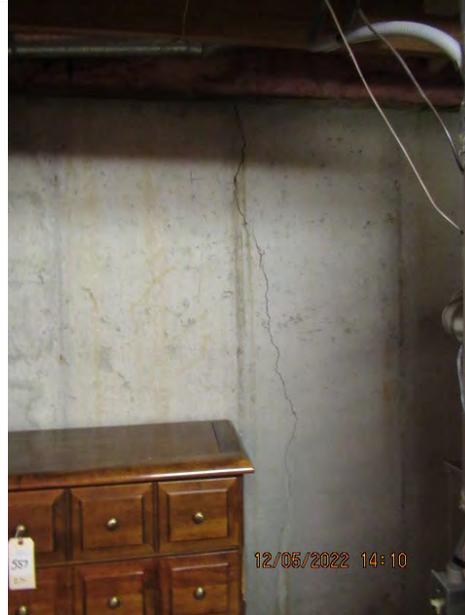
12. The rear walkout basement is completely finished except for a mechanical room area that is a rear of garage. There are 2 vertical cracks in reinforced concrete basement walls in the mechanical room. One is 2.5mm in width and is not offset. The other is in corner where rear of garage and basement wall meet common wall with adjoining property. This crack varies in width up to 5/8” in width and is entire height of basement wall. There is no visible reinforcing steel in the crack. The reinforced concrete basement wall is 7’-8 ½ tall. There is no evidence of ground water or storm water entering these basement wall cracks.

Foundation Crack in Basement Mechanical Room Wall

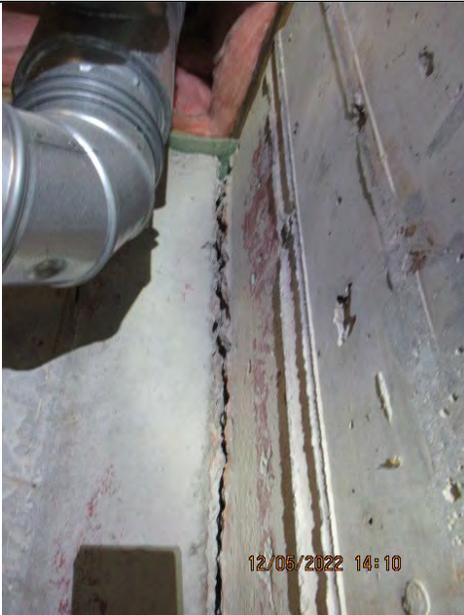
Foundation Crack in Basement Mechanical Room Wall

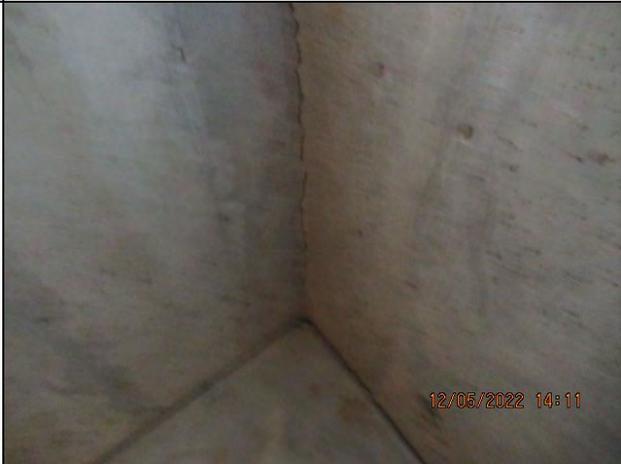
Foundation Crack in Basement Mechanical Room Wall

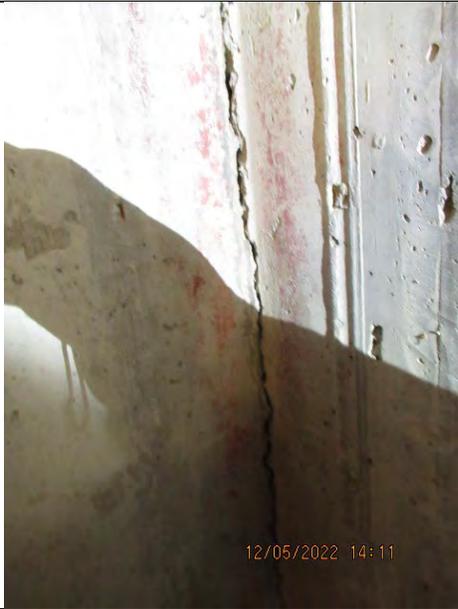
Foundation Crack in Basement Mechanical Room Wall

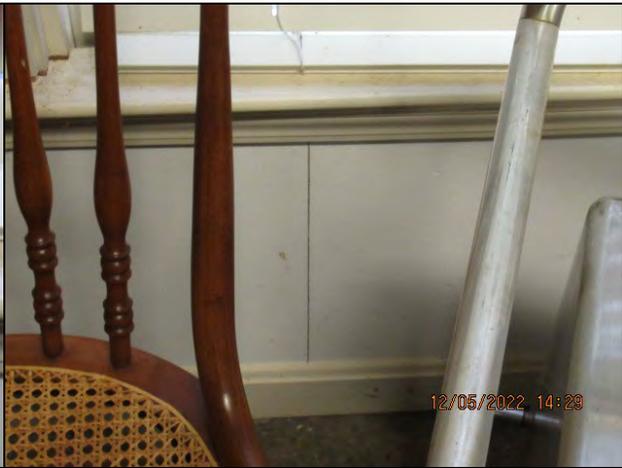
Drywall Crack in Garage Front Wall

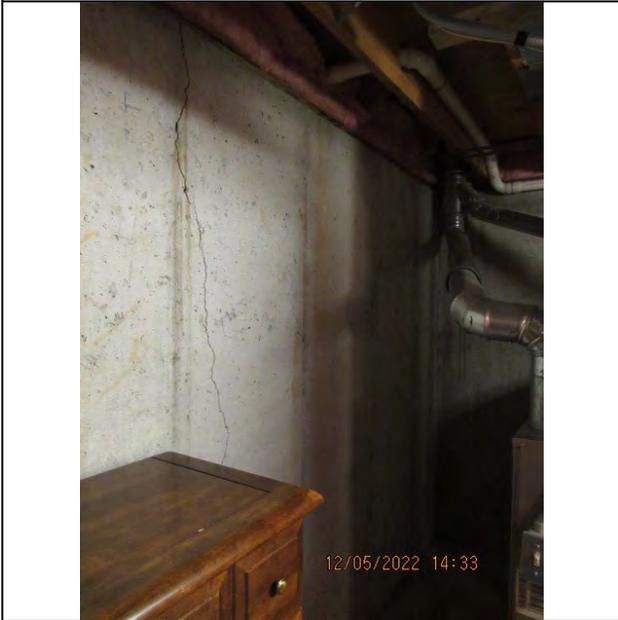
Foundation Crack in Basement Mechanical Room Wall

- 29. Separated garage windowsill and trim should be re-caulked and painted to match existing. Repair using exterior polyurethane caulking.
- 30. The large crack in corner of basement mechanical room needs to be repaired with injected concrete crack sealer as stated in item # 26 above but it also needs to be reinforced since there is no visible steel tying the 2 walls together. Reinforce as shown on attached detail.

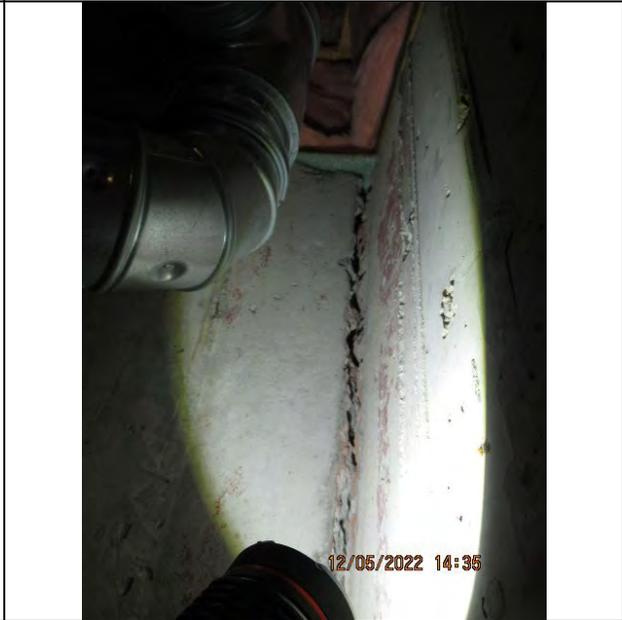
Foundation Crack in Basement Mechanical Room Wall

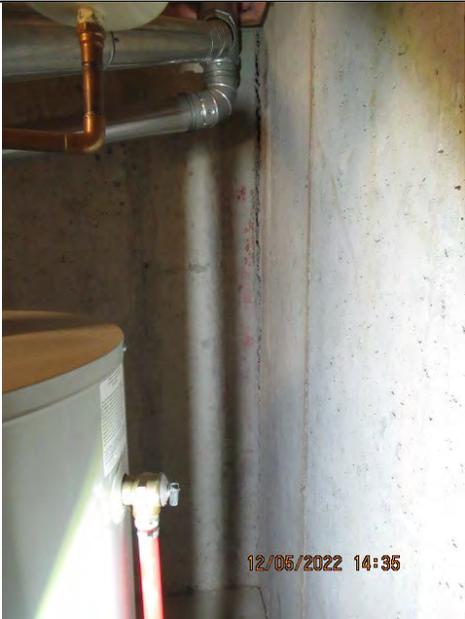
Foundation Crack in Basement Mechanical Room Wall

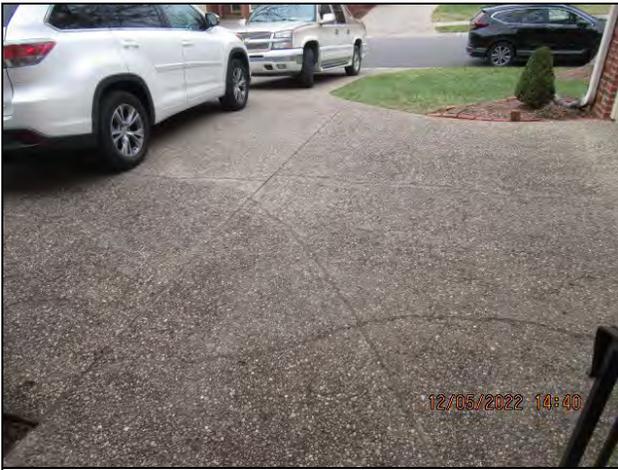
Repaired Concrete Driveway Slab Cracks

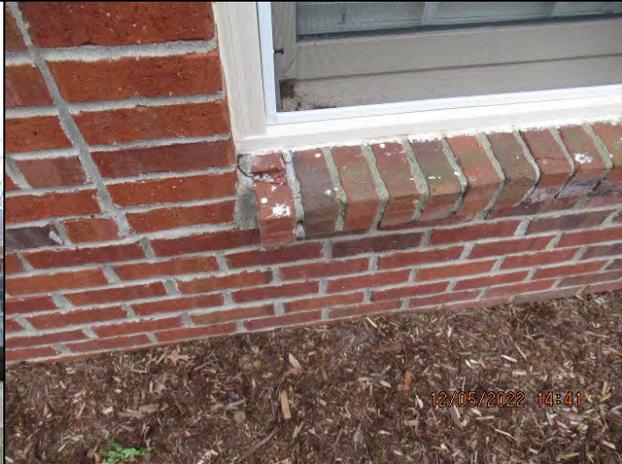
Brick Veneer Masonry Joint Cracks Front Facade

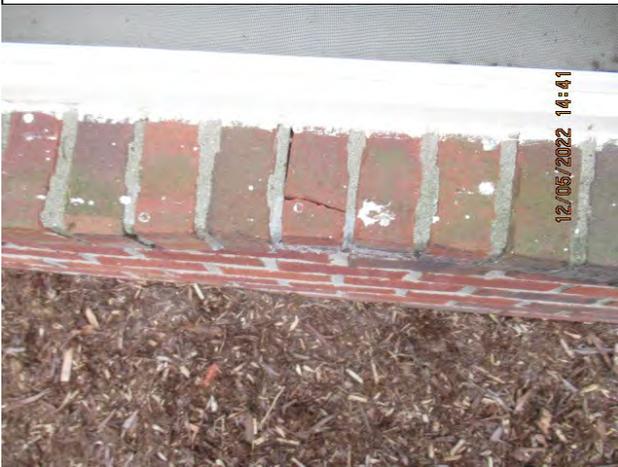
Brick Veneer Masonry Joint Cracks Front Facade

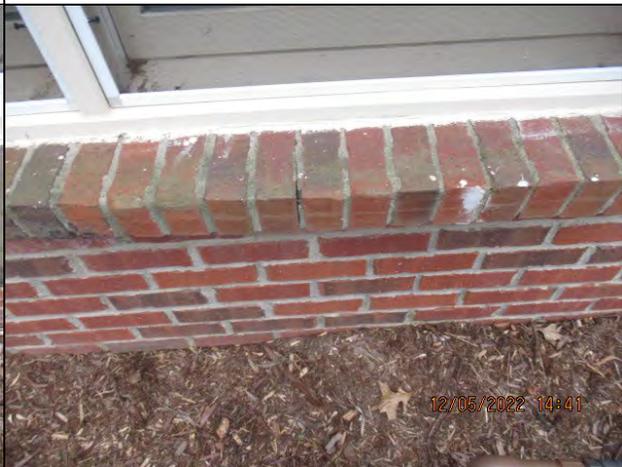
Brick Veneer Masonry Joint Cracks Front Facade

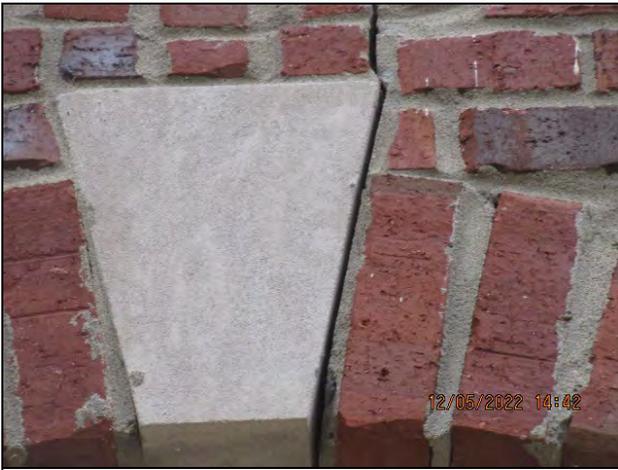
Brick Veneer Masonry Joint Cracks Front Facade

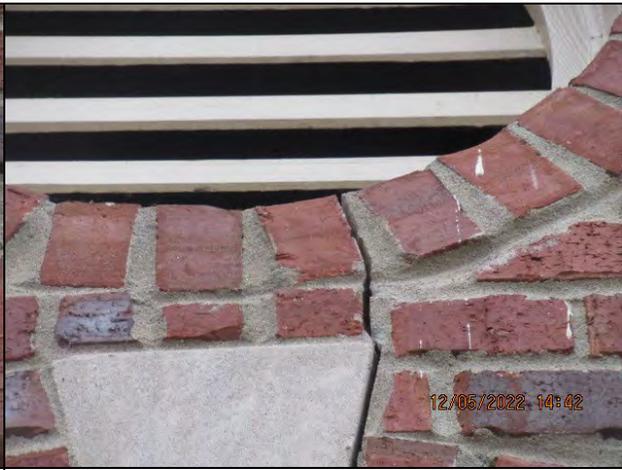
Brick Veneer Masonry Joint Cracks Front Facade

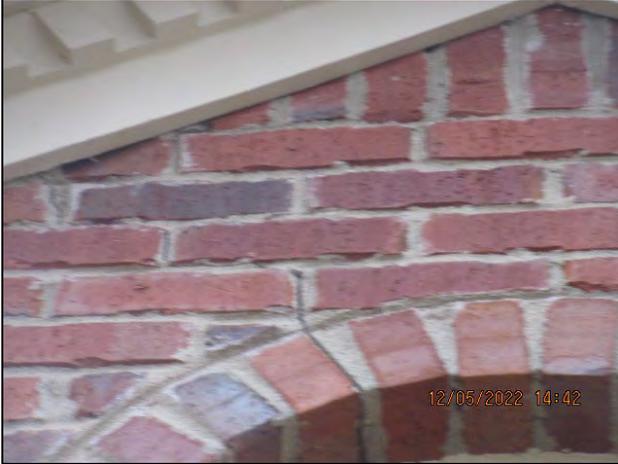
Brick Veneer Masonry Joint Cracks Front Facade

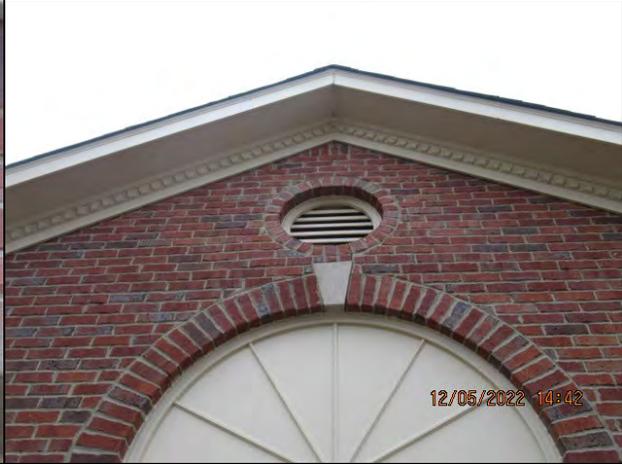
Brick Veneer Masonry Joint Cracks Front Facade

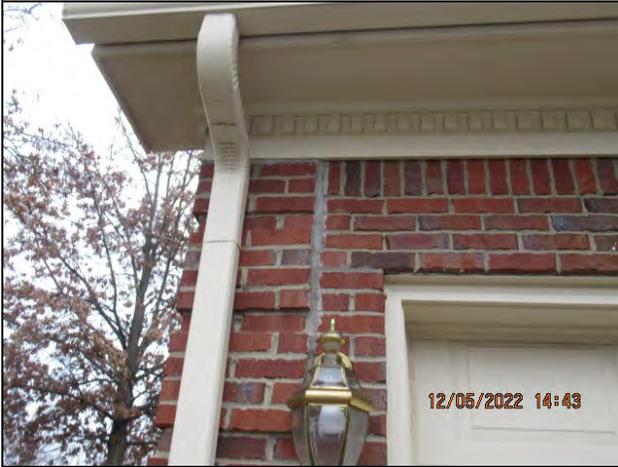
Previous Repaired Brick Veneer Masonry Joint Crack Front Facade

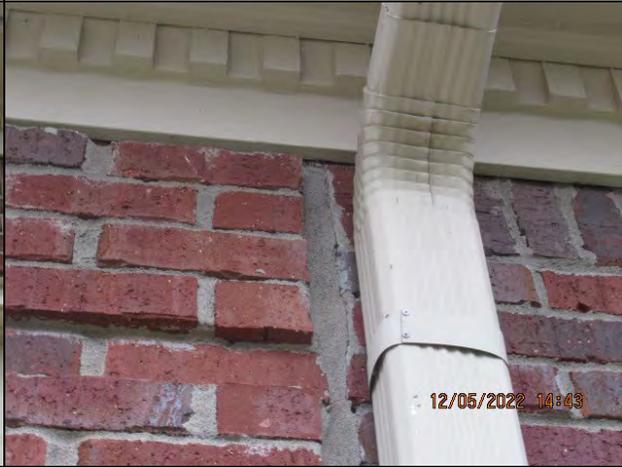
Previous Repaired Brick Veneer Masonry Joint Crack Right Side Facade

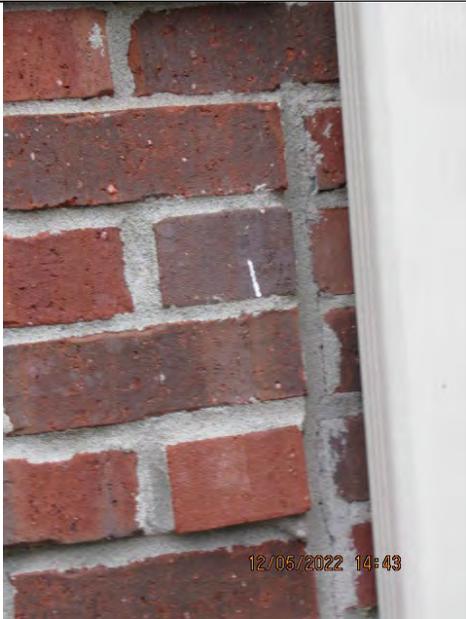
Previous Repaired Brick Veneer Masonry Joint Crack Right Side Facade

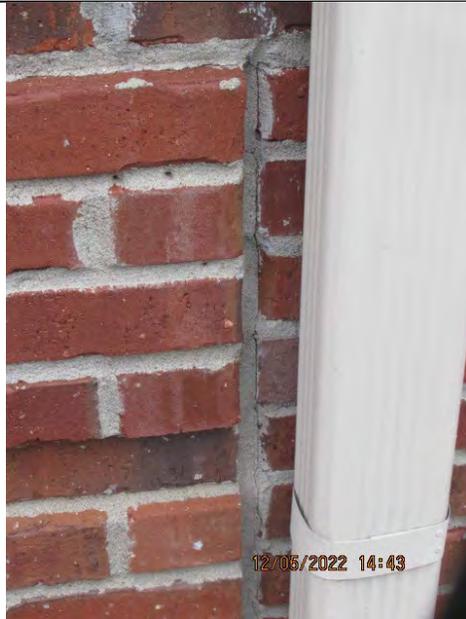
Previous Repaired Brick Veneer Masonry Joint Crack Right Side Facade

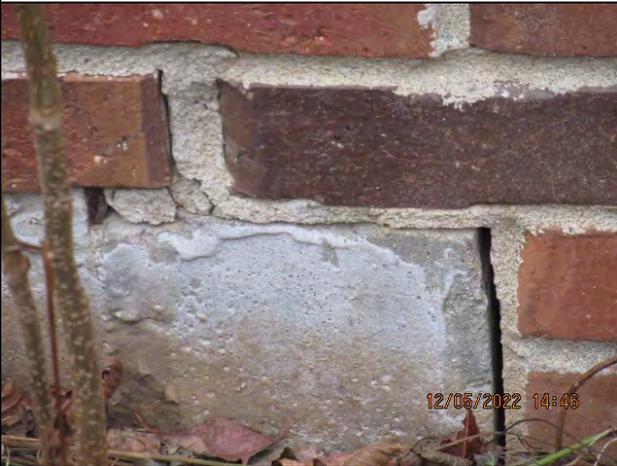
Brick Veneer Masonry Joint Crack Right Side Facade

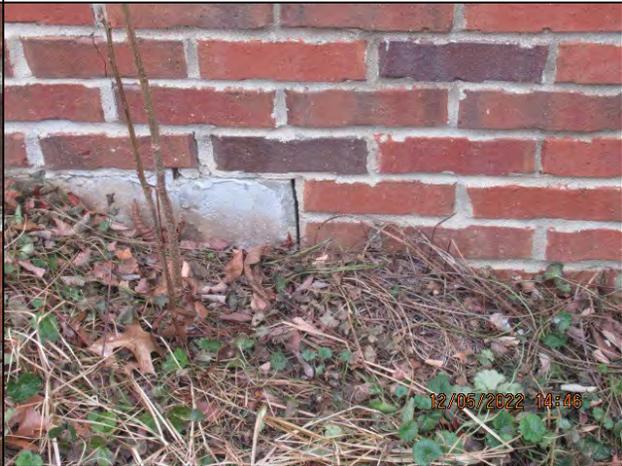
Brick Veneer Masonry Joint Crack Right Side Facade

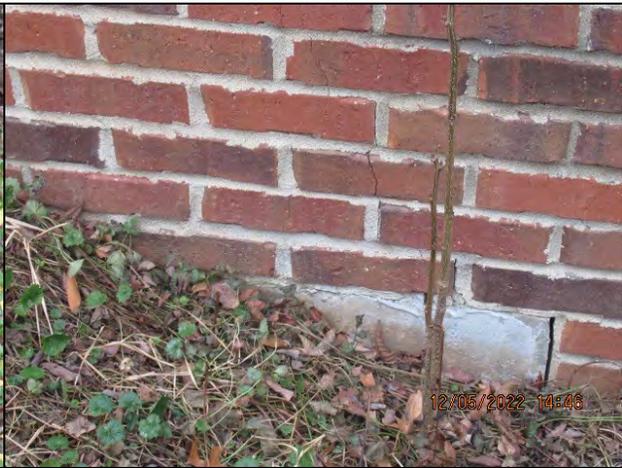
Brick Veneer Masonry Joint Crack Right Side Facade

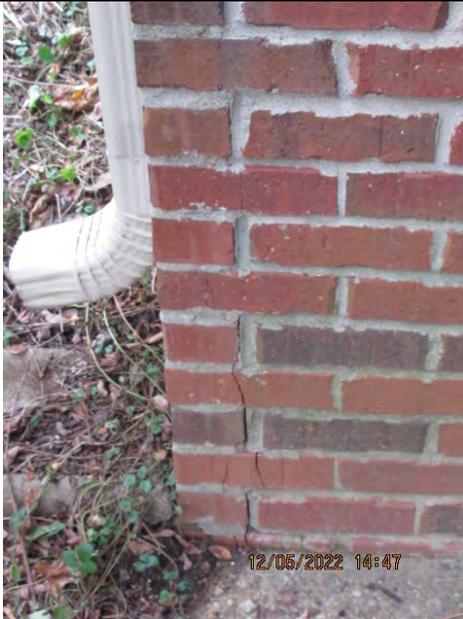
Brick Veneer Masonry Joint Cracks Rear Facade

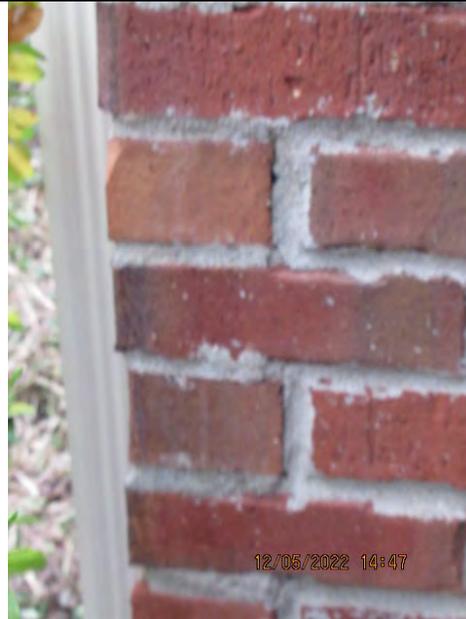
Brick Veneer Masonry Joint Cracks Rear Facade

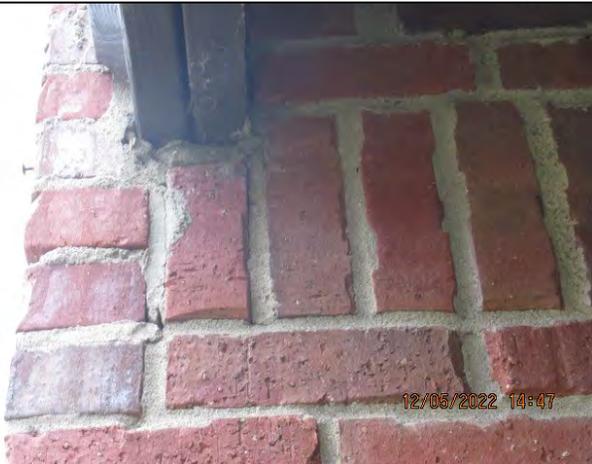
Brick Veneer Masonry Joint Cracks Rear Facade

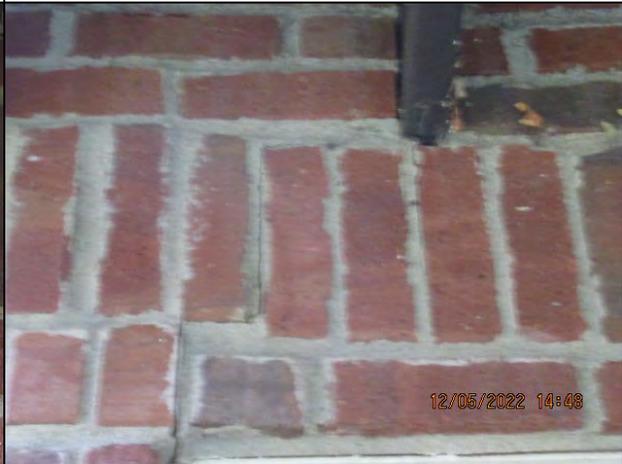
Brick Veneer Masonry Joint Cracks Rear Facade

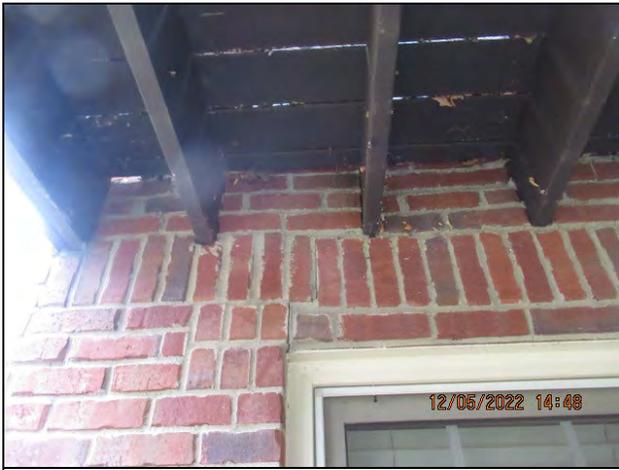
Brick Veneer Masonry Joint Cracks Rear Facade

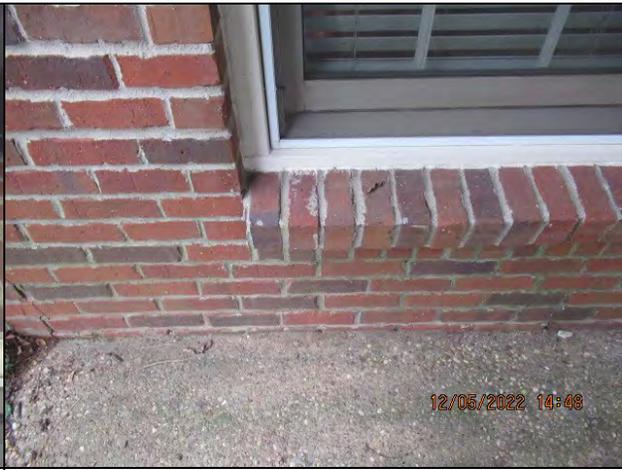
Brick Veneer Masonry Joint Cracks Rear Facade

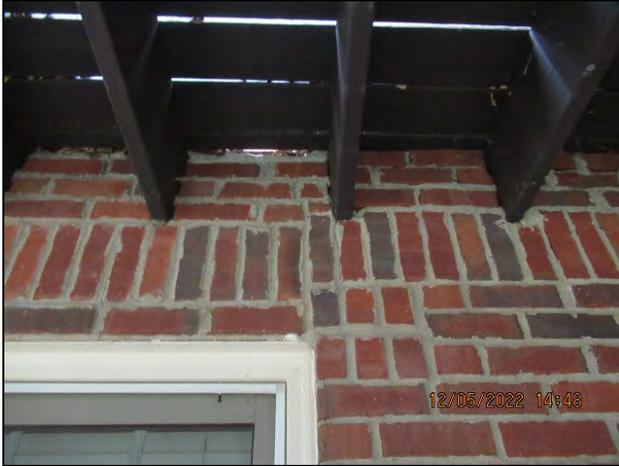
Brick Veneer Masonry Joint Cracks Rear Facade

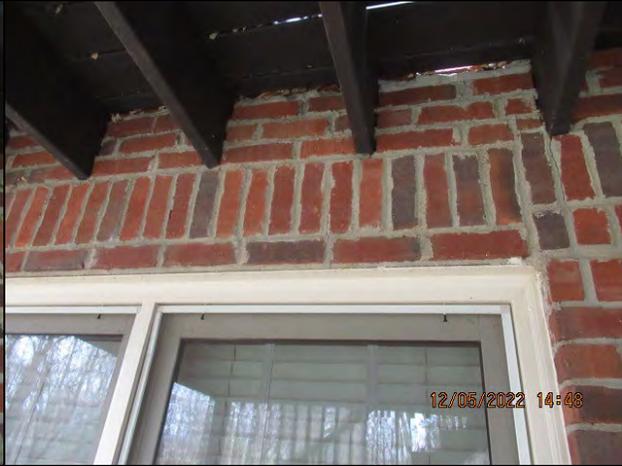
Brick Veneer Masonry Joint Cracks Rear Facade

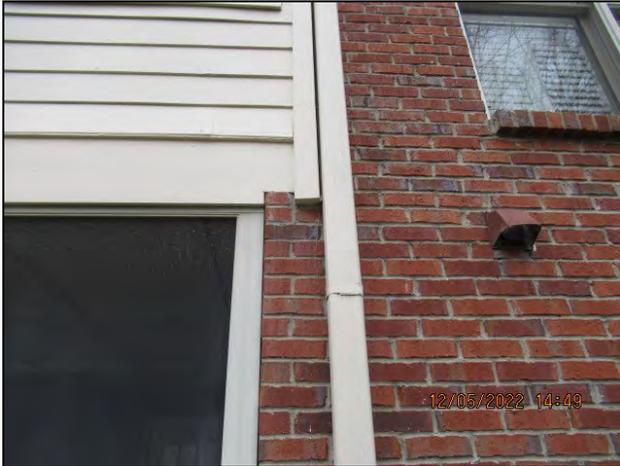
Brick Veneer Masonry Joint Cracks Rear Facade

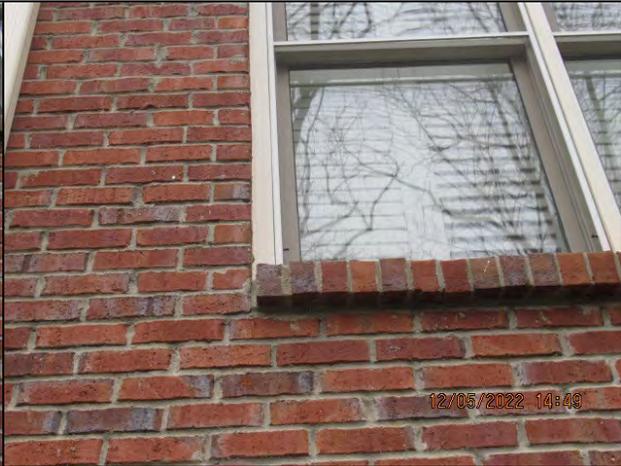
Brick Veneer Masonry Joint Cracks Rear Facade

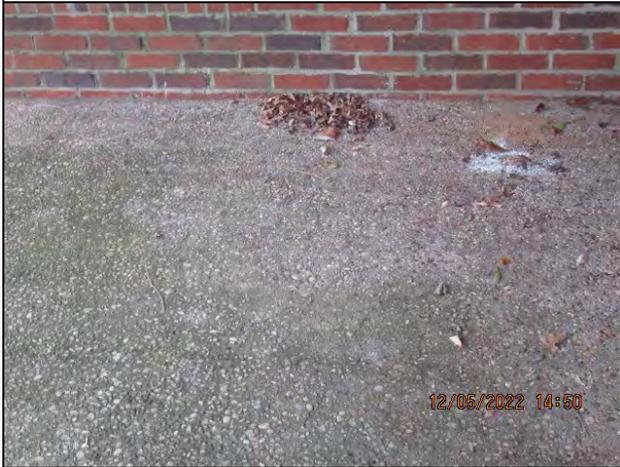
15. All windows and doors were operable.
16. There is a crack in joint connection of rear concrete patio to the brick veneer and also a crack in the patio slab itself in one location. Neither of these are offset.

Rear Patio Slab Cracks Detail

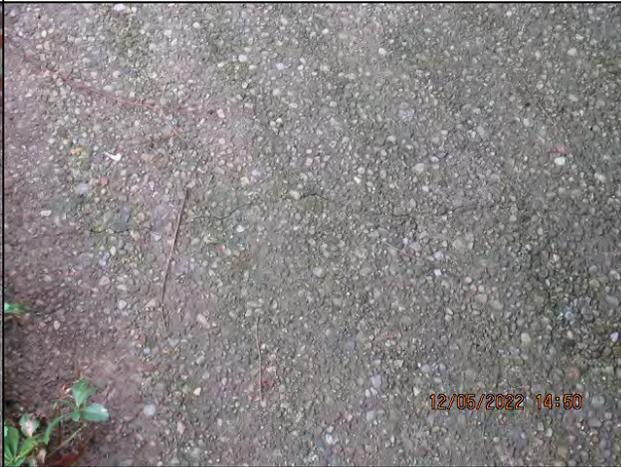
Rear Patio Slab Cracks Detail

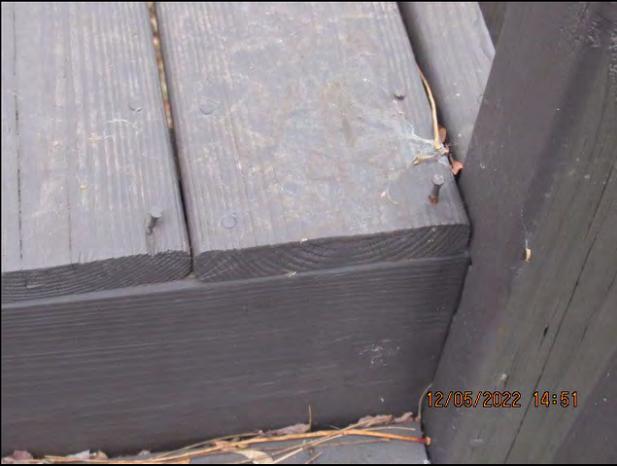
17. The caulking seam has failed at rear wood deck where the Hardi-Board wall connects the brick veneer wall.
18. There are several loose nails on wood deck that connect deck boards to framing on the rear deck.

Loose Nails Rear Patio Detail

- 28. All loose nails and missing nails on rear deck boards should be removed and replaced with exterior deck screws to securely fasten deck boards to deck framing structure.

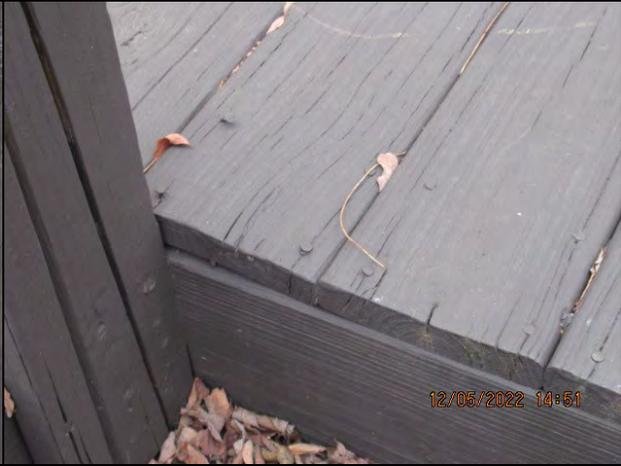
Loose Nails Rear Patio Detail

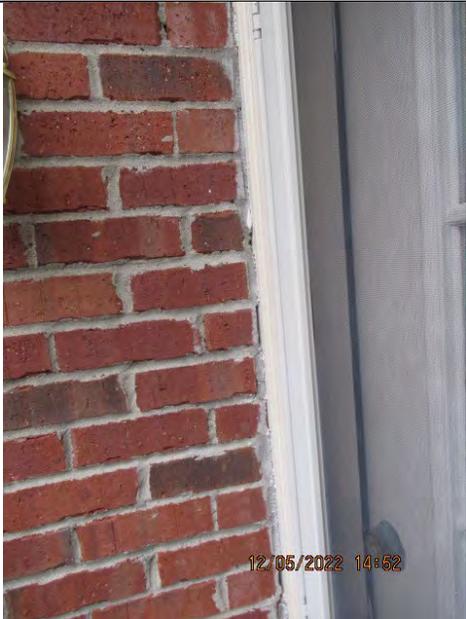
Caulking Seam Crack at 2nd Floor Deck

- 27. The failed caulking joint between Hardi-Board siding and brick veneer walls at rear deck should be recalced to keep storm water infiltration from entering walls and causing further damage. Repair using exterior polyurethane caulking.

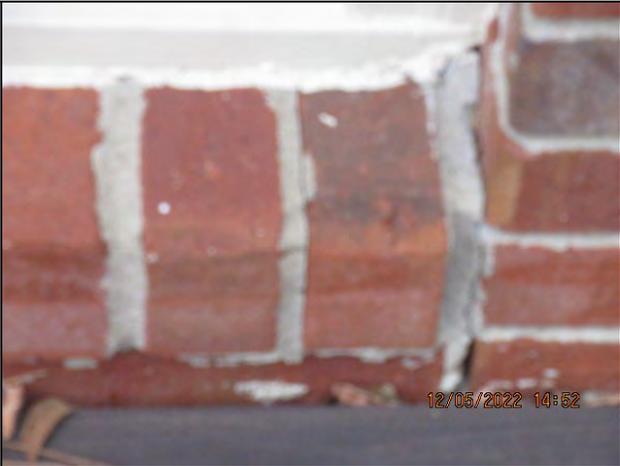
Brick Veneer Masonry Joint Cracks Rear Facade

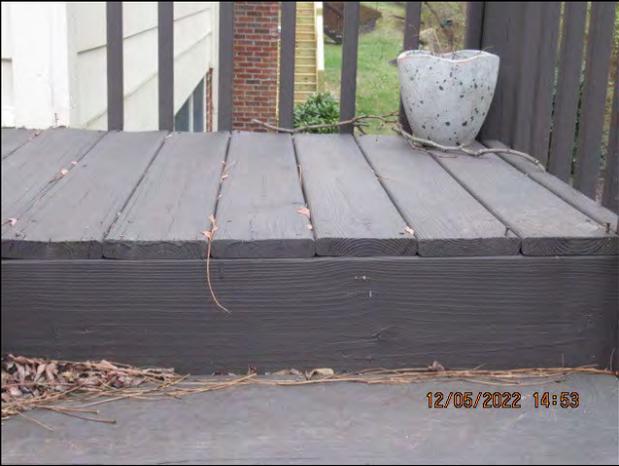
Loose Nails Rear Patio Detail

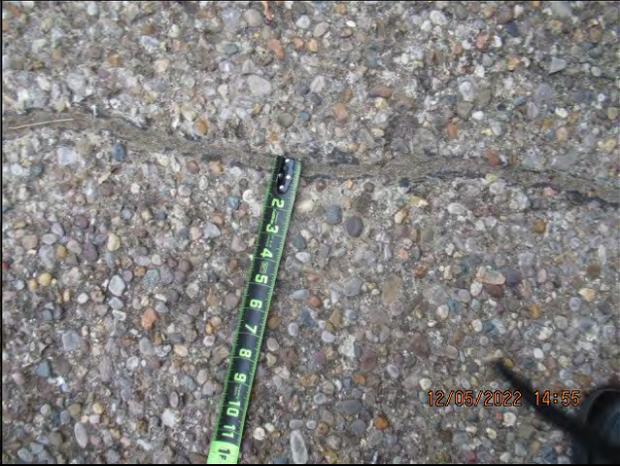
Driveway Concrete Slab Repaired Crack Detail
