Wood Destroying Insect Inspection Report Notice: Please read important consumer information on page 2.							
Section I. General Information	Company's Pest Control Business Lic. No. Date of Inspection						
Inspection Company, Address & Phone	LPCO-474 2023-08-04		2023-08-04				
Black Diamond Termite & Pest Control, Inc.	Address of Property Inspected						
4911 Hamburg Pike	3204 SENECA PARI						
Jeffersonville, IN 47130 (812) 944-0453 (502) 585-1919	Louisville, KY 40207

Inspection Photos

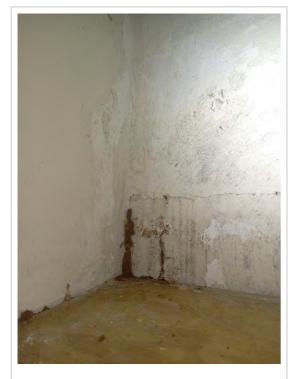
termites in shelter tube in garage

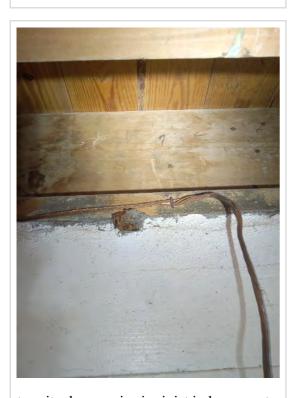
termite damage in rim joist in basement

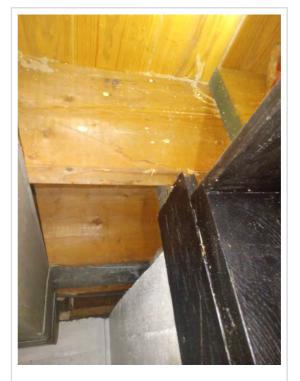
termite damage in floor joist in basement
