Home Inspection Report

53 W. Harris St.

Cuthbert, GA

Inspected on Tue, Jan 31 2023 at 10:00 AM

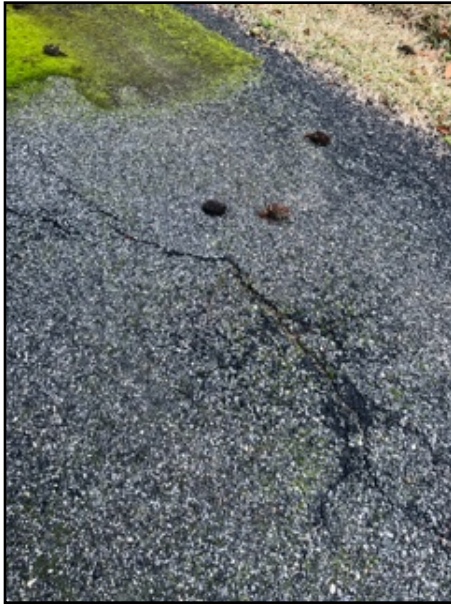
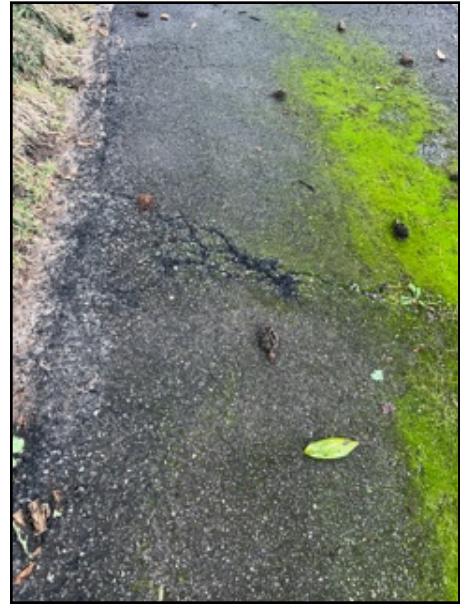
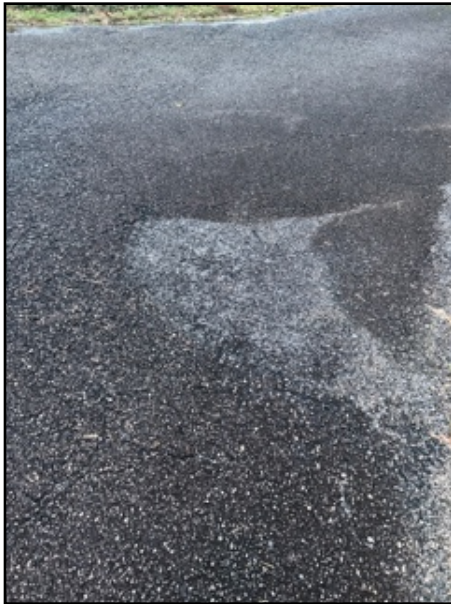
Driveway- Driveway has cracking in some areas throughout. This can be caused by settlement of the ground beneath, or underground roots. Recommend seal cracks or repair/resurface as deemed necessary by a qualified contractor.

1) Comment 3: Driveway- Driveway has cracking in some areas throughout. This can be caused by settlement of the ground beneath, or underground roots. Recommend seal cracks or repair/resurface as deemed necessary by a qualified contractor.

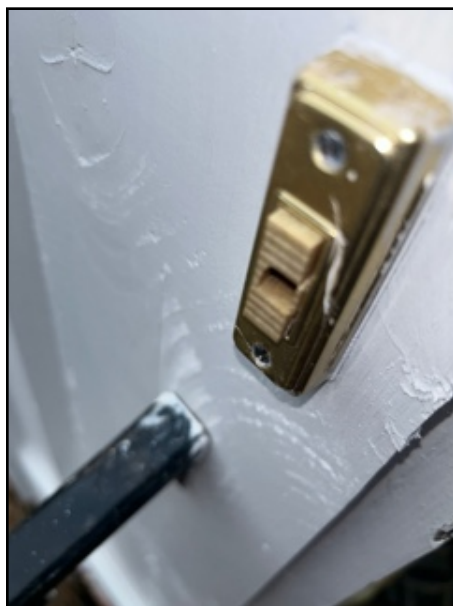
Figure 4-1

Exterior- Front door bell not functioning. Recommend repair.

2) Comment 4: Exterior- Front door bell not functioning. Recommend repair.

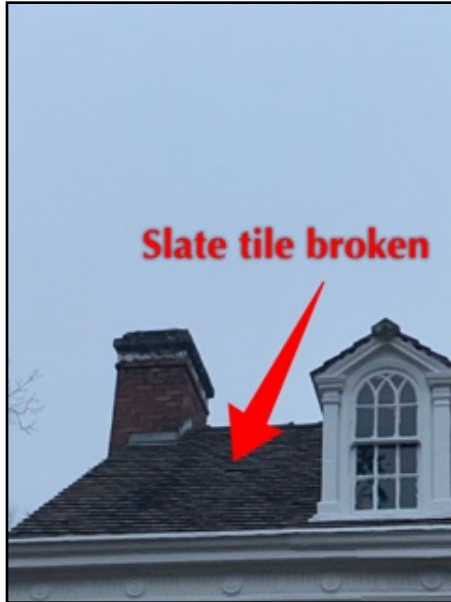
Figure 5-1

Roofing- in the front, there is visual evidence of a broken shingle. Recommend repair as necessary.

3) Comment 5: Roofing- in the front, there is visual evidence of a broken shingle. Recommend repair as necessary.

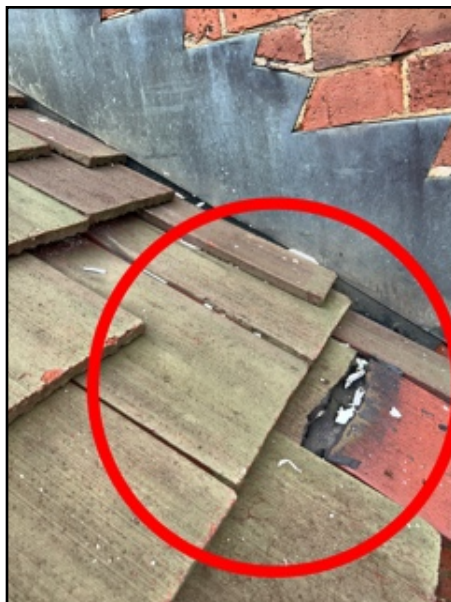
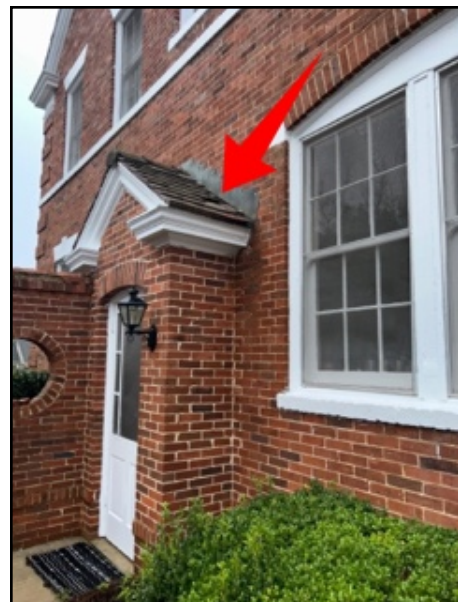
Roofing- on the left side above the left side entrance, a tile shingle is missing. Recommend repair as necessary to prevent leaks.

4) Comment 6: Roofing- on the left side above the left side entrance, a tile shingle is missing. Recommend repair as necessary to prevent leaks.

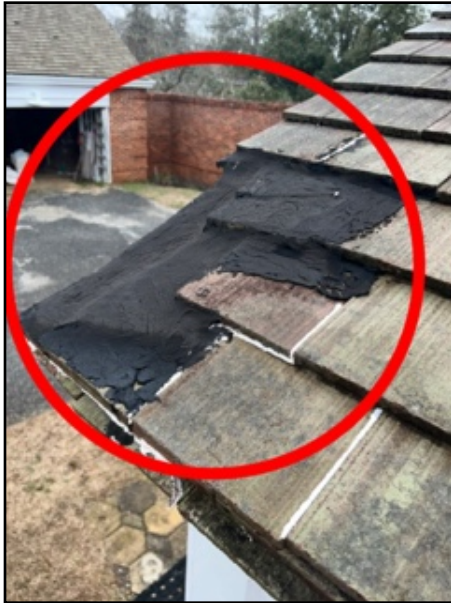
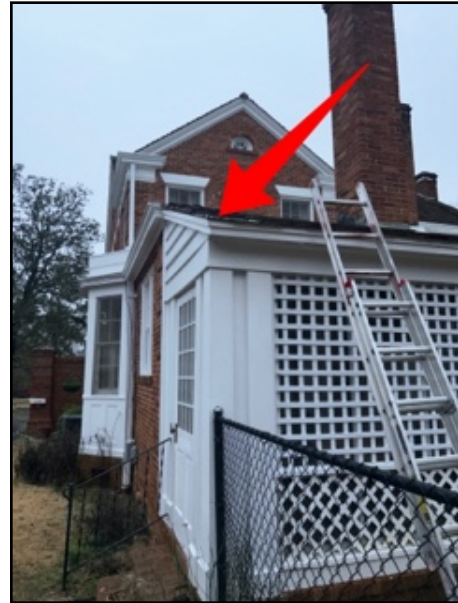
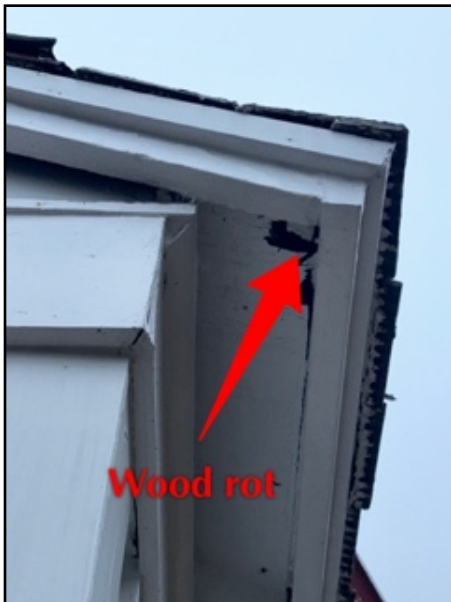
Roofing- on the back left corner, there is missing tiles and an unprofessional repair. There is evidence of leaks in this area because there is wood rot underneath on the soffit. Recommend repair as necessary.

5) Comment 7: Roofing- on the back left corner, there is missing tiles and an unprofessional repair. There is evidence of leaks in this area because there is wood rot underneath on the soffit. Recommend repair as necessary.

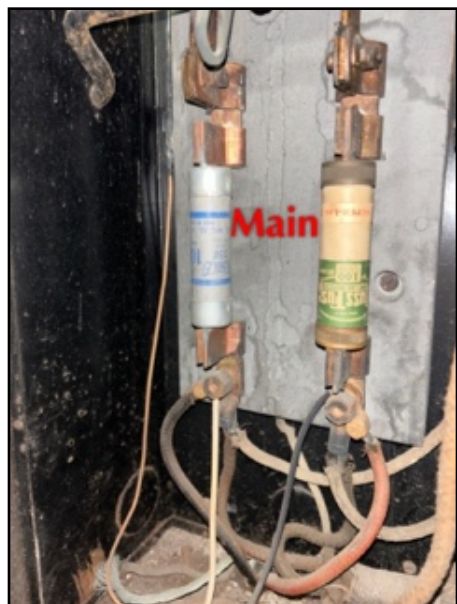
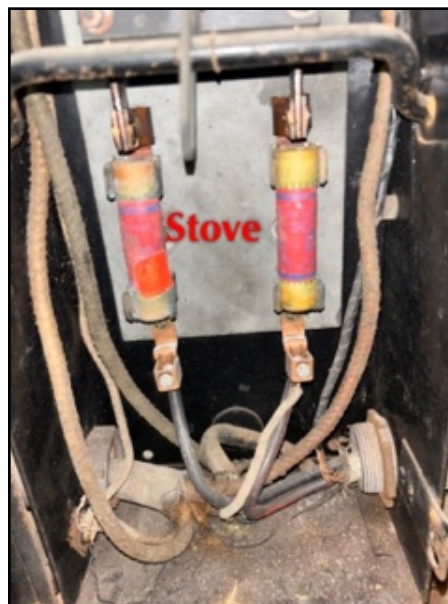
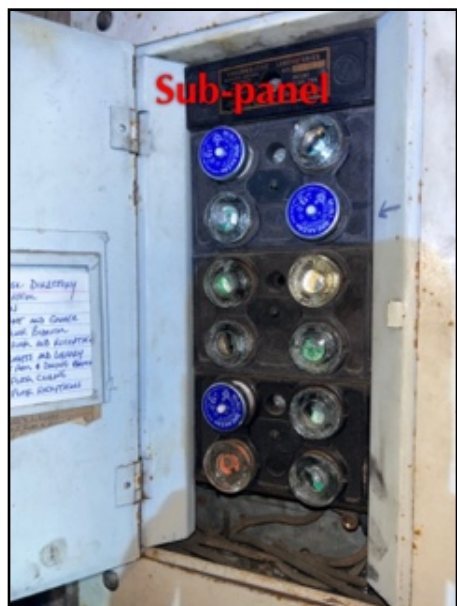
Electrical- Fused electrical panels were discontinued in the 1970's they were found to be unreliable and inconvenient. Recommend inspection by a licensed electrician for recommendations and estimates of replacement to a standard breaker panel.

7) Comment 10: Electrical- Fused electrical panels were discontinued in the 1970's they were found to be unreliable and inconvenient. Recommend inspection by a licensed electrician for recommendations and estimates of replacement to a standard breaker panel.

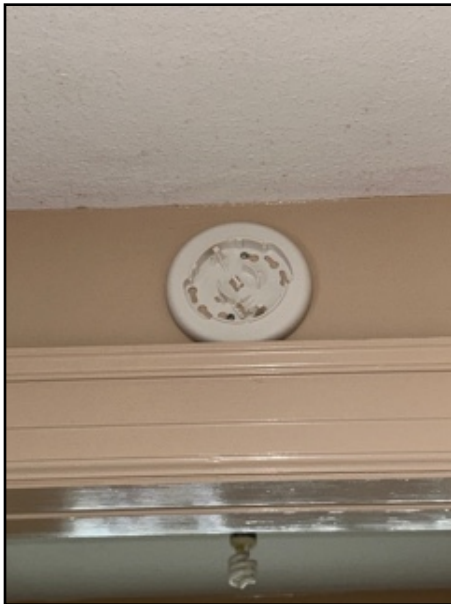
Figure 11-1

Smoke detectors are missing. Recommend installing for safety.

8) Comment 11: Smoke detectors are missing. Recommend installing for safety.

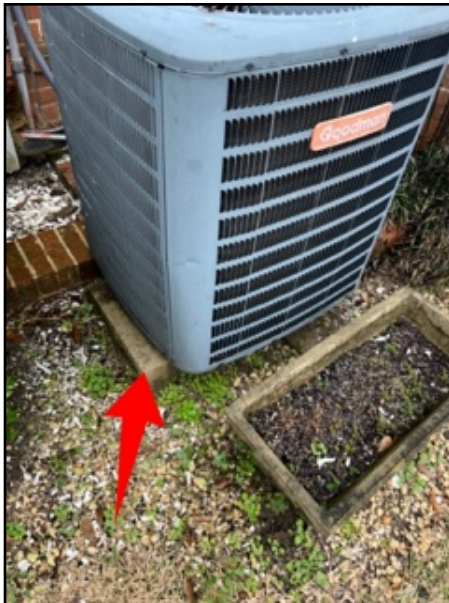
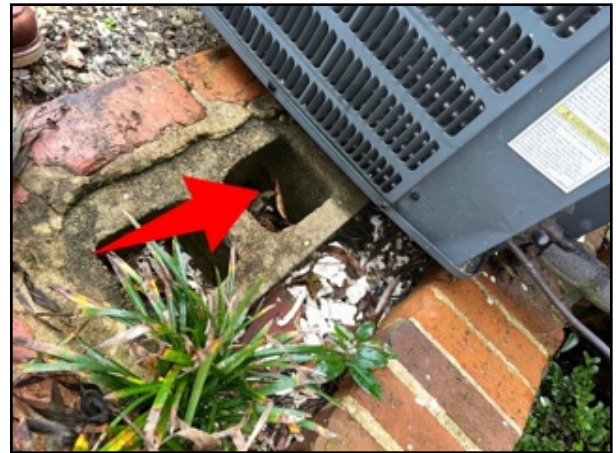
HVAC- the exterior compressor unit is not resting on solid foundation. Unit rocks back and fourth. The unit is not stable. Recommend supporting with shims or what is needed to stabilize the unit.

9) Comment 13: HVAC- the exterior compressor unit is not resting on solid foundation. Unit rocks back and fourth. The unit is not stable. Recommend supporting with shims or what is needed to stabilize the unit.

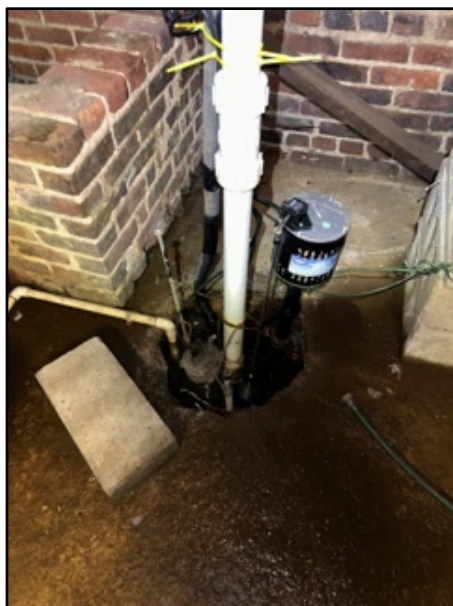
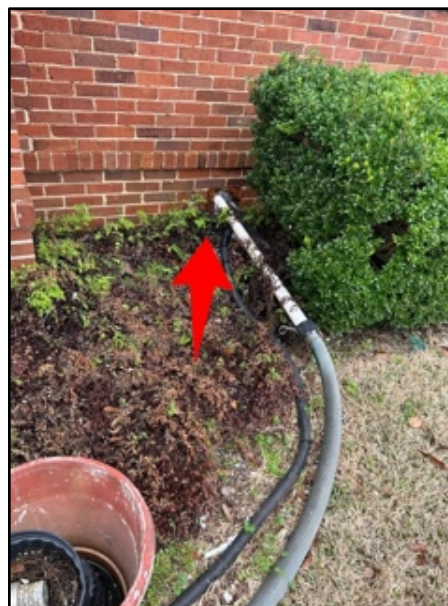
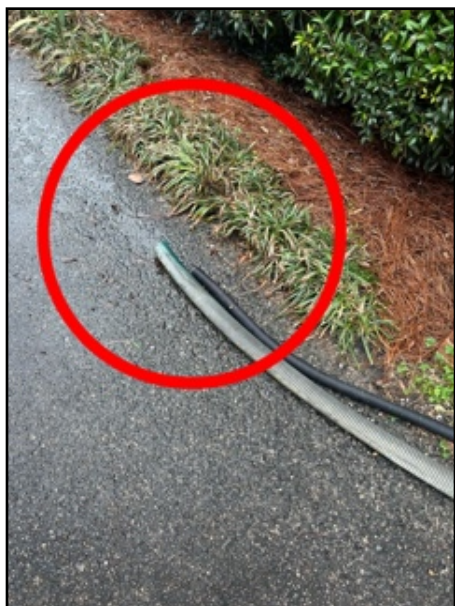
Plumbing- the basement sump pumps discharge outside the home in the drive way. Recommend re-routing drain pipes to connect with the sewer underground.

10) Comment 14: Plumbing- the basement sump pumps discharge outside the home in the drive way. Recommend re-routing drain pipes to connect with the sewer underground.

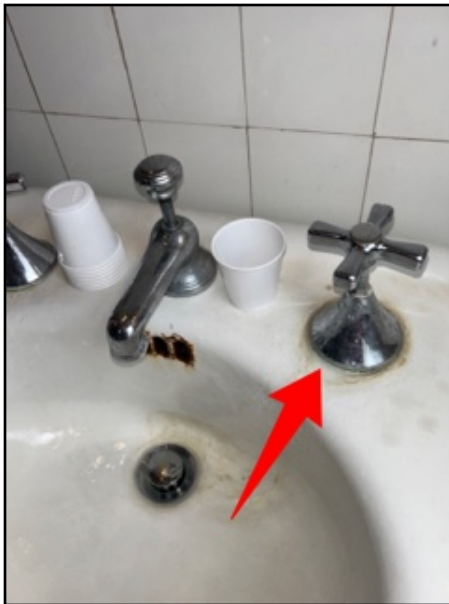
Figure 16-1

Bathroom 3- at the sink, the right faucet leaks around the base when it is turned on. Recommend repair.

11) Comment 16: Bathroom 3- at the sink, the right faucet leaks around the base when it is turned on. Recommend repair.

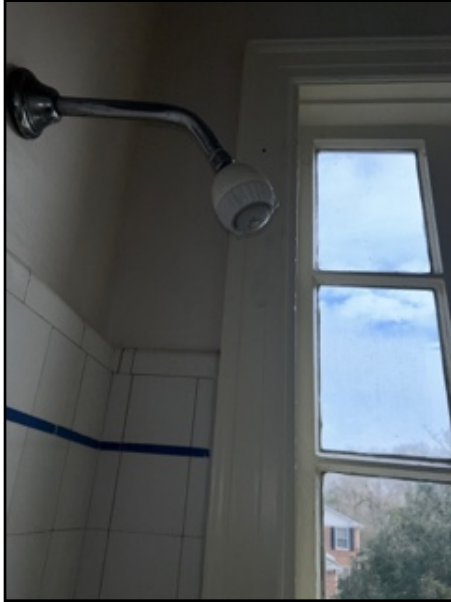
Figure 17-1

Bathroom 4- the shower has no running water at either knob. Recommend evaluation and repair as necessary.

12) Comment 17: Bathroom 4- the shower has no running water at either knob. Recommend evaluation and repair as necessary.
