SENTRY INSPECTION SERVICES, LLC / SENTRY HOME INSPECTIONS

RESIDENTIAL PROPERTY INSPECTION

112 Loblolly Rd SW
Moultrie, GA 31768

MARCH 17, 2023

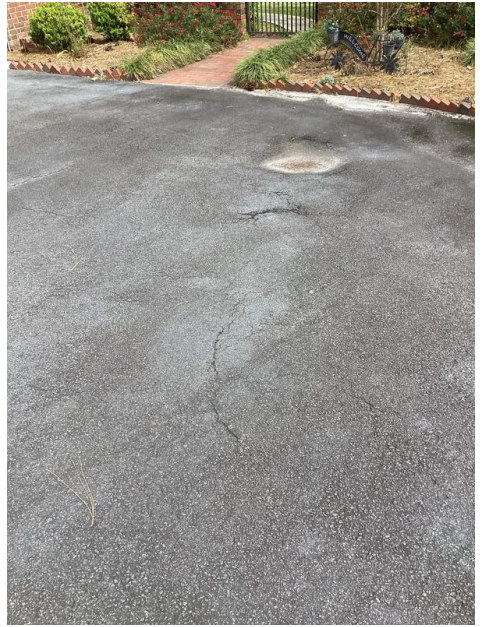
Driveway and Walkway Condition: Typical Settlement / Shrinkage Cracks

Settlement / shrinkage cracks were present on the concrete surface (<1/4 inch wide). These can typically be from standard settlement, from admixtures or the composition of the concrete, or weather conditions when the concrete was poured. I recommend sealing these cracks at a minimum, to prevent further damage.

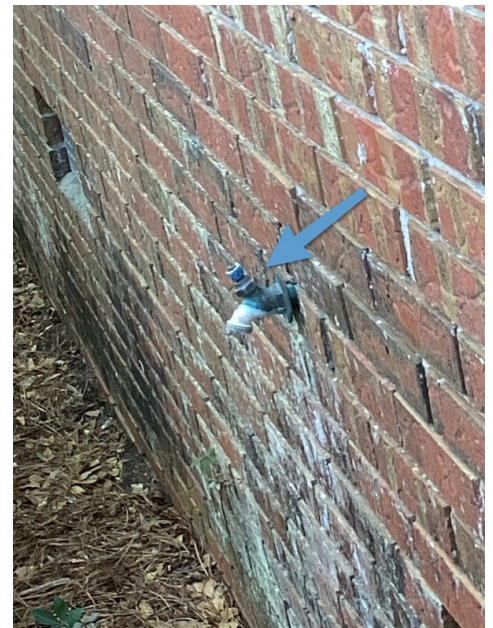
HANDLE MISSING

Contact a qualified professional.

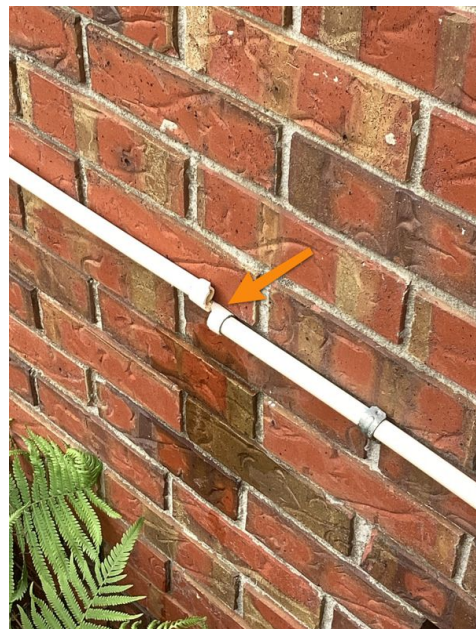
2.14.2 Exterior Spigots

BROKEN WATER PIPE
