Property Inspection Report

Cover Page This report is marked up by executor of the estate Mike Matre to show the repairs that have been done. Repair invoices are attached., 229-869-1111, mike@matreforestry.com

1231 Hilltop Drive, Albany, GA 31707
Inspection prepared for: Mike Matre
Date of Inspection: 4/17/2025 Time: 0900 Hours
Weather: Sunny
Inspection Fee Paid CK#2217

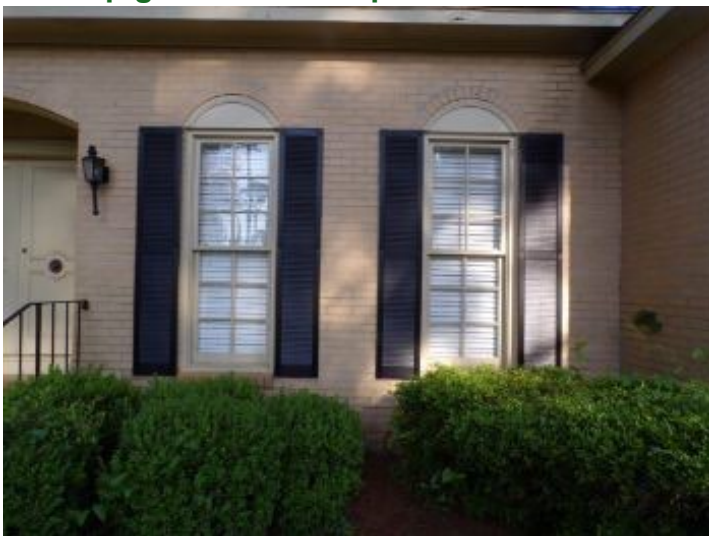
Windows are painted/sealed shut

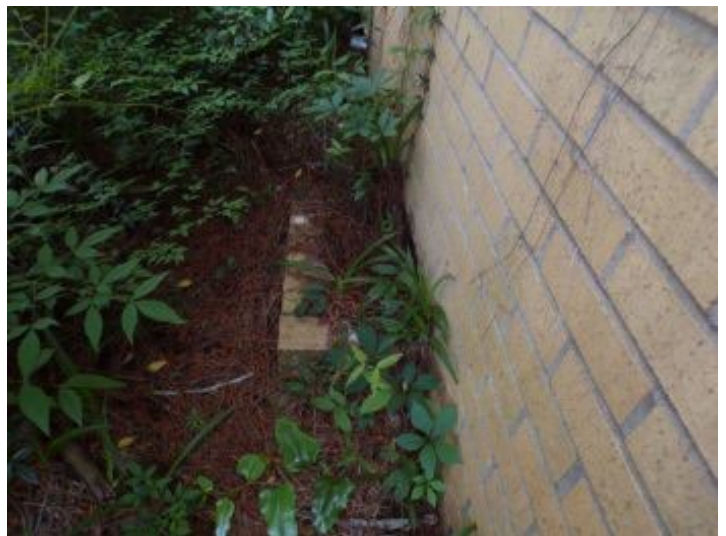
- 1.1. The windows are painted shut. Recommend having at least one operating window in each room.
- 1.2. The foundation vent wells are full of debris. Recommend having all vent wells cleaned out for proper drainage. **Foundation vents have been cleared.**

Foundation wells full of debris

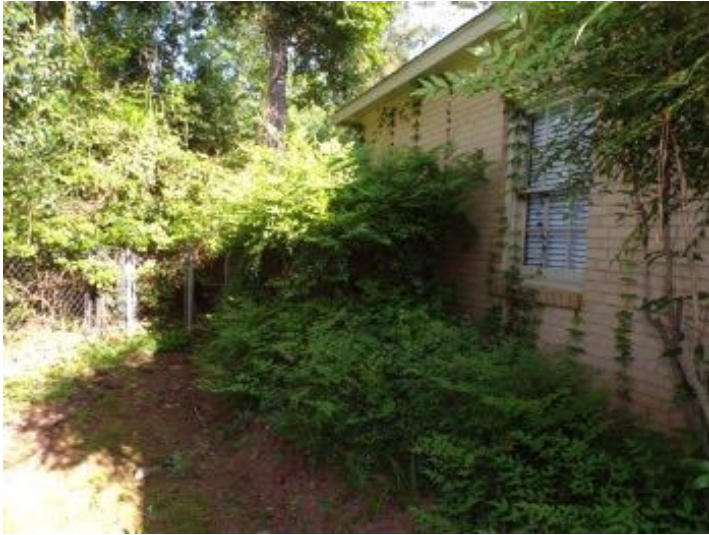
- 1.3. Overgrown vegetation. Recommend cutting back all vegetation that touches structure. **Vegetation has been cut away from structure.**
- 1.4. Dryer vents into foundation vent well. Recommend having vent extended out of well and add cover.

Overgrown vegetation

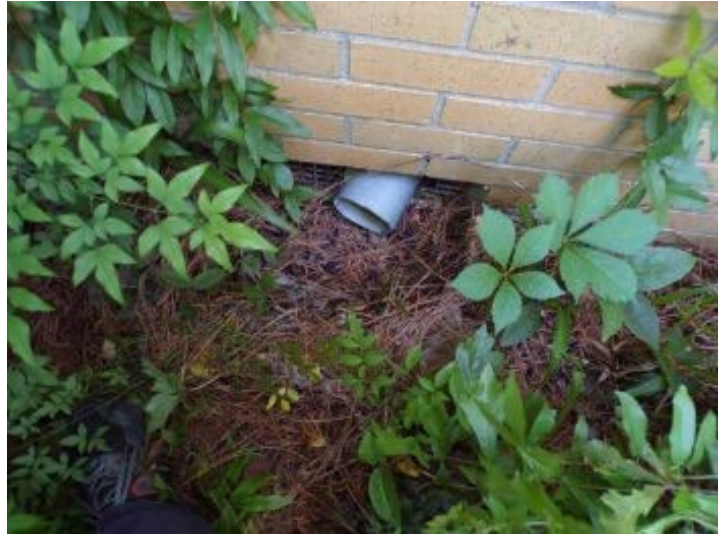
Dryer vents into foundation well

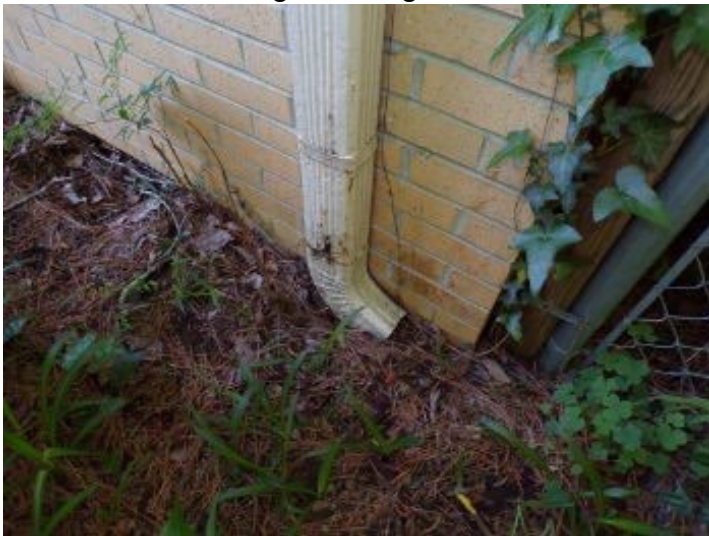
- 1.5. The downspout discharge too close to the foundation wall. Recommend adding extension pipe to discharge away from foundation wall.
- 1.6. The rear water spigot would not turn on. It may be possible to turn handle with a pair of pliers and get it to operate. **Rear spigot has been replaced.**

Downspout discharges at foundation wall

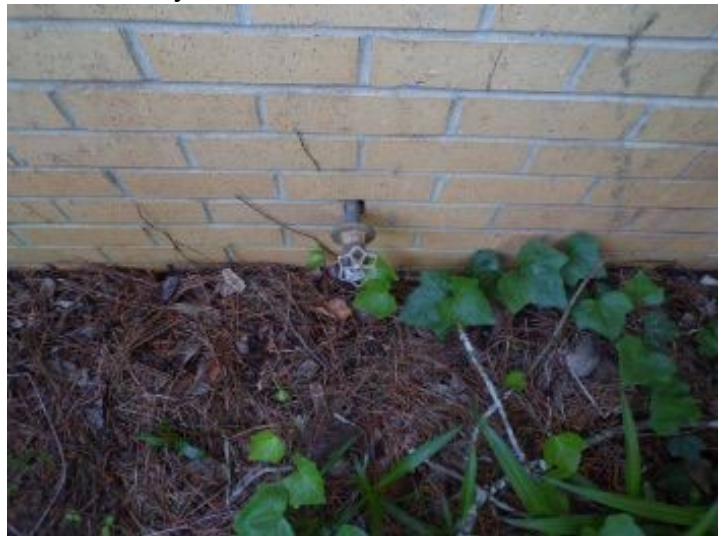
Rear spigot would not operate

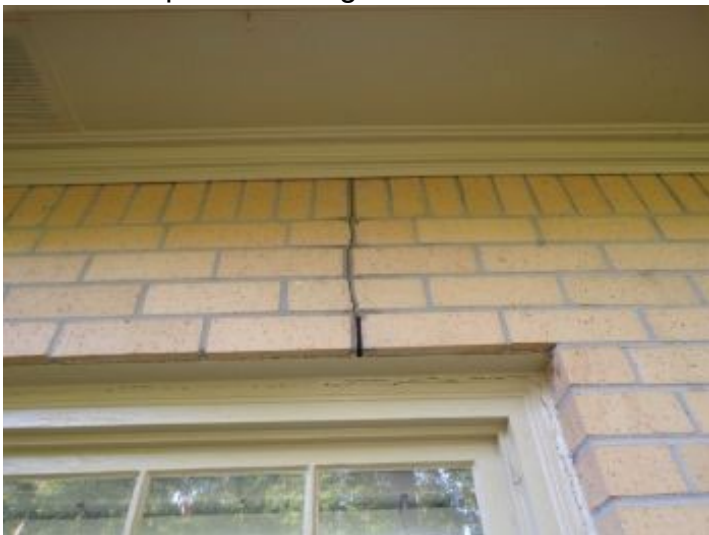
- 1.7. Settlement crack over rear bedroom window. No action needed.
- 1.8. Weak ground on outside outlets. Recommend review and repair by licensed electrician.

Settlement crack over rear window

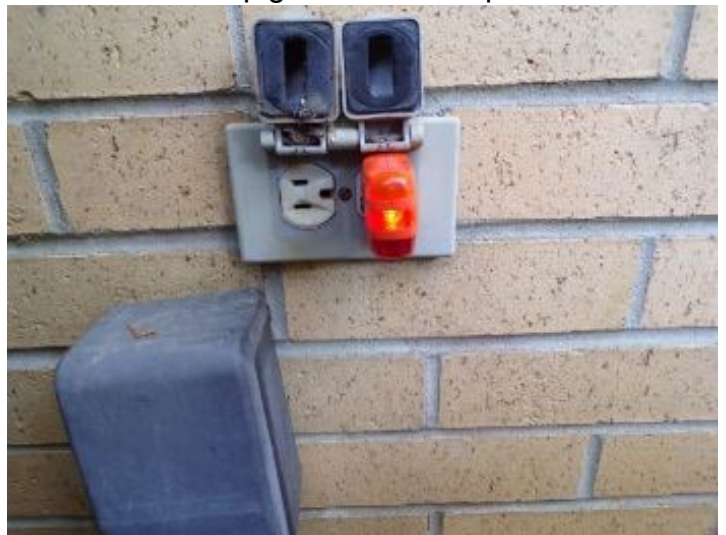
Weak ground outside outlet

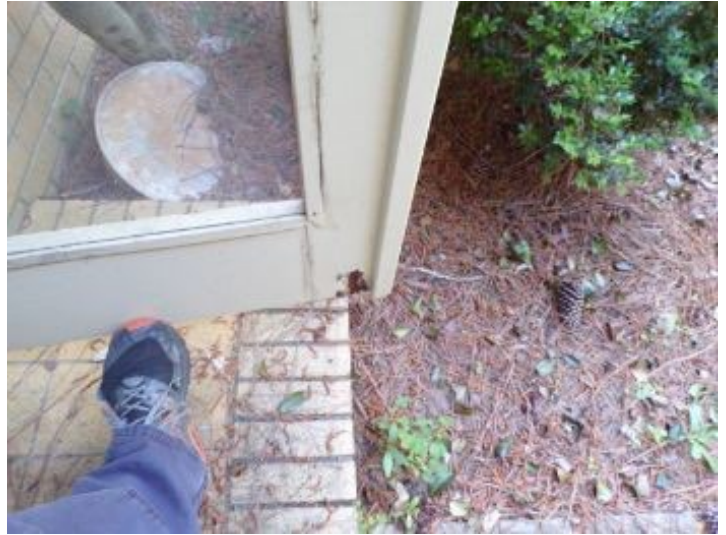
- 1.9. Minor damage to the rear screen door and screen. Recommend repair of screens and reattach the bottom lock. **Screen and latch were replaced.**
- 1.10. Raised and crack driveway slab.

Damaged screen doors at rear

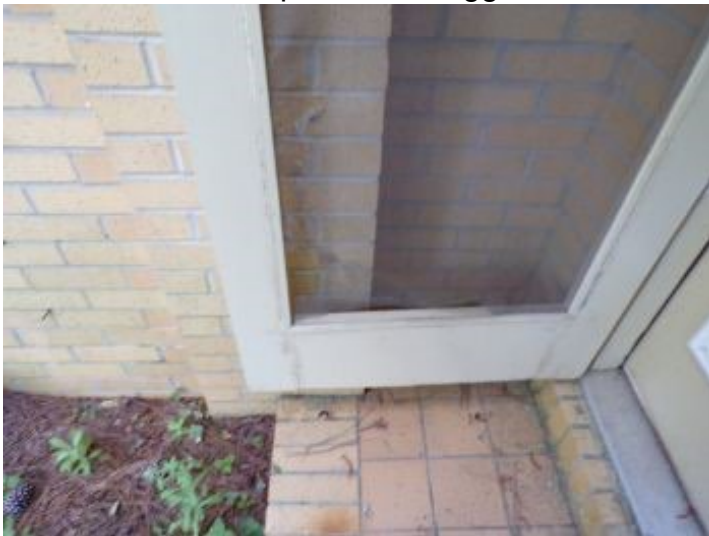
Damaged screen doors at rear

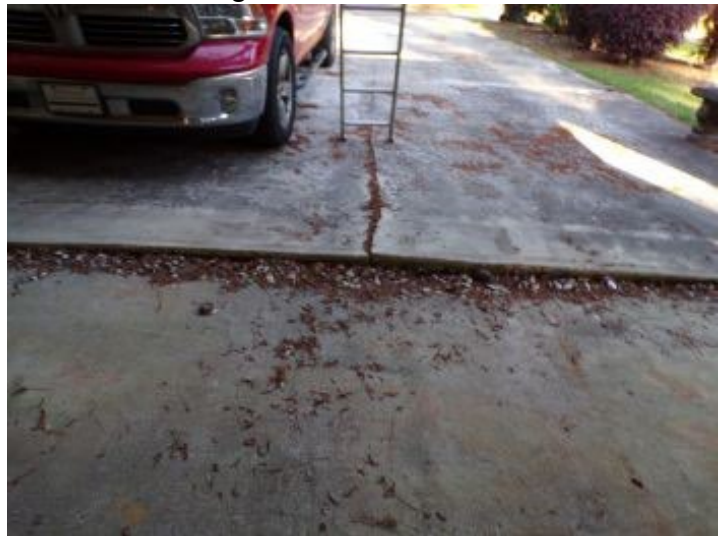
Raised and cracked slab at driveway

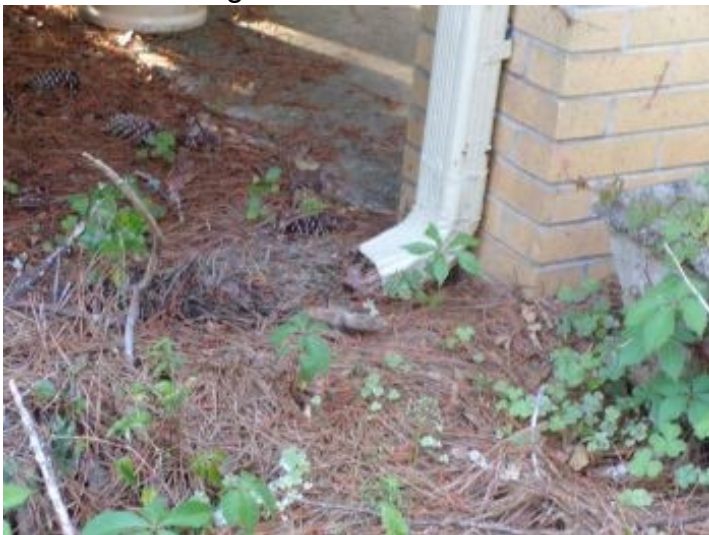
Clogged downspouts

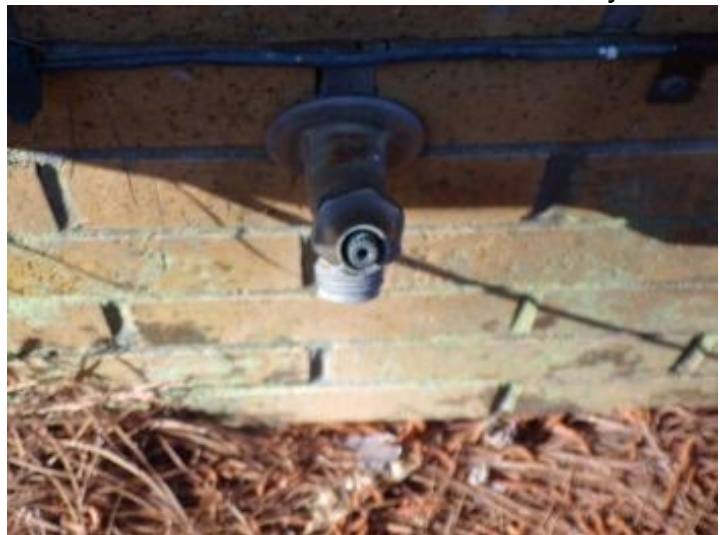
- 1.11. Missing handle on right side water spigot. Recommend replacement of missing handle. **Right side spigot has been replaced.**

Missing handle on side spigot

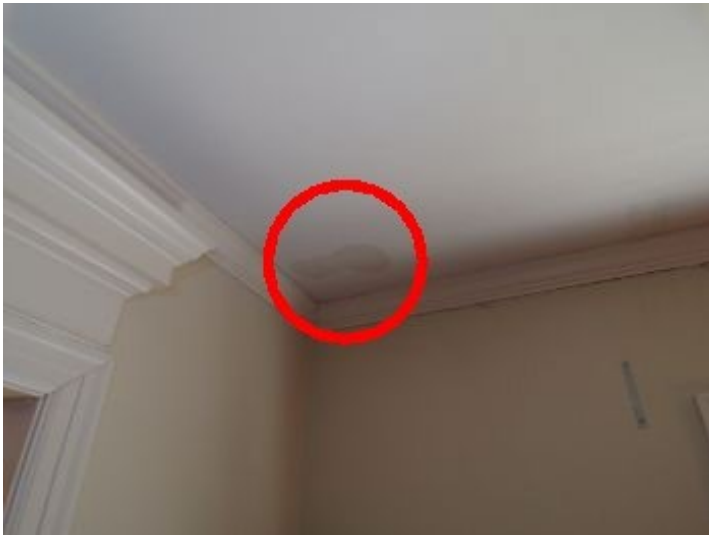
- 1.1. There are several old small water stains on the ceilings through-out. All areas tested dry and there were no visible issues noted in the attic. Recommend stain blocking then paint to match.

Old water stain in formal living room

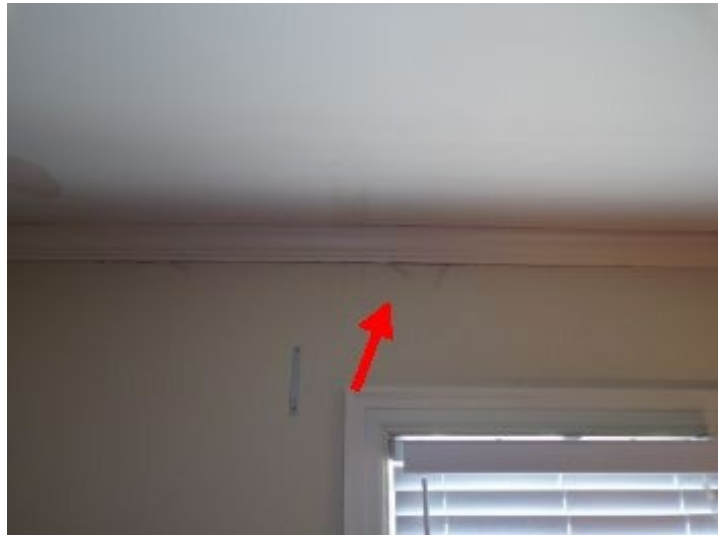
Old water stain in formal living room

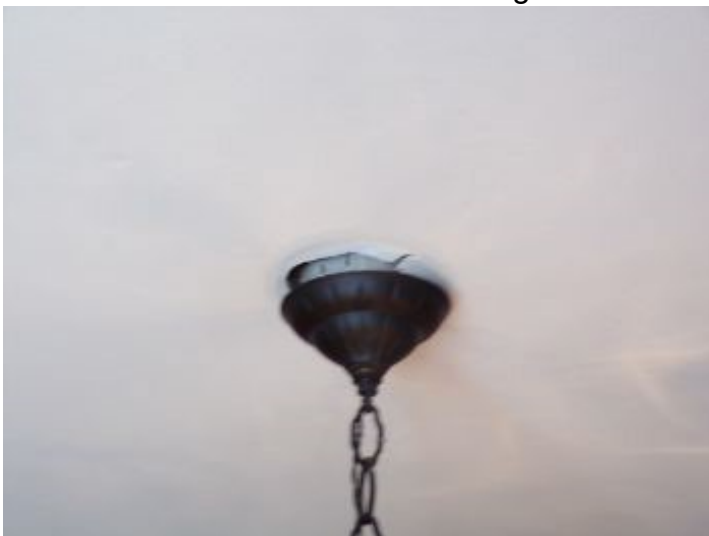
- 1.3. The dining room light fixture box is coming out of the ceiling. Recommend review and repair by licensed electrician. **Light fixture box has been secured by B&B Electrical.**

Dining room electrical box coming out of ceiling

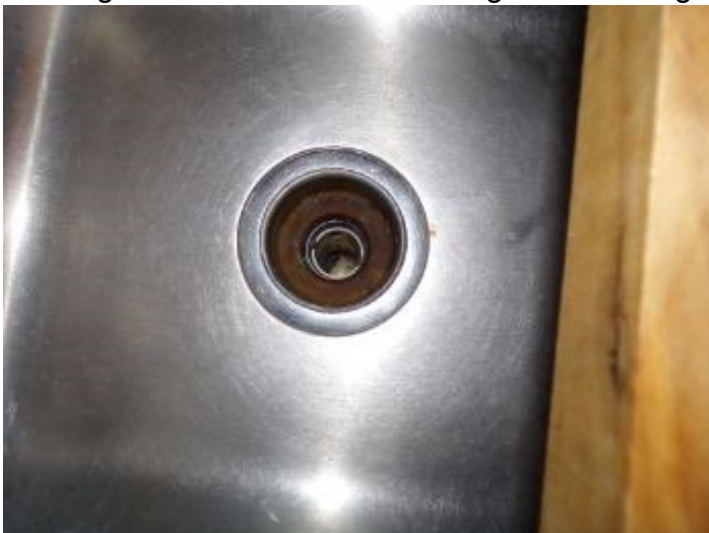
- 1.4. The stove was not tested due to large amount of dishes present. Recommend testing stove once items have been removed.
- 1.5. Broken kitchen sink strainer basket. Recommend replacement of sink strainer basket. **Sinker strainer were replaced by Metro plumbing.**

Broken kitchen sink strainer drain

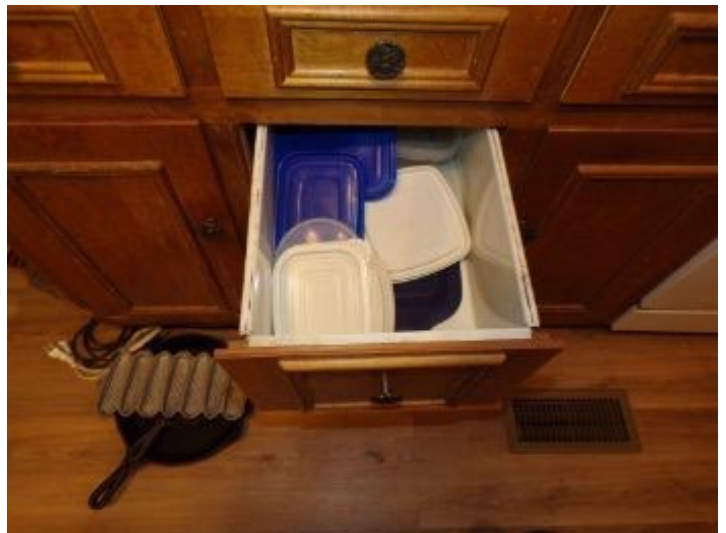
Metal drawer used in kitchen cabinet

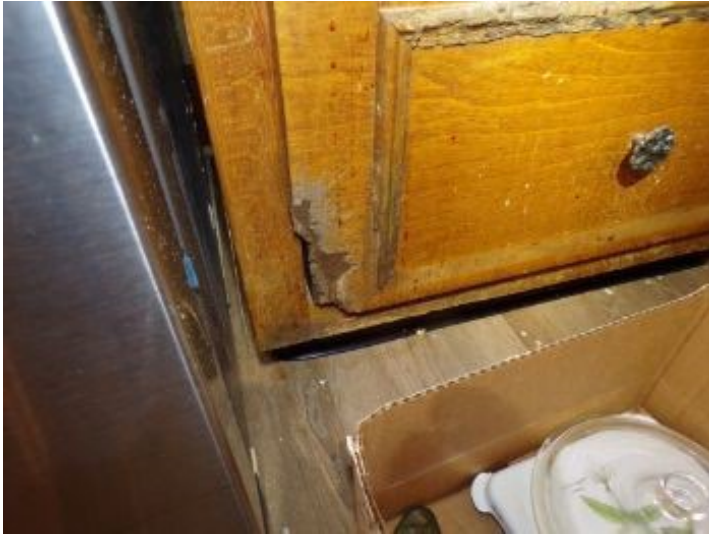
Damaged drawer front

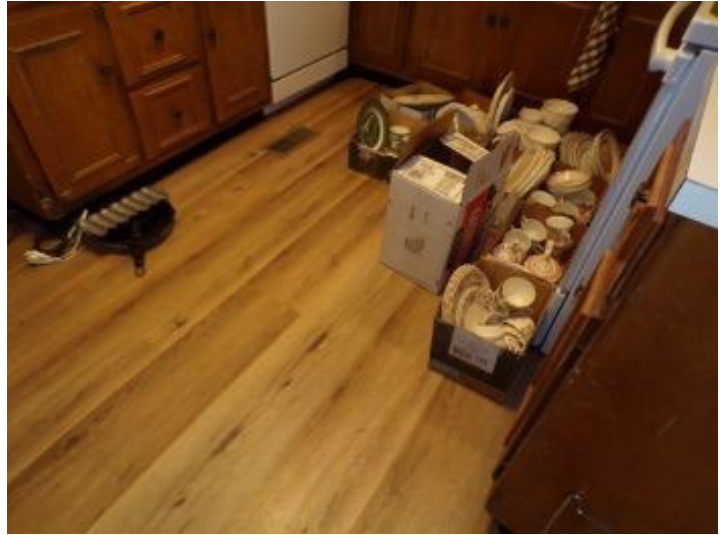
- 1.8. The kitchen floor has a slight slope. In my opinion this can be repaired by adding some support under kitchen floor joist.
- 1.9. Recommend having fireplace serviced before use.

Slope in kitchen floor

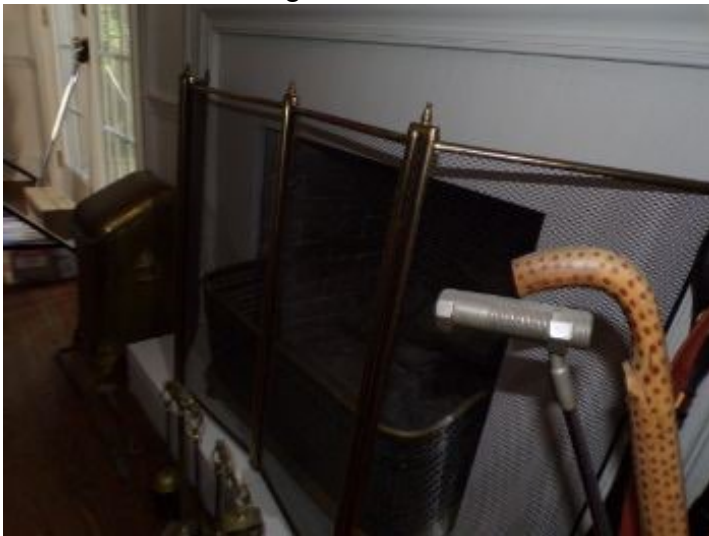
Recommend having fireplace serviced

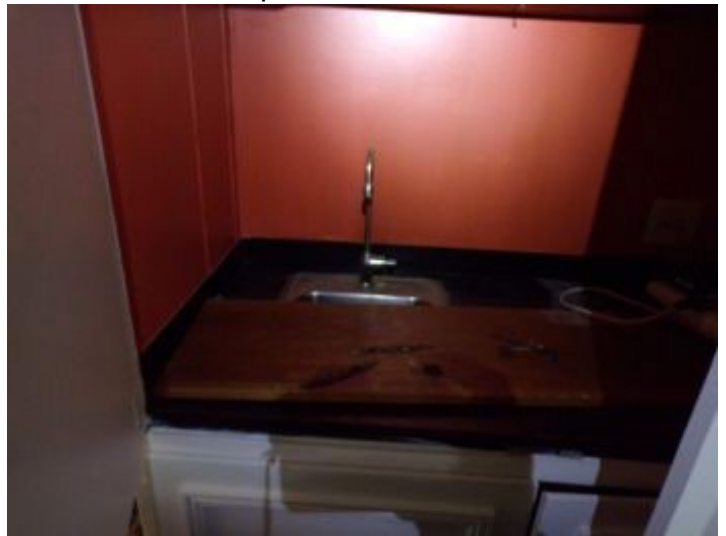
- 1.10. The bar sink was not tested due to couch being in front of cabinets. Recommend tested sink and checking for leaks once couch has been removed. **The sink was tested and repaired by Metro plumbing company.**

Bar sink not tested

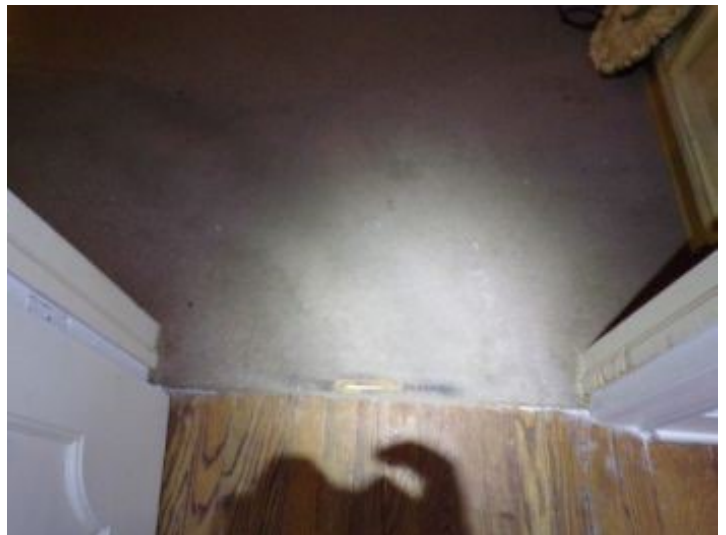
Worn/damaged carpets

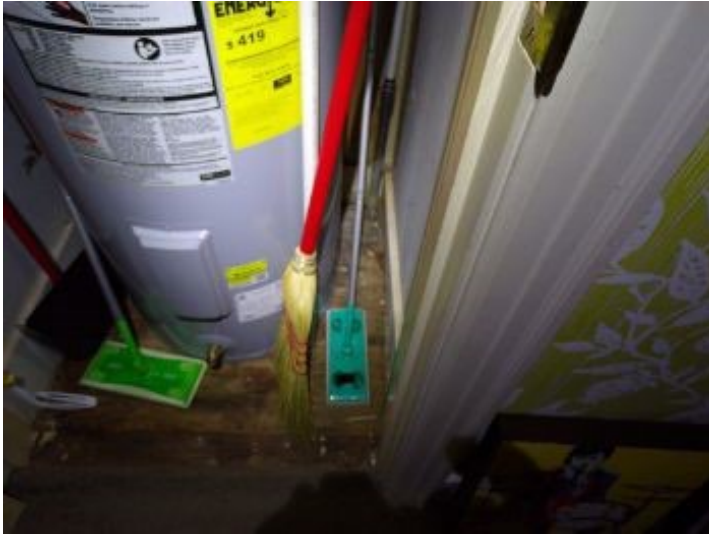
No finish floor under water heater

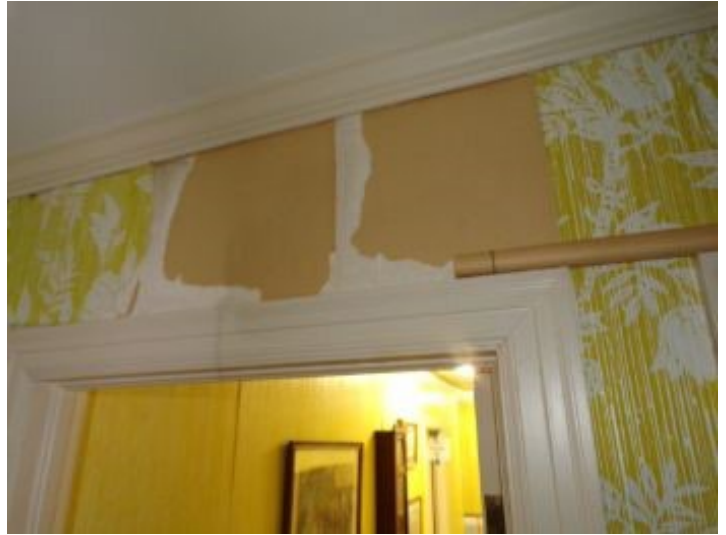
Damaged wallpaper

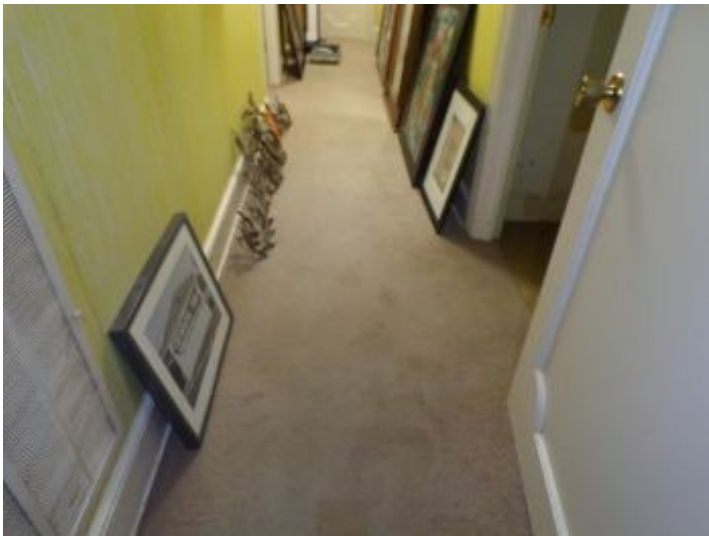
- 1.15. There is a squeak in the hallway floor. This may be from a sub-floor joint and if so it can be repaired by adding cross block between floor joist under joint area.

Squeak in hallway floor

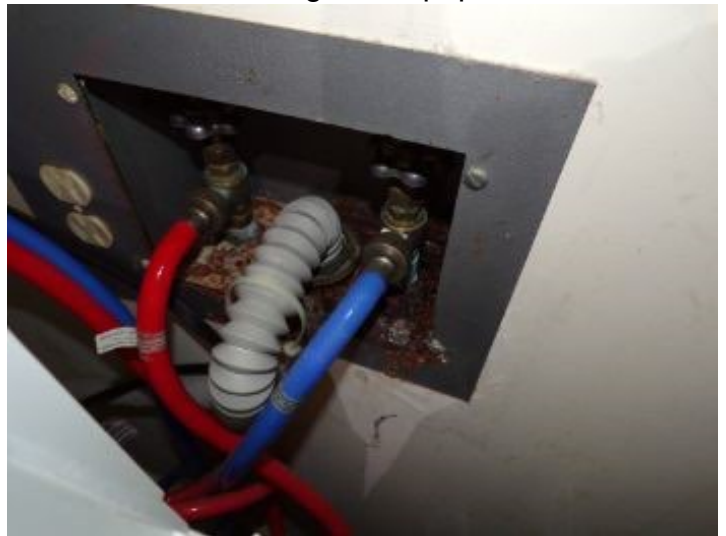
- 1.16. The washing machine supply is leaking. Recommend review and repair by licensed plumber. **The washing machine supply valves were replaced by Metro plumbing.**

Washing machine supplies are leaking

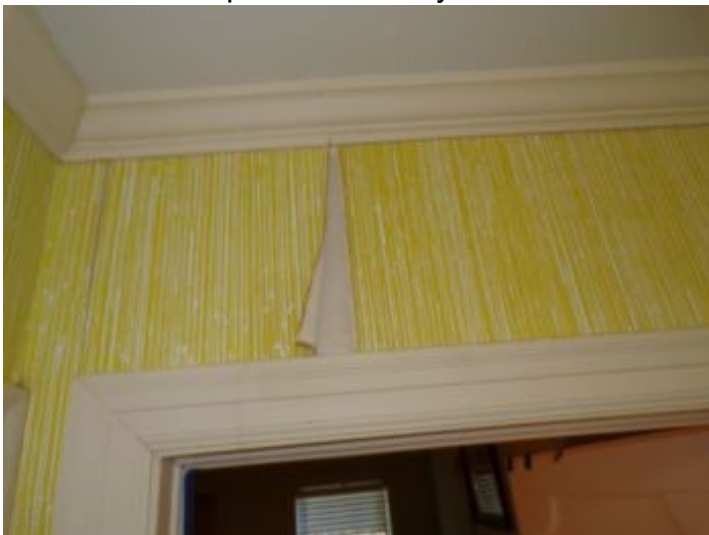
Damaged wallpaper

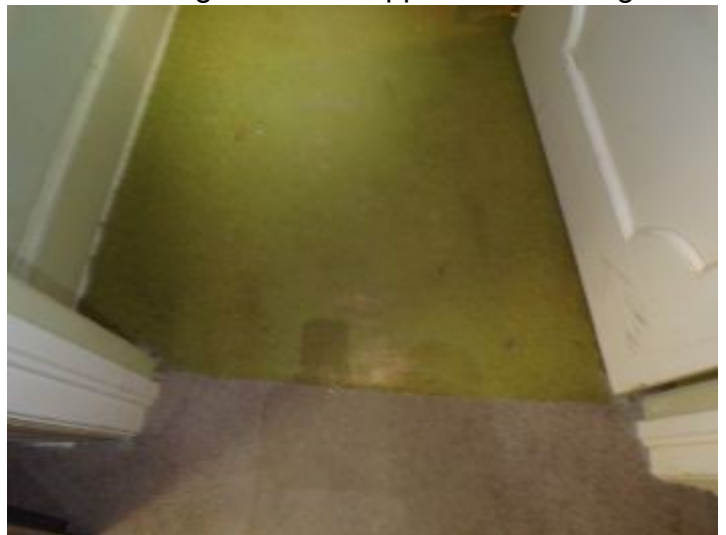
Worn/damaged carpet

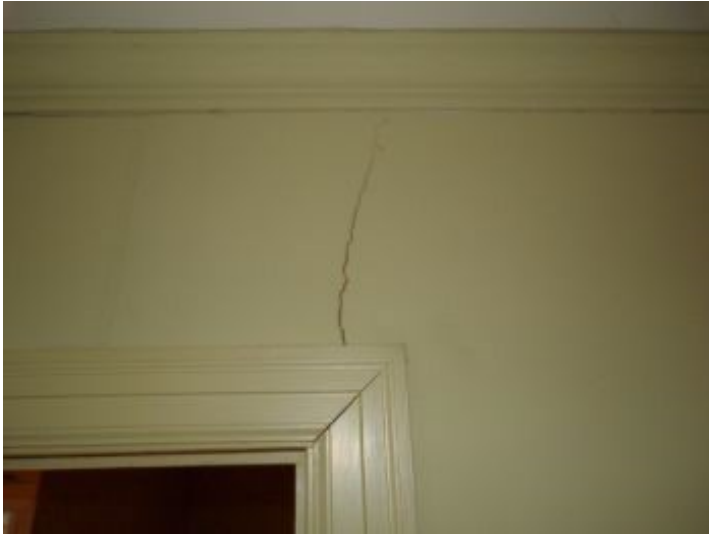
Stress crack over bathroom door

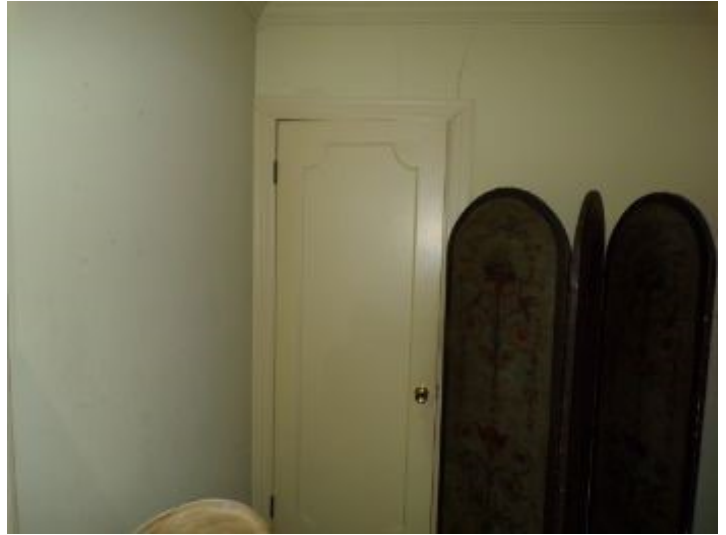
Bathroom door would not close

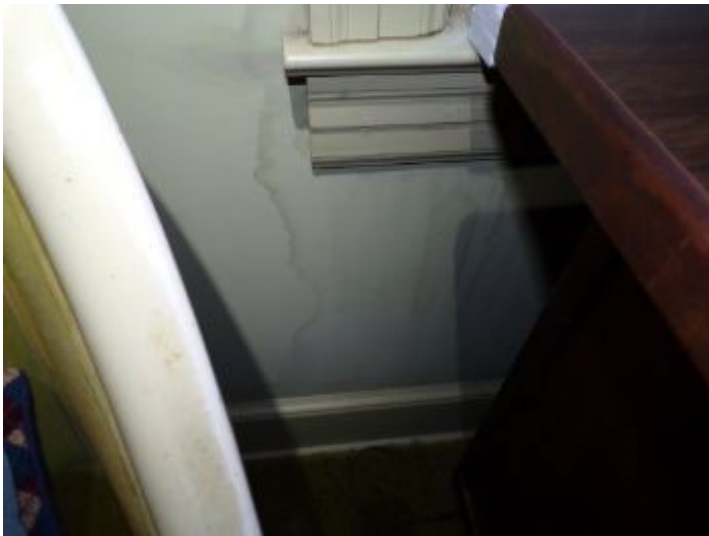
Old water stains under window

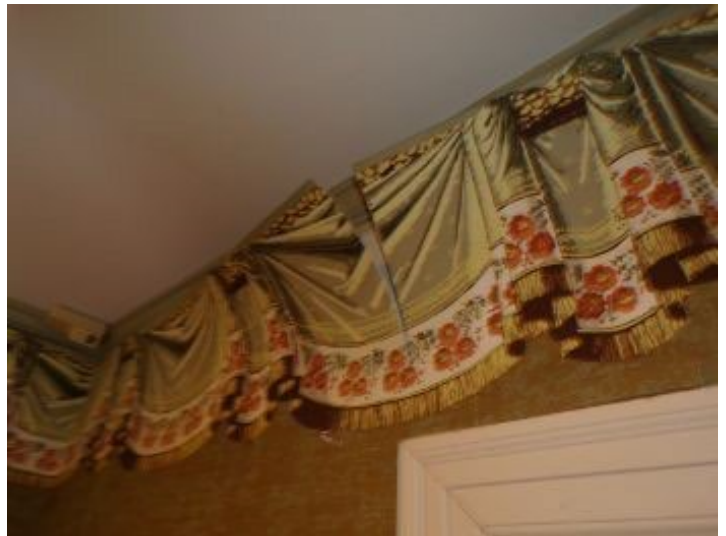
Damaged wallpaper

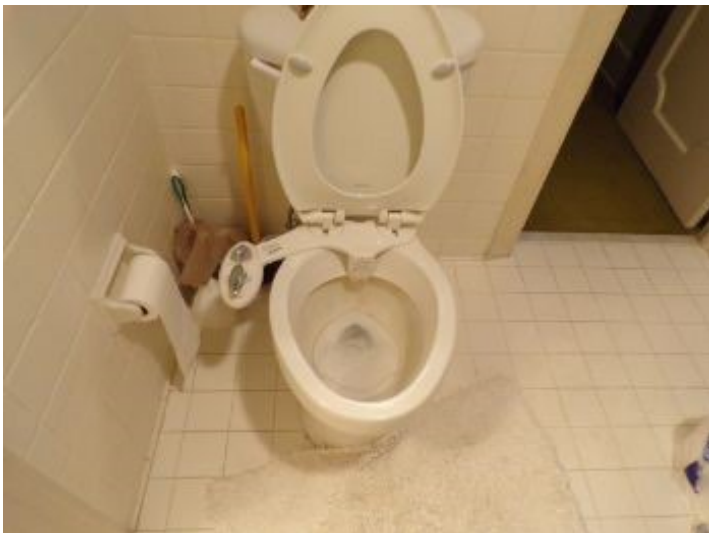
- 1.19. Master bathroom toilet is loose. Recommend replacement of wax seal then secure back to floor flange. **Toilet was repaired by Metro plumbing.**

Master bathroom toilet is loose

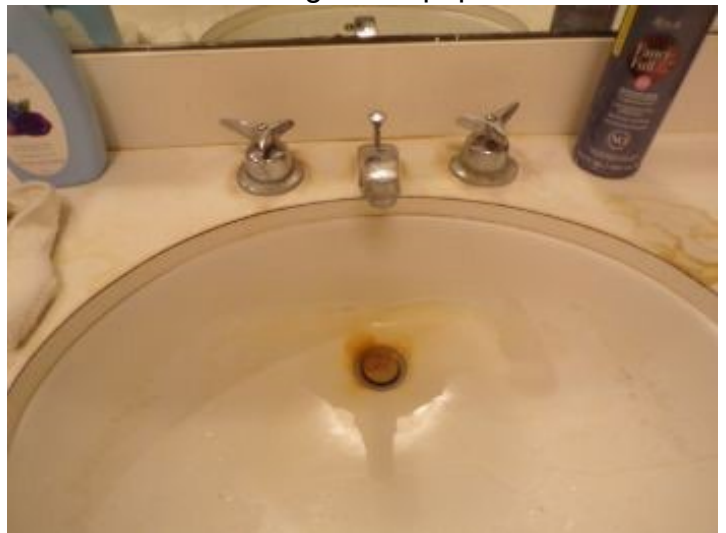
Master bathroom sink faucet drips

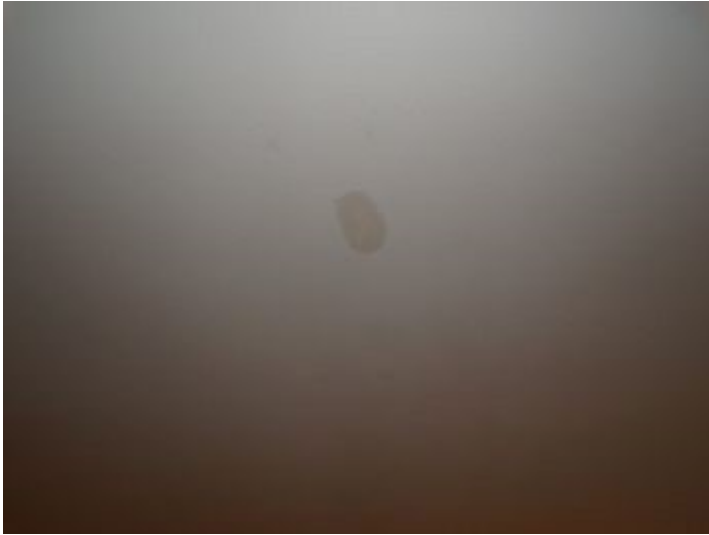
Old water stain on ceiling

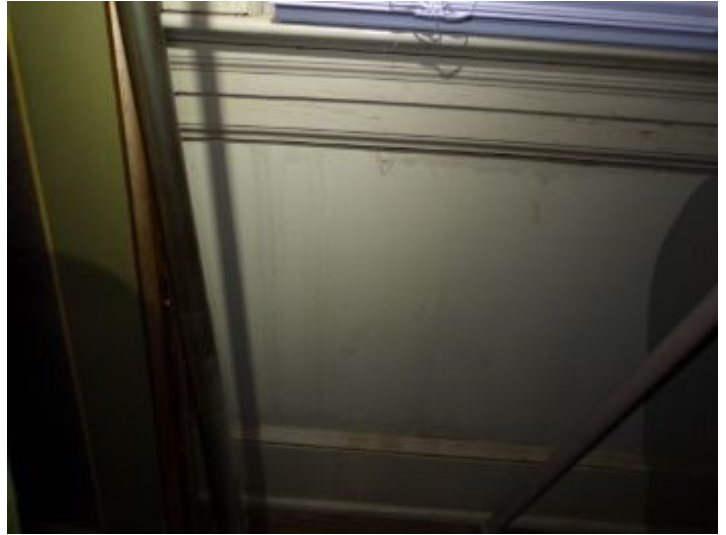
Old water stains under window

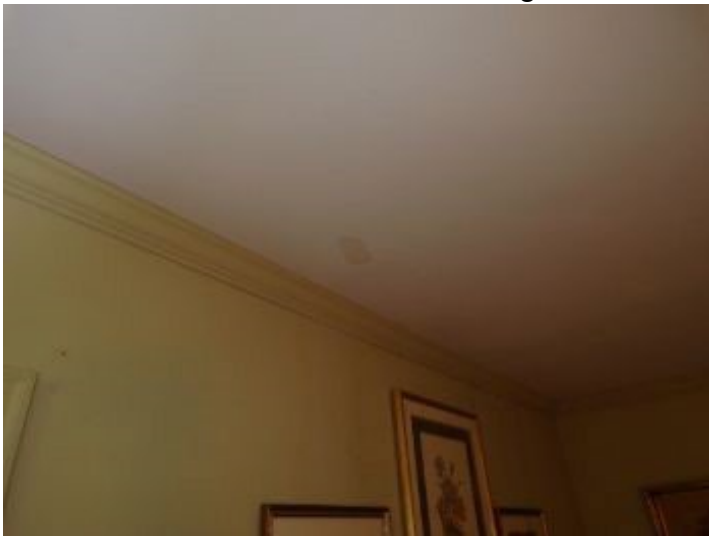
Old water stain on ceiling

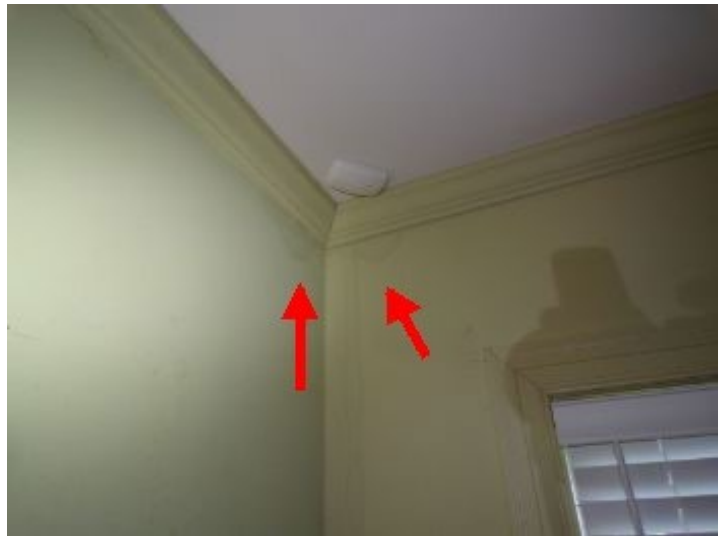
Old water stain on wall

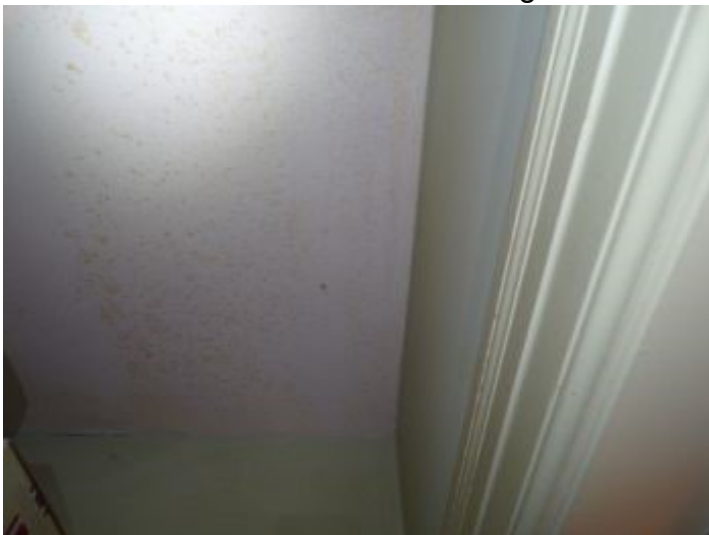
Cracked ceiling finish in hallway closet

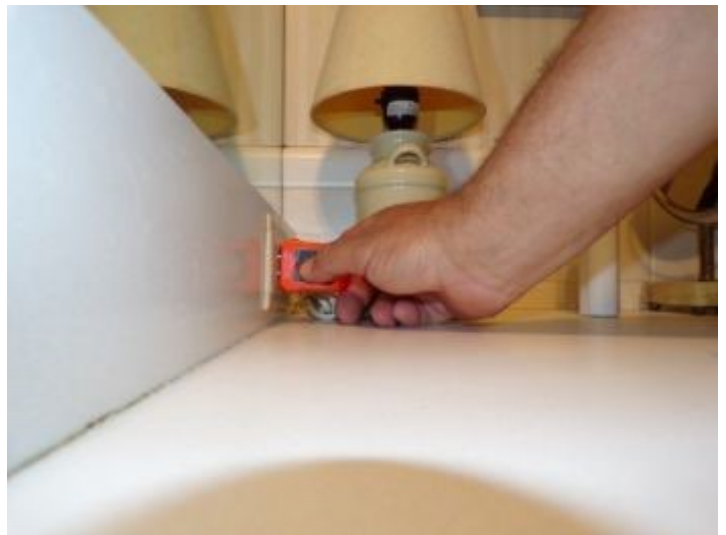
- 1.22. There is no **GFCI** protection in bathrooms or kitchen. Recommend adding GFCI protection to all wet areas. **GFCI protection has been added by B&B Electrical.**

No GFCI protection

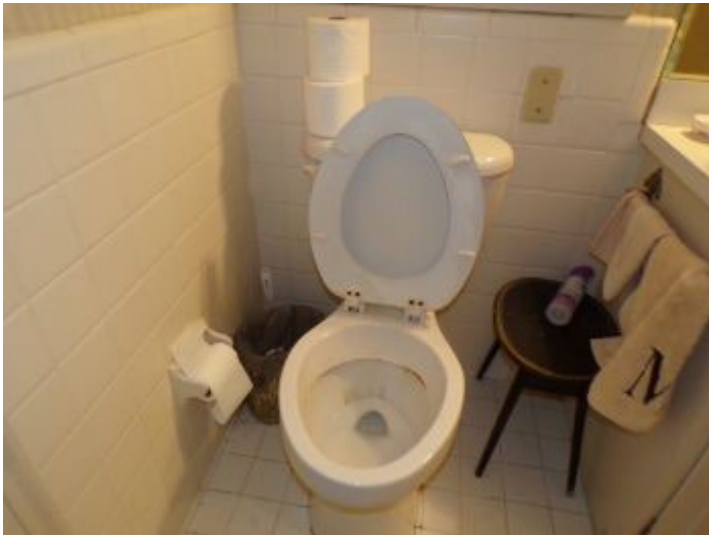
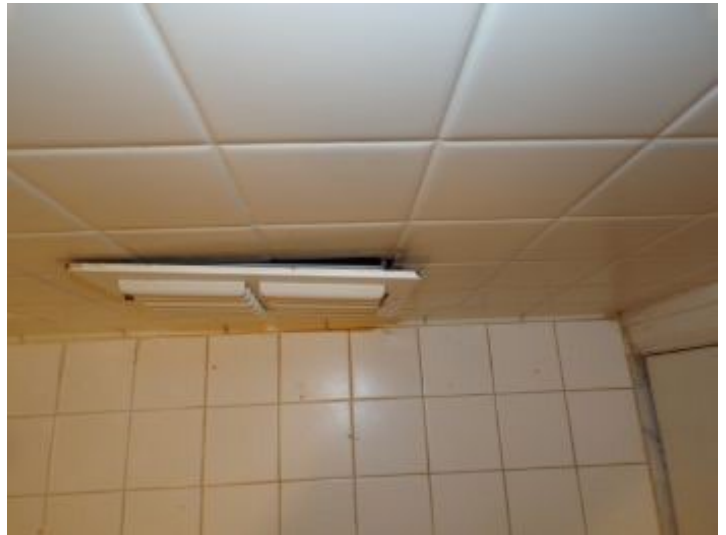
- 1.23. The Jack and Jill bathroom toilet has a continuous run in the bowl and is loose at the floor. Recommend replacement of flapper valve and wax seal then secure toilet back to floor flange.

- 1.24. Loose HVAC wall register in Jack and Jill bathroom. Recommend adding proper screws to secure register. **Proper fastener has been added to secure register.**

Jack and Jill bathroom has continuous run and is Vent cover is loose loose

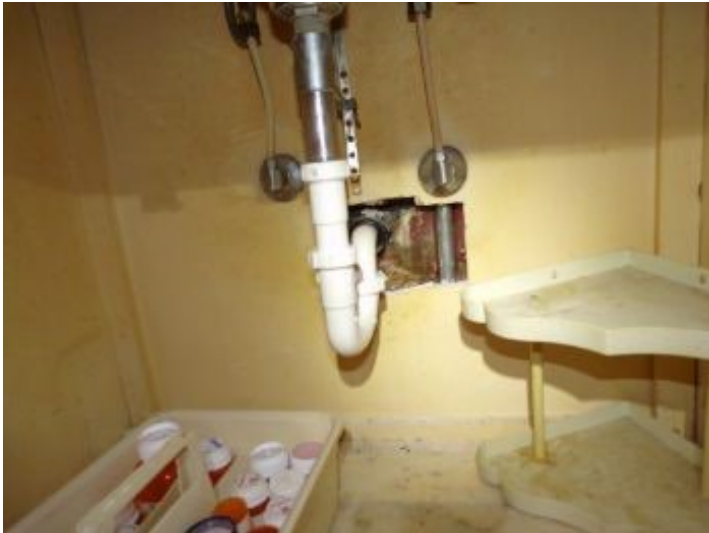
- 1.25. The wall under the Jack and Jill bathroom vanity was cut out for plumbing repairs. Recommend review and repair by handyman.

Cut wall under bathroom vanity

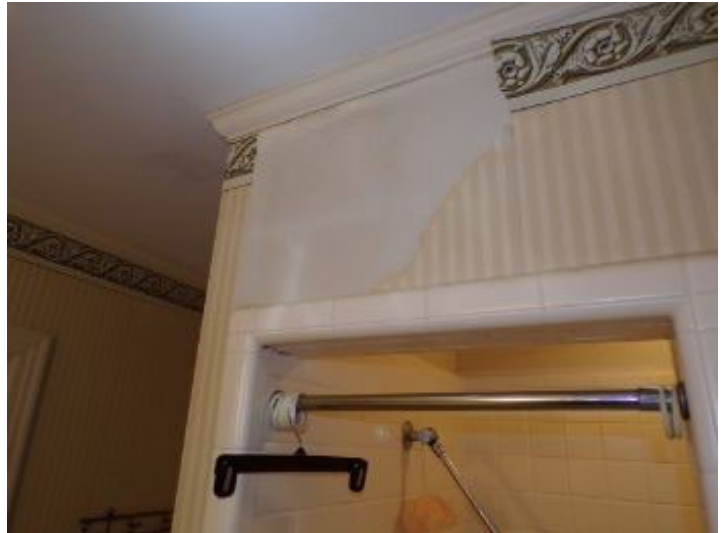
Damaged wallpaper

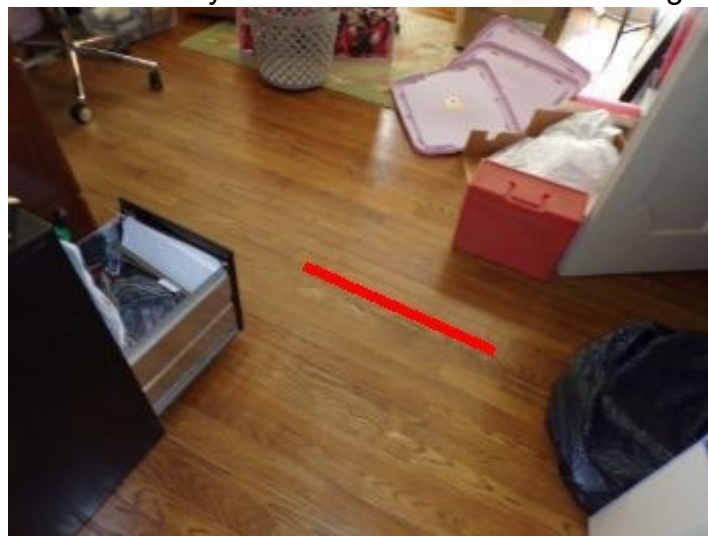
1.26. There is a small hump in the office floor. Recommend review by flooring company.

Small hump in office floor

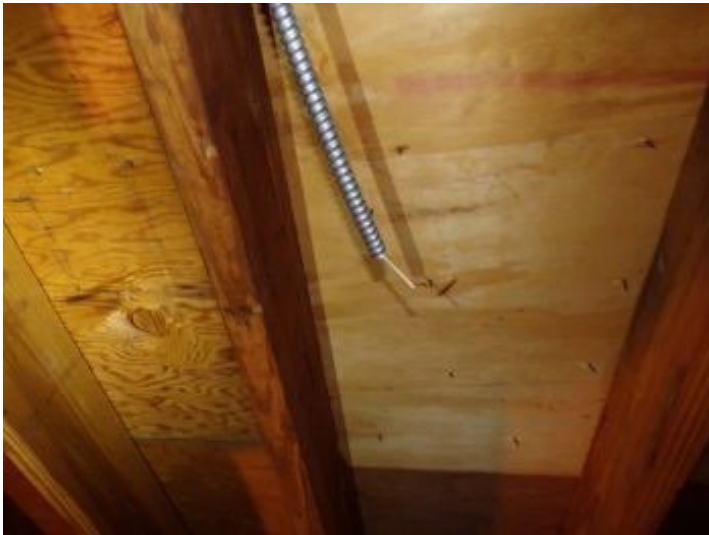
Exposed wire from old attic fans

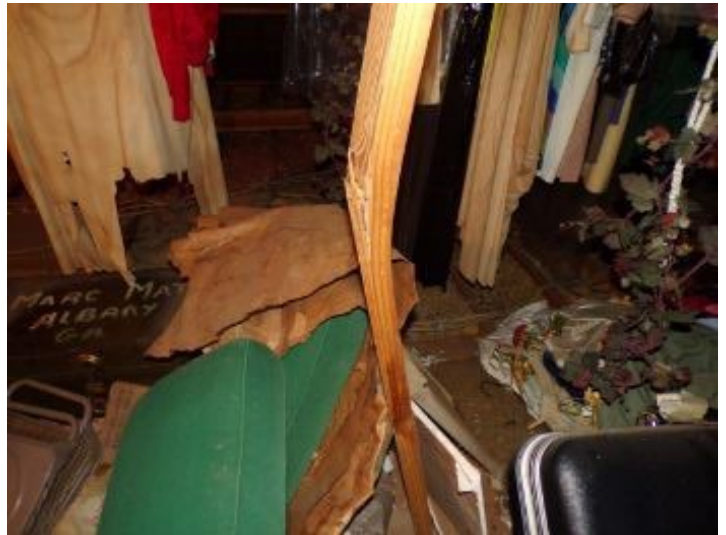
Broken ridge beam brace

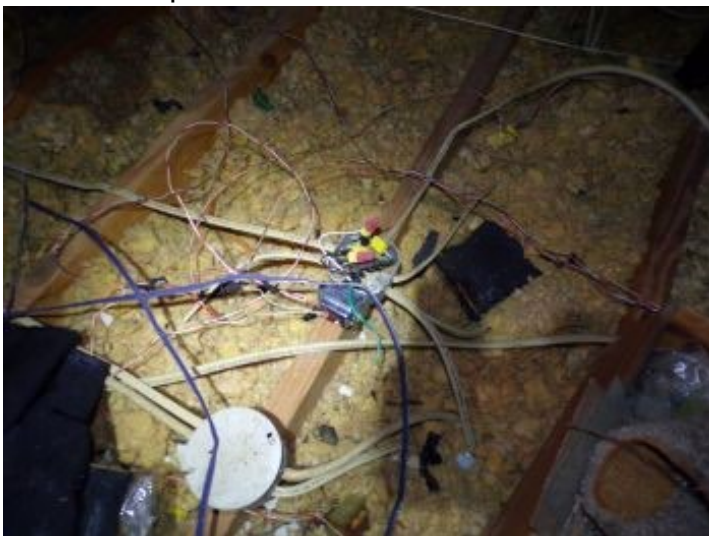
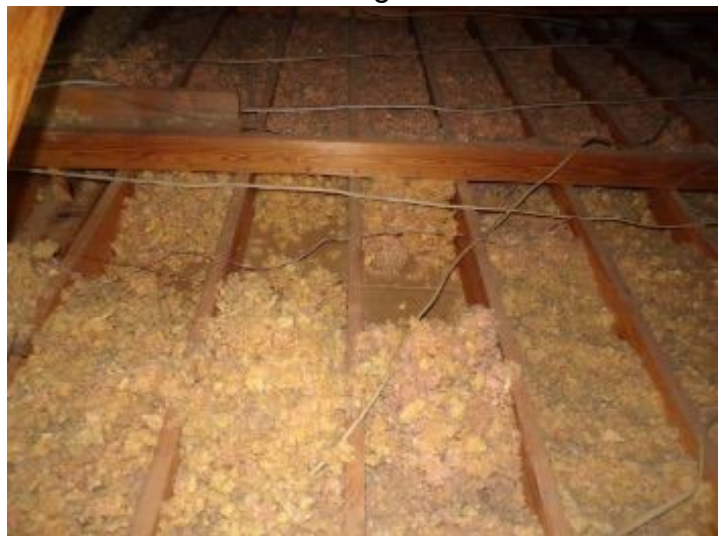
Open junction boxes

Missing insulation

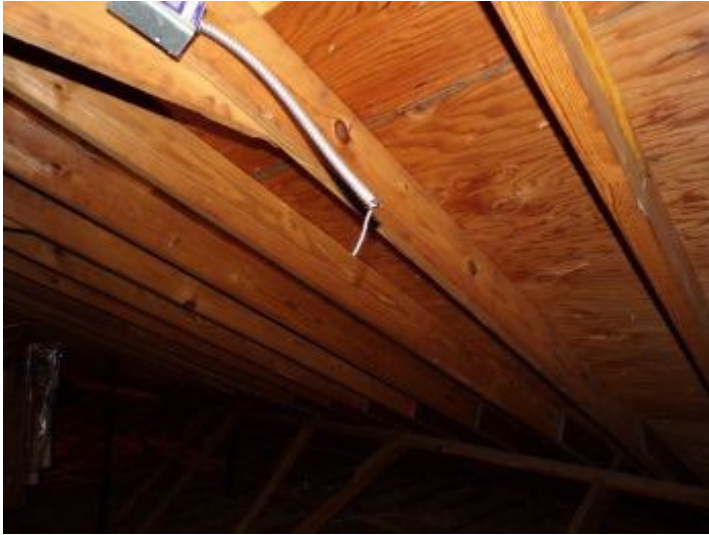
Exposed wire from old attic fans

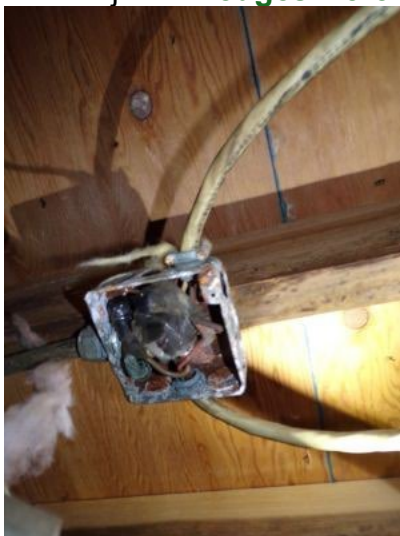
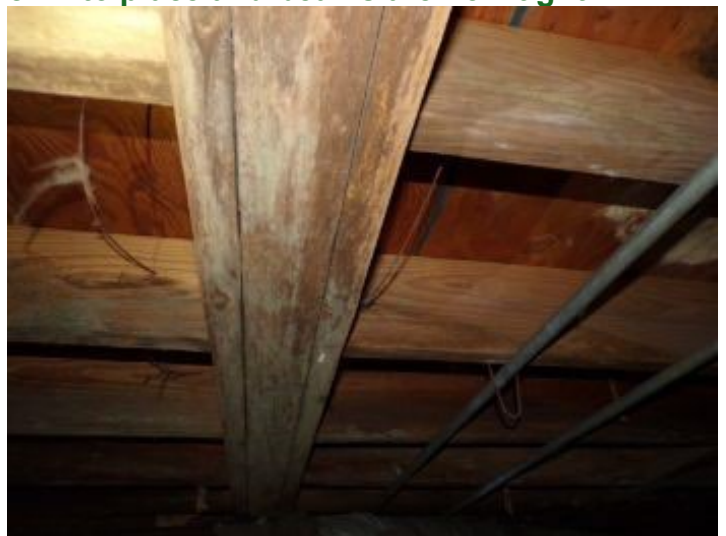
Open junction box

Old fungus issues

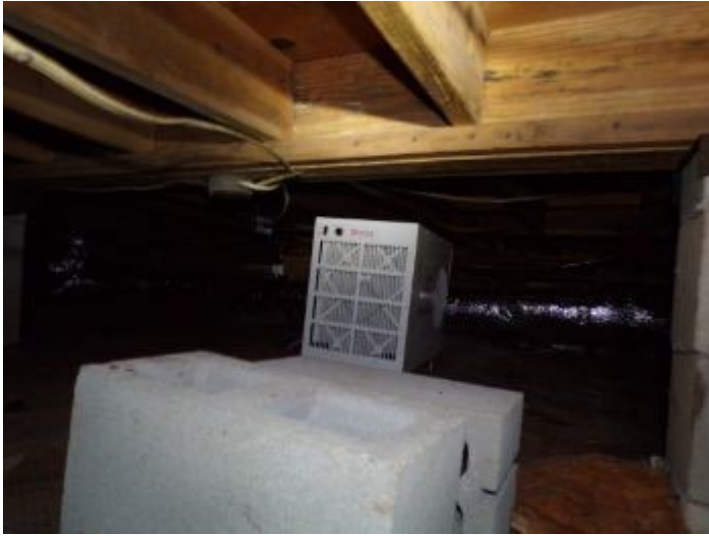
Dehumidifier present

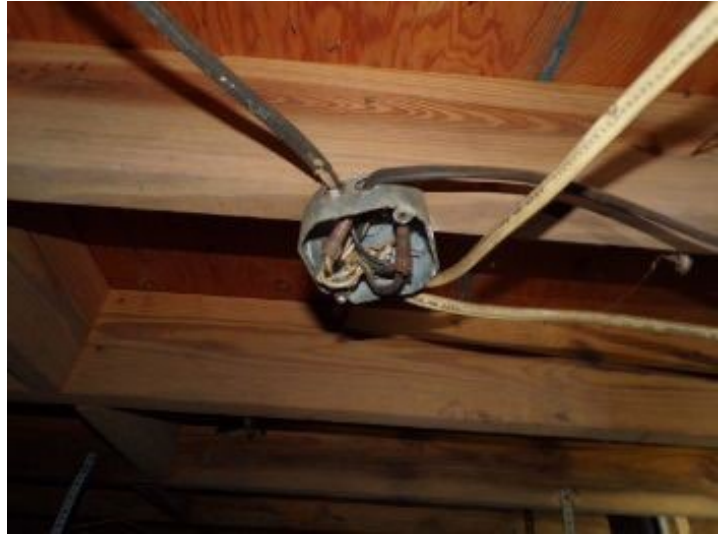
Open junction box

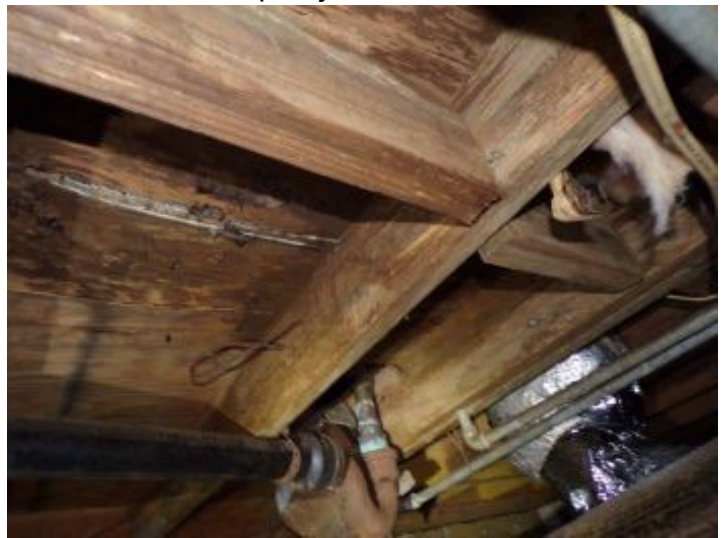
- 1.3. Old water damage sub-floor under master bathroom area. Area was dry at time of inspection and may have been caused by an old leak.
- 1.4. The TPV for the water heater terminates into the crawlspace. Recommend extending drain to exterior of structure. **Drain was extended to outside of structure by Metro plumbing.**

Water damaged sub-floor under m
bathroom area
