Property Inspection Report

Cover Page This report is marked up by executor of the estate Mike Matre to show the repairs that have been done. Repair invoices are attached., 229-869-1111, mike@matreforestry.com

1231 Hilltop Drive, Albany, GA 31707
Inspection prepared for: Mike Matre
Date of Inspection: 4/17/2025 Time: 0900 Hours
Weather: Sunny
Inspection Fee Paid CK#2217

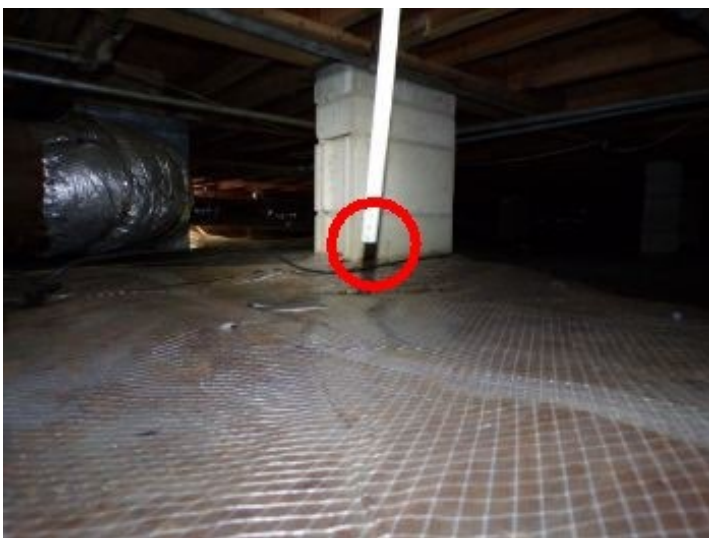
TPV for water heater terminates in crawlspace

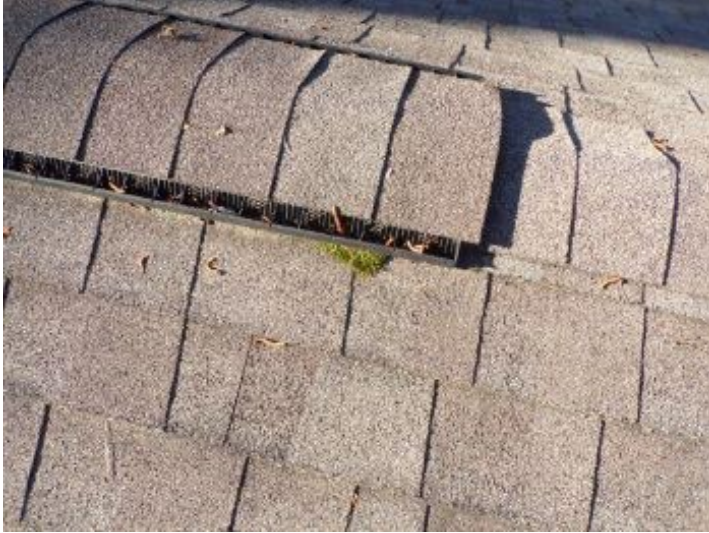
1.1. The roof is showing signs of aging. The following issues were noted at time of inspection. In my opinion roof will need to be replaced within the next 5 years. a) Moss growing on shingles

Moss growing on shingles

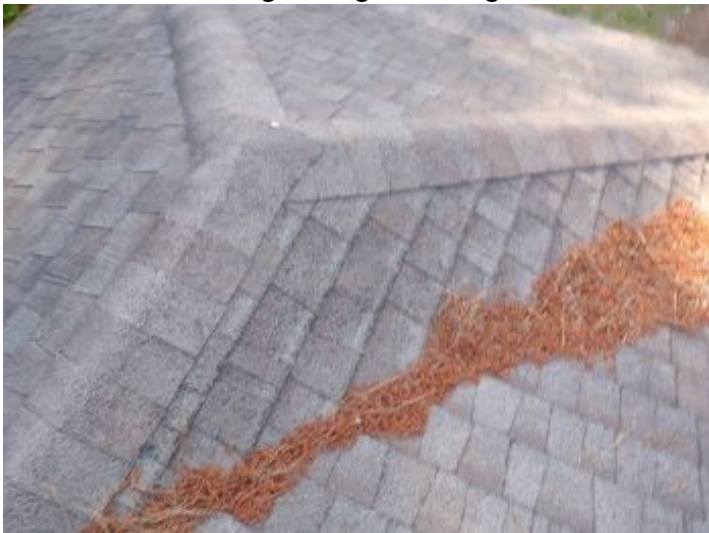
Worn and missing granular

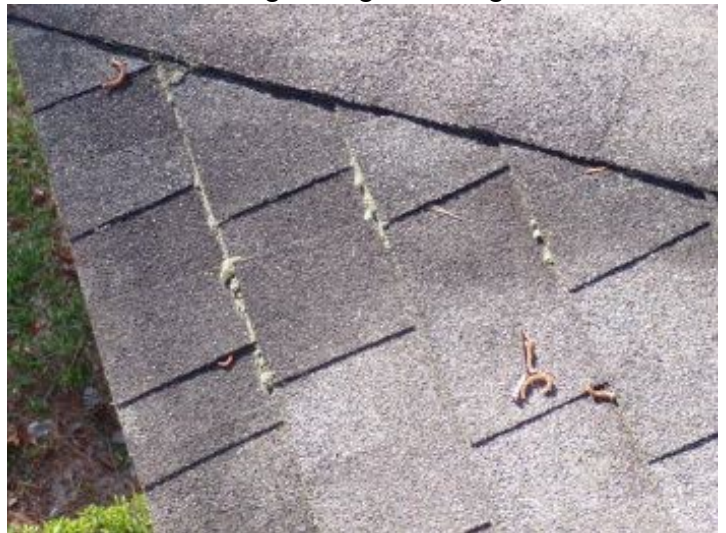
Moss growing on shingles

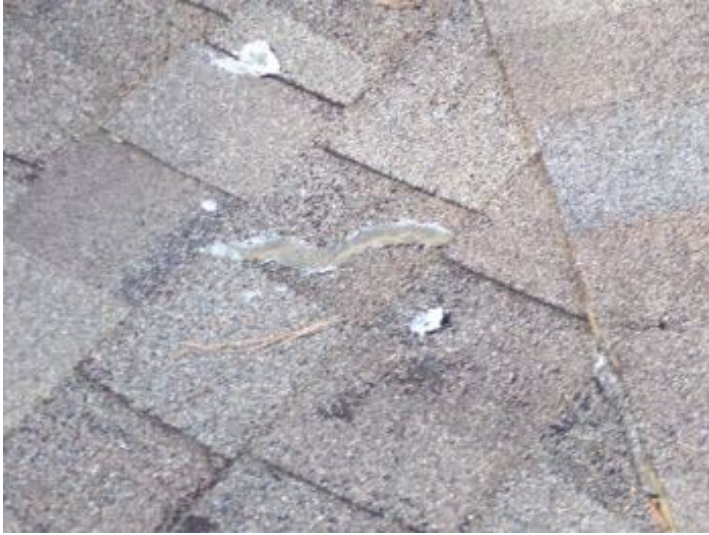
c) Damaged shingles at front corner ridge

Damaged shingles

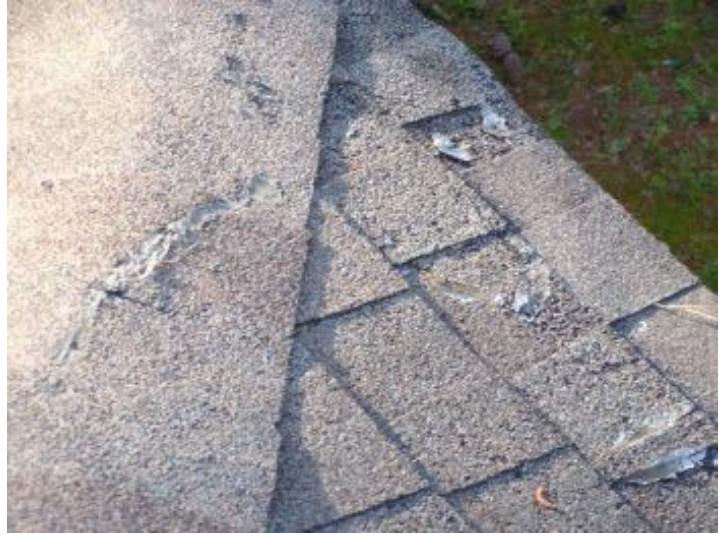
Damaged shingles

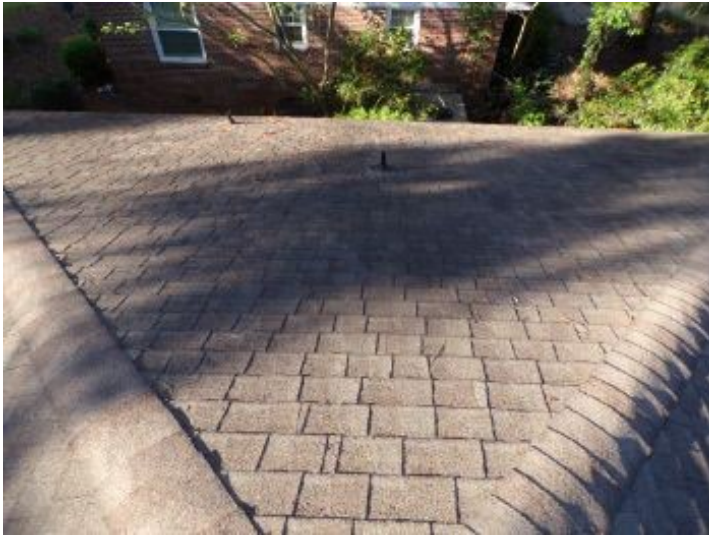
Worn shingles

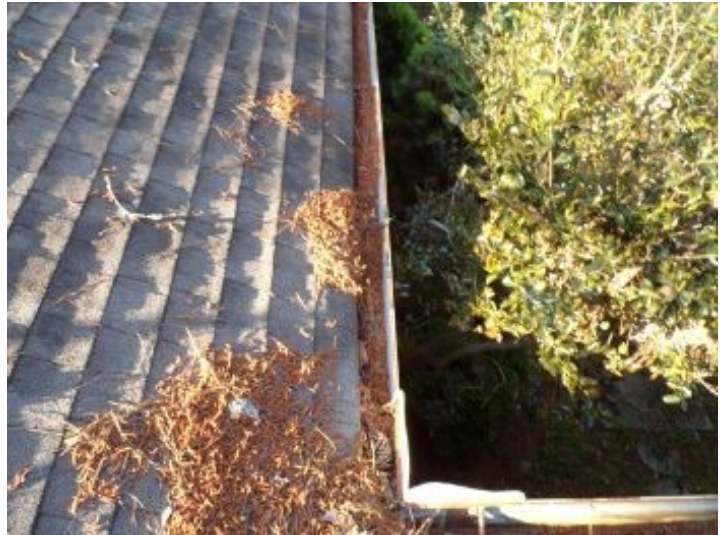
1.2. The gutters are full of debris and the downspouts appear to be clogged. Recommend having the gutter system cleaned. **Gutters have been cleaned.**

Gutters full of debris

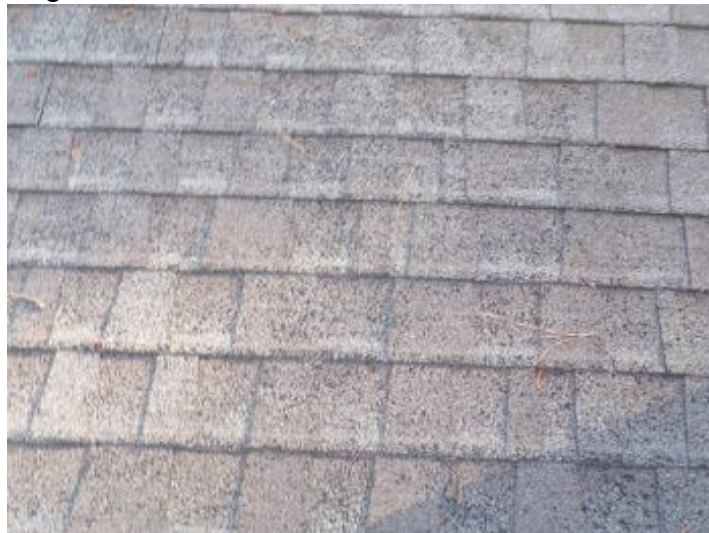
Worn shingles

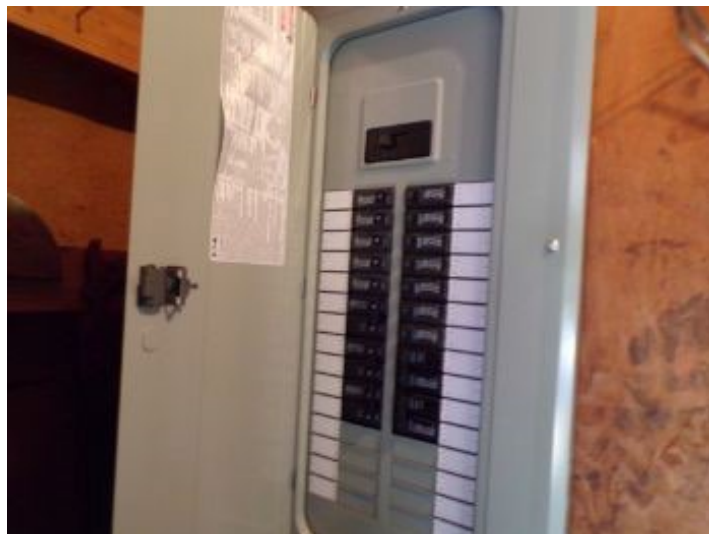
1.1. Eaton 200 amp main breaker style panel located in outside storage room. The system is not completely labeled. Recommend having panel labeled by licensed electrician. **Panel has been labeled by B&B Electrical.**

Eaton 200 amp main breaker style panel in outside storage room / Not labeled
