Property Inspection Report

Southern Home Consultants, Inc.

Report #: 021326WO8.

2813 Shamrock N.
Tallahassee, FL 32309.

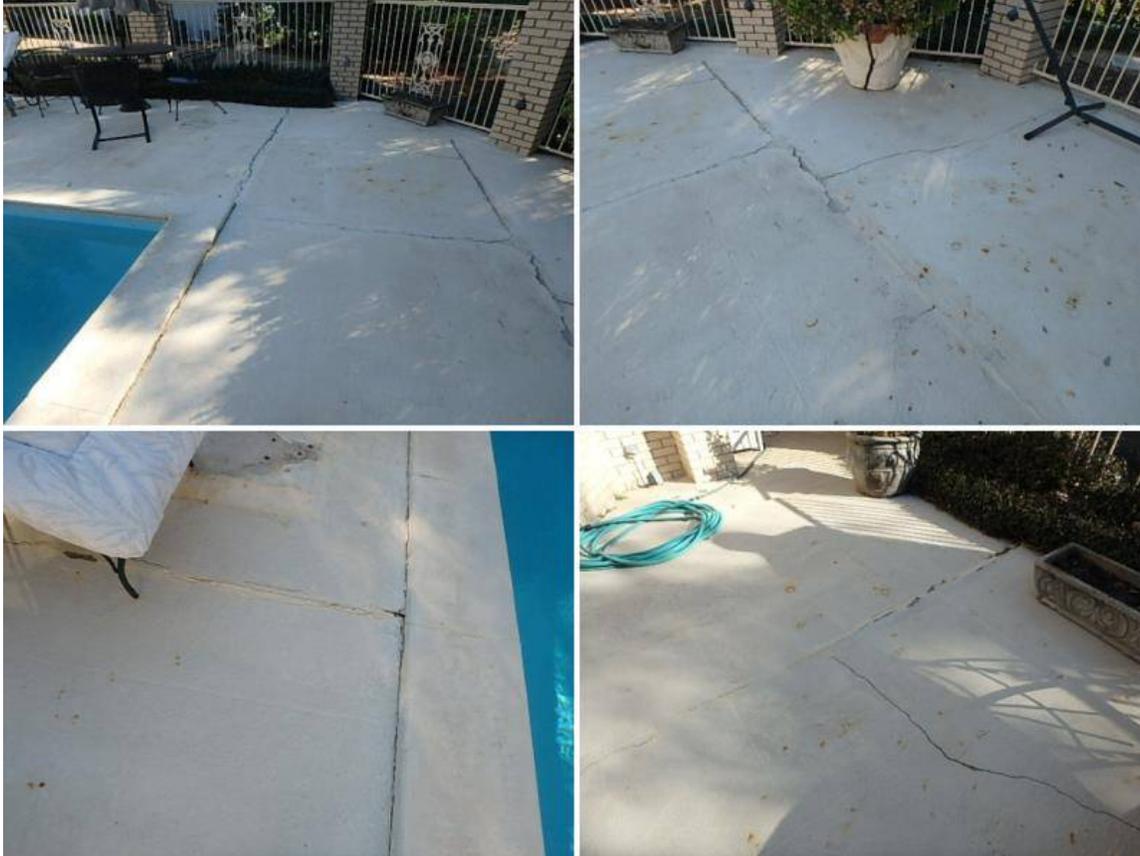
6. Various areas of raised and settled concrete noted around the pool area.

7. The pool patio surface drain appears to be clogged or blocked in various locations. Recommend cleaning and ensuring proper drainage of pool patio.

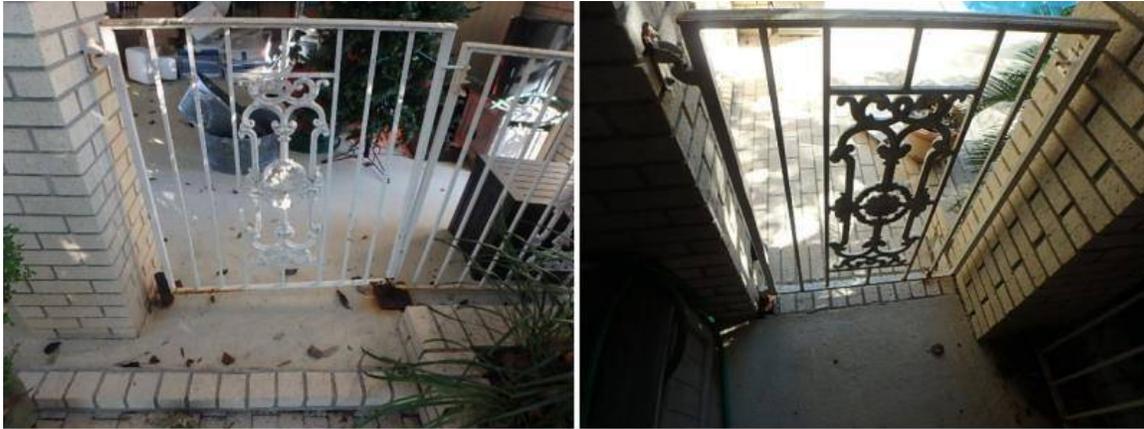
9. Rust damage noted at the 2 gates from the carport to the rear patio.

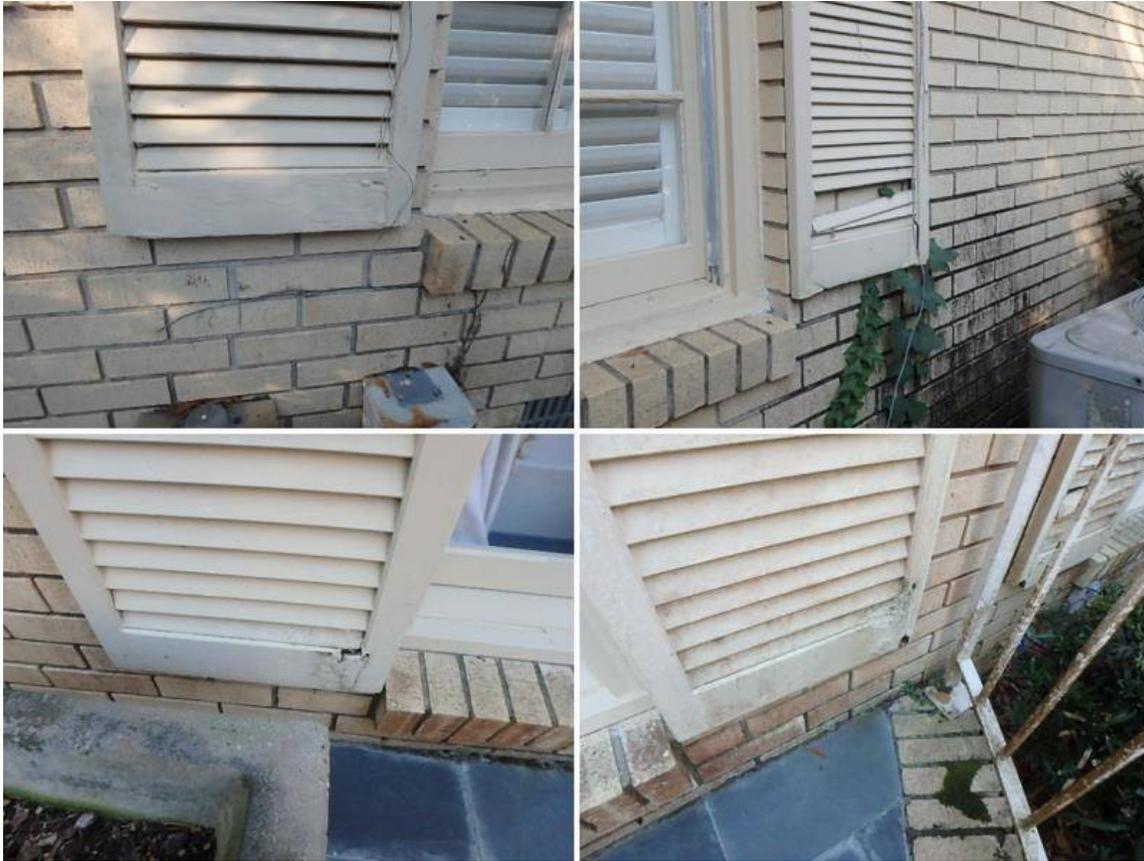
12. Various areas of wood rot noted at the decorative shutters. Representative pictures.

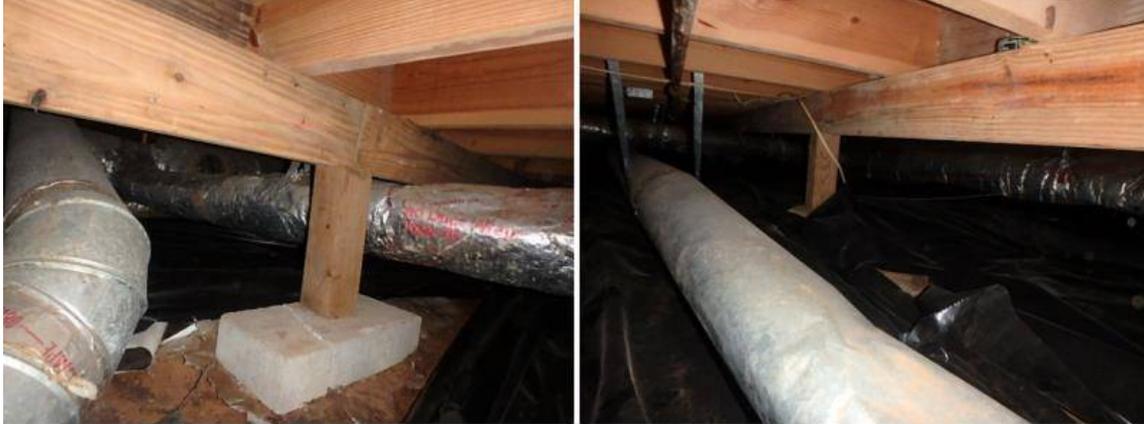
16. There are various added support beams under the floor joists in the crawlspace. It appears that these supports have been added to combat sagging or settling floors. Wood supports are resting on dry stack masonry blocks. Some cracking and settlement noted at masonry blocks under Under wood supports.

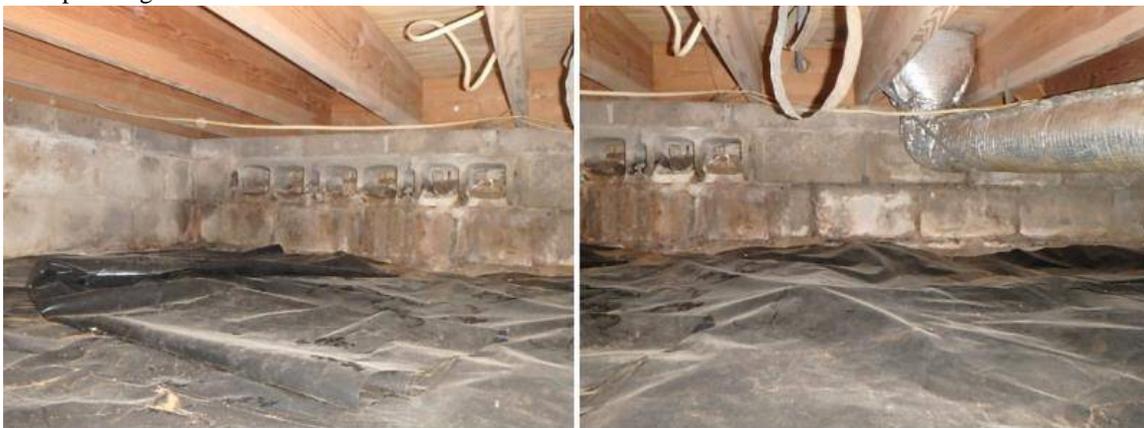
18. Evidence of moisture intrusion noted through the front foundation wall. Recommend improving site drainage and/or waterproofing as needed.

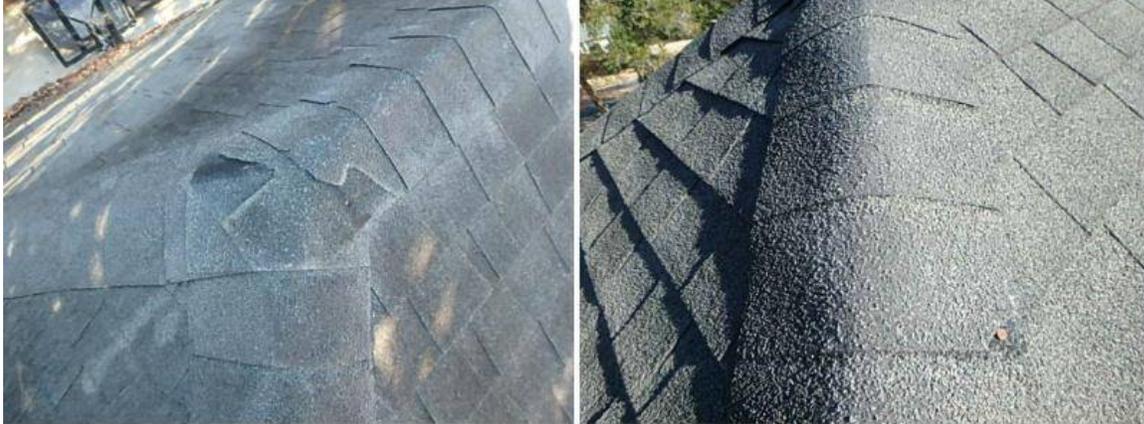
19. The roofing shingles show signs of aging with loss of aggregate, brittleness and exposed fiberglass mesh. Roof shingles appear to be nearing the end of their useful life.

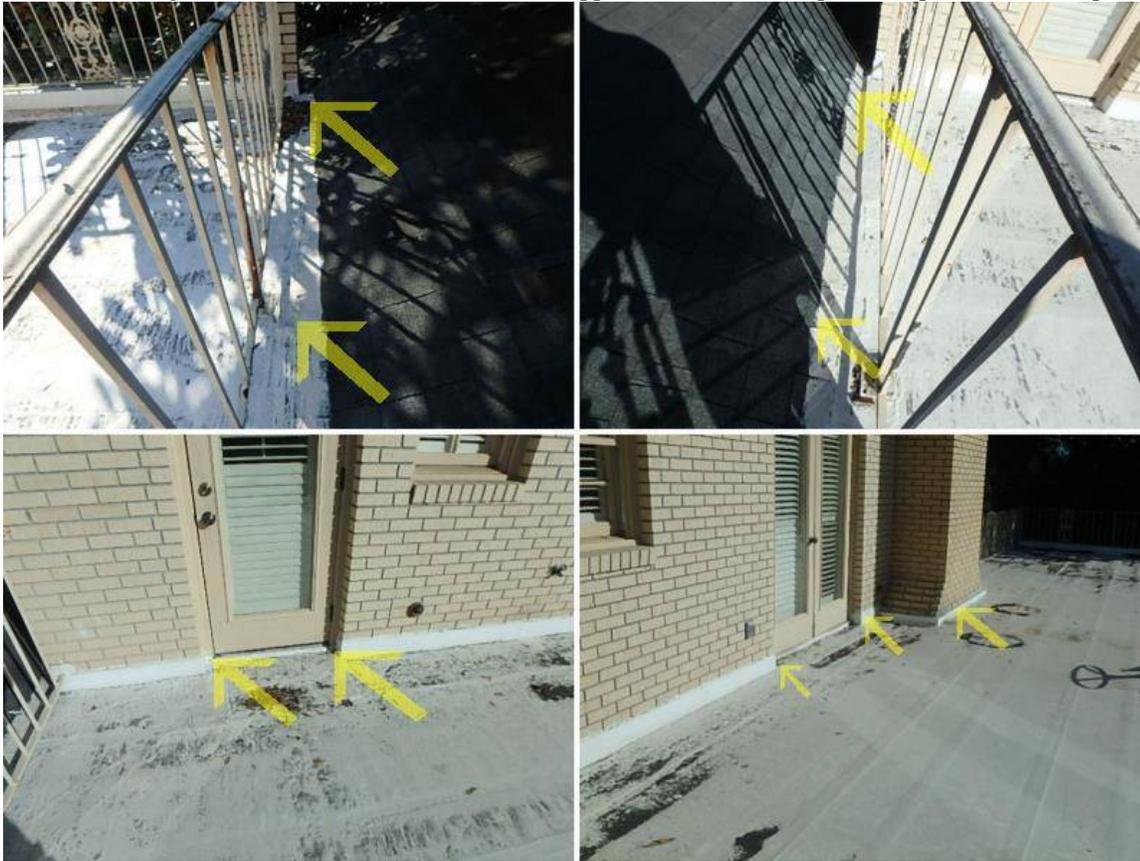
22. This roof has various areas of patching and repairs and sealant. Special care should be taken to properly maintain this roof and transitions to adjacent roofs and walls. Moisture staining and evidence of leakage noted as visible from the carport attic area. The ceiling below this area in the rear sunroom appears to have been repaired or painted at some point.

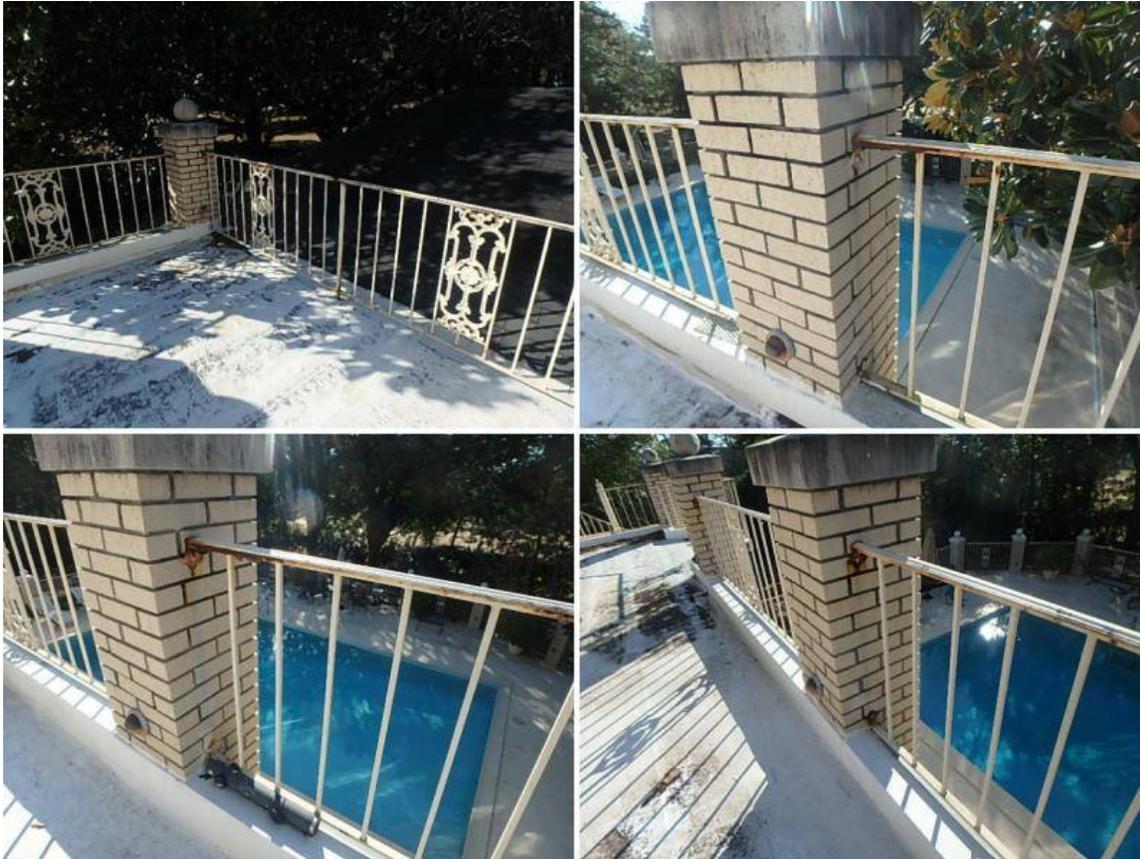
25. Various areas of rust and damage noted at the metal handrail around the upper rear roof.

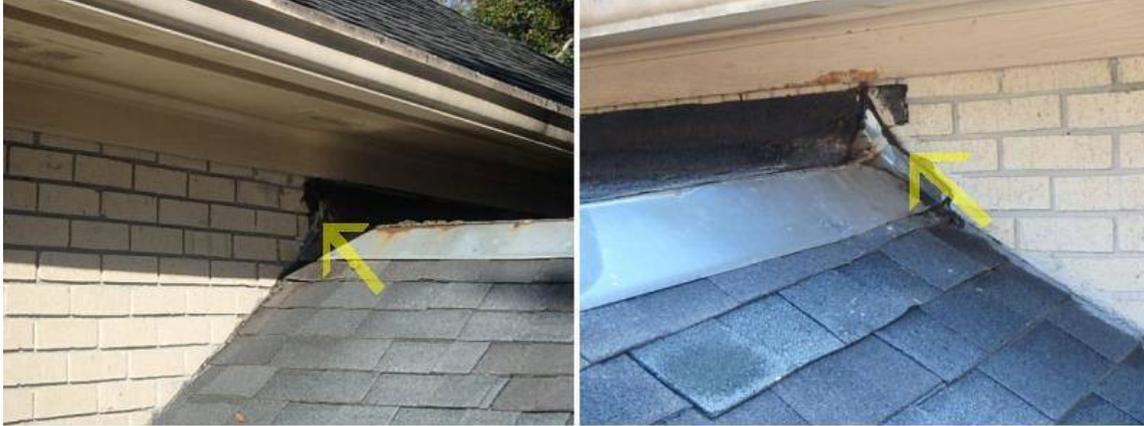
26. Separated, flashing, and sealant noted at the roof to all intersections on either side.

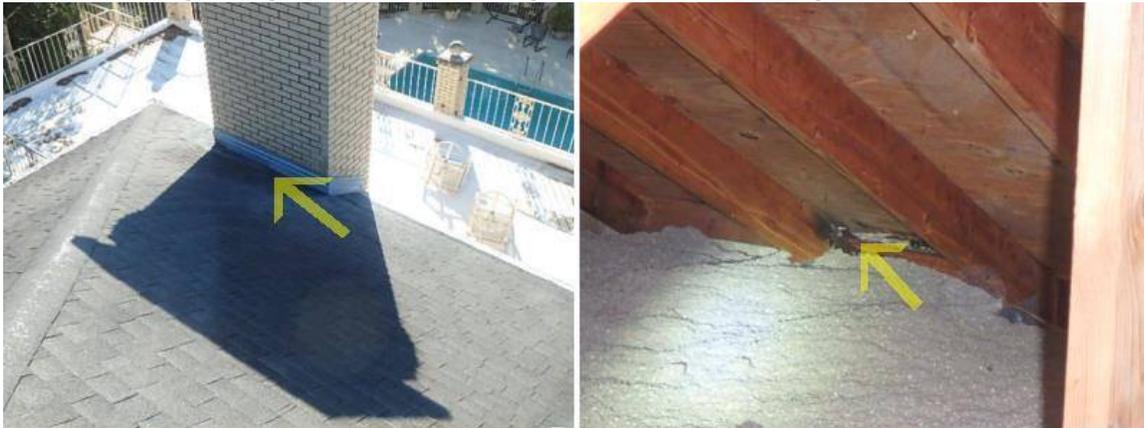
29. No chimney cricket is installed. Recommend installing a proper cricket to divert water and debris from around the chimney. Moisture staining, damage and evidence of leakage noted to the roof decking below this transition.

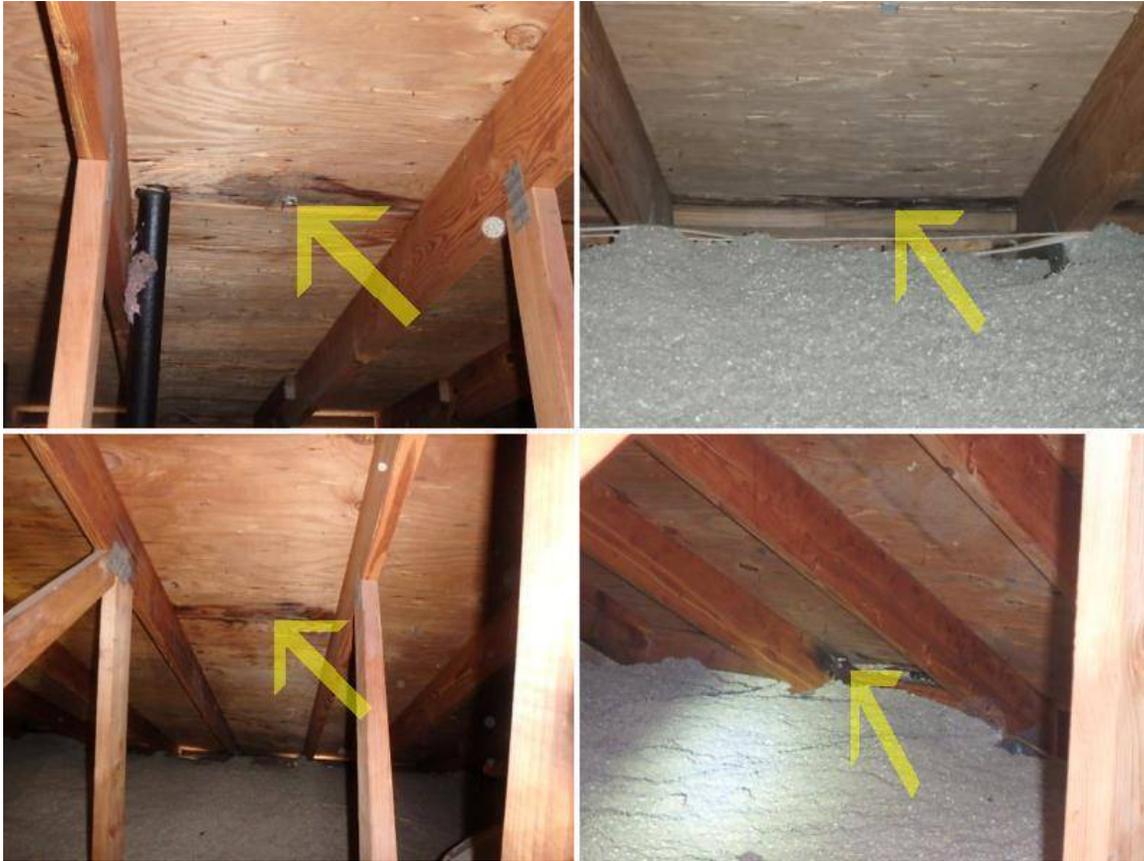
31. Moisture staining and evidence of leakage noted at the roof decking in various locations in the main attic.

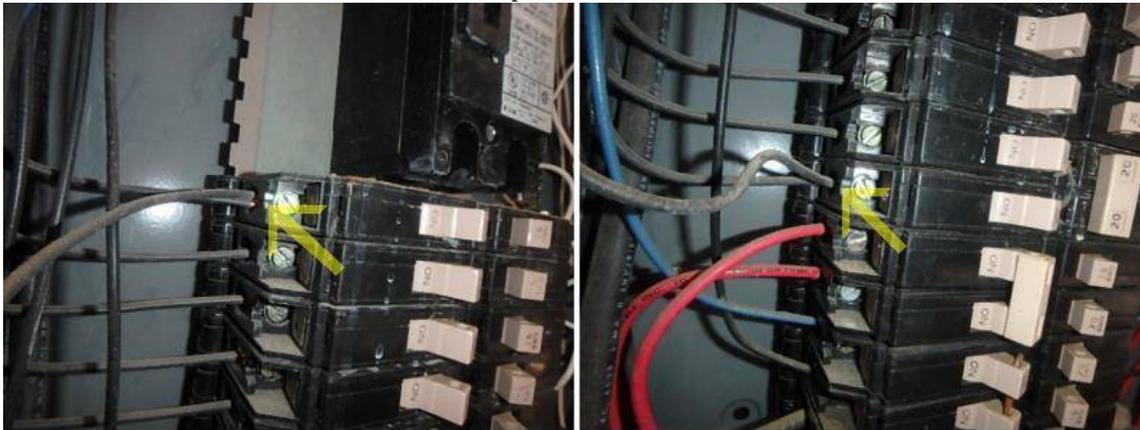
40. Multiple wires are connected to a single lug on a circuit breaker in the electrical panel where only one wire should be connected. Two locations noted in the left side panel.

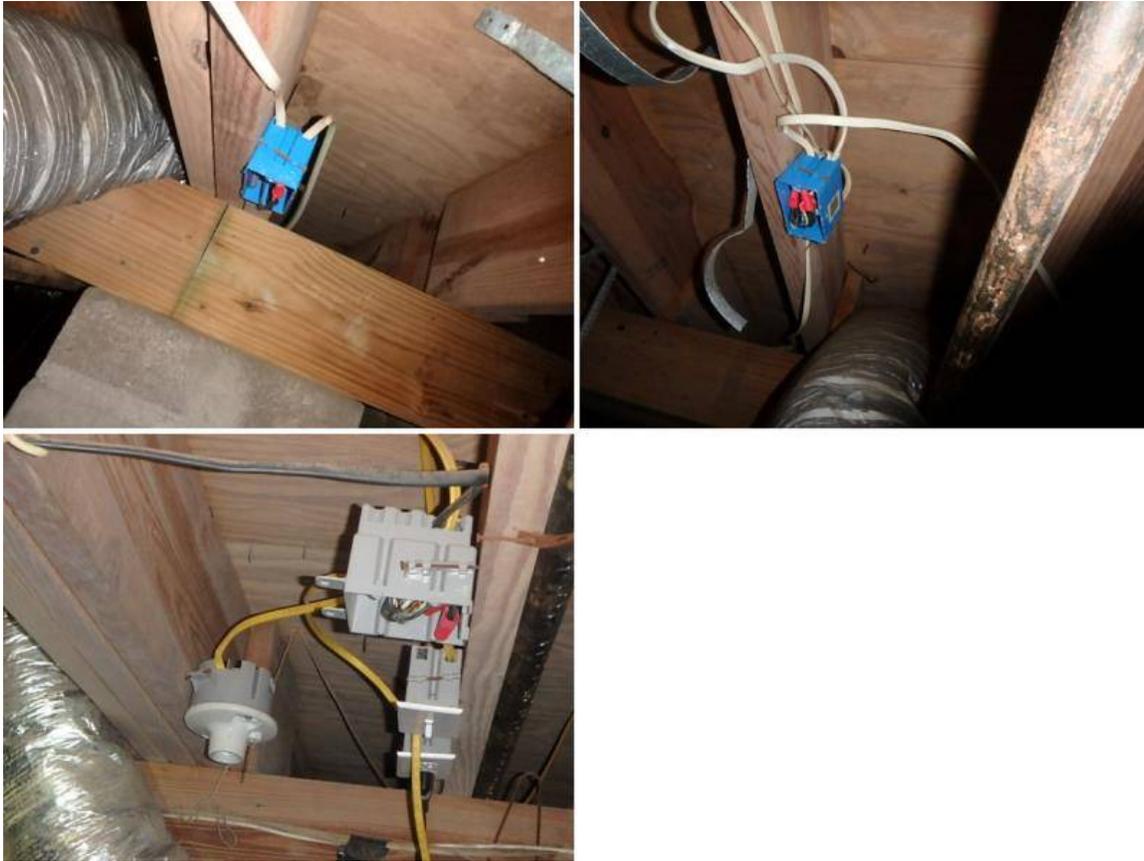
45. Recommend properly capping all junction boxes in the crawlspace that are currently without a cover.

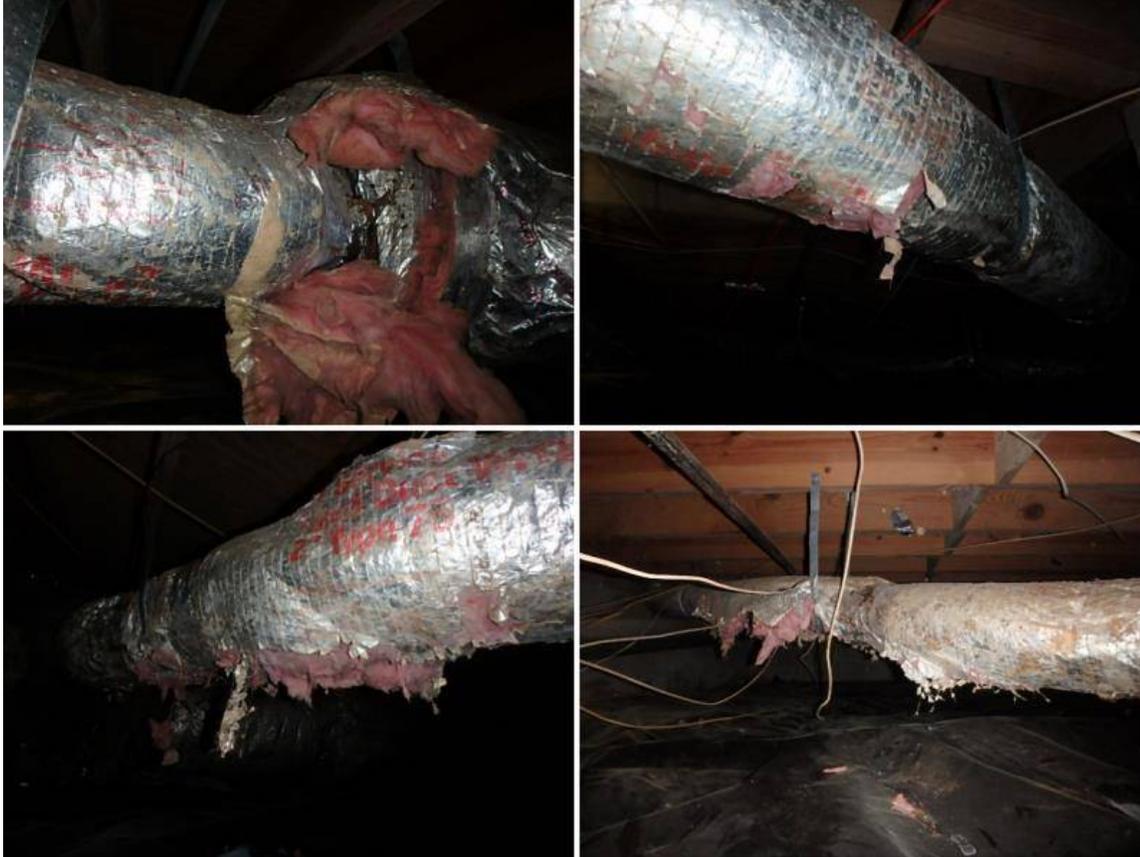
55. Various areas of damaged HVAC ductwork in insulation noted in the crawlspace.

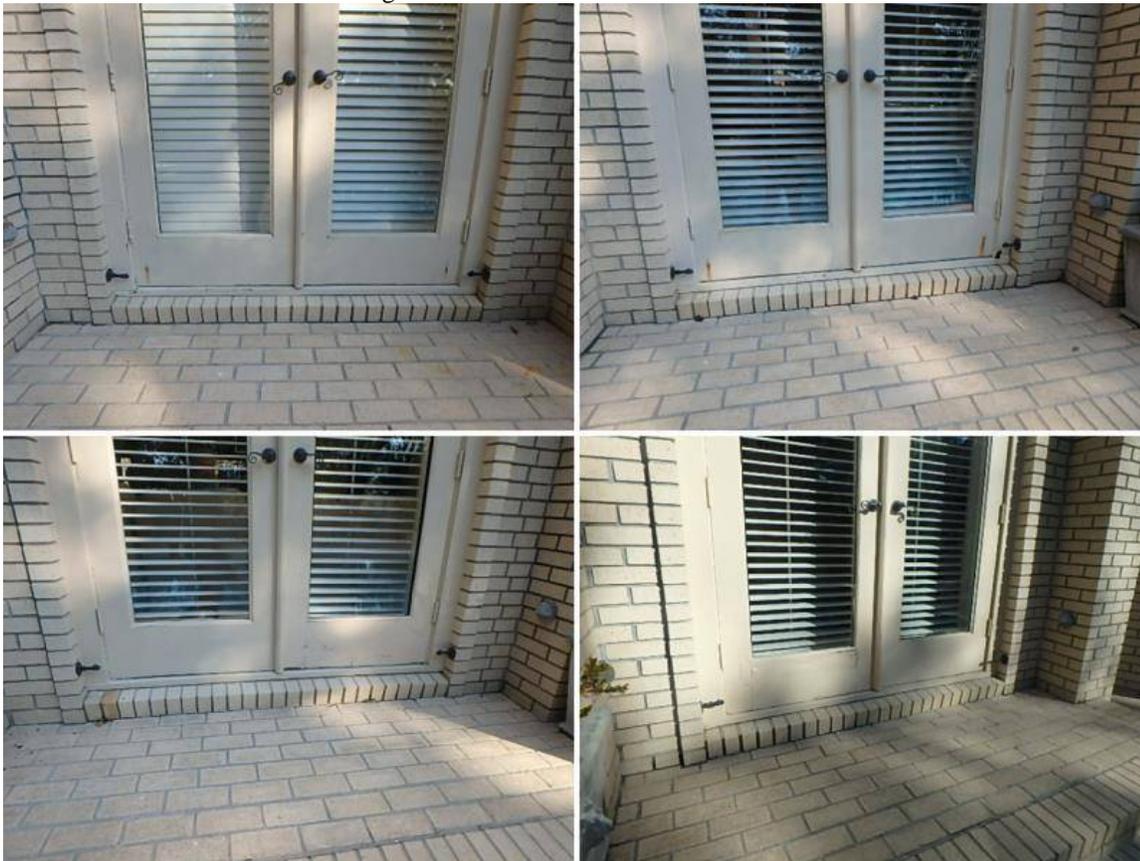
60. See notes above. General damage / rot noted at the rear doors.

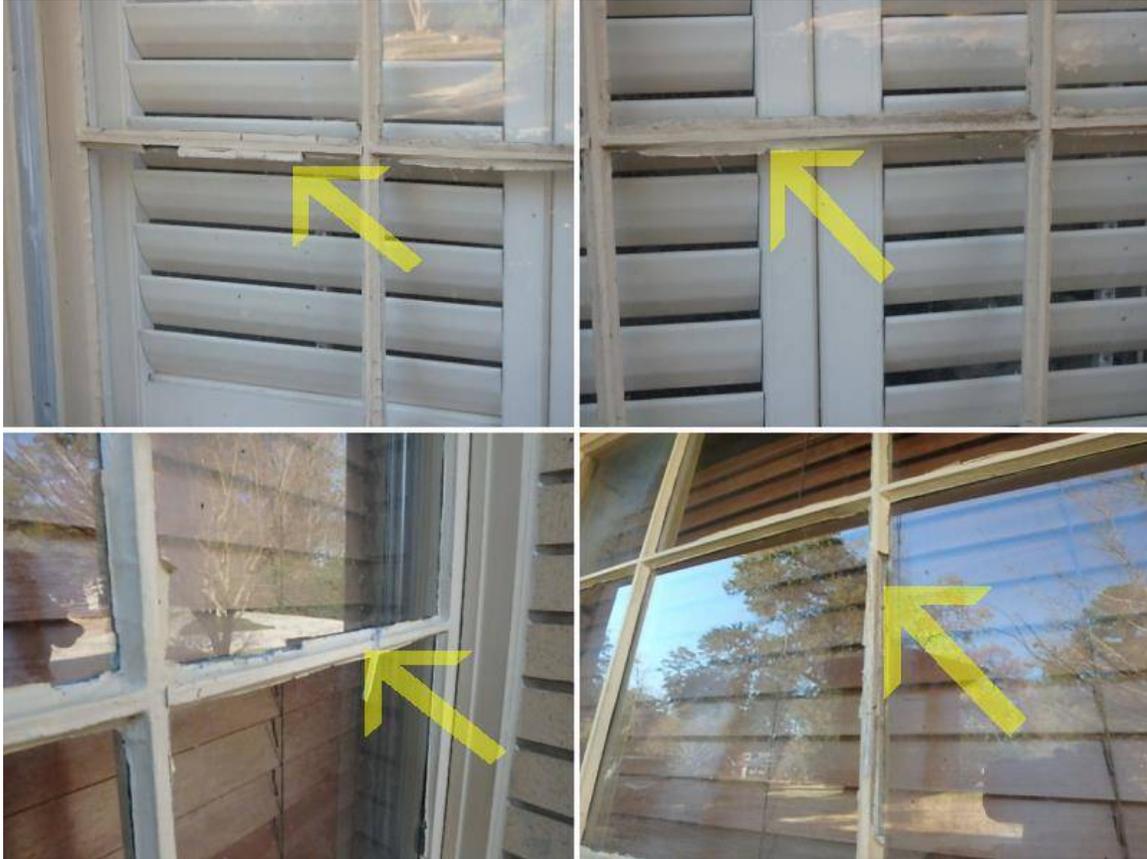
64. Windows are older and difficult to operate in various locations. Various areas of damaged or deteriorated glazing noted around window panes. Representative pictures.

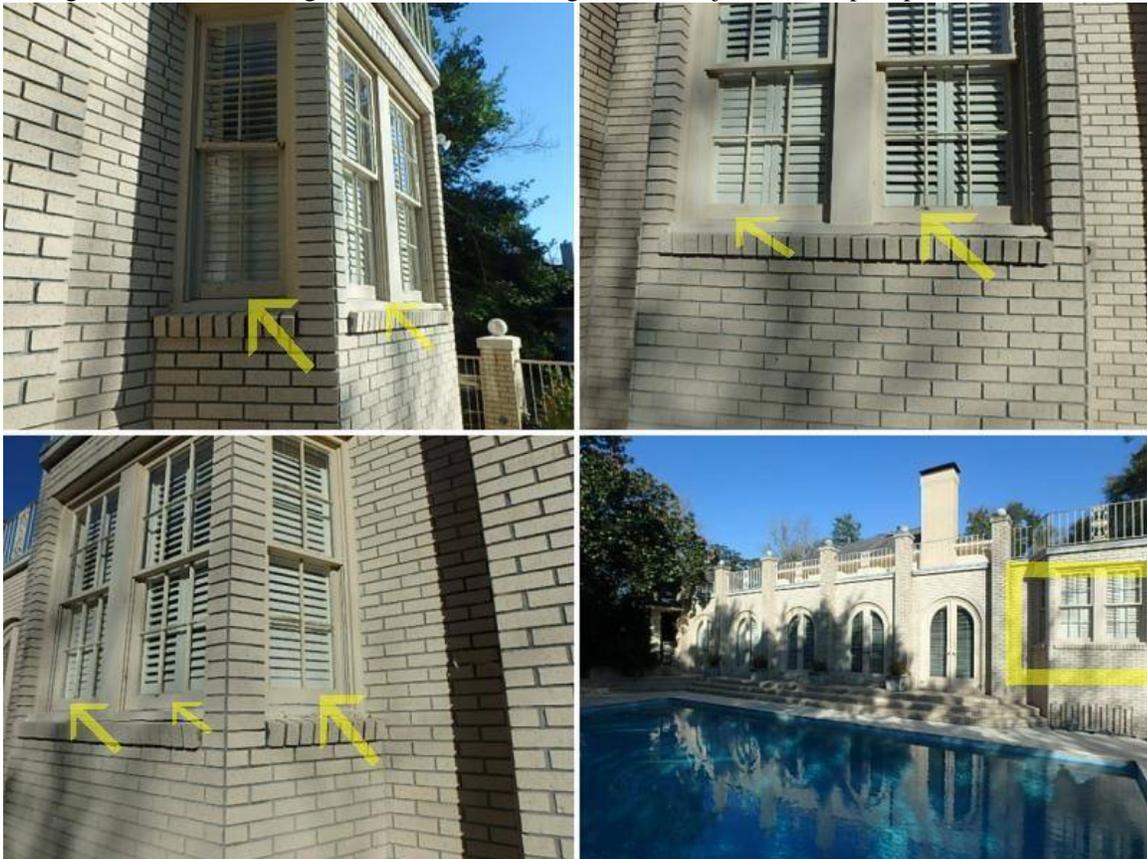
65. Significant rot and damage noted at the rear facing windows adjacent to the pool patio here.

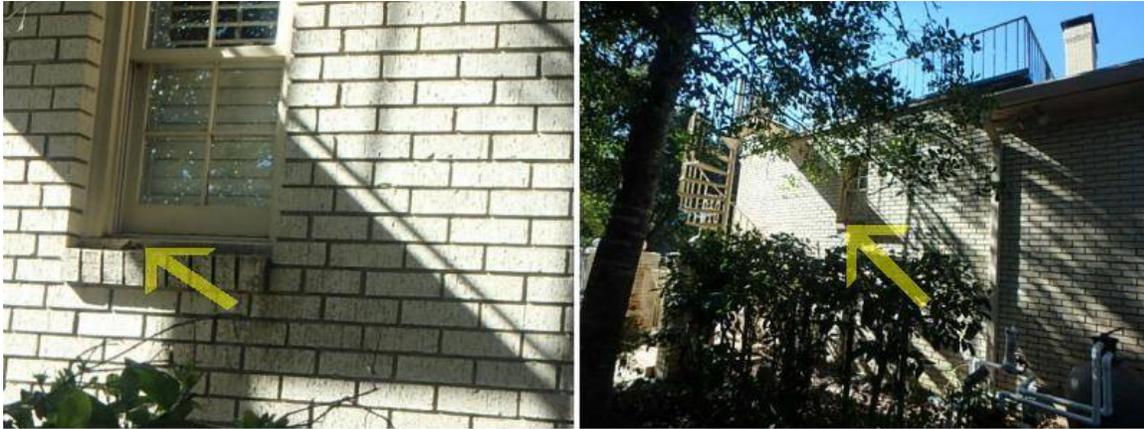
66. Significant rot and damage noted at the left side window near the spiral staircase.

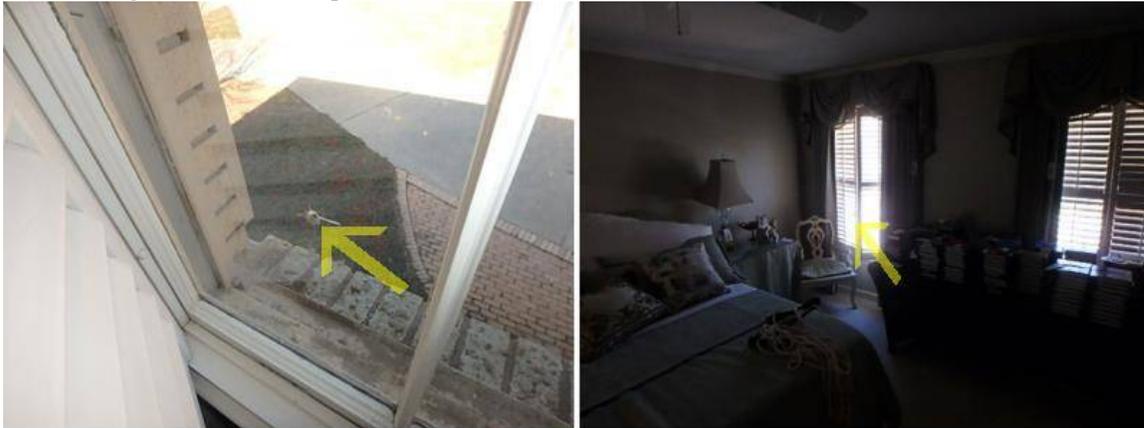
68. Broken glass noted at the upstairs master bedroom window here.

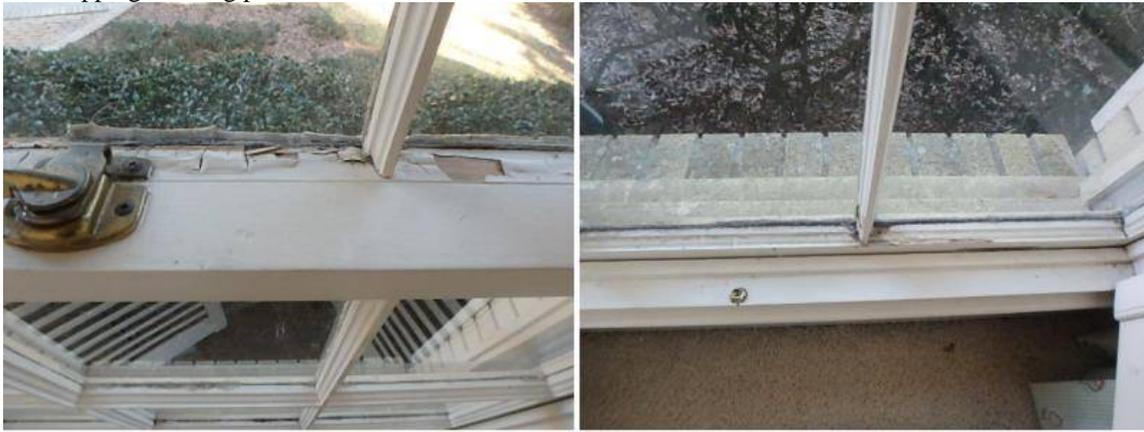
70. Chipping / flaking paint and finish noted at various windows.

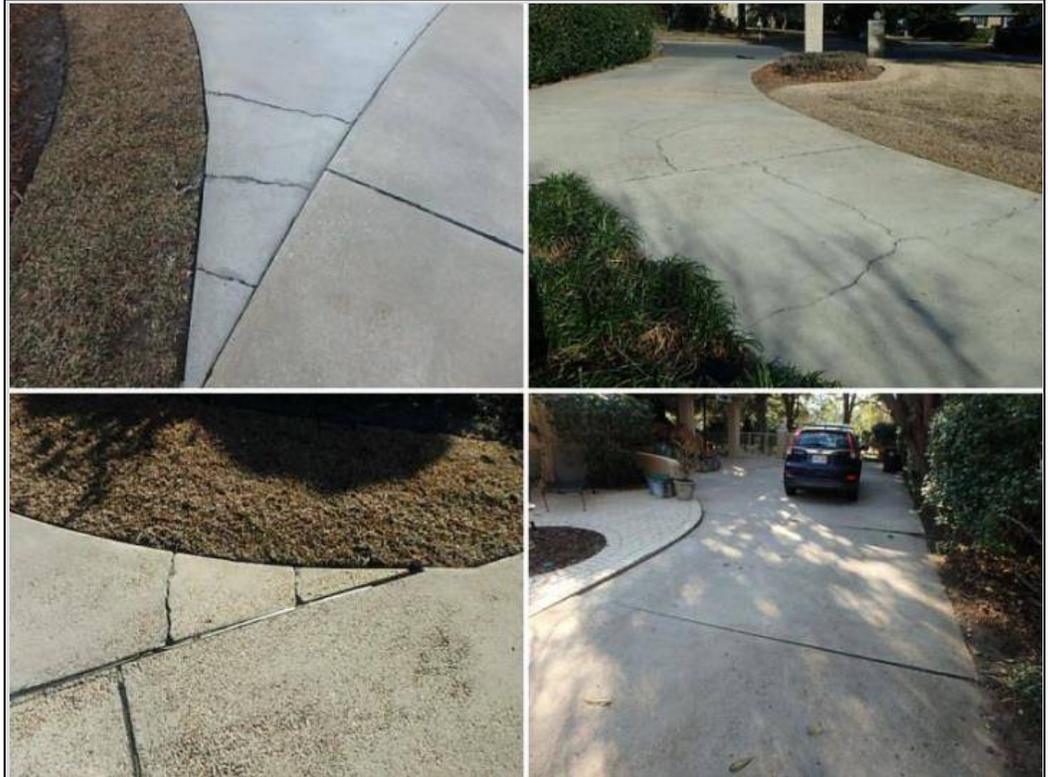
Driveway has areas of cracking and settlement.

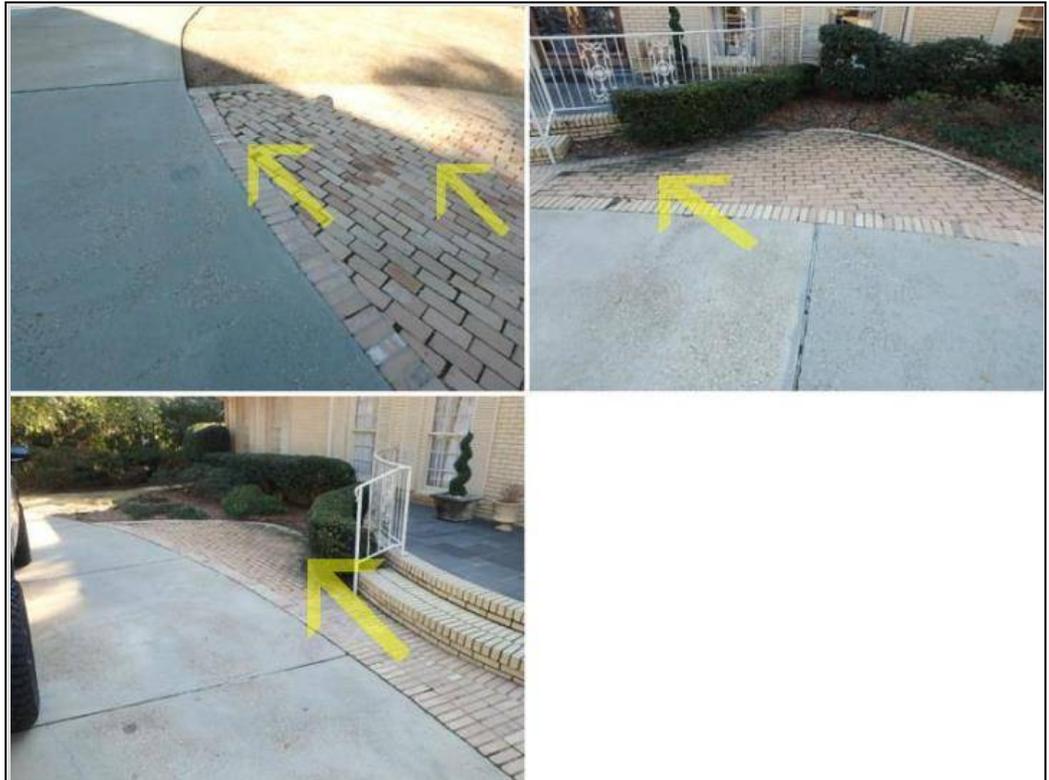
Areas of raised and settled brick pavers noted at the front driveway and walk areas. Some areas appear to hold or trap water during rain events.

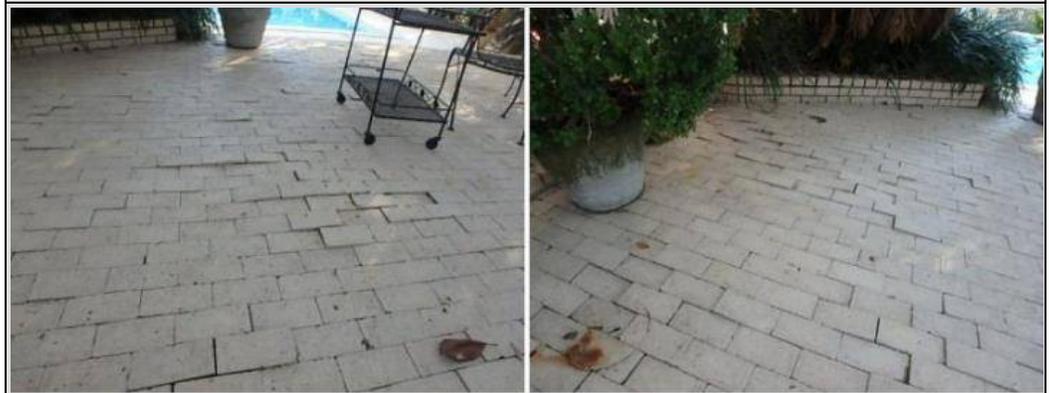
Various areas of raised and settled bricks noted at the right side rear patio.

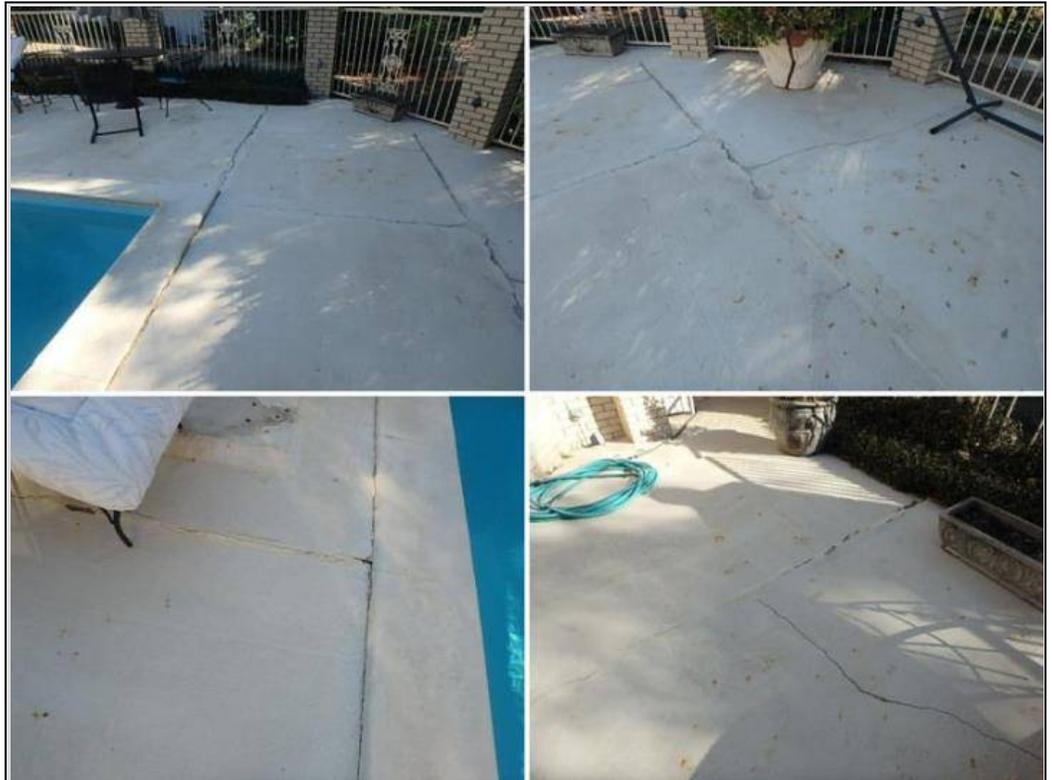
*Various areas of raised and settled concrete noted around the pool area.
The pool patio surface drain appears to be clogged or blocked in various locations. Recommend cleaning and ensuring proper drainage of pool patio.*

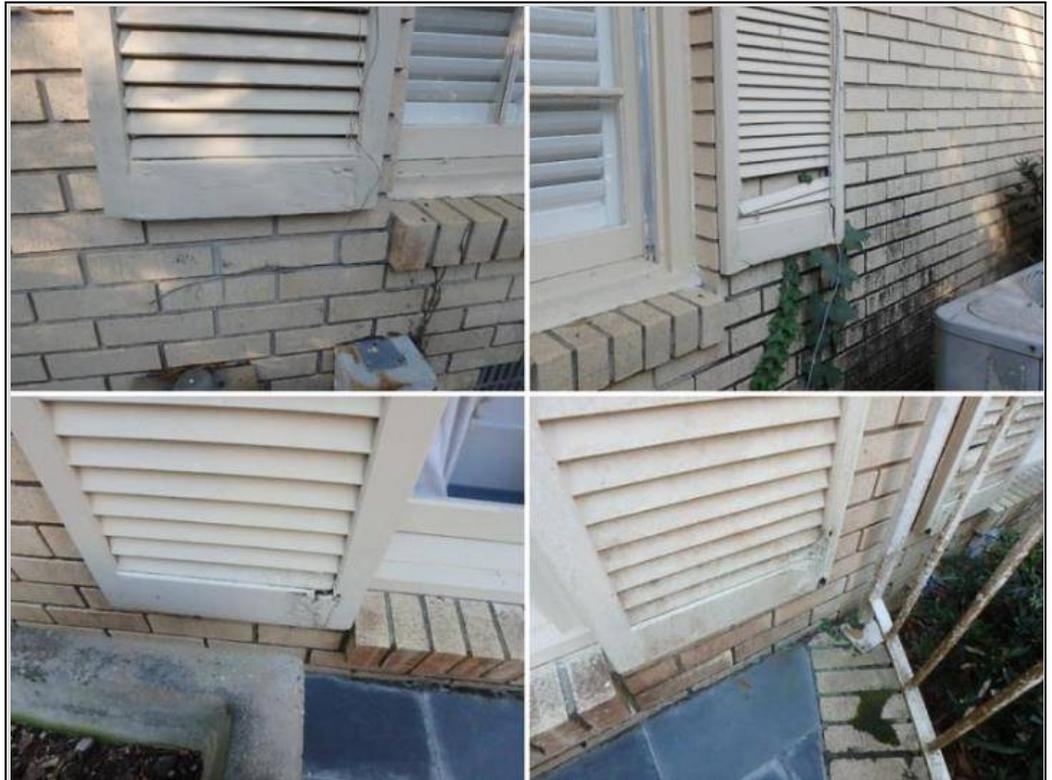
Various areas of wood rot noted at the decorative shutters. Representative pictures.

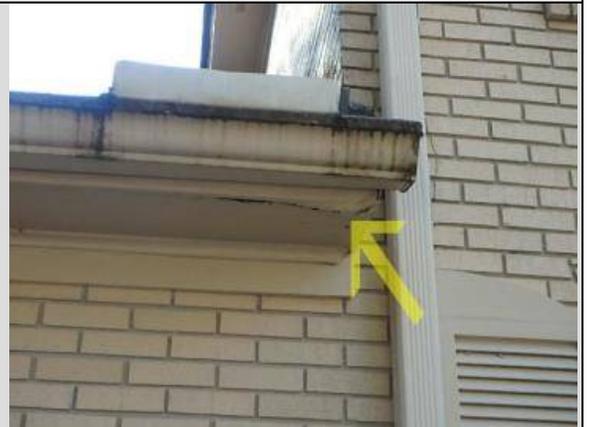
Rot at front soffit trim left of the front entry. Damage appears to be from roof leakage.

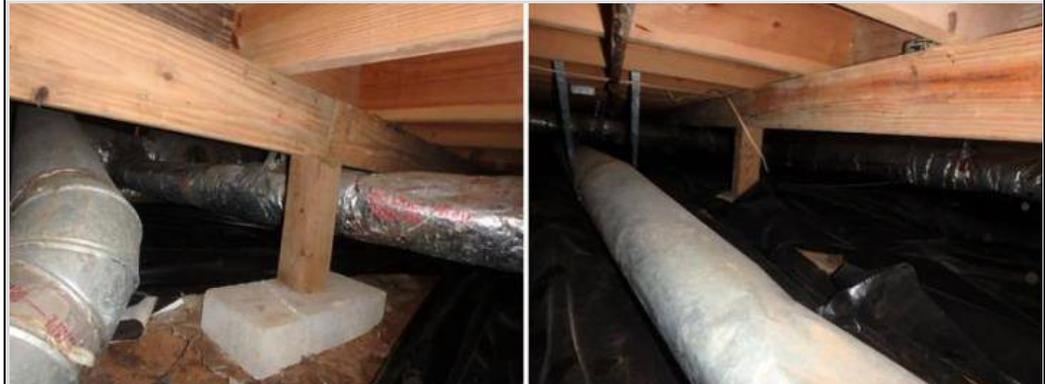
There are various added support beams under the floor joists in the crawlspace. It appears that these supports have been added to combat sagging or settling floors. Wood supports are resting on dry stack masonry blocks. Some cracking and settlement noted at masonry blocks under Under wood supports.

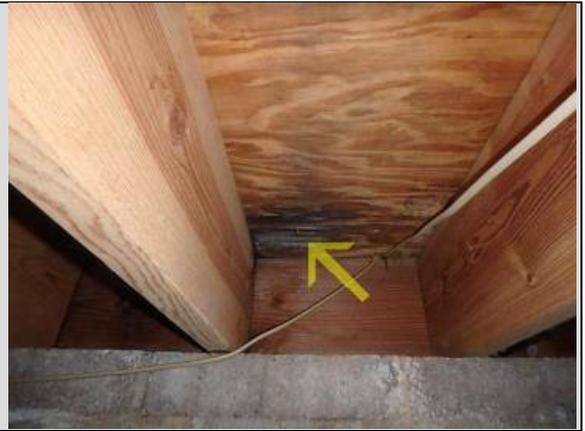
Moisture staining and evidence of leakage noted at the subfloor under the front exterior entry transition to the main wall.

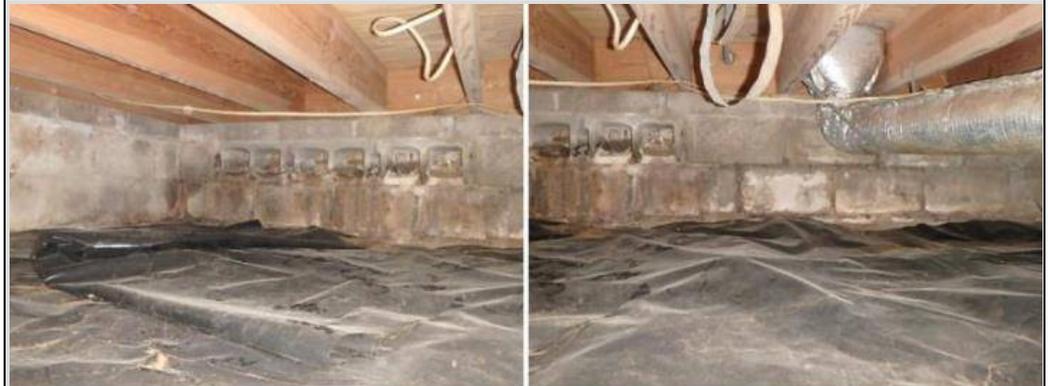
Evidence of moisture intrusion noted through the front foundation wall. Recommend improving site drainage and/or waterproofing as needed.

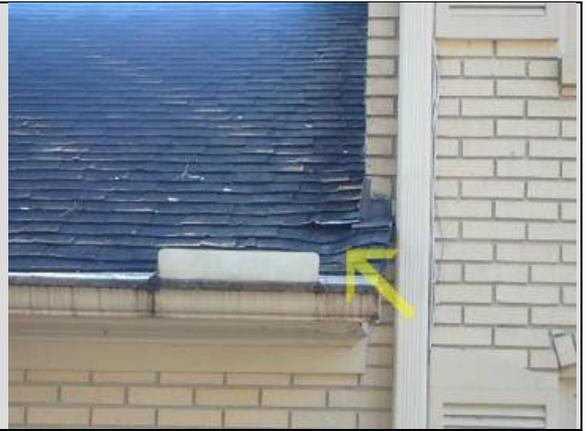
Low / depressed area and evidence of leakage noted at the front roof here. Wood rot noted below this area. Active leakage appears to be occurring.

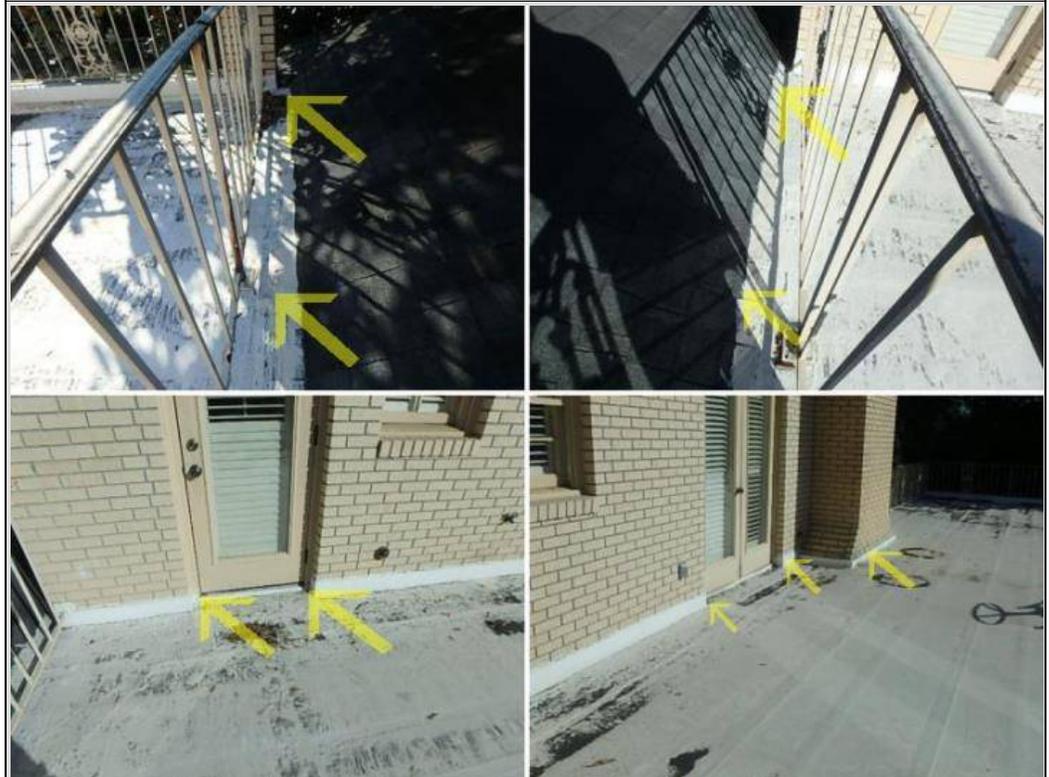
This roof has various areas of patching and repairs and sealant. Special care should be taken to properly maintain this roof and transitions to adjacent roofs and walls. Moisture staining and evidence of leakage noted as visible from the carport attic area. The ceiling below this area in the rear sunroom appears to have been repaired or painted at some point.

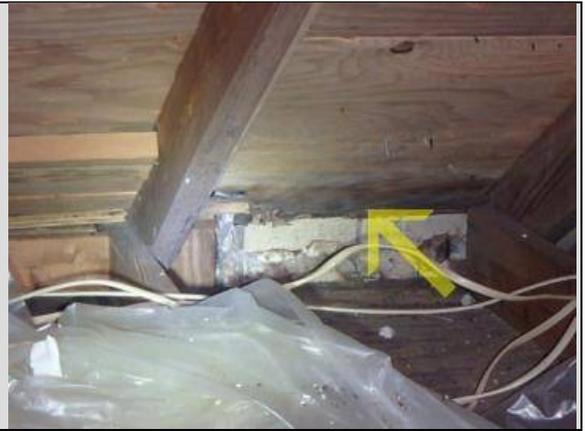
See notes above. Areas of staining, damage and evidence of leakage noted at the roof decking adjacent to the rear, low sloped roof. (Visible from the carport attic)

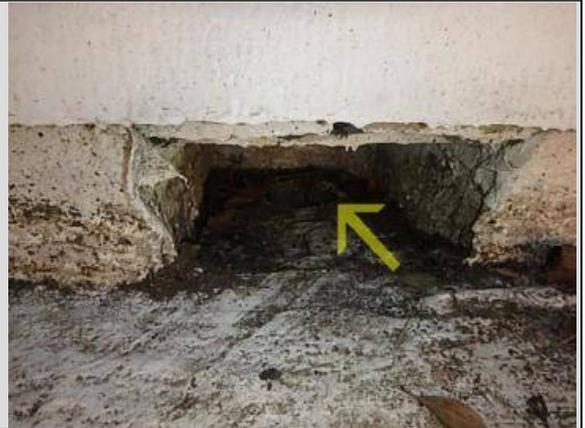
This roof drains by downspouts that are concealed inside of the rear brick wall. Location of discharge is not known. Recommend ensuring that these pipes are maintained and kept clear of debris. Inspection limited.
