Property Inspection Report

Southern Home Consultants, Inc.

Report #: 021326WO8.

2813 Shamrock N.
Tallahassee, FL 32309.

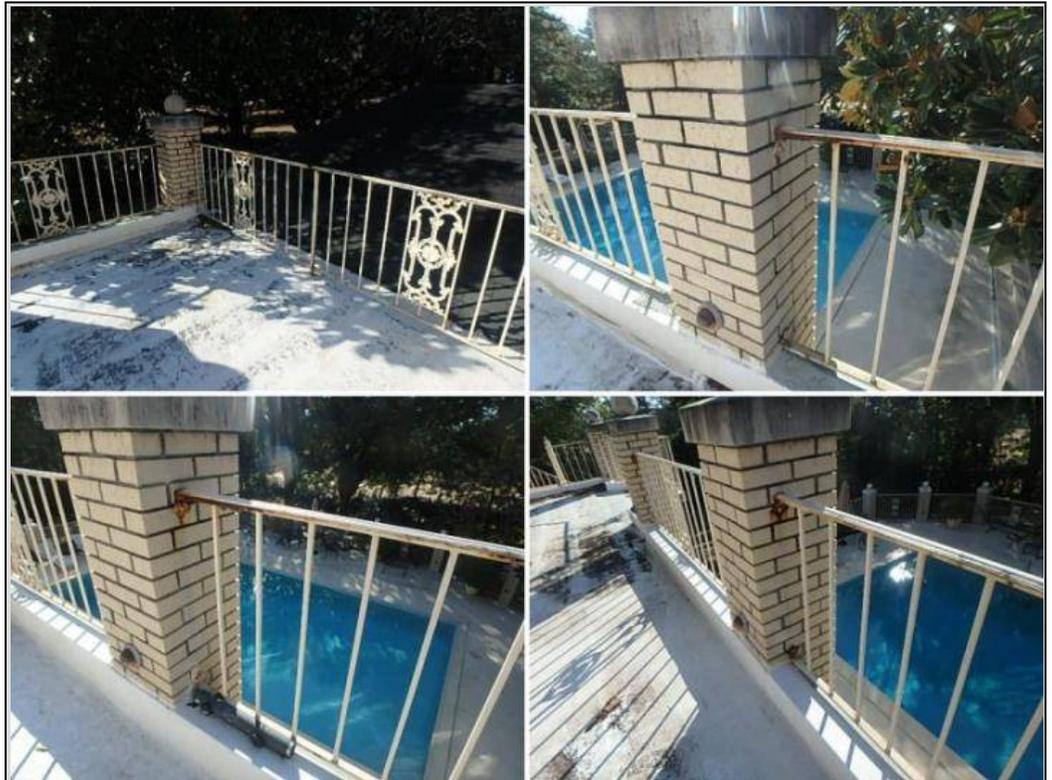
Various areas of rust and damage noted at the metal handrail around the upper rear roof.

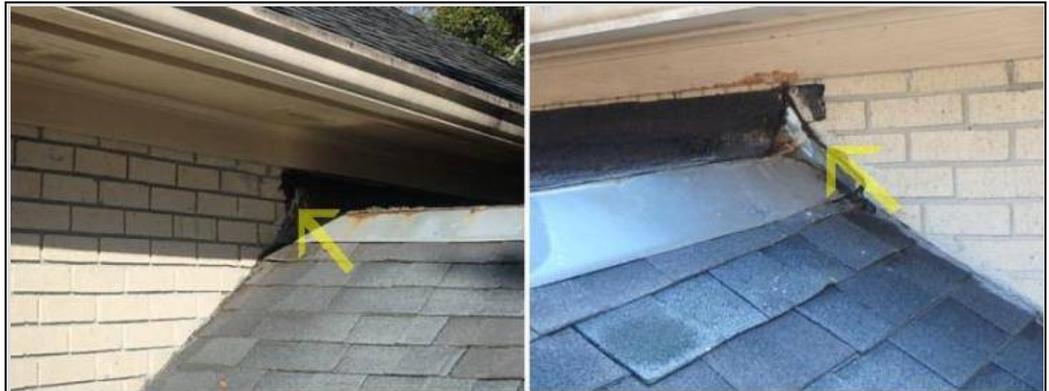
Separated, flashing, and sealant noted at the roof to all intersections on either side.

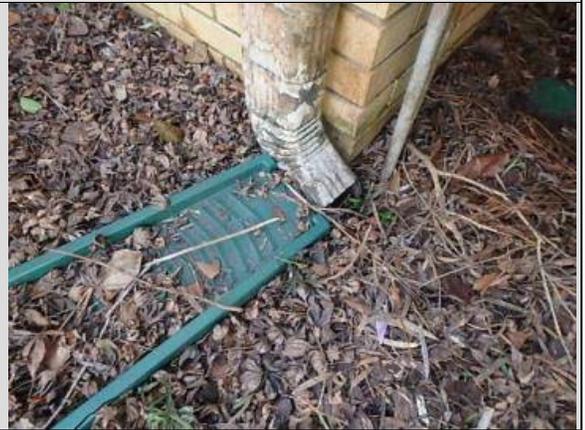
Recommend cleaning gutters and downspouts and properly extending downspouts away from the foundation.

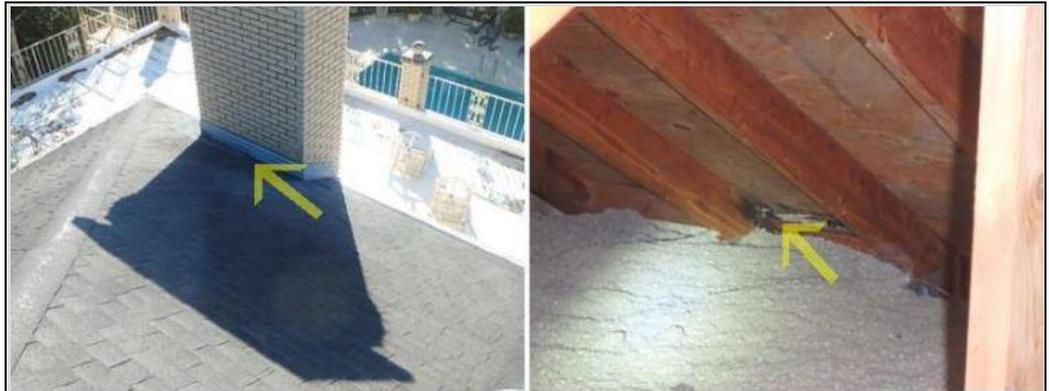
No chimney cricket is installed. Recommend installing a proper cricket to divert water and debris from around the chimney. Moisture staining, damage and evidence of leakage noted to the roof decking below this transition.

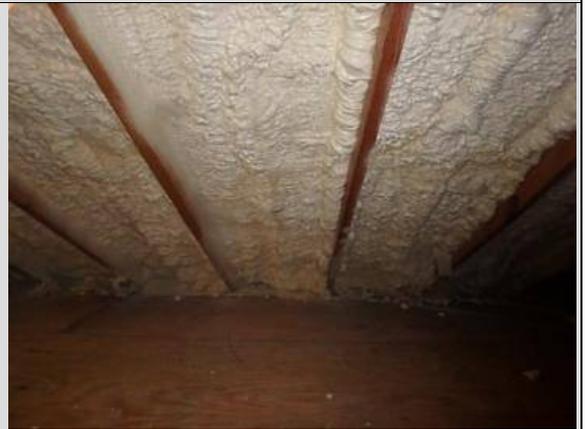
FYI: The spray foam insulation on the roof decking appears to be closed cell type insulation. Typical spray foam insulation on roof decking is open cell which allows visibility of water / staining in the event of a roof leak.

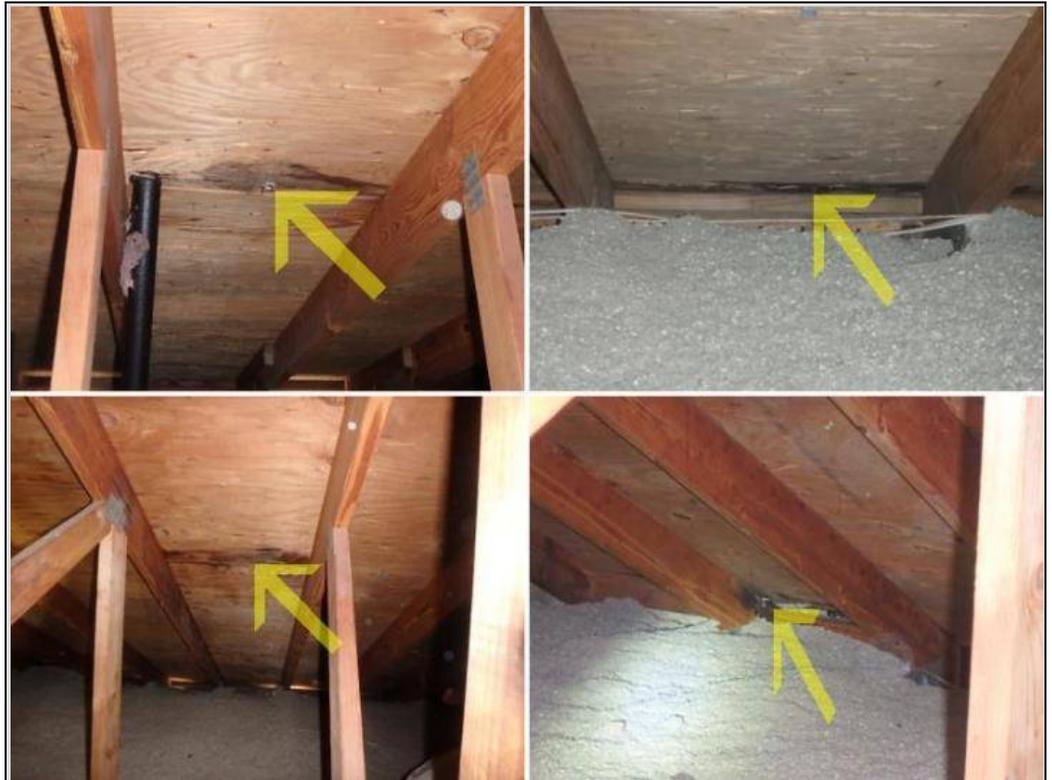
Moisture staining and evidence of leakage noted at the roof decking in various locations in the main attic.

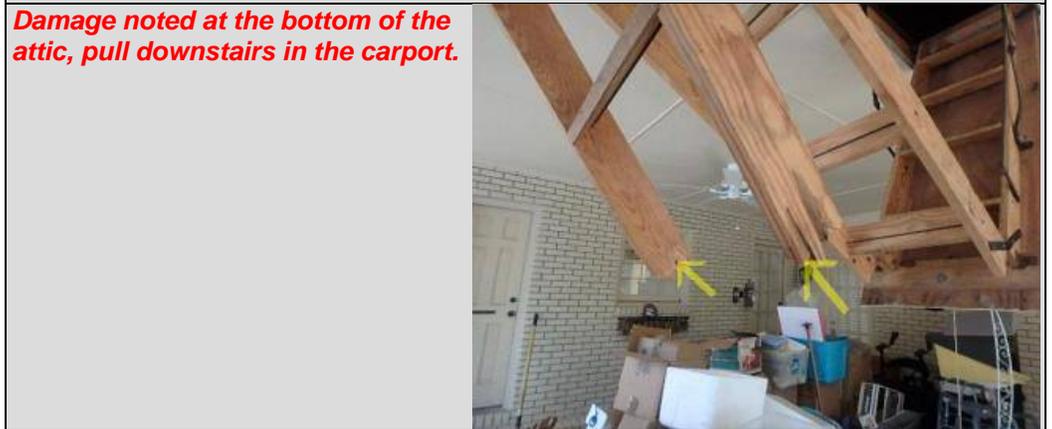
Damage noted at the bottom of the attic, pull downstairs in the carport.

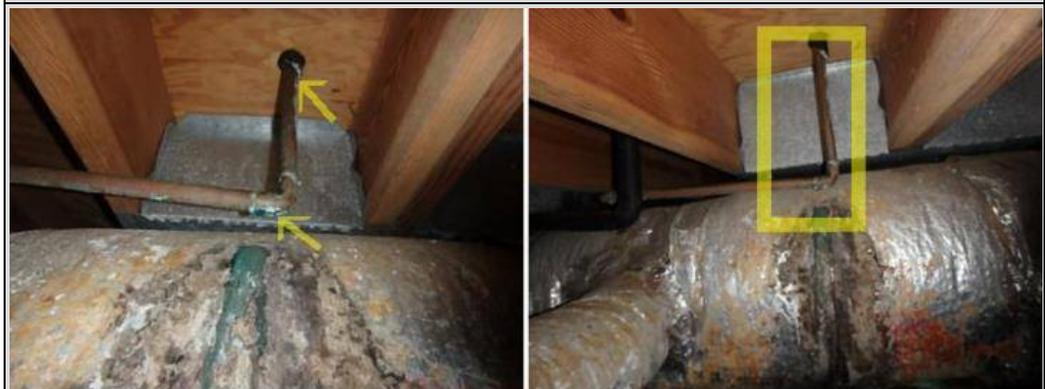
Dripping noted from the supply line in the crawlspace under the water heater that is in the closet adjacent to the front entry foyer.

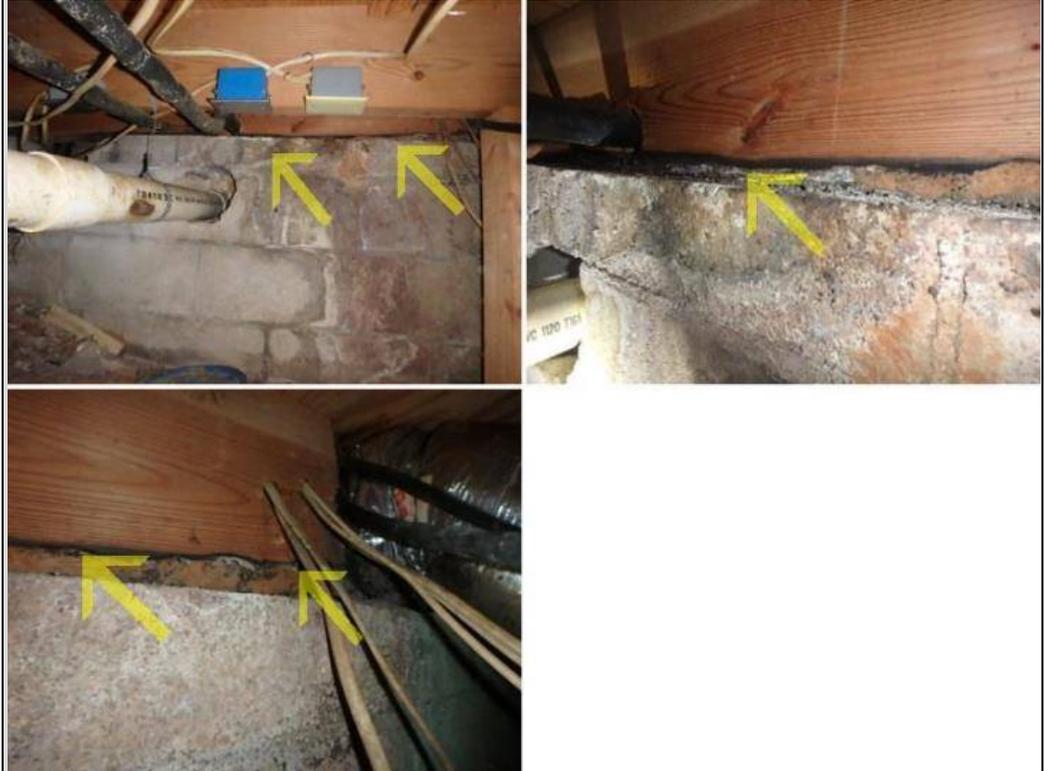
Evidence of leakage noted around the sewer line in the crawlspace that protrudes from the slab area under the laundry room and carport bathroom. Staining and rot noted at the Framing in this location.

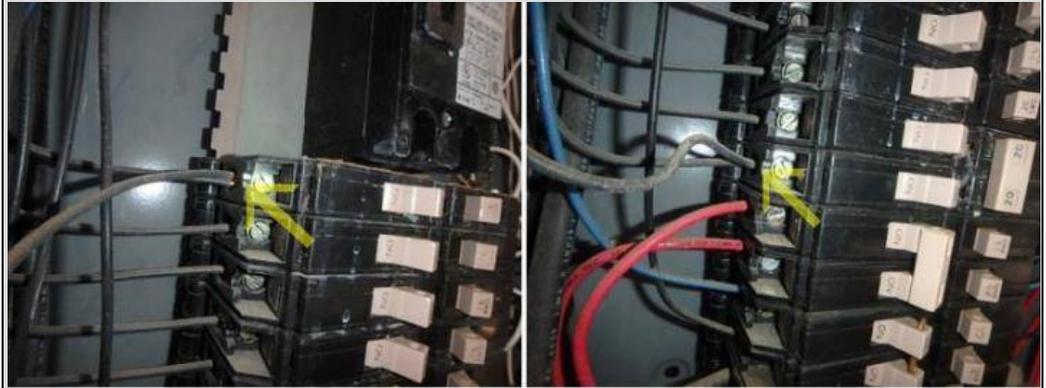
Multiple wires are connected to a single lug on a circuit breaker in the electrical panel where only one wire should be connected. Two locations noted in the left side panel.

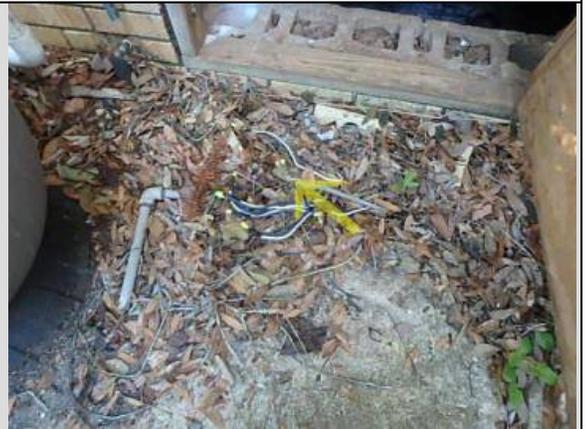
Exposed wiring noted adjacent to the crawlspace access door. The Gray wire tested for being energized at time of inspection.

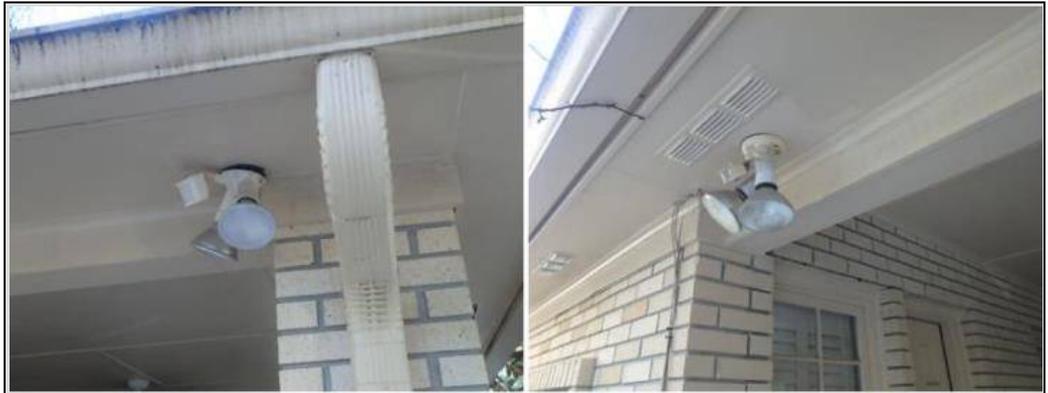
Loose / damaged exterior flood fixtures noted at the right side.

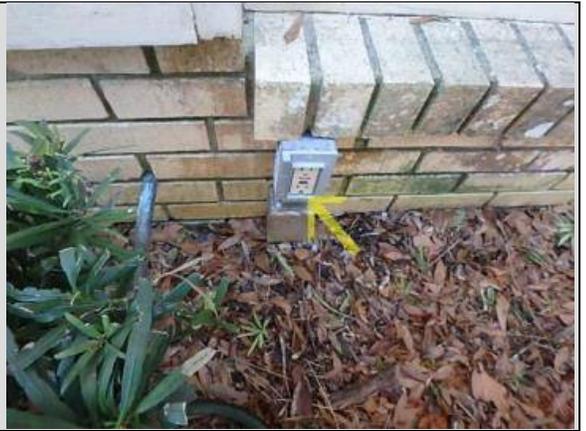
The front exterior electrical outlet is missing the weather resistant cover.

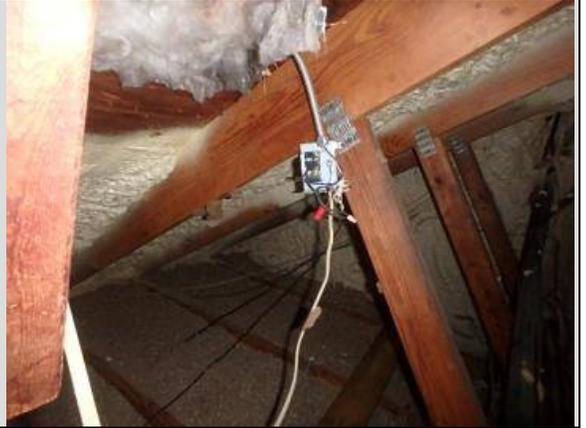
Exposed wiring at junction box for vent fan in attic area.

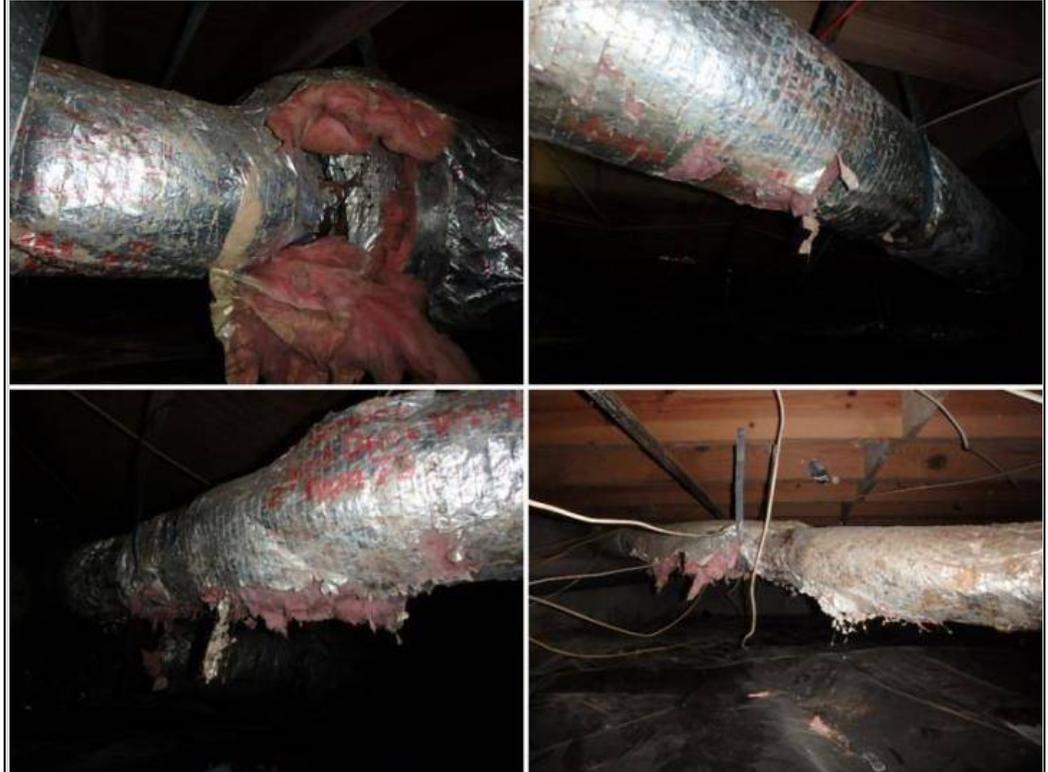
Various areas of damaged HVAC ductwork in insulation noted in the crawlspace.

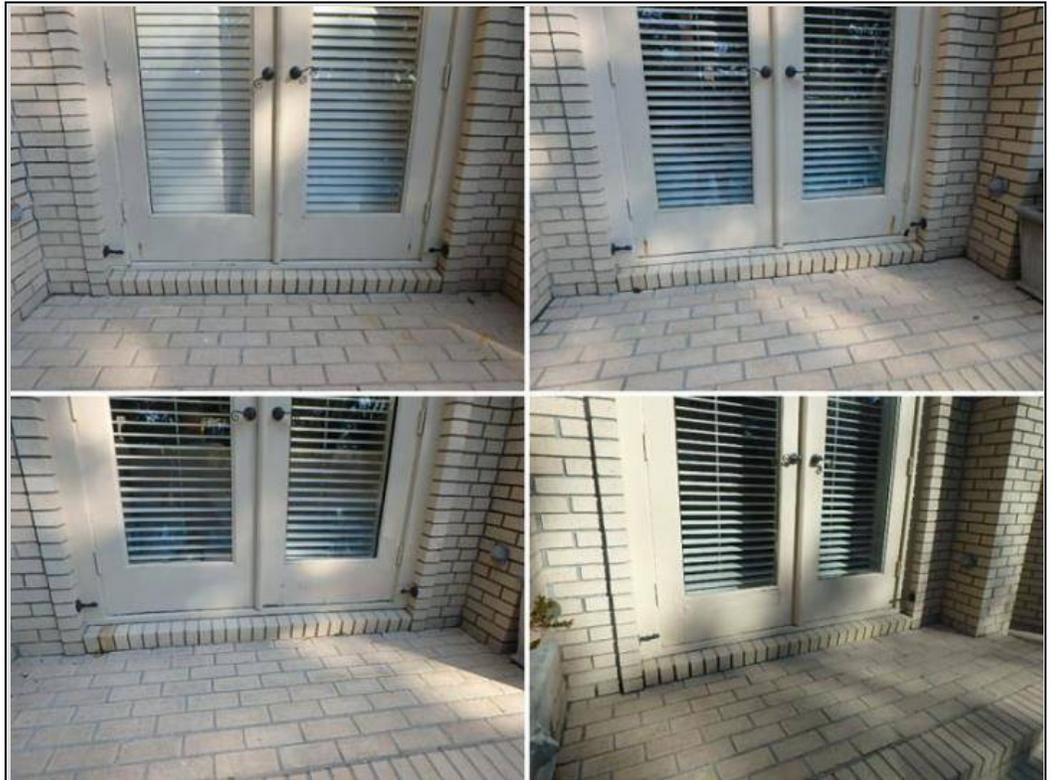
See notes above. General damage / rot noted at the rear doors.

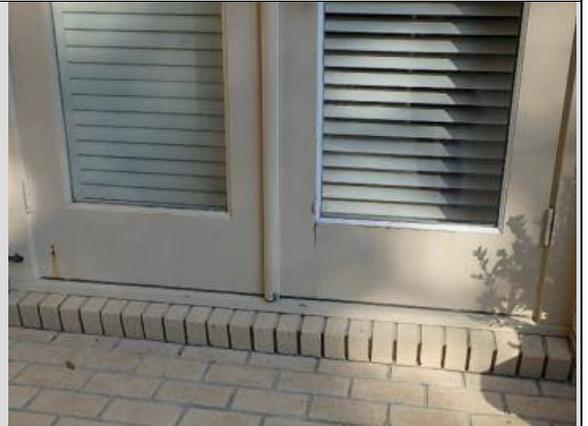
See notes above. General damage / rot noted at the rear doors.

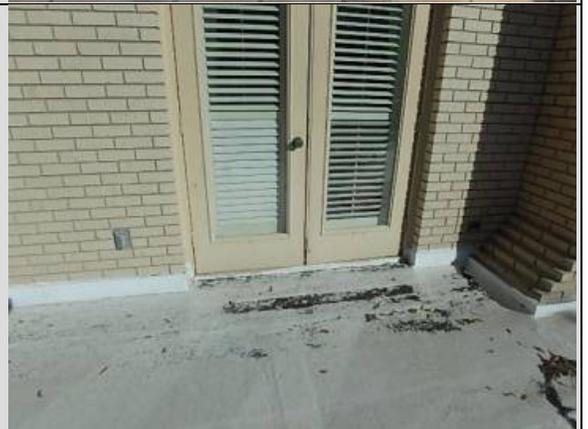
Rust damage and wood rot noted at the rear upper balcony exterior door.

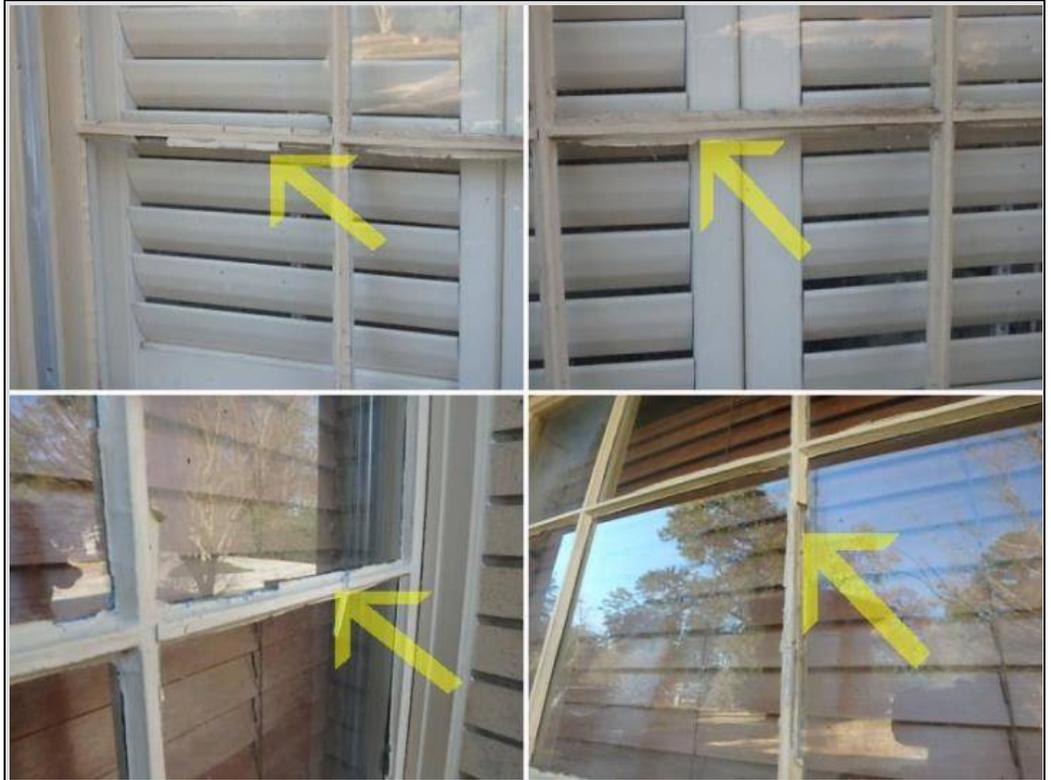
Windows are older and difficult to operate in various locations. Various areas of damaged or deteriorated glazing noted around window panes. Representative pictures.

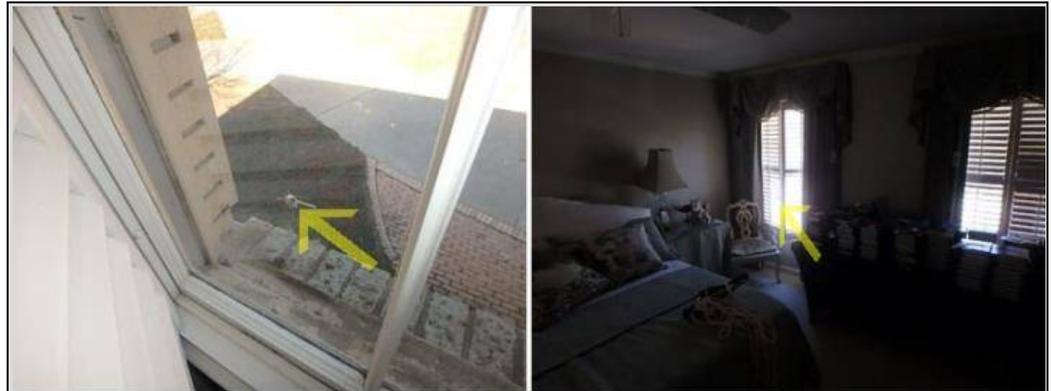
Evidence of leakage noted at the window above the toilet in the upstairs master bathroom. Rot noted at window.

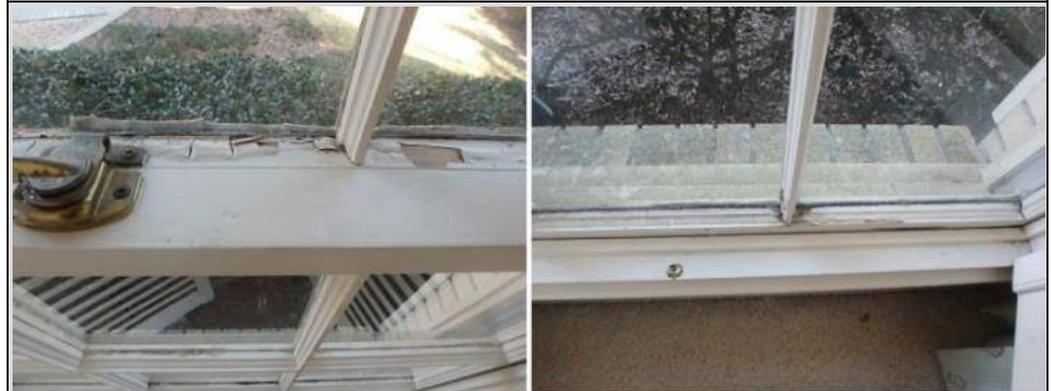
Broken glass noted at the upstairs master bedroom window here. Window screens are not installed.

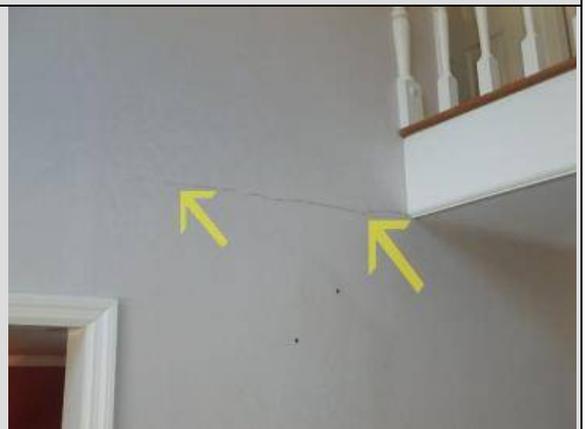
Cracking and evidence of settlement noted at the wall adjacent to the front entry foyer area. See also notes regarding additional support added in crawlspace area. Some settlement appears to have occurred.

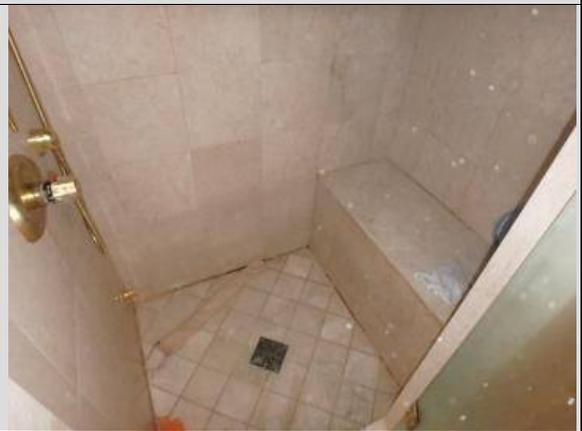
Areas of cracking / chipping tile grout noted in the shower.

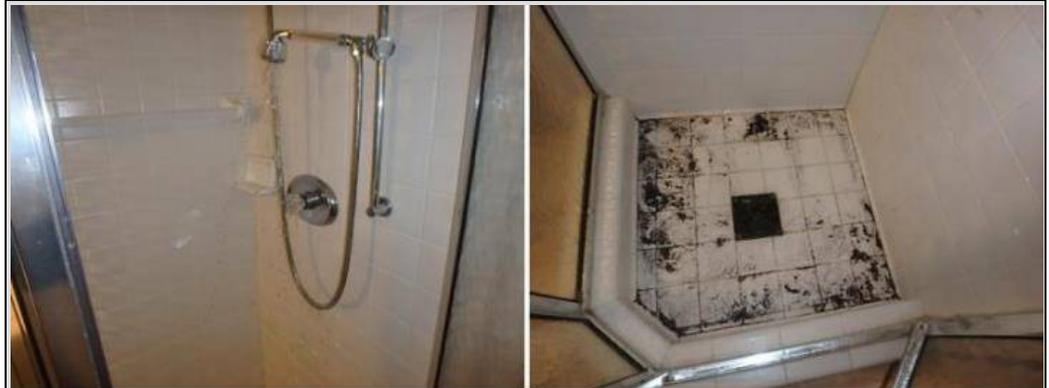
The shower controls were difficult to operate. Evidence of water backing up in the shower area. Debris noted at the base of the shower.

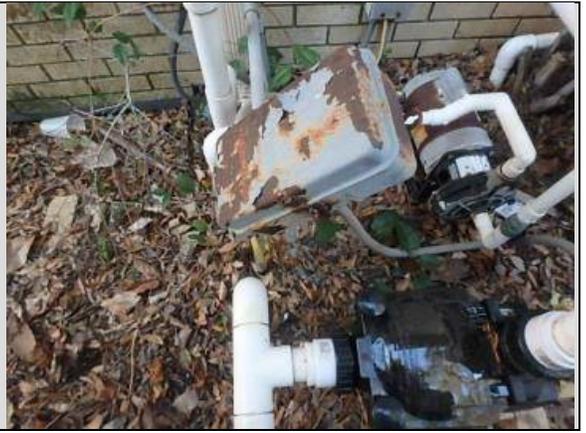
Rust and damage noted at the pool electrical timer box.
