Inspection Report

Weeks Auction Group

Property Address: 11376 Salem Rd. Pavo Ga 31778

South Georgia Home Inspections

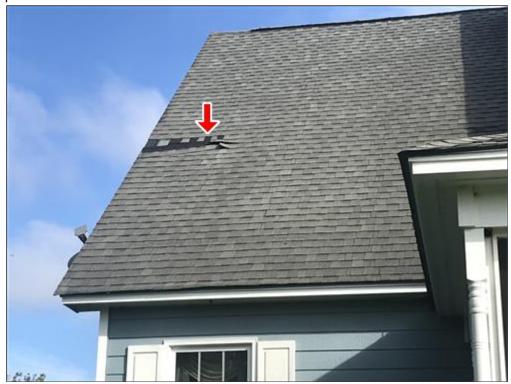
D. Picture 1

D. The Roof shingles are missing at the front of home. This damage should be repaired or replaced. A qualified person should repair or replace as needed.

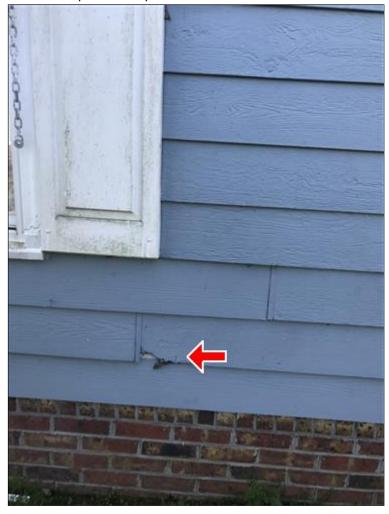
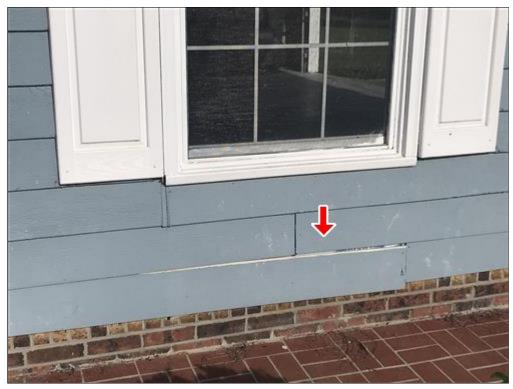
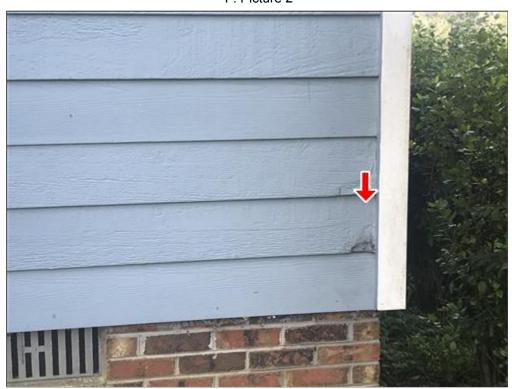
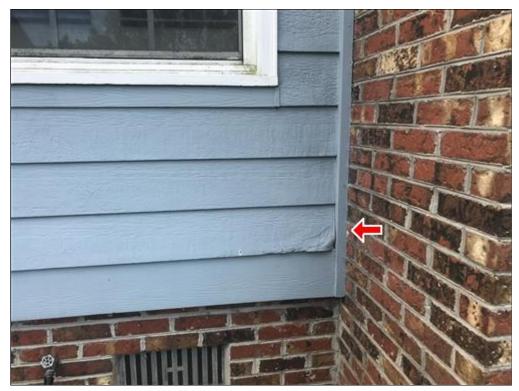
F. The composite board siding in areas is starting to deteriorate in areas, further deterioration will occur if not corrected. I recommend a qualified person further inspect and repair as needed.

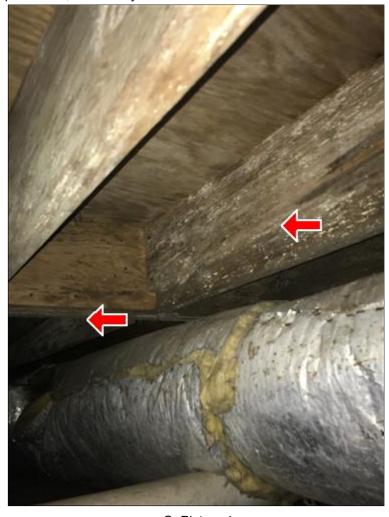
G. Picture 1

G. Signs of fungi growth is present on the floor system in crawlspace in one area. We did not inspect, test or determine if this growth is or is not a health hazard. The underlying cause is moisture. Th duct work being close to the floor system is the issue also, there is no vapor barrier, this is for your information.

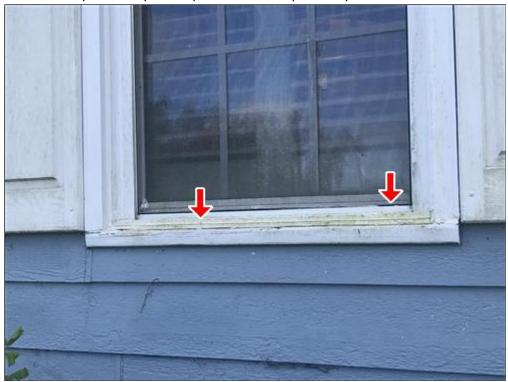
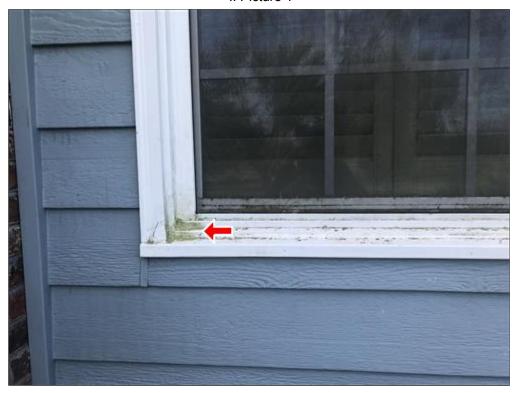
I. The sill plate is deteriorated at left side (facing front) and right side (facing front) on multiple windows. Further deterioration may occur if not repaired. A qualified person should repair or replace as needed.

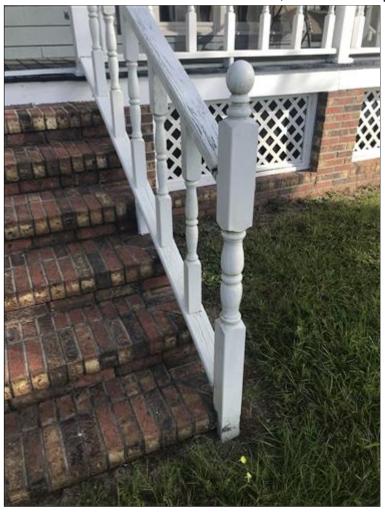
K. Picture 1

K. (1) The wooden hand rails at the front and the rear of the home are loose, this is a small repair.

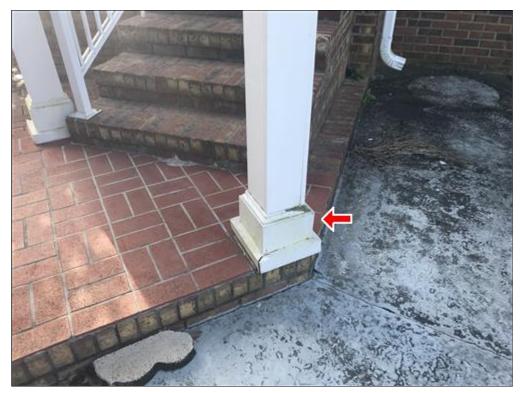
K. Picture 2 Damaged column trim. (small repair)

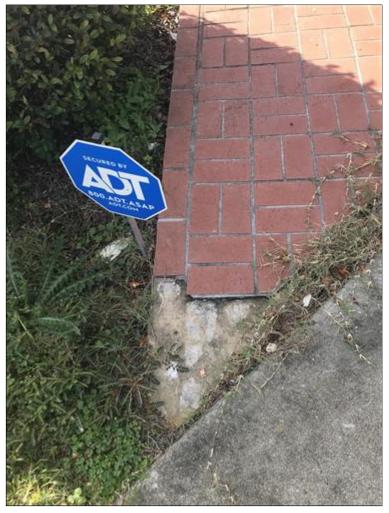
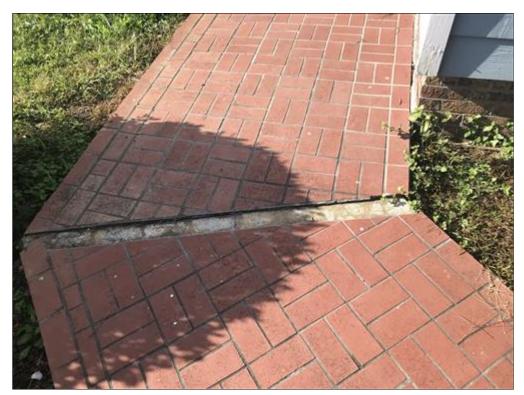
(2) The brick pavers at the right side (facing front) loose, and missing in areas. . A qualified person should repair or replace as needed.

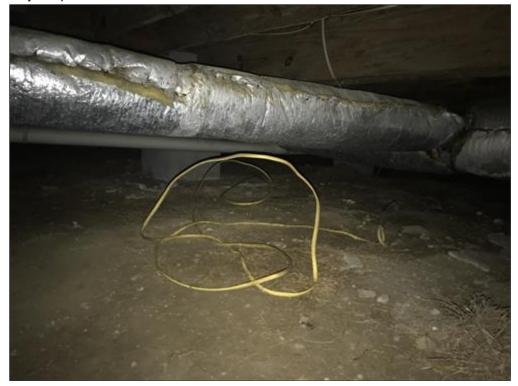
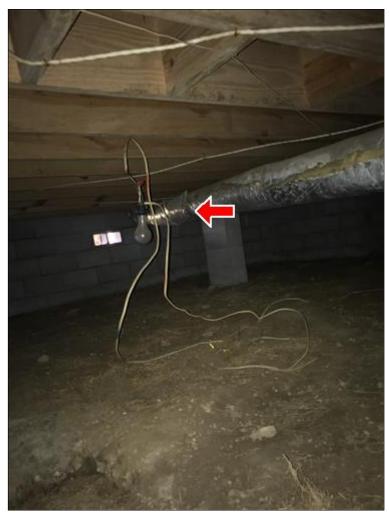
A. There is a flood light in the crawl space that is not properly wired, this cold be a hazard in the future, I recommend further investigation by a qualified electrician.

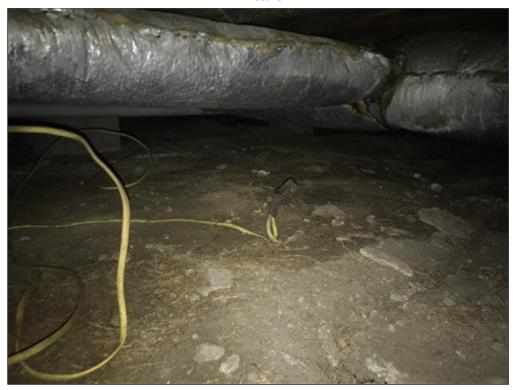
A. Picture 2 Wires layin on ground, not properly secured.

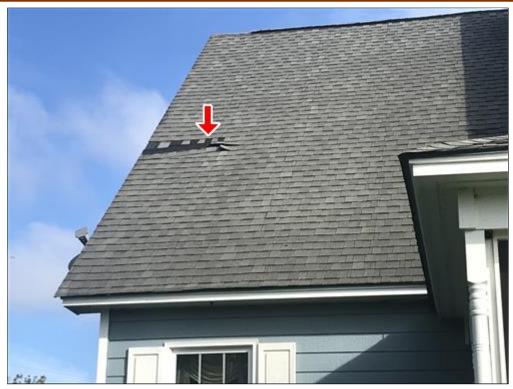
D. Picture 1

The Roof shingles are missing at the front of home. This damage should be repaired or replaced. A qualified person should repair or replace as needed.

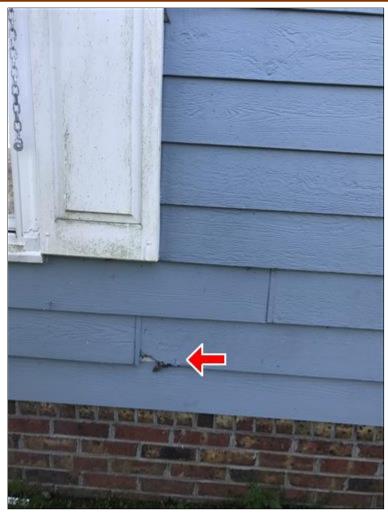
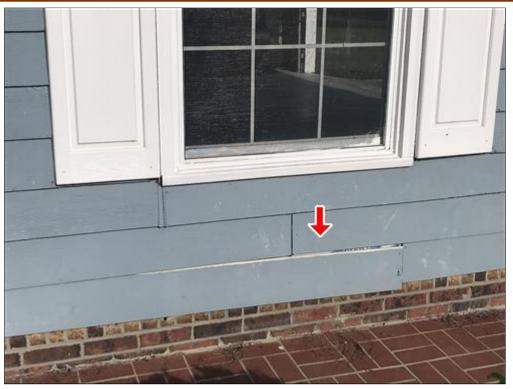
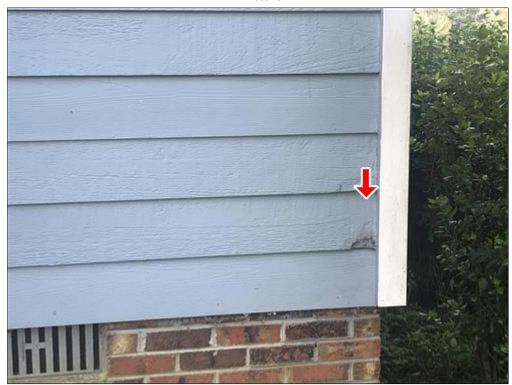
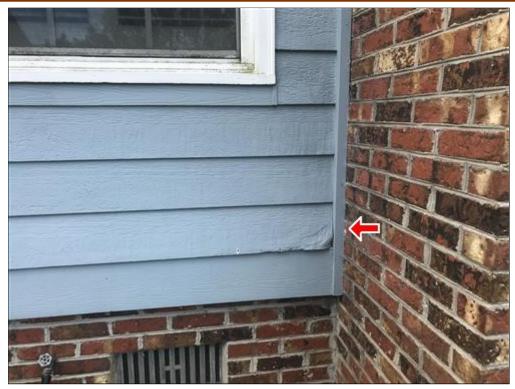
The composite board siding in areas is starting to deteriorate in areas, further deterioration will occur if not corrected. I recommend a qualified person further inspect and repair as needed.

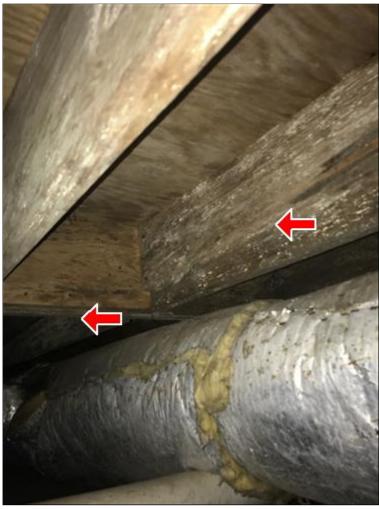
G. Picture 1

Signs of fungi growth is present on the floor system in crawlspace in one area. We did not inspect, test or determine if this growth is or is not a health hazard. The underlying cause is moisture. Th duct work being close to the floor system is the issue also, there is no vapor barrier, this is for your information.

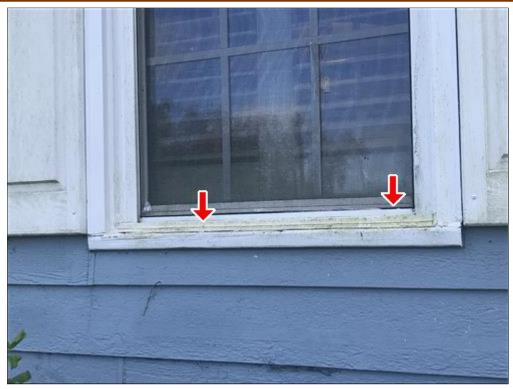
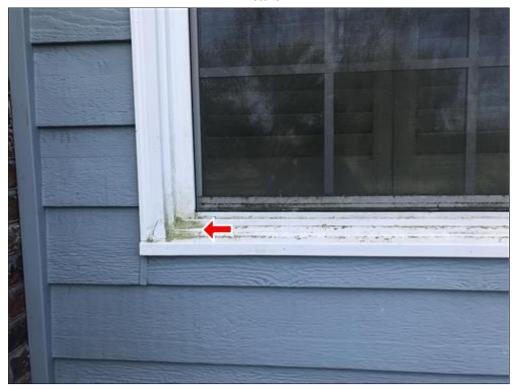
The sill plate is deteriorated at left side (facing front) and right side (facing front) on multiple windows. Further deterioration may occur if not repaired. A qualified person should repair or replace as needed.

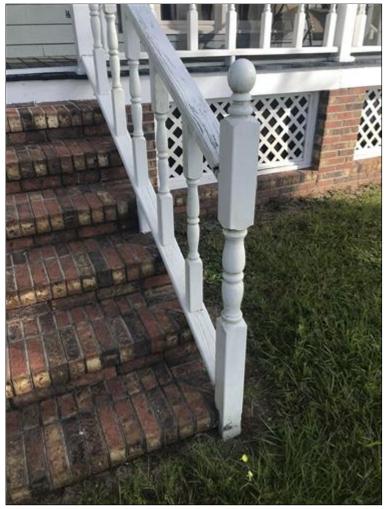
K. Picture 1

(1) The wooden hand rails at the front and the rear of the home are loose, this is a small repair.

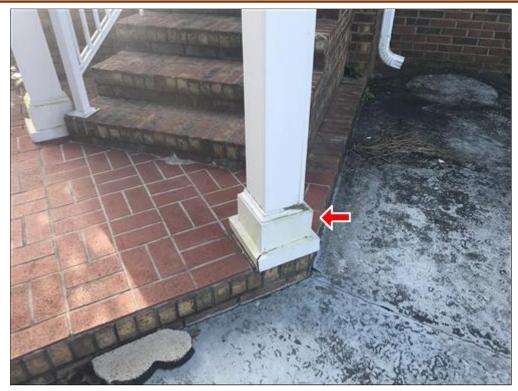
K. Picture 2 Damaged column trim. (small repair)

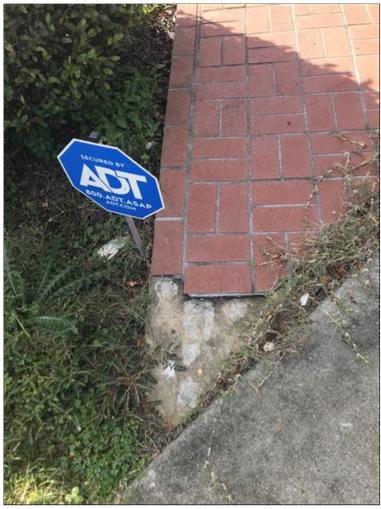
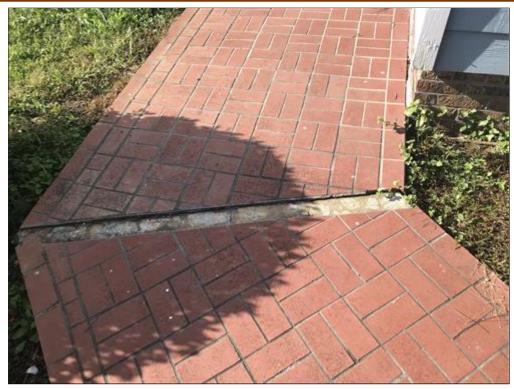
(2) The brick pavers at the right side (facing front) loose, and missing in areas. . A qualified person should repair or replace as needed.

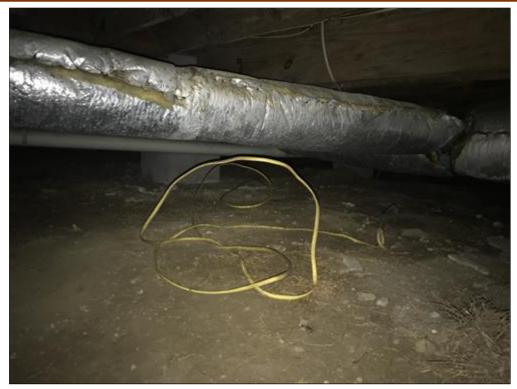
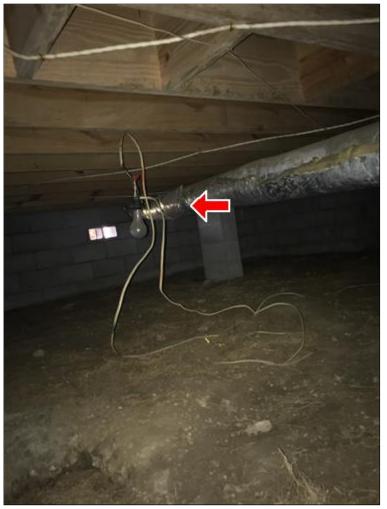
There is a flood light in the crawl space that is not properly wired, this cold be a hazard in the future, I recommend further investigation by a qualified electrician.

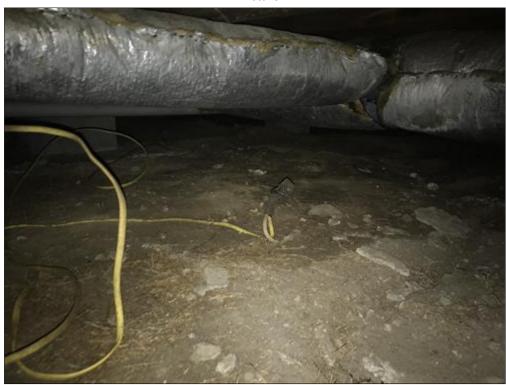
A. Picture 2 Wires layin on ground, not properly secured.
