Subject: Associate Health Complaint Investigation Bank of America - Blaine Banking Center 277 G Street, Blaine, Washington Mail Code: WA4-105

ARCADIS' INVESTIGATION

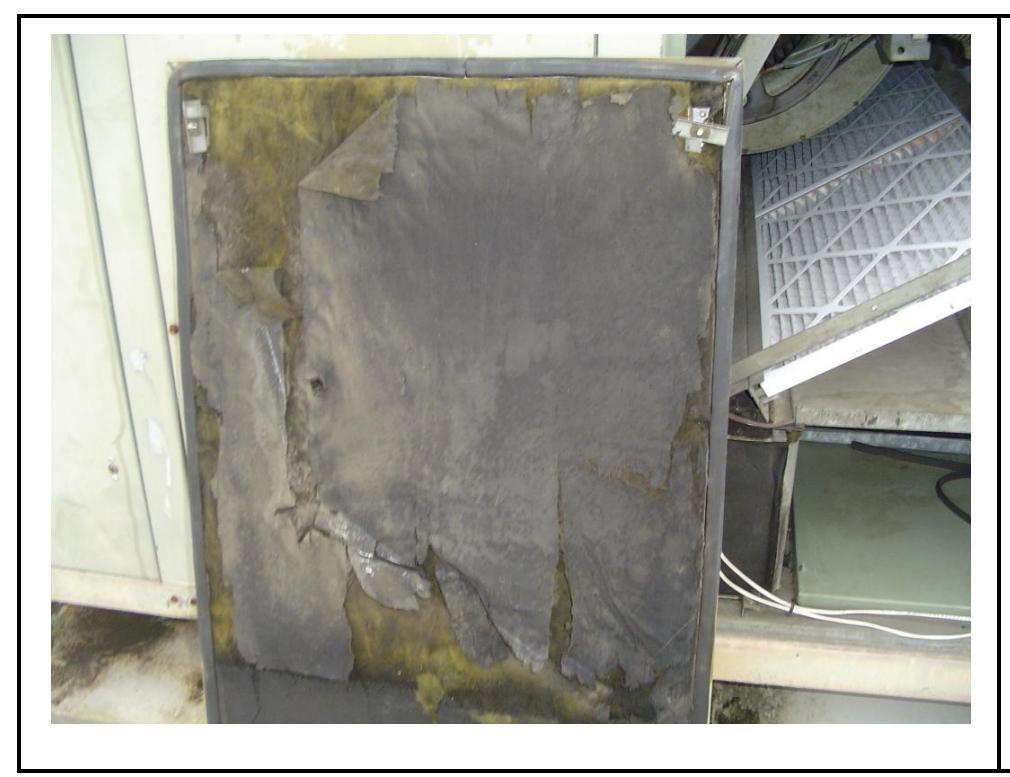
Photograph #3

- 1. No visible suspect mold or evidence of water intrusion was observed in the lobby, break room and drive-thru teller room.
- 2. Dirt and dust was observed on the air diffusers and return vents in the lobby area.
- 3. The Bank of America space appeared to be positively pressurized relative to the exterior.
- 4. Fiberglass insulation on the HVAC inspection panel by the filters and the panel next to the air handler motor was observed to be dry, dirty and deteriorating. However, the HVAC filters and cooling coils appeared to be clean.

Description of Photograph: Fiberglass insulation on inside of HVAC unit cover plate – showing heavy deterioration.

• Replace or repair the damaged fiberglass insulation in the HVAC unit.

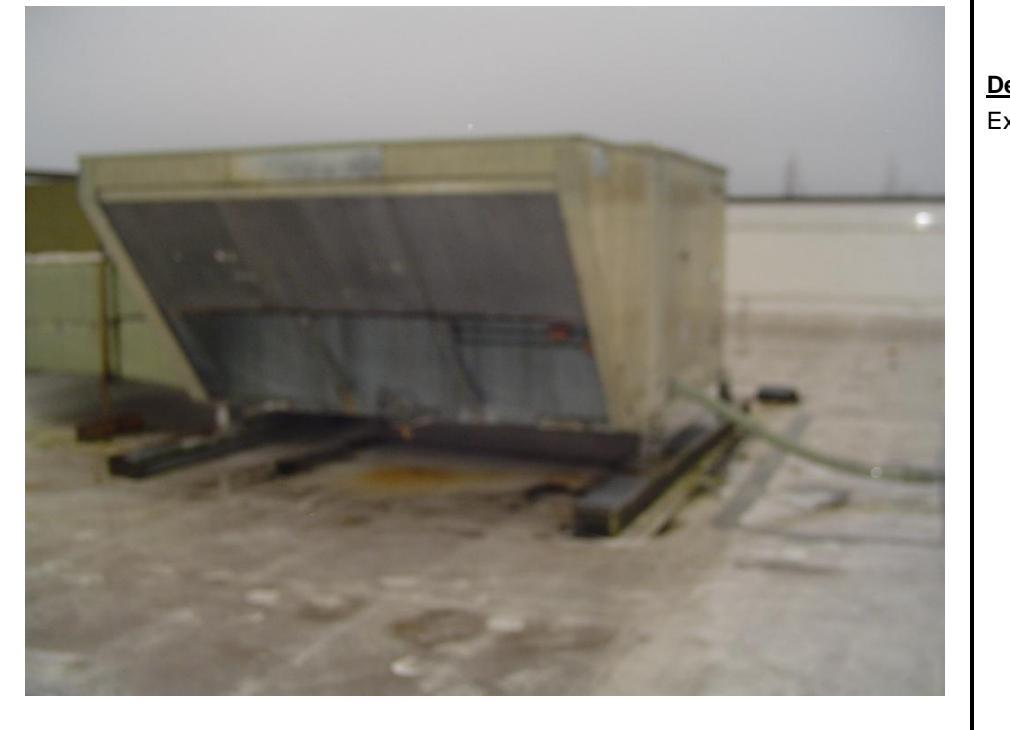
Photograph #4

Description of Photograph: Exterior HVAC unit on roof.
