Home Inspections, LLC

# Inspection Report

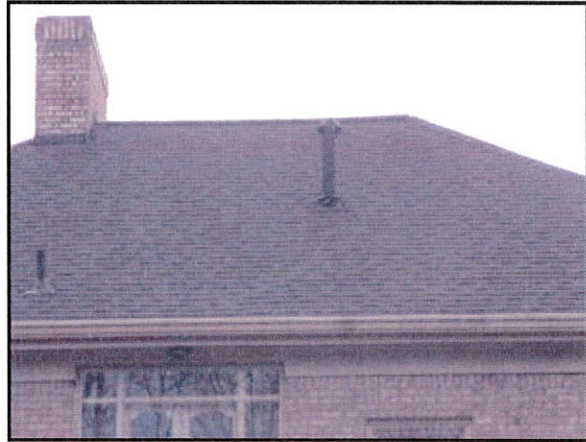
1.0 Picture 6 Roof covering

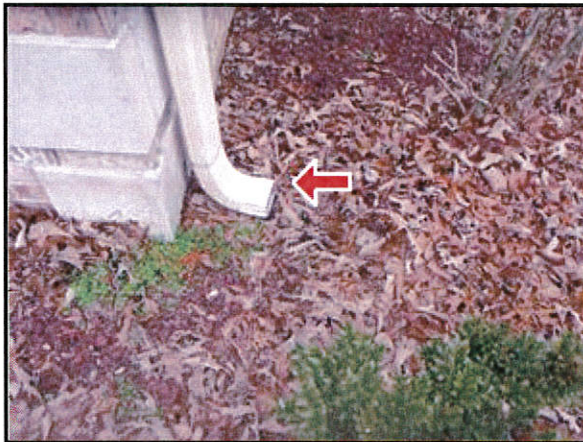
1.3 Picture 1 Downspouts terminate too close to the house

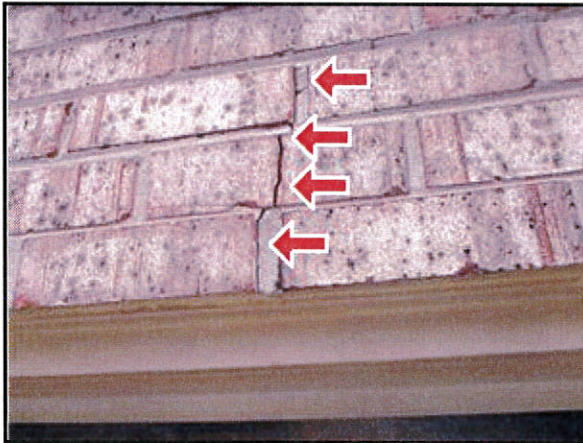
2.0 Picture 1 Cracks noted in brick and brick mortar over the garage door , left of the garage door and above rear window at utility room .

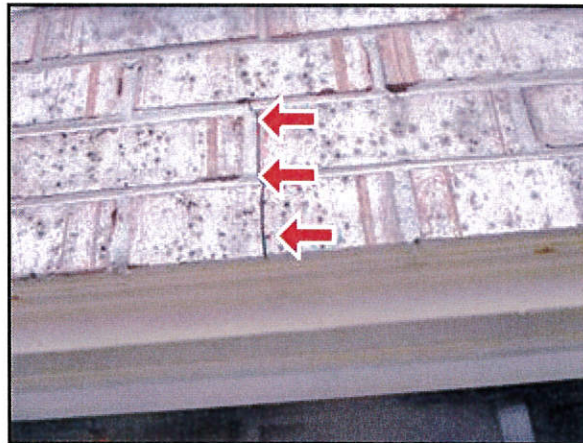
2.0 Picture 2 Crack in brick / mortar above garage door

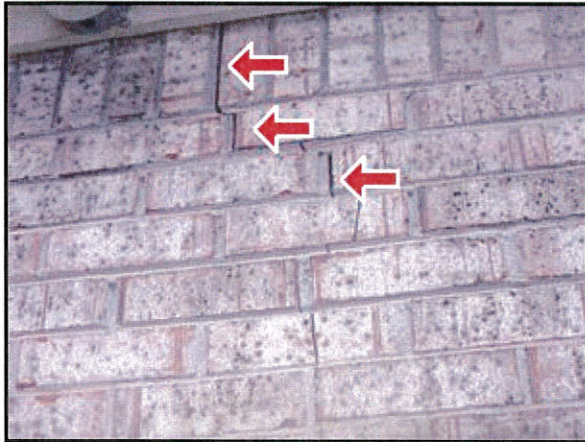
2.0 Picture 3 Stair step crack in brick mortar left of garage door

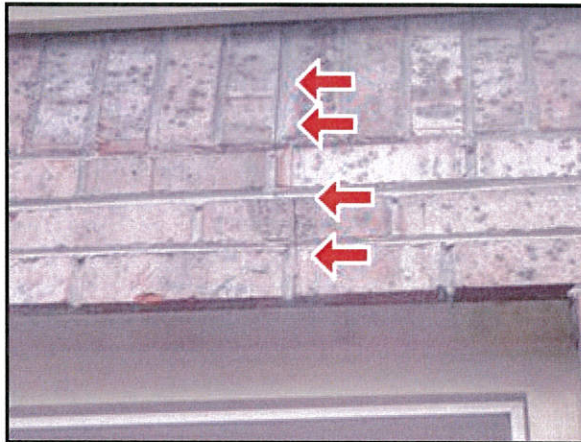
2.0 Picture 4 Vertical crack in brick mortar over utility room window

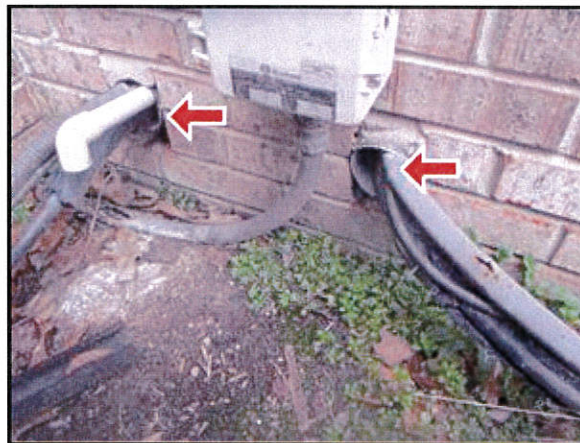
2.0 Picture 5 Pipe and wire penetrations through exterior walls were not sealed .

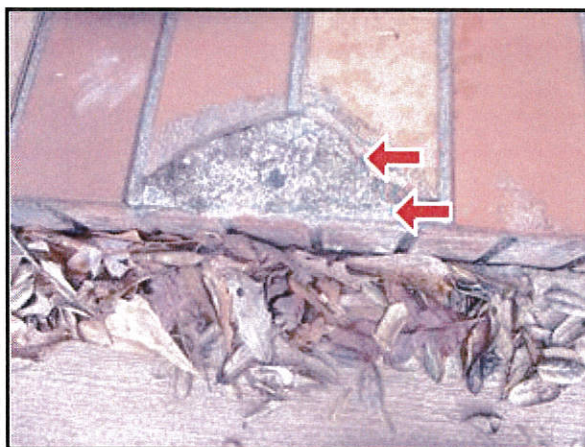
2.3 Picture 1 Stair tread paver at front entry steps

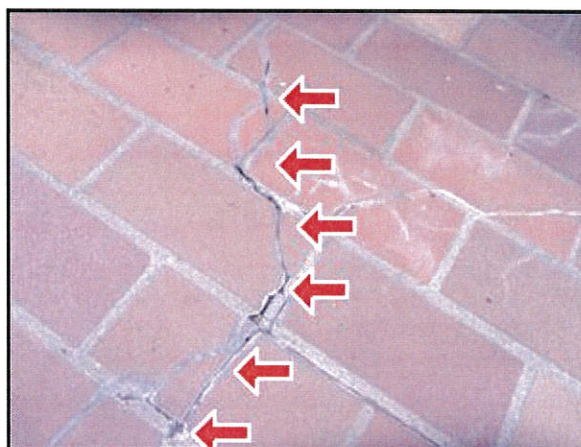
2.3 Picture 2 Cracks noted in brick pavers and

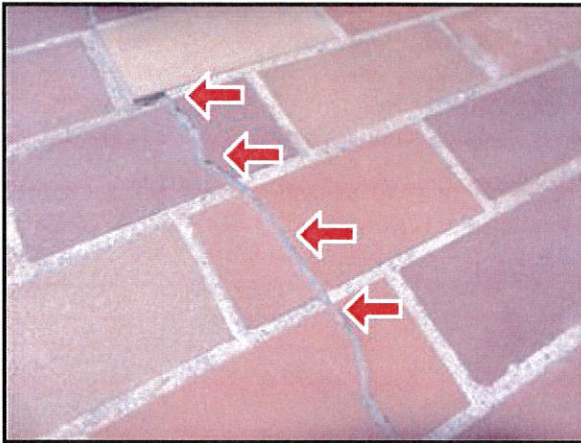
2.3 Picture 3 Previous patching and slightly raised edges noted at front porch brick paver floor .

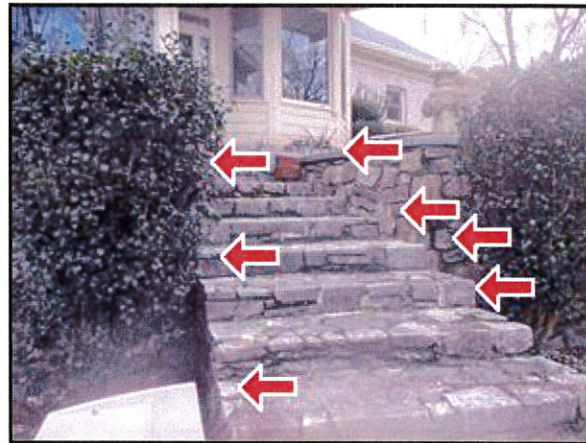
2.3 Picture 4 There was no guard or handrailing installed at rear exterior steps .

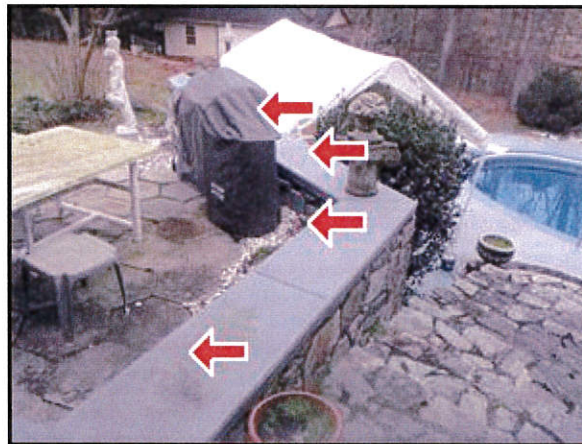
2.3 Picture 5 There was no guard railing installed at rear patio / retaining wall .

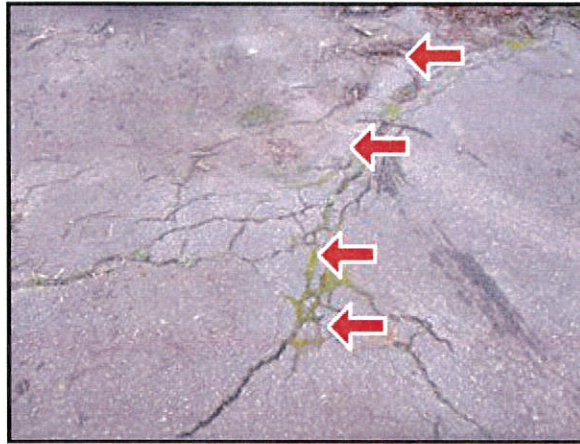
2.4 Picture 1 Cracks and raised edges noted on driveway at various locations .

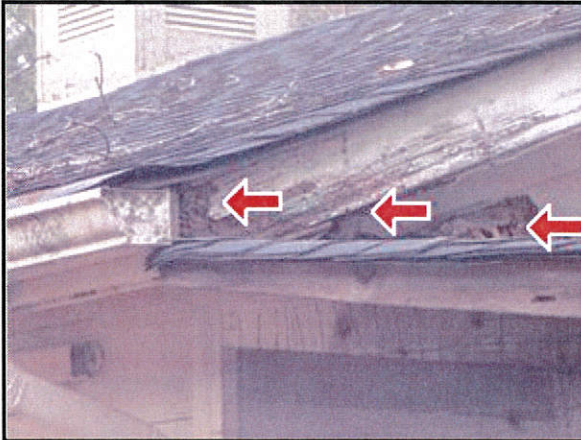
2.6 Picture 1 Fascias and soffits were water damaged and deteriorated at various locations around the detached shop building .

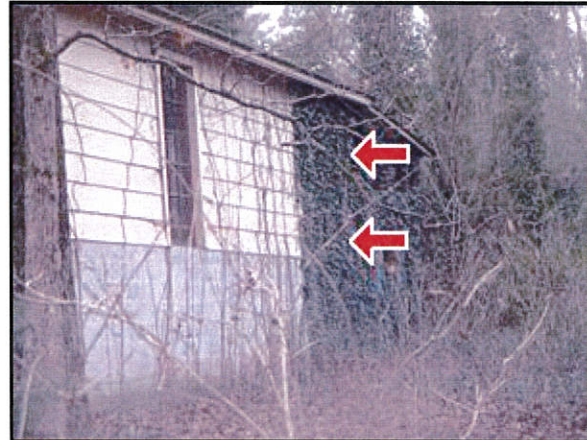
2.6 Picture 2 Exterior walls at detached building were not fully visible due to vegetation growing on exterior walls .

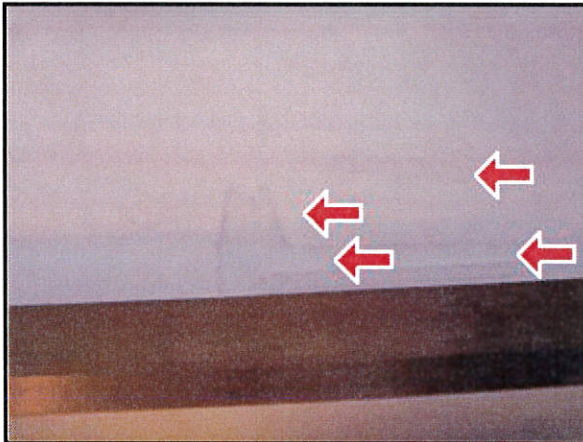
4.0 Picture 1 Old , dry water stains noted on kitchen ceiling .

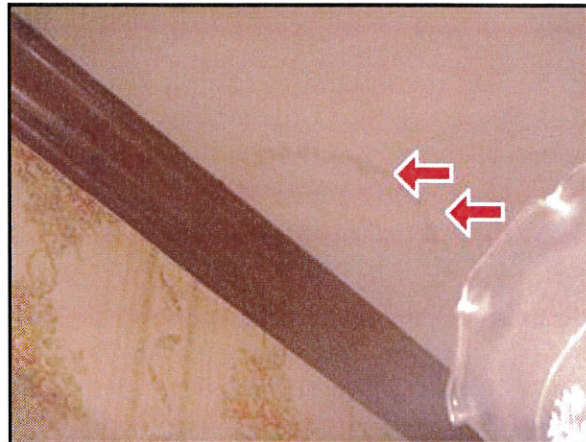
4.0 Picture 2 Old , dry water stains noted on upstairs guest bathroom ceiling and upstairs left rear guest bedroom ceiling

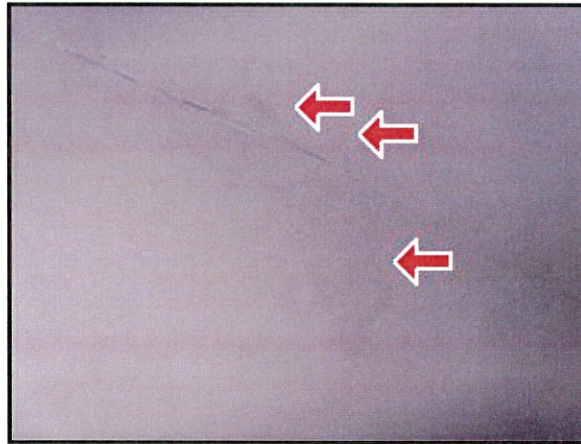
4.0 Picture 3 Old , dry water stains on upstairs left rear guest bedroom ceiling

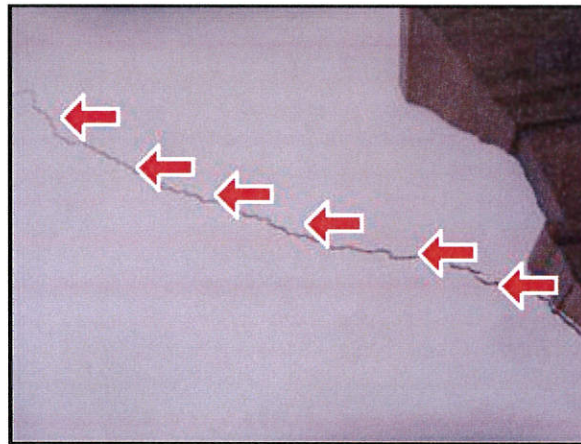
4.1 Picture 1 Crack noted on wall beside master bedroom door .

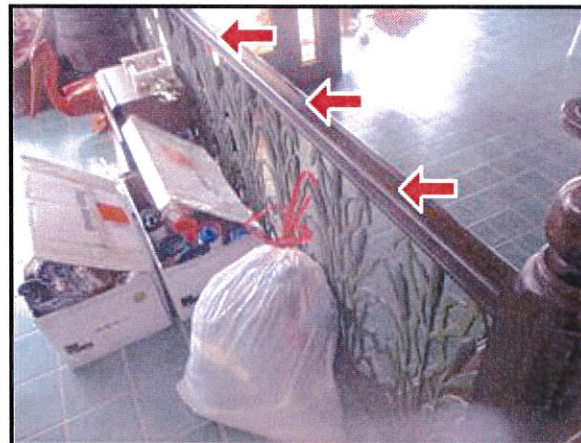
4.3 Picture 1 Guard railing in sun room was very loose

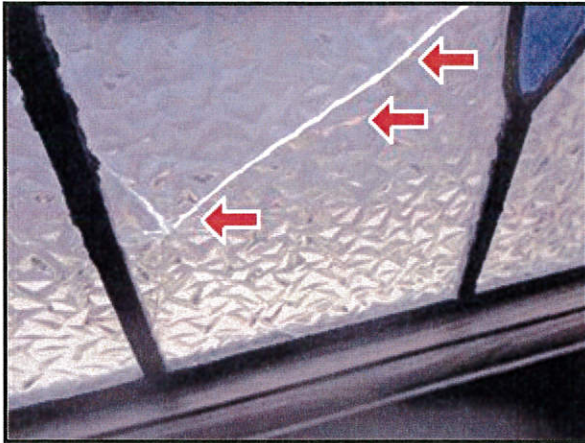
4.6 Picture 1 Cracks noted in stained glass windows located upstairs at various areas .

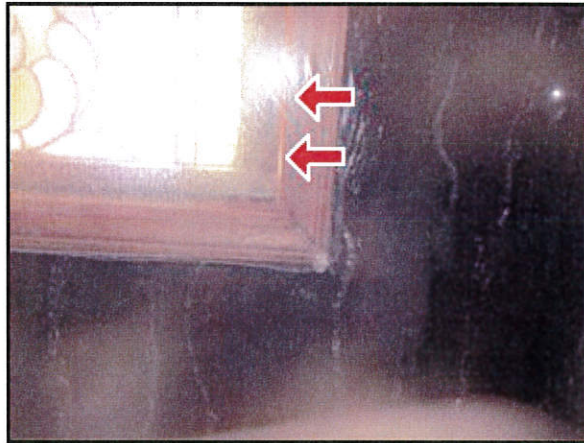
4.6 Picture 2 Air gaps noted around window at upstairs guest bathroom

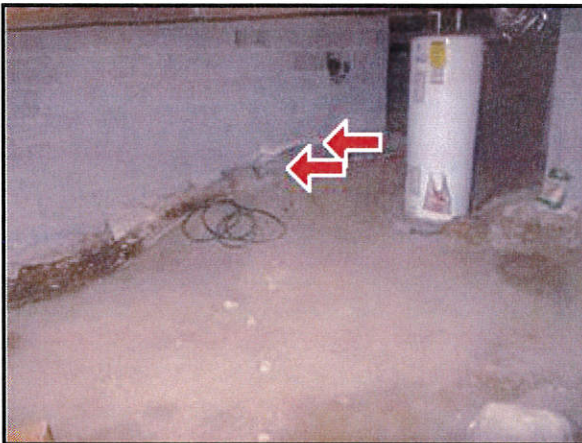
5.0 Picture 1 Old , dry moisture stains noted on crawl space foundation block walls at various locations .

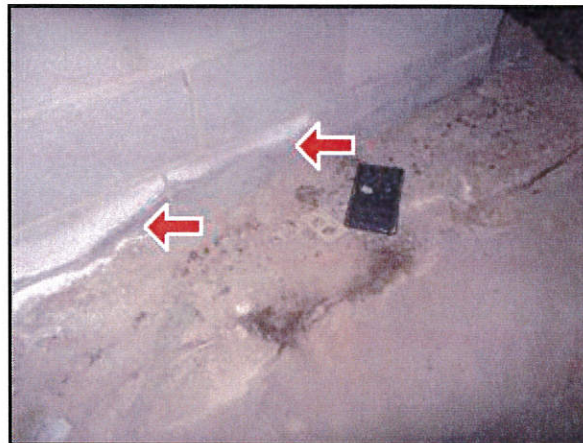
5.0 Picture 2 Old , dry moisture stains on block foundation walls in crawl space

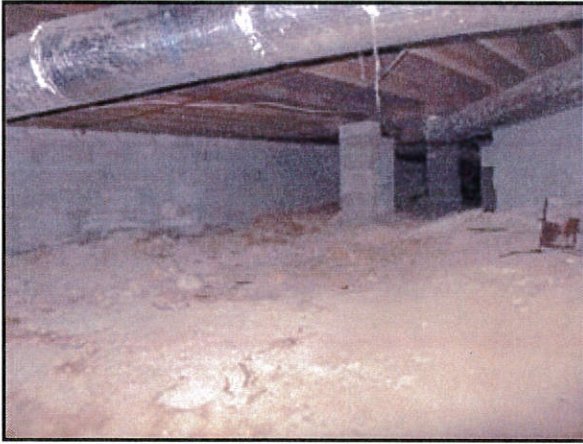
5.0 Picture 3 Crawl space

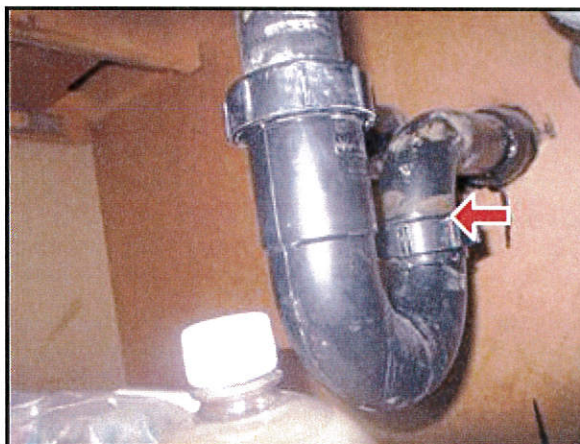
## 6.0 Picture 1 Leak noted at left master sink drain .

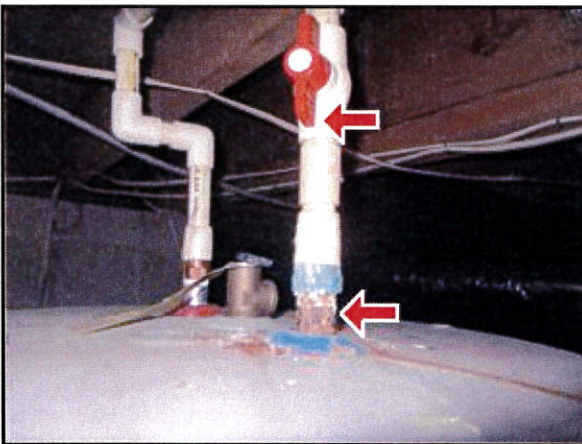
6.1 Picture 1 Leak noted at water heater supply shut off valve .

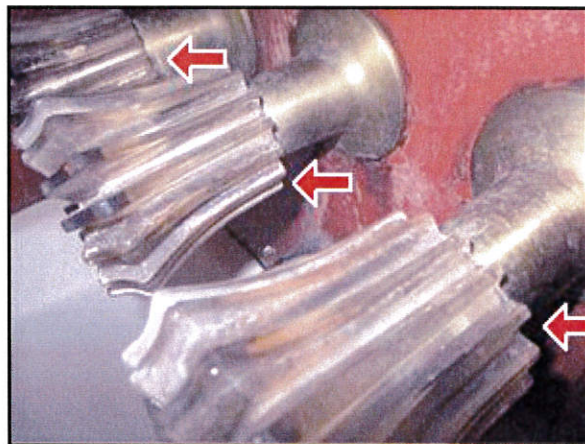
6.1 Picture 2 Tub valves at downstairs guest bathroom leaked while running water at tub .

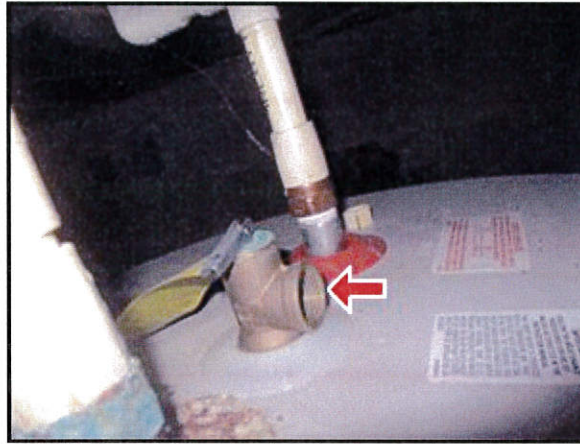
6.2 Picture 1 Required water heater temperature pressure relief over flow drain was not installed .

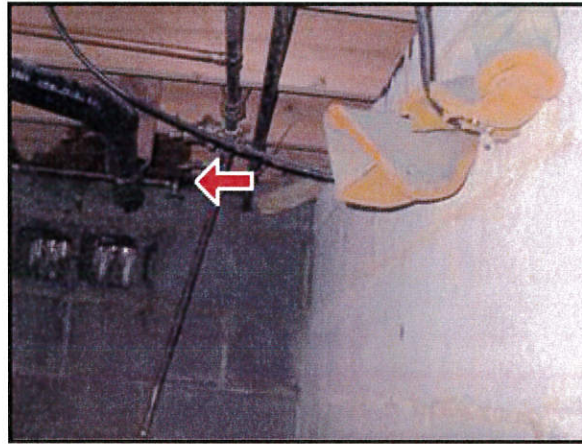
6.3 Picture 1 Main water shut off valve is located in crawl space below utility room

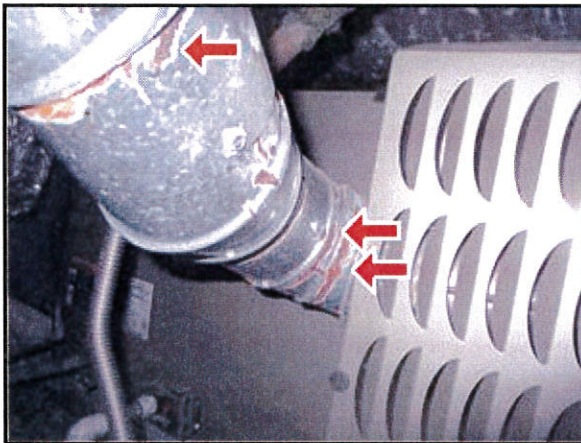
6.4 Picture 1 Rust and corrosion noted on furnace flue in crawl space .

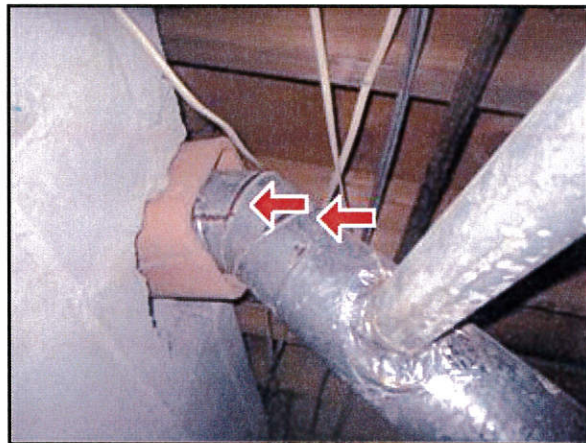
6.4 Picture 2 Rust on furnace flue in crawl space .

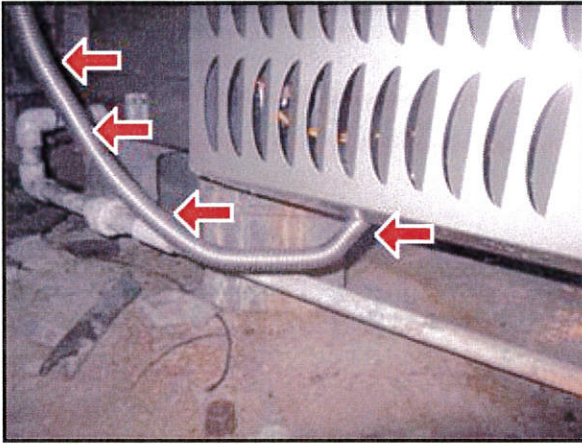
6.4 Picture 3 Flexible gas connector was installed into furnace cabinet in the crawl space .

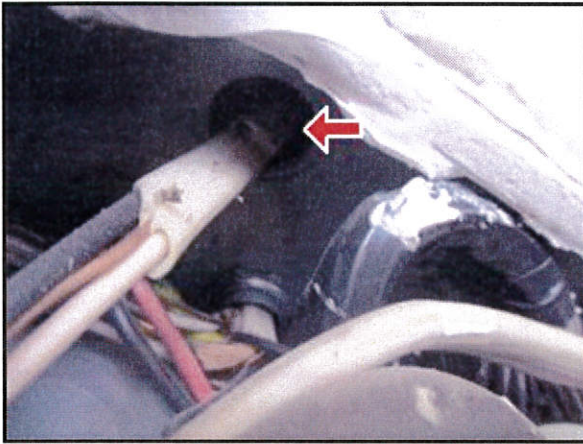
7.1 Picture 1 Missing wire bushing noted inside main panel .

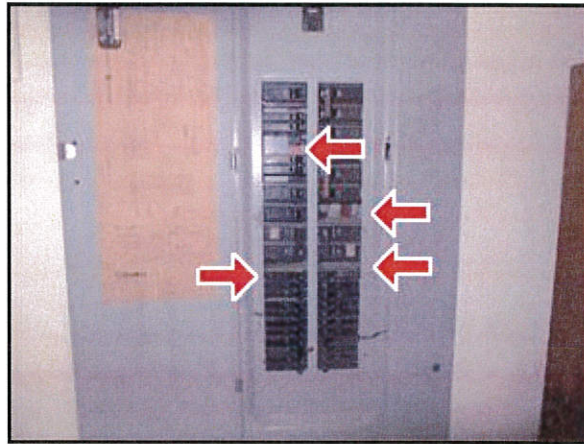
7.1 Picture 2 Unused openings in main electrical panel cover were not sealed as required .

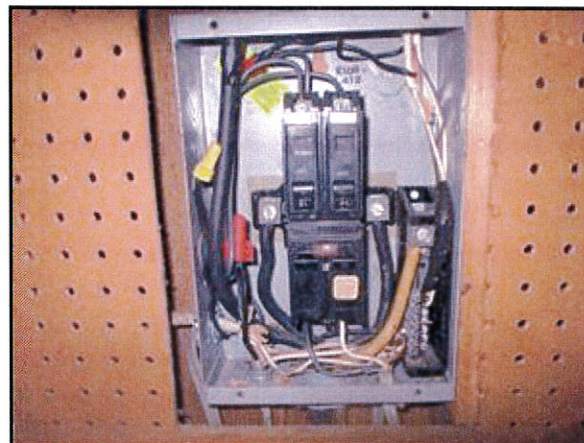
7.2 Picture 4 Sub panel in the detached shop building with cover removed

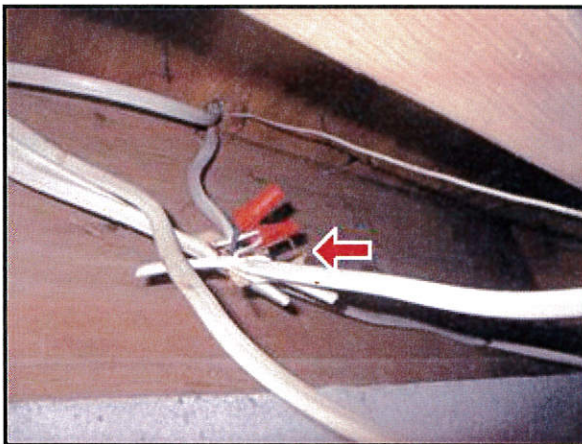
7.3 Picture 1 Open electrical splices noted in the crawl space

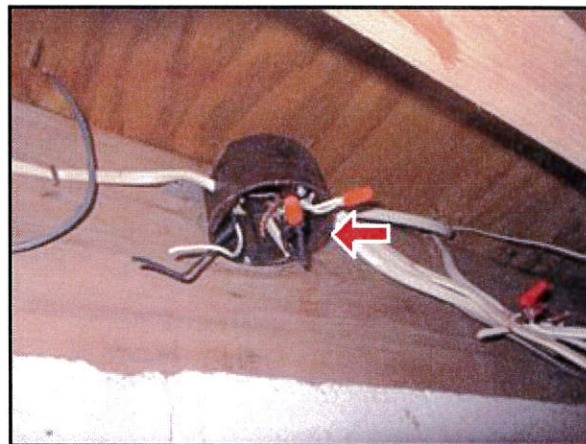
7.3 Picture 2 Missing electrical box covers noted in the crawl space

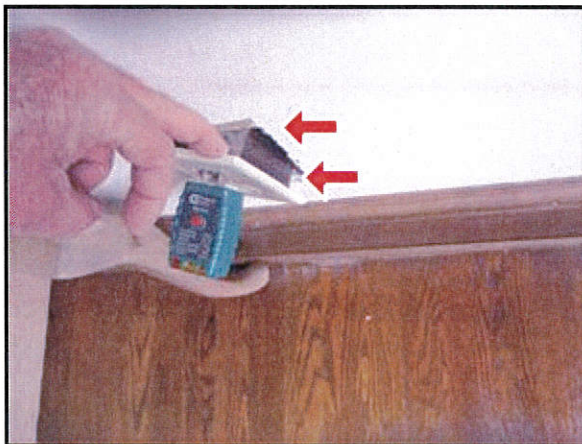
7.3 Picture 3 Electrical box at upstairs hallway was not properly secured inside wall as required .

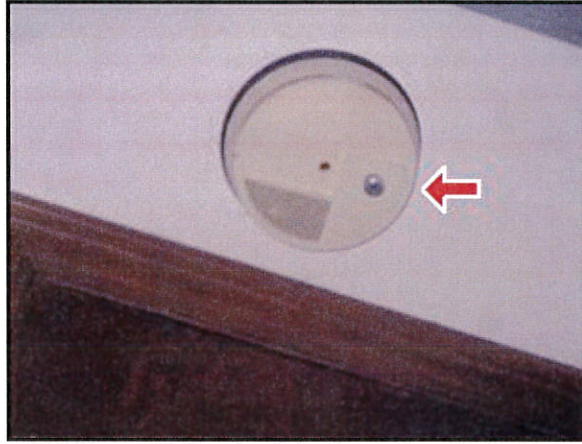
7.7 Picture 1 Smoke detectors are outdated by today's standards and at the end of their useful service life

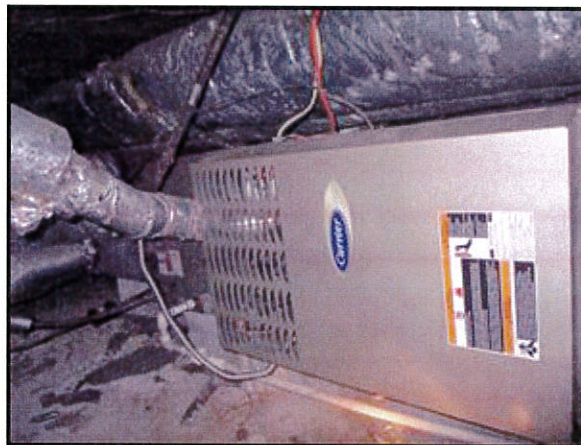
8.0 Picture 3 Furnace / air handler located in crawl space

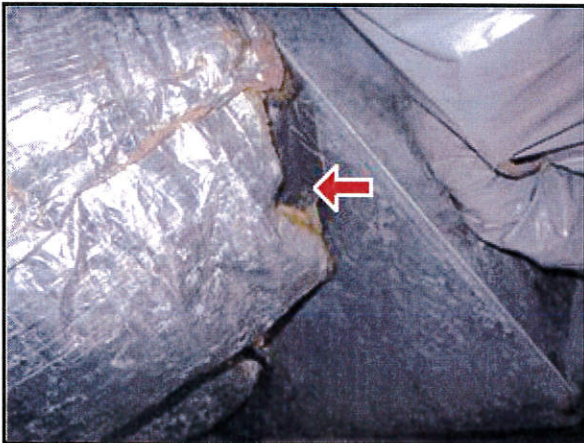
8.3 Picture 1 HVAC duct work was not properly sealed to air handler plenums

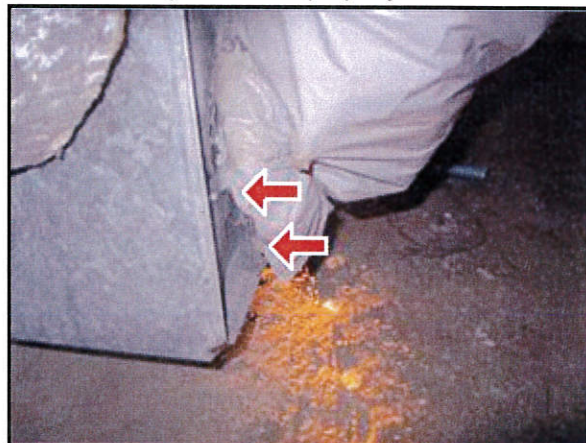
8.3 Picture 2 Duct work not properly sealed to plenum

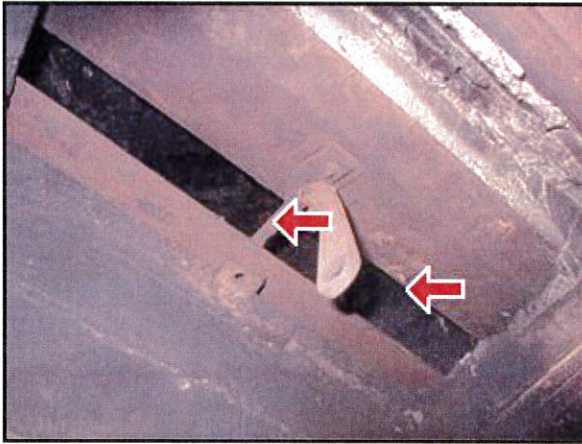
8.5 Picture 1 Fireplace dampers were damaged at fireplaces located in breakfast area and front living room .

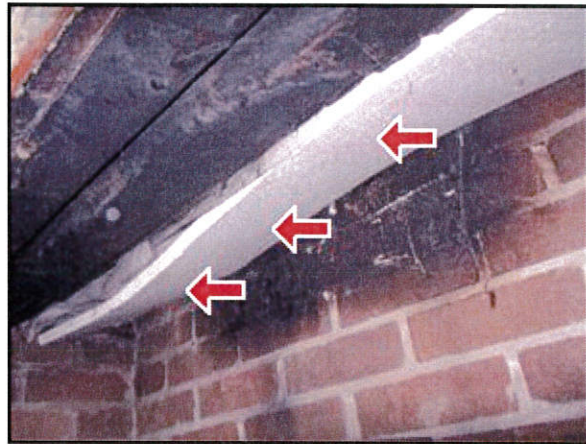
8.5 Picture 2 Fireplace chimney flue at fireplace located in sun room was sealed closed .

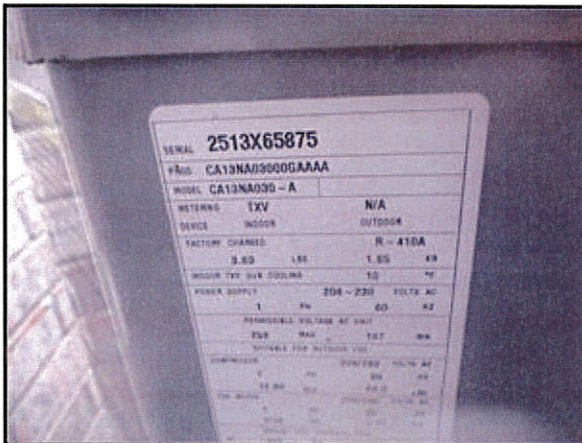
8.8 Picture 1 Air conditioning manufacturers data plate

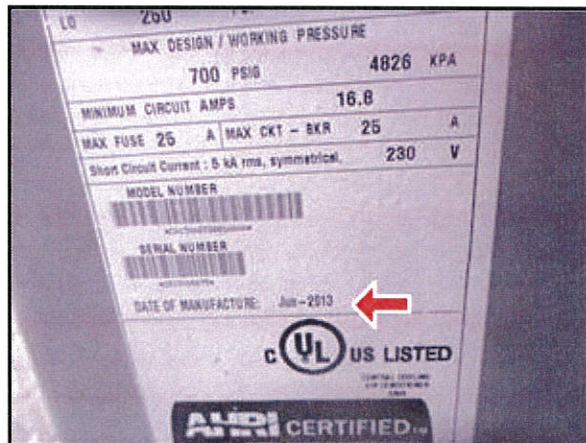
8.8 Picture 2 Air conditioning manufacturers date

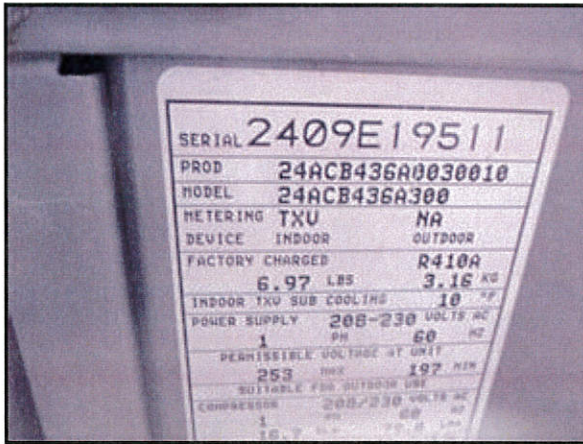
8.8 Picture 3 Air conditioning manufacturers data plate

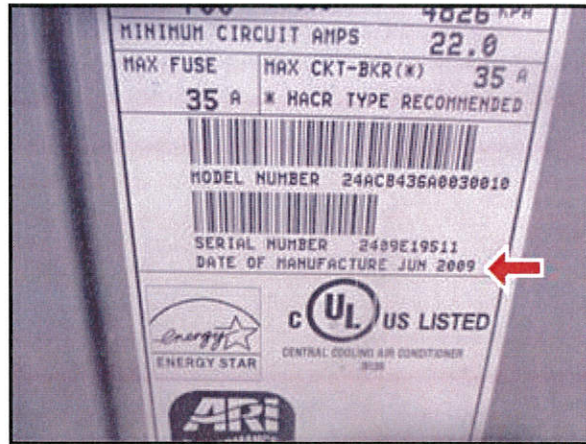
8.8 Picture 4 Air conditioning manufacturers date plate

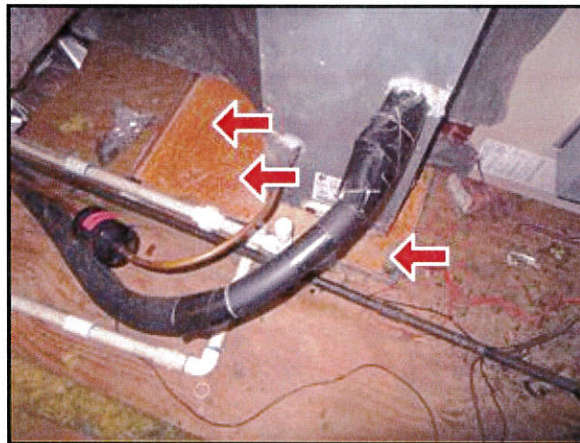
8.8 Picture 5 Evaporator unit catch pan located in the attic was rusted .

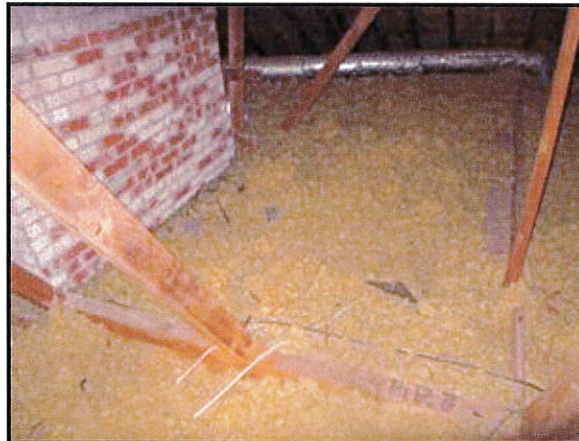
9.0 Picture 1 View of attic insulation

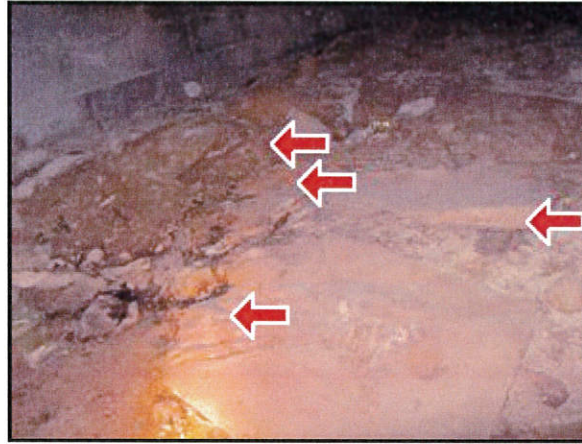
9.2 Picture 1 Cellulose debris in crawl space . No vapor barrier installed .

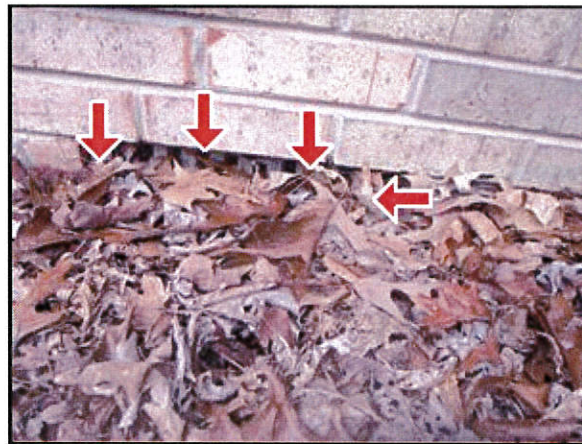
9.3 Picture 1 Foundation vent located at front of home ( left of front entry ) was below grade level .

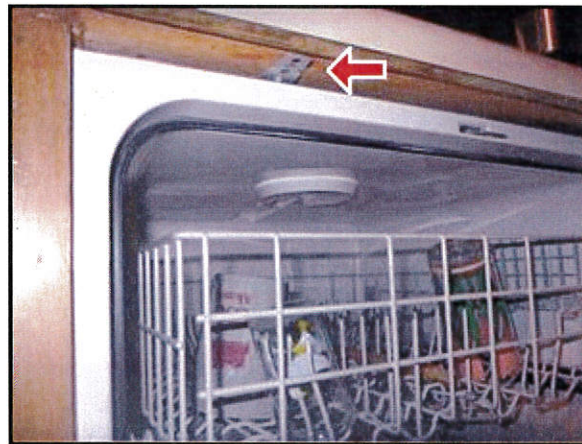
10.0 Picture 1 Dishwasher not secured to cabinet

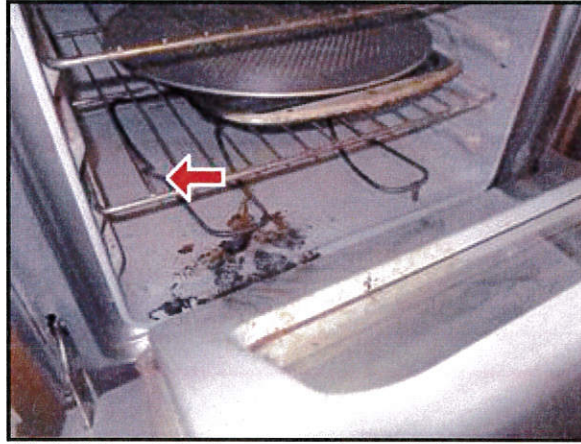
10.1 Picture 1 Bottom oven element at upper oven was damaged and inoperable .

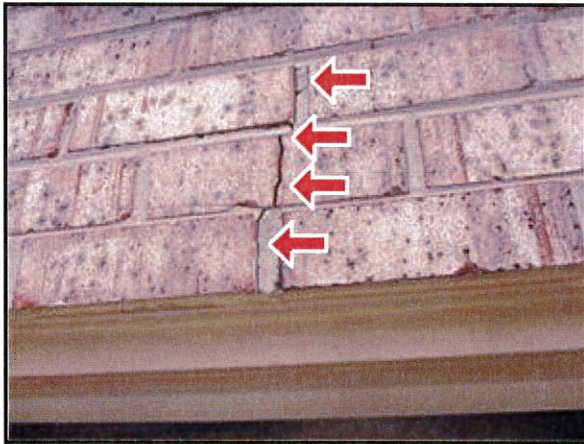
2.0 Picture 1 Cracks noted in brick and brick mortar over the garage door , left of the garage door and above rear window at utility room .

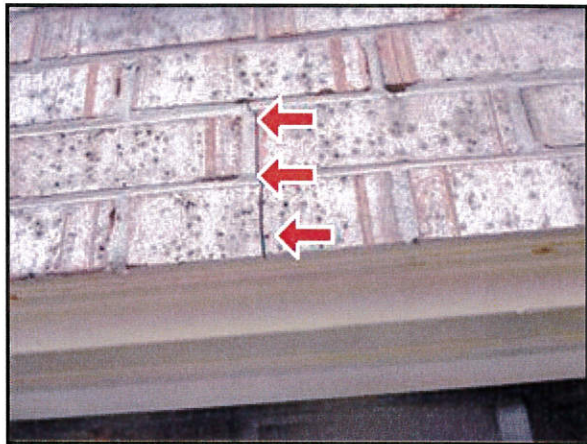
2.0 Picture 2 Crack in brick / mortar above garage door

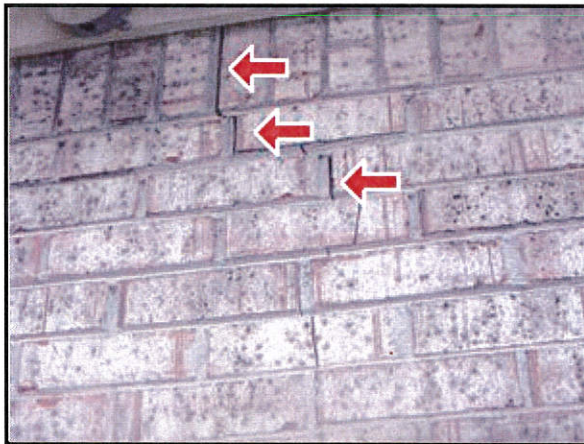
2.0 Picture 3 Stair step crack in brick mortar left of garage door

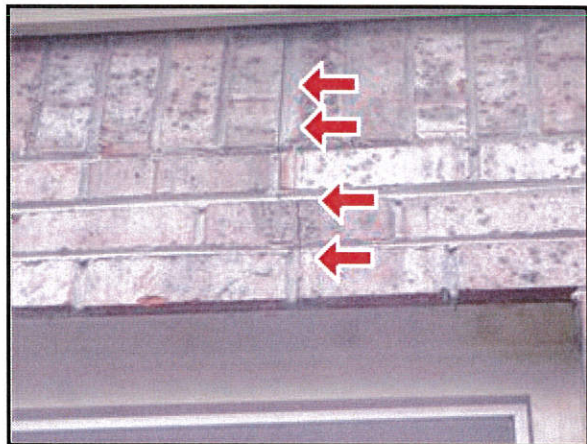
2.0 Picture 4 Veryical crack in brick mortar over utility room window

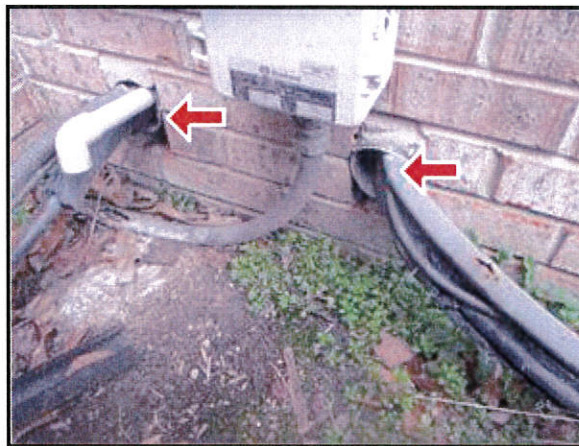
2.0 Picture 5 Pipe and wire penetrations through exterior walls were not sealed .

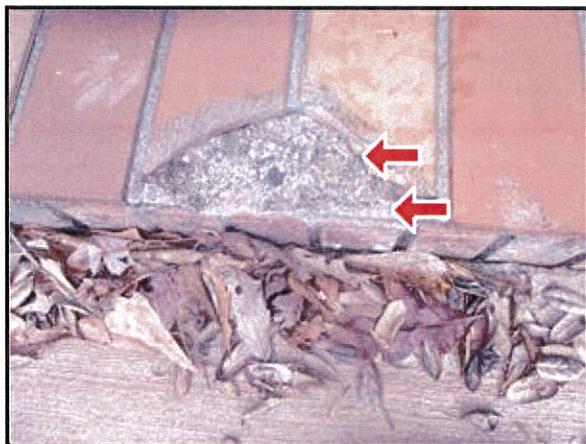
2.3 Picture 1 Stair tread paver at front entry steps was damaged .

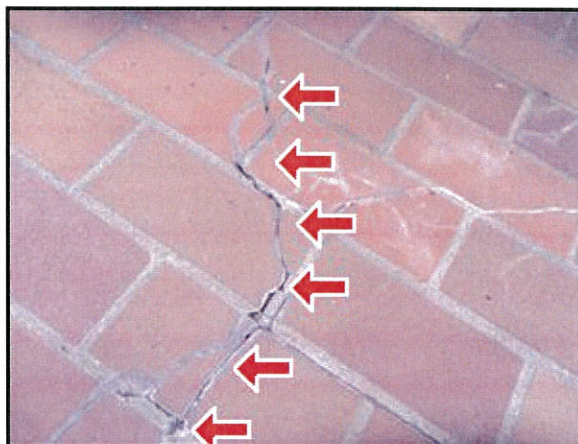
2.3 Picture 2 Cracks noted in brick pavers and paver mortar at front entry porch .

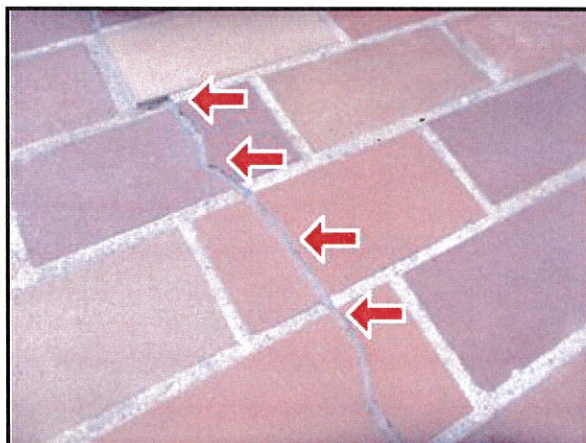
2.3 Picture 3 Previous patching and slightly raised edges noted at front porch brick paver floor .

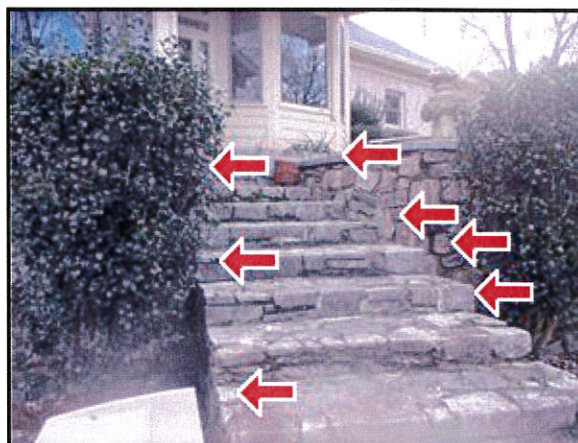
2.3 Picture 4 There was no guard or handrailing installed at rear exterior steps .

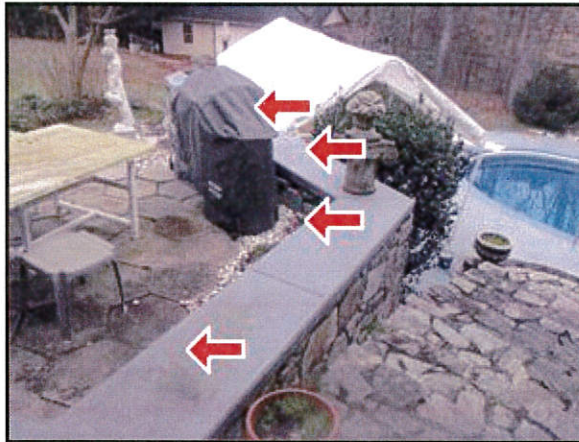
2.3 Picture 5 There was no guard railing installed at rear patio / retaining wall .

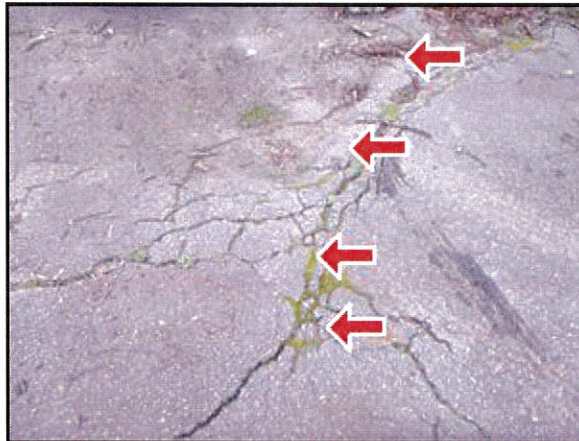
2.4 Picture 1 Cracks and raised edges noted on driveway at various locations .

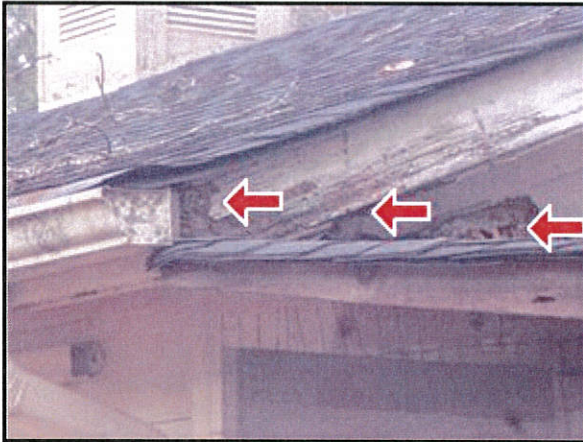
2.6 Picture 1 Fascias and soffits were water damaged and deteriorated at various locations around the detached shop building .

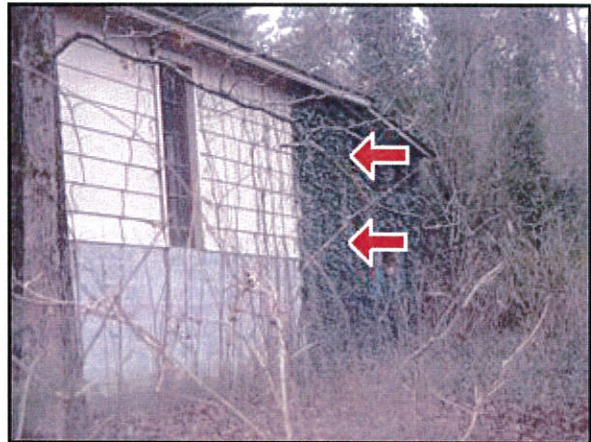
2.6 Picture 2 Exterior walls at detached building were not fully visible due to vegetation growing on exterior walls .

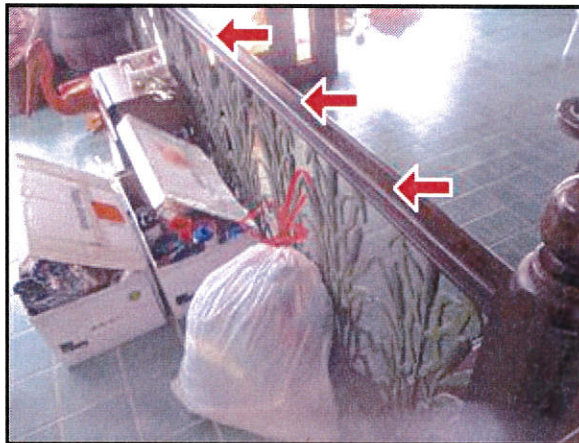
4.3 Picture 1 Guard railing in sun room was very loose

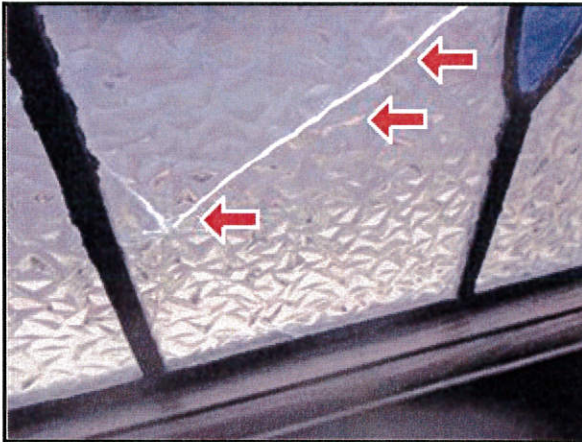
4.6 Picture 1 Cracks noted in stained glass windows located upstairs at various areas .

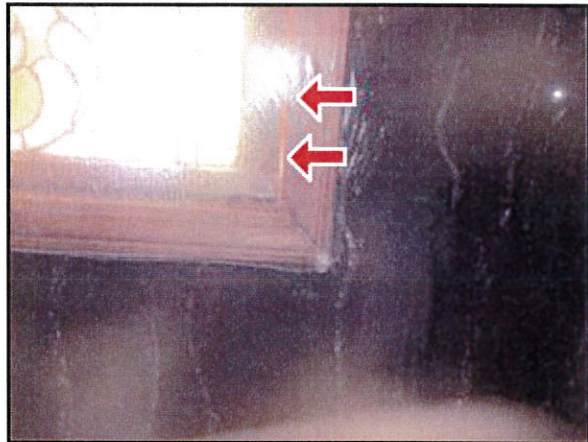
4.6 Picture 2 Air gaps noted around window at upstairs guest bathroom

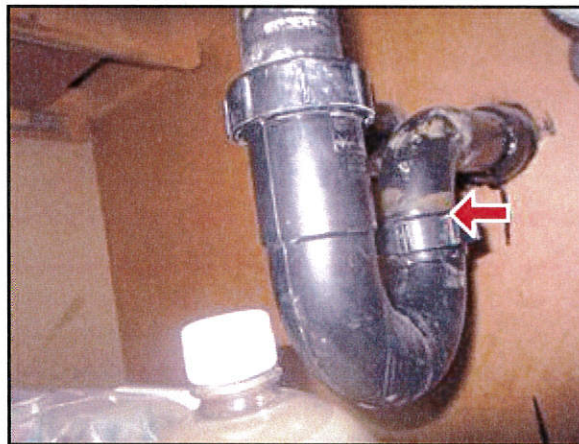
6.0 Picture 1 Leak notec at left master sink drain .

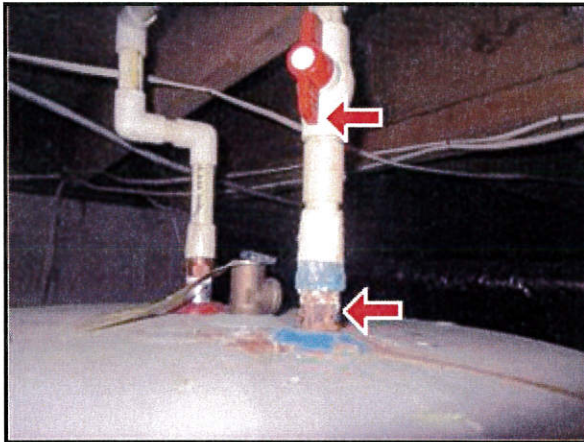
6.1 Picture 1 Leak noted at water heater supply shut off valve .

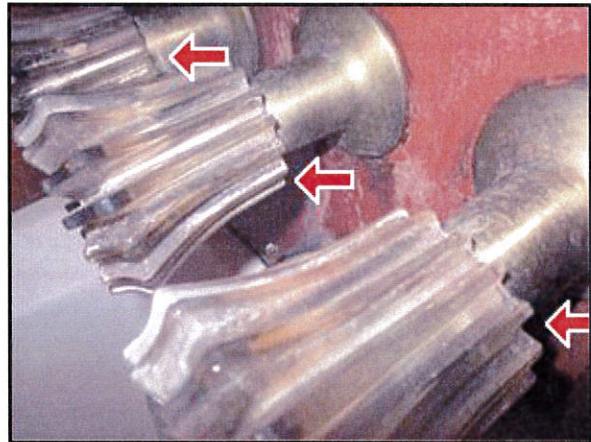
6.1 Picture 2 Tub valves at downstairs guest bathroom leaked while running water at tub .

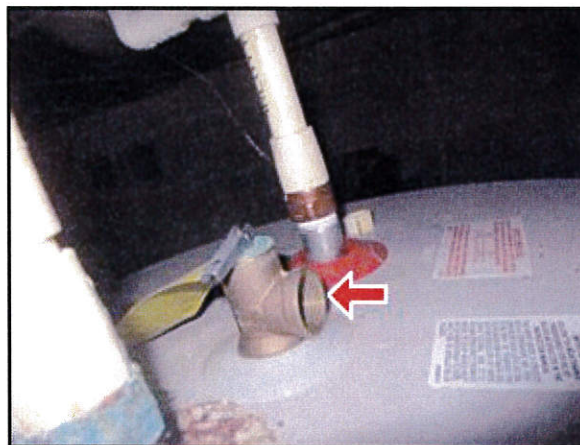
6.2 Picture 1 Required water heater temperature pressure relief over flow drain was not installed .

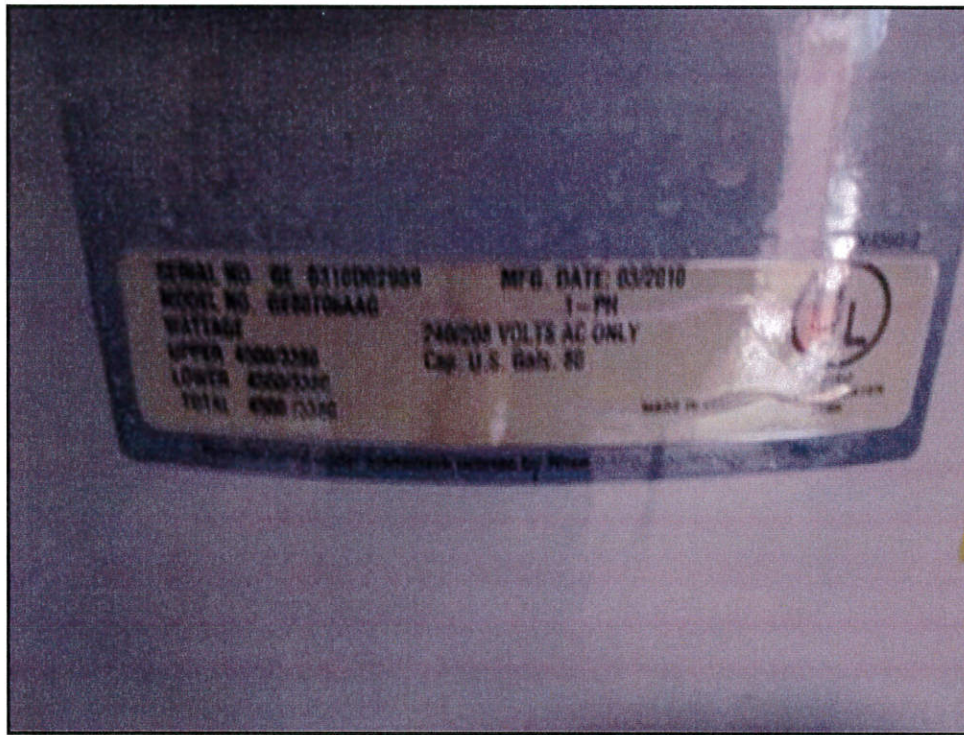
6.2 Picture 2 Water heater manufacturers data plate

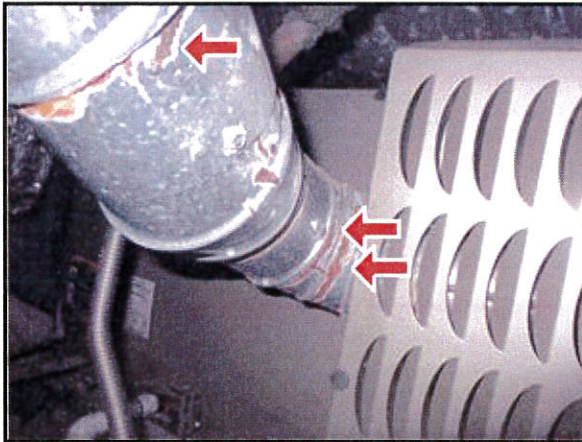
6.4 Picture 1 Rust and corrosion noted on furnace flue in crawl space .

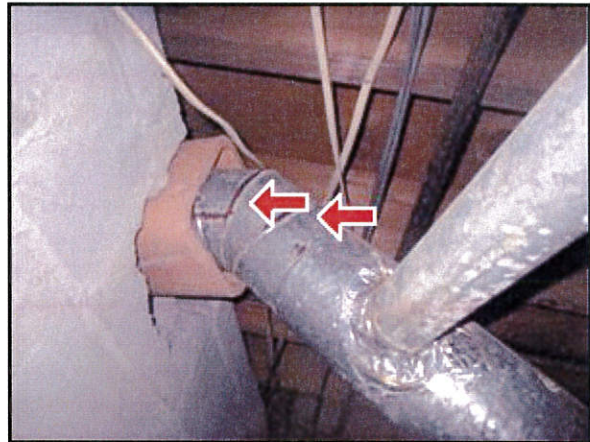
6.4 Picture 2 Rust on furnace flue in crawl space .

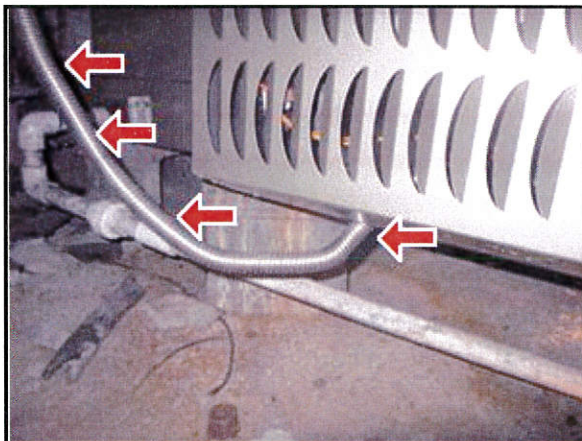
6.4 Picture 3 Flexible gas connector was installed into furnace cabinet in the crawl space .

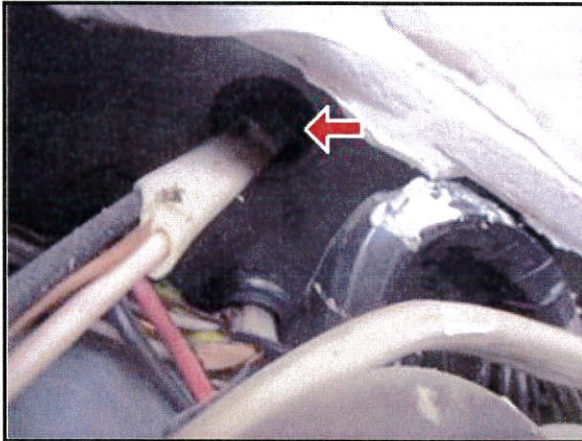
7.1 Picture 1 Missing wire bushing noted inside main panel .

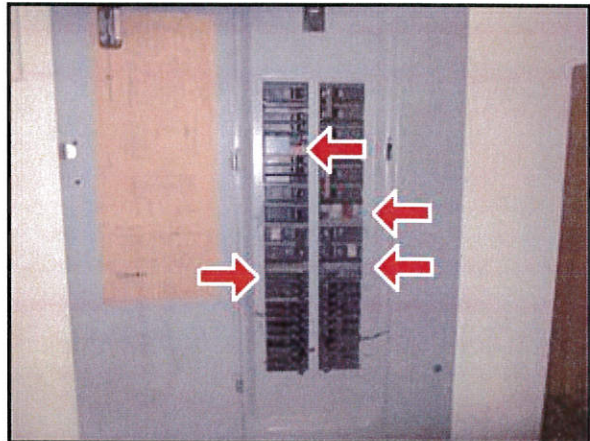
7.1 Picture 2 Unused openings in main electrical panel cover were not sealed as required .
