Home Inspections, LLC

# Inspection Report

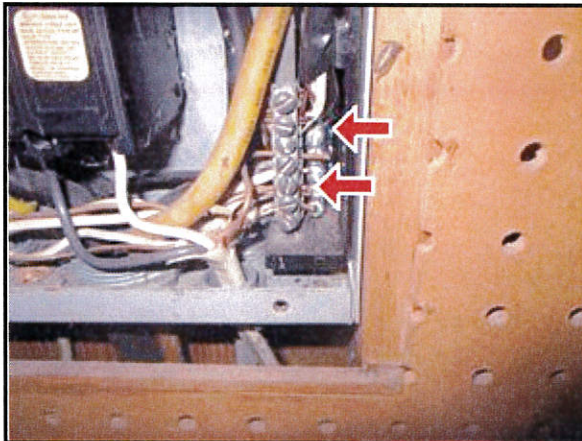
7.2 Picture 1 Ground and neutral wires were bonded together at the sub panel located at the detached shop

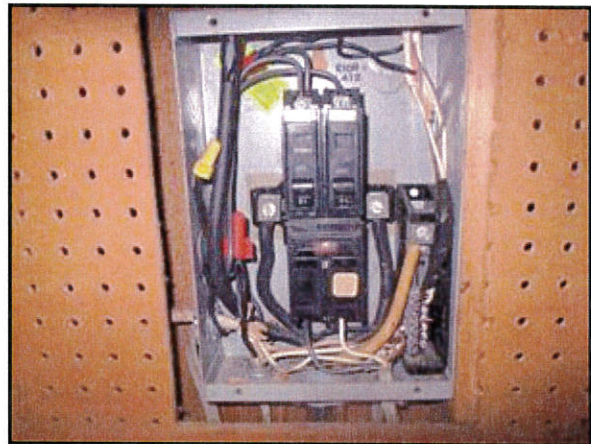
7.2 Picture 4 Sub panel in the detached shop building with cover removed

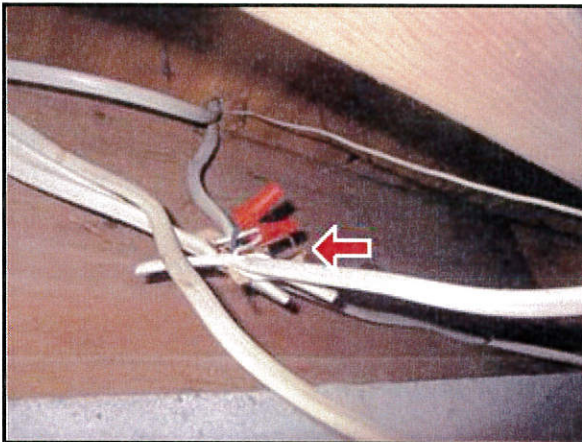
7.3 Picture 1 Open electrical splices noted in the crawl space

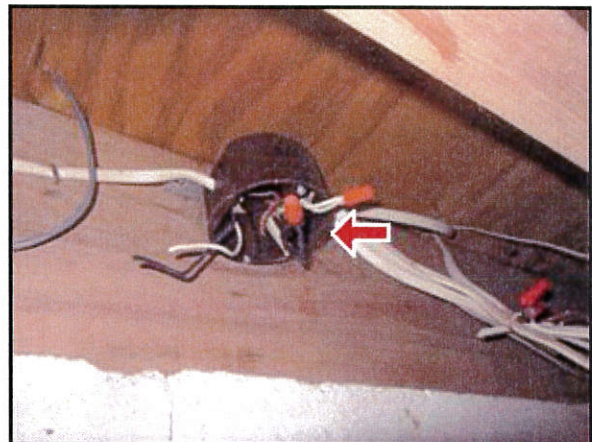
7.3 Picture 2 Missing electrical box covers noted in the crawl space

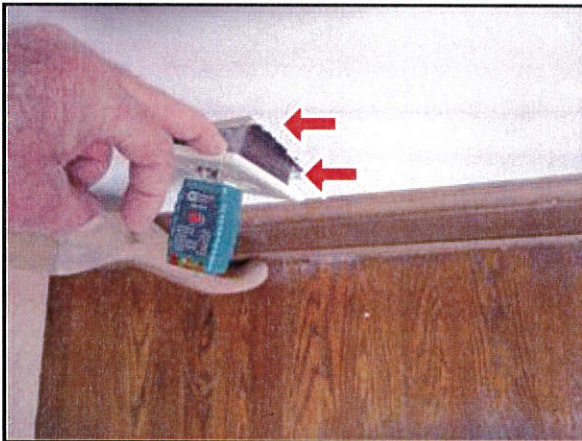
7.3 Picture 3 Electrical box at upstairs hallway was not properly secured inside wall as required .

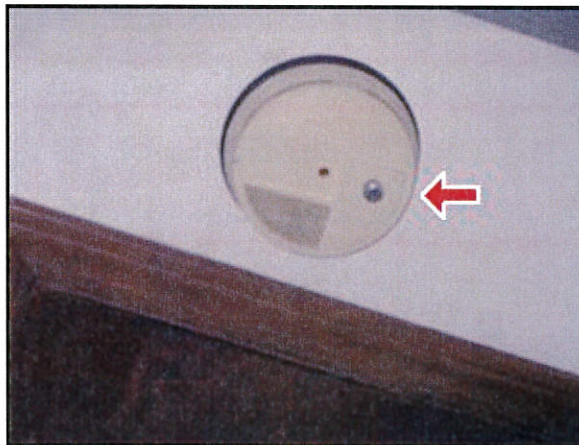
7.7 Picture 1 Smoke detectors are outdated by today's standards and at the end of their useful service life

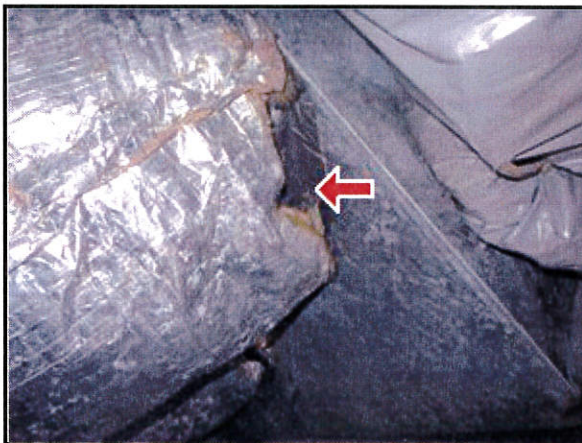
8.3 Picture 1 HVAC duct work was not properly sealed to air handler plenums

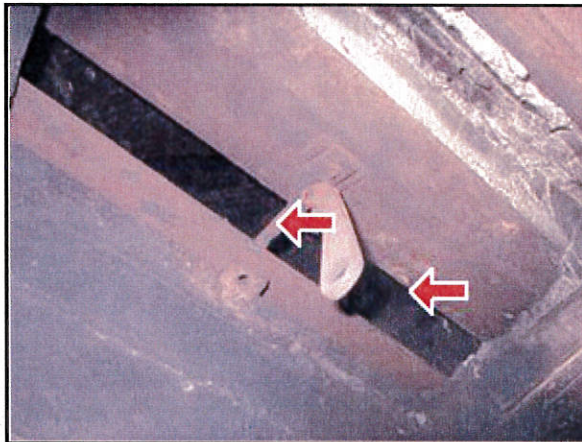
8.5 Picture 1 Fireplace dampers were damaged at fireplaces located in breakfast area and front living

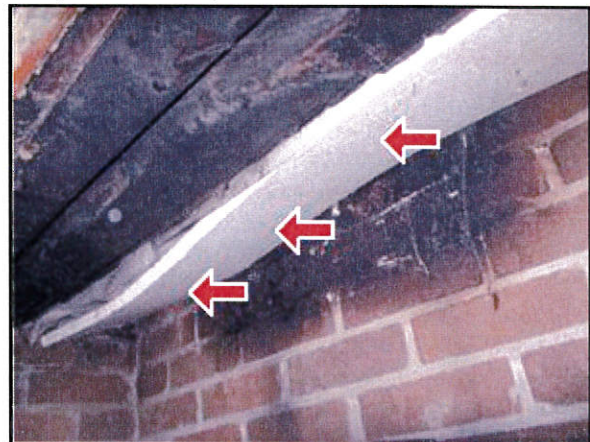
8.5 Picture 2 Fireplace chimney flue at fireplace located in sun room was sealed closed .

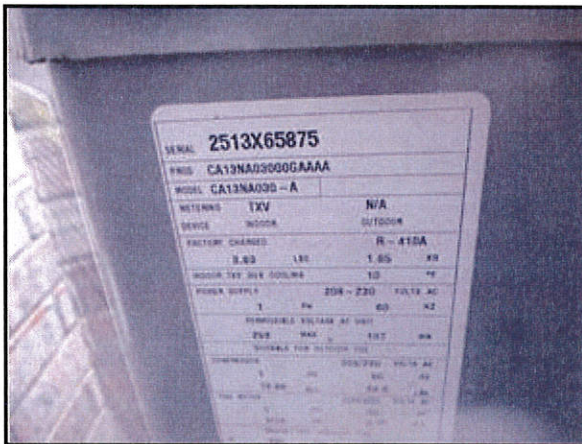
8.8 Picture 1 Air conditioning manufacturers data plate

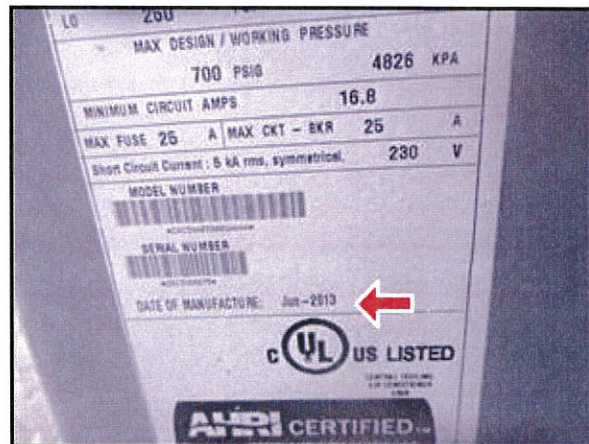
8.8 Picture 2 Air conditioning manufacturers date

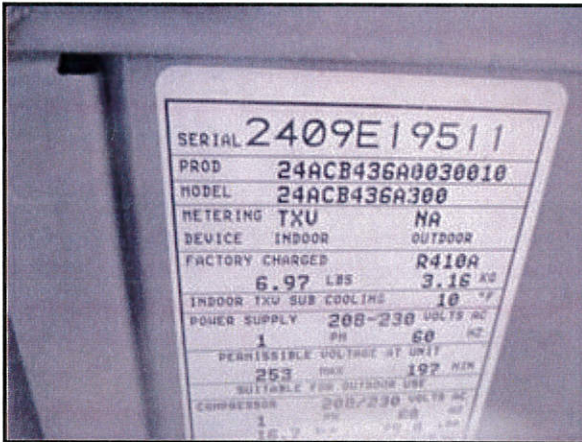
8.8 Picture 3 Air conditioning manufacturers data plate

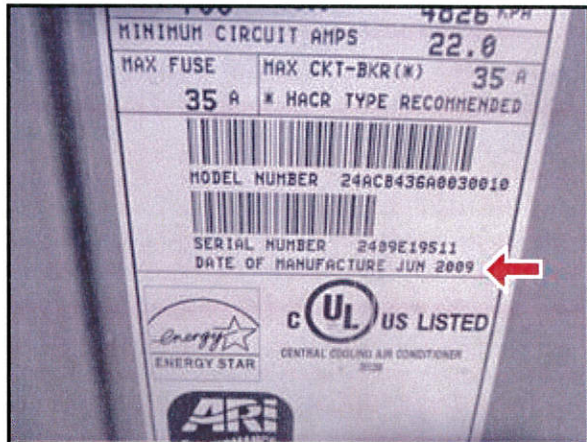
8.8 Picture 4 Air conditioning manufacturers date

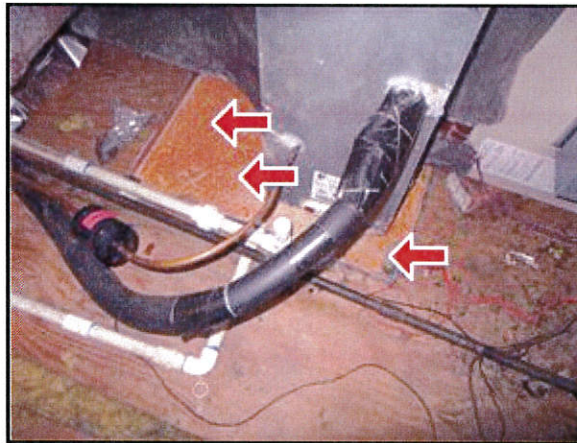
8.8 Picture 5 Evaporator unit catch pan located in the attic was rusted .

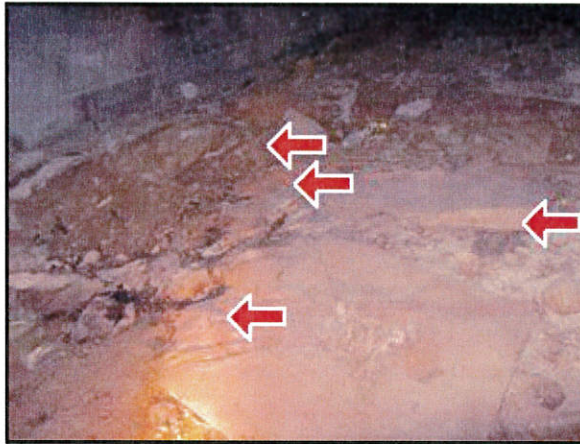
9.2 Picture 1 Cellulose debris in crawl space . No vapor barrier installed .

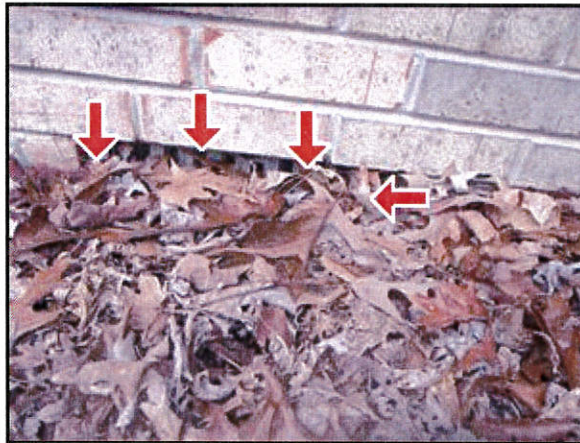
9.3 Picture 1 Foundation vent located at front of home ( left of front entry ) was below grade level .

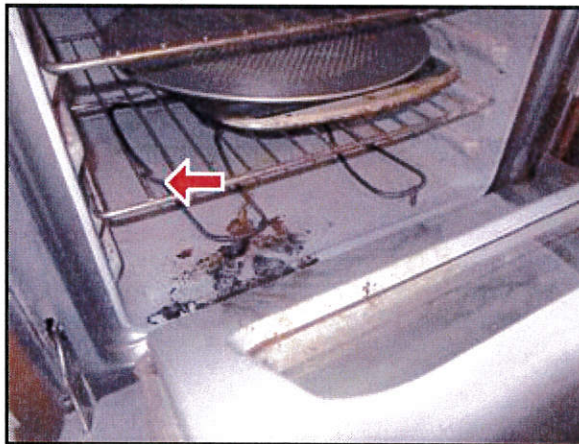
10.1 Picture 1 Bottom oven element at upper oven was damaged and inoperable .
