Soil Evaluation Report

Project number: 06001**Applicant:** James M. Fraser
3905 Creekwood Place
Earlsville, VA 22936
434-825-5912**Owner:****Date:**
8/21/2006**Health Department:**
Orange**Project name:**
"ASHLEYMARIE ESTATES" subd. of {TMP
53-19}**Lot:**
04**Site:**
unified**Location:** The site is on the north side of US 33, across from Chestnut Grove Church, or about 0.8 miles east of Eheart.Position in Landscape: sideslope & shoulderSlope: 5-8%Depth to rock or impervious strata, in.: None maximum: _____ minimum: _____Depth to seasonal water table (gray mottling or color), in.: NoneFree water present: No Range in inches: _____Percolation rate estimated: YesTexture class: IIIEstimated rate average at depth: 55Estimated rate slowest hole: 70Percolation test preformed: No

Project number	06001
Lot	04
Site	unified

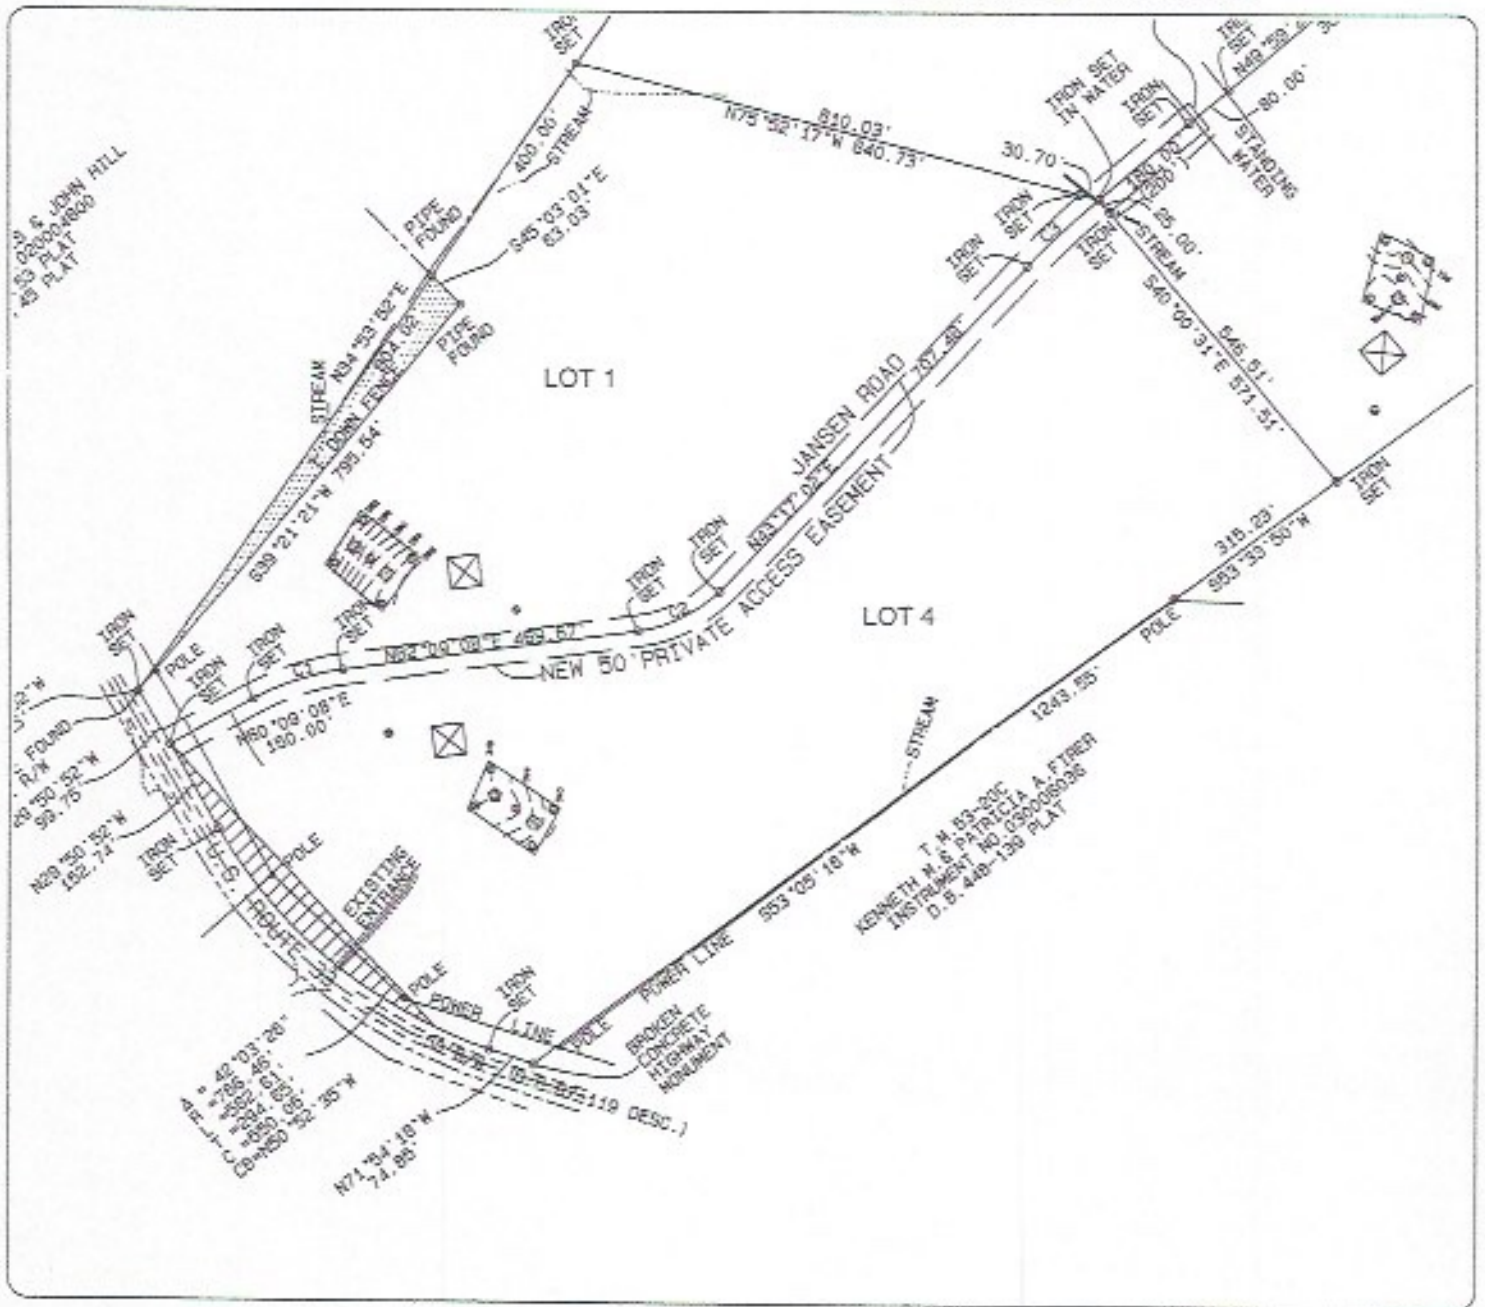
Sketch of: page 3 of 5

Lot 4

being a portion of

Tax Map 53, Parcel 19

showing proposed

Drainfield, Well, & House Site

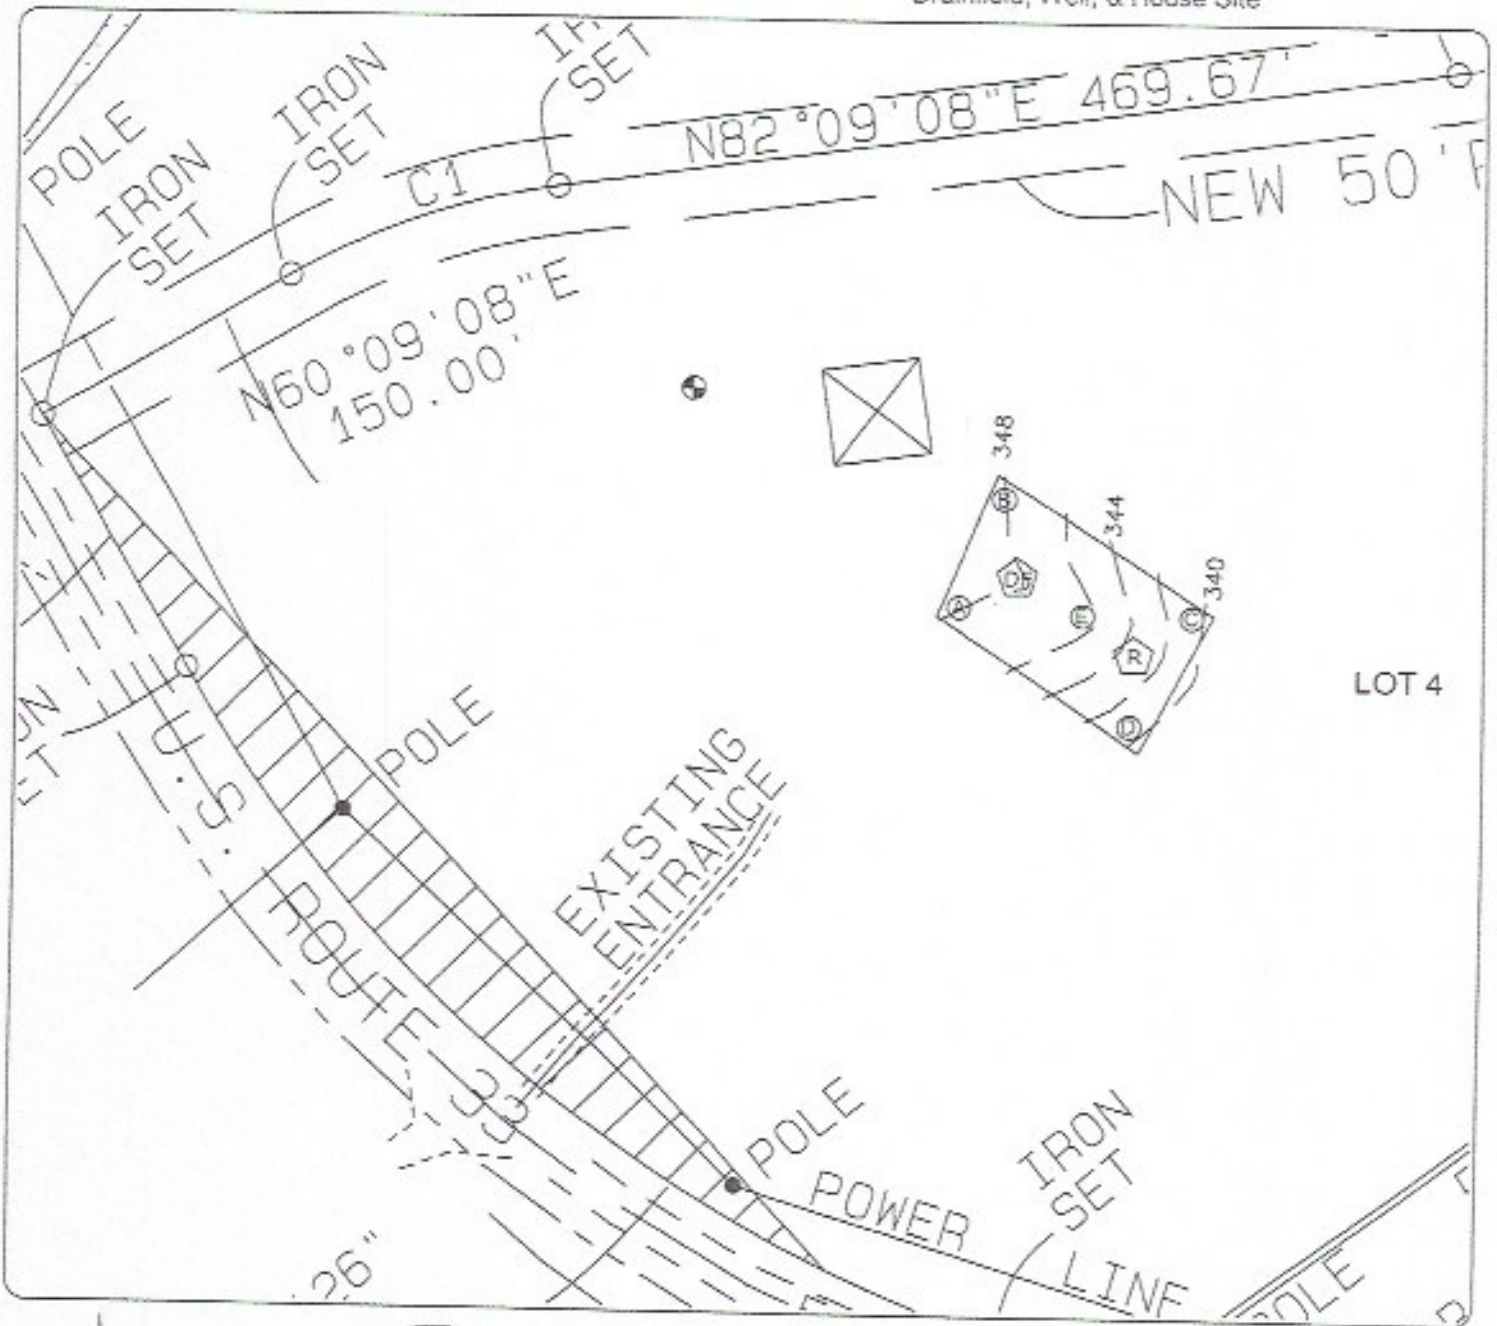
Detail of:

Lot 4

being a portion of

Tax Map 53, Parcel 19

showing proposed

Drainfield, Well, & House Site
