Inspection Report

807 Ridge Rd
Telford Pa 18969

A1 House Prep LLC and Inspections

Date: 02/25/20	Time: 09:30 AM	Report ID: 6806 Jacquelyn Maurer
Property: 807 Ridge Rd Telford Pa 18969	Customer: Jacquelyn Maurer	Real Estate Professional: Lon Clemmer Sanford Alderfer Real Estate

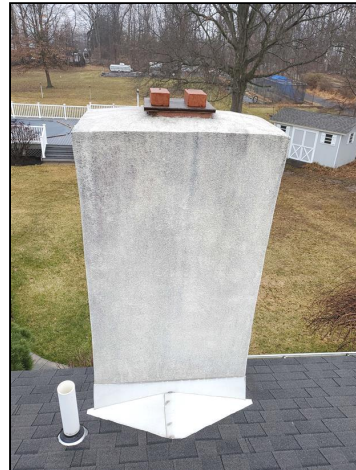
1.3 Item 1(Picture)

Unused capped chimney. FYI

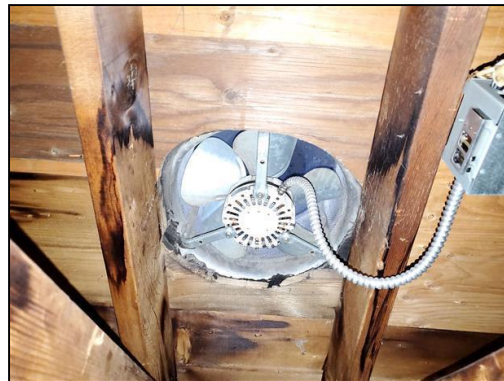
1.8 Item 1(Picture)

Attic ventilation fan was nonfunctional on the day of the inspection. Recommend to repair or replace ventilation fan as needed by a qualified person or professional.

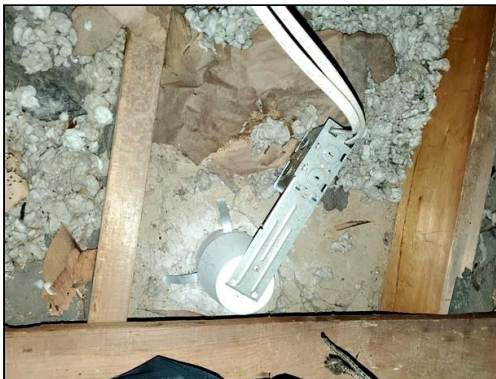
1.9 Item 1(Picture)

Areas of missing insulation in the attic. Recommend to install more insulation as needed by a qualified person or professional.

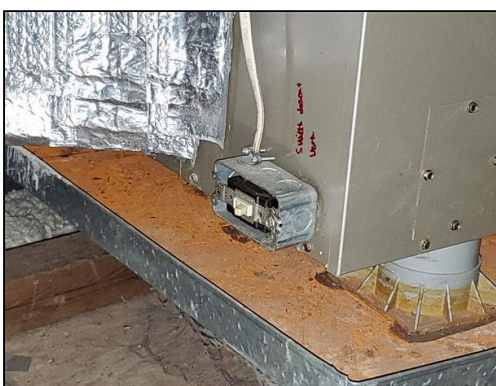
1.10 Item 1(Picture)

Missing a coverplate on one receptacle in the attic. Recommend to install a coverplate as needed by a qualified person.

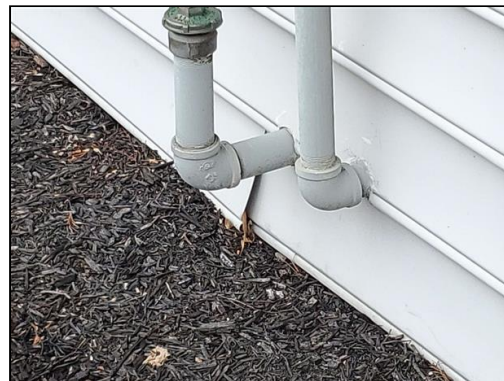
2.0 Item 1(Picture)

Loose vinyl siding at the front of the house. Recommend to secure siding as needed by a qualified professional.

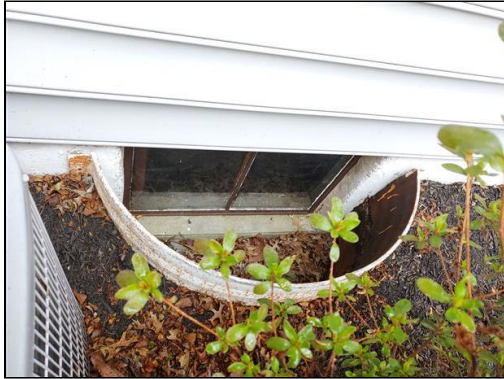
2.1 Item 1(Picture)

🏠 Missing window well covers. Suggest to install clear plastic well covers over window wells to prevent potential well saturation which could overflow window sill and spill into the basement. **This is considered optional.**

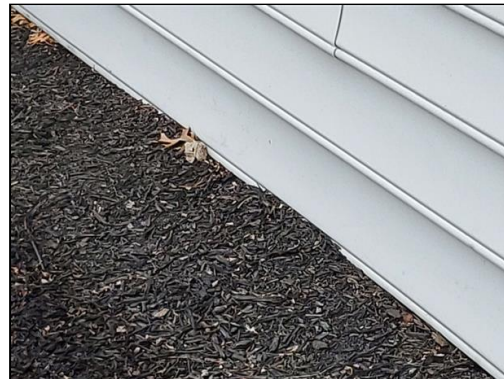
2.3 Item 1(Picture)

🏠 (1) Mulch is covering siding.
Recommend to pull back mulch to prevent insect penetration.

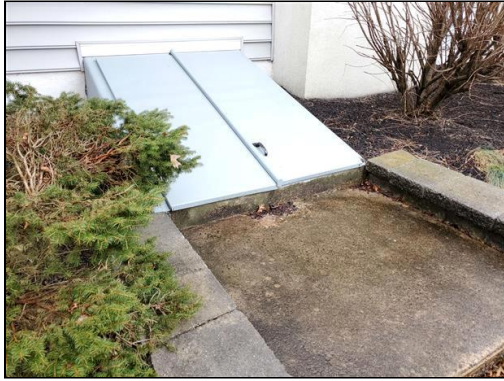
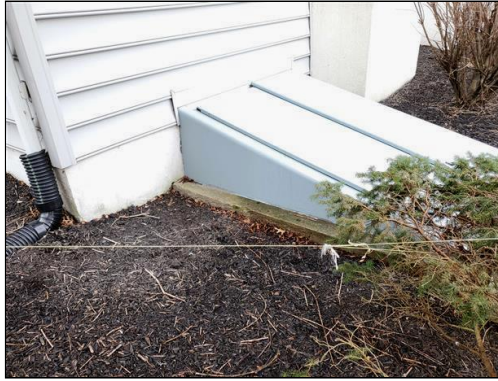
2.3 Item 2(Picture)

🏠 (2) Negative grading around the bilco door. Highly recommend to correct grading as needed by a professional landscaper. Negative grading can cause unseen structural issues and water penetration if not corrected.

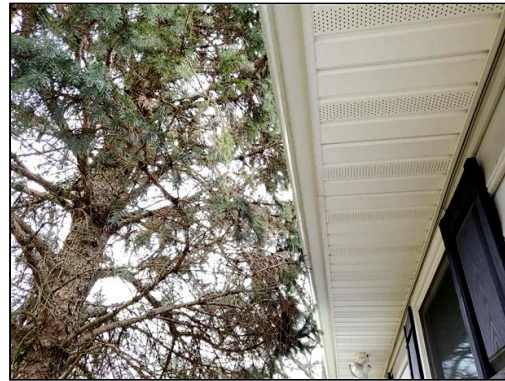
2.3 Item 4(Picture)

🏠 (3) Large tree overhanging the house. Recommend to trim back tree as needed by a qualified professional. Potential for shingle damage exists.

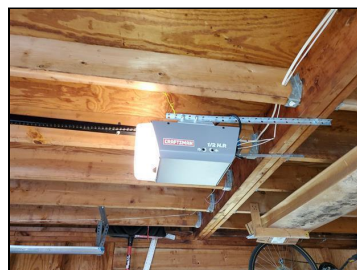
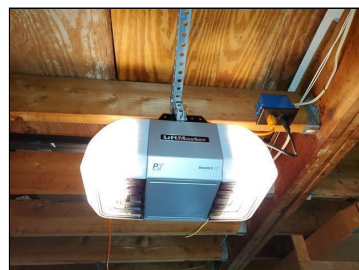
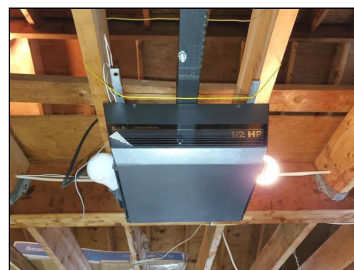
3.4 Item 1(Picture)

All garage doors needed excessive pressure for the auto reverse function to work properly. Recommend to adjust doors as needed by a qualified person for auto reverse to work correctly. Potential safety hazard exists.

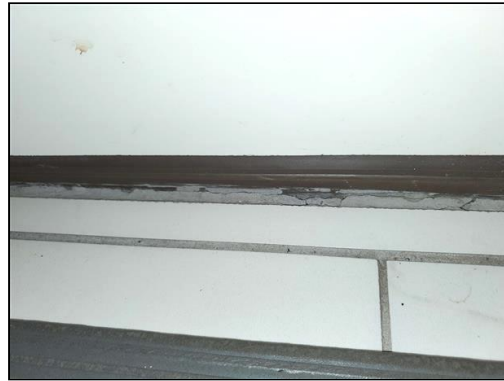
4.0 Item 1(Picture)

Cracked grouting between kitchen and sunroom. Recommend to regrout as needed by a qualified person.

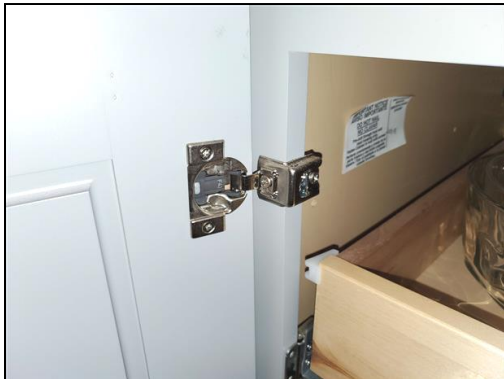
4.6 Item 1(Picture)

Loose kitchen cabinet hardware. Suggest to tighten and adjust hardware as needed to restore to original condition.

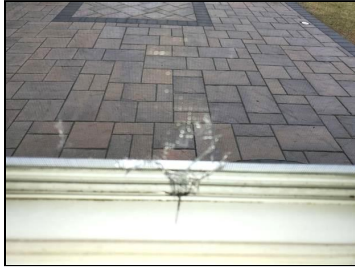
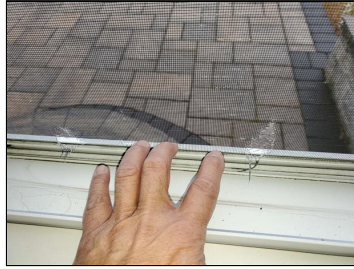
5.0.D Item 1(Picture)

🏠 (1) 2 damaged screens in the sunroom. Recommend to replace screens as needed by a qualified person. This is considered normal maintenance.

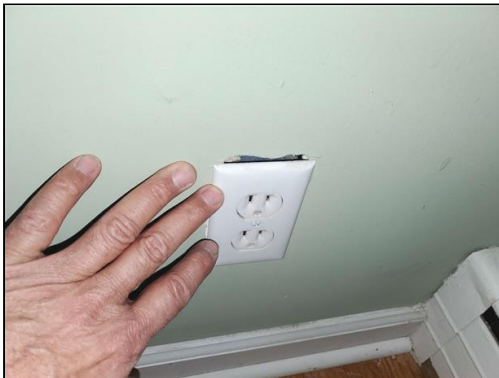
5.7.E Item 1(Picture)

One loose receptacle located in the owners' suite. Recommend to secure as needed by a qualified person.

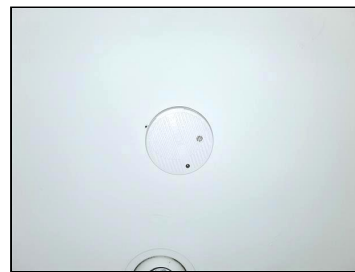
5.8.F Item 1(Picture)

Smoke detector in the hallway was nonfunctional. Recommend to replace as needed by a qualified person.

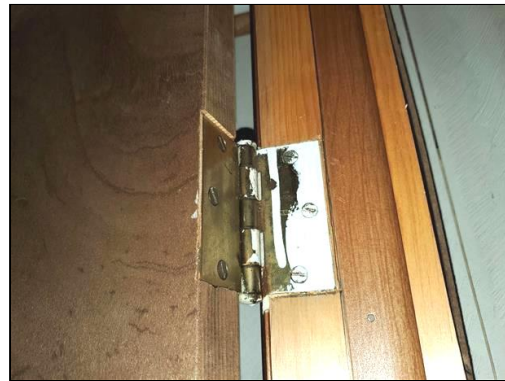
5.2.G Item 1(Picture)

Loose door hinge on one door in the basement. Recommend to tighten hinge as needed by a qualified person.

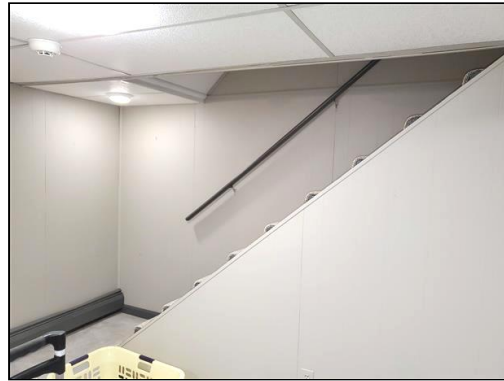
5.6.G Item 1(Picture)

🏠 Steps are missing handrails and guardrails. Recommend to replace missing handrails and guardrails as needed by a qualified person. Potential safety hazard exist.

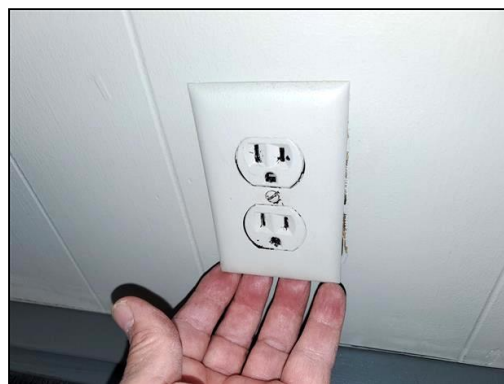
5.7.G Item 1(Picture)

🏠 Loose receptacle located in the finished basement. Recommend to secure receptacle as needed by a qualified person.

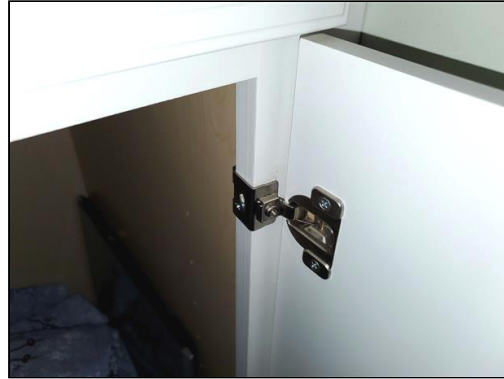
6.7 Item 1(Picture)

Loose hardware in hall bathroom cabinet. Suggest to repair as needed by a qualified person.

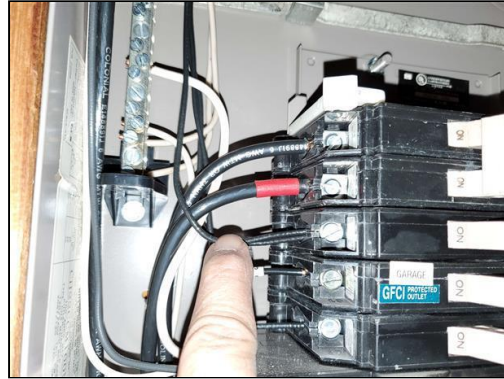
8.2 Item 1(Picture)

1 double tapped breaker located in the sub panel located in the garage. Recommend to have panel inspected and repaired as needed by a qualified electrician. Potential safety hazard exists.

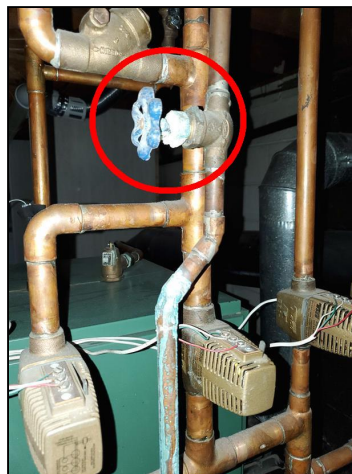
9.2 Item 1(Picture)

Leaking valve above heater.
Recommend to repair as needed by a qualified plumber.

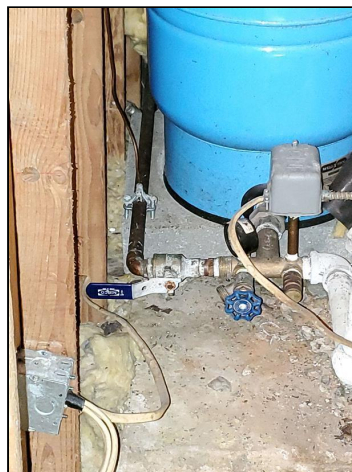
9.3 Item 1(Picture)

The main shut off is the blue lever located in the basement. This is for your information.

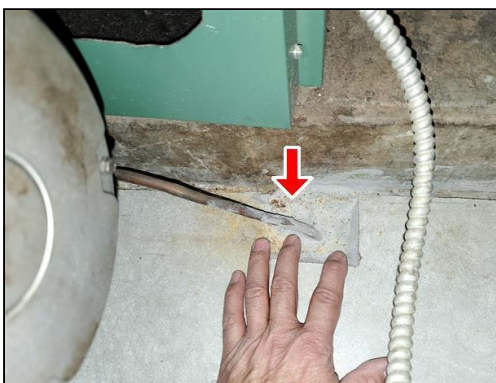
9.4 Item 1(Picture)

Copper oil line is embedded in the concrete slab. Recommend to replace copper line with plastic coated line to prevent potential line leakage. Potential environmental hazard exists.

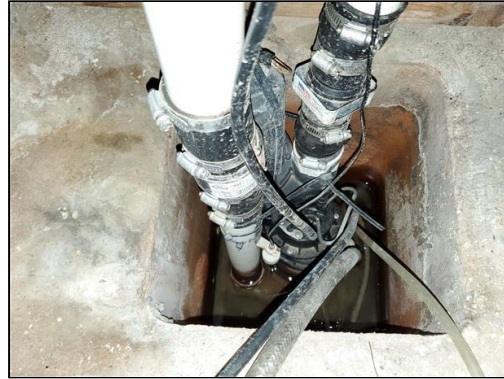
9.7 Item 1(Picture)

- Missing a coverplate on the sump pump. Recommend to install a coverplate as needed by a qualified person.
- Battery Back up sump pump was nonfunctional. Recommend to repair or replace the battery back up sump pump as needed by a qualified person.

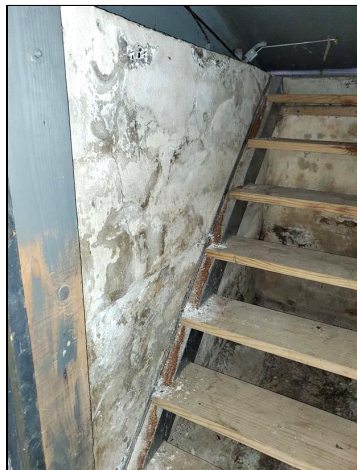
11.3 Item 1(Picture)

Signs of past water penetration at the bilco doors. Recommend to correct negative grading as needed to prevent further water penetration. Also suggest to paint walls with a dryloc type paint.

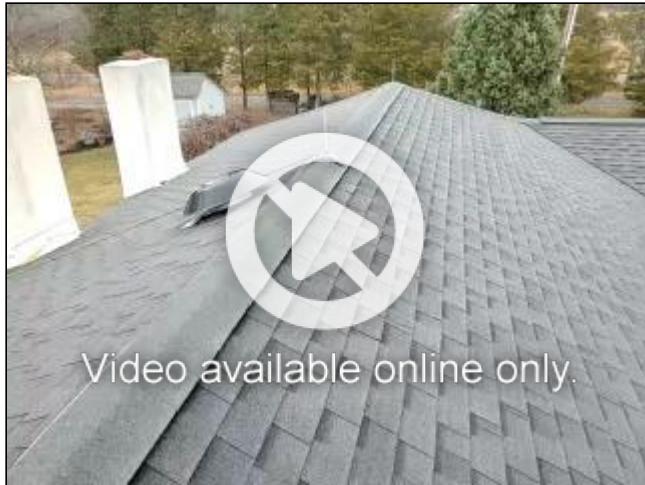
1.0 Item 1(Video) *** ROOF VIDEO ***

Suggest to view roof video for more information.

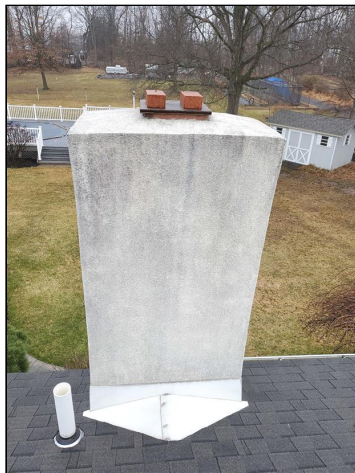
1.3 Item 1(Picture)

Unused capped chimney. FYI

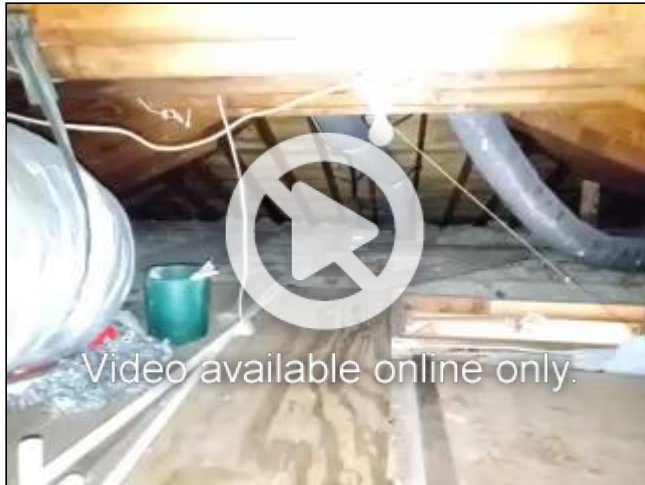
1.5 Item 1(Video) *** ATTIC VIDEO ***

Suggest to view attic video for more information.

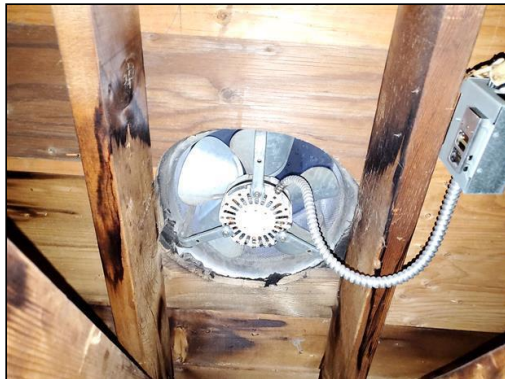
1.8 Item 1(Picture)

Attic ventilation fan was nonfunctional on the day of the inspection. Recommend to repair or replace ventilation fan as needed by a qualified person or professional.

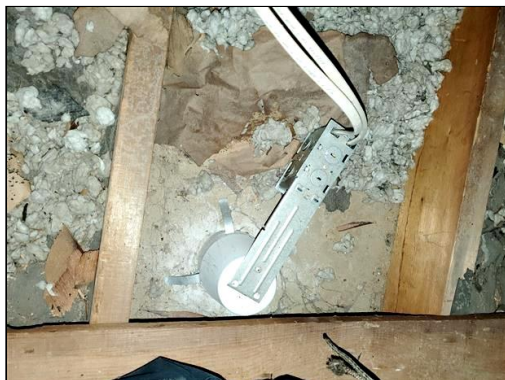
1.9 Item 1(Picture)

Areas of missing insulation in the attic. Recommend to install more insulation as needed by a qualified person or professional.

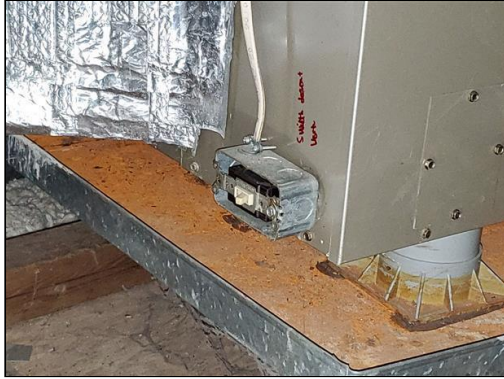
1.10 Item 1(Picture)

Missing a coverplate on one receptacle in the attic. Recommend to install a coverplate as needed by a qualified person.

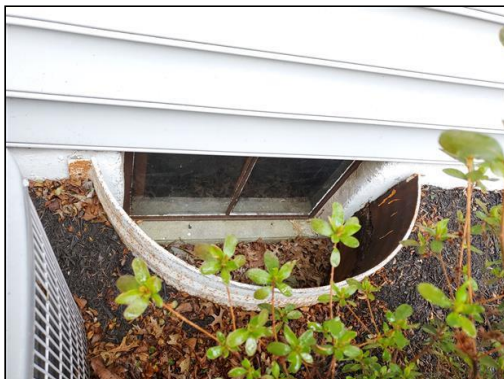
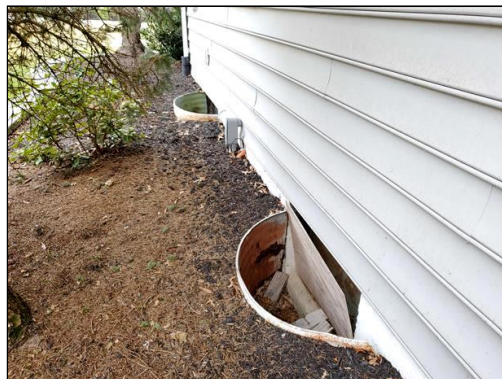
2.1 Item 1(Picture)

Missing window well covers. Suggest to install clear plastic well covers over window wells to prevent potential well saturation which could overflow window sill and spill into the basement. **This is considered optional.**

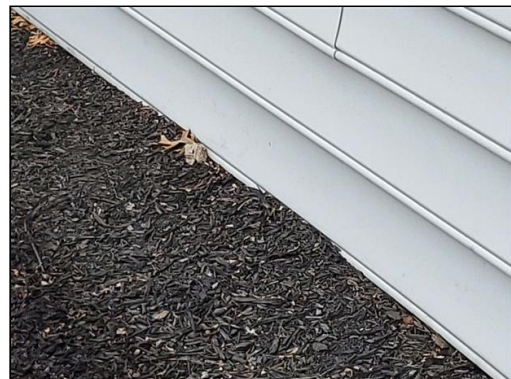
2.3 Item 1(Picture)

(1) Mulch is covering siding. Recommend to pull back mulch to prevent insect penetration.

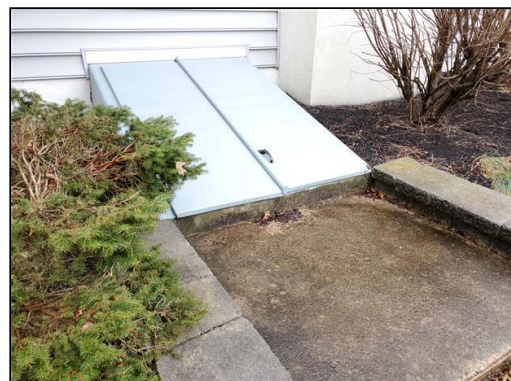
2.3 Item 2(Picture)

(2) Negative grading around the bilco door. Highly recommend to correct grading as needed by a professional landscaper. Negative grading can cause unseen structural issues and water penetration if not corrected.

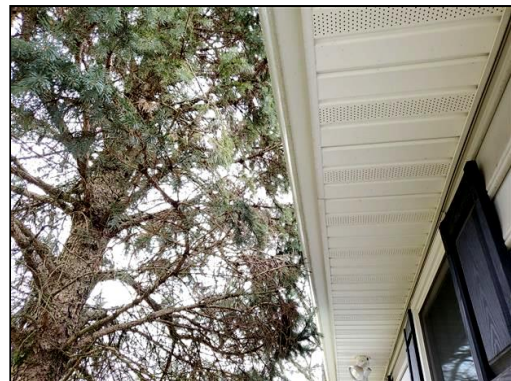
2.3 Item 4(Picture)

(3) Large tree overhanging the house. Recommend to trim back tree as needed by a qualified professional. Potential for shingle damage exists.

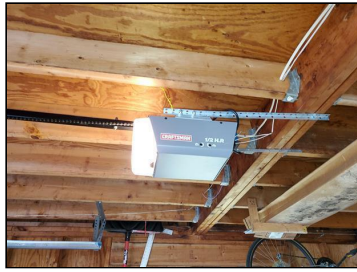
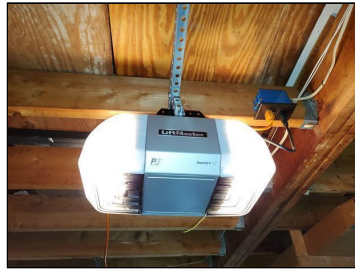
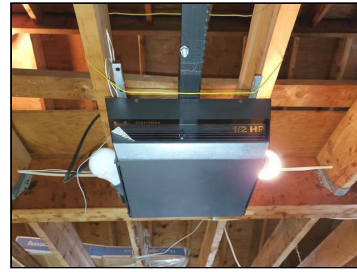
3.4 Item 1(Picture)

All garage doors needed excessive pressure for the auto reverse function to work properly. Recommend to adjust doors as needed by a qualified person for auto reverse to work correctly. Potential safety hazard exists.

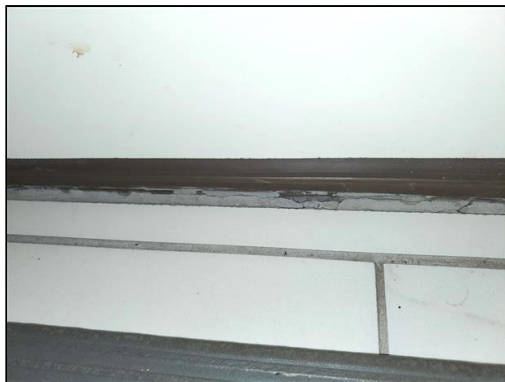
4.0 Item 1(Picture)

Cracked grouting between kitchen and sunroom. Recommend to regrout as needed by a qualified person.

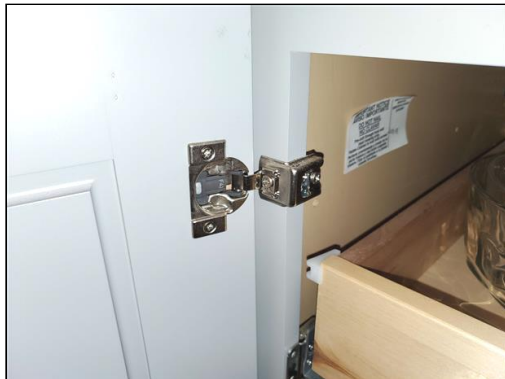
4.6 Item 1(Picture)

Loose kitchen cabinet hardware. Suggest to tighten and adjust hardware as needed to restore to original condition.

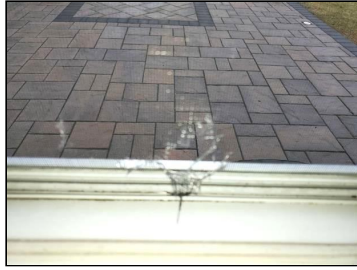
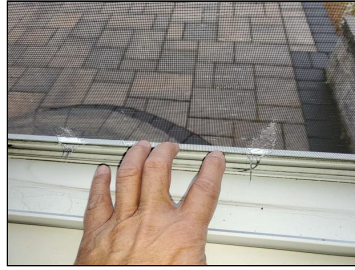
5.0.D Item 1(Picture)

(1) 2 damaged screens in the sunroom. Recommend to replace screens as needed by a qualified person. This is considered normal maintenance.

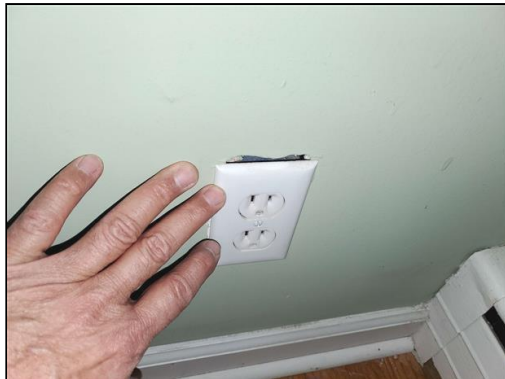
5.7.E Item 1(Picture)

One loose receptacle located in the owners' suite. Recommend to secure as needed by a qualified person.

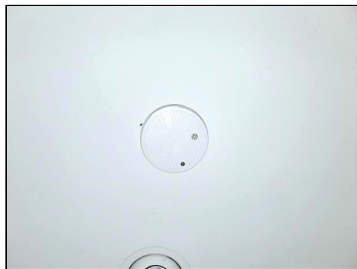
5.8.F Item 1(Picture)

Smoke detector in the hallway was nonfunctional. Recommend to replace as needed by a qualified person.

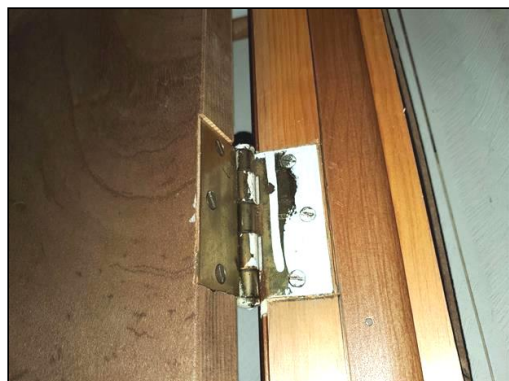
5.2.G Item 1(Picture)

Loose door hinge on one door in the basement. Recommend to tighten hinge as needed by a qualified person.

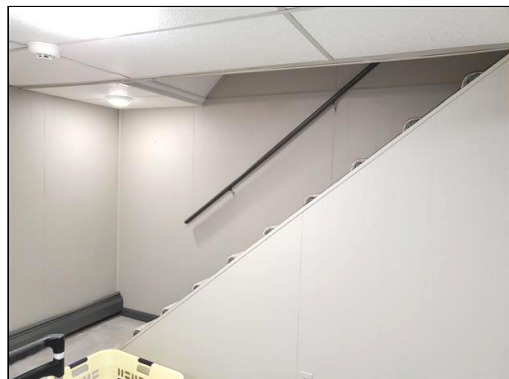
5.6.G Item 1(Picture)

Steps are missing handrails and guardrails. Recommend to replace missing handrails and guardrails as needed by a qualified person. Potential safety hazard exist.

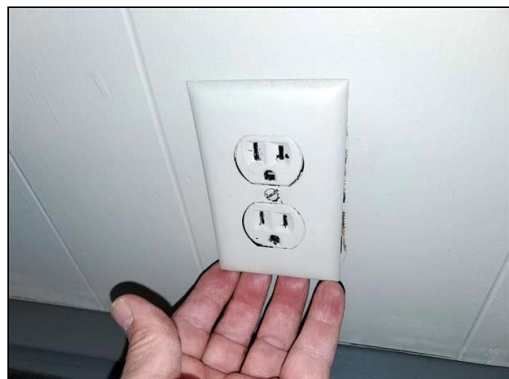
5.7.G Item 1(Picture)

Loose receptacle located in the finished basement. Recommend to secure receptacle as needed by a qualified person.

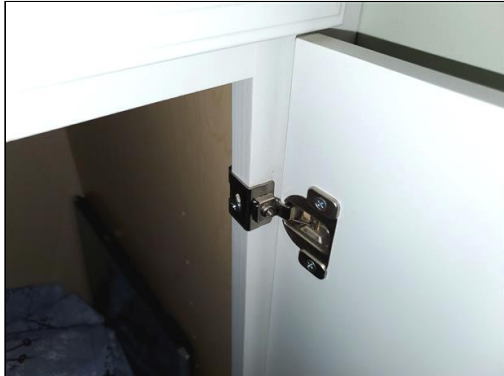
6.7 Item 1(Picture)

Loose hardware in hall bathroom cabinet. Suggest to repair as needed by a qualified person.

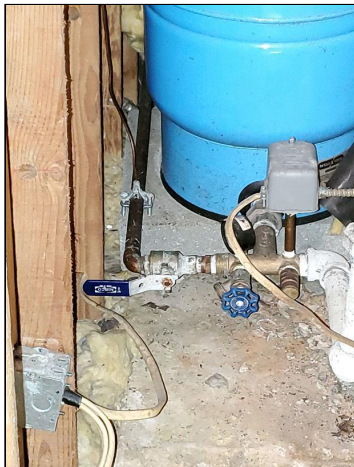
9.3 Item 1(Picture)

The main shut off is the blue lever located in the basement. This is for your information.

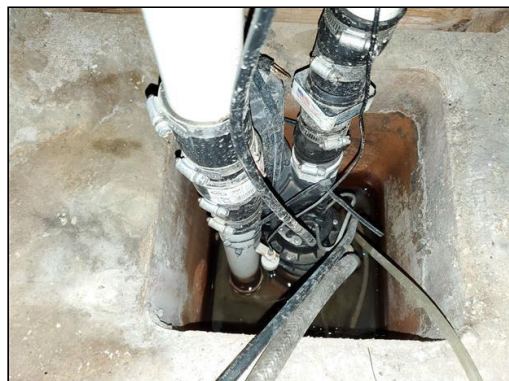
9.7 Item 1(Picture)

- Missing a coverplate on the sump pump. Recommend to install a coverplate as needed by a qualified person.
- Battery Back up sump pump was nonfunctional. Recommend to repair or replace the battery back up sump pump as needed by a qualified person.

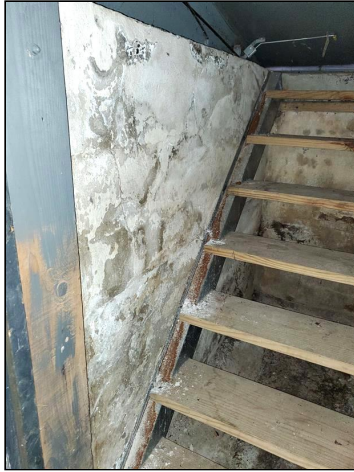
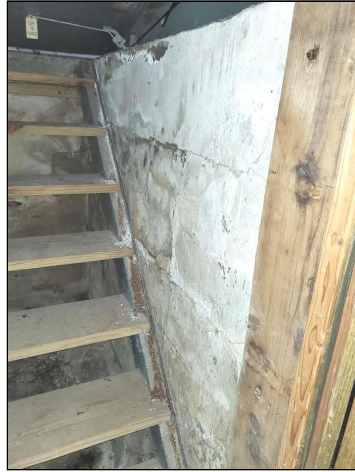
11.3 Item 1(Picture)

Signs of past water penetration at the bilco doors. Recommend to correct negative grading as needed to prevent further water penetration. Also suggest to paint walls with a dryloc type paint.

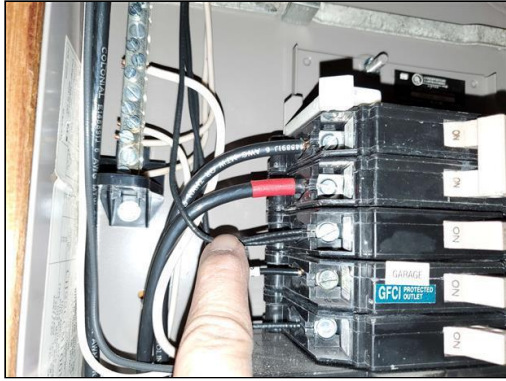
8.2 Item 1(Picture)

1 double tapped breaker located in the sub panel located in the garage. Recommend to have panel inspected and repaired as needed by a qualified electrician. Potential safety hazard exists.

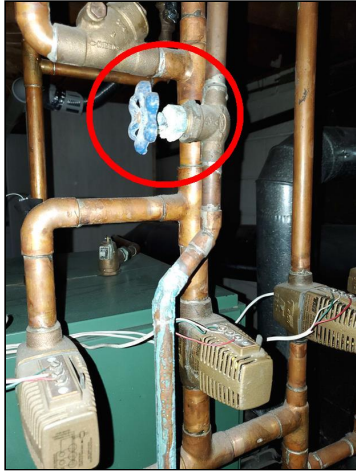
9.2 Item 1(Picture)

Leaking valve above heater. Recommend to repair as needed by a qualified plumber.

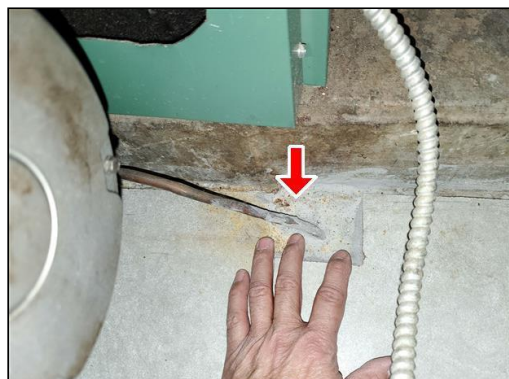
9.4 Item 1(Picture)

Copper oil line is embedded in the concrete slab. Recommend to replace copper line with plastic coated line to prevent potential line leakage. Potential environmental hazard exists.
