Inspection Report

Property Address:
2577 Old Bethlehem Pike
Sellersville Pa 18960

A1 House Prep LLC and Inspections

Date: 09/30/20	Time: 12:00 PM	Report ID: 6922 Nelson & Diane Brown
Property: 2577 Old Bethlehem Pike Sellersville Pa 18960	Customer: Nelson Brown	Real Estate Professional: Michelle Hunsberger Alderfer Real Estate

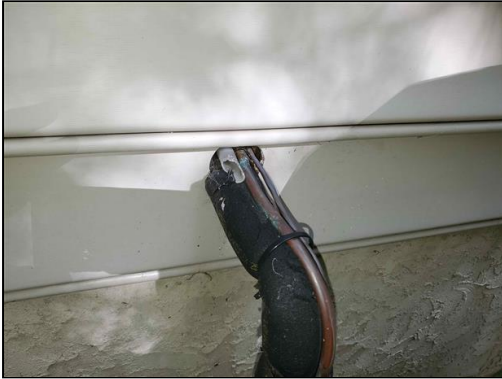
2.0 Item 1(Picture)

The hole in siding needs closing off with sealant or liquid foam at the exterior where compressor lines enter the home.

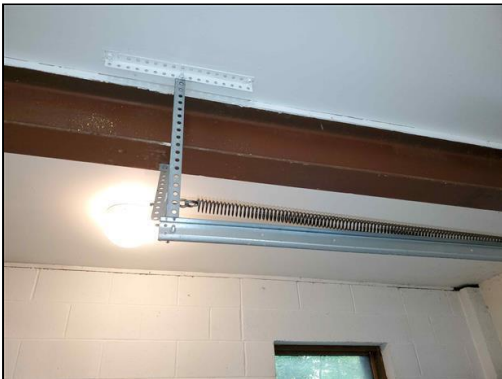
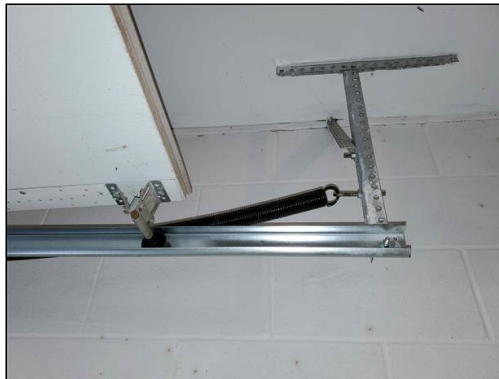
3.3 Item 1(Picture)

Missing safety cables inside of garage door springs. Recommend to replace missing safety cables as needed by a qualified person. Potential safety hazard exist.

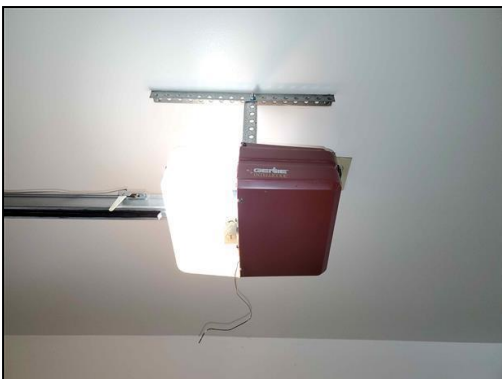
3.4 Item 1(Picture)

Garage door needed excessive pressure for the auto reverse function to work properly. Recommend to adjust door as needed by a qualified person for auto reverse to work correctly. Potential safety hazard exists.

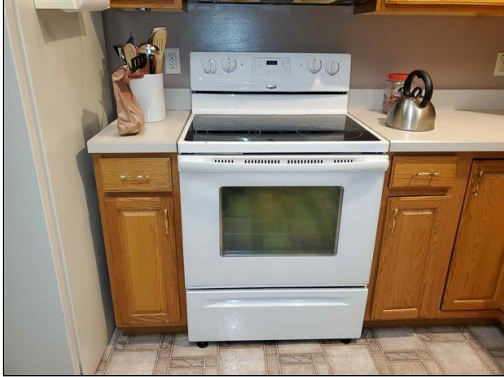
4.13 Item 1(Picture)

Oven was fully functional. Suggest to install an anti tip device as discussed. This is considered an added safety precaution against a potential scalding accident to a small child.

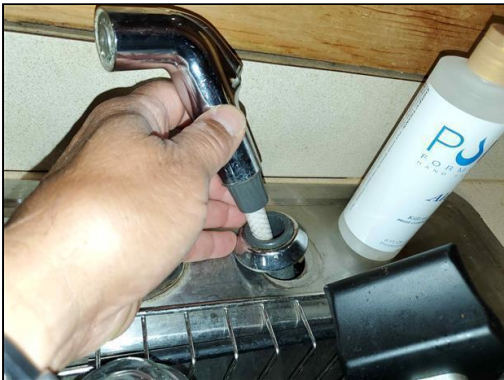
4.8 Item 1(Picture)

Loose sprayer connection. Recommend to secure as needed by a qualified person.

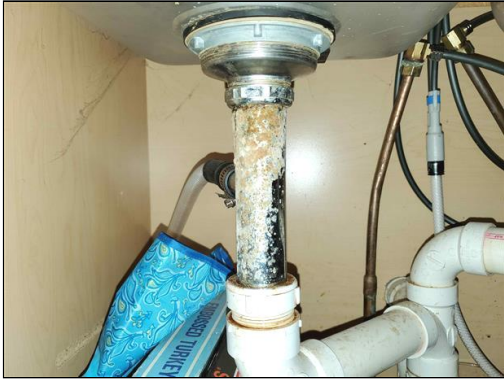
4.10 Item 1(Picture)

Metal drainpipes under the kitchen sink are deteriorated and in need of replacement. Recommend to replace deteriorated pipes as needed before a leak reoccurs. Replace deteriorated pipes by a qualified plumber.

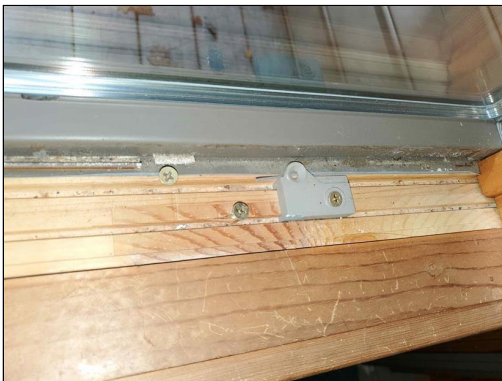
5.0.C Item 1(Picture)

(1) Missing one window crank in sunroom. Recommend to replace crank hardware as needed by a qualified person.

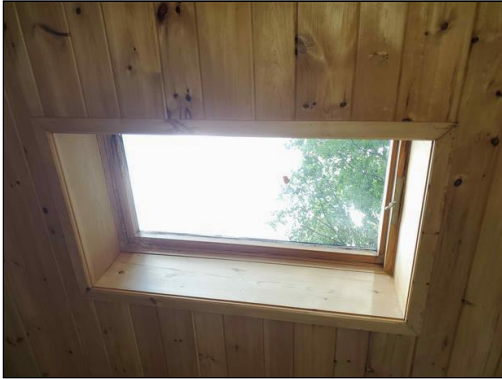
5.0.C Item 2(Picture)

(2) Water stains on skylight frame in sunroom. Checked with moisture meter and area was dry. **FYI**

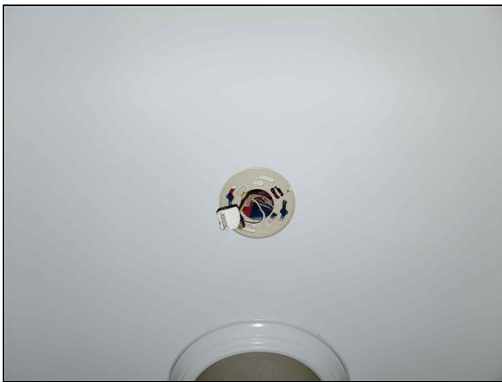
5.8.D Item 1(Picture)

Missing a smoke detector in the loft area. Recommend to replace smoke detector as needed by a qualified person.

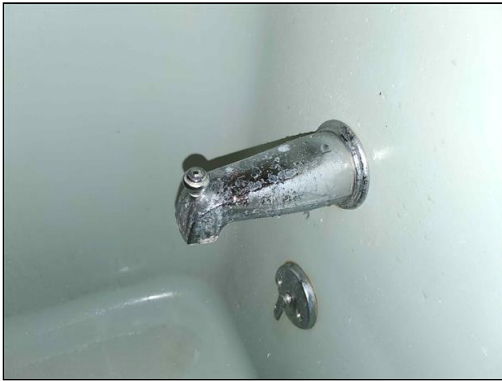
6.8.B Item 1(Picture)

(1) Shower diverter valve in the hall bath is not functioning properly. Recommend to replace diverter valve as needed by a qualified plumber.

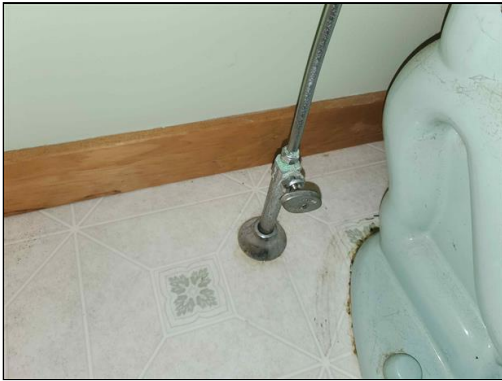
6.8.B Item 2(Picture)

(2) Slight leak at the water shut off valve to the toilet. Recommend to replace valve as needed by a qualified person or plumber.

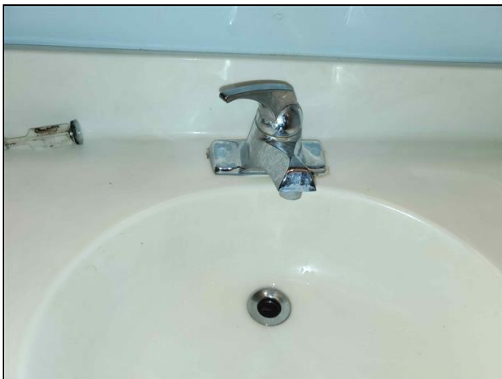
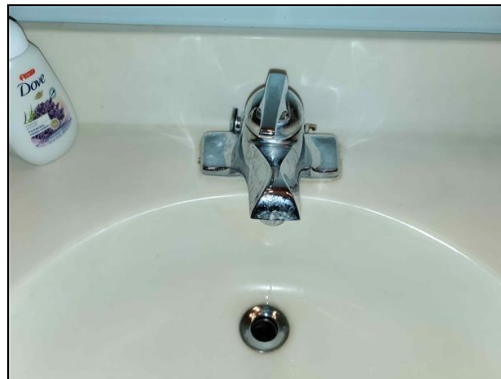
6.9.C Item 1(Picture)

Both sink stoppers are disconnected in the owners' suite bath. Recommend to connect stoppers as needed by a qualified person or plumber.

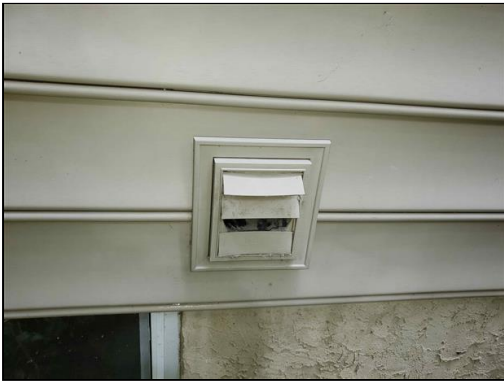
7.8 Item 1(Picture)

Damaged dryer vent. Suggest to replace vent as needed by a qualified person.

Suggest to clean dryer vent on an annual basis. **FYI**

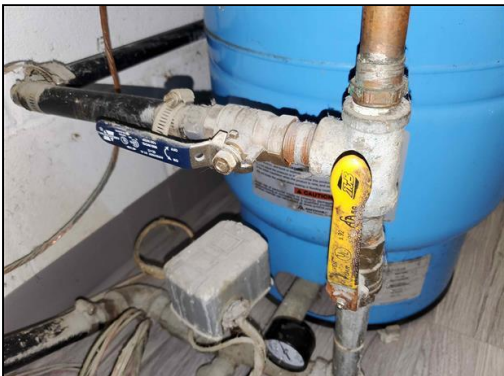
9.3 Item 1(Picture)

The main shut off is the blue and yellow lever located in the laundry area. **FYI**

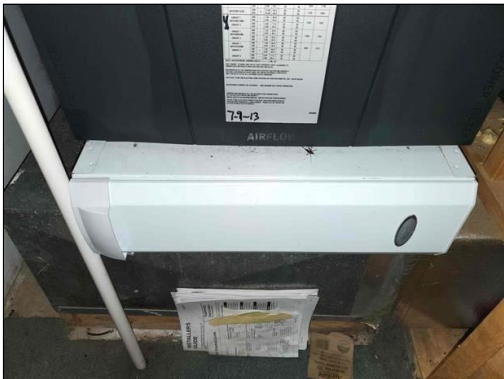
10.3 Item 1(Picture)

Air filter location. **FYI**
