Inspection Report

Property Address:
124 Fairway Dr
Harleysville Pa 19438

A1 House Prep LLC and Inspections

Date: 09/29/20	Time: 10:00 AM	Report ID: 6921 Susan Douglas
Property: 124 Fairway Dr Harleysville Pa 19438	Customer: Susan Douglas	Real Estate Professional: Michelle Hunsberger Alderfer Real Estate

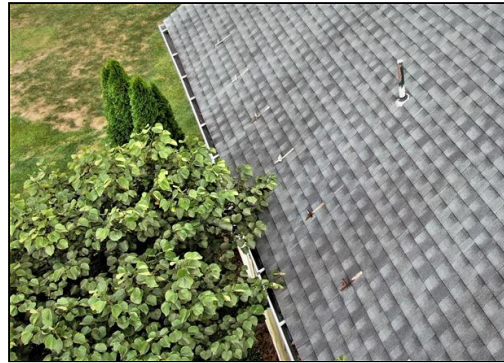
1.0 Item 1(Picture)

📌 The tree limbs that are in contact with roof or hanging near roof should be trimmed.

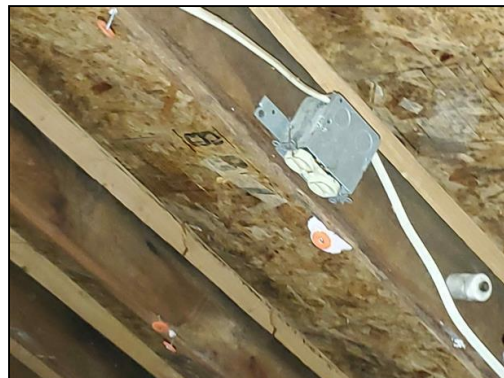
1.9 Item 1(Picture)

Missing a cover plate on one receptacle in the attic. Suggest to install a coverplate as needed by a qualified person.

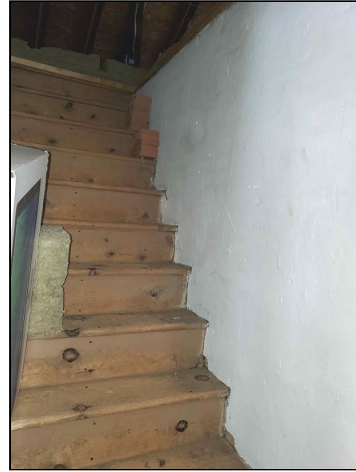
1.10 Item 1(Picture)

Suggest to install a handrailing at the attic steps. Potential tripping hazard exists. **FYI**

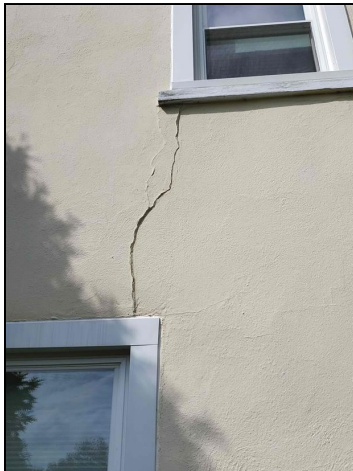
2.0 Item 1(Picture)

Typical fractures and cracks in stucco exterior. Recommend to fill or repair cracks as needed by a qualified professional. This will help prevent further deterioration.

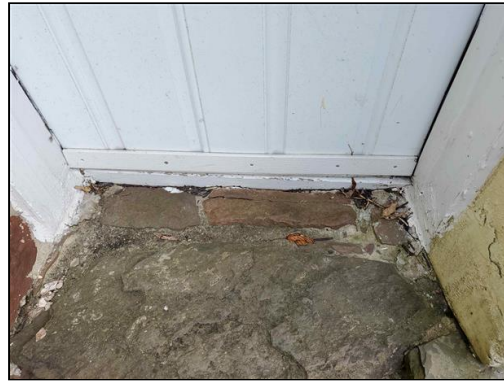
2.2 Item 1(Picture)

🏠 Negative grade at the basement entrance door. Recommend to correct as needed to prevent water penetration.

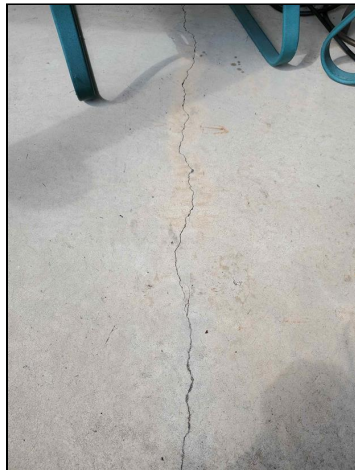
2.3 Item 1(Picture)

🏠 (1) Typical settlement cracks in front concrete patio. Recommend to patch or repair cracks as needed by a qualified person or professional. This would be considered normal maintenance.

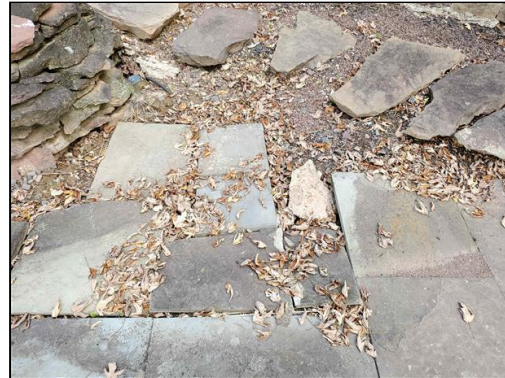
2.3 Item 5(Picture)

(3) Loose and rotated pavers at the rear of the house. Recommend to reset pavers as needed by a qualified person. This is considered normal maintenance.

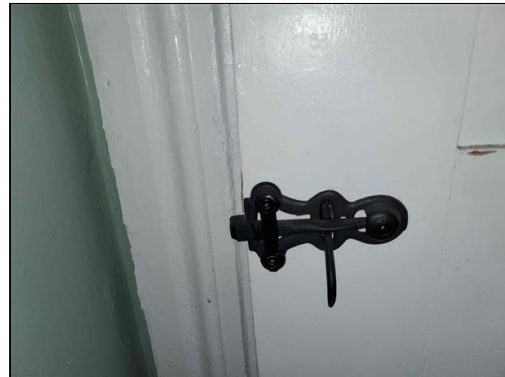
3.3.A Item 1(Picture)

📌 Missing hardware on one door in the kitchen. Recommend to replace hardware as needed by a qualified person.

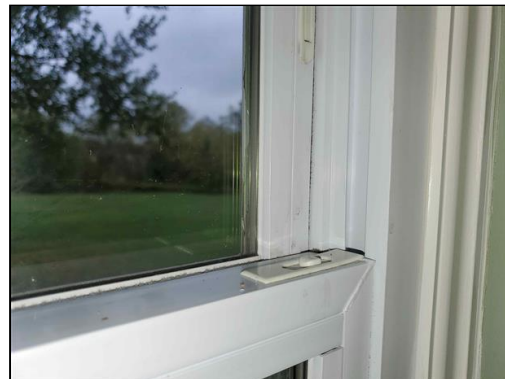
3.5.A Item 1(Picture)

📌 Broken spring balancer on one kitchen window. Recommend to repair hardware as needed by a qualified person.

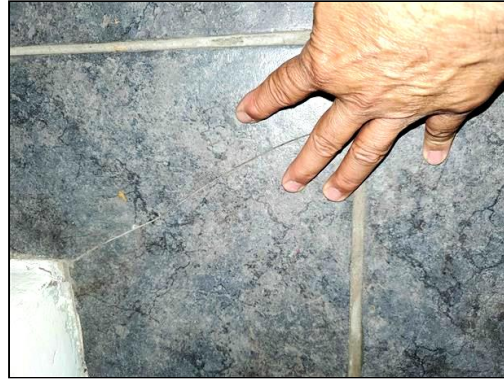
3.0.B Item 1(Picture)

One cracked floor tile in the in law suite kitchen. Recommend to replace tile as needed by a qualified person.

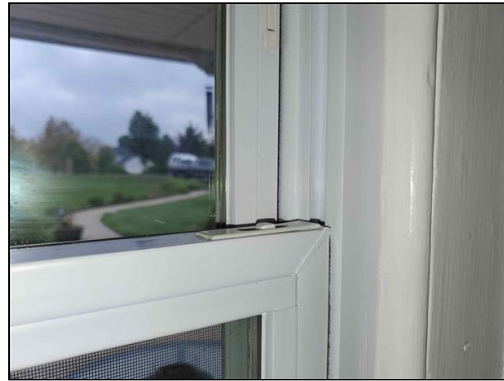
4.0.D Item 1(Picture)

One window in the dining room has a broken spring balancer. Recommend to repair spring balancers as needed by a qualified window installer.

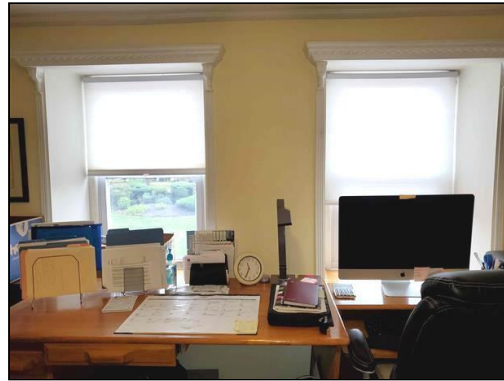
4.0.F Item 1(Picture)

Unable to access windows.
Recommend to have windows
inspected for function.

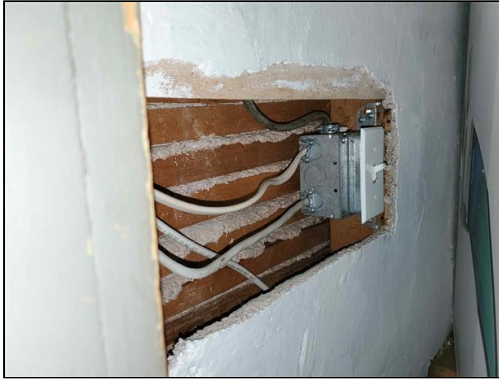
4.1.H Item 1(Picture)

Recommend to finish drywall in bedroom #2 closet leading to attic.

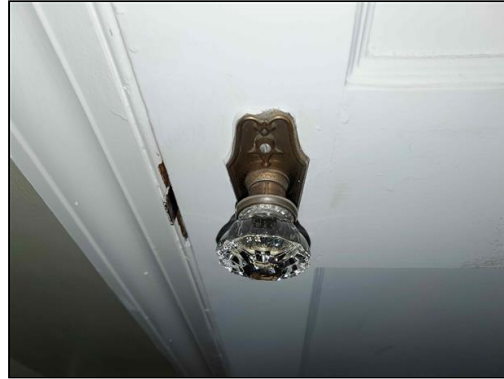
4.2.I Item 1(Picture)

Loose hardware on one door in bedroom #3. Suggest to adjust hardware as needed by a qualified person. **FYI**

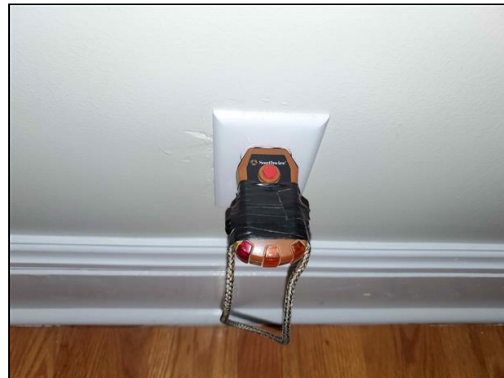
4.7.K Item 1(Picture)

1 reverse polarity receptacle located in the inlaw living room. Recommend to repair reverse polarity receptacle as needed by a qualified professional.

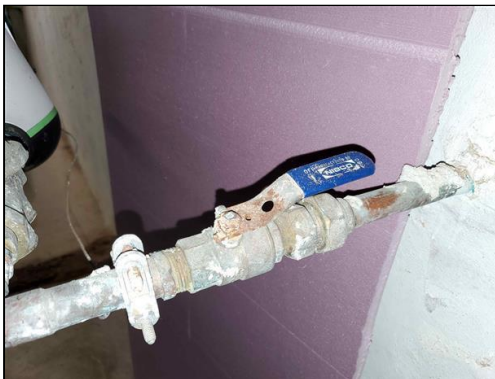
8.3 Item 1(Picture)

The main shut off is the blue lever located in the basement. This is for your information.

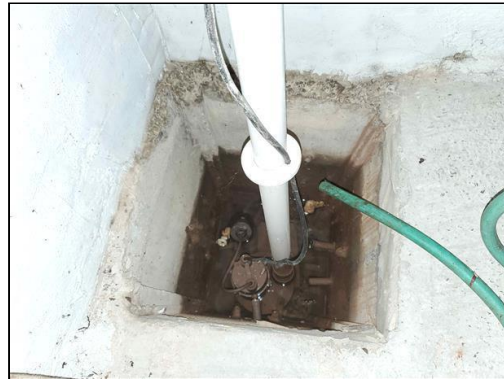
8.7 Item 1(Picture)

Sump pump is missing a cover plate. Recommend to install a cover plate by a qualified person.

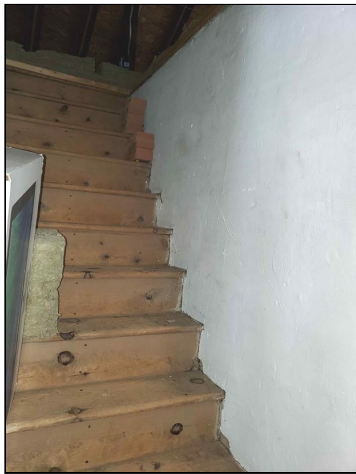
1.10 Item 1(Picture)

Suggest to install a handrailing at the attic steps. Potential tripping hazard exists. **FYI**

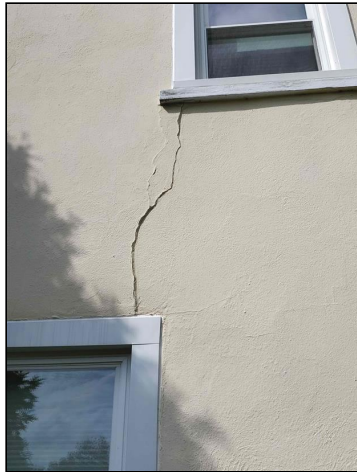
2.0 Item 1(Picture)

Typical fractures and cracks in stucco exterior. Recommend to fill or repair cracks as needed by a qualified professional. This will help prevent further deterioration.

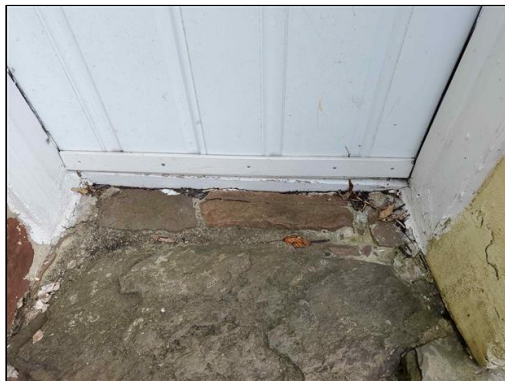
2.2 Item 1(Picture)

Negative grade at the basement entrance door. Recommend to correct as needed to prevent water penetration.

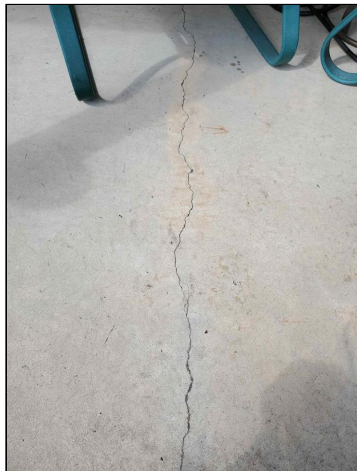
2.3 Item 1(Picture)

(1) Typical settlement cracks in front concrete patio. Recommend to patch or repair cracks as needed by a qualified person or professional. This would be considered normal maintenance.

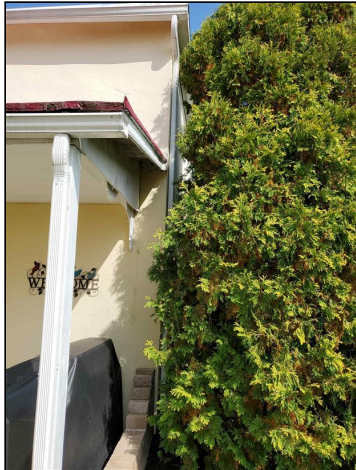
2.3 Item 3(Picture)

(2) Shrubbery and tree are growing too close to the siding for proper ventilation. Recommend to trim shrubbery and tree a minimum of 12 to 16 inches away from the siding to restore proper ventilation. This would be considered normal maintenance.

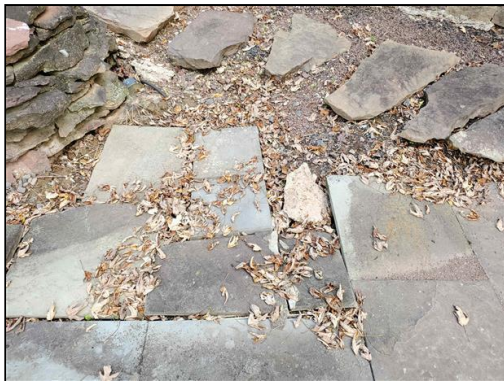
2.3 Item 5(Picture)

(3) Loose and rotated pavers at the rear of the house. Recommend to reset pavers as needed by a qualified person. This is considered normal maintenance.

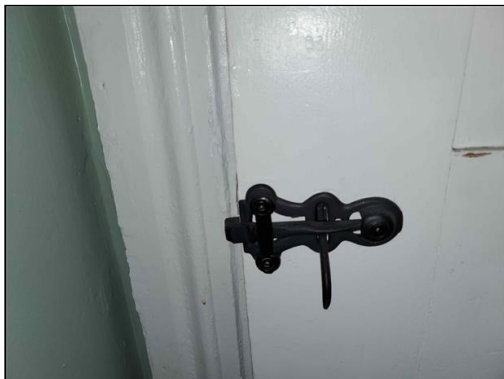
3.3.A Item 1(Picture)

Missing hardware on one door in the kitchen. Recommend to replace hardware as needed by a qualified person.

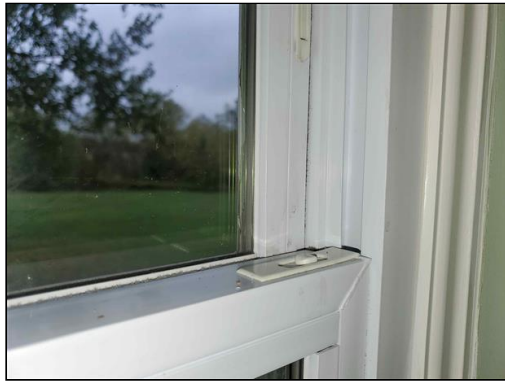
3.5.A Item 1(Picture)

Broken spring balancer on one kitchen window. Recommend to repair hardware as needed by a qualified person.

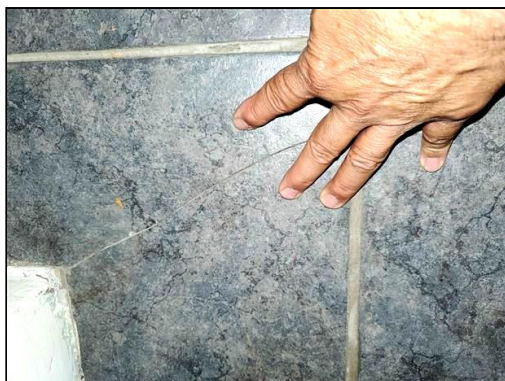
3.0.B Item 1(Picture)

One cracked floor tile in the in law suite kitchen. Recommend to replace tile as needed by a qualified person.

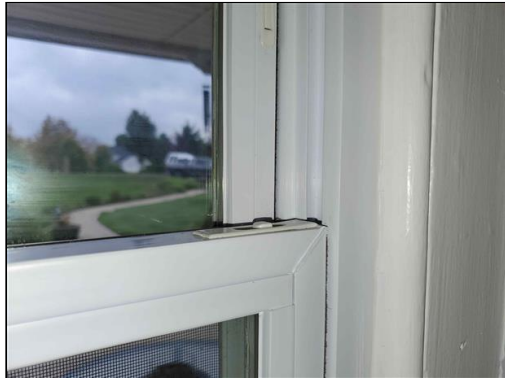
4.0.D Item 1(Picture)

One window in the dining room has a broken spring balancer. Recommend to repair spring balancers as needed by a qualified window installer.

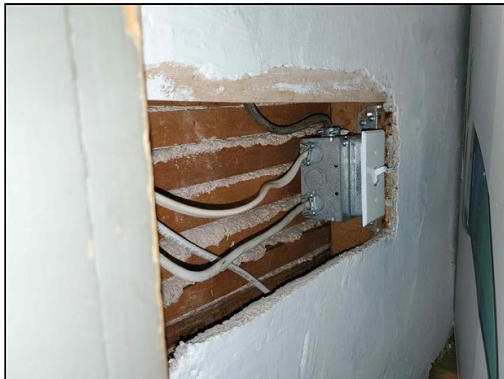
4.1.H Item 1(Picture)

Recommend to finish drywall in bedroom #2 closet leading to attic.

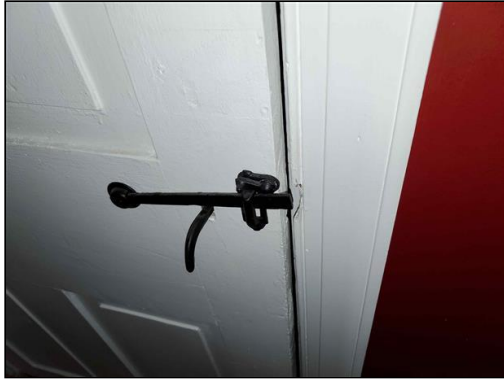
4.2.H Item 1(Picture)

Bedroom #2 door hardware is not latching properly. Recommend to adjust or repair hardware as needed by a qualified person.

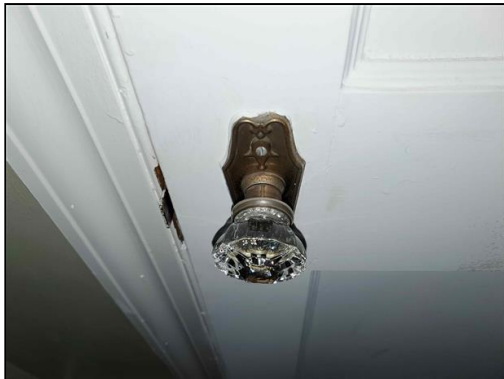
4.2.I Item 1(Picture)

Loose hardware on one door in bedroom #3. Suggest to adjust hardware as needed by a qualified person. **FYI**

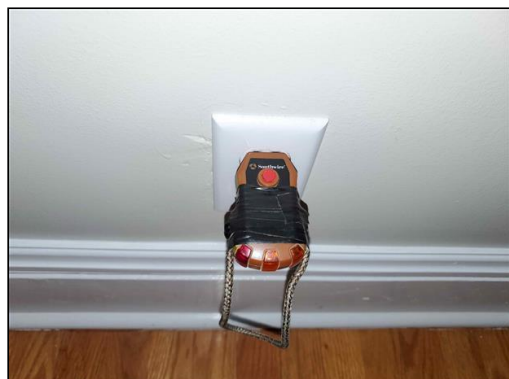
4.7.K Item 1(Picture)

1 reverse polarity receptacle located in the inlaw living room. Recommend to repair reverse polarity receptacle as needed by a qualified professional.

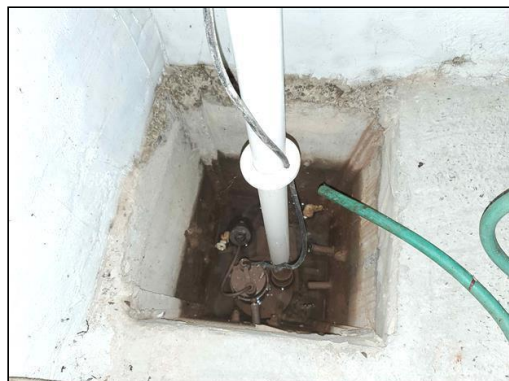
8.7 Item 1(Picture)

Sump pump is missing a cover plate. Recommend to install a cover plate by a qualified person.
