## **ASBESTOS SURVEY REPORT**

**JACKSON OPS CENTER  
4855 WEST FRONTAGE ROAD  
JACKSON, MISSISSIPPI**

**Terracon Project No. 49077048**

**February 26, 2007**

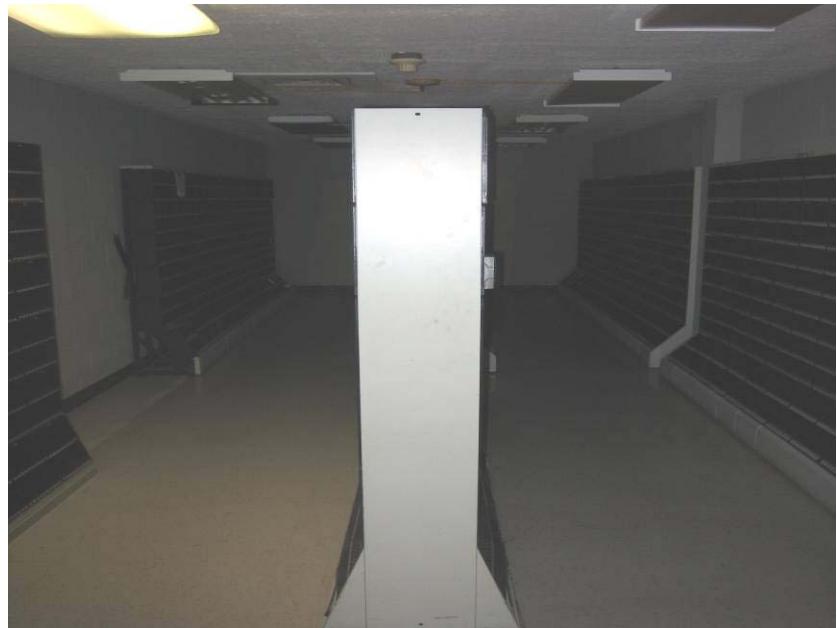
The 6"x6", 9"x9", and 12"x12" floor tiles are located throughout the facility. Most of the ACM floor tiles are under carpet or non-ACM floor tile. The floor tiles are considered Category I non-friable ACM in good condition.

The ceiling texture is located in the vacant tape vault and is considered Category II non-friable ACM. The ceiling texture is considered non-friable as long as the material is in good condition.

**Photo 2:** Vacant tape vault, asbestos-containing floor tile and ceiling texture is in this room.

Terracon recommends that the identified ACM be removed and disposed of by a MDEQ licensed asbestos abatement contractor prior to the renovation of the structure.

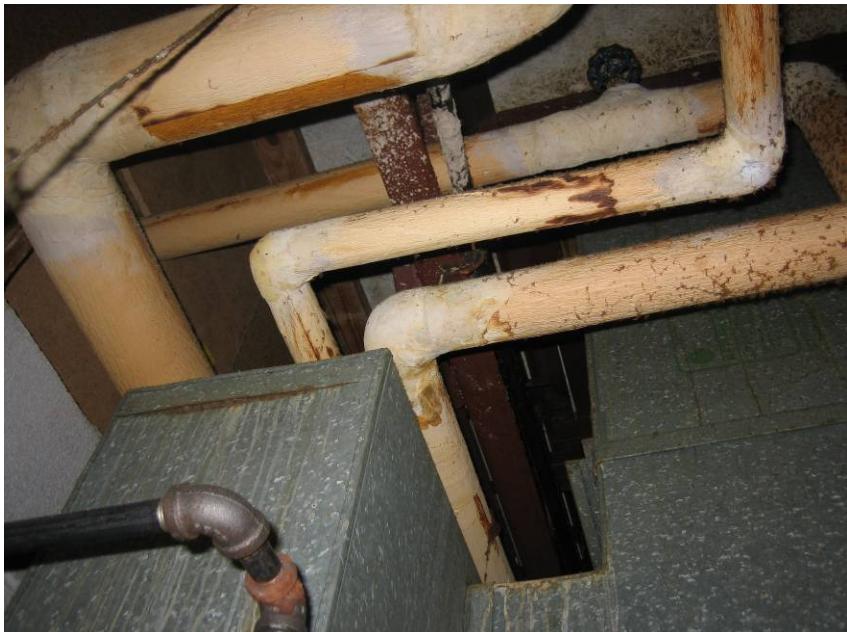
The pipe elbows are located on the heating water supply pipes in the mechanical room and the domestic water piping located throughout the facility. The heating water supply elbows are considered to be Category II non-friable ACM in good condition. These are considered non-friable because of the wrapping over the elbows. The domestic water line elbows are considered friable ACM in good condition.

**Photo 3:** Asbestos-containing hard pipe elbows above the kitchen.

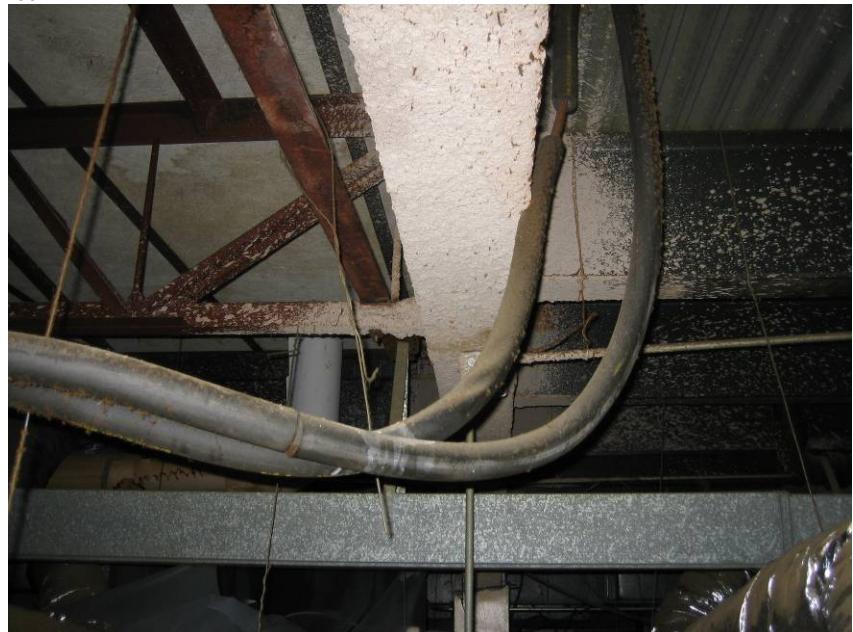
The tan fireproofing is located on the beams of the structure located above the ceiling in the west half of the original structure. This material was observed along the perimeter wall of the server room, above the kitchen and break room. This material is considered friable ACM in fair condition.

It is listed in fair condition because of the damage/debris visible on top of the suspended ceiling tiles.

**Photo 4:** Asbestos-containing fireproofing above the kitchen.

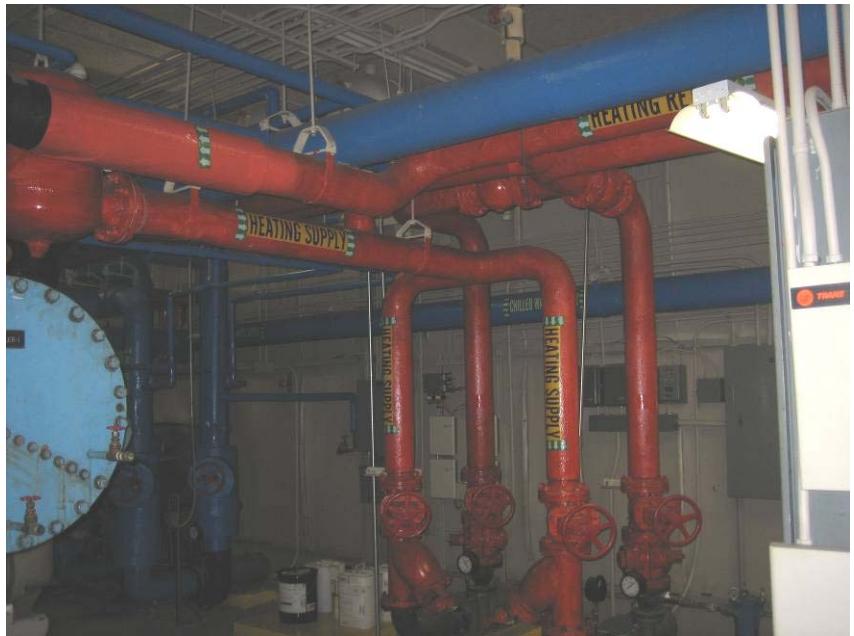
**Photo 5:** Asbestos-containing pipe elbows in the mechanical room.
