**Complete Home Inspection
by Mark Watkins
770-527-1865**

**1456 Drayton Woods
Drive Tucker, GA 30084**

Inspected 4/8/16 1:00 PM

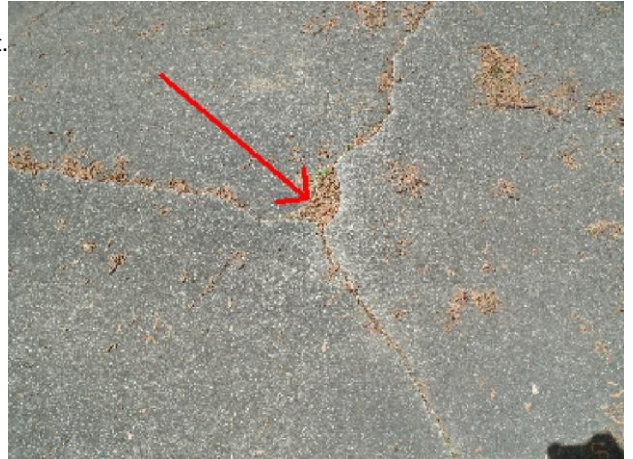
Driveway

Some cracks and slight settlement were noted. Seal cracks with concrete caulking to prevent water penetration and further settlement.

Some cracks and slight settlement were noted. Seal cracks with concrete caulking to prevent water penetration and further settlement.

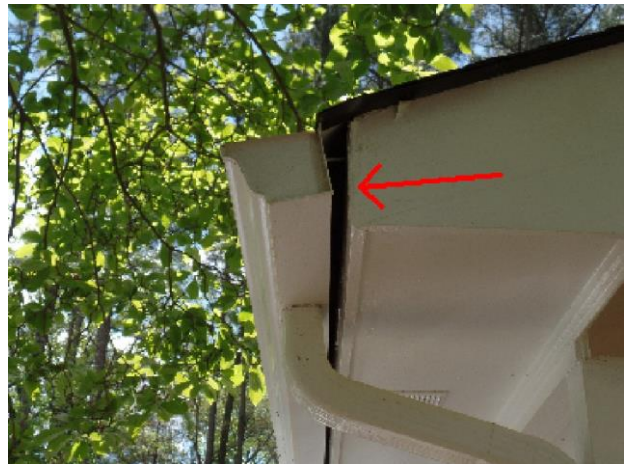
Secure loose gutter over the front of the garage.

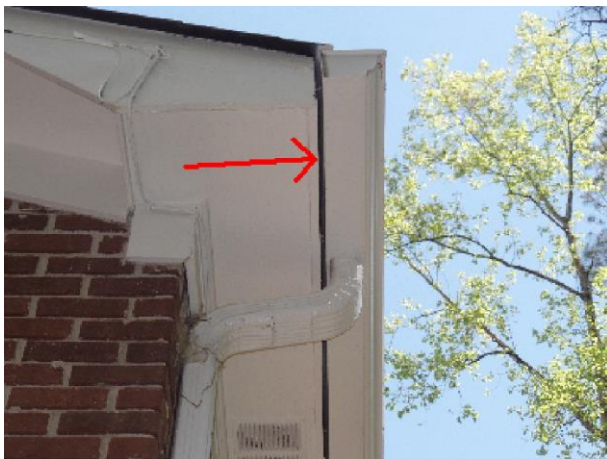
Secure loose gutter on the right side of the home.

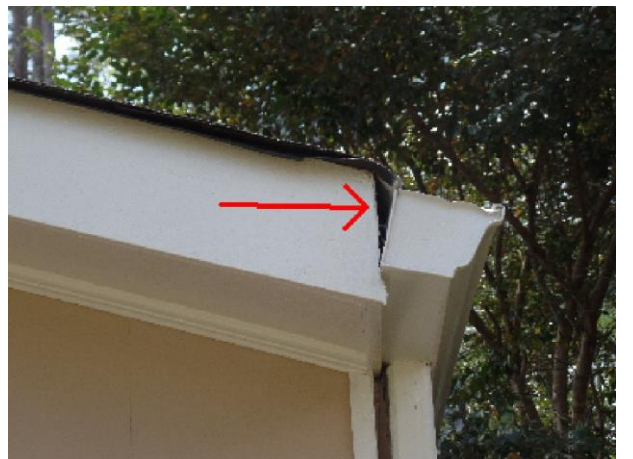
Secure loose gutter in the back of the home.

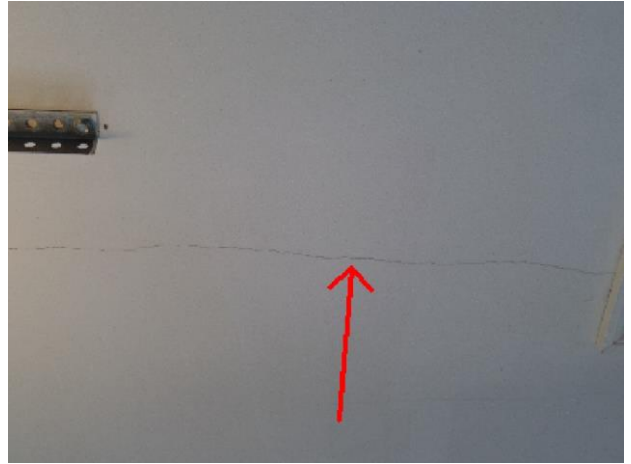
Garage Interior Ceiling

Repair minor drywall cracks in the garage ceiling.

Repair minor drywall cracks in the garage ceiling.

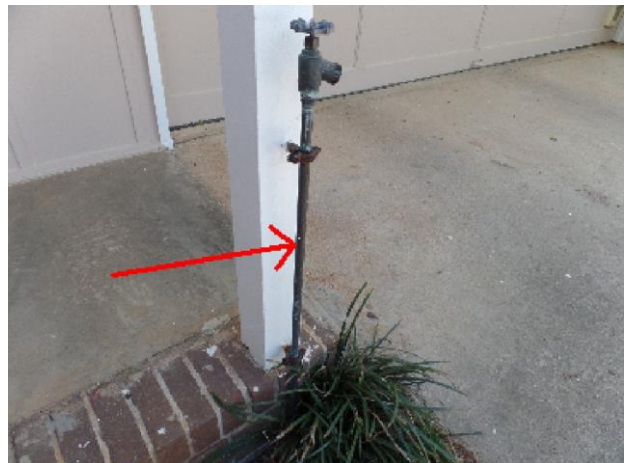
Type of Outside Spigots

It would be advisable to insulated the exposed water line for the front exterior spigot to prevent from freeze breaks.

Unprotected hose connections should be shut off and drained before first freeze each year.

It would be advisable to insulated the exposed water line for the front exterior spigot to prevent from freeze breaks.

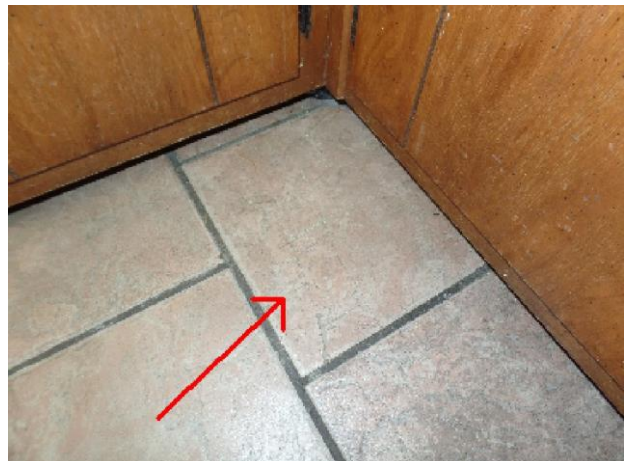
Kitchen Floors

Replace one cracked tile in the kitchen (the corner between the sink and the cook top).

Replace one cracked tile in the kitchen (the corner between the sink and the cook top).

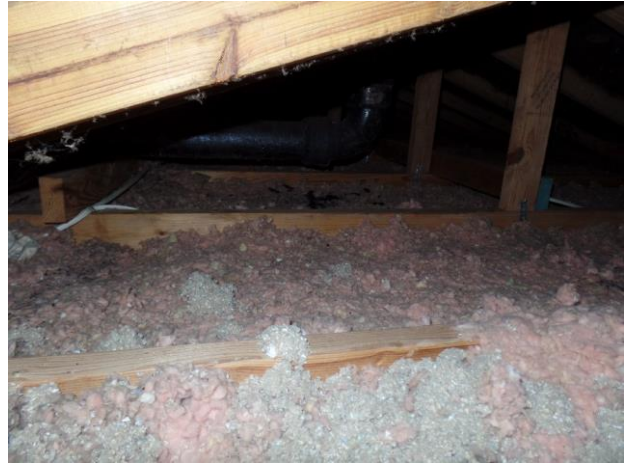
Attic Insulation Thickness

Average thickness of insulation is 4".

Very little insulation installed and suggest adding more. R-30 is suggested (approximately 8 more inches).

Average thickness of insulation is 4".

Very little insulation installed and suggest adding more. R-30 is suggested (approximately 8 more inches).

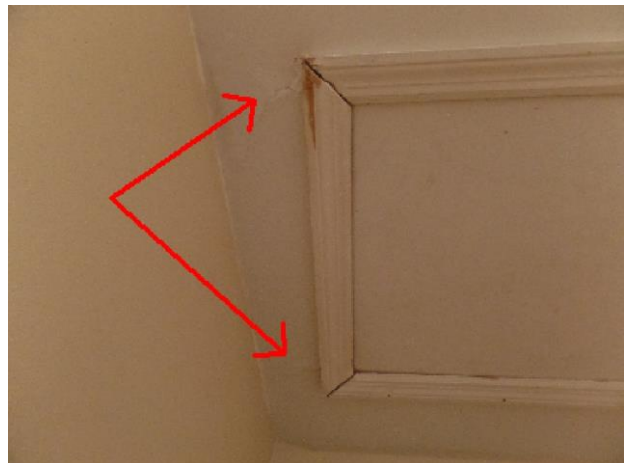
Interior Ceilings

Repair cracks at the corners of the attic hatch in the hallway.

Repair cracks at the corners of the attic hatch in the hallway.

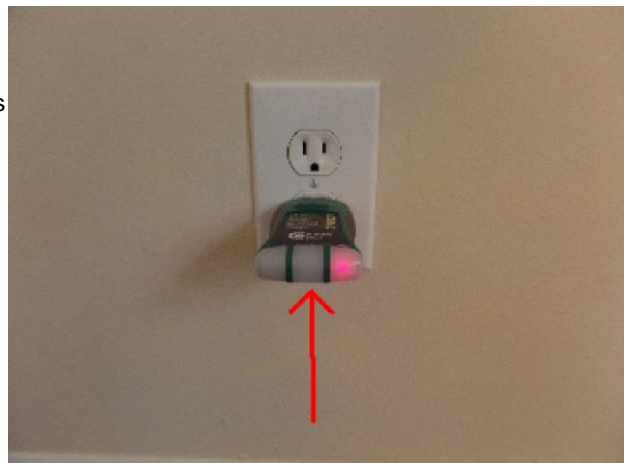
Interior Outlets

A few three prong ungrounded outlets noted and should be repaired.

Receptacles that are not grounded are recommend to have a surge protector installed when using high powered and sensitive electronics (computers, sound systems, televisions, microwaves, etc.).

A few three prong ungrounded outlets noted and should be repaired.

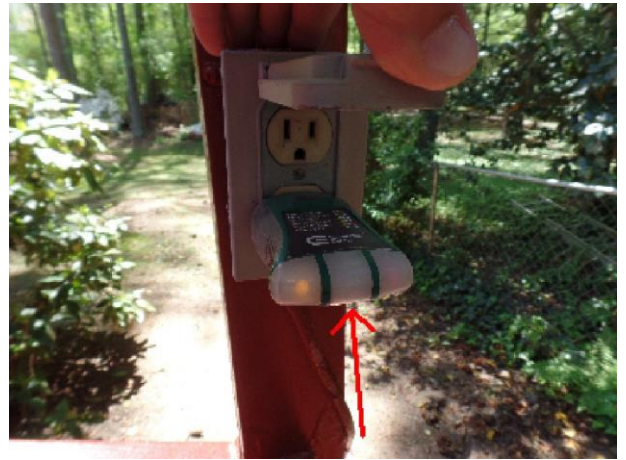
Outside Outlets

Deck exterior outlet has reverse polarity and needs to be repaired. REVERSE POLARITY means the wiring is backwards. The black wire should connect to the gold screw and the white wire should connect to the silver screw.

Deck exterior outlet has reverse polarity and needs to be repaired. REVERSE POLARITY means the wiring is backwards. The black wire should connect to the gold screw and the white wire should connect to the silver screw.

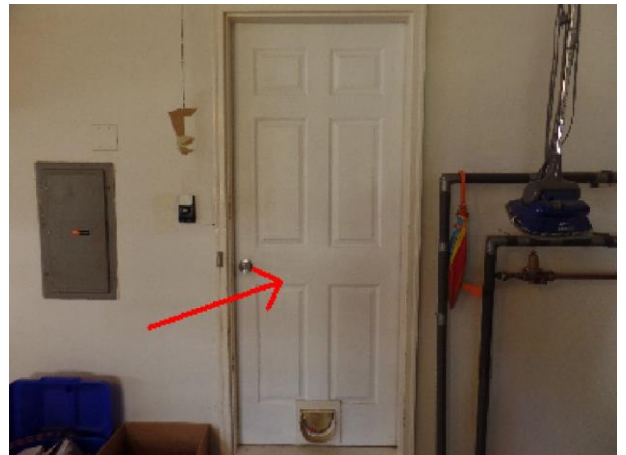
Entry Doors

Non fire rated door between house and garage and should be replaced with a proper fire rated door.

Non fire rated door between house and garage and should be replaced with a proper fire rated door.

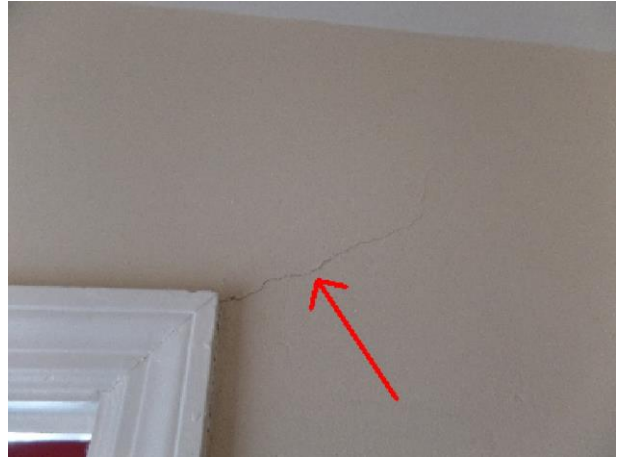
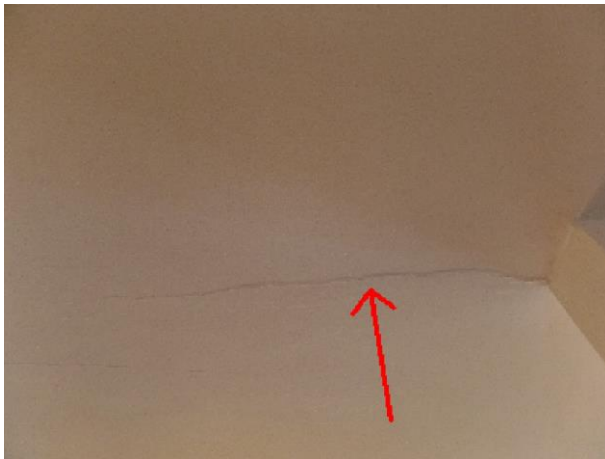
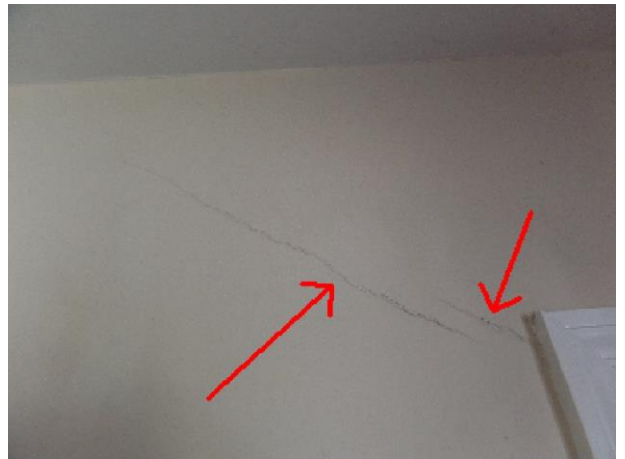
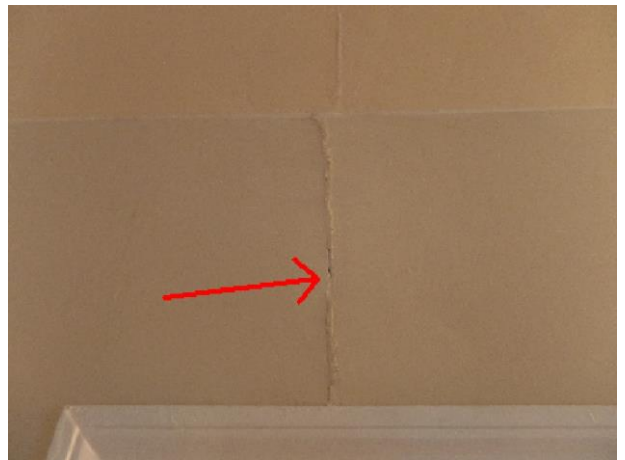
Interior Walls

Stress cracks noted at the corners of both master bathroom doors in foyer and master bedroom. Also cracks noted above the hallway entry above the jamb and on the ceiling. This usually indicates settlement. It appears that these issues have been resolved. However, This should be evaluated by a qualified structural contractor and all required repairs need to be made.

Stress cracks noted at the corners of both master bathroom doors in foyer and master bedroom. Also cracks noted above the hallway entry above the jamb and on the ceiling. This usually indicates settlement. It appears that these issues have been resolved. However, This should be evaluated by a qualified structural contractor and all required repairs need to be made.

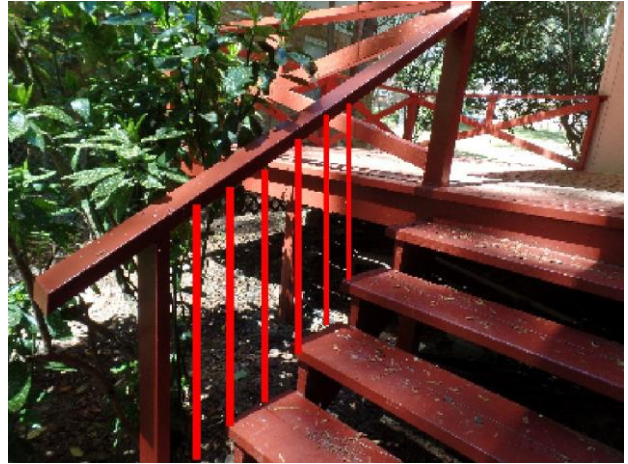
Hand Rail

Install missing balusters 4" on center for the hand rail on the deck steps.

Install missing balusters 4" on center for the hand rail on the deck steps.

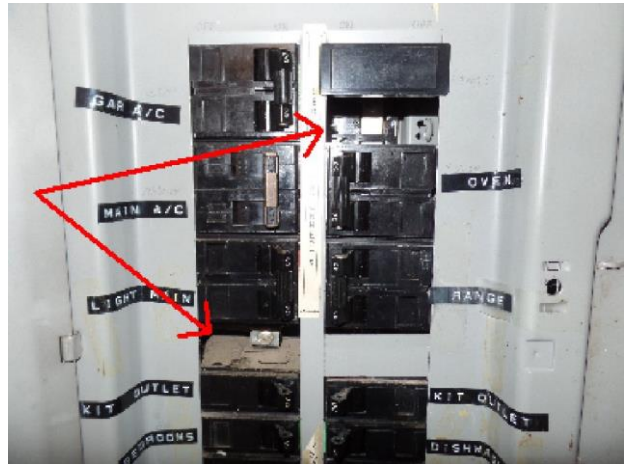
Main Panel

Replace two missing panel cover knock out seals in the breaker box in the garage.

Replace two missing panel cover knock out seals in the breaker box in the garage.
