Report of
Phase I Environmental Site Assessment

Metaldyne
507 W. Indiana Street
201 Leanne Drive
Edon, Williams County, Ohio 43518

March 2, 2007

PSI Project 888-6E146-2

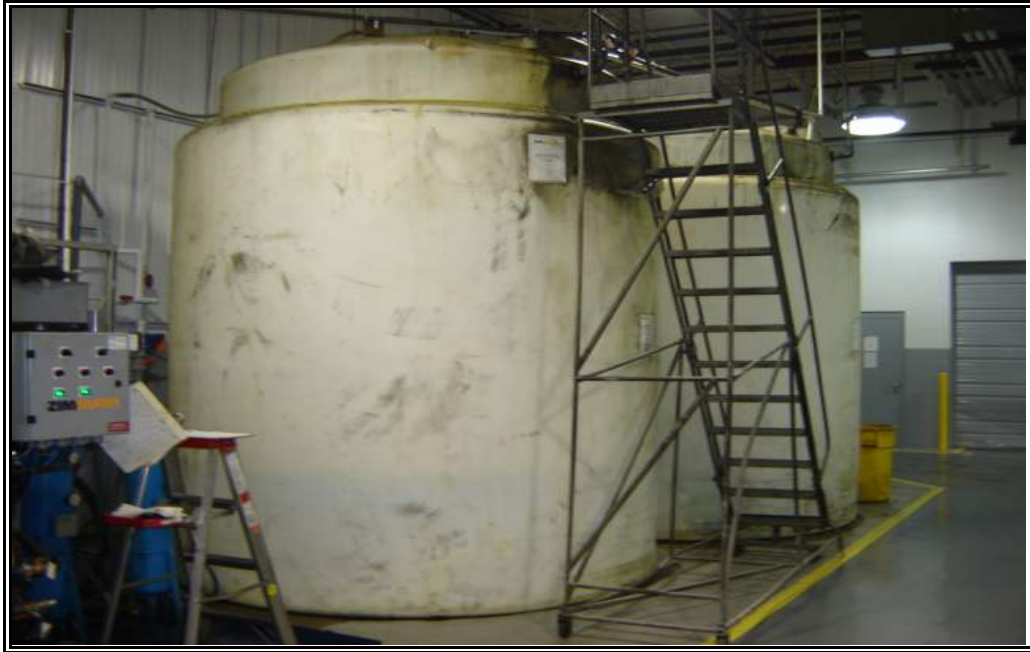
2
2

During the site reconnaissance, PSI observed three ASTs along the south wall of the manufacturing area in Plant #1. According to Mr. Herman, the tanks are used in connection with the coolant recycling system. There are two 5,000-gallon ASTs which are labeled "Feedstock" and "Storage". These tanks are used to store waste coolant generated during the machining processes. The waste coolant is then fed through a recycling system where the recycled coolant is pumped into a 3,000-gallon "Blend Tank". The tanks are double walled, fiberglass construction. De minimis staining was observed on the concrete in the vicinity of the tanks. Based on the condition of the tanks and the secondary containment, the ASTs are not considered evidence of a recognized environmental condition.

View of the ASTs used as part of the coolant recycling system, located in Plant #1.

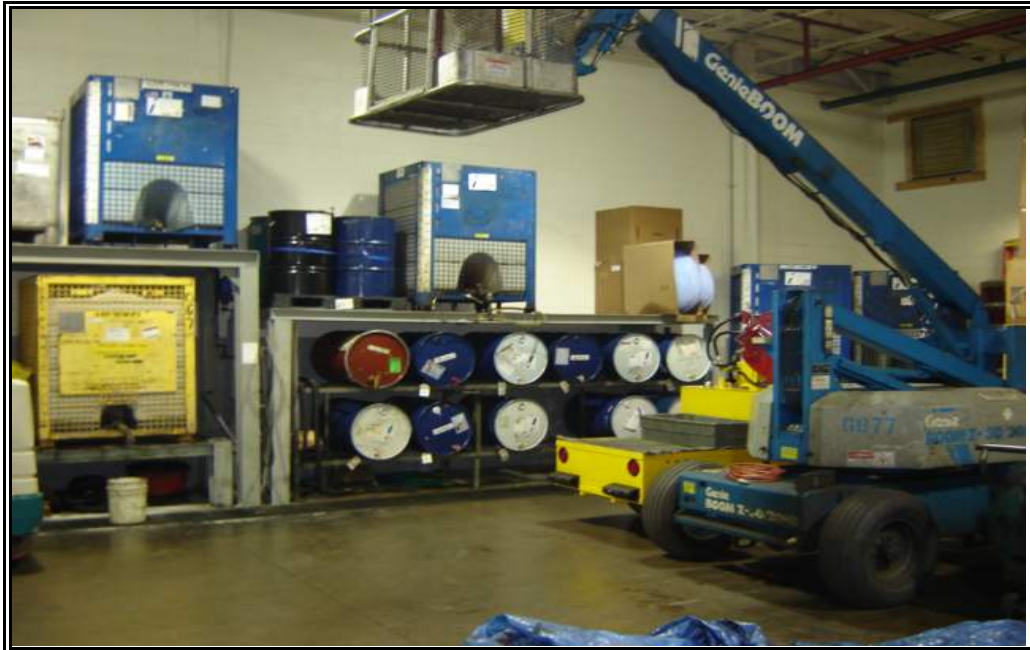
2
3

PSI observed numerous 55-gallon drums stored in the oil/chip room. According to Mr. Herman, bulk oil and coolant are delivered in 55-gallon drums. The drums are stored on their sides in three-story metal shelving units. The drums appeared to be in good condition. De minimus leaks and stains were observed on the drums and on the ground beneath them. He reported that spills or leaks drain through the floor drain into the oil/coolant separator. Mr. Herman indicated that once the drums are empty, the delivery firm picks them up for disposal. Based on the condition of the drums, they are not considered evidence of a recognized environmental condition.

View of the drum and AST storage located within the oil/chip room of Plant #1.

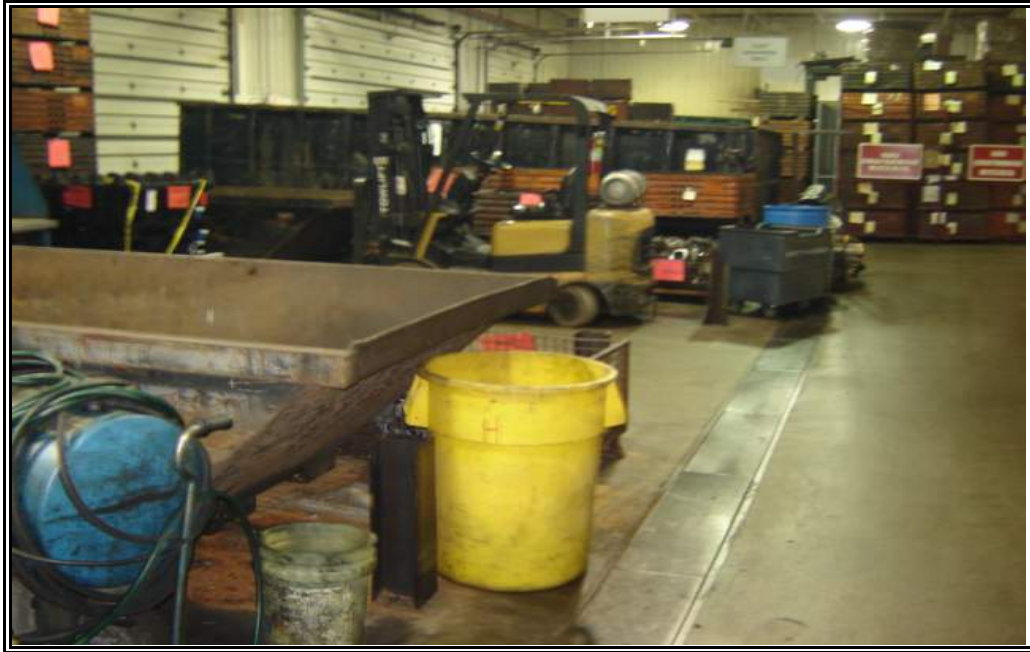
2
4

During the site reconnaissance, tool and die machines were observed throughout the plant area and in the oil/chip room. De minimus oil staining was observed in the vicinity of the machines in the plant area. According to Mr. Herman, there are no floor drains located in the manufacturing portion of the facility. Staining was observed in the oil/chip room in the vicinity of the chip dumpsters, ASTs, and around the drum storage area.

There is a trench drain located in the oil/chip room which drains into an oil collection system. The interior stains were all located on a concrete floor and no cracks were observed in the floor. The staining within the areas appeared to be confined to the concrete and a de minimis condition; therefore, the staining is not considered evidence of a recognized environmental condition.

View of the chip dumpsters and trench drain system in the oil/chip room in Plant #1.

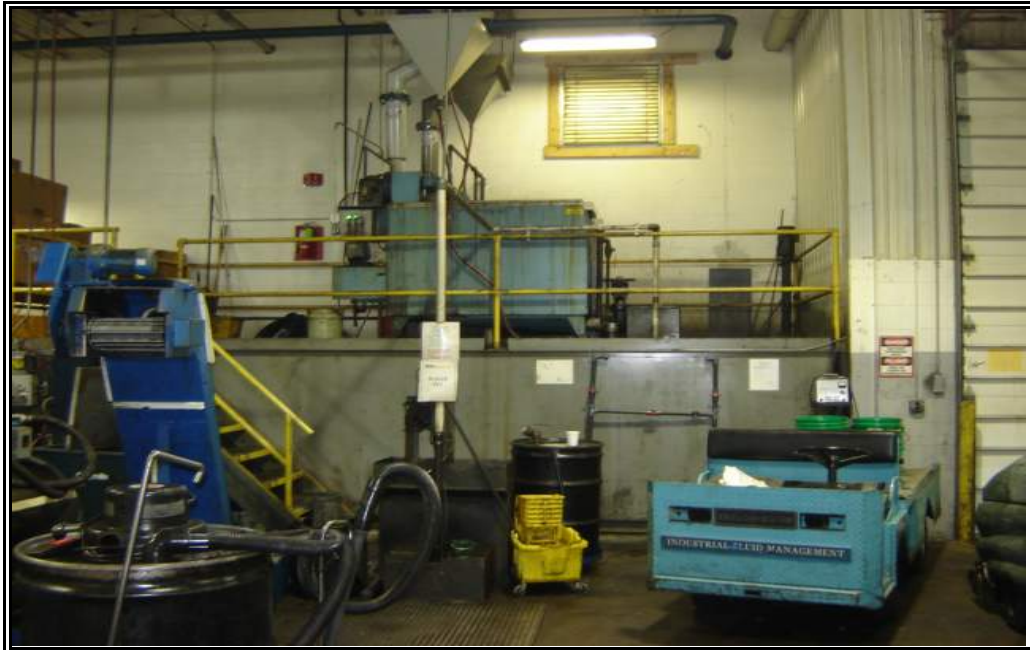
2
5

View of the waste coolant separator system in the oil/chip room of Plant #1.

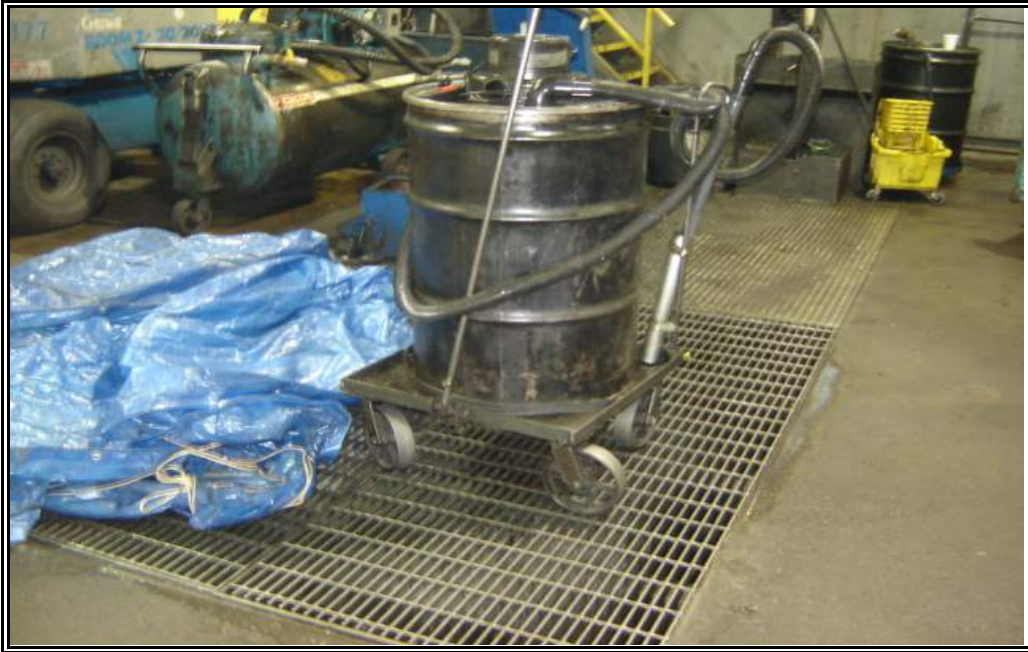
2
6

PSI observed one 7,000-gallon below-ground pit, constructed of concrete, at Plant #1. Plant #2 had a similar pit that was approximately 500-gallons in size. The pits were used to contain waste lubricants and coolants and were continuously filtered with a filter unit located above ground. Additionally, floor trenches were used to carry lubricating oil from scrap metal roll-off containers into the pit. The oil was periodically pumped from the pits by a contractor for filtering or recycling. According to Mr. Herman, he was informed that the below-ground pits and trenches were designed to prevent leakage of fluids upon his inquiry with the engineering firm that was involved in construction of the plants.

Since the manufacturing has been discontinued at Plant #2, the separator and filtration system are no longer in use. PSI observed no conditions that indicated breaches to containment. Based on the age of the containment systems and the lack of information regarding the condition of the concrete in the pit, there is a possibility that waste oil or coolant has breached the containment. PSI recommends installation of a pit liner to prevent potential releases.

View of the waste coolant and oil separator (below grade containment) in the oil/chip room of Plant #1.

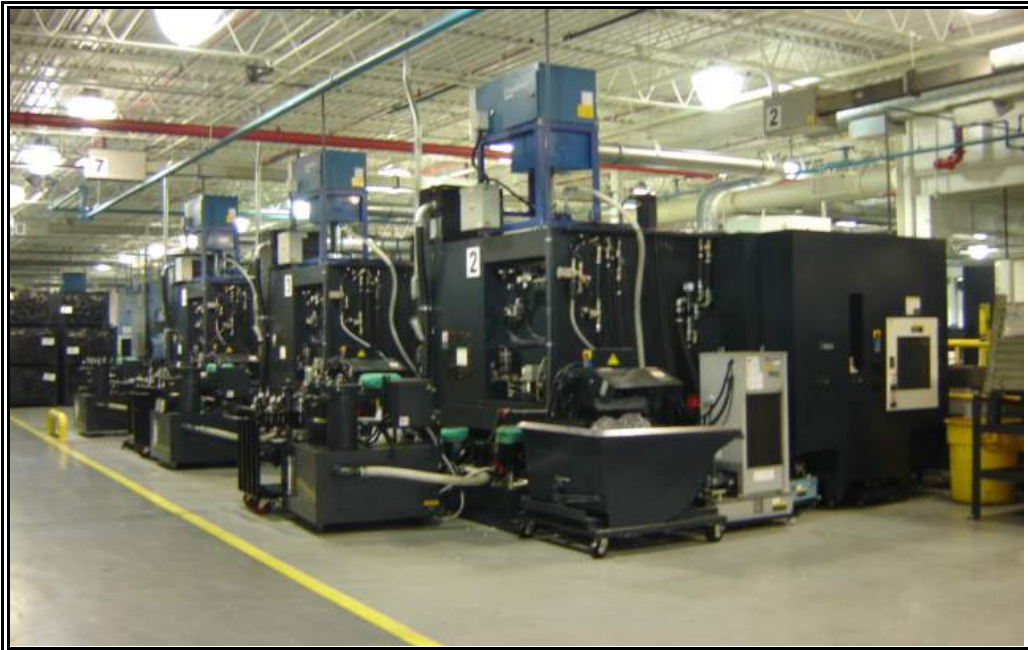
2
8

View of the manufacturing area in Plant #1.
