Project Site: NC Finishing - Spencer, NC

SITE PHOTOGRAPHS

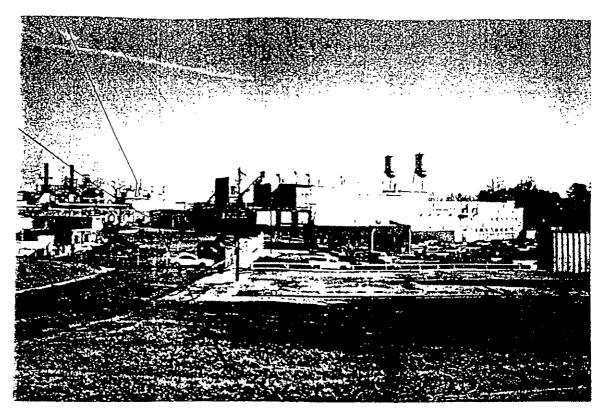
1. View of the North Carolina Finishing Company (NCF) plant site (Subject Site).

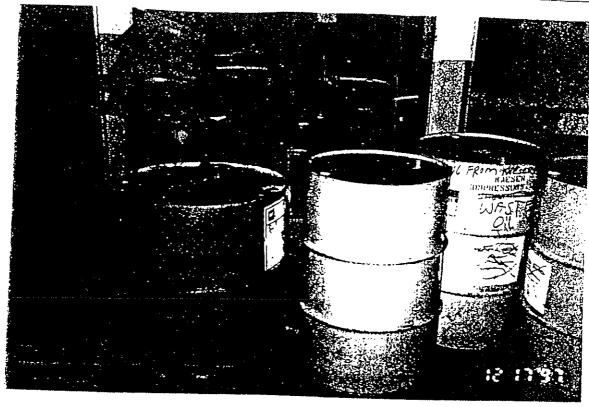
3. View of the drum storage area located within the NCF plant.

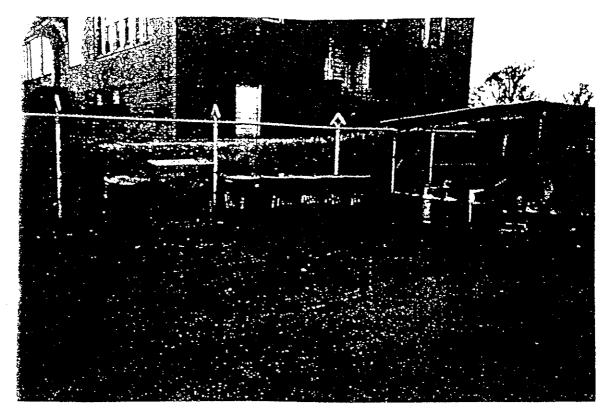
5. View of on-site abandoned school house and garage area including drums stored in this area.

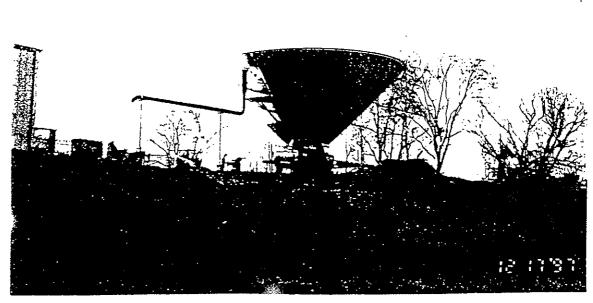
- During soil excavation activities for the construction of the foundation structure for the Claricone, the construction contractor encountered buried solid waste materials including construction debris, wood, shop rags and black ash. According to on-site personnel, the Claricone is located above an inactive and abandoned former burn pit/landfill for the Subject Site. The specific types of waste materials that were buried and subsequently burned at the site are unknown. The burn pit/landfill was utilized for an unknown period of time prior to 1984 for the dumping and subsequent burning of waste materials generated at the Subject Site. According to Mr. Richard Shoaf, with North Carolina Finishing Company, this burn pit/landfill was utilized for the disposal of paper, cardboard and remnant cloth materials and was approximately 75 square feet in size when he began work at the facility in 1962. He was unsure of other materials that may have been placed in this burn pit/landfill. No removal of waste material from the burn pit/landfill area has been conducted in the past. The regulatory status of this landfill is unknown at this time.

6. View of the on-site Claricone, located on an inactive landfill.

- 7. The regulatory status of the burn pit/landfill underneath the Claricone should be determined through the North Carolina Division of Waste Management. Dependant upon

the regulatory status determination, a subsurface investigation in the area of the burn pit/landfill may be warranted.

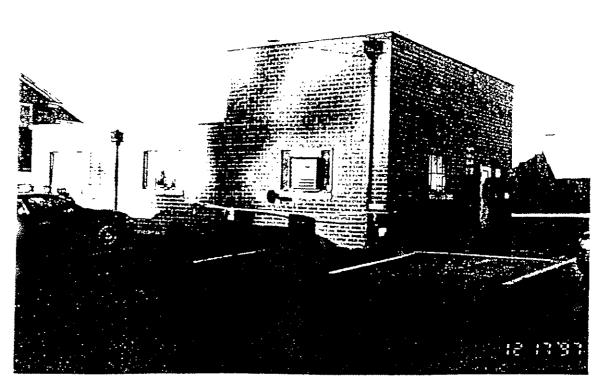
Mr. Chandler stated that the state requested additional information with regard to the CSA written for the 550 and 2,000-gallon UST site near the garage area, which was forwarded to the state for review. He further stated that there has been no response to date regarding this information.

7. View near the maintenance garage and the location of the removed 2,000-gallon and 550-gallon diesel/gasoline USTs.

- 4. Upon receipt of a response from the state with regard to the 550 and 2,000 gallon UST site, ensure that recommendations from the state are implemented.

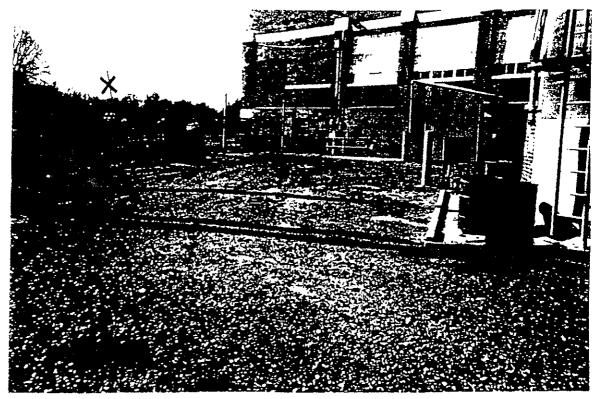
According to Mr. Chandler, the CAP for the 20,000-gallon UST site has been implemented at the Subject Site inluding free product removal in September, 1997, and sampling of monitor wells in December, 1997.

8. View of the location of the removed 20,000-gallon No. 2 fuel oil UST.

- Coal remnants identified in the former emergency coal storage area should be removed and disposed properly.
- 3. Ensure the continued implementation of the 20,000-gallon UST site CAP.

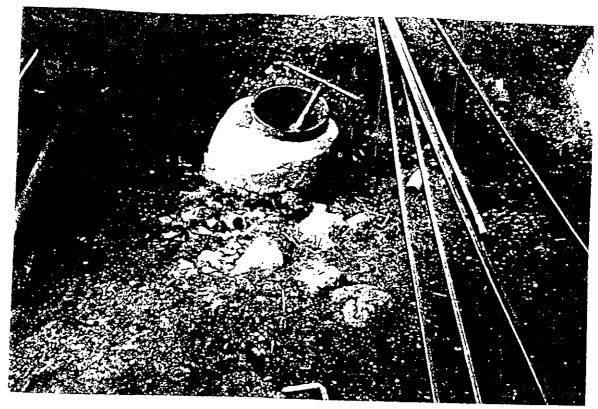
- 6. Diesel-like odors were detected from subsurface soils associated with the installation of a conveyor belt assembly near the center of the Plant Site during August 1997. An investigation into the origin of the odors indicated the presence of a previously unknown, and abandoned, 550 gallon UST. A small quantity of sludge and residual diesel product

were removed from the UST and the steel UST was subsequently removed from the Plant Site tract. The UST removal was reportedly supervised by A & D Environmental located in High Point, North Carolina. No copy of this report was available for review by Maxim at the Subject Site at the time of this inspection.

9. View of the location of the removed 550-gallon diesel UST (supervised by A & D Environmental).

- 6. Unless a report containing laboratory analysis of soil samples collected from the excavation of the 550-gallon tank is forthcoming from A & D Environmental, and these analyses indicate that a release did not occur from this tank, a subsurface investigation is warranted in this area to assess the presence or absence of environmental impairment.

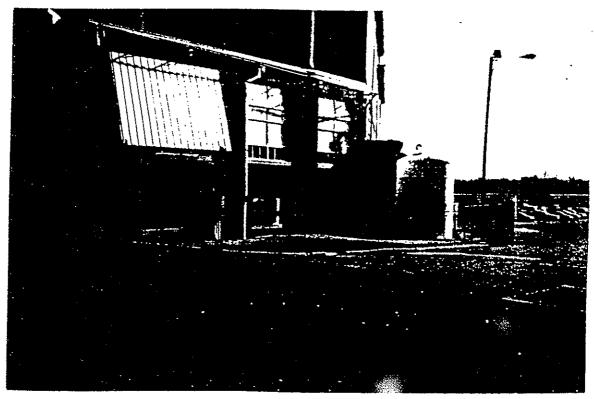
- According to the UST Closure Assessment Report, dated December 1990, on September 21, 1990, Pyramid Environmental, Inc. conducted a UST closure assessment of a 3,000-gallon kerosene UST located at the northwestern corner of the Plant Building. The Assessment Report concluded that further investigation of the site was needed and recommended that a comprehensive site assessment (CSA) be completed. A Subsurface Investigation Report (Pyramid Environmental, September 14, 1991) recommended that the monitoring well in this area be sampled for the next seven quarters and a quarterly report be prepared and submitted to the NCDEHNR. There were no additional reports with regard to the former 3,000-gallon UST site available for review by Maxim at the Subject Site at the time of this inspection.

10. View of the location of the removed 3,000-gallon kerosene UST.

- 5. The current regulatory status of the 3,000-gallon kerosene UST site should be determined. If this site has not been closed by the state, request closure if applicable.

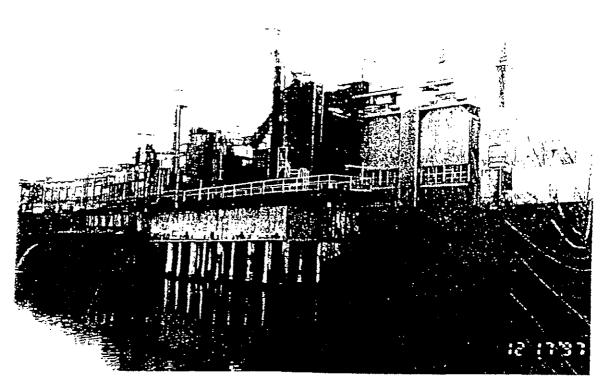
11. View of the on-site boilers and control room.

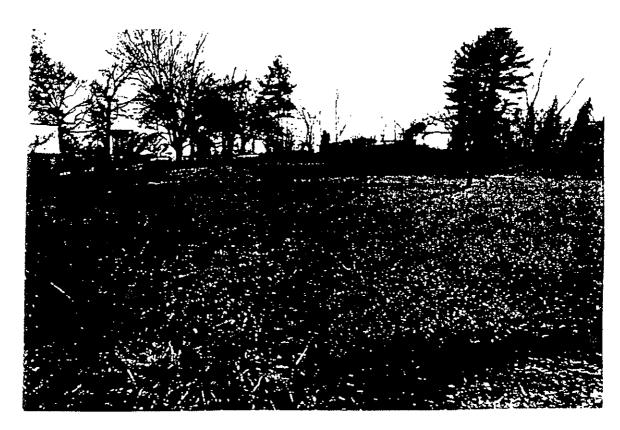
12. View of the on-site former boiler ash storage area.

- 1. The regulatory status of the boiler ash stockpile area should be determined. A subsurface investigation is warranted in this area to assess the presence or absence of environmental impairment, including the laboratory analysis of polyaromatic hydrocarbons (PAH) and metals at a minimum.

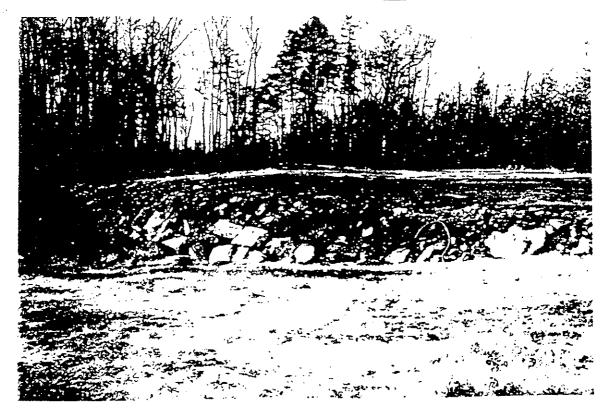
- 8. The active construction debris landfill is located adjacent to the WWTP. Construction debris including bricks and wood fragments are placed into this landfill. This landfill is less than one acre in size. According to personnel at Fieldcrest Cannon, it was believed that North Carolina regulations do not require that construction debris landfills, less than one acre in size, be permitted with the state. According to Mr. Bill Hocutt, with the North Carolina Division of Waste Management Solid Waste Section, Construction and Demolition (C & D) Landfills must be permitted with the state regardless of size, however, Land Clearing and Inert Debris (LCID) Landfills, less than 2 acres, do not

require permitting with the state (15A NCAC 13B.0563). Mr. Hocutt further stated that when determining the landfill type, it is helpful to refer to the definition of Beneficial Fill (15A NCAC 13B.0562(1)) which states that no permit is required for beneficial fill when the fill material consists only of inert debris strictly limited to concrete, brick, concrete block, uncontaminated soil, rock and gravel.

13. View of the on-site active landfill containing construction debris.

- 8. The regulatory status of the active construction debris landfill located adjacent to the WWTP should be determined through the North Carolina Division of Waste Management. Dependant upon the regulatory status determination, a subsurface investigation in the area of the active construction debris landfill may be warranted.

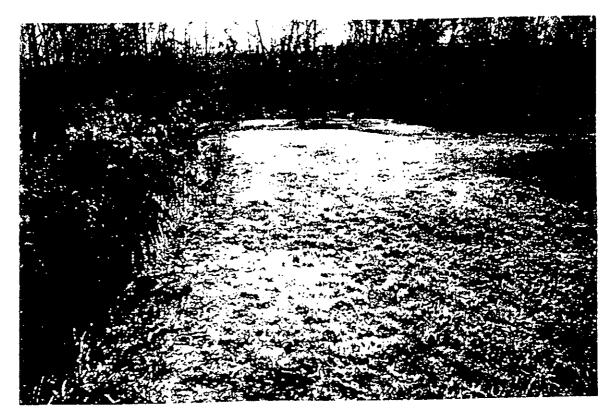
- The inactive landfill is located south of the WWTP. This landfill has not been active for three to four years. According to Mr. Richard Shoaf, with North Carolina Finishing Company, construction debris (including bricks and wood) from the NCF Plant was placed into the landfill. The landfill was later covered with fill material and seeded. Mr. Shoaf further stated that this landfill was less than one acre in size. The regulatory status of this landfill is unknown at this time.

14. View of the on-site inactive landfill located south of the waste water treatment plant.

- 9. The regulatory status of the inactive landfill located south of the WWTP should be determined through the North Carolina Division of Waste Management. Dependant upon the regulatory status determination, a subsurface investigation in the area of the inactive landfill may be warranted.
