**PHASE I
ENVIRONMENTAL SITE ASSESSMENT**

Tennessee Starbucks Portfolio - Five (5) Properties

**Starbucks - Chattanooga
4503 Highway 58
Chattanooga, Tennessee 37416**

**IVI Due Diligence Services, Inc.
IVI Project No.: 70923604
October 8, 2007**

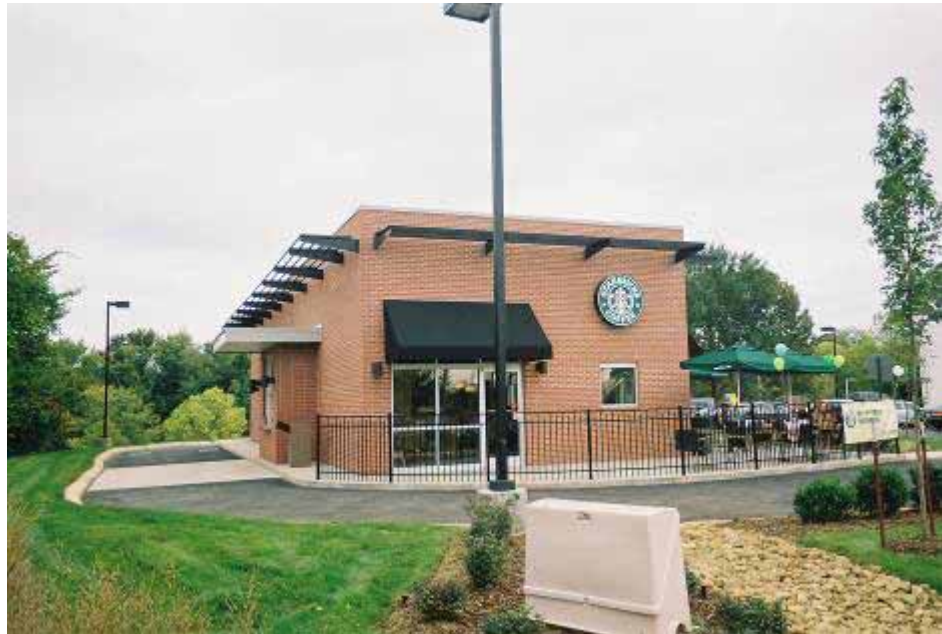
1

Front Facade of Subject

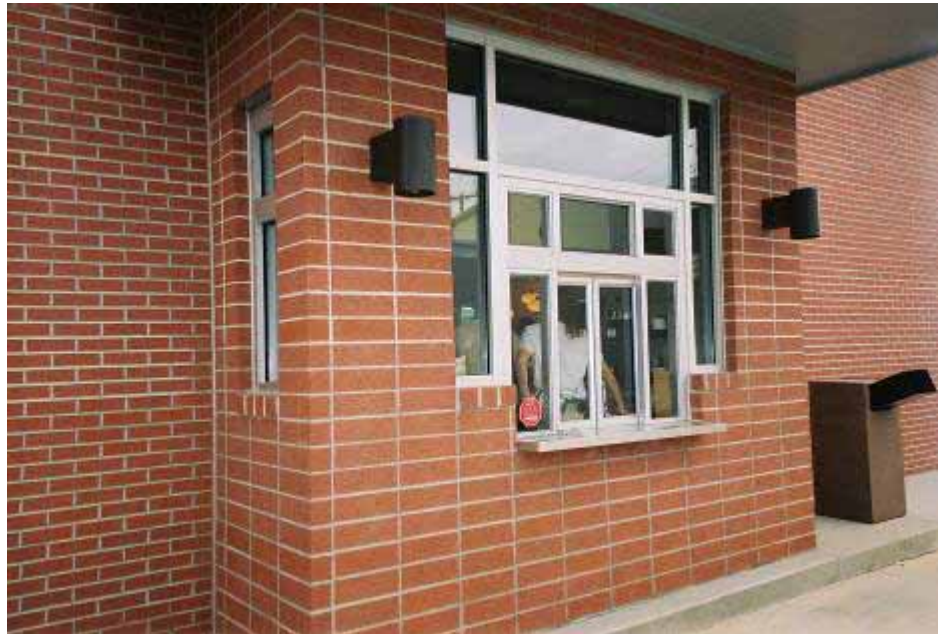
5

Drive-Through Window

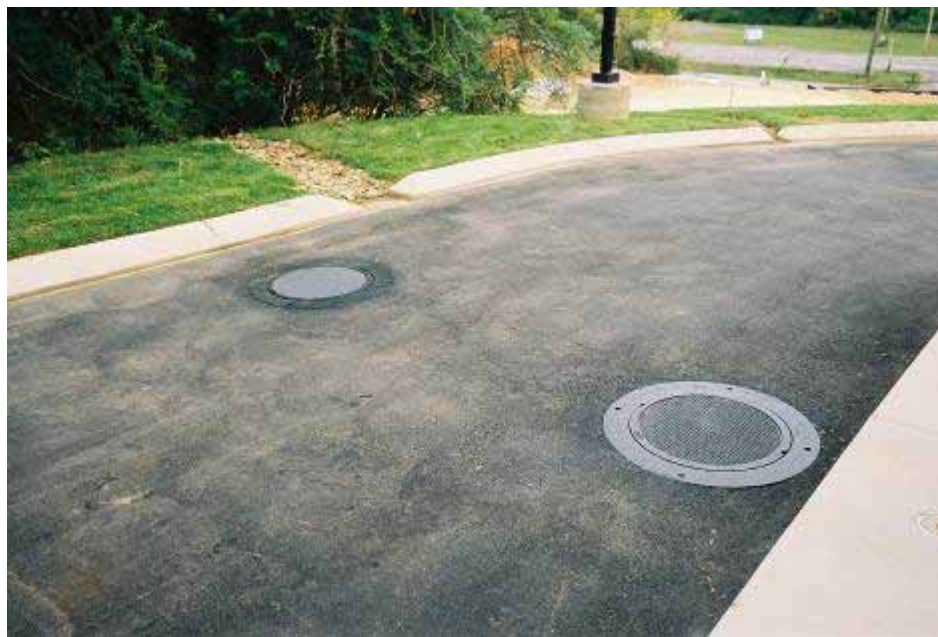
6

Grease Trap Location in Drive-Through

According to Mr. Brian Powell, property superintendent and site contact, who has been involved with the property for the past year, the Subject was previously a Waffle House restaurant prior to construction of the existing improvements. Mr. Powell stated that the previous building was removed by others prior to his involvement. He stated that the Subject had only the foundation of the previous building, which was removed. Mr. Powell stated that the Waffle House had a grease trap which was also removed because a new, larger grease trap was to be installed as part of the new build-out.

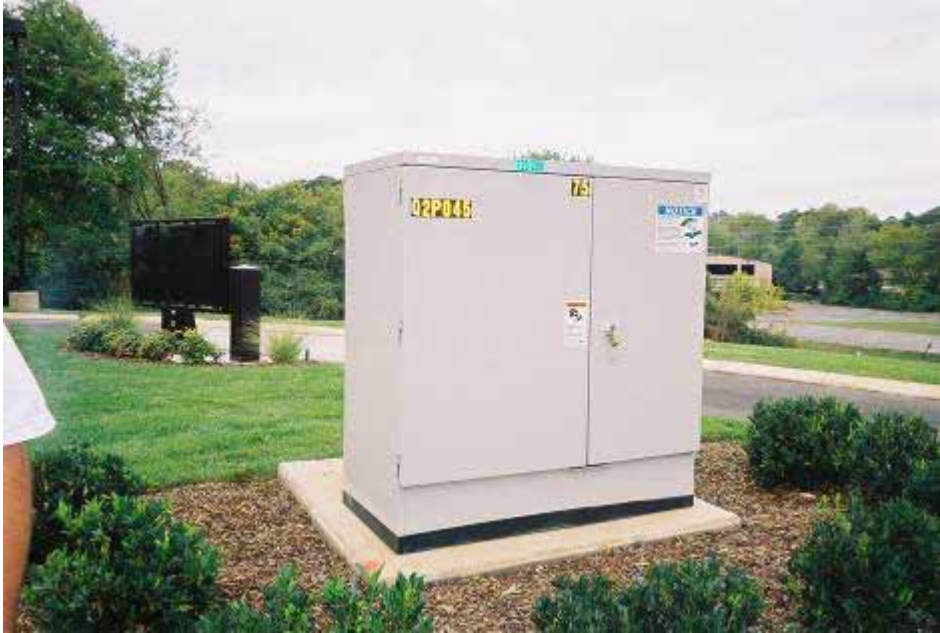
8

Utility-Owned Electric Transformer

IVI observed one utility-owned pad-mounted electrical transformer on-site. According to Mr. Powell, the transformer was recently installed as part of the existing improvements. The previous building had used overhead power, and all lines and poles for the previous electrical surface had been removed from the property.

Based on its age, it is unlikely that the transformer, which was not labeled, contains PCBs. Of importance, the electrical transformer was observed to be in good condition.

Notwithstanding the foregoing, in accordance with *Title 40—Protection of Environment, Chapter 1—Environmental Protection Agency, Subchapter R—Toxic Substance Control Act (TSCA), Part 761—Polychlorinated Biphenyls (PCBs), Manufacturing, Processing, Distribution in Commerce, and Use Prohibitions*, the owner of the transformers, Electric Power Board (EPB), is responsible for the transformers' maintenance and remediation in the event of a leak.

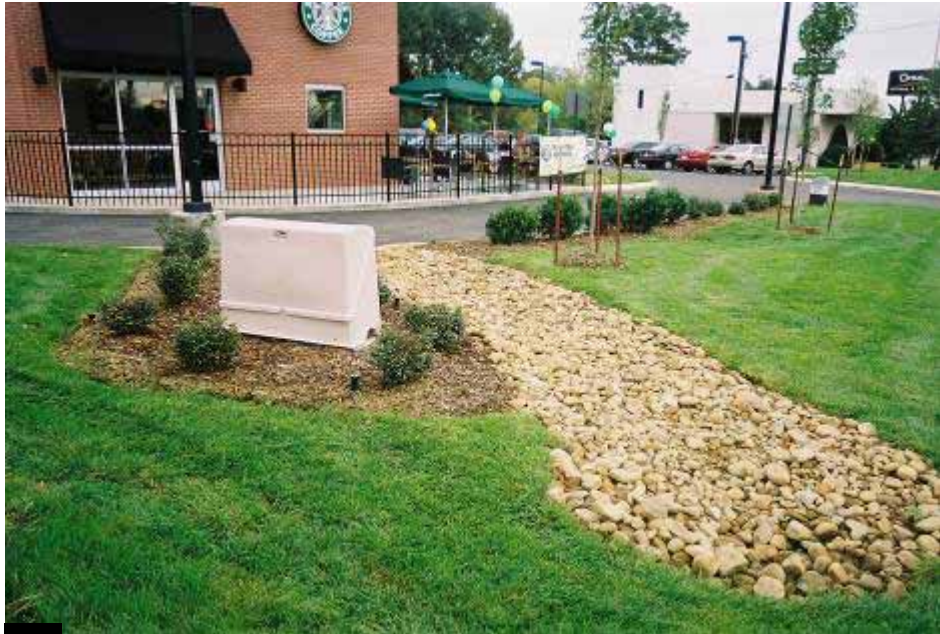
9

Backflow Prevention Device and Drainage Area along front of Subject

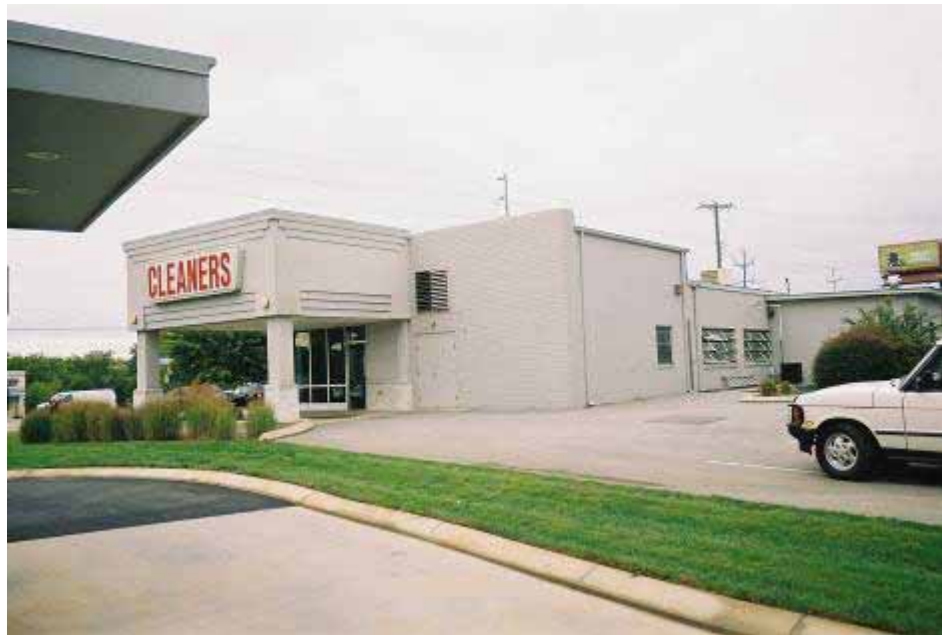
14

Surrounding Property to the West – Adjacent Cleaners

The adjacent dry cleaning facility known as Kleen-A-Matic, was identified on EDR’s Drycleaner Database, however, the facility is not listed in any databases indicating that it is a generator of hazardous waste, nor is it reported as having had any spills, releases, or violations. Refer to Sections 5.6 and 6.2 for more information regarding same.

Property Name/ Address	Distance/ Direction	Facility ID No.	Presumed Hydrogeologic Relationship	Regulatory Status
Kleen-A-Matic 4501 Highway 58	Adjacent/ West	D-33-103	Crossgradient	No violations, spills, or releases reported

This facility is not listed in any databases indicating that it is a generator of hazardous waste, nor is it reported as having had any spills, releases, or violations. However, based on its proximity to the Subject, length of operations (50+ years, the nature of drycleaning chemicals, their long-term persistence in the environment, and the harmful breakdown product that can occur when denatured (i.e. vinyl chloride); it is possible that contamination originating at this facility has entered the soils and groundwater in the surrounding area. Notwithstanding, IVI reviewed a previous subsurface study conducted in February 2007, which was entitled *Soil Vapor Survey Report*, prepared by MEI (see Section 5.6). This survey involved the use of six (6) Gore-Sorber modules installed within the proposed building (Starbucks) footprint to confirm the presence or absence of vapors emanating from soil or groundwater contaminated by dry cleaning solvent from this adjacent facility. The modules were installed to a total depth of 30” below ground surface (bgs). The survey did not report concentrations of volatile organic compounds (VOCs) exceeding the Permissible Exposure Limits (PELs)
