RE: 5021 Martins Point Rd, Kitty Hawk, NC 27949

## SUMMARY OF SALIENT FEATURES

# RESIDENTIAL APPRAISAL REPORT

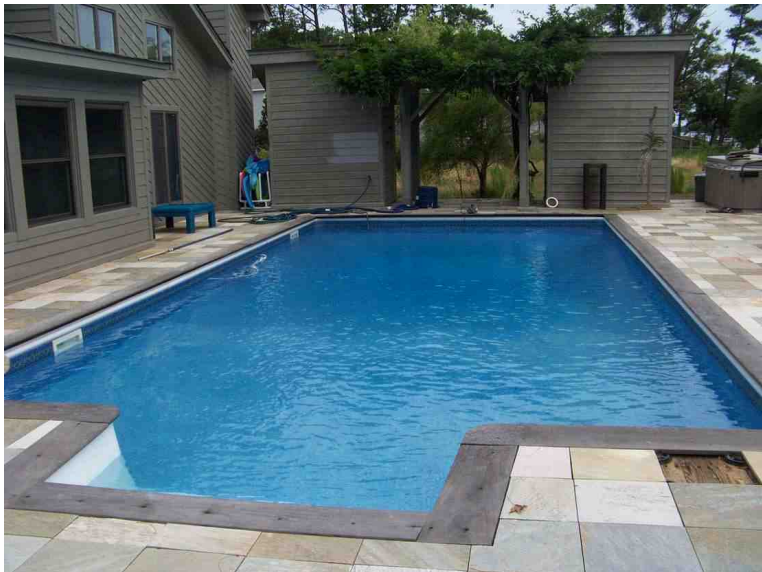
Private Swimming Pool - There is no fence around the pool area as currently required by NC Residential Code. Note there is a missing tile in the photo and a few of the tiles appeared loose when walking on them.

1. Zoning Compliance in the report is marked as non-conforming due to the fact there is not a proper fence/barrier in place surrounding the private swimming pool as required by North Carolina Residential Code. This is a potential safety/liability issue that could impact any future owner's ability to obtain homeowner's insurance.

4. Some needed repairs were observed and are noted in the report such as the ceiling damage in the sunroom and the missing/loose tiles around the swimming pool.

5. Adjustments were made to the sales comparables that have fences around their swimming pools and needed repairs were factored into the Condition rating of subject. Therefore, the appraisal report is made "as is".

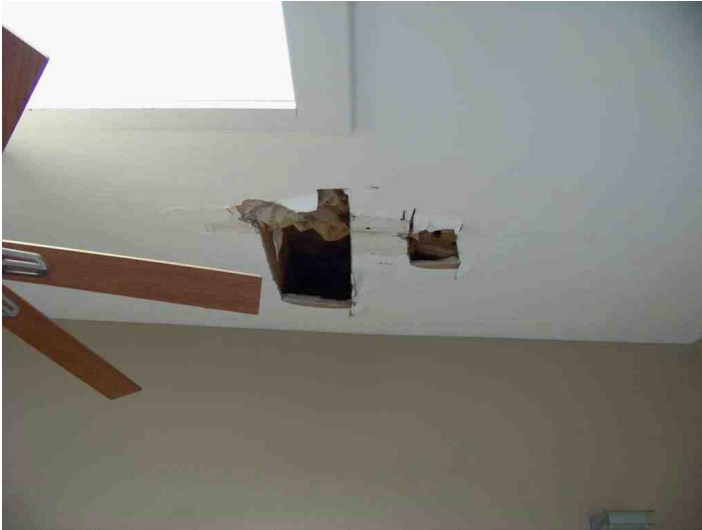
**Sheetrock Damage in the Ceiling to the First Floor Sunroom**
