Home Inspection Report

Property Address:
76 Monte Vista Lane
Stanardsville, VA 22973

Date: 11/16/2020	Time: 09:00 AM	Report ID: 111620-76 MONTE VISTA LN
Property: 76 Monte Vista Lane Stanardsville, VA 22973	Customer: Alexandra Ladd	Real Estate Professional: Megan Perry Roy Wheeler Realty Co.

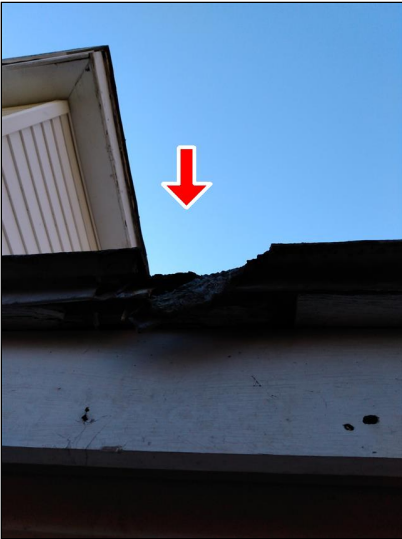
1.0 Item 1(Picture) Example of damaged roofing.

1.0 (1) The roof covering shows potential impact damage & gaps, especially at the edges. The wooden roof sheathing is deteriorated at the edges.

(2) Recommend a licensed and qualified professional evaluate the roofing for repair or replacement.

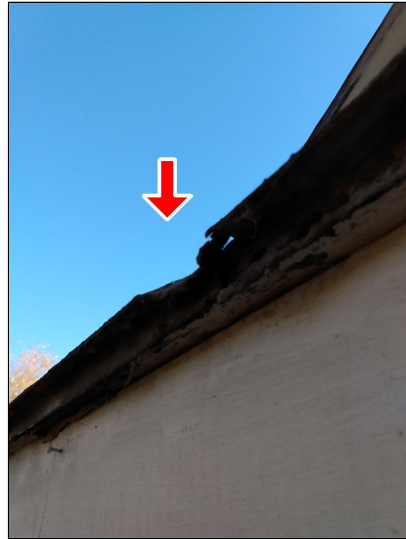
1.0 Item 2(Picture) Example of damaged roofing.

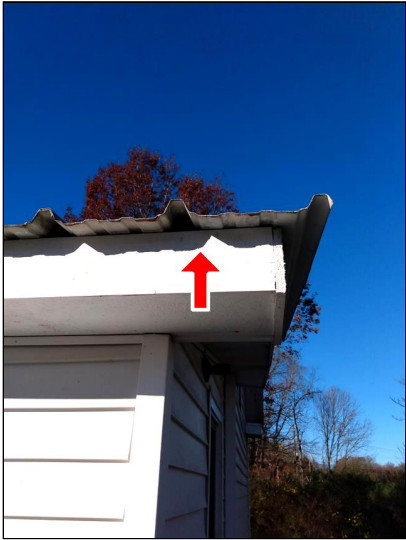
1.1 (1) The roofing application is missing flashing in many areas.

1.1 Item 1(Picture) Example of an area with no flashing.

(3) Recommend a licensed and qualified professional 1) install flashing where missing and 2) repair or replace existing flashing.

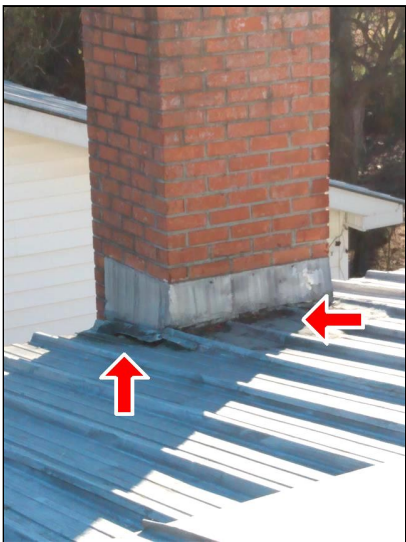
(2) The flashing around the 3 chimneys is pulling up in areas. Some areas show tar repairs.

1.1 Item 2(Picture) Example of flashing pulling up and tar repairs.

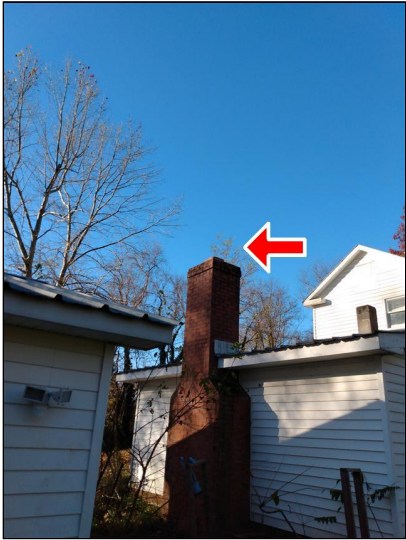
1.2 (1) The three chimneys at the home do not have caps installed.

1.2 Item 1(Picture) No cap.

(2) Recommend a licensed and qualified professional install chimney caps.

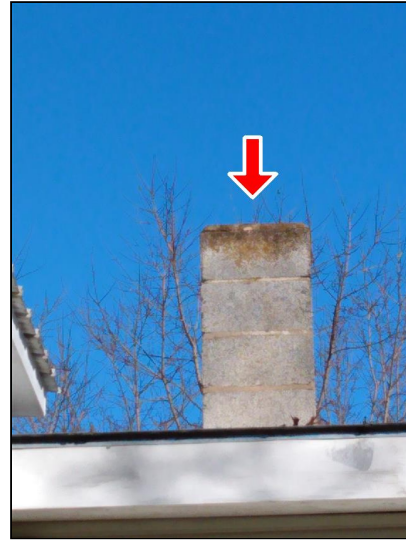
1.2 Item 3(Picture) No cap.

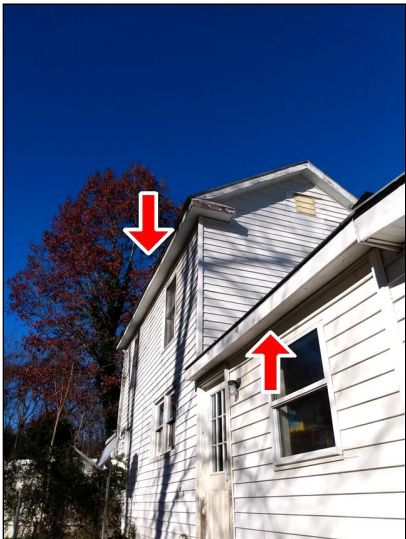
1.3 (1) The home does not have a gutter system installed.

1.3 Item 1(Picture) No gutters.

(3) Recommend a licensed and qualified professional install a gutter system around the home and garage.

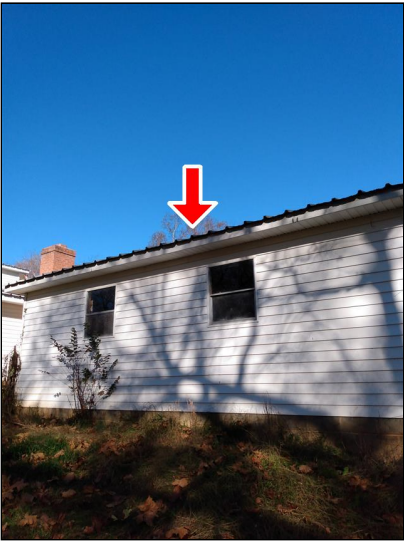
(2) The garage does not have a gutter system installed.

1.3 Item 2(Picture) No gutters.

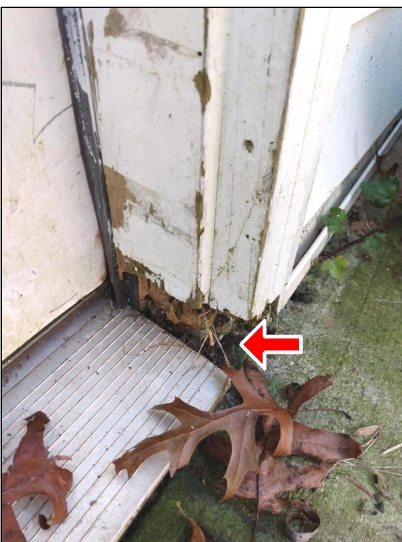
2.0 (1) In general, door trims around the home are showing moisture damage, flaking and missing paint.

2.0 Item 1(Picture) Moisture damage.

(5) **Recommend a licensed and qualified professional evaluate the siding, flashing & trim around the home for repair or replacement of individual components.**

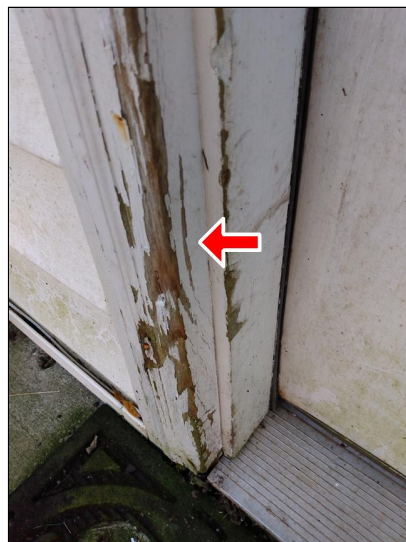
2.0 Item 2(Picture) Flaking/missing paint.

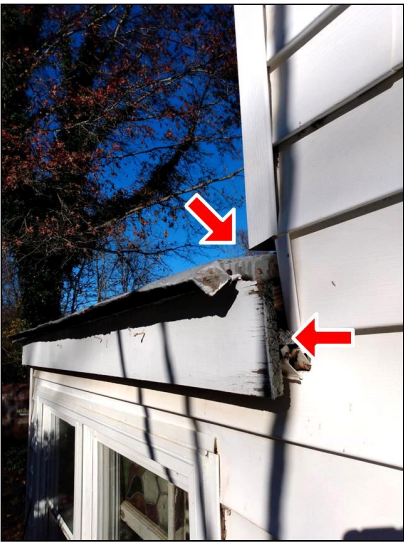
(3) In several areas around the home, joined sections do not seal the structure from the elements.

2.0 Item 4(Picture) Example of an unsealed/finished join area.

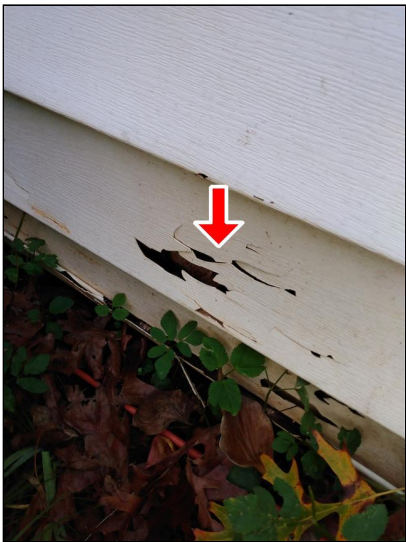
(4) There are areas of broken and damaged siding around the home.

2.0 Item 5(Picture) Broken.

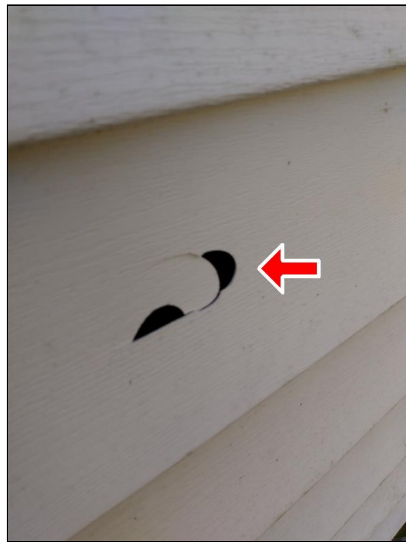
2.0 Item 6(Picture) Broken.

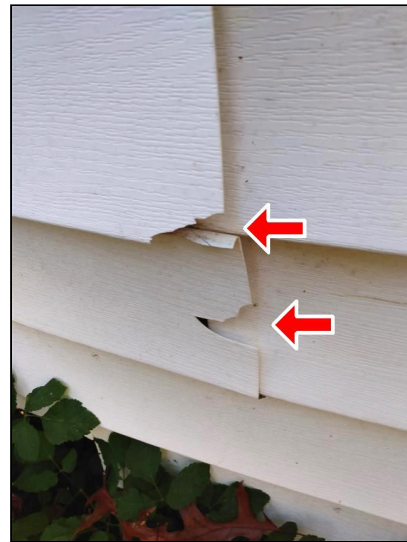
2.0 Item 7(Picture) Damaged.

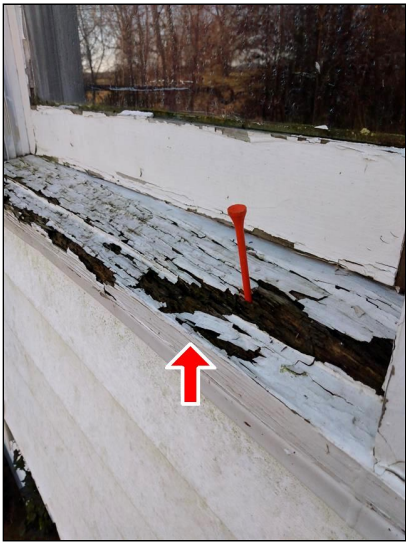
2.2 (1) In general, exterior window trims and the windows themselves are showing moisture damage around the home.

2.2 Item 1(Picture) Example of moisture damage.

(2) Recommend a licensed and qualified professional repair or replace the windows around the home and their exterior trims.

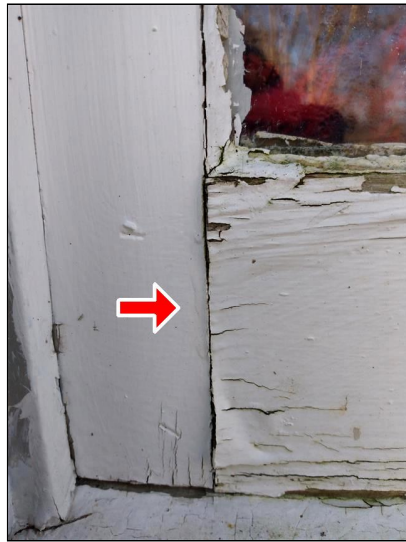
2.2 Item 2(Picture) Example of moisture damage.

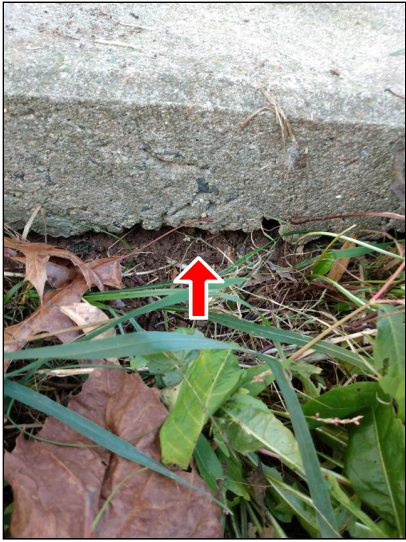
2.4 (1) Concrete patios around the home are showing undermining. Continued erosion under these patios will likely result in cracking/heaving, etc. Recommend monitoring.

2.4 Item 1(Picture) Example of Undermining.

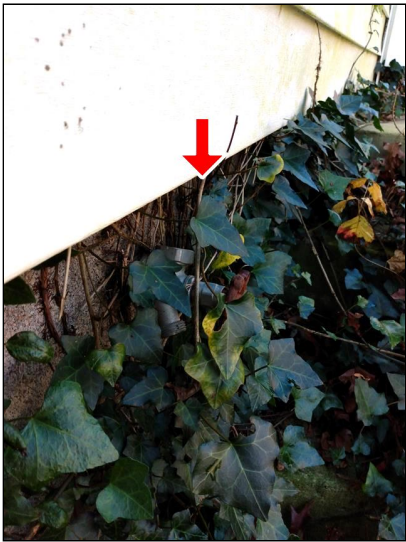
(2) Vegetation is in contact with the structure.

2.4 Item 2(Picture) Trim back at least 12".

(4) **Recommend a licensed and qualified professional trim any vegetation in contact with the structure back at least 12".**

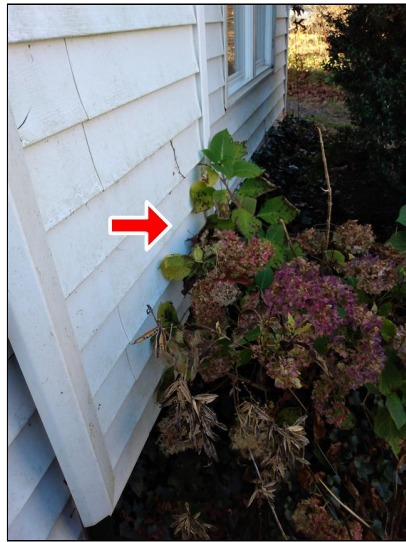
2.4 Item 3(Picture) Trim back at least 12".

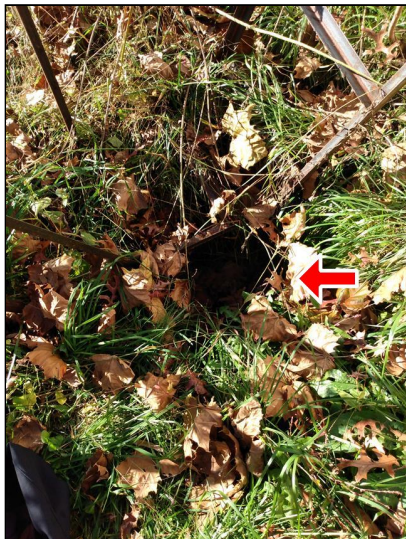
(3) At the rear of the home, between the house in the garage, there is a deep hole at grade. The inspector inserted in the 18-in screwdriver and hit something solid in its travel downward. You may want to ask the current owners about what is going on in this location.

2.4 Item 4(Picture) Deep hole.

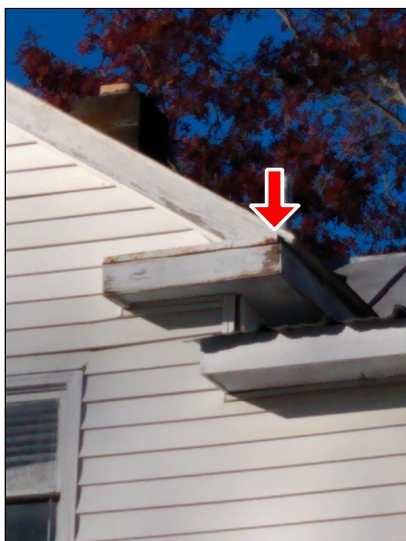
2.5 (1) In general, eaves, soffits and fascias around the home are showing the need for maintenance.

2.5 Item 1(Picture) Moisture damage.

(2) Recommend a licensed and qualified professional evaluate the eaves, soffits and fascias around the home for repair or replacement.

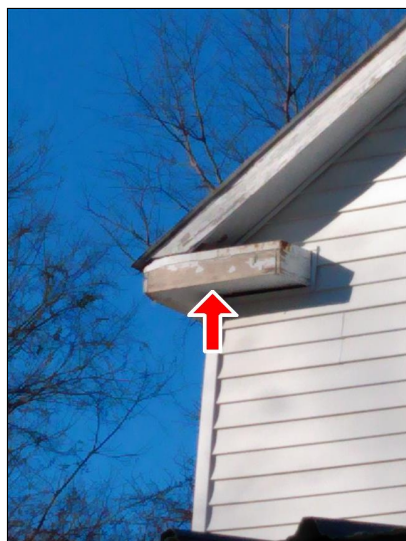
2.5 Item 2(Picture) Peeling paint, separated materials.

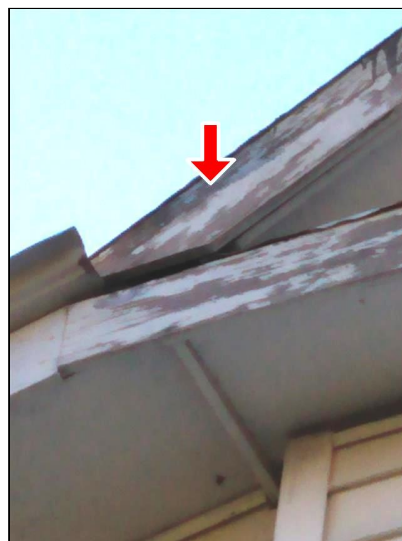
2.5 Item 3(Picture) Peeling paint, separated materials.

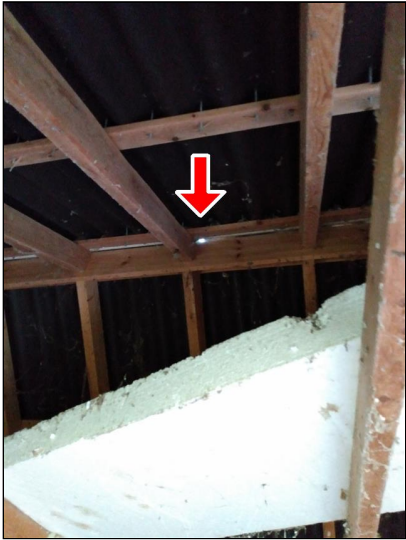
2.6 (1) There is a hole in the roof of the outbuilding.

2.6 Item 1(Picture) Hole.

(2) Recommend a licensed and qualified professional repair or replace the outbuilding's roof.

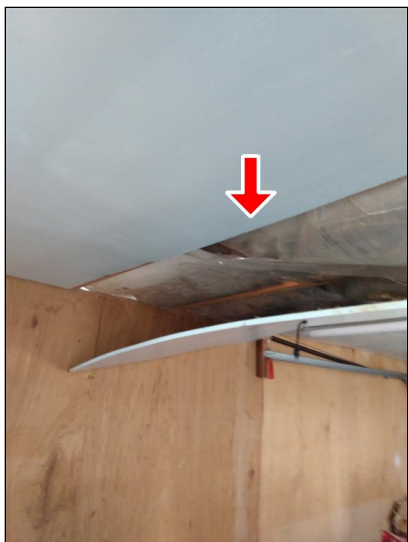
3.0 (1) The ceiling in the left garage bay has failed and is falling.

3.0 Item 1(Picture) Falling.

(2) Recommend a licensed and qualified professional repair or replace the garage ceiling.

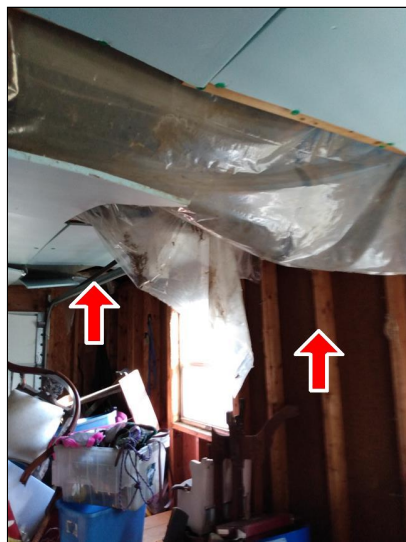
3.0 Item 2(Picture) Falling.

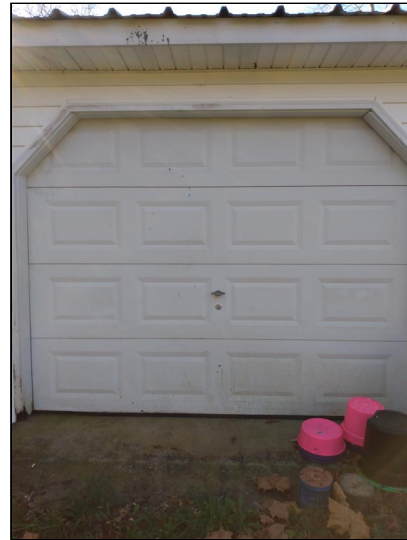
3.3 The garage was filled with personal items which limited the visual component of the inspection. The left side garage door was locked and could not be operated.

3.3 Item 3(Picture) Locked.

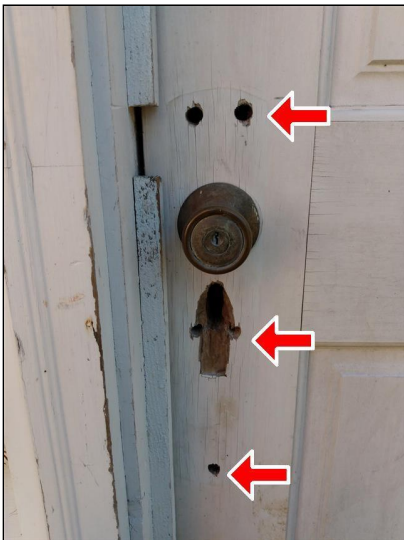
3.4 (1) The occupant garage door has holes from a former handle's installation.

3.4 Item 1(Picture) Holes.

(3) **Recommend a licensed and qualified professional 1) repair or replace the occupant garage door and 2) repair or replace the trims at the bottoms of the garage doors.**

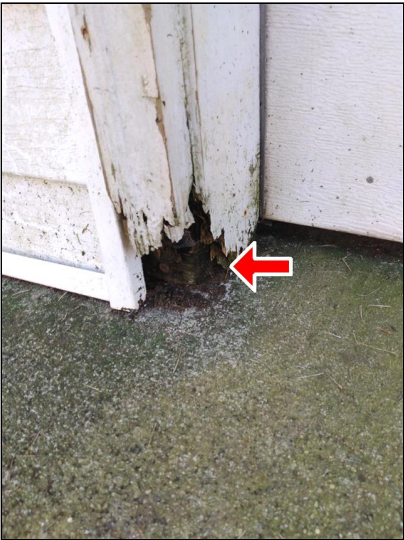
(2) There is moisture damage at the bottom of the garage doors

3.4 Item 2(Picture) Moisture damage.

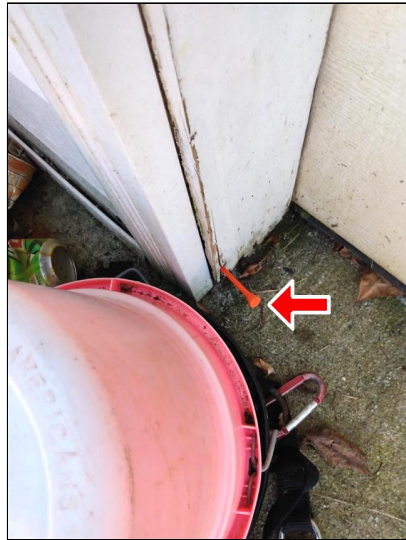
3.4 Item 3(Picture) Moisture damage.

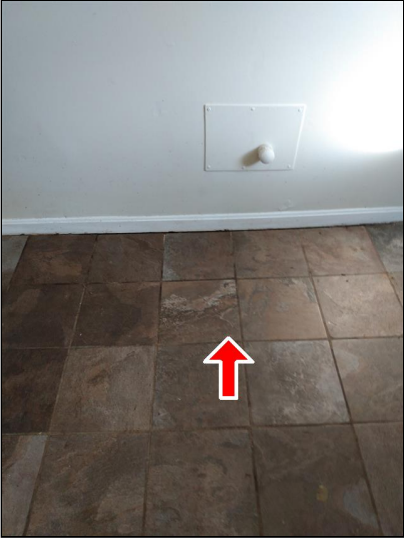
4.2 (1) The flooring in the home is wavy and shows a general deflection & downward direction towards the rear of the structure. Please see section 5.3.

4.2 Item 1(Picture) Example of wavy flooring.

(6) Recommend a licensed and qualified professional 1) test the black fuzzy substance and further advise the client and 2) evaluate the flooring in the home for repair or replacement of individual components.

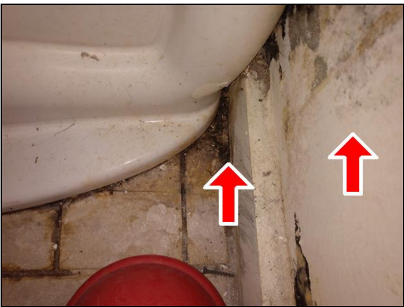
(2) On the first level's bathroom floor, there is a black fuzzy substance (potential mold) present.

4.2 Item 2(Picture) Black fuzzy substance.

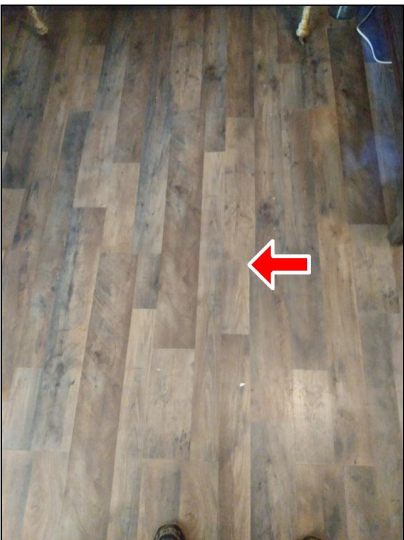
(3) The laminated flooring in the left side middle bedroom is not secured to the subfloor.

4.2 Item 3(Picture) Flooring is popped up.

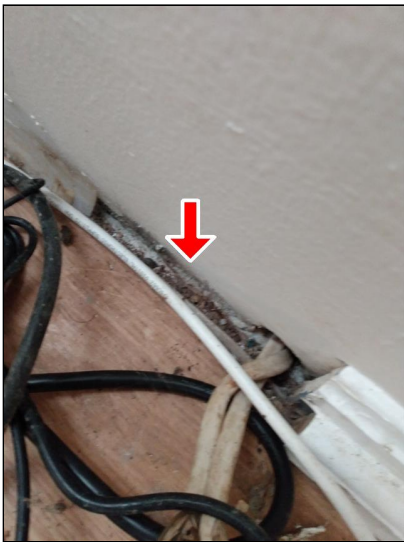
(4) The flooring around the home shows many areas of missing molding and gaps.

4.2 Item 4(Picture) Example of missing molding & gaps between floors & walls.

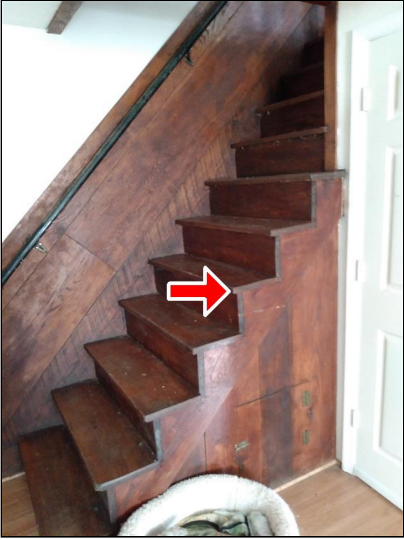
4.3 (1) The stairs are missing handrailing on the right hand side.

4.3 Item 1(Picture) No railing.

(4) Recommend a licensed and qualified professional address 1) install handrailing at the right side of the stairs and 2) repair or replace existing handrailing as necessary.

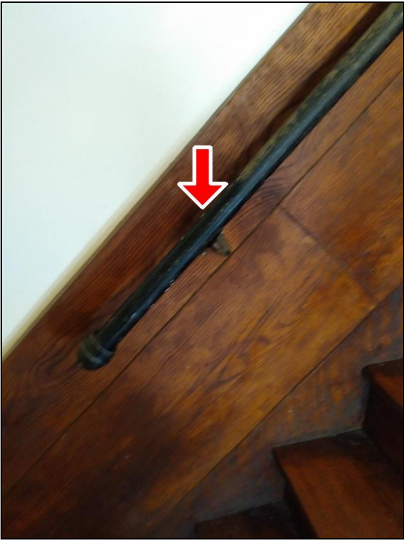
(2) The handrailing to the second floor is broken at the bottom.

4.3 Item 2(Picture) Here.

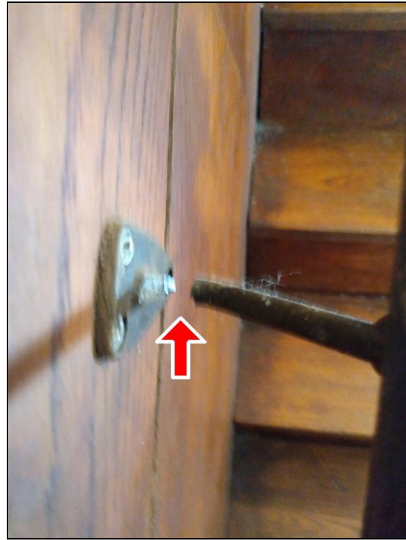
4.3 Item 3(Picture) Broken.

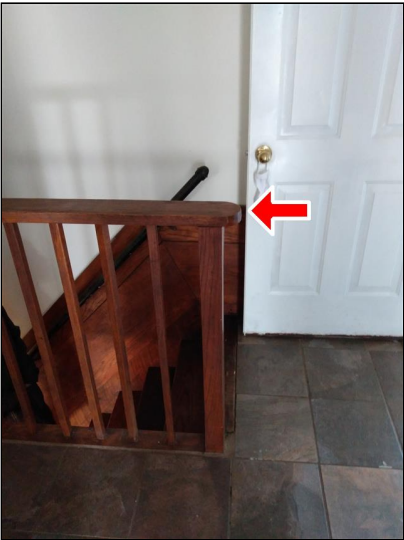
(3) The handrailing at the top of the stairs is loose.

4.3 Item 4(Picture) Loose.

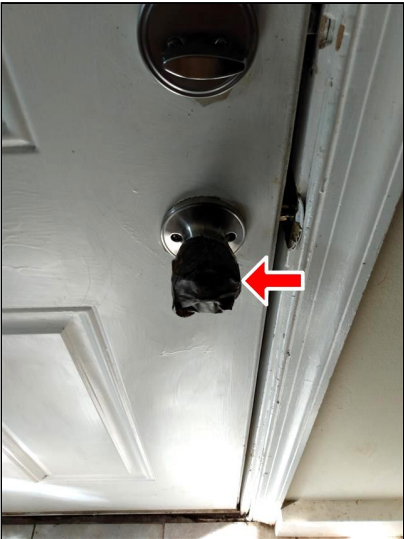
4.5 (1) The front door's knob has been taped over.

4.5 Item 1(Picture) Taped over.

(3) Recommend a licensed and qualified professional 1) ensure that the front door knob is operational and 2) apply weather stripping or otherwise seal the right side door to ensure a consistent weather and fauna barrier.

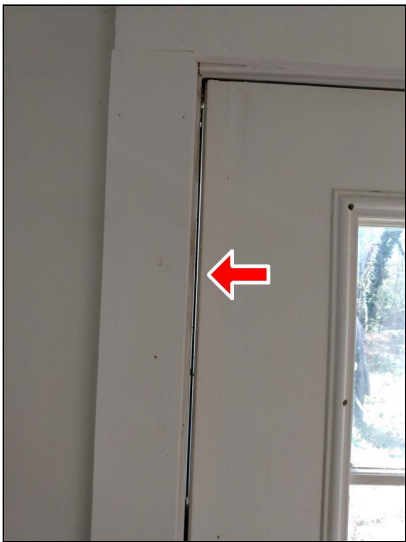
(2) Air and daylight are passing between the right side door and its framing.

4.5 Item 2(Picture) Air & daylight.

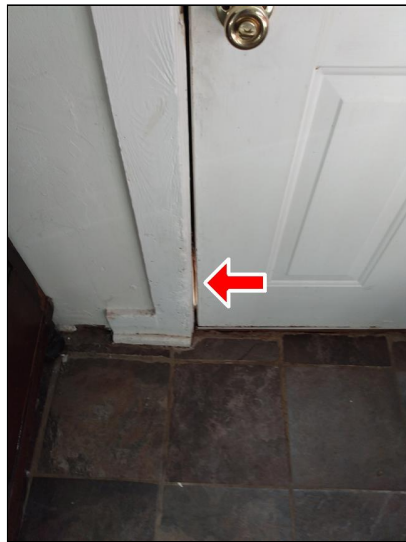
4.5 Item 3(Picture) Air & daylight.

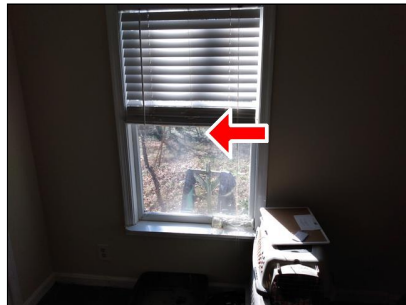
4.6 Item 2(Picture) Inoperable.

(4) Recommend a licensed and qualified professional repair or replace the windows around the home as needed.

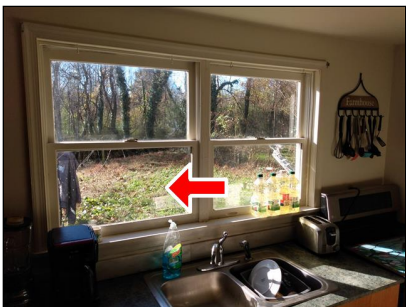
(2) The windows above the kitchen sink were inoperable at the time of the inspection. The left side window has a broken thermal seal.

4.6 Item 3(Picture) Both inoperable. Left side broken thermal seal.

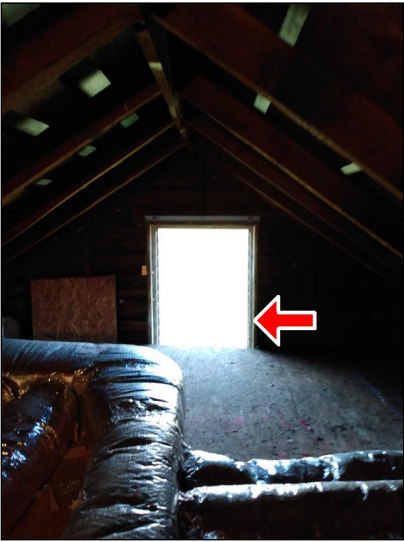
(3) The jalousie window in the attic was inoperable at the time of the inspection.

4.6 Item 4(Picture)
Inoperable.

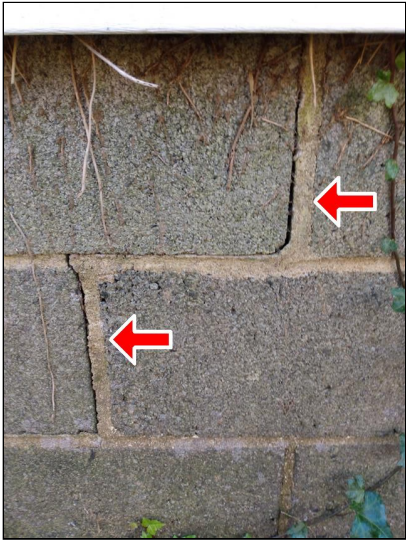
5.0 (1) The foundation shows a areas of step cracking without deflection. Recommend monitoring. Please see section 5.3.

5.0 Item 1(Picture) Cracking without deflection.

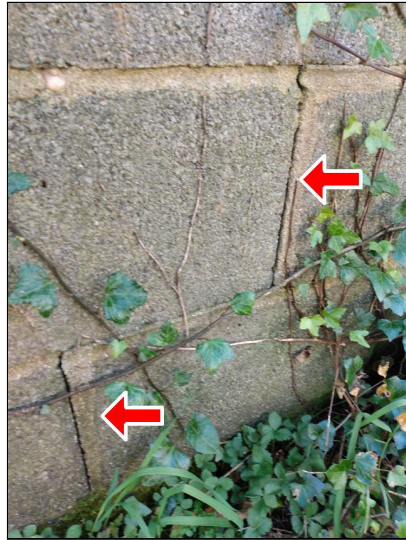
5.0 Item 2(Picture) Cracking without deflection.

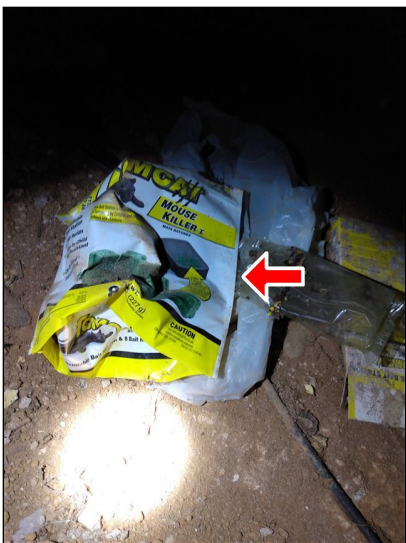
(2) There is evidence of rodent control in the crawlspace.

5.0 Item 3(Picture) Rodent control.

(5) Recommend a licensed and qualified professional 1) remove any vegetation growing in the crawlspace and ensure that it will not regrow and 2) perform a pest inspection around the home.

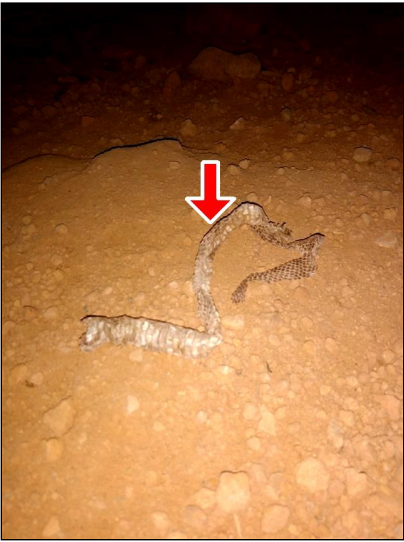
(3) There is evidence of reptile activity on the crawlspace floor.

5.0 Item 4(Picture) Reptile activity.

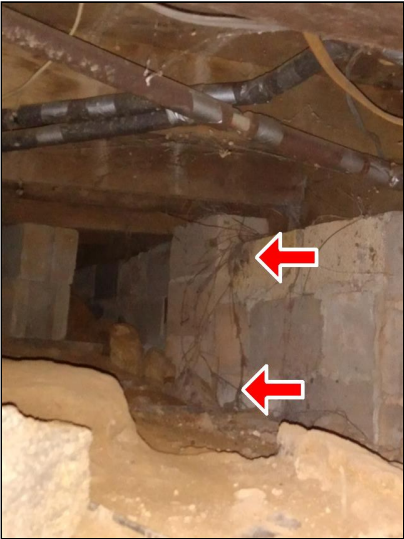
(4) Vegetation is growing inside the crawlspace.

5.0 Item 5(Picture) Vegetation.

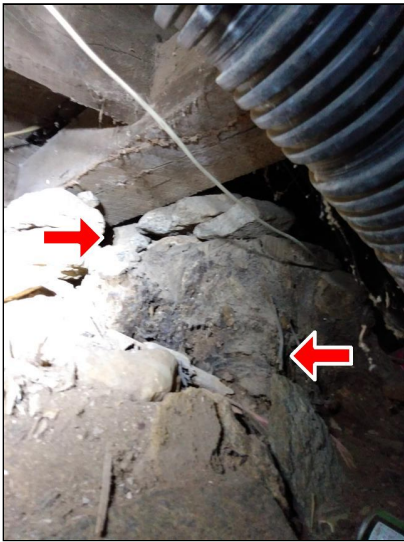
5.2 (1) A tree stump is being used as an improvised pier in the crawlspace.

5.2 Item 1(Picture) Stump & dry stacked stone.

(2) Recommend a licensed and qualified professional 1) remove the tree stump, 2) install a proper pier, and while onsite, 3) evaluate all the piers under the home and further advise the client.

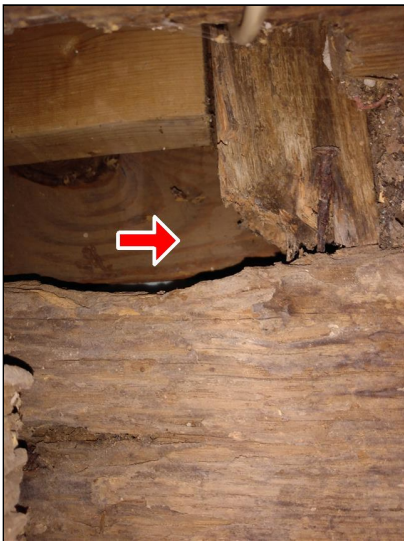
5.3 (1) Floor structure in the crawlspace shows dry rot, moisture damage and potential wood destroying organism (WDO) activity. The inspector could not determine if the activity were recent.

5.3 Item 1(Picture) Example of dry rot.

(5) Recommend a licensed and qualified structural engineer evaluate the home and further advise the client. Additionally recommend a licensed and qualified professional 1) test the black, white & yellow fuzzy substances and further advise the client and 2) perform a pest inspection around the home.

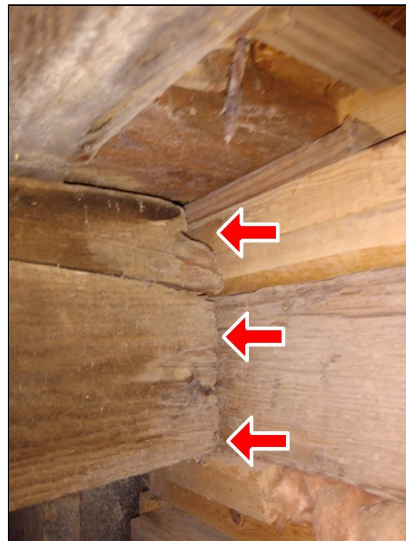
5.3 Item 2(Picture) Example of dry rot.

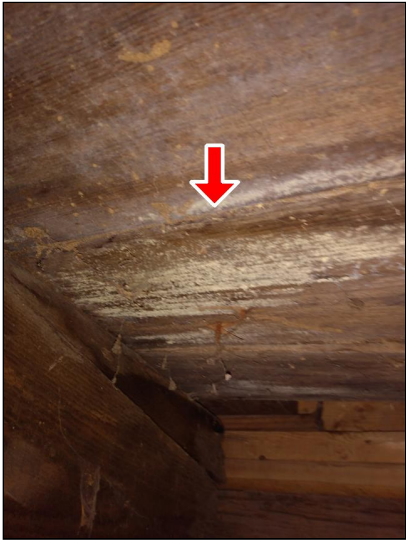
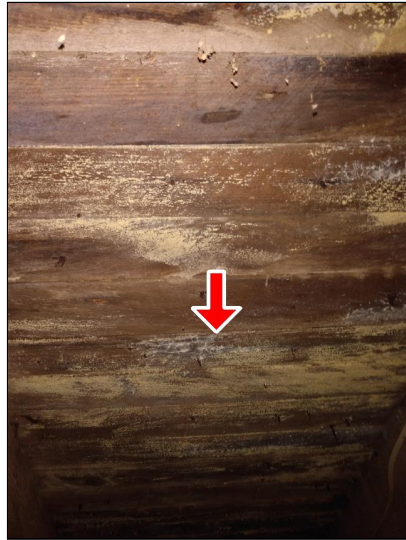
(2) The floor beams & joists, as seen in the crawlspace, have a black, white & yellow fuzzy substances (potential molds) on them.

5.3 Item 3(Picture) Example of the fuzzy substances.

5.3 Item 4(Picture) Example of the fuzzy substances.

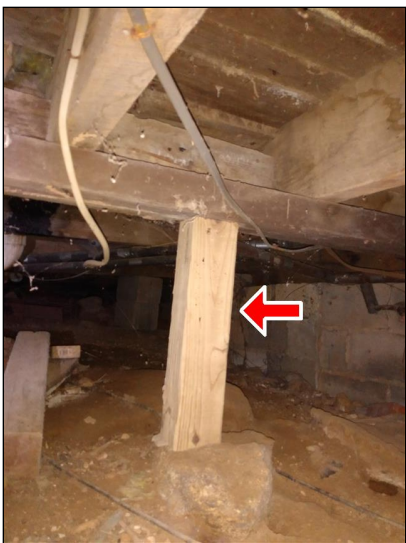
(3) There have been repairs to sub flooring that may not be done properly.

5.3 Item 5(Picture) A wooden pier, not plumb.

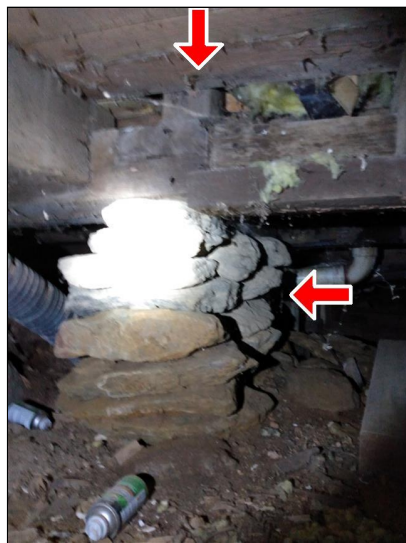
5.3 Item 6(Picture) Dry stacked stone with repair above.

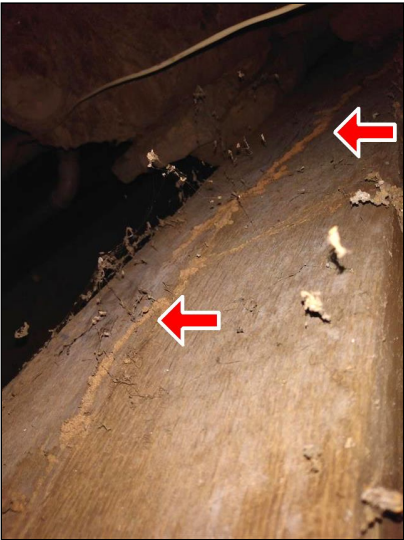
(4) There are mud tubes from potential termite activity seen on flooring materials in the crawlspace.

5.3 Item 7(Picture) Mud tubes.

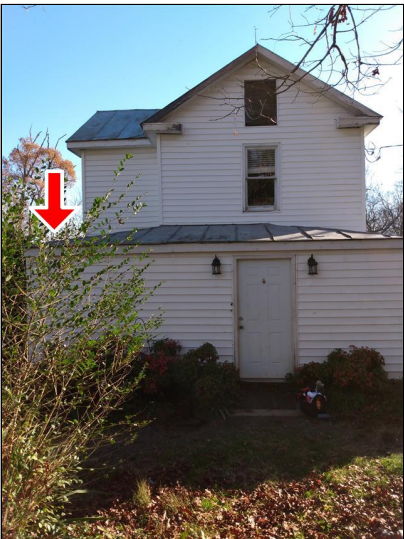
5.5 (1) The roof structure of the front entrance porch is sagging to the left.

5.5 Item 1(Picture) Sagging.

(5) Recommend a licensed and qualified professional 1) evaluate the front entrance porch roof structure and further advise the client, 2) seal the attic area to ensure a consistent weather and fauna barrier, and 3) perform a pest inspection around the home.

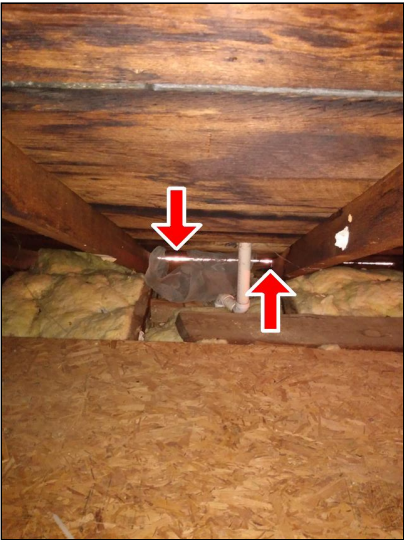
(2) Daylight is seen in many areas of the attic space.

5.5 Item 2(Picture) Daylight.

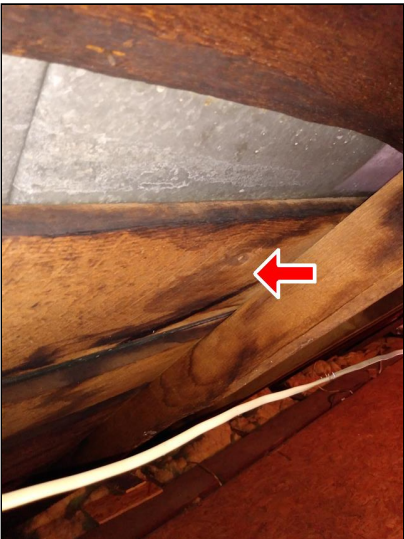
(3) Roof structure shows dark staining from probable past moisture contact. Recommend monitoring.

5.5 Item 3(Picture) Example of dark staining.

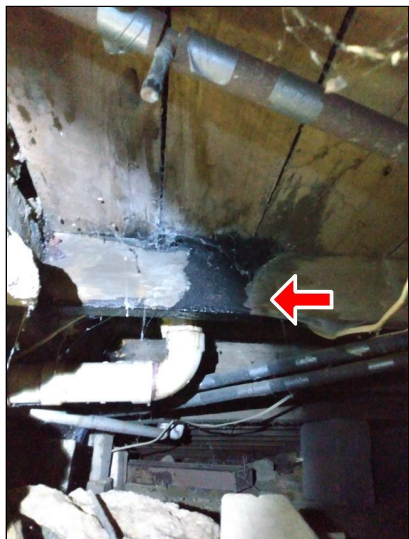
6.0 (1) Inside the crawlspace, there is an apparent drain waste leak from the main floor's bathroom. The floor structure underneath is wet to the touch and shows dark staining.

6.0 Item 1(Picture) Wet with dark staining.

(2) Recommend a licensed and qualified professional eliminate the leak(s). Please see section 5.3.

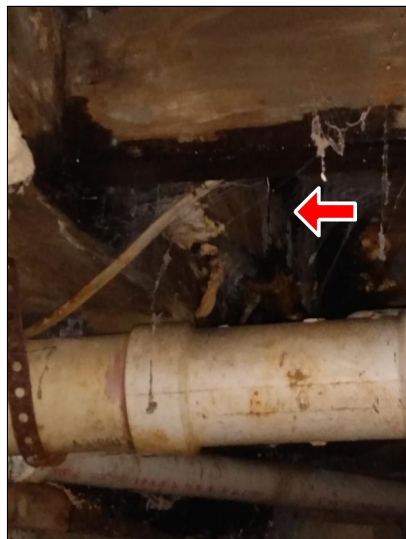
6.0 Item 2(Picture) Wet with dark staining.

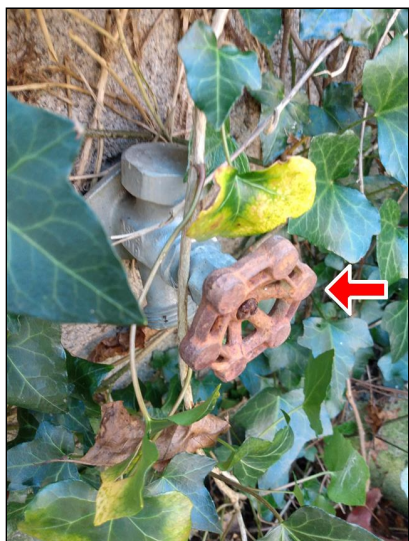
6.1 (1) The hose bib at the left exterior of the home approximately, 10 feet from the heat pump, did not deliver water at the time of the inspection.

6.1 Item 1(Picture) Did not deliver water.

(3) **Recommend a licensed and qualified professional ensure that both the hose bib and sink are functional.**

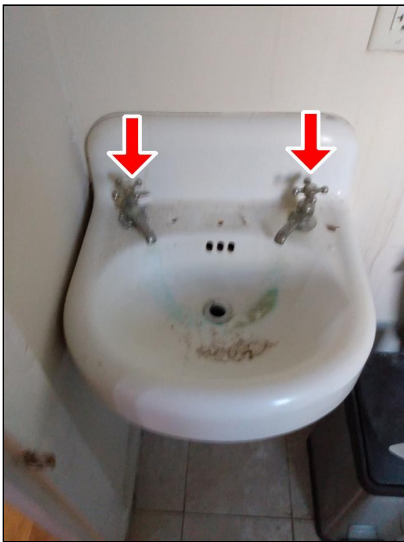
(2) The sink in the downstairs bathroom did not deliver water at the time of the inspection.

6.1 Item 2(Picture) Did not deliver water.

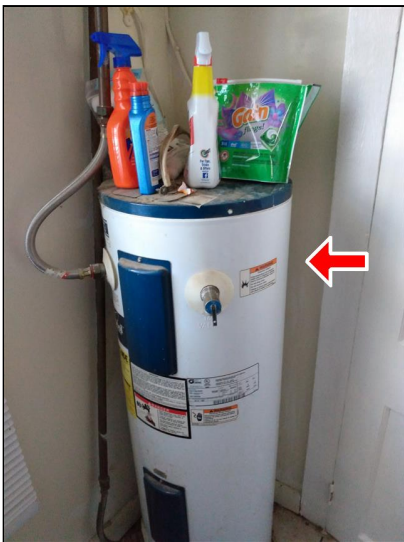
6.2 (1) There is no temperature, pressure & relief (TPR) extension installed at the water heater.

6.2 Item 1(Picture) Water heater.

(2) Recommend a licensed and qualified professional install a TPR extension to within 6 inches of the floor.

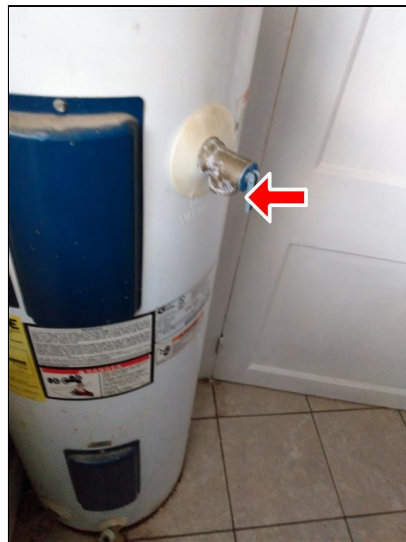
6.2 Item 2(Picture) No TPR extension.

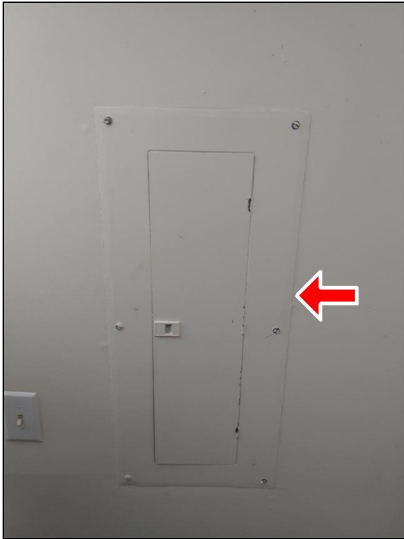
(2) The main distribution pan is located in the living room. It was painted shut and the dead front cover was not removed.

7.0 Item 1(Picture) Main distribution panel.

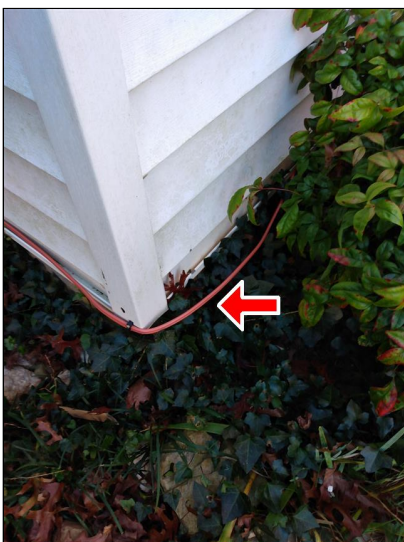
7.4 (1) The wiring for the heat pump is simply laid on the ground in areas and is not properly secured.

7.4 Item 1(Picture) Heat pump wiring.

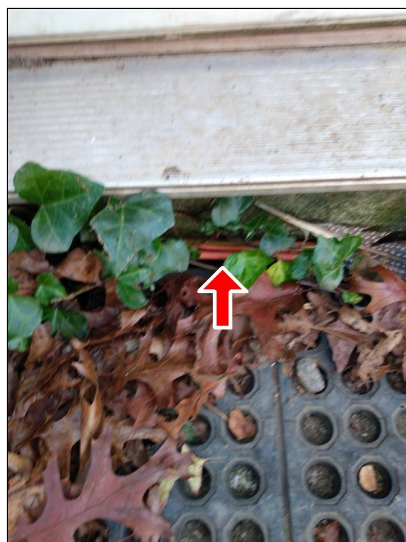
7.4 Item 2(Picture) Heat pump wiring.

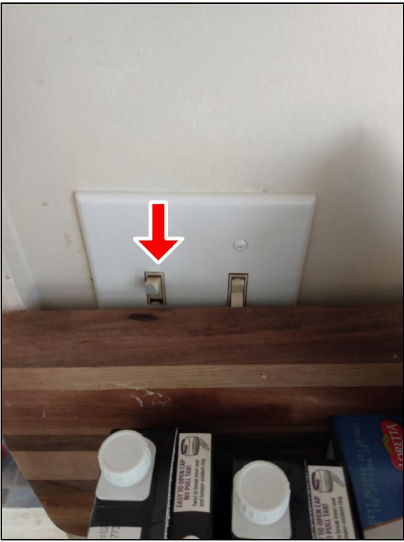
(2) The left switch in the two gang wall switch at the left side of the kitchen appears to operate nothing.

7.4 Item 3(Picture) Mystery switch.

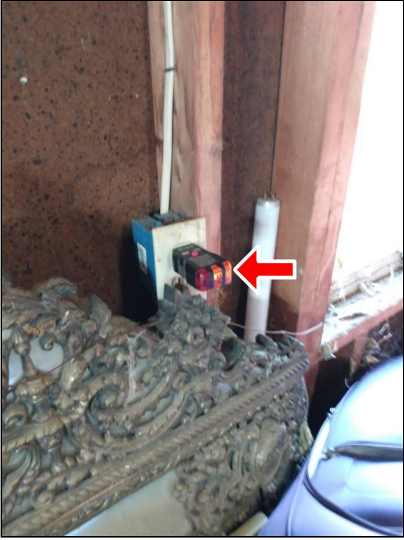
7.5 (1) The garage receptacles are not GFCI protected.

7.5 Item 1(Picture) Not GFCI protected.

(3) Recommend a licensed and qualified professional provide GFCI protection for the areas mentioned in this section.

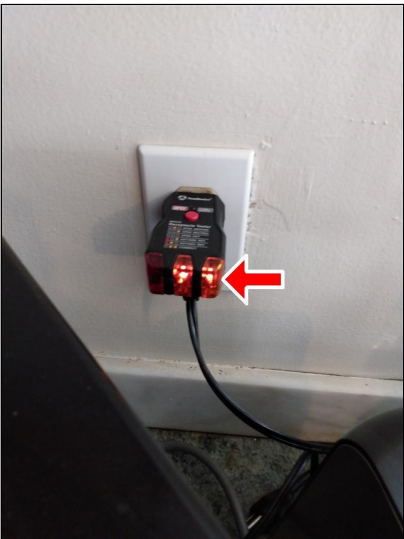
(2) The receptacle to the left of the kitchen sink is not GFCI protected. It appears to be connected to a malfunctioning GFCI receptacle behind the range.

7.5 Item 2(Picture) Not GFCI protected.

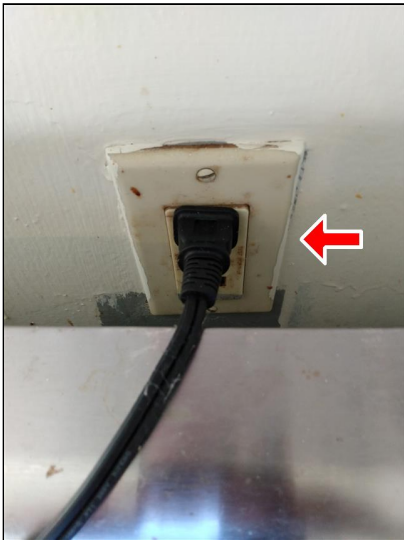
7.6 (1) The GFCI receptacle behind the kitchen range did not trip with the inspector's testing tool.

7.6 Item 1(Picture) Not GFCI protected.

(4) **Recommend a licensed and qualified professional repair or replace the GFCI receptacles mentioned in this section.**

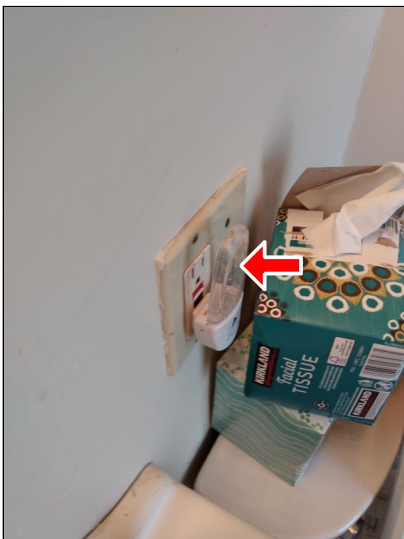
(2) The GFCI receptacle in the upstairs bathroom extinguishes the overhead lighting when tripped. The receptacle re-energized but overhead lighting did not. The inspector re-tested the circuit and the GFCI receptacle tripped and reset. This time, the over head lighting did not re-illuminate.

7.6 Item 2(Picture) Odd GFCI operation.

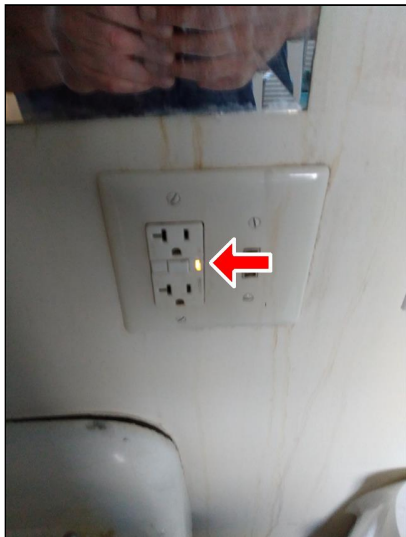
(3) The GFCI receptacle in the downstairs bathroom to the right of the sink was tripped at the time of the inspection. It would not reset to re-energize. Overhead lighting in this room may be connected to this receptacle because it was extinguished at the time of the inspection.

7.6 Item 3(Picture) Did not reset to re-energize.

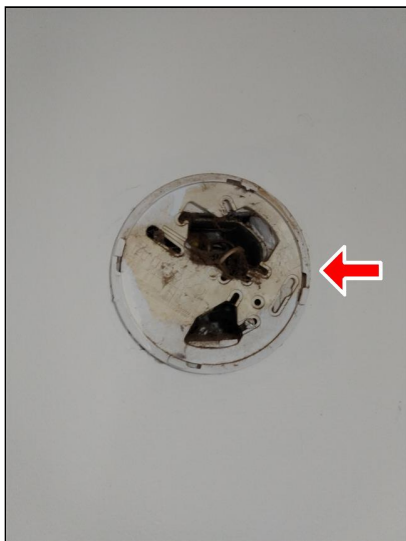
(2) There is a missing smoke detector at the top of the second floor landing.

7.8 Item 1(Picture) Missing.

(3) **Recommend a licensed and qualified professional provide smoke detection capabilities at this home.**

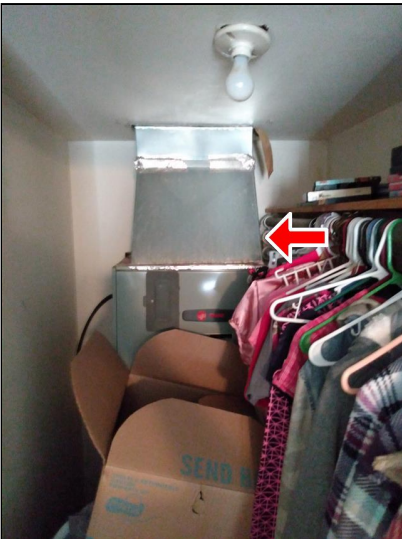
(2) The air handler is located in the upstairs front bedroom closet. The inspection of this equipment was limited because personal items were blocking access. For example, the inspector could not see the equipment's service tag.

8.0 Item 3(Picture) Air handler.

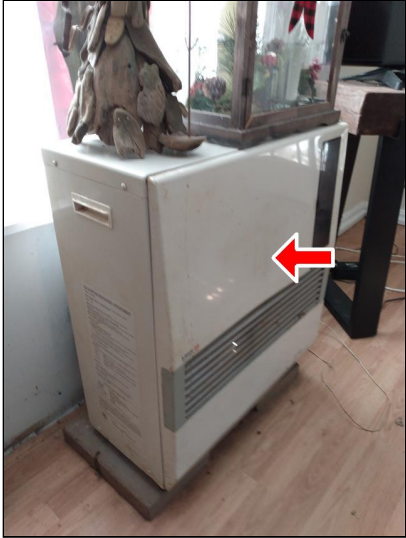
(3) The inspector could not get the oil space heater to operate. Also the installation clearances are very close to the wall.

8.0 Item 4(Picture) Not tested.

(6) Recommend a licensed and qualified professional 1) ensure that the oil heater is safely and correctly installed to the manufacturer's specification, 2) ensure that the oil heater is functional, 3) ensure that the baseboard heat in the rear fireplace room is functional, 4) ensure that the kitchen baseboard heat is functional.

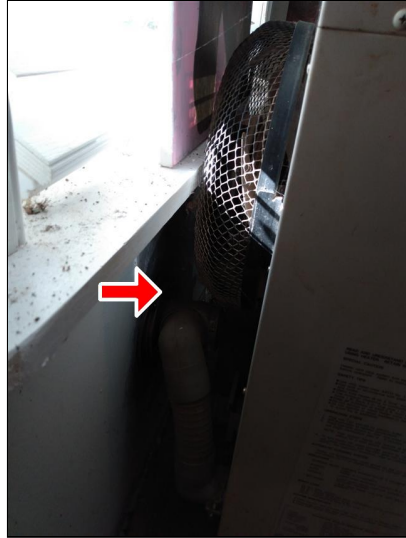
8.0 Item 5(Picture) In contact with combustibles.

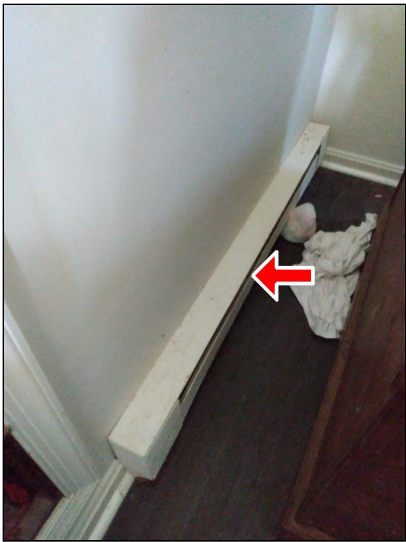
(4) The baseboard heat in the rear fireplace room was inoperable at the time of the inspection.

8.0 Item 6(Picture) Inoperable.

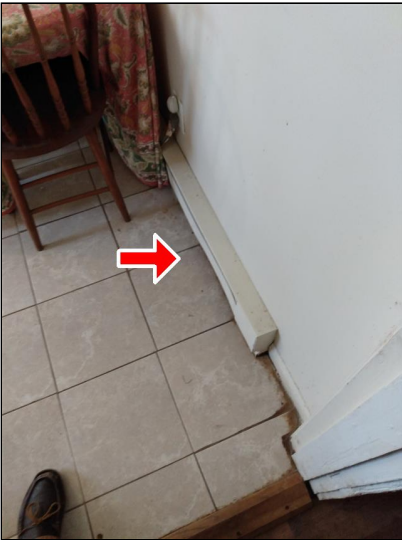
(5) The inspector could not determine how to turn on the kitchen's electric baseboard heat.

8.0 Item 7(Picture) Kitchen's electric baseboard heat.

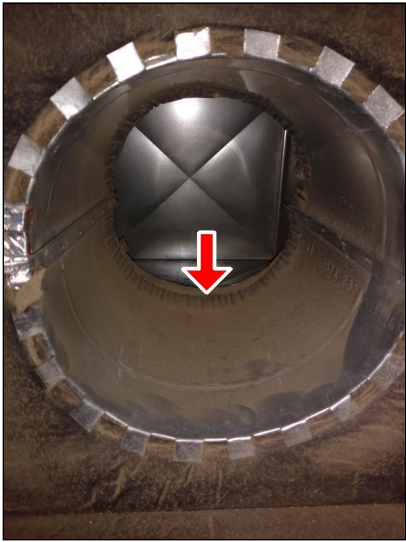
(2) HVAC ducting in the home is dirty. Also, there is debris in the ducting system rattling during operation.

8.3 Item 2(Picture) Dirty.

(5) Recommend a licensed and qualified professional 1) replace HVAC filters before moving in, 2) clean and inspect the HVAC ducting in the home, 3) ensure that the suction line bundle at the exterior of the home is secure, 4) seal this area of siding to the elements, and 5) evaluate the home for an additional return and further advise the client.

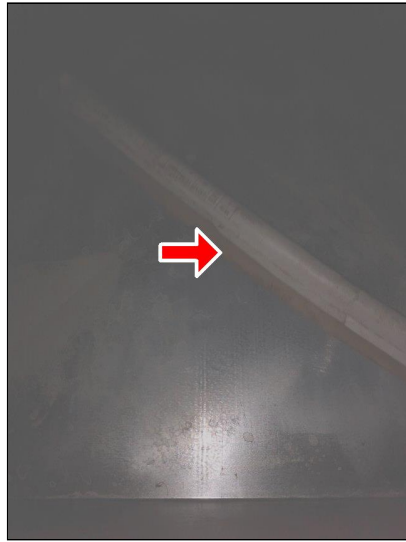
8.3 Item 3(Picture) Debris in ducting.

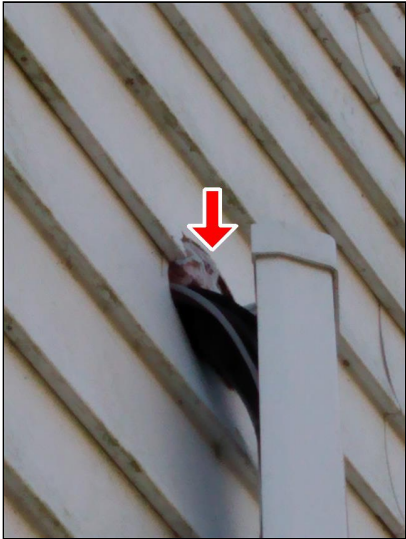
(3) The HVAC's suction line supply bundle entering the house shows gaps.

8.3 Item 4(Picture) Gaps.

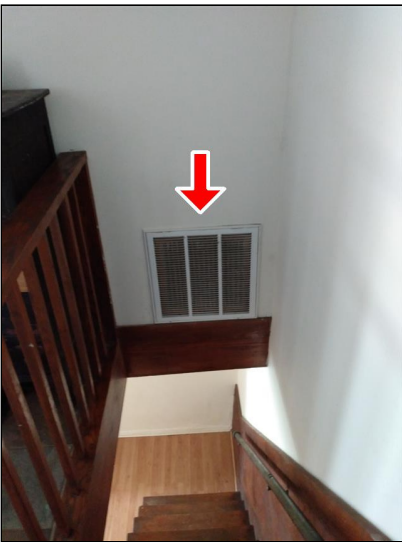
(4) The HVAC system only has one return in the home.

8.3 Item 5(Picture) One return.

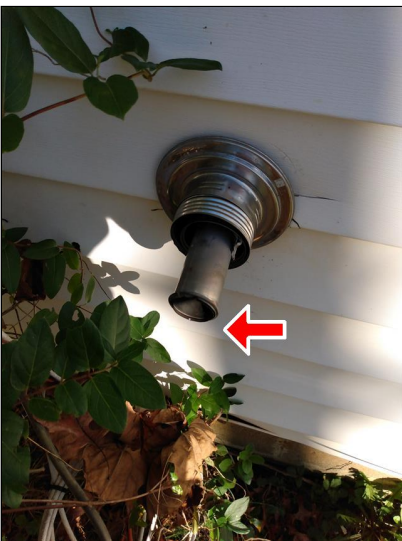
8.5 (1) The flue for the oil space heater in the right front room is not properly terminated at the exterior.

8.5 Item 1(Picture) No cap or heat shield.
