Home Inspection Report

Property Address:
76 Monte Vista Lane
Stanardsville, VA 22973

Date: 11/16/2020	Time: 09:00 AM	Report ID: 111620-76 MONTE VISTA LN
Property: 76 Monte Vista Lane Stanardsville, VA 22973	Customer: Alexandra Ladd	Real Estate Professional: Megan Perry Roy Wheeler Realty Co.

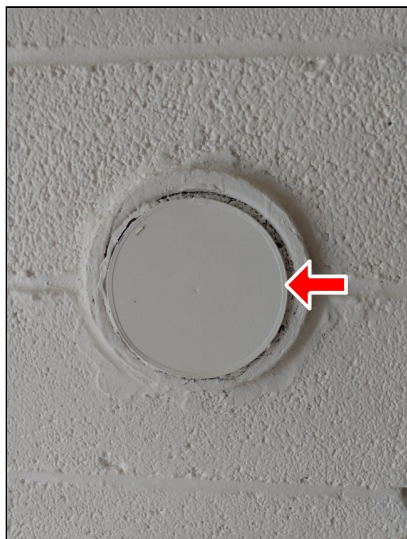
(2) As information for the client, there are several circular flue hookups throughout the home. Recommend a licensed and qualified professional clean and inspect these inlets before hooking up an appliance to any of them.

8.5 Item 2(Picture) Clean and inspect before use.

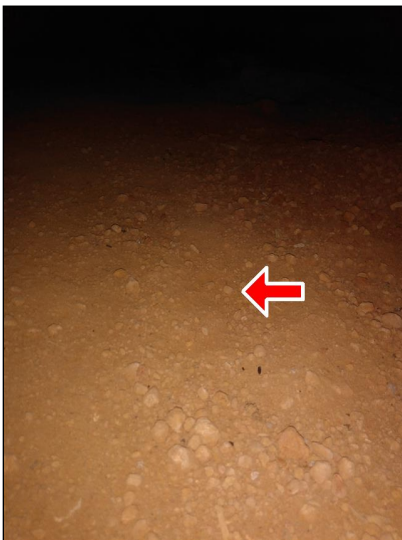
9.2 (1) The crawlspace does not have a vapor barrier installed.

9.2 Item 1(Picture) Bare crawsapce soil.

(2) Recommend a licensed and qualified professional cover 100% of the crawlspace with vapor barrier.

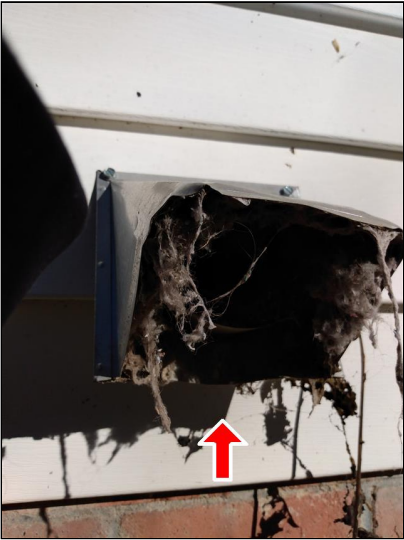
9.4 (1) The dryer vent is full of lint and debris.

9.4 Item 1(Picture) Lint & debris.

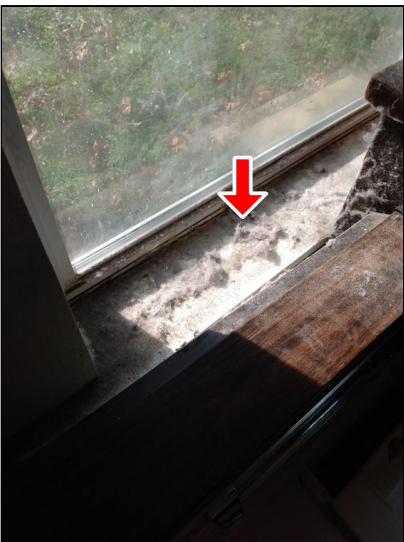
(2) There is lint inside of the laundry room.

9.4 Item 2(Picture) Lint.

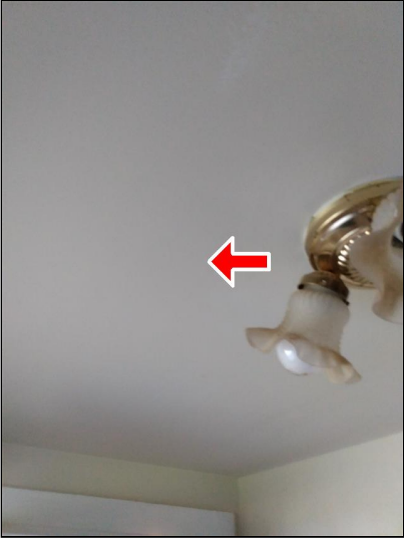
(3) Although probably not required at the time of the build, there are no exhaust fans in the bathrooms. You may want to consider having bathroom exhaust systems installed.

9.4 Item 3(Picture) No exhaust fan.

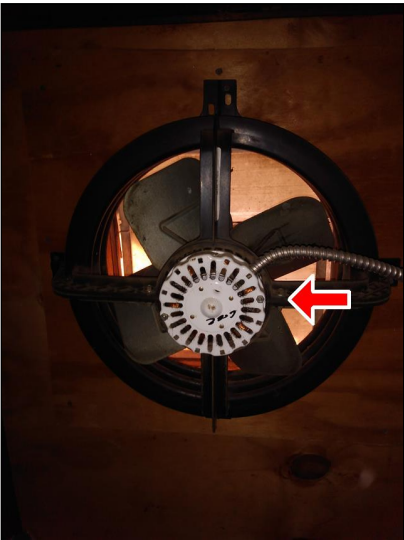
9.5 (1) The thermostatically controlled attic fan was inoperable at the time of the inspection.

9.5 Item 1(Picture)
Inoperable.
