# Inspection Report

**Property Address:**  
4696 Pine Valley Dr  
Macon GA 31210

<b>Date:</b> 1/23/2026	<b>Time:</b> 09:00 AM	<b>Report ID:</b> 20260123-4696-Pine-Valley-Dr
<b>Property:</b> 4696 Pine Valley Dr Macon GA 31210	<b>Customer:</b> Steve Slocumb	<b>Real Estate Professional:</b>

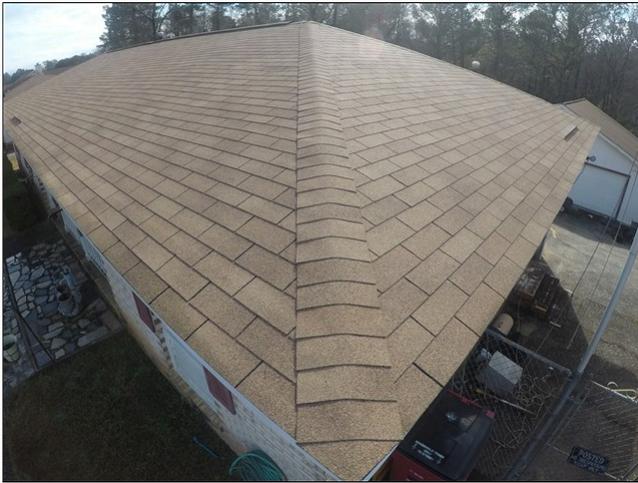
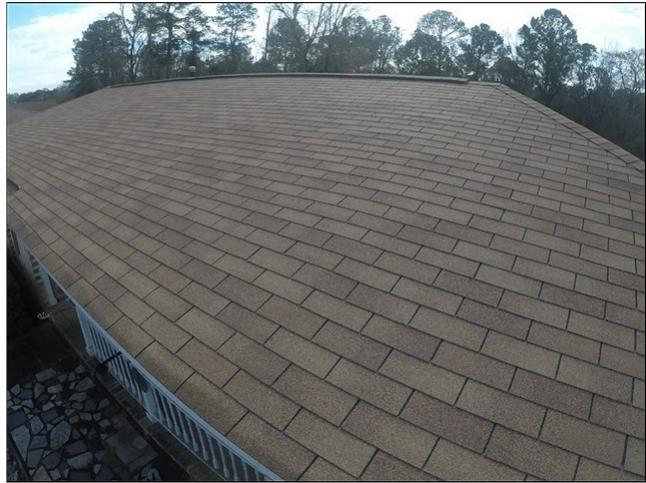
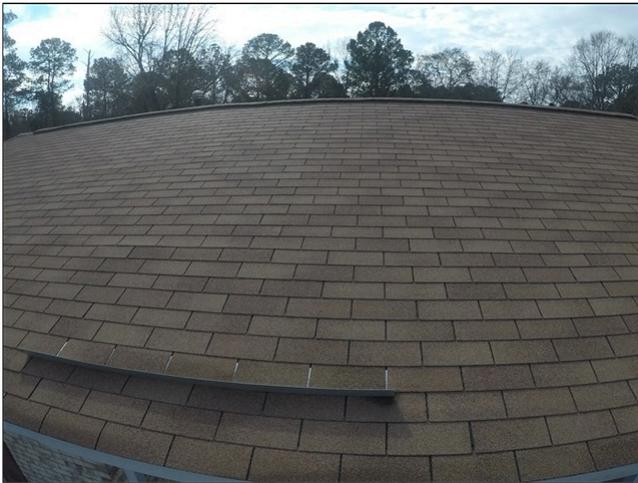
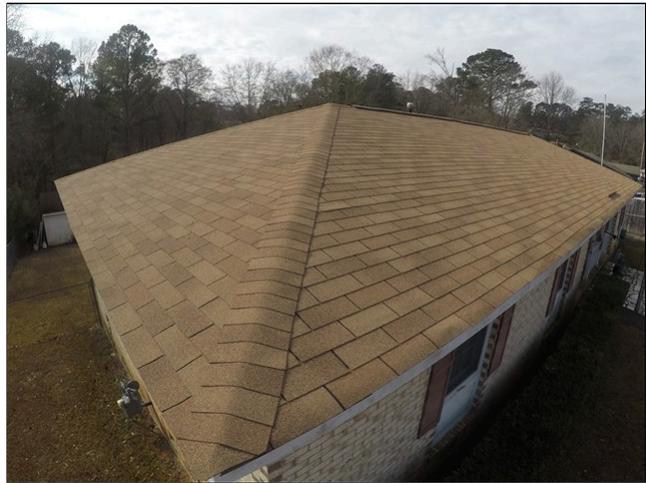
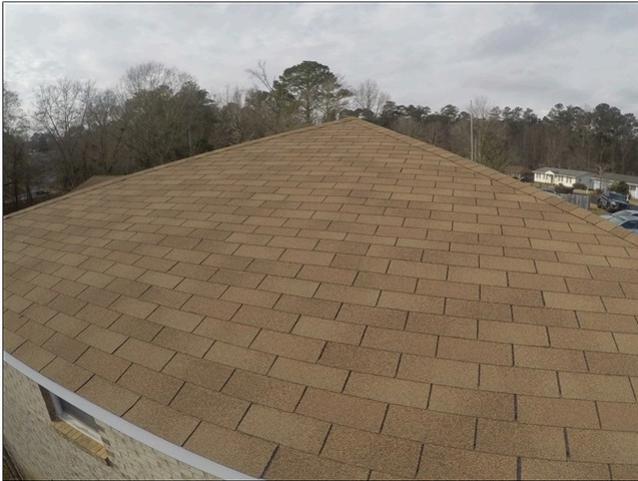
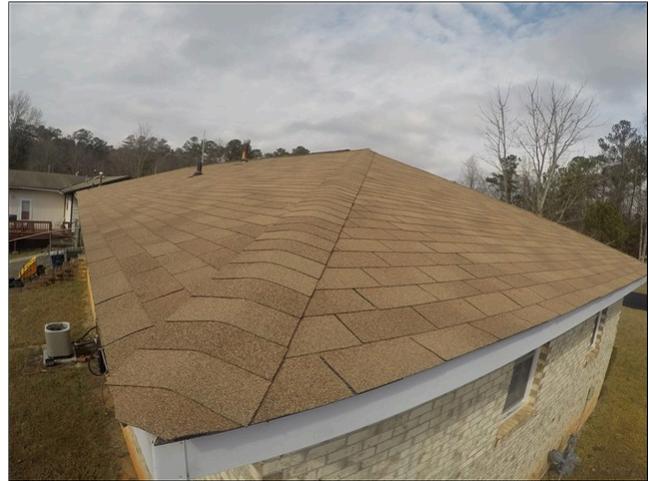
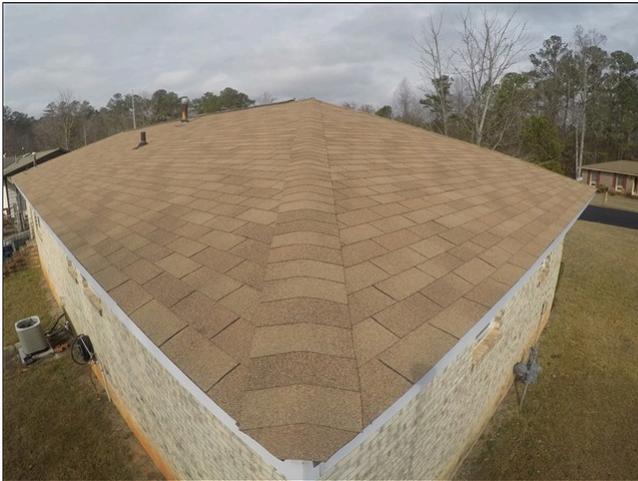
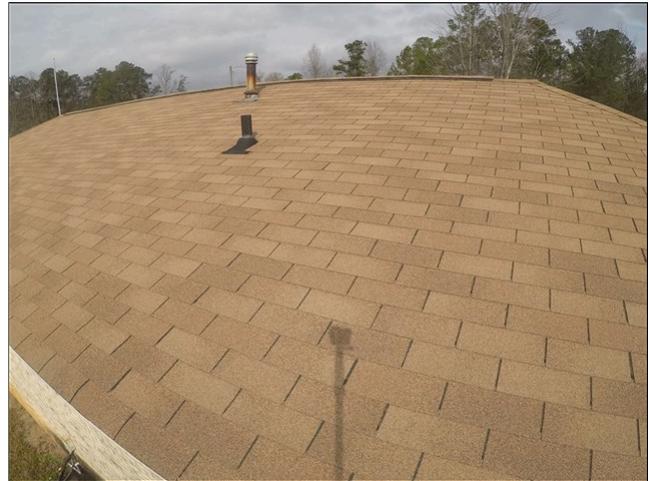
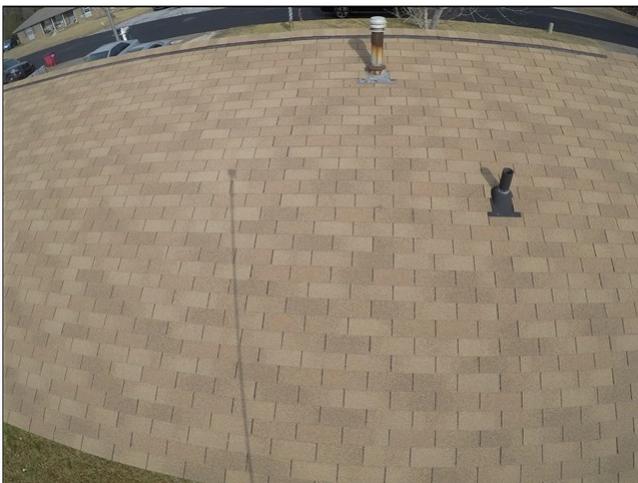
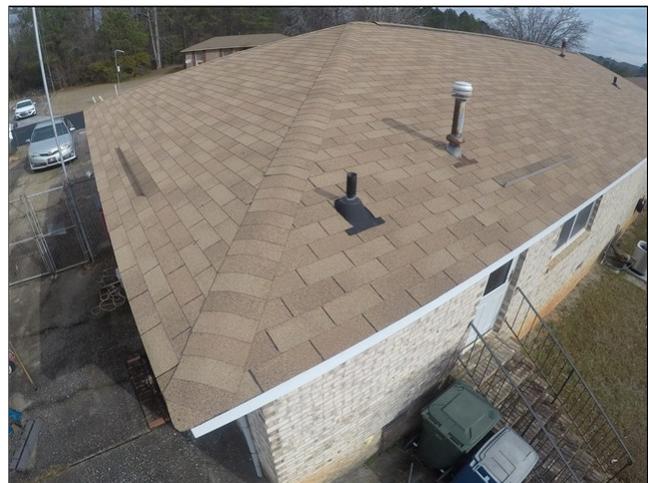
**Comments:** Inspected  
Roof Inspected

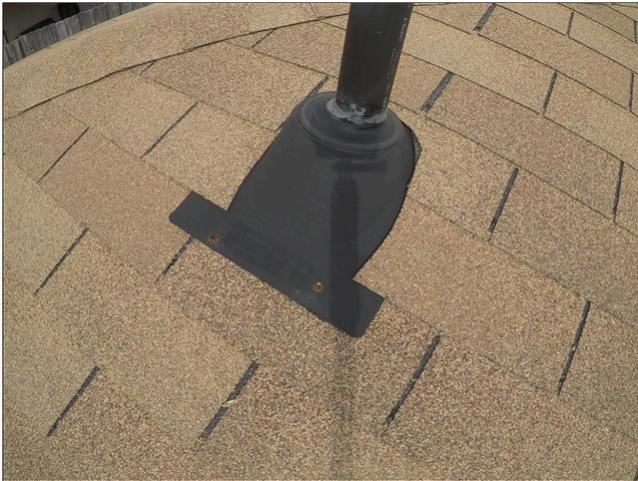
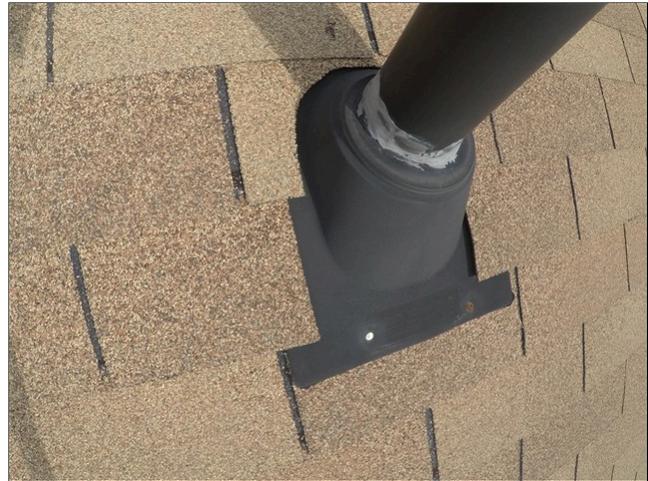
Roof boots at the rear of the home have exposed nail heads, this can lead to rust and potential moisture intrusion overtime. Recommend repair or replace as needed by qualified contractor.

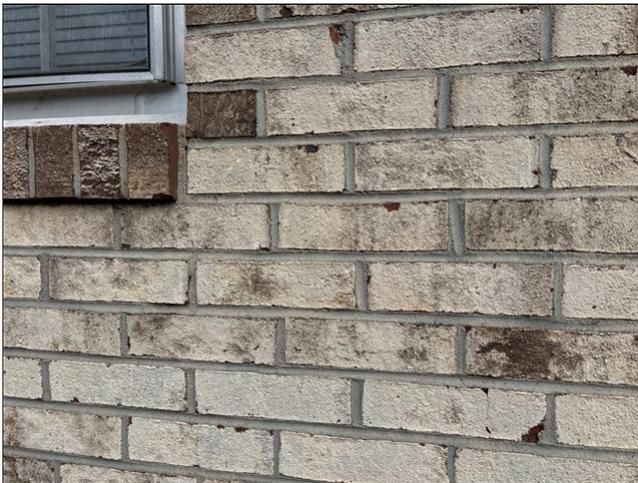
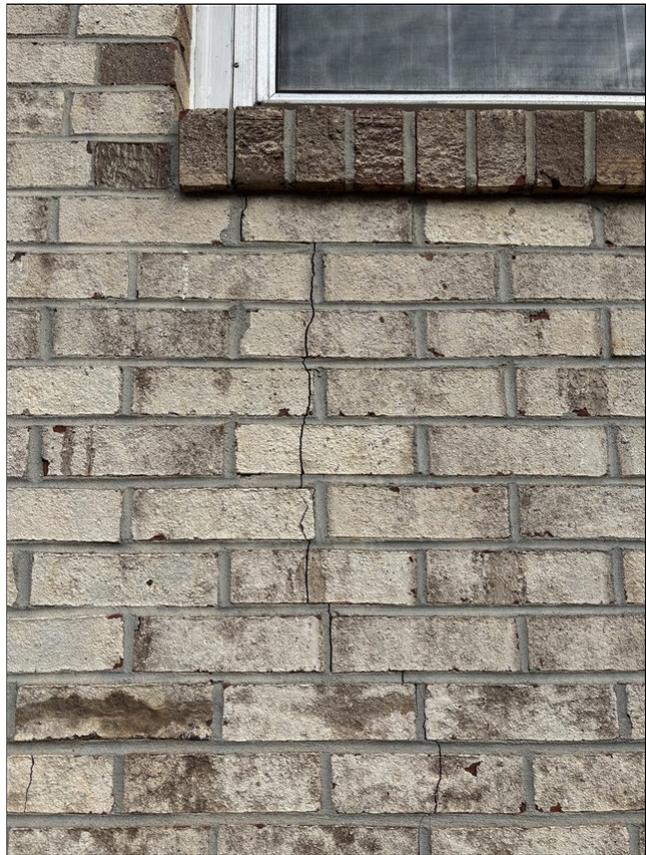
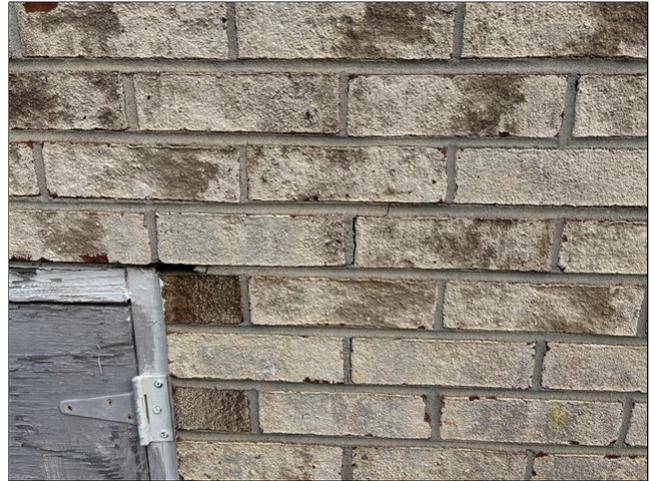
Exterior mortar joint cracks at the rear of the home in several areas, this is caused by common settling overtime. The cracks can be sealed with mortar to prevent moisture intrusion. Recommend repair as needed by qualified contractor.

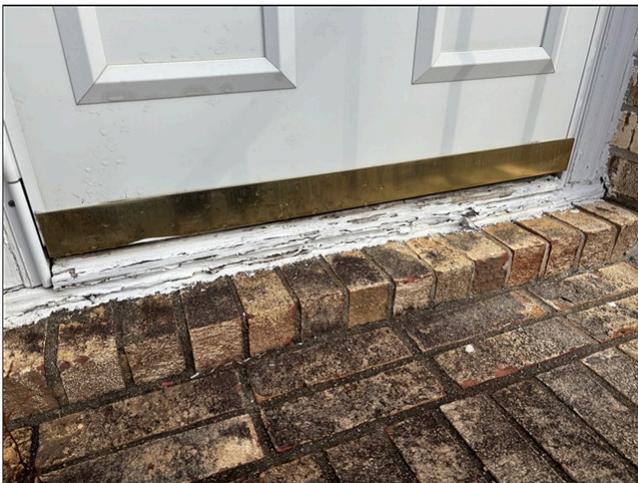
2.1 Item 1 (Picture)

(1) The base of the rear door frame is deteriorated from moisture intrusion. Recommend repair or replace as needed by qualified contractor.

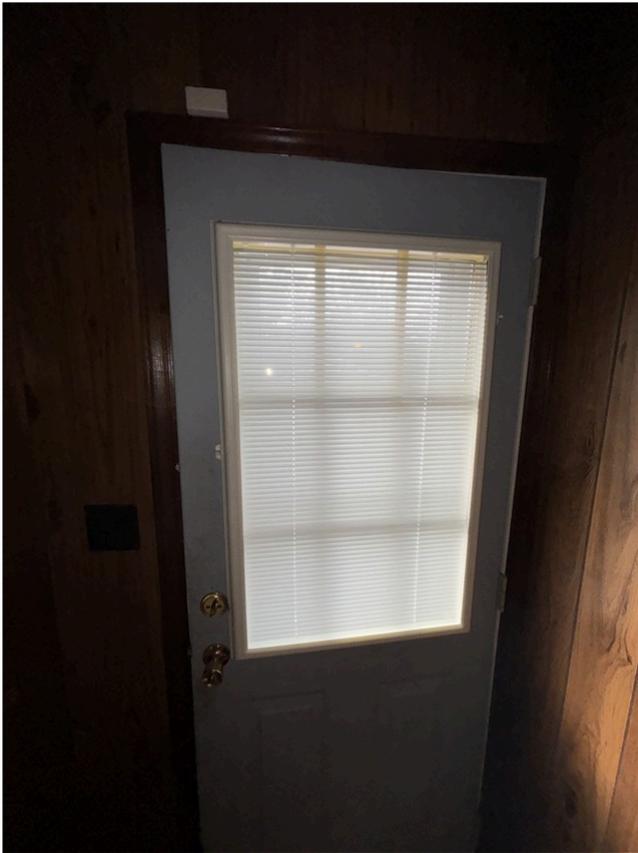
2.1 Item 2 (Picture)

(2) The rear exterior door hits the frame when closing, the door should be adjusted. Recommend repair or replace as needed by qualified contractor.

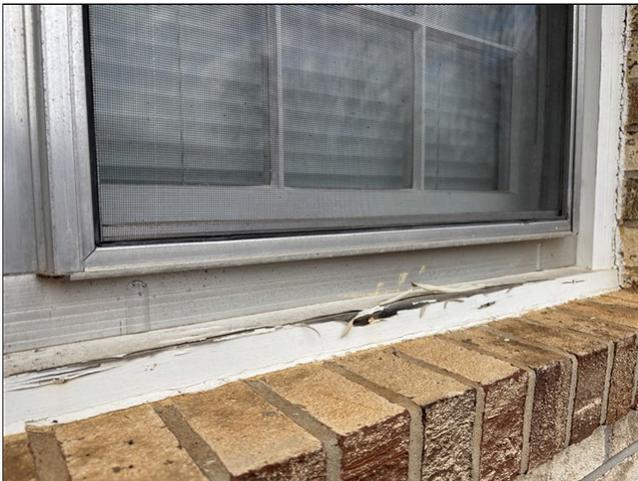
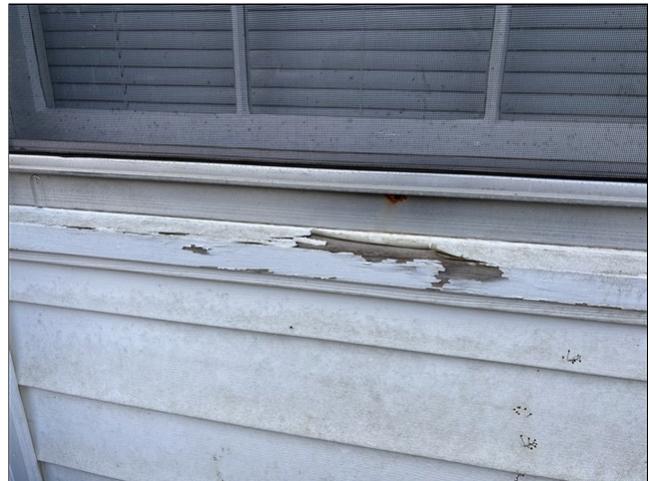
Deterioration at the windows around the home, the paint is peeling at the windows. Recommend resurfacing the windows and repair or replace as needed by qualified contractor.

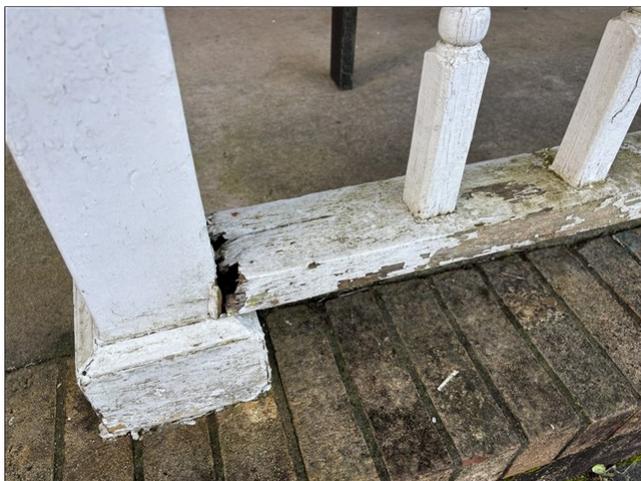
2.3 Item 1 (Picture)

(1) Handrail at the front porch is deteriorated and rotted, this could lead to injury. Recommend repair or replace as needed by qualified contractor.

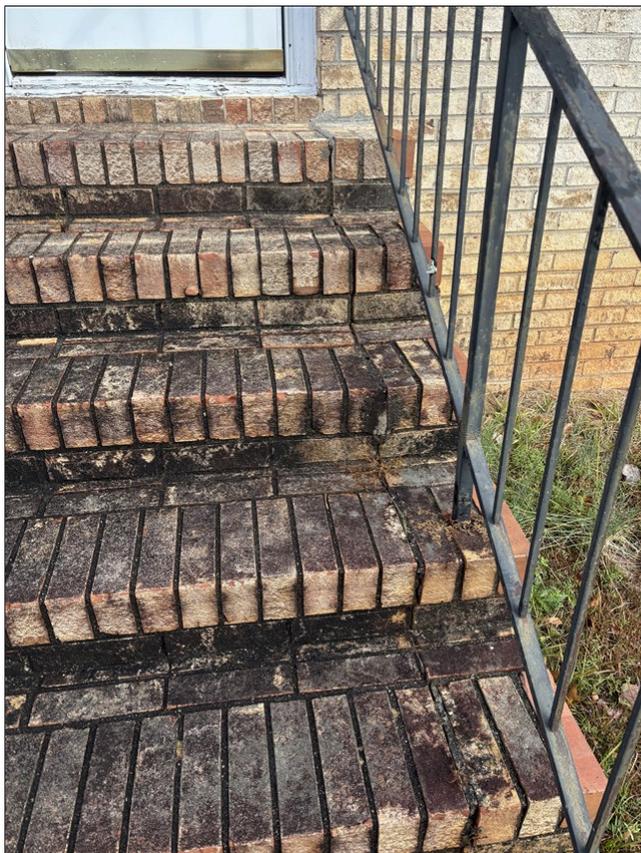
2.3 Item 2 (Picture)

(2) The rear steps have voids and gaps at the mortar joints. These areas should be re pointed or sealed to prevent further deterioration. A qualified contractor should repair or replace

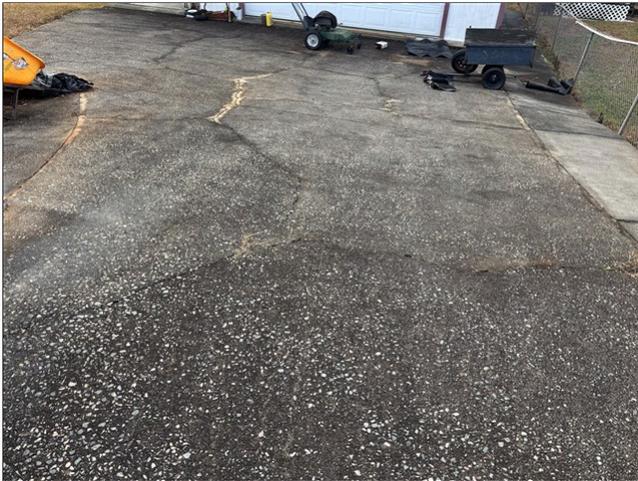
2.4 Item 1 (Picture)

(1) The concrete driveway has some small cracks. These are considered cosmetic at this point. No further action is required at this time.

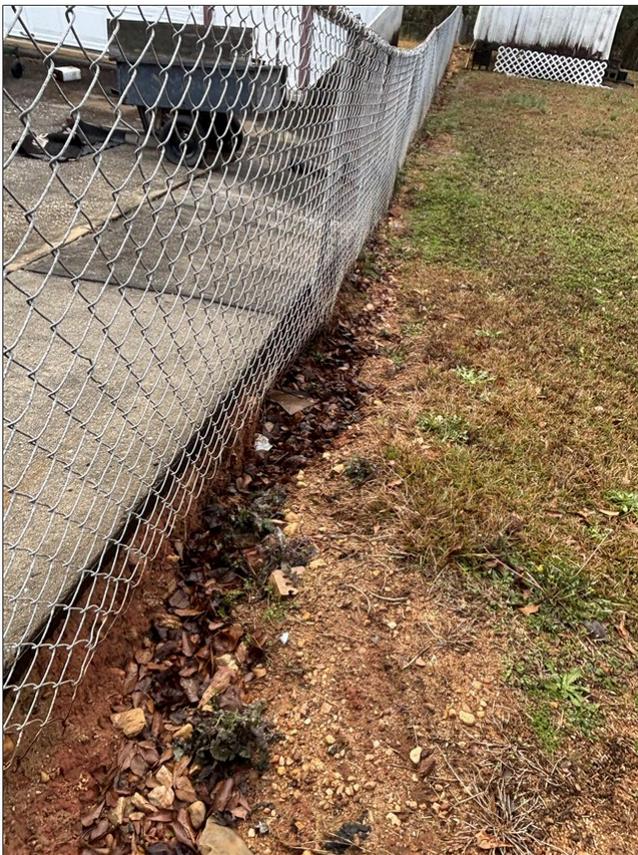
2.4 Item 2 (Picture)

(2) Soil erosion was observed along the edge of the driveway leading to the detached garage at the rear of the home. The driveway runs adjacent to the property line, and the erosion appears to be occurring primarily on the neighboring property; however, the loss of supporting soil is extending beneath the driveway slab. This condition may contribute to settlement or movement of the slab over time. Recommend further evaluation and repair as needed by a qualified contractor to stabilize the soil and prevent future movement or damage to the driveway.

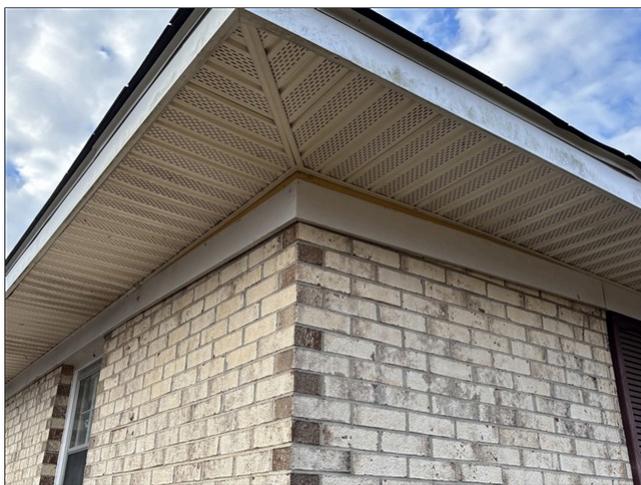
2.5 Item 1 (Picture)

Fascia falling at the left front of the home, this can expose the siding underneath to moisture or pest intrusion causing further damage overtime. Recommend repair or replace as needed by qualified

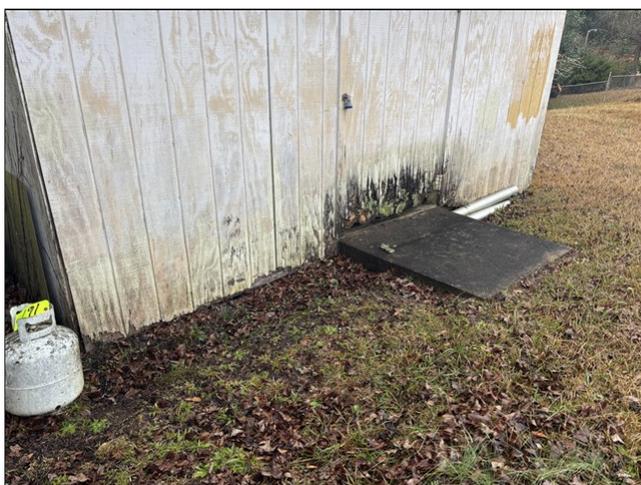
2.6 Item 1 (Picture)

(1) The front of the shed shows signs of major deterioration, this is likely caused by moisture buildup against the front of the shed. Recommend repair or replace as needed by qualified contractor.

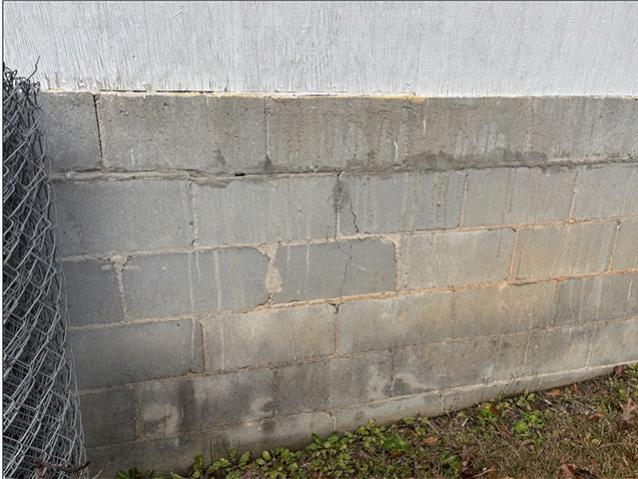
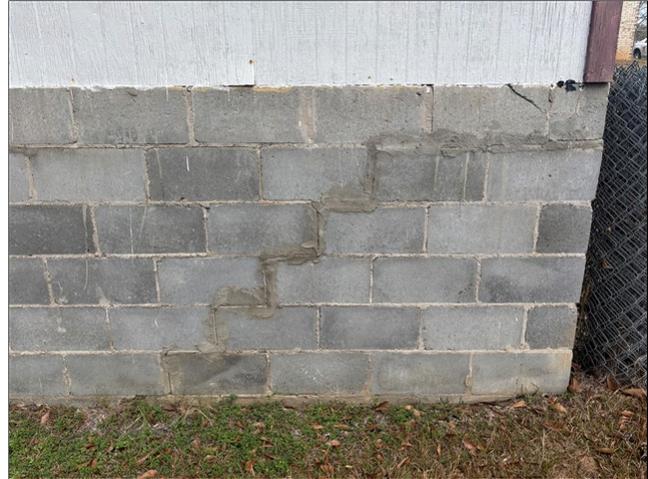
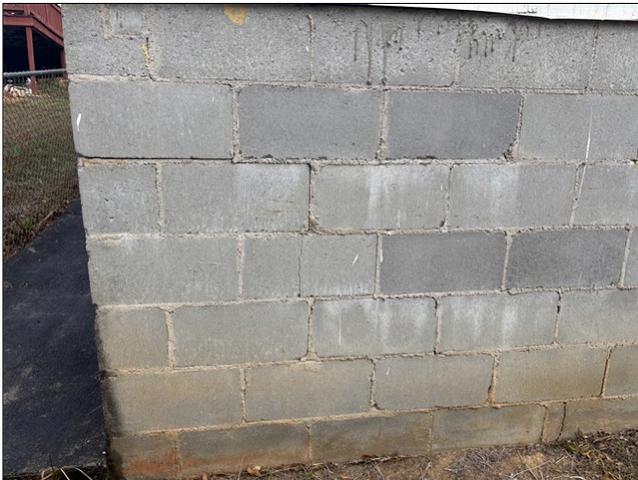
(2) Signs of common settling cracks in the foundation of the detached garage, there are no major signs of movement. The cracks can be sealed to prevent moisture intrusion that can lead to further damage.

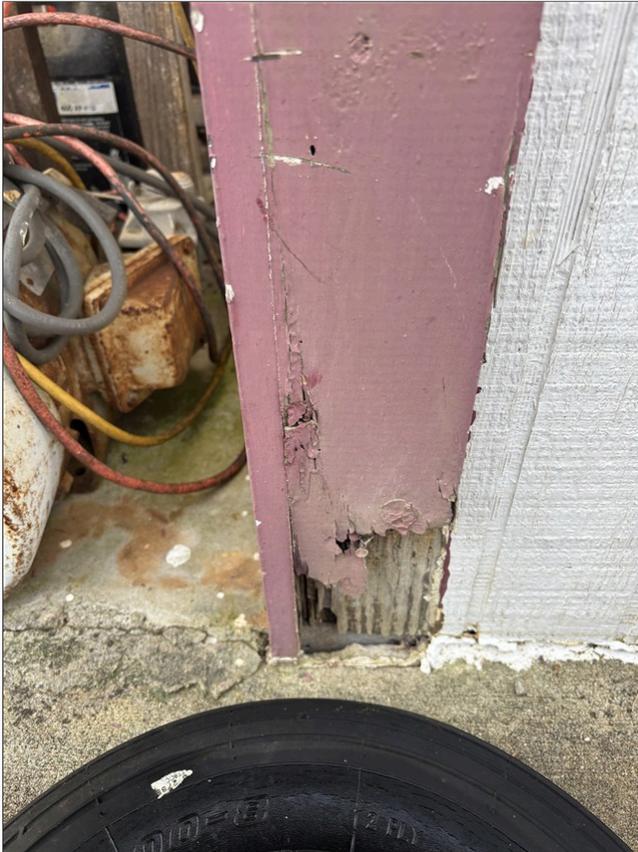
2.6 Item 6 (Picture)

(3) Signs of potential termite intrusion in the detached garage, i am not a qualified pest control expert so i am unable to determine if this is an active intrusion. Recommend qualified exterminator inspect and treat as needed.

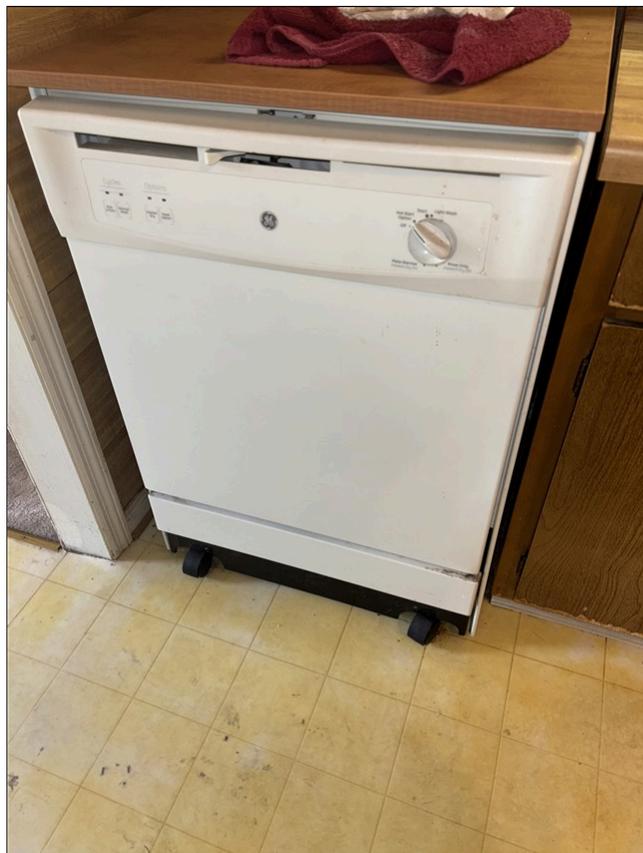
3.0 Item 1 (Picture)

(1) General Electric Dishwasher

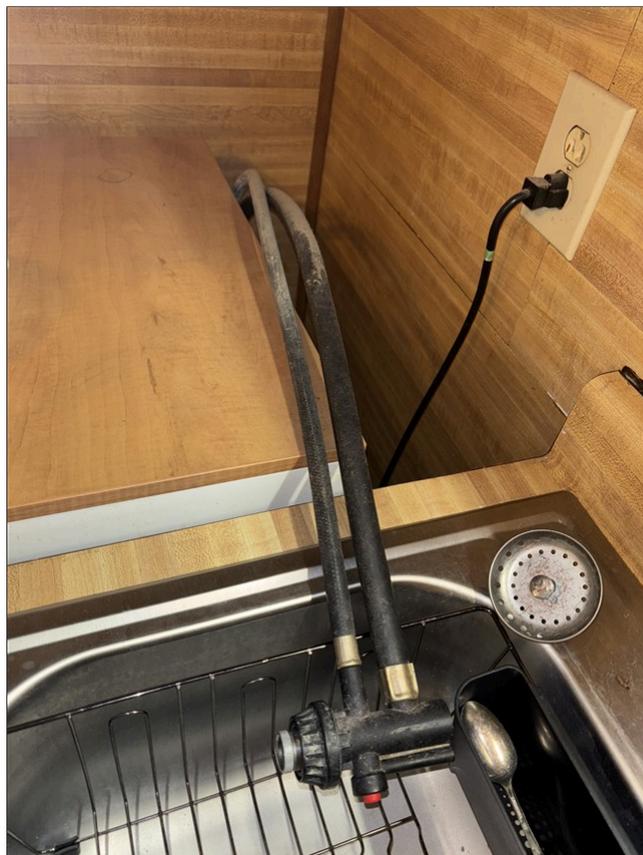
3.0 Item 2 (Picture)

(2) The dishwasher is a temporary unit that is designed to move. The water to the unit is not properly connect. Recommend repair or replace as needed by qualified contractor.

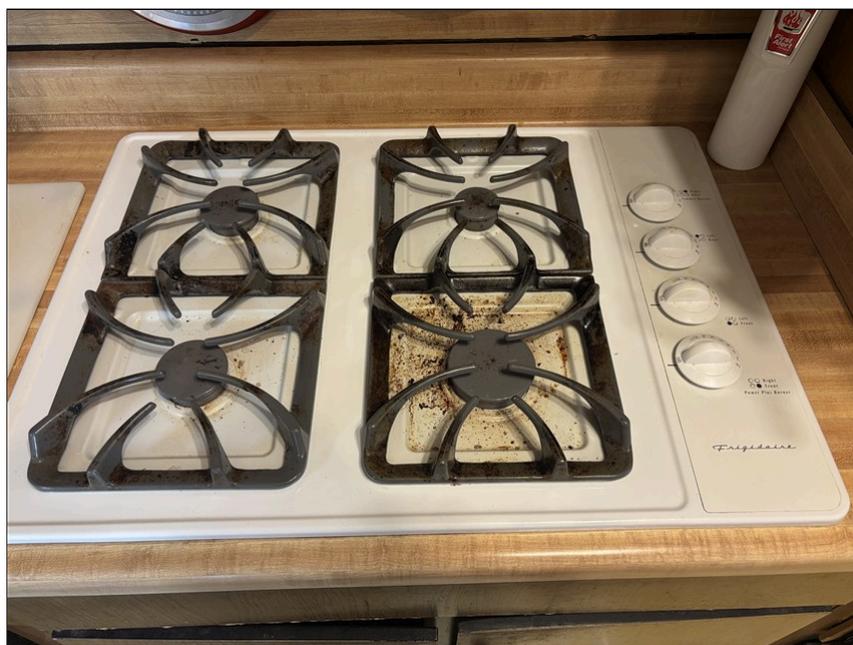
3.1 Item 1 (Picture)

(1) Frigidaire Cooktop - GAS

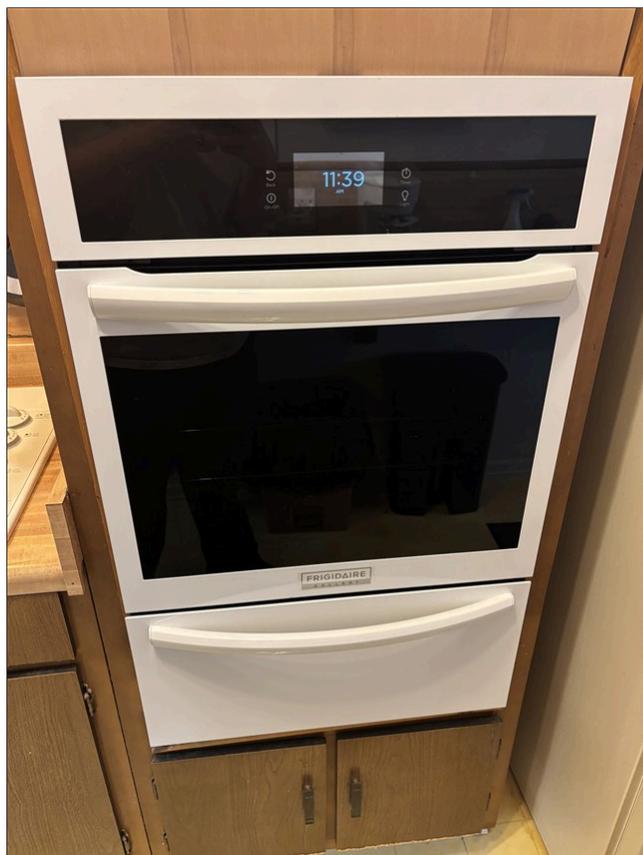
3.1 Item 2 (Picture)

(2) Frigidaire Oven

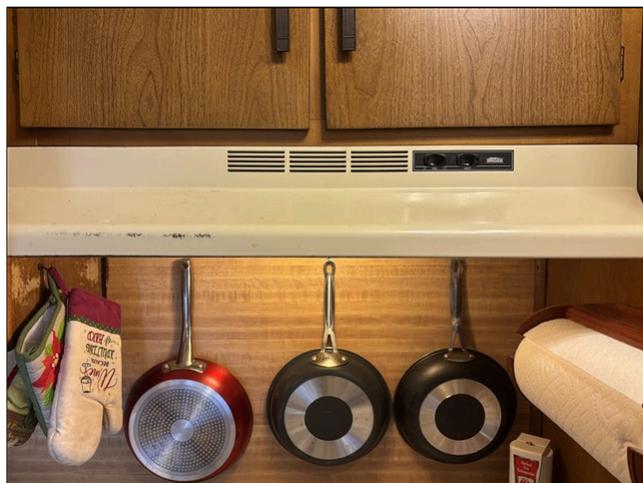
3.2 Item 1 (Picture)

**Comments:** Inspected  
Broan Vented Hood Vent

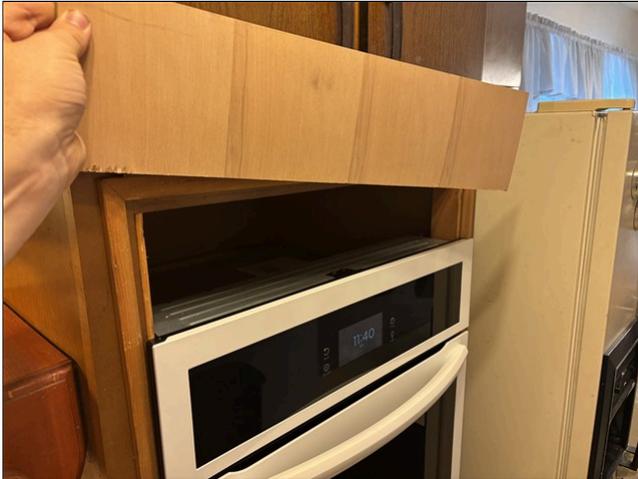
4.0 Item 1 (Picture)

Large gap over the top of the oven, this could be a safety hazard. The gap has been covered with a piece of wood but is not solid mounted. Recommend repair or replace as needed by qualified contractor.

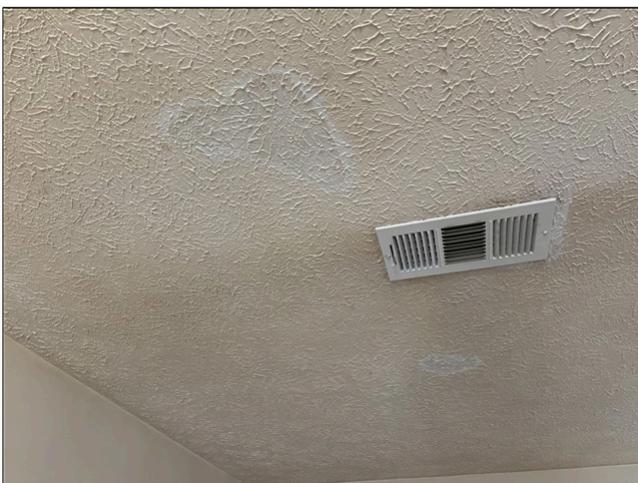
4.2 Item 1 (Picture)

(1) Signs of previous leaks in the living room ceiling, the areas were not actively wet during time of inspection and are likely previous leaks that have been repaired before the roof replacement.

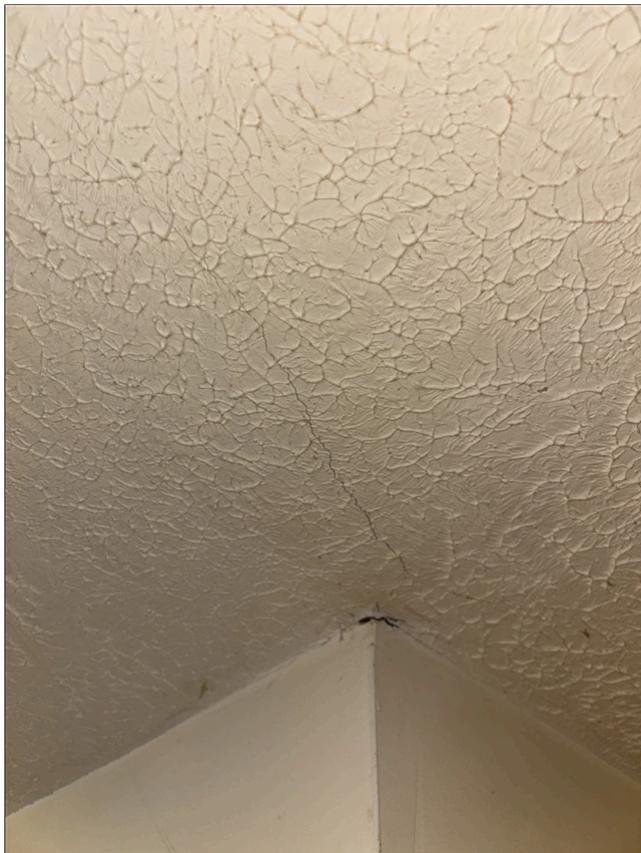
4.2 Item 2 (Picture)

(2) The ceiling in hallway reveals hairline cracks, the paper tape seam is loose from settlement. I recommend a qualified finisher correct as needed.

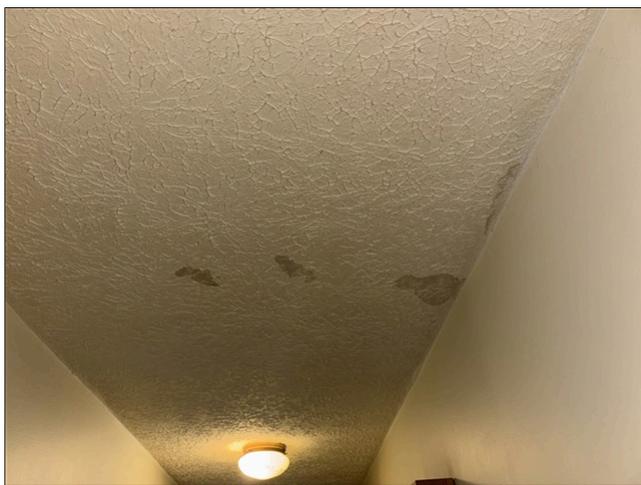
4.2 Item 3 (Picture)

(3) Signs of previous leaks in the hallway, the areas were not actively wet during time of inspection and is likely from before the roof replacement. Recommend repair or replace as needed by qualified contractor.

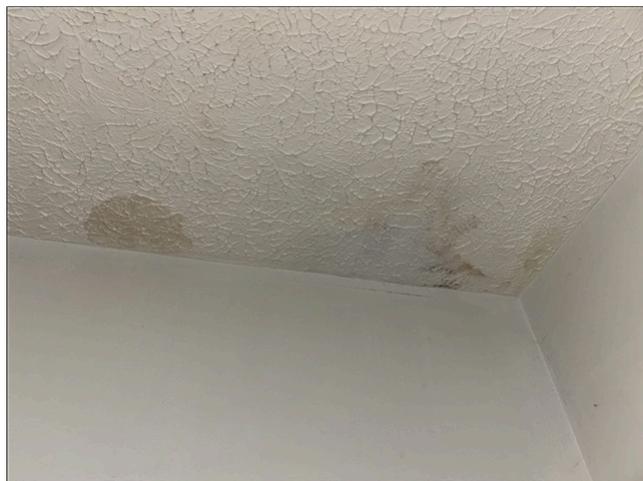
4.2 Item 4 (Picture)

(4) The ceiling has a stain indicating a leak did or still exists at the Guest bath. I am unable to determine if a repair is needed due to a lack of rain. I recommend monitor and repair leak if detected.

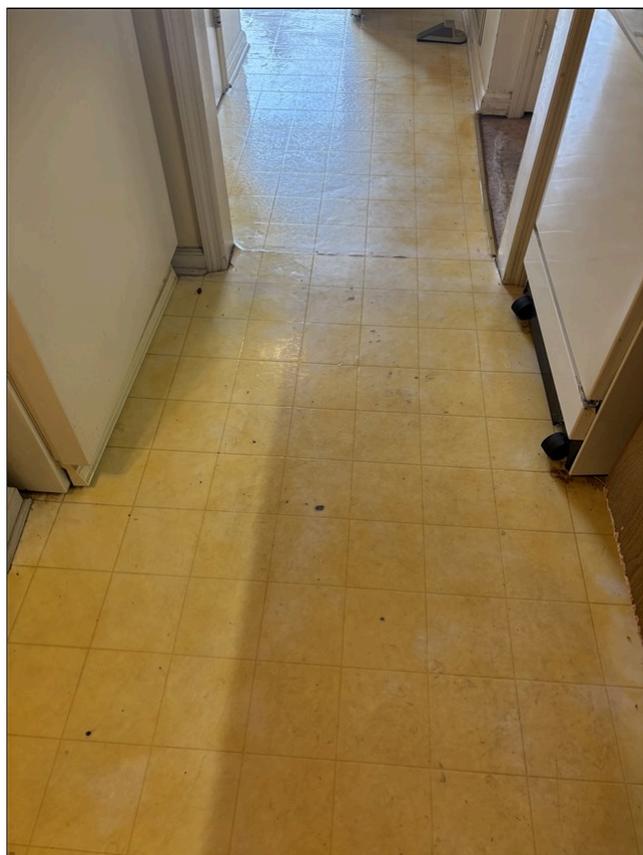
4.3 Item 1 (Picture)

(1) Damage to the linoleum throughout the home, with staining that has turned it yellow, and multiple holes through out. Recommend Repair or replace as needed by qualified contractor.

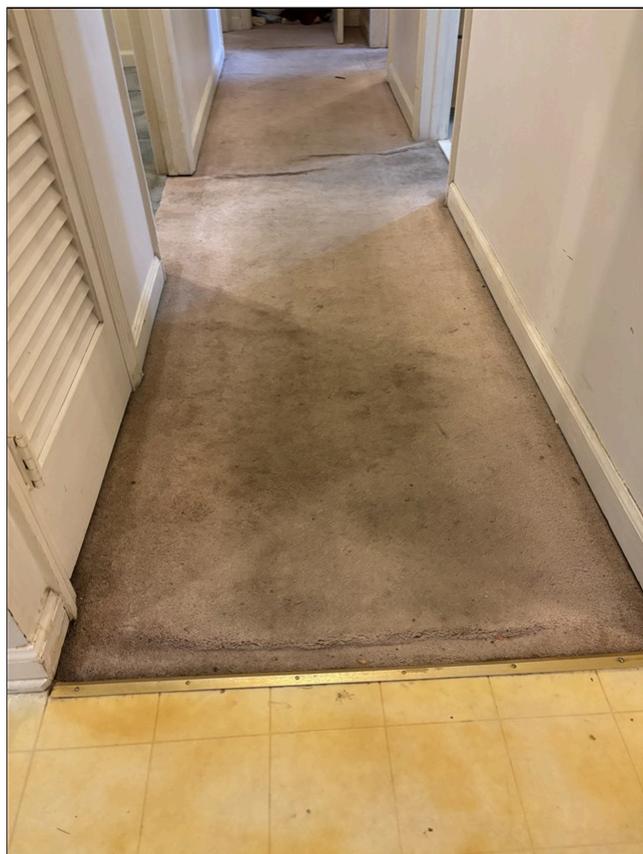
4.3 Item 5 (Picture)

(2) The carpet throughout the home is loose, wrinkled, and appears to be aged. Loose carpeting can present a trip hazard. Additionally, the home shows indications that previous occupants smoked indoors, which may have resulted in odors and residue being absorbed into the carpet. Recommend replacement of the carpeting as needed for improved safety, comfort, and indoor air quality.

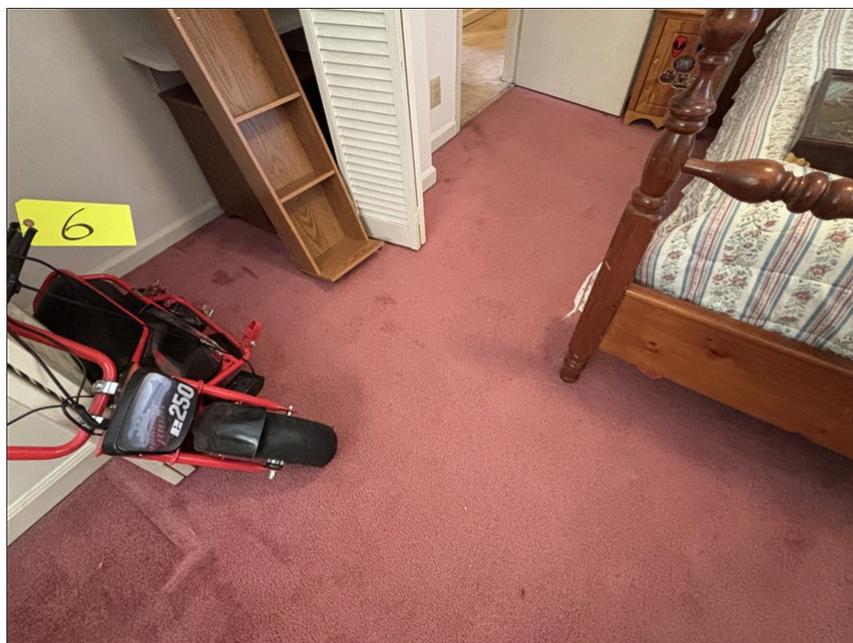
4.3 Item 6 (Picture)

(3) The subflooring in the front guest bedroom is squeaking and popping in several places . This can be repaired by securing the subfloor to the floor joists and should not be considered a structural defect. A qualified contractor should repair or replace.

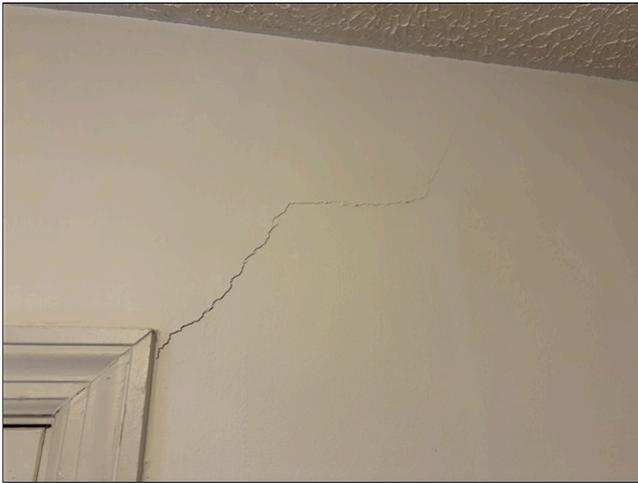
4.4 Item 1 (Picture)

(1) The wall in the entrance hallway reveals hairline cracks from settlement. This appears to be cosmetic in nature. I recommend a qualified finisher correct as needed.

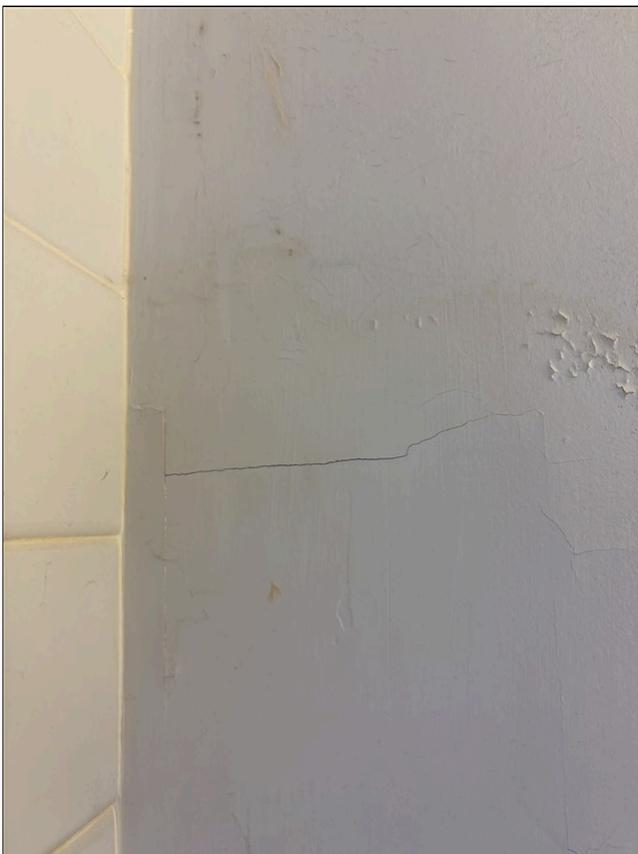
4.4 Item 2 (Picture)

(2) The wall in the master bath reveals hairline cracks from settlement. This appears to be cosmetic in nature. I recommend a qualified finisher correct as needed.

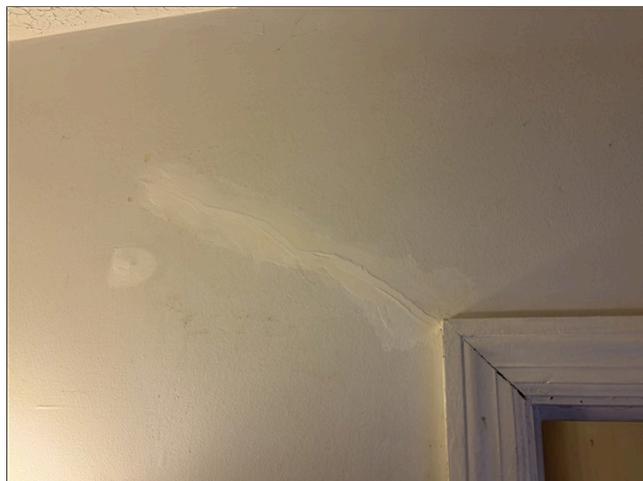
4.4 Item 3 (Picture)

(3) The wall in master bathroom reveals hairline cracks from settlement. This appears to be cosmetic in nature. I recommend a qualified finisher correct as needed.

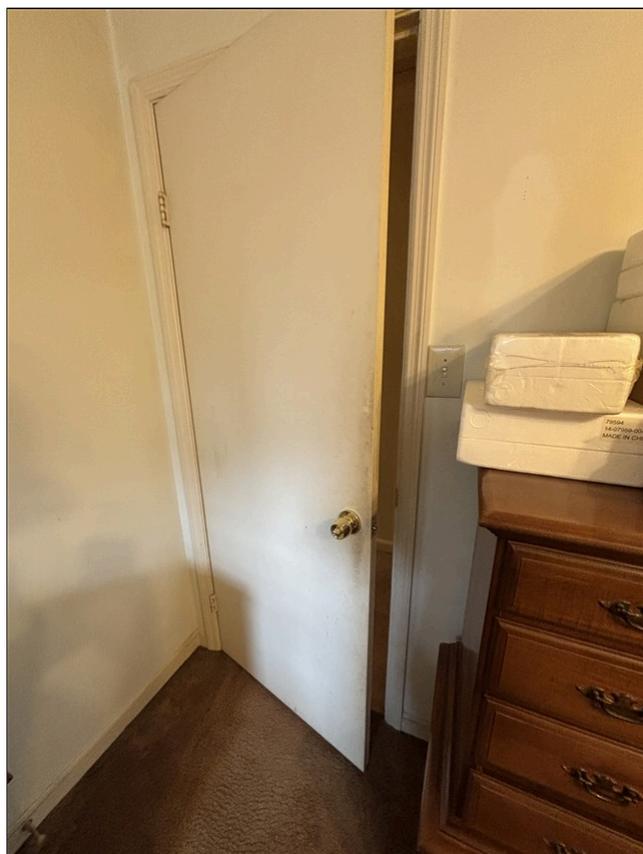
4.7 Item 1 (Picture)

(1) The master bedroom door did not latch properly, the door should be adjusted. Recommend repair or replace as needed by qualified contractor.

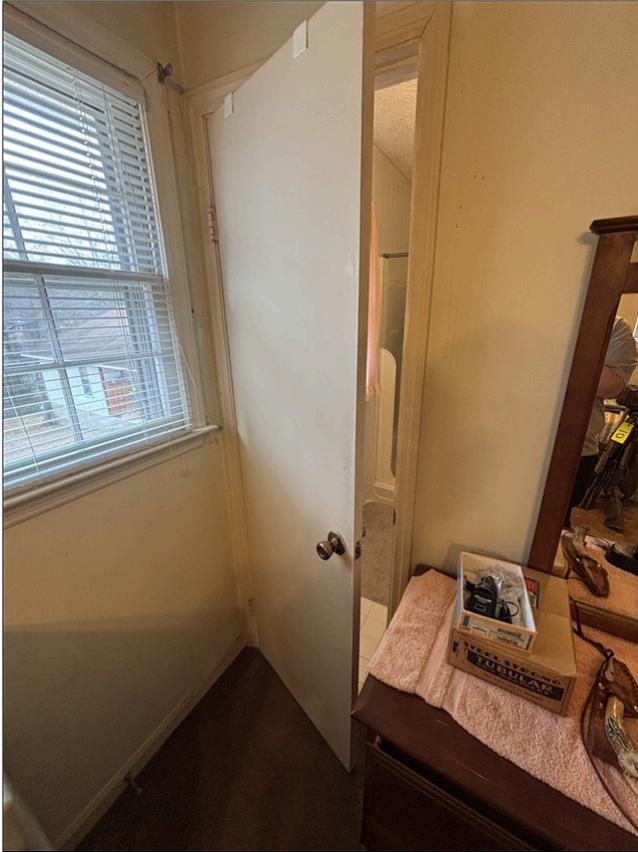
4.7 Item 2 (Picture)

(2) The master bathroom door does not latch properly, the door should be adjusted. Recommend repair

or replace as needed by qualified contractor.

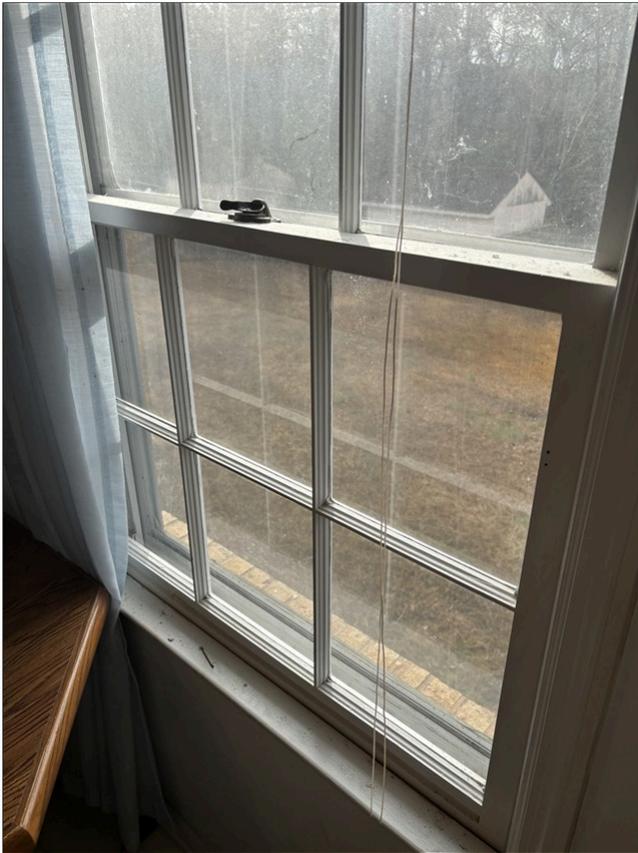
4.8 Item 1 (Picture)

All windows are stuck and painted shut. This is a safety issue if the window will not open in the event of a fire. The windows should open and close properly . A qualified person should repair or replace as needed.

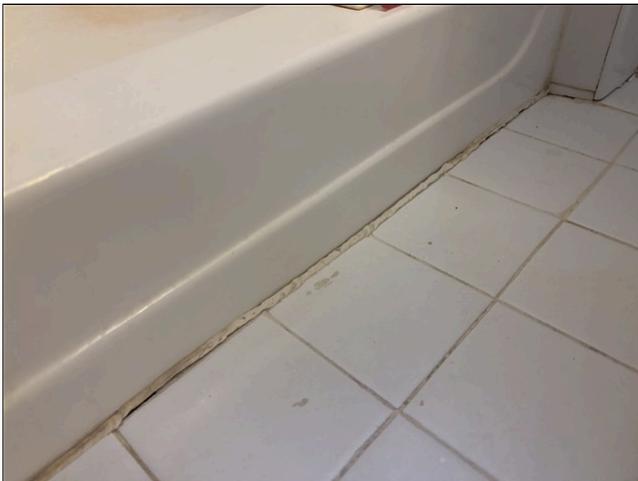
5.6 Item 1 (Picture)

I recommend silicone caulk along floor and threshold of shower at master bath. This can allow for moisture intrusion causing further damage.

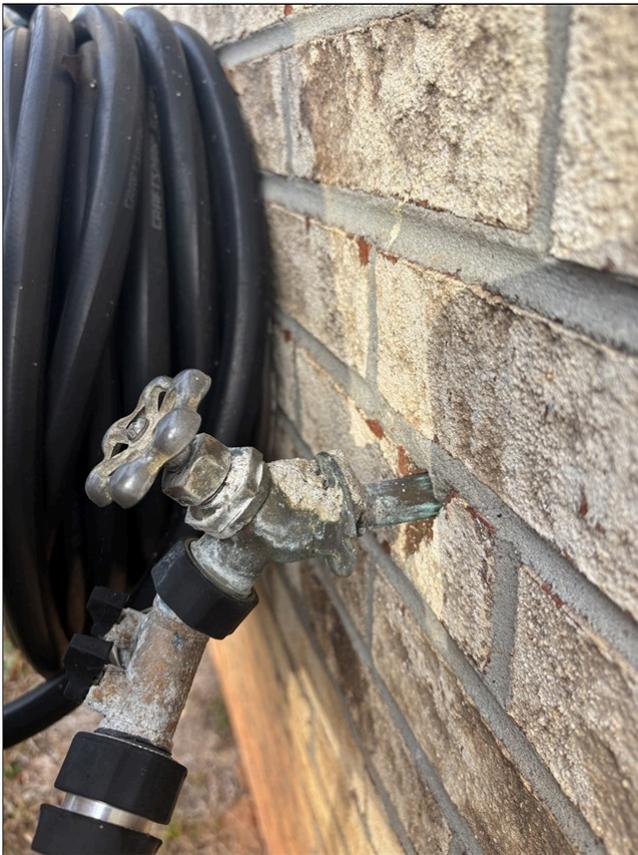
6.0 Item 1 (Picture)

(1) The water spigot at the rear of the home is loose in the wall, this can lead to leaks at the crawlspace. Recommend hard mounting the spigot to the wall to prevent damages, Repair or replace as needed..

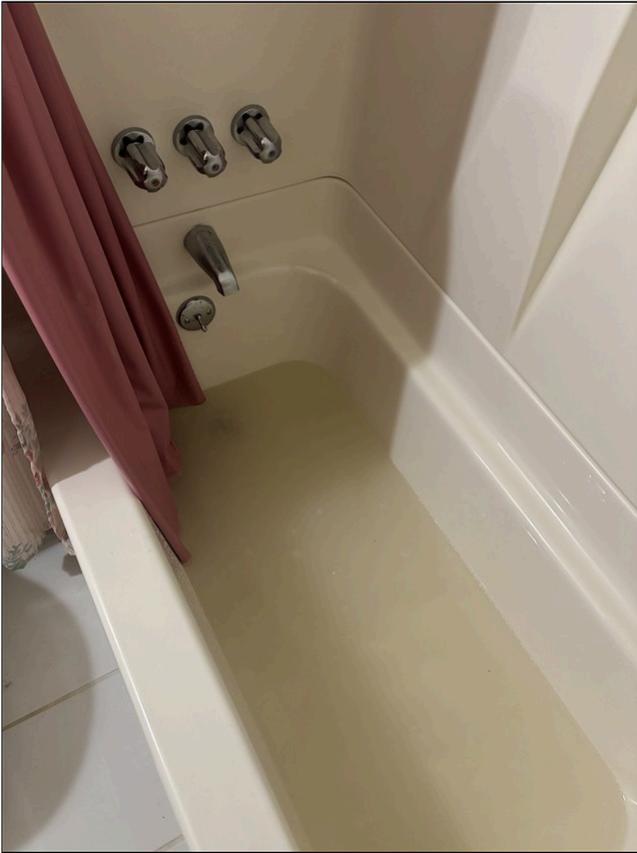
6.0 Item 2 (Picture)

(2) The water observed at multiple fixtures throughout the home appeared cloudy when operated at the time of inspection. Additionally, the water heater (manufactured in 2020) was not heating water, as the pilot light was found to be off. The cause of these conditions was not determined during the inspection. Recommend further evaluation and repair as needed by a qualified plumber or water heater technician.

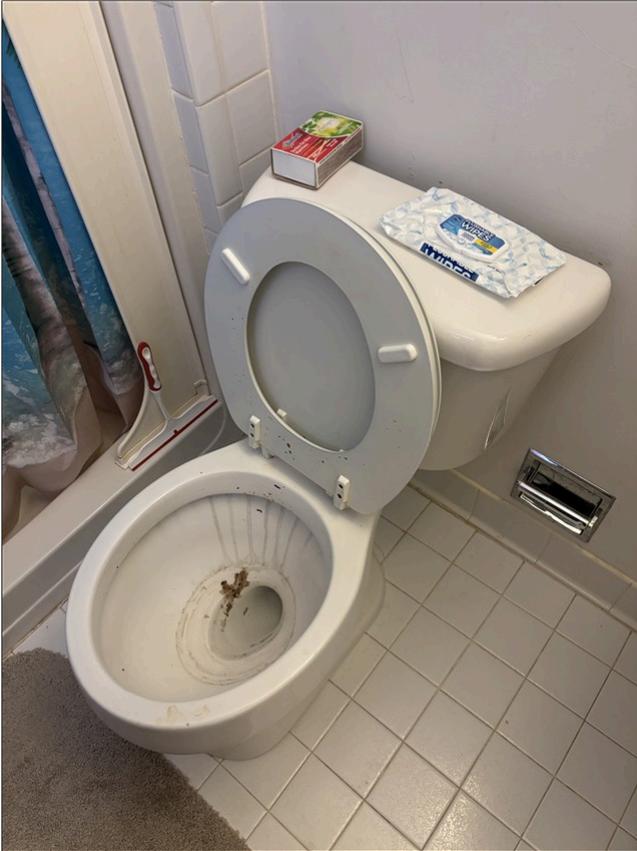
6.0 Item 3 (Picture)

(3) The toilet is loose at floor at the Master bath. Repairs may involve re-setting the toilet on a new wax seal. I recommend a qualified licensed plumber repair or correct as needed.
