# Inspection Report

**Property Address:**  
4696 Pine Valley Dr  
Macon GA 31210

<b>Date:</b> 1/23/2026	<b>Time:</b> 09:00 AM	<b>Report ID:</b> 20260123-4696-Pine-Valley-Dr
<b>Property:</b> 4696 Pine Valley Dr Macon GA 31210	<b>Customer:</b> Steve Slocumb	<b>Real Estate Professional:</b>

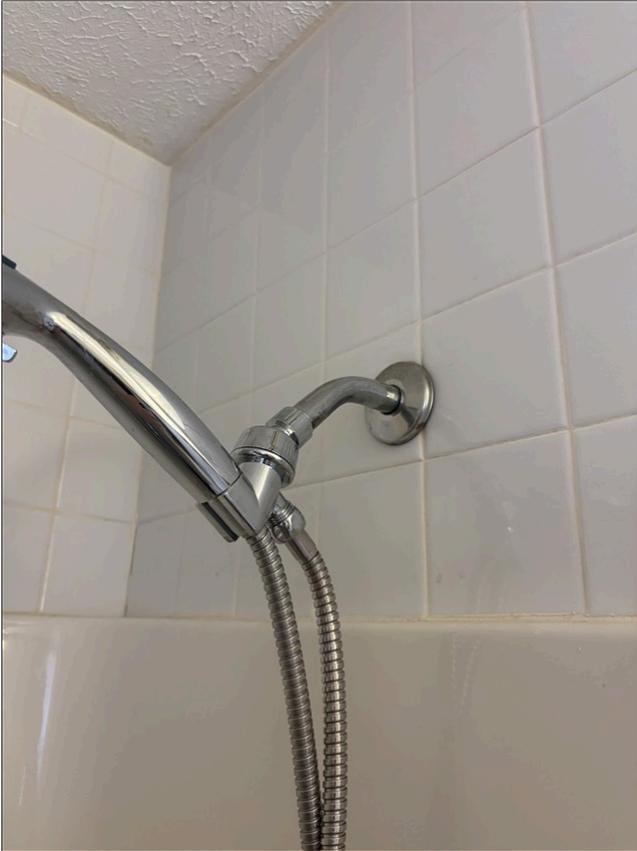
6.0 Item 4 (Picture)

(4) The shower head piping is loose in the wall and needs to be secured at the master bath. A qualified person should repair or replace.

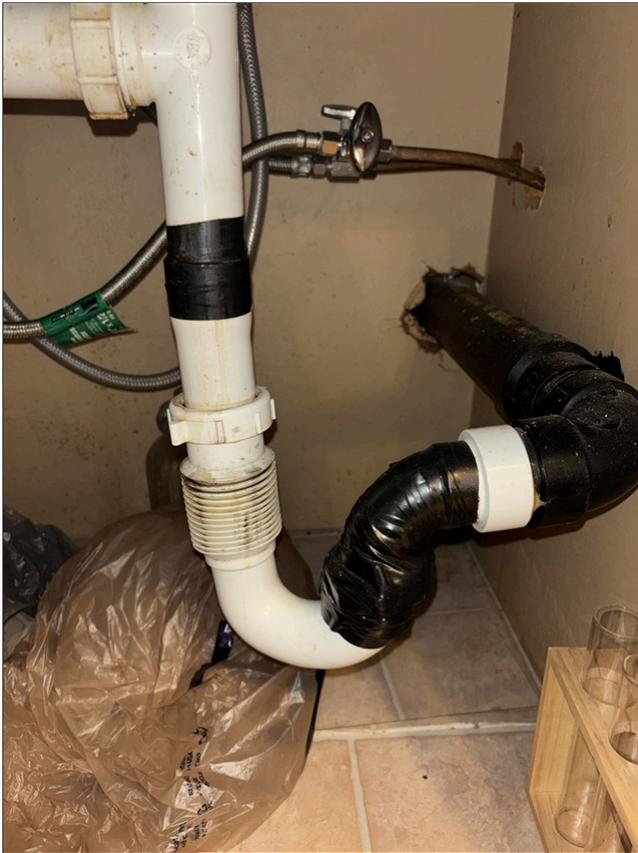
6.1 Item 1 (Picture)

(1) Plumbing drain under the kitchen sink is taped together, this could lead to leaks overtime causing further damage. Recommend repair or replace as needed by qualified contractor.

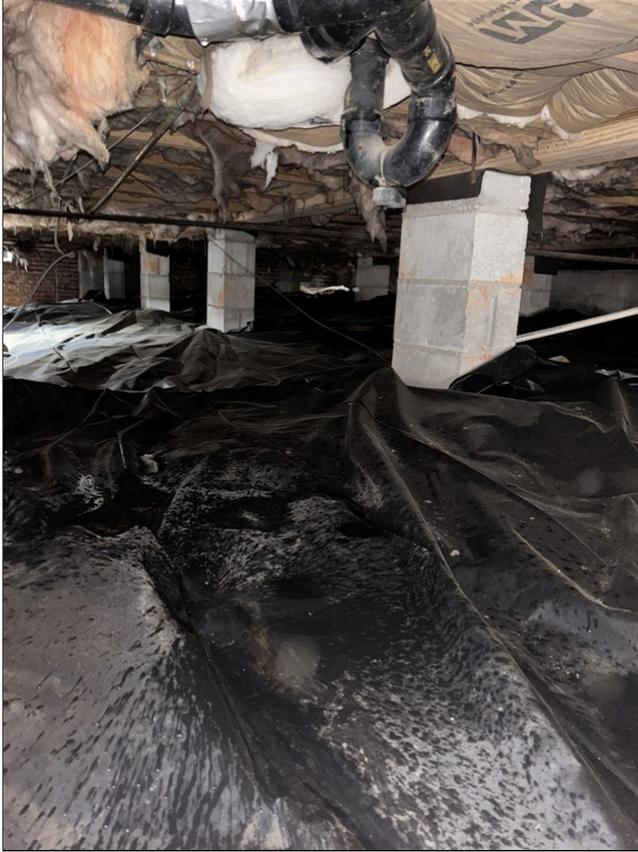
6.1 Item 2 (Picture)

(2) Plumbing drain in the crawlspace has a large leak, the pipes are taped together with duct tape. This can lead to moisture intrusion in the crawlspace causing further damages. Recommend repair or replace as needed by qualified contractor.

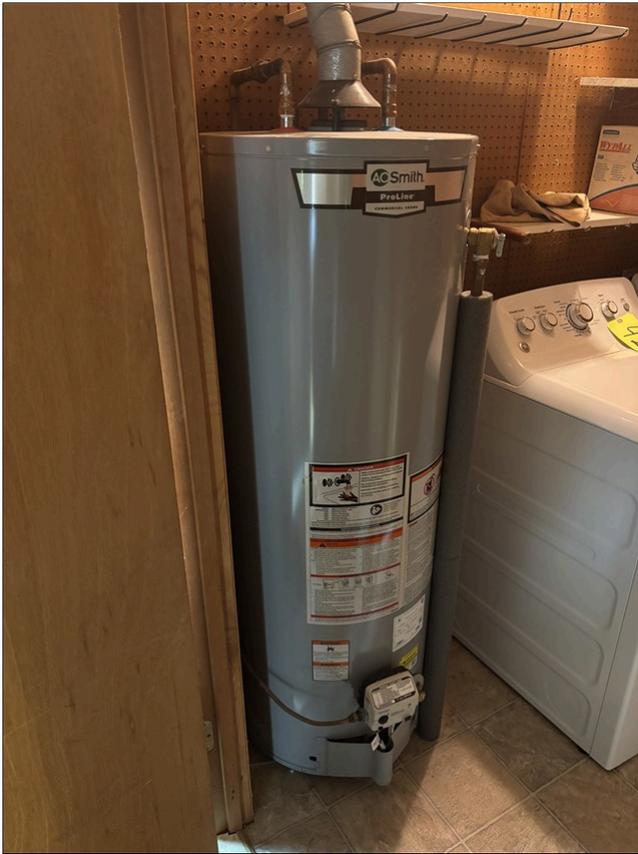
6.2 Item 1 (Picture)

(1) 2020 - 40 Gallon - AO Smith Hot Water Heater

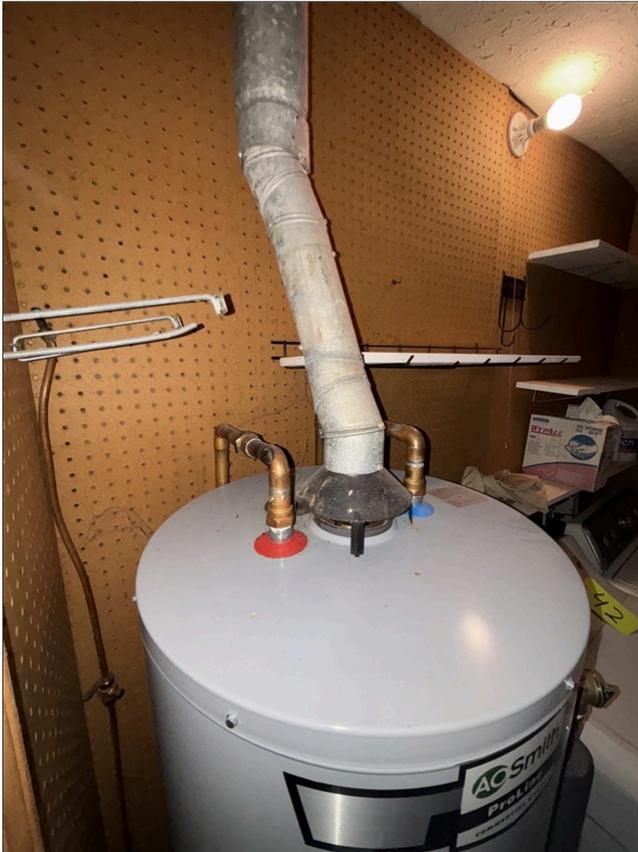
6.2 Item 3 (Picture)

(2) Your water heater does not have a "Thermal Expansion tank" installed to relieve tank pressure and prevent a possible leak at the T&P or "pop-off" valve. Recent changes in code in 2007 require one when a new water heater is installed. A licensed plumber should install an expansion tank.

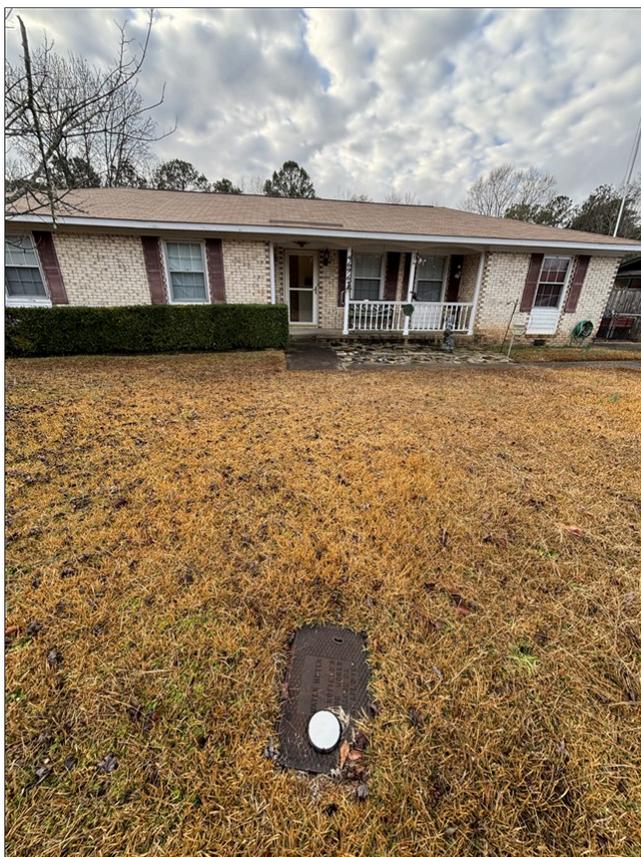
6.3 Item 1 (Picture)

The water meter and main shut off are located in the front yard .

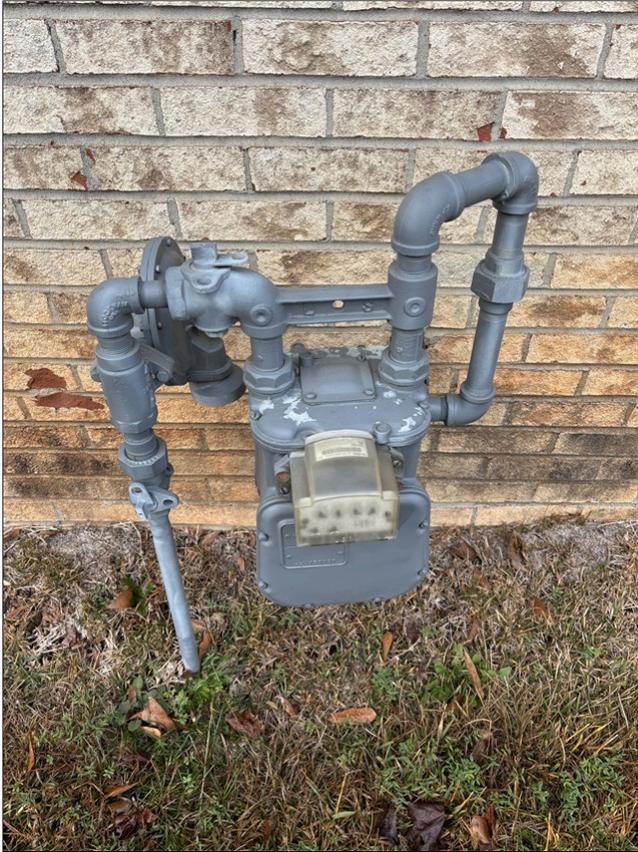
6.5 Item 1 (Picture)

The main fuel shut off is at gas meter outside

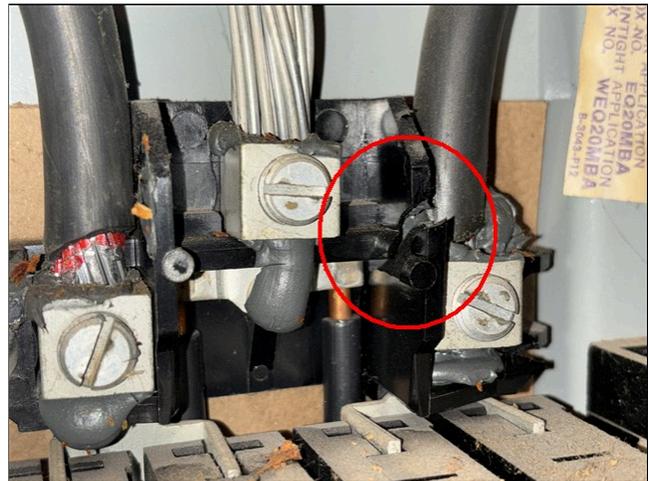
7.0 Item 2 (Picture)

The bracket securing the main service conductors inside the electrical panel was observed to have a small crack. Damage to this component could allow the service conductors to become loose, creating a significant safety hazard. Recommend evaluation and repair or replacement as needed by a qualified electrician.

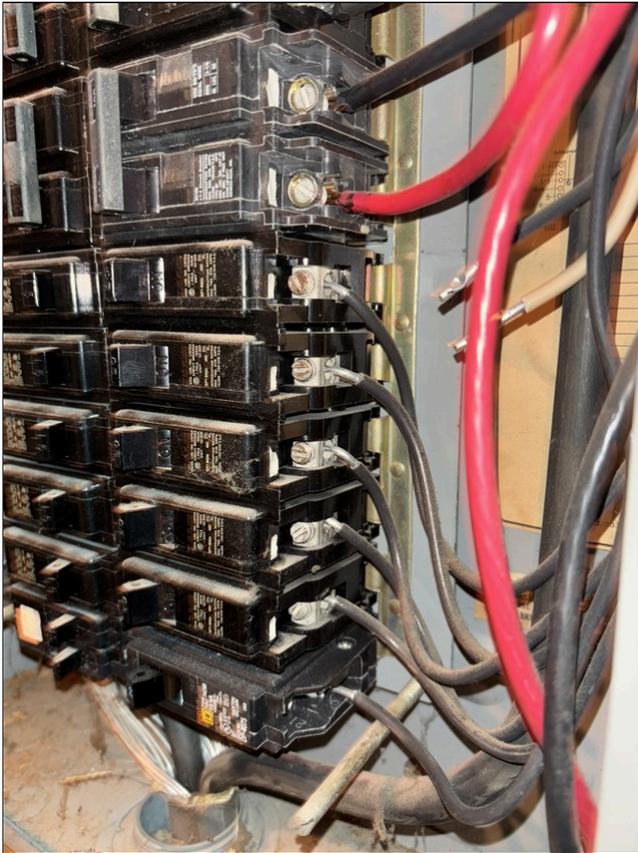
7.2 Item 1 (Picture)

(1) Aluminum wire is installed on 120 VAC branch electrical circuits in the subject house. These single strand, branch circuit aluminum wires were used widely in houses during the mid 1960s and 1970s. According to the U.S. Consumer Product Safety Commission, problems due to expansion can cause overheating at connections between the wire and devices (switches and outlets) or at splices, which has resulted in fires. For further information on aluminum wiring contact the U.S. Consumer Product Safety Commission via the Internet at <http://www.cpsc.gov/> . It is recommended that the electrical system be evaluated by a licensed electrical contractor.

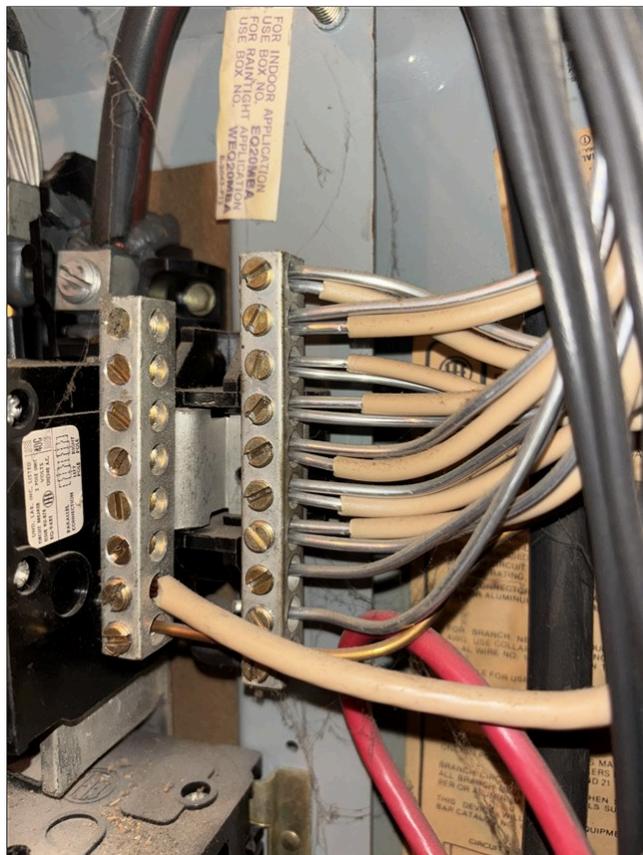
7.2 Item 3 (Picture)

(2) Multiple grounding conductors were observed terminated under a single lug (double-lugged). Most terminals are designed to accept only one conductor, and this condition may result in a loose or improper connection. Recommend evaluation and correction as needed by a qualified electrician.

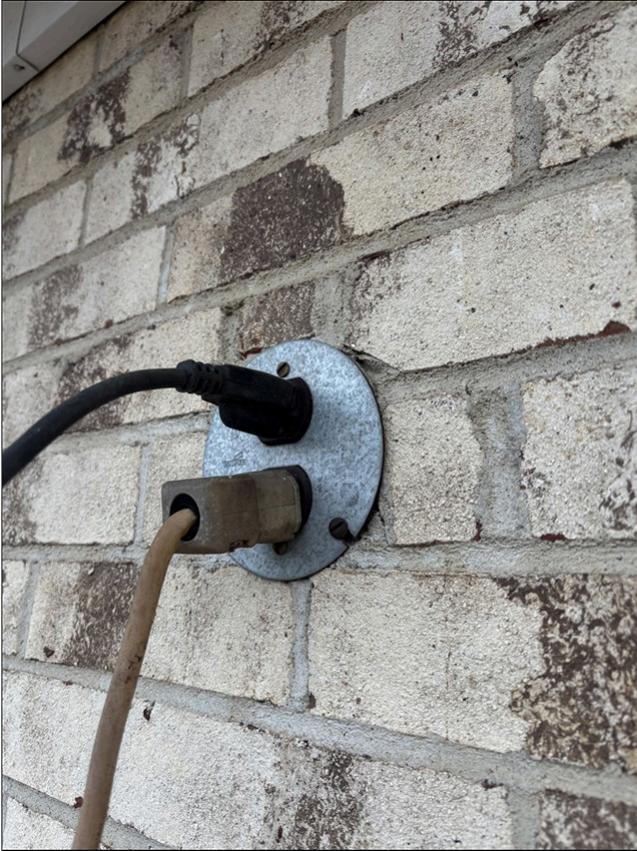
7.3 Item 1 (Picture)

(1) The exterior electrical outlet located at the right rear of the home is not properly covered and is not GFCI protected. This condition presents a potential safety hazard, especially in wet conditions. Recommend installation of a weather-resistant cover and GFCI protection by a qualified electrician to improve safety and meet current standards.

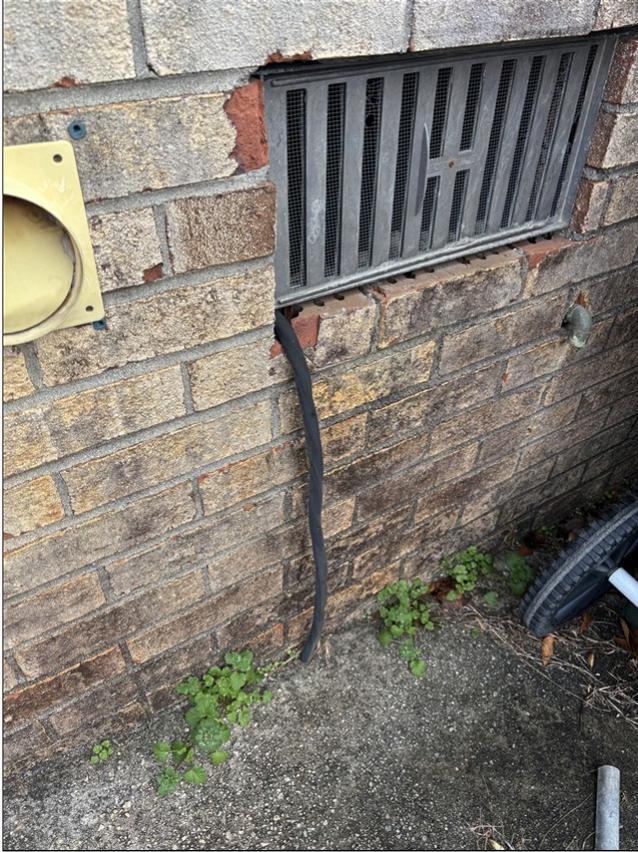
7.3 Item 2 (Picture)

(2) Exposed electrical wiring at the rear of the home, this is likely power leading to the detached garage, this leaves the wire exposed to sun damage or external damaging. Recommend installing a conduit for the wiring to run through for protection.

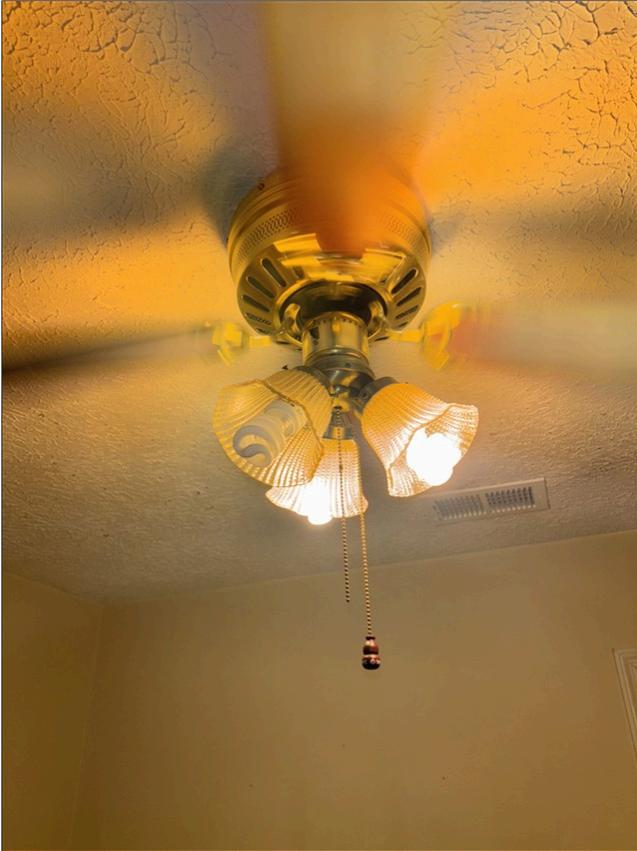
7.3 Item 3 (Picture)

(3) Light out at the guest bedroom, this can be a simple bulb replacement or possible electrical issue. Recommend repair or replace as needed.

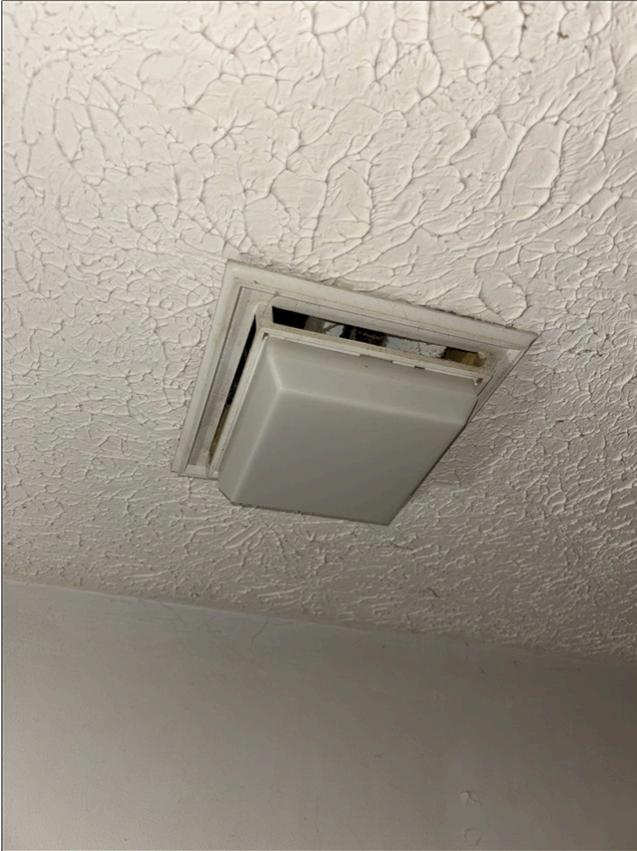
7.3 Item 4 (Picture)

(4) Light and fan at the guest bathroom did not work properly when tested. Recommend repair or replace as needed by qualified contractor.

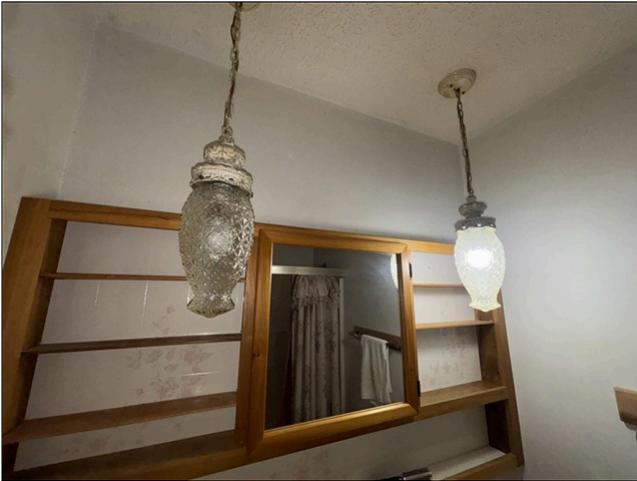
7.3 Item 5 (Picture)

(5) Light out at the guest bathroom, this could be a simple bulb replacement or possible electrical issue. Recommend repair or replace as needed.

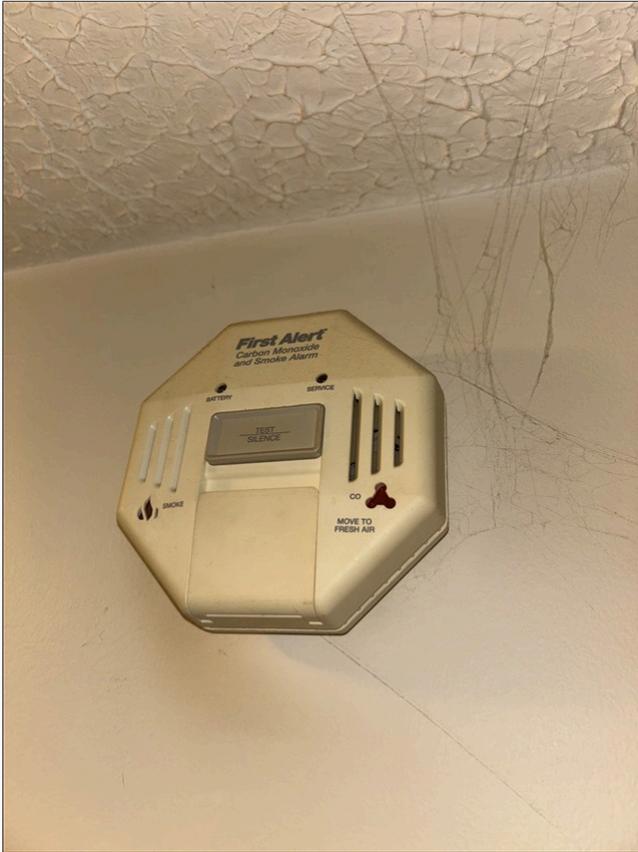
7.8 Item 1 (Picture)

(2) The smoke alarms in this home are over 10 years old and should be replaced. The National Fire Protection Association issued NFPA standard 72 that says all smoke alarms and carbon monoxide detectors should be replaced when they are 10 years old or sooner. A qualified person should replace all smoke alarms. for more info: <https://www.nachi.org/smoke-alarm-inspection.htm>

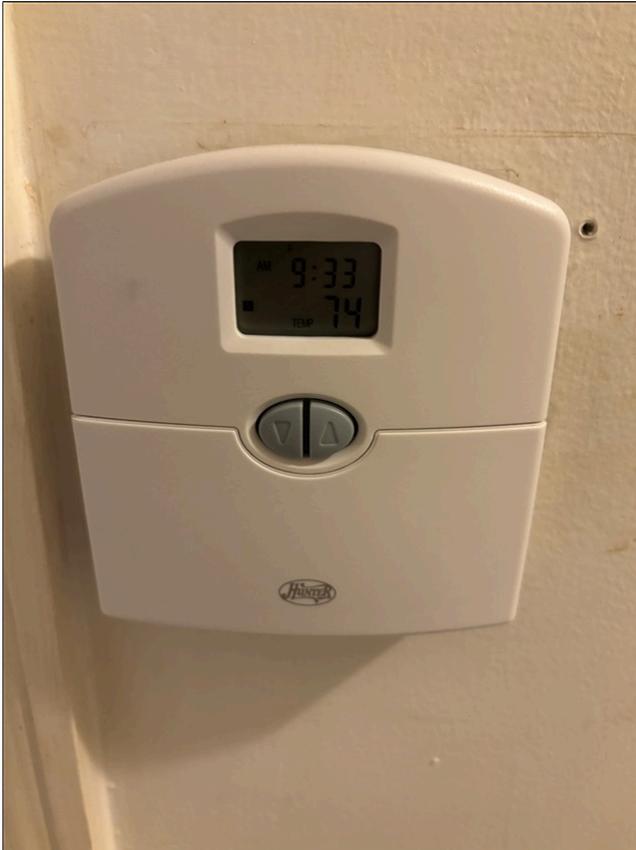
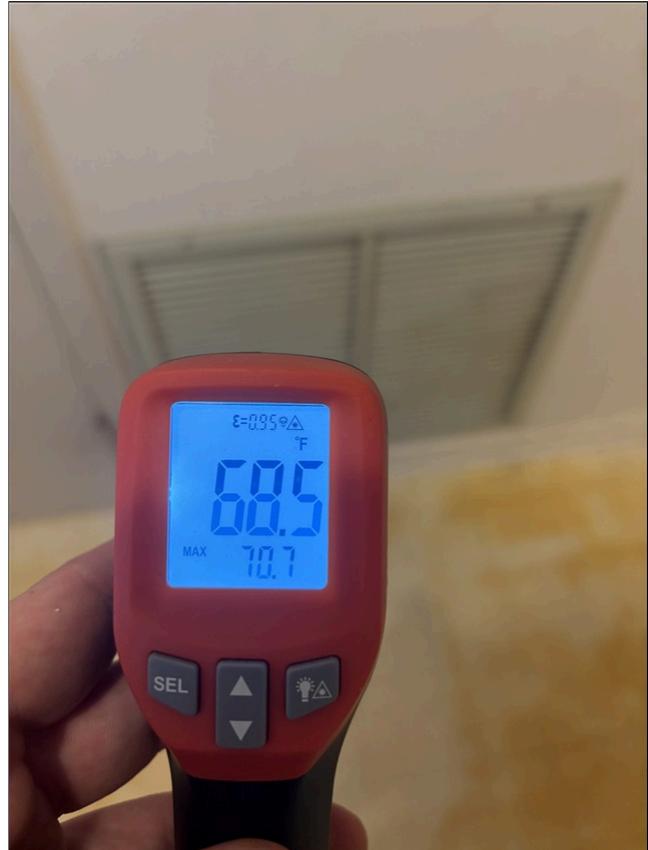
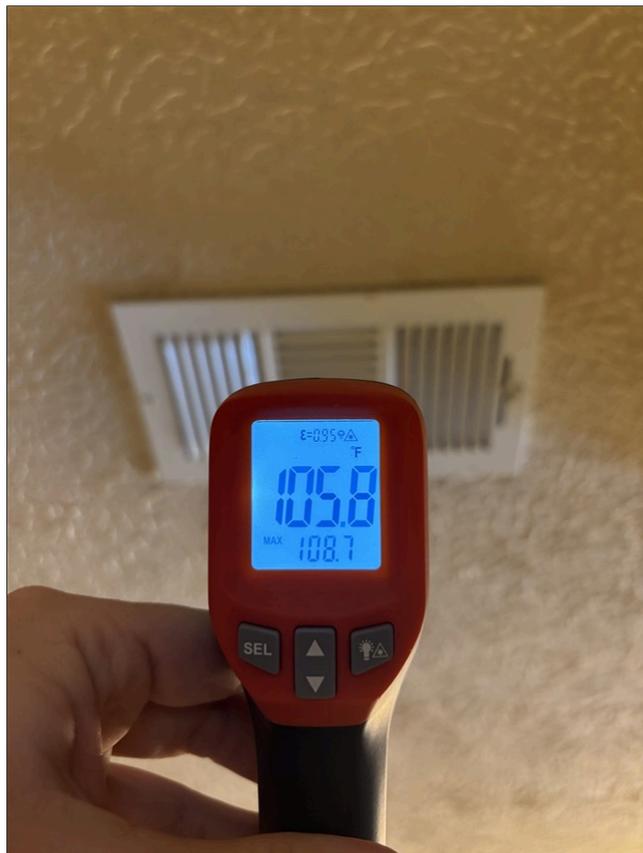
The ambient air test was performed by using thermometers on the air handler of Heat Pump in heat mode to determine if the difference in temperatures of the supply and return air are between 14 degrees and 22 degrees which indicates that the unit is cooling or heating as intended. The supply air temperature on your system read 105.8 degrees, and the return air temperature was 68.5 degrees. **This indicates that the unit was operating properly at the time of the inspection.**

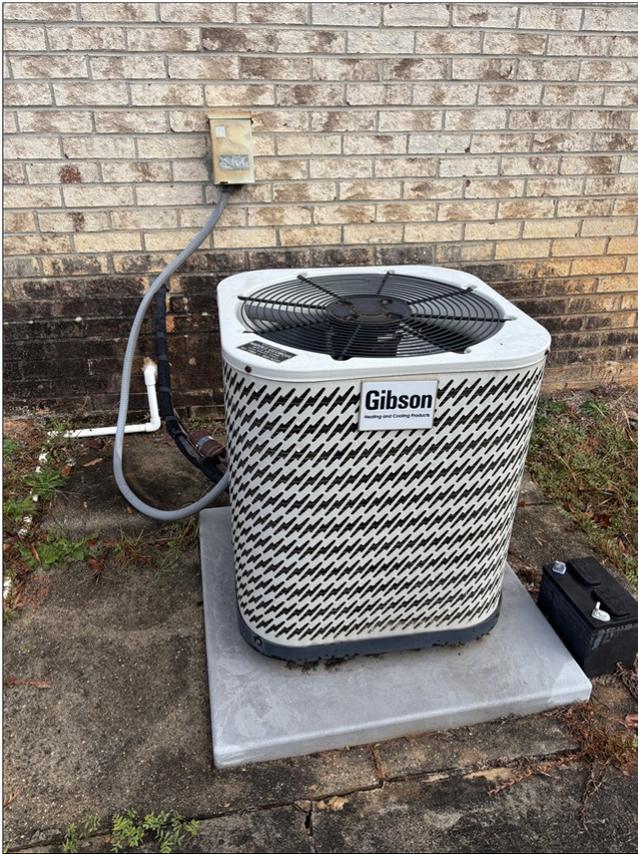
8.3 Item 1 (Picture)

(1) 2011 - 2.5 Ton - Gibson Condenser Unit

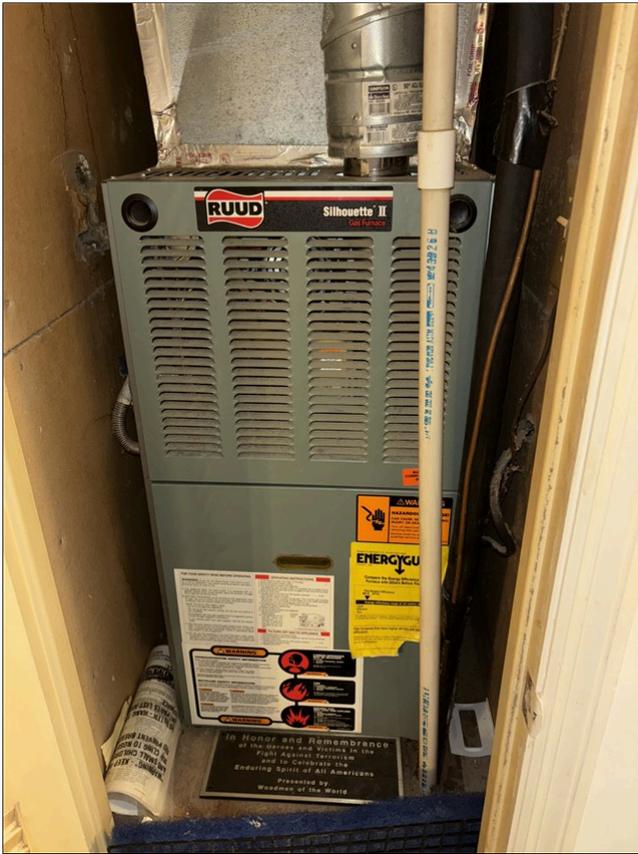
8.3 Item 3 (Picture)

(2) No data plate on the furnace - 2.5 Ton - GAS - Ruud Furnace

(3) The age of the Furnace unit is unknown, the data plate was not located on the unit. Recommend repair or replace as needed by qualified contractor.

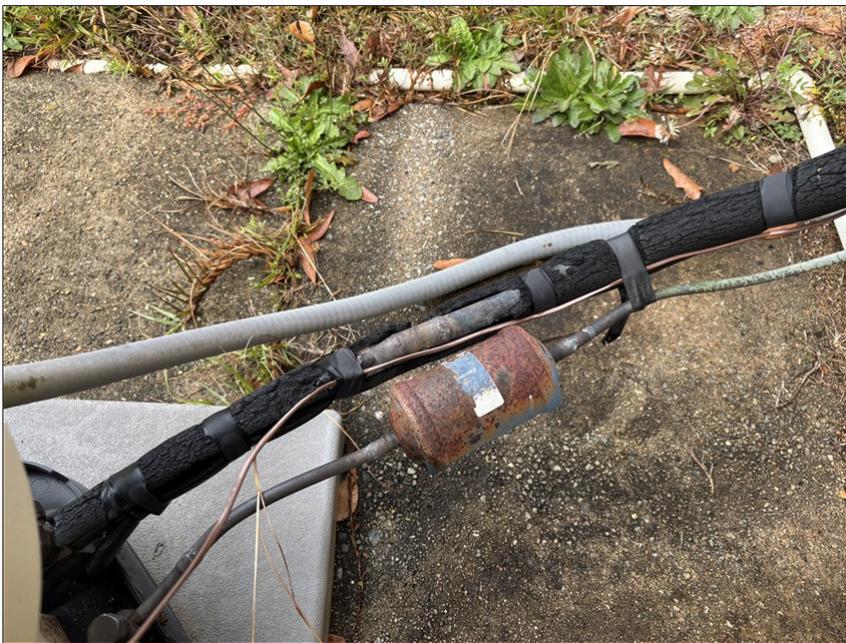
8.3 Item 4 (Picture)

(4) The insulation is deteriorated on the freon lines at the exterior condenser unit. This will degrade the efficiency of the unit. Replace the missing or deteriorated insulation as needed.

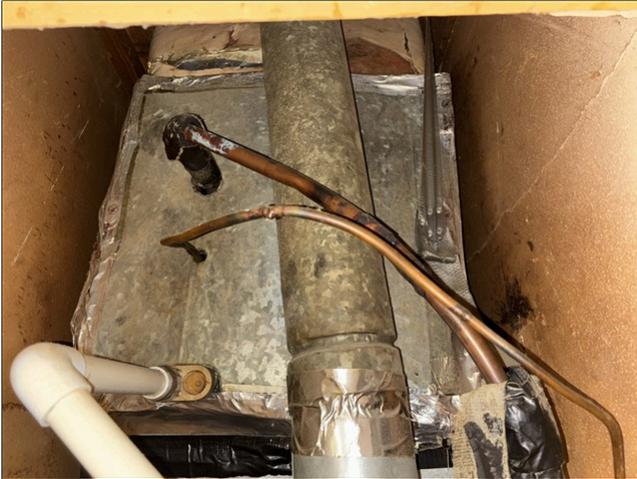
8.3 Item 5 (Picture)

(5) The refrigerant (Freon) lines at the furnace unit located in the closet were observed to be exposed and missing insulation. Lack of insulation can reduce system efficiency and may contribute to

condensation issues. Recommend repair or installation of proper insulation as needed by a qualified HVAC contractor.

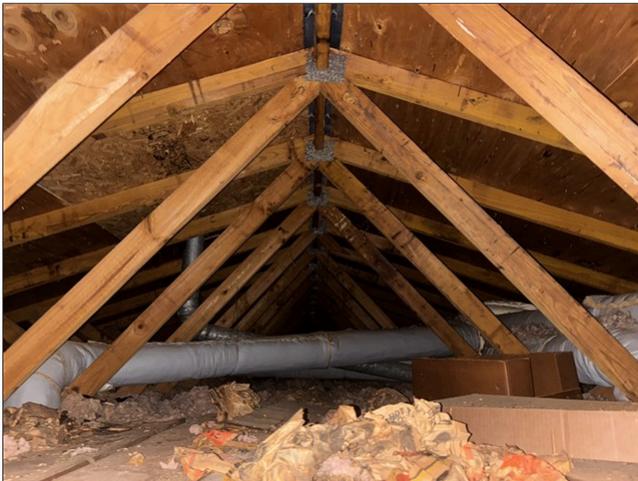
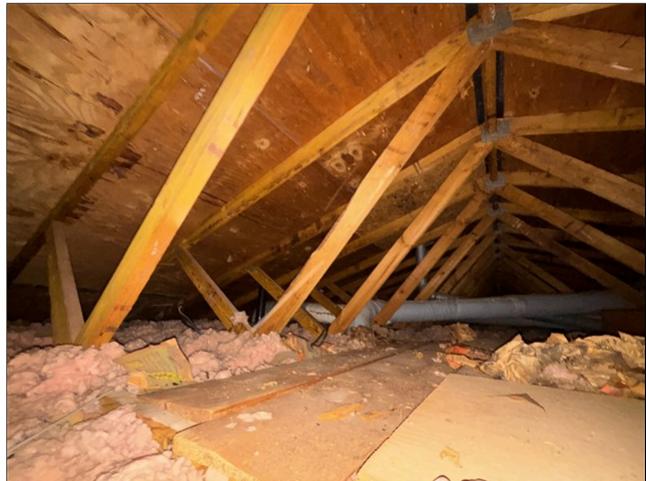
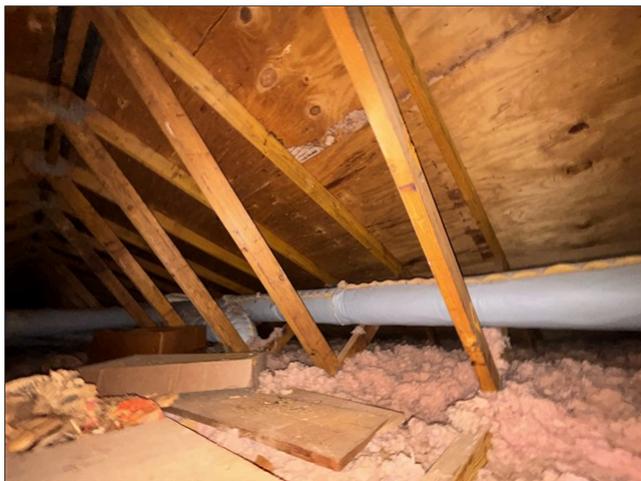
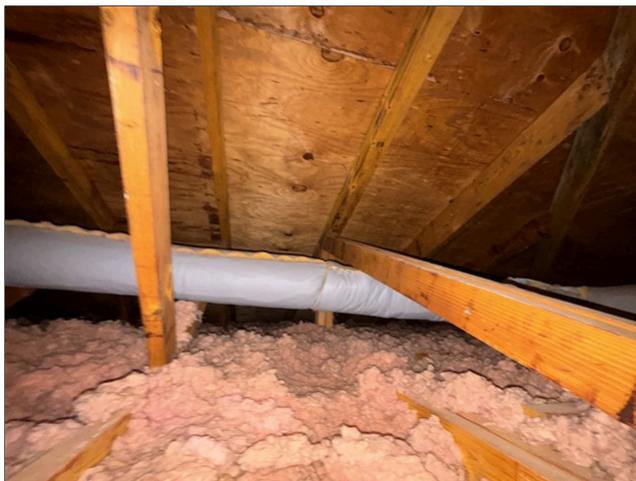
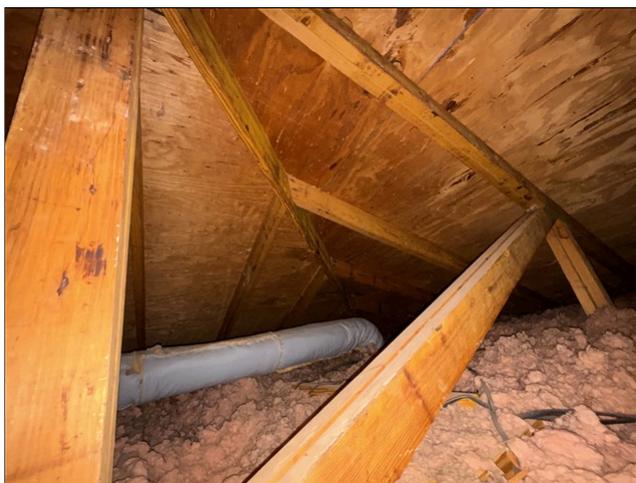
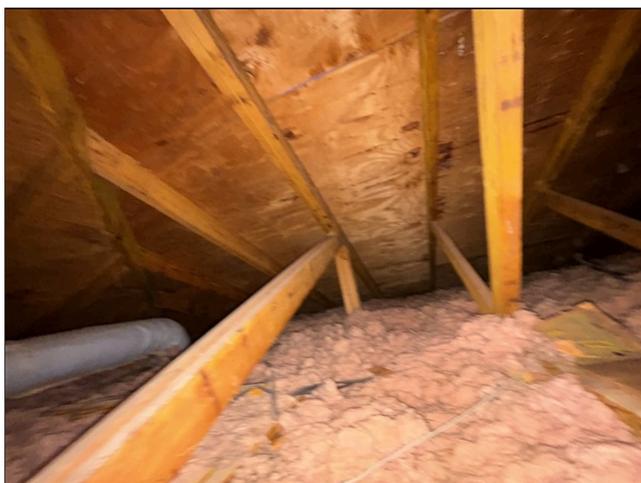
Attic space inspected

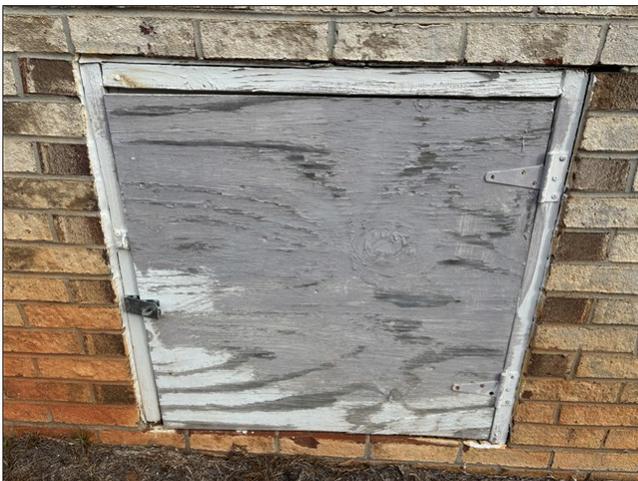
9.5 Item 1 (Picture)

(1) The crawlspace door shows signs of deterioration, and the paint is peeling. The door can be resurfaced and painted to prevent intrusion that could lead to further damaged. Recommend repair or replace as needed by qualified contractor.

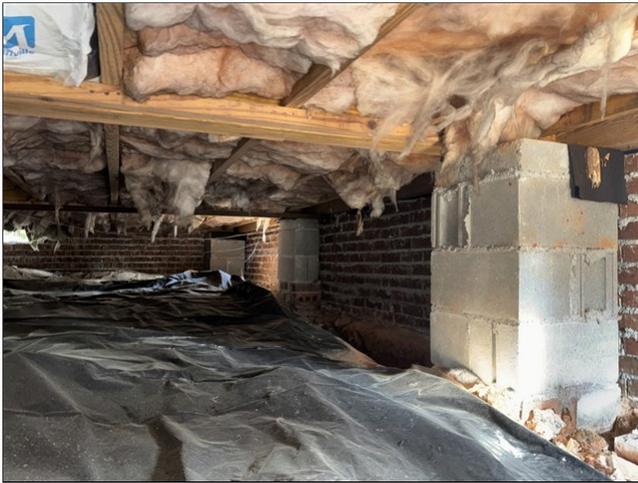
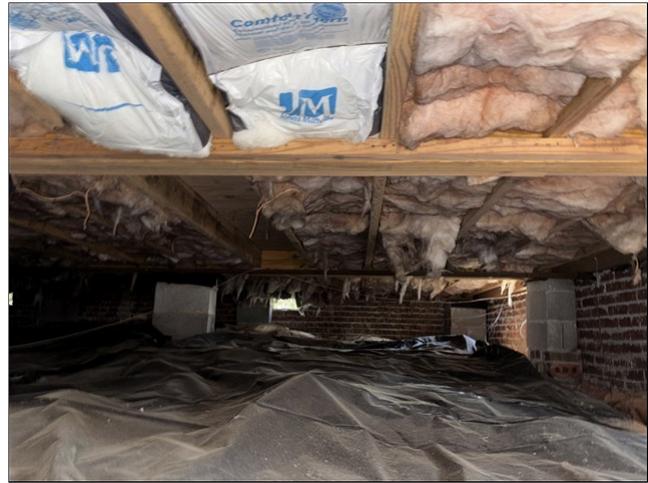
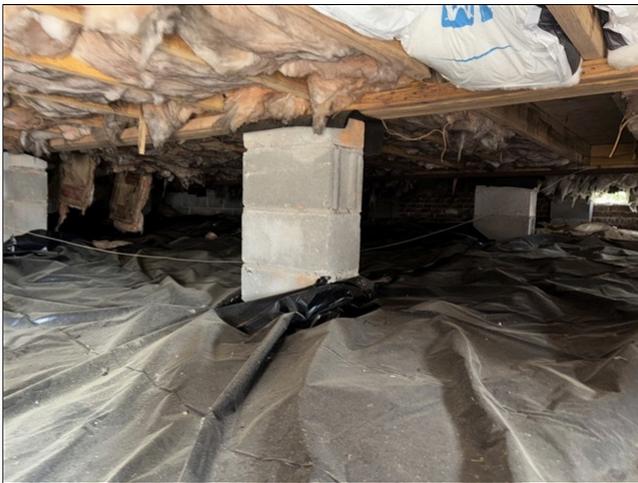
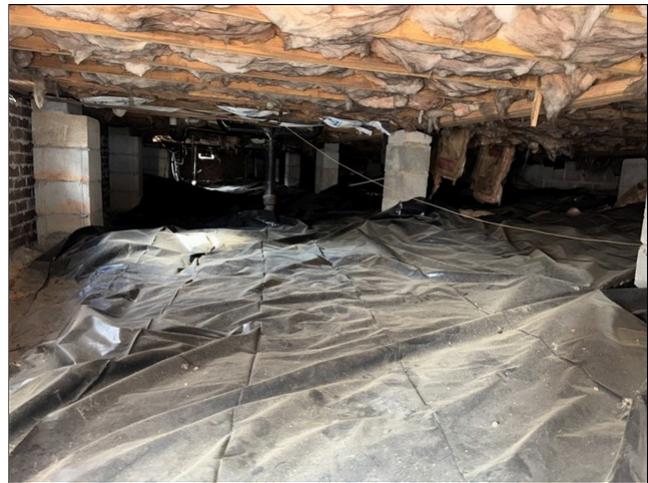
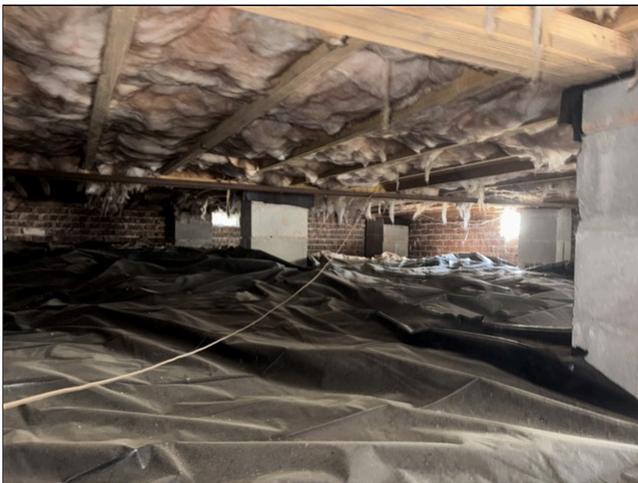
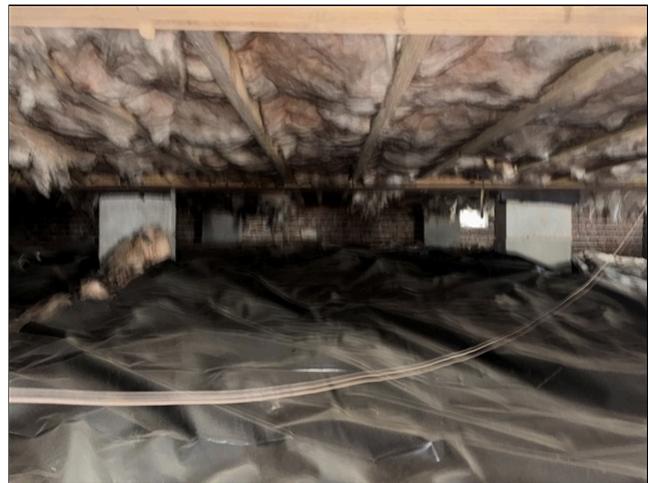
(2) Crawlspace Inspected

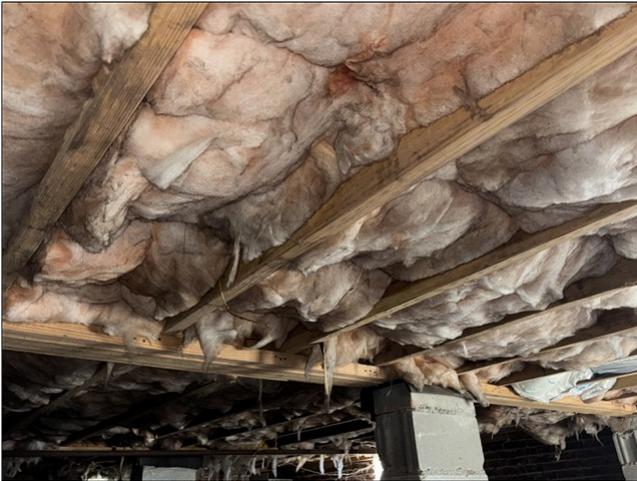
9.5 Item 9 (Picture)

(3) The insulation in the crawlspace was observed to be discolored, consistent with past or ongoing moisture intrusion. Moisture-damaged insulation may lose effectiveness and contribute to unfavorable conditions. Recommend further evaluation and repair or replacement as needed, along with addressing the source of moisture, by a qualified contractor.

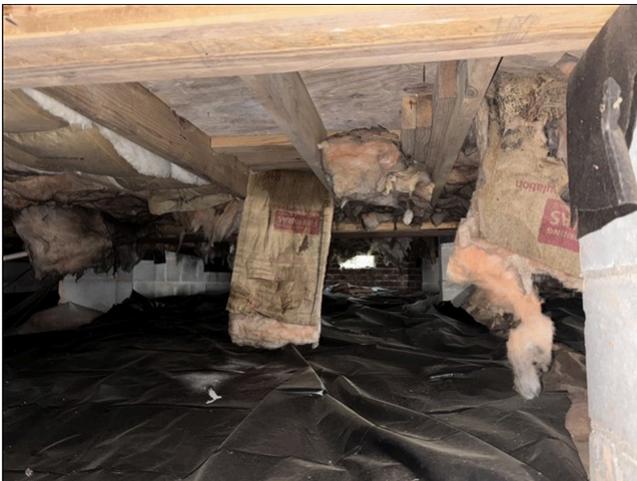
10.1 Item 1 (Picture)

The insulation is loose/fallen in the crawlspace. Insulation that has fallen to the ground or has become damp from the ground or from condensation usually needs to be replaced with new insulation. A qualified contractor should inspect and repair as needed.

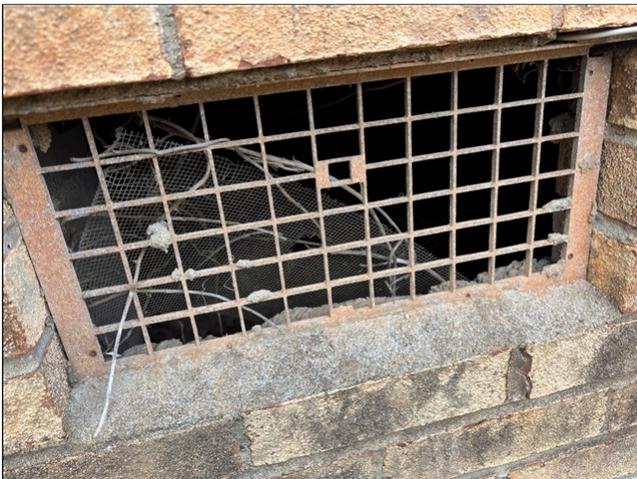
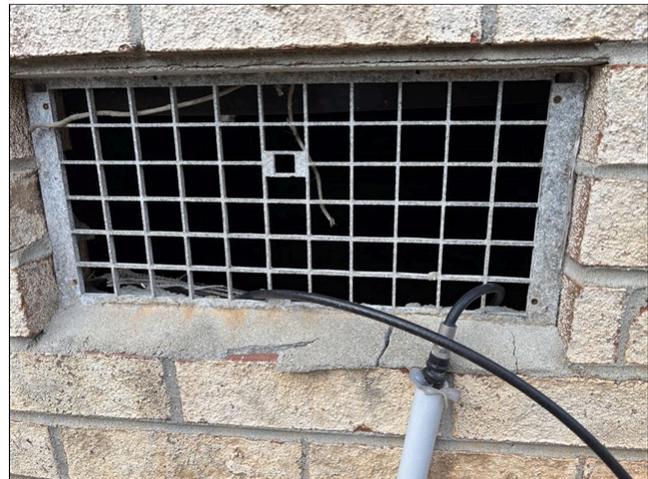
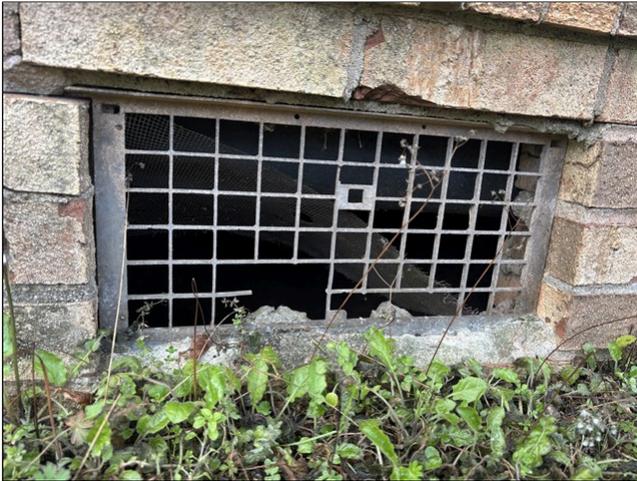
The screens behind the crawlspace grates are loose and falling, this can allow for pest intrusion into the crawlspace that can cause further damage overtime. Recommend repair or replace as needed by qualified contractor.

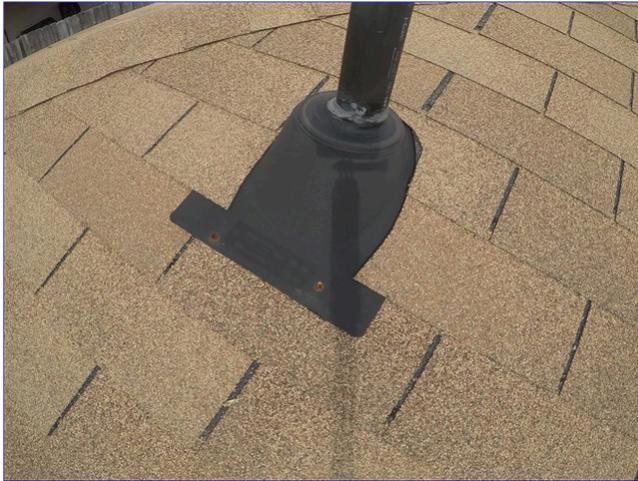
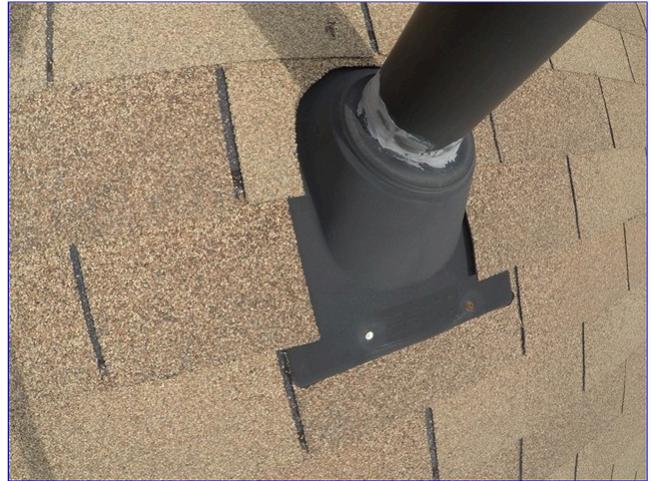
Roof boots at the rear of the home have exposed nail heads, this can lead to rust and potential moisture intrusion overtime. Recommend repair or replace as needed by qualified contractor.

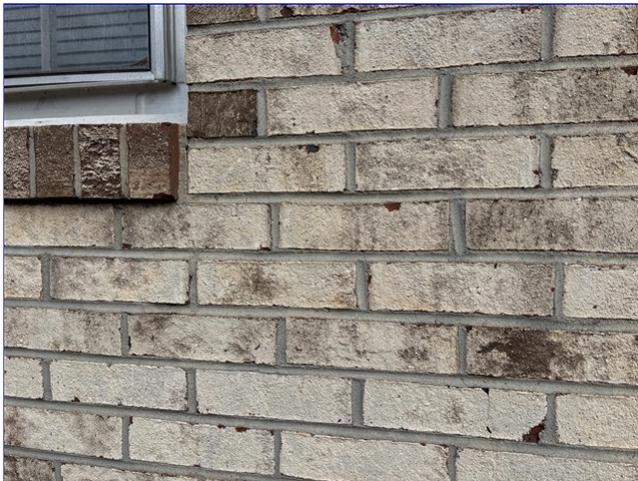
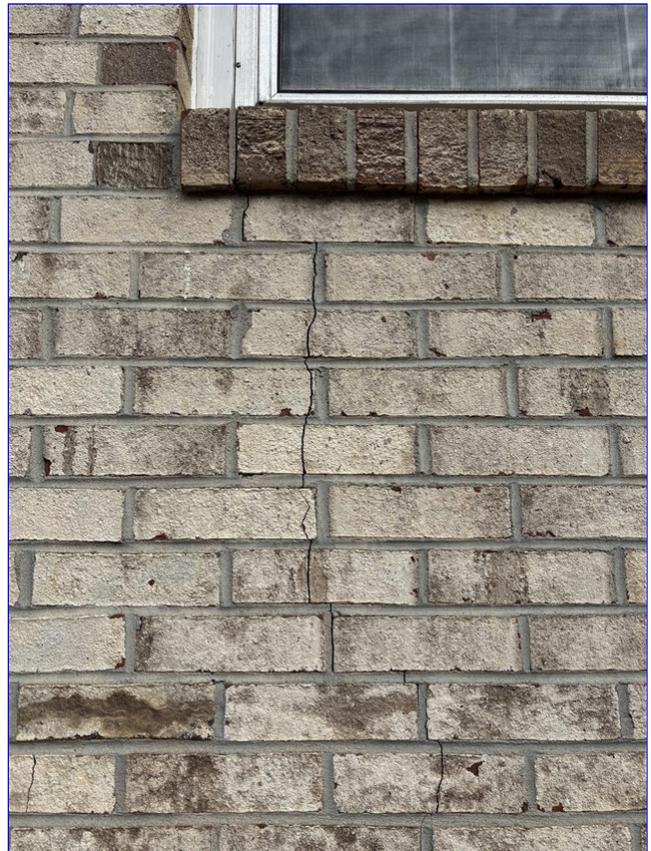
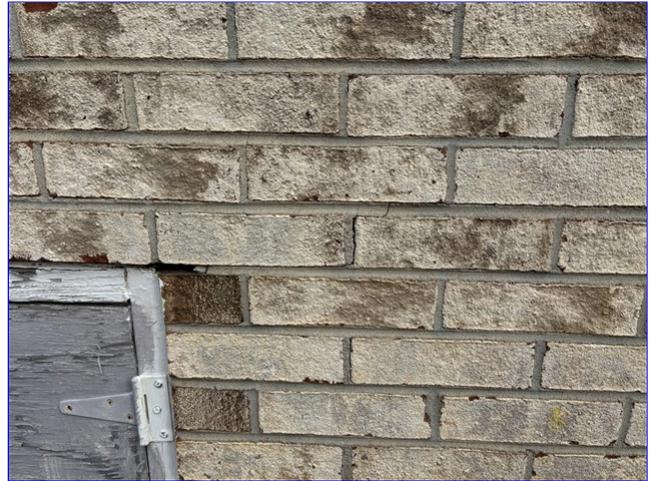
Exterior mortar joint cracks at the rear of the home in several areas, this is caused by common settling overtime. The cracks can be sealed with mortar to prevent moisture intrusion. Recommend repair as needed by qualified contractor.

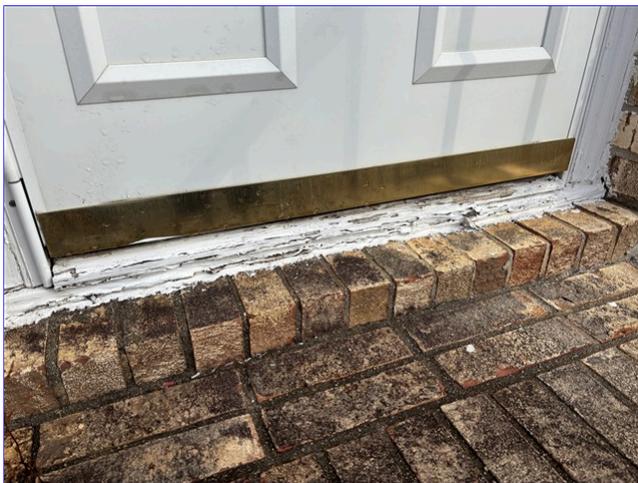
2.1 Item 1 (Picture)

(1) The base of the rear door frame is deteriorated from moisture intrusion. Recommend repair or replace as needed by qualified contractor.

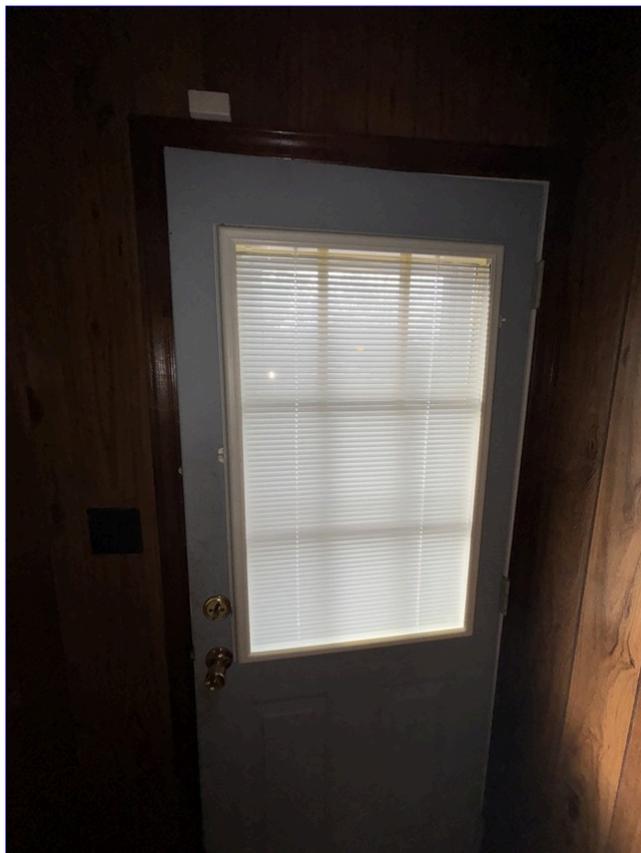
2.1 Item 2 (Picture)

(2) The rear exterior door hits the frame when closing, the door should be adjusted. Recommend repair or replace as needed by qualified contractor.

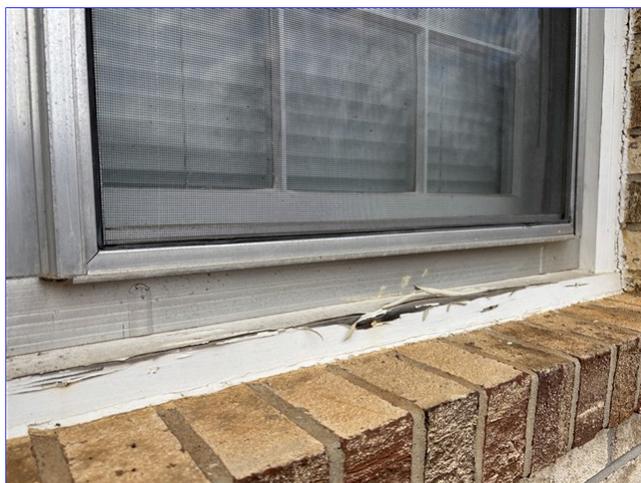
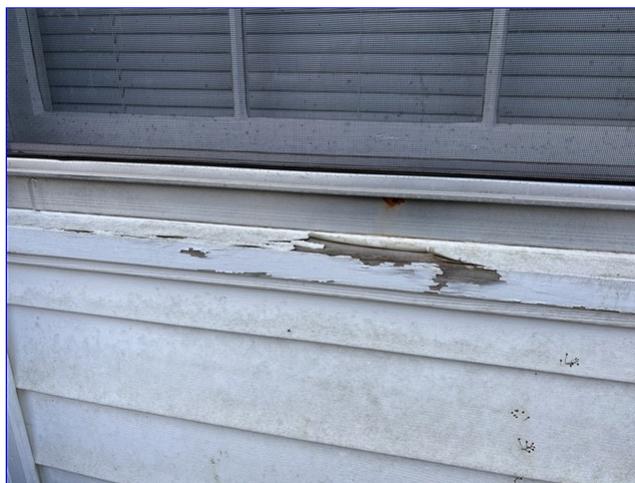
Deterioration at the windows around the home, the paint is peeling at the windows. Recommend resurfacing the windows and repair or replace as needed by qualified contractor.

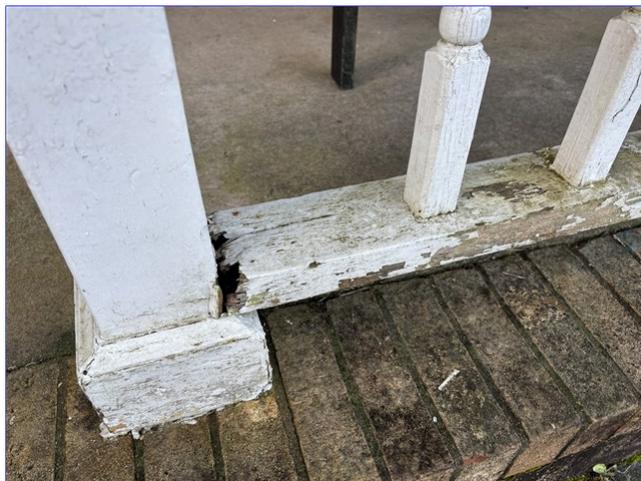
2.3 Item 1 (Picture)

(1) Handrail at the front porch is deteriorated and rotted, this could lead to injury. Recommend repair or replace as needed by qualified contractor.
