# Inspection Report

**Property Address:**  
4696 Pine Valley Dr  
Macon GA 31210

<b>Date:</b> 1/23/2026	<b>Time:</b> 09:00 AM	<b>Report ID:</b> 20260123-4696-Pine-Valley-Dr
<b>Property:</b> 4696 Pine Valley Dr Macon GA 31210	<b>Customer:</b> Steve Slocumb	<b>Real Estate Professional:</b>

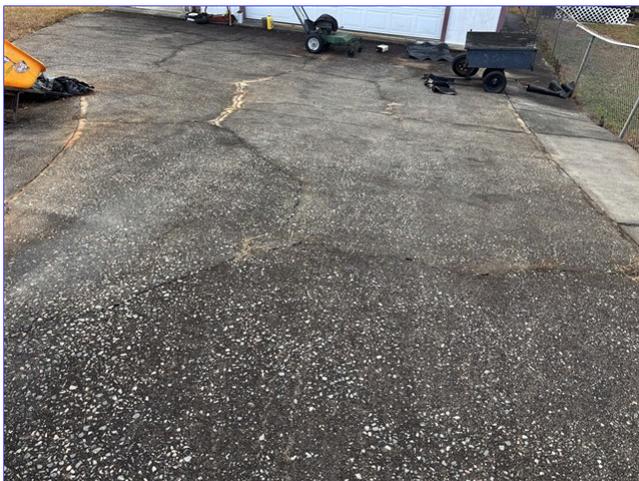
2.4 Item 1 (Picture)

(1) The concrete driveway has some small cracks. These are considered cosmetic at this point. No further action is required at this time.

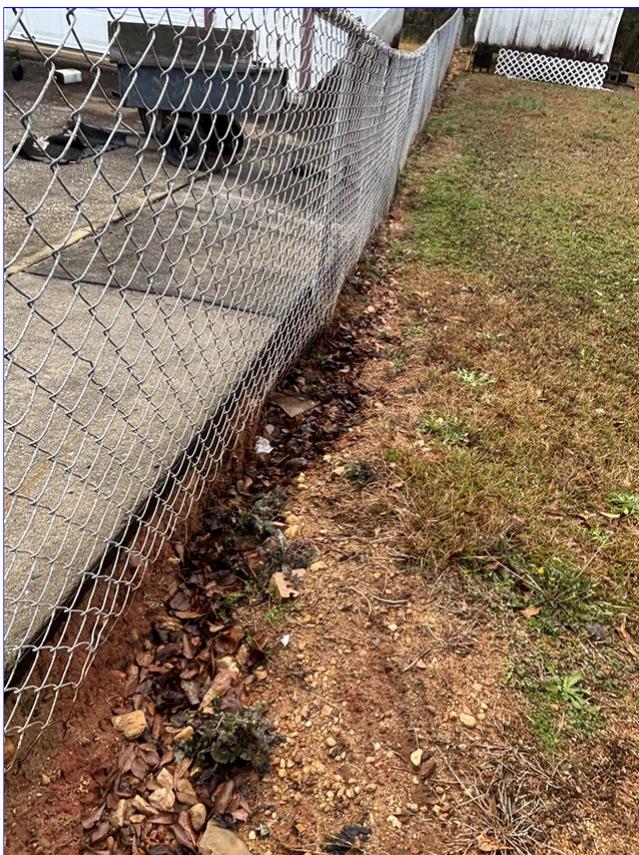
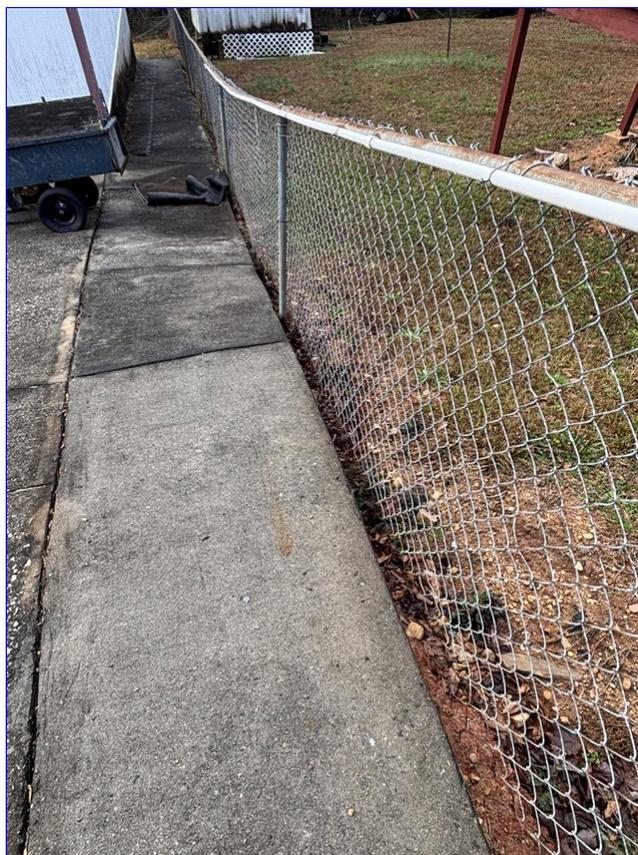
(2) Soil erosion was observed along the edge of the driveway leading to the detached garage at the rear of the home. The driveway runs adjacent to the property line, and the erosion appears to be occurring primarily on the neighboring property; however, the loss of supporting soil is extending beneath the driveway slab. This condition may contribute to settlement or movement of the slab over time. Recommend further evaluation and repair as needed by a qualified contractor to stabilize the soil and prevent future movement or damage to the driveway.

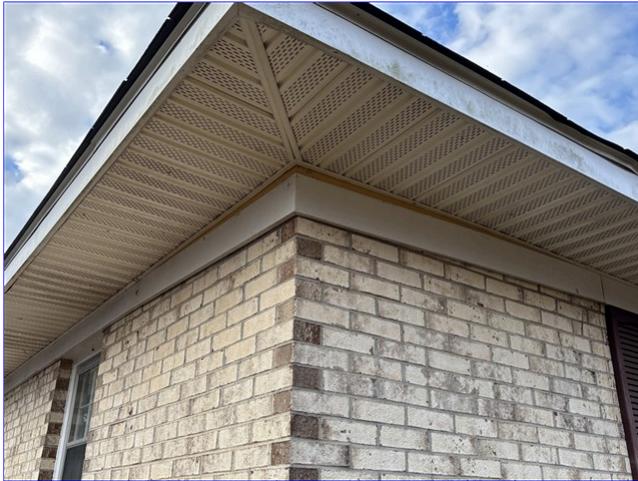
2.5 Item 1 (Picture)

Fascia falling at the left front of the home, this can expose the siding underneath to moisture or pest intrusion causing further damage overtime. Recommend repair or replace as needed by qualified contractor.

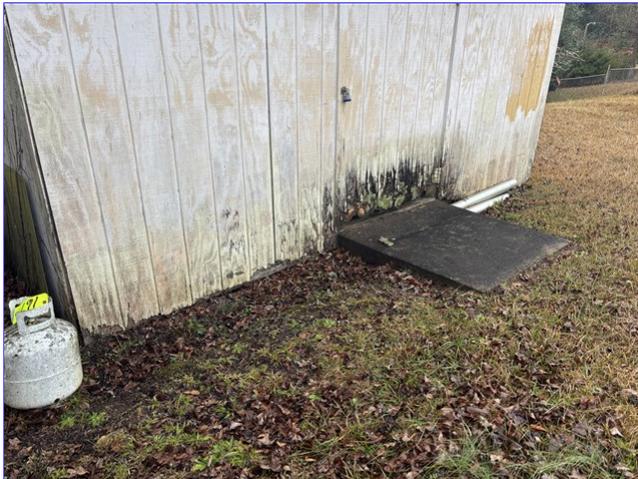
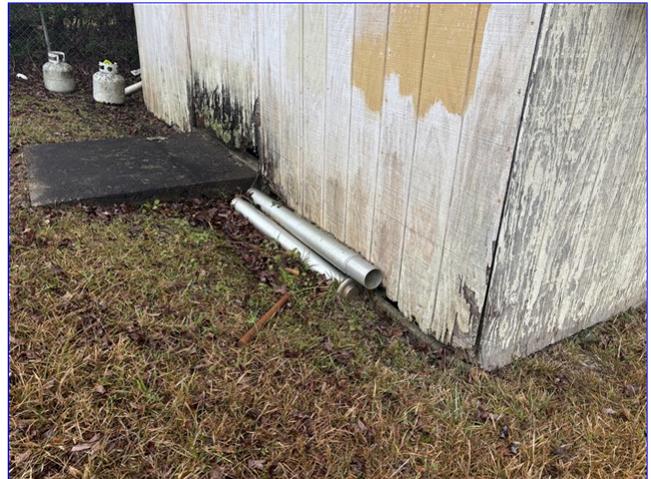
(1) The front of the shed shows signs of major deterioration, this is likely caused by moisture buildup against the front of the shed. Recommend repair or replace as needed by qualified contractor.

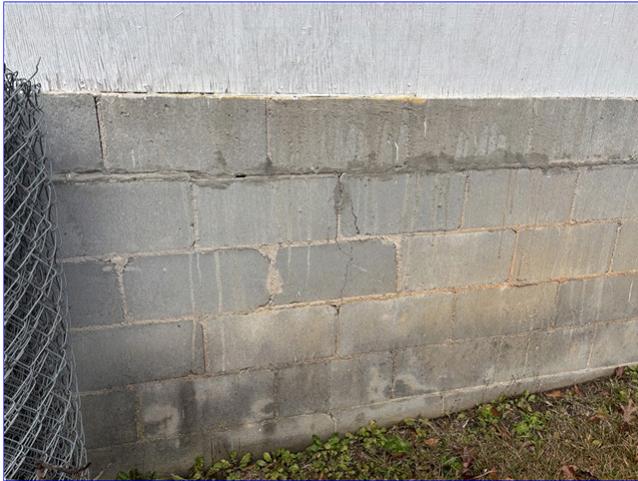
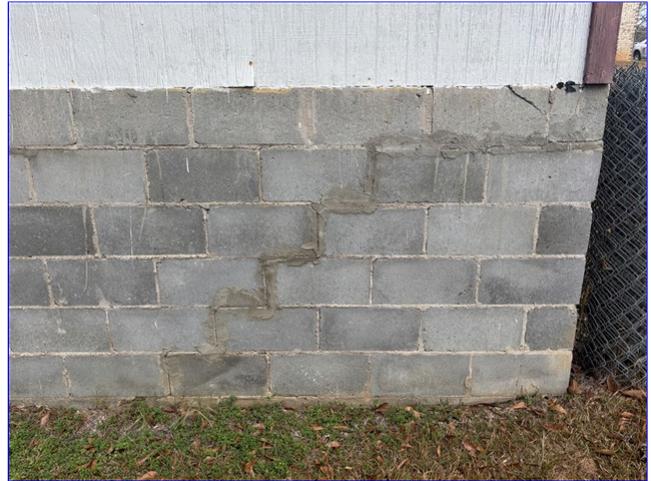
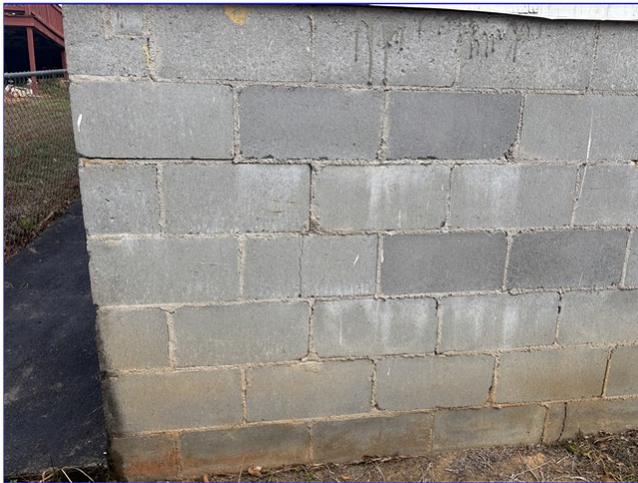
(2) Signs of common settling cracks in the foundation of the detached garage, there are no major signs of movement. The cracks can be sealed to prevent moisture intrusion that can lead to further damage.

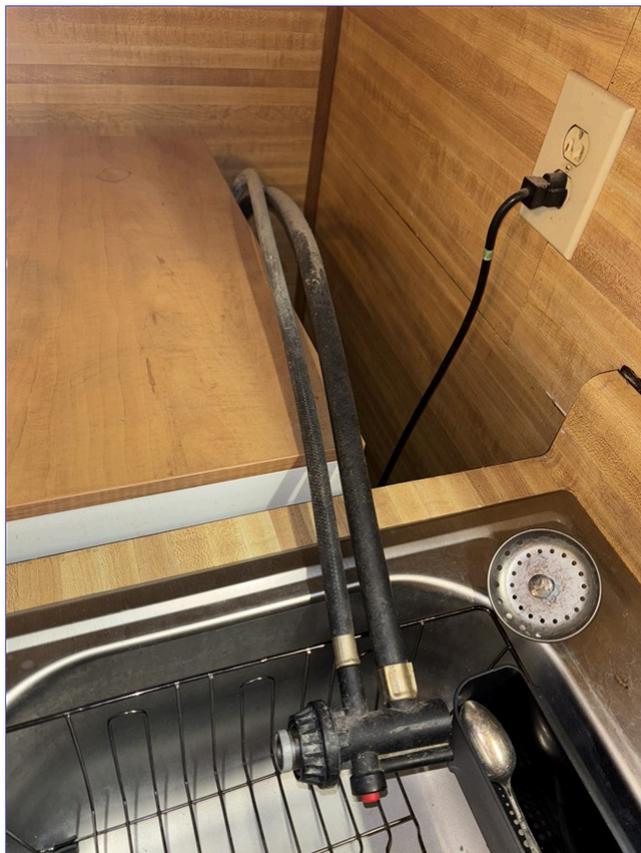
3.0 Item 2 (Picture)

(2) The dishwasher is a temporary unit that is designed to move. The water to the unit is not properly connect. Recommend repair or replace as needed by qualified contractor.

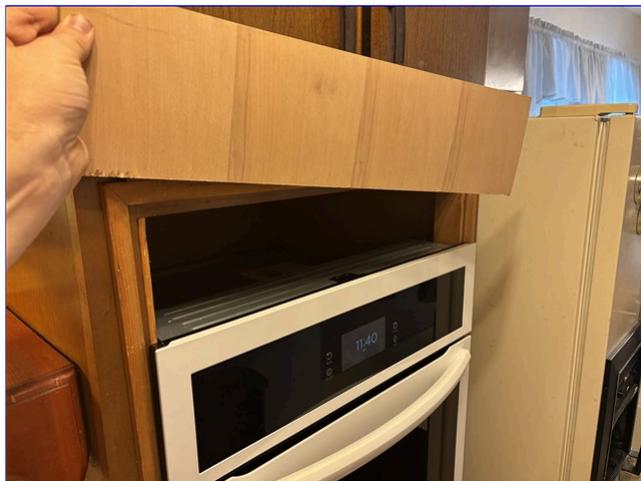
4.0 Item 1 (Picture)

Large gap over the top of the oven, this could be a safety hazard. The gap has been covered with a piece of wood but is not solid mounted. Recommend repair or replace as needed by qualified contractor.

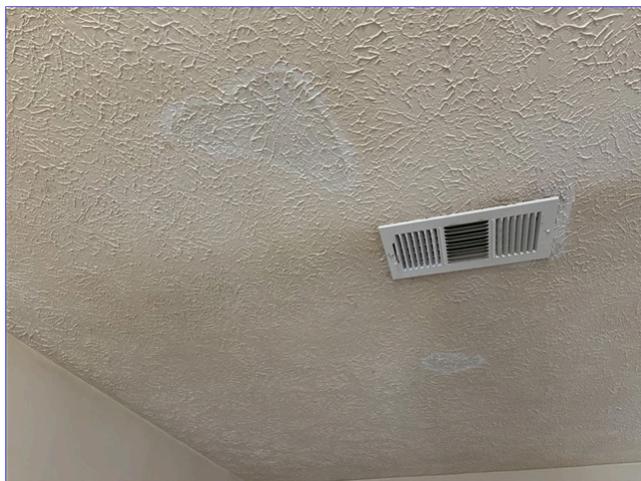
4.2 Item 1 (Picture)

(1) Signs of previous leaks in the living room ceiling, the areas were not actively wet during time of inspection and are likely previous leaks that have been repaired before the roof replacement.

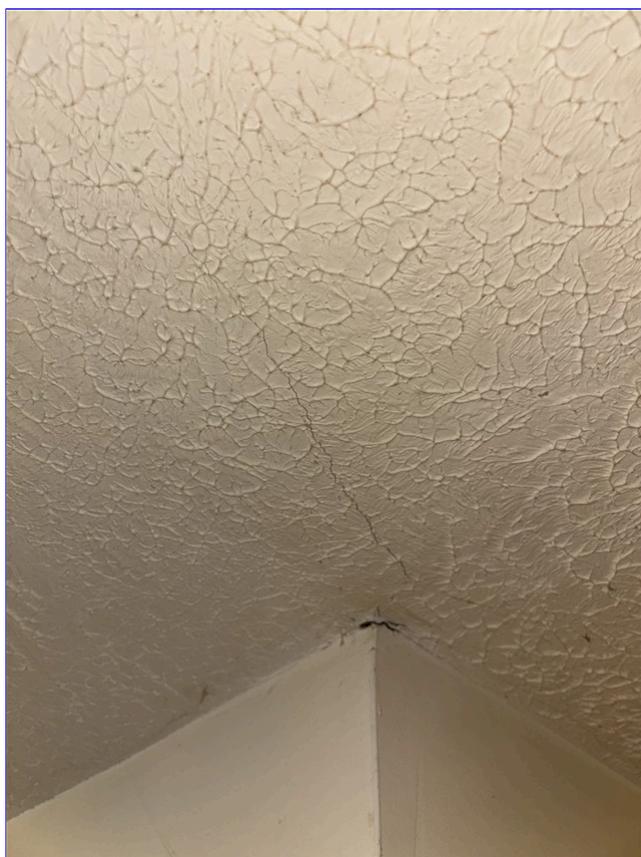
4.2 Item 2 (Picture)

(2) The ceiling in hallway reveals hairline cracks, the paper tape seam is loose from settlement. I recommend a qualified finisher correct as needed.

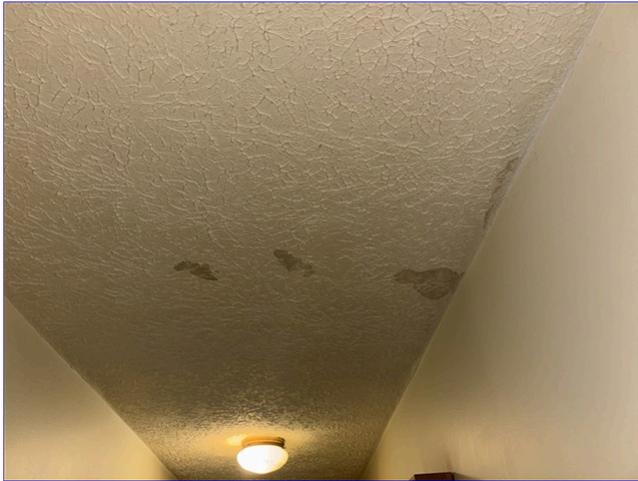
4.2 Item 3 (Picture)

(3) Signs of previous leaks in the hallway, the areas were not actively wet during time of inspection and is likely from before the roof replacement. Recommend repair or replace as needed by qualified contractor.

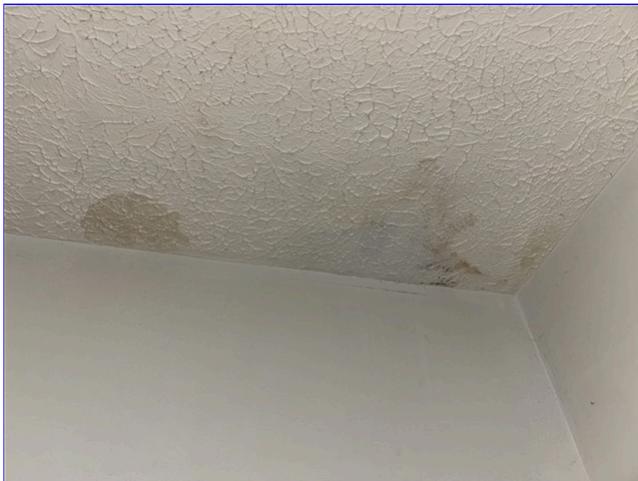
4.2 Item 4 (Picture)

(4) The ceiling has a stain indicating a leak did or still exists at the Guest bath. I am unable to determine if a repair is needed due to a lack of rain. I recommend monitor and repair leak if detected.

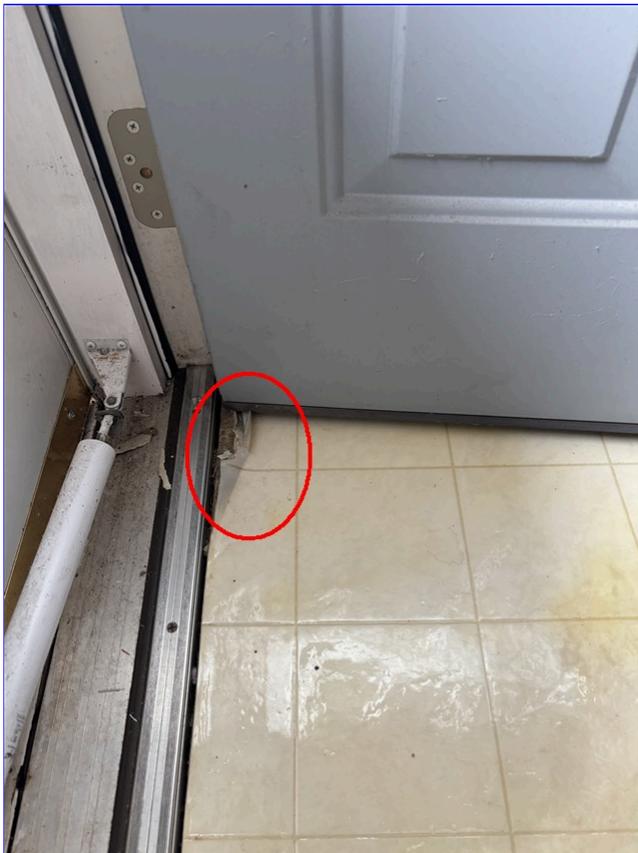
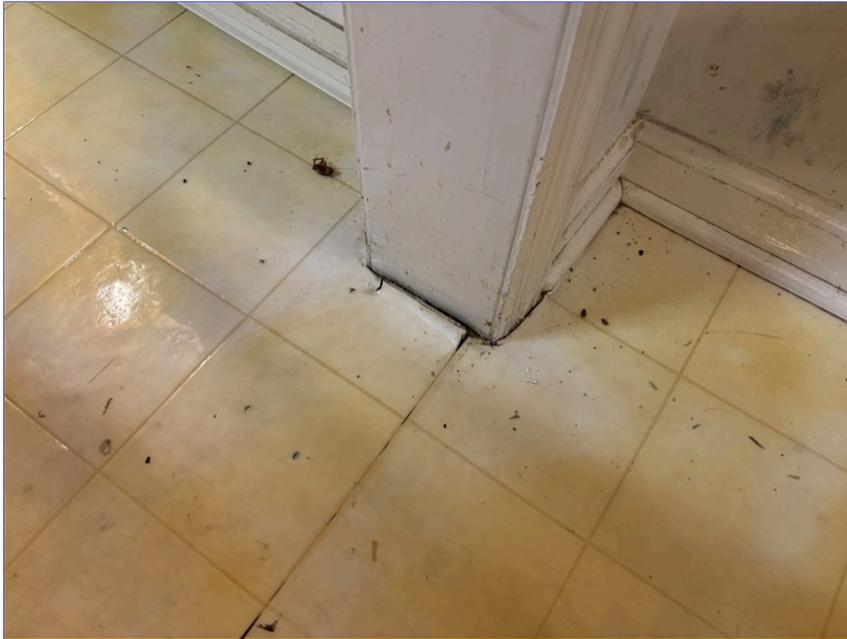
(1) Damage to the linoleum throughout the home, with staining that has turned it yellow, and multiple holes through out. Recommend Repair or replace as needed by qualified contractor.

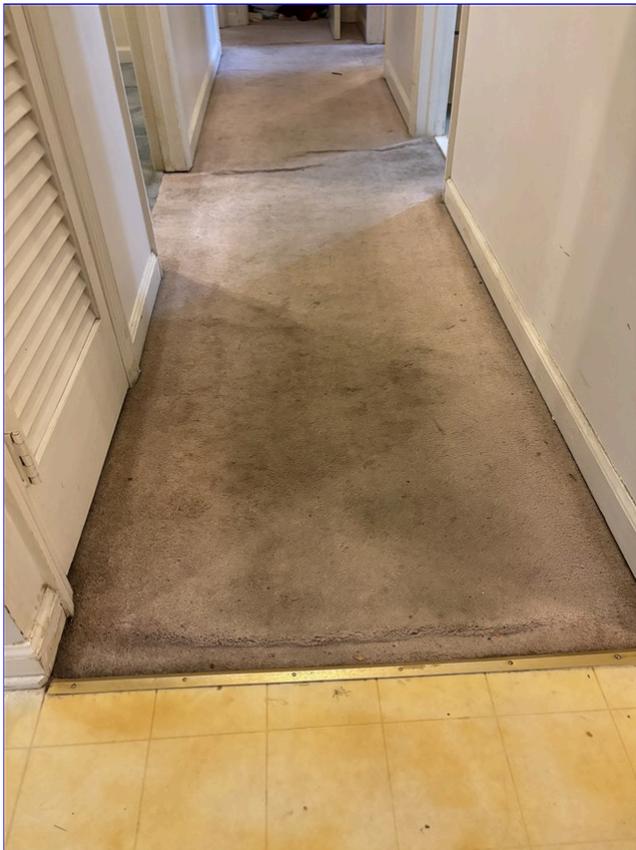
4.3 Item 5 (Picture)

(2) The carpet throughout the home is loose, wrinkled, and appears to be aged. Loose carpeting can present a trip hazard. Additionally, the home shows indications that previous occupants smoked indoors, which may have resulted in odors and residue being absorbed into the carpet. Recommend replacement of the carpeting as needed for improved safety, comfort, and indoor air quality.

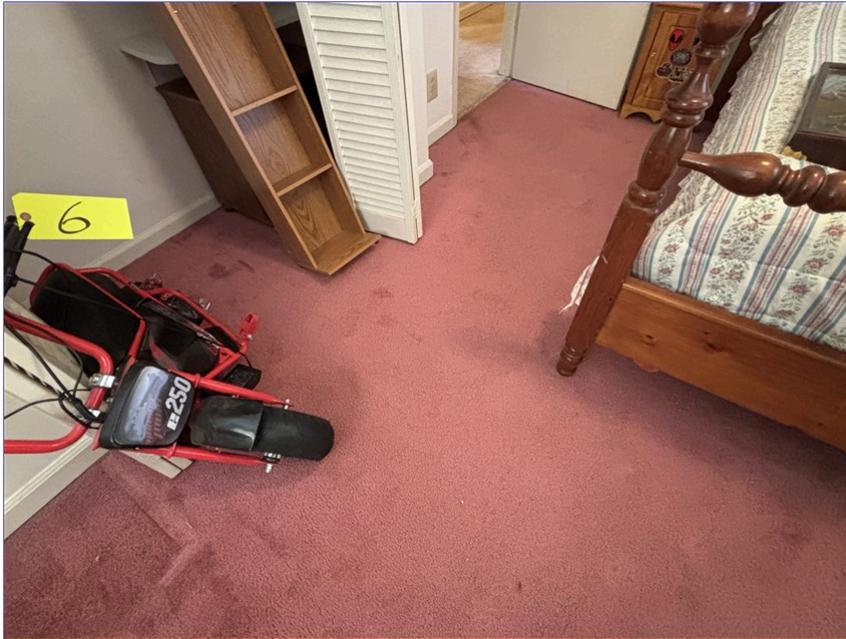
4.3 Item 6 (Picture)

(3) The subflooring in the front guest bedroom is squeaking and popping in several places . This can be repaired by securing the subfloor to the floor joists and should not be considered a structural defect. A qualified contractor should repair or replace.

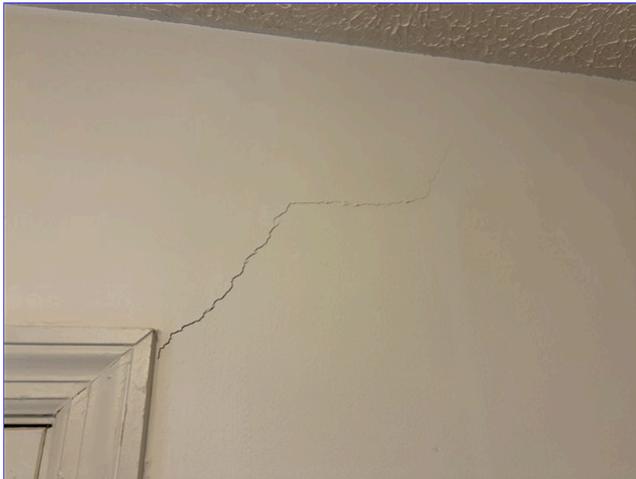
4.4 Item 1 (Picture)

(1) The wall in the entrance hallway reveals hairline cracks from settlement. This appears to be cosmetic in nature. I recommend a qualified finisher correct as needed.

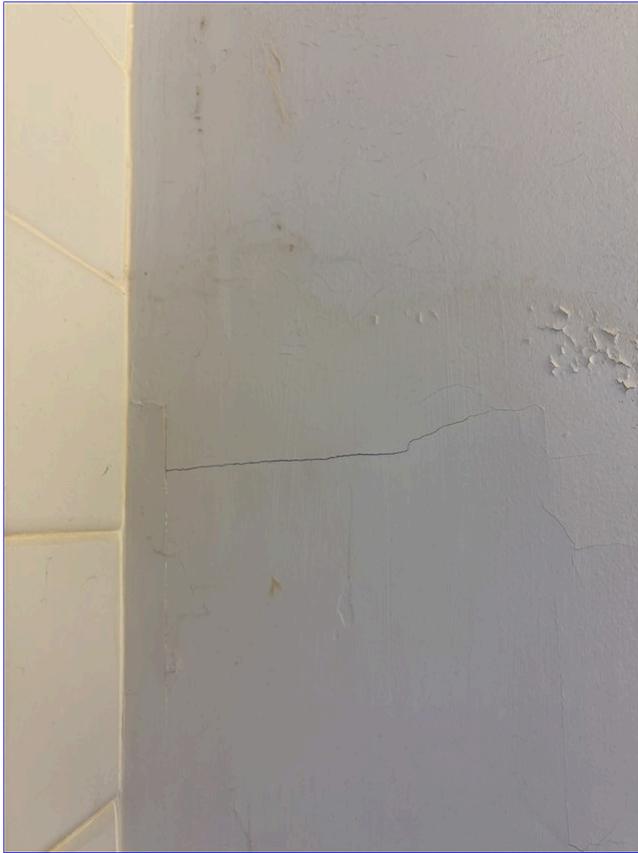
4.4 Item 2 (Picture)

(2) The wall in the master bath reveals hairline cracks from settlement. This appears to be cosmetic in nature. I recommend a qualified finisher correct as needed.

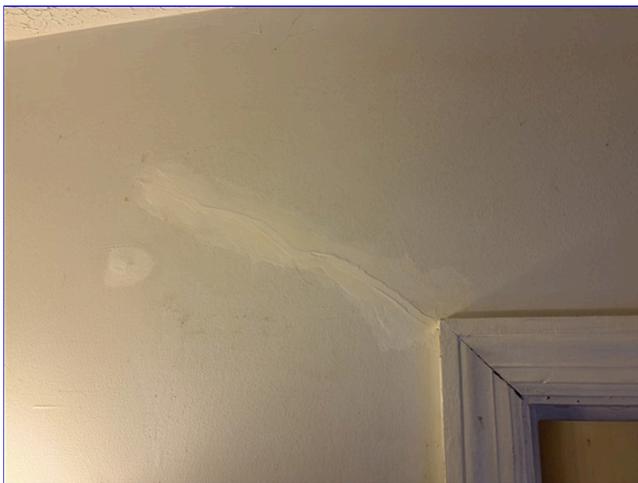
4.4 Item 3 (Picture)

(3) The wall in master bathroom reveals hairline cracks from settlement. This appears to be cosmetic in nature. I recommend a qualified finisher correct as needed.

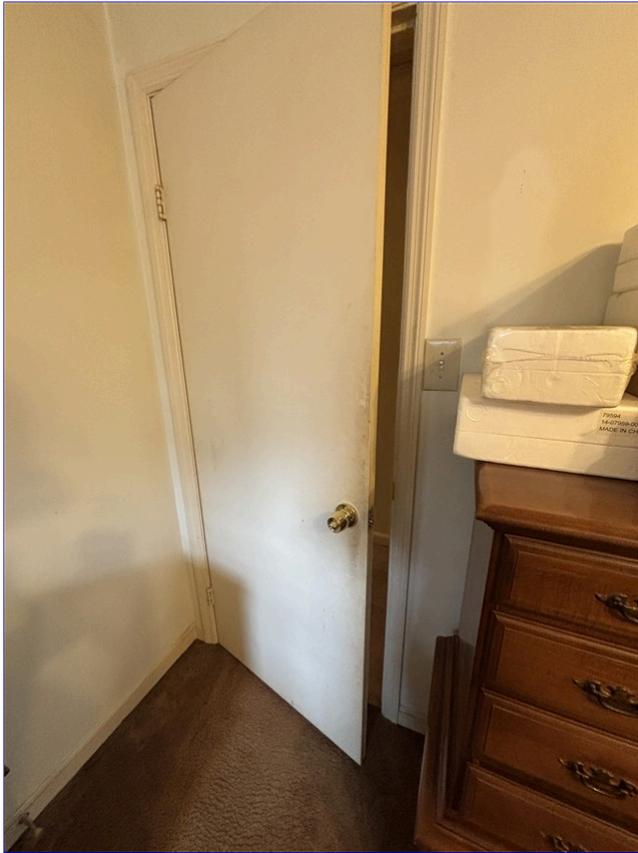
4.7 Item 1 (Picture)

(1) The master bedroom door did not latch properly, the door should be adjusted. Recommend repair or replace as needed by qualified contractor.

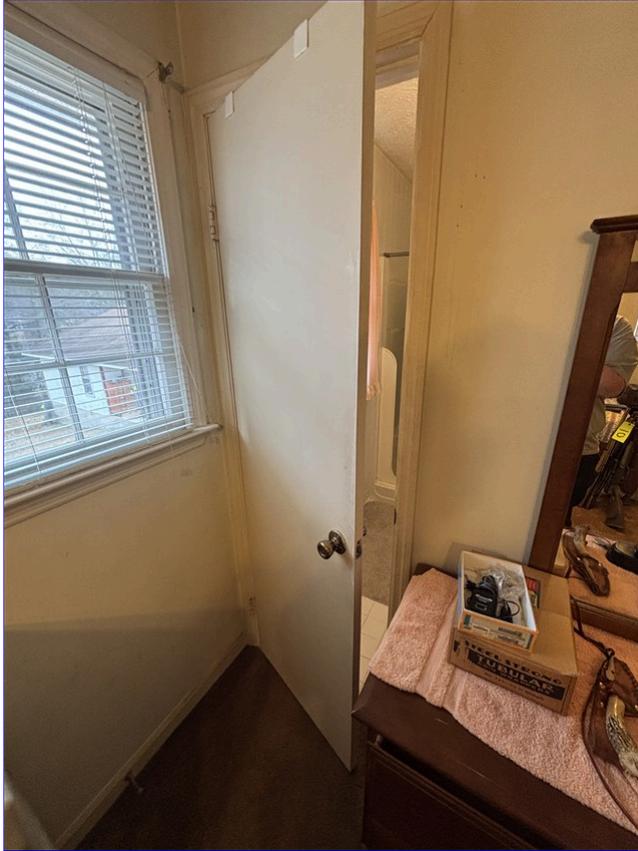
4.7 Item 2 (Picture)

(2) The master bathroom door does not latch properly, the door should be adjusted. Recommend repair or replace as needed by qualified contractor.

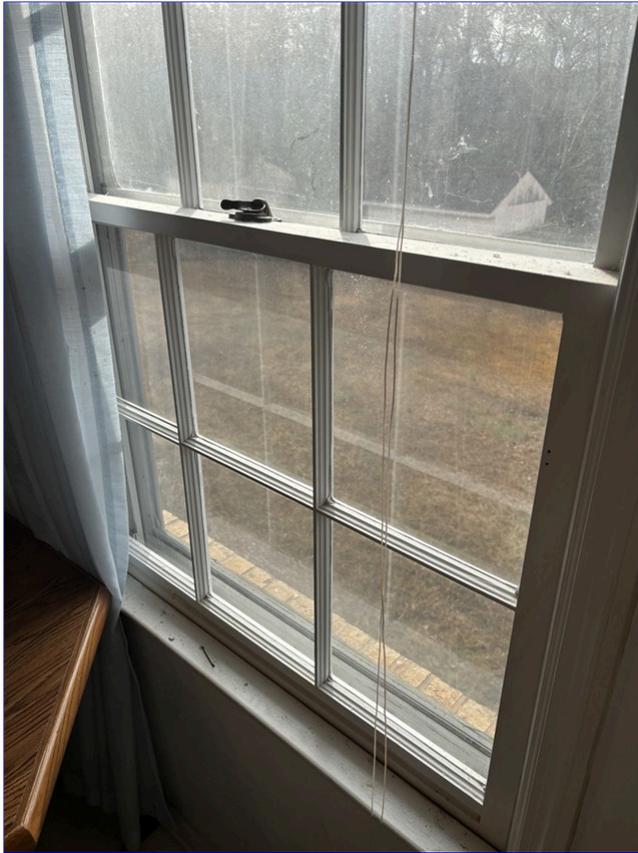
4.8 Item 1 (Picture)

All windows are stuck and painted shut. This is a safety issue if the window will not open in the event of a fire. The windows should open and close properly . A qualified person should repair or replace as needed.

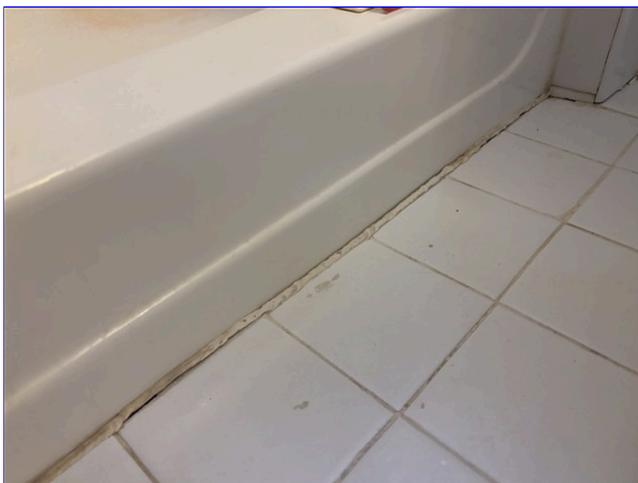
5.6 Item 1 (Picture)

I recommend silicone caulk along floor and threshold of shower at master bath. This can allow for moisture intrusion causing further damage.

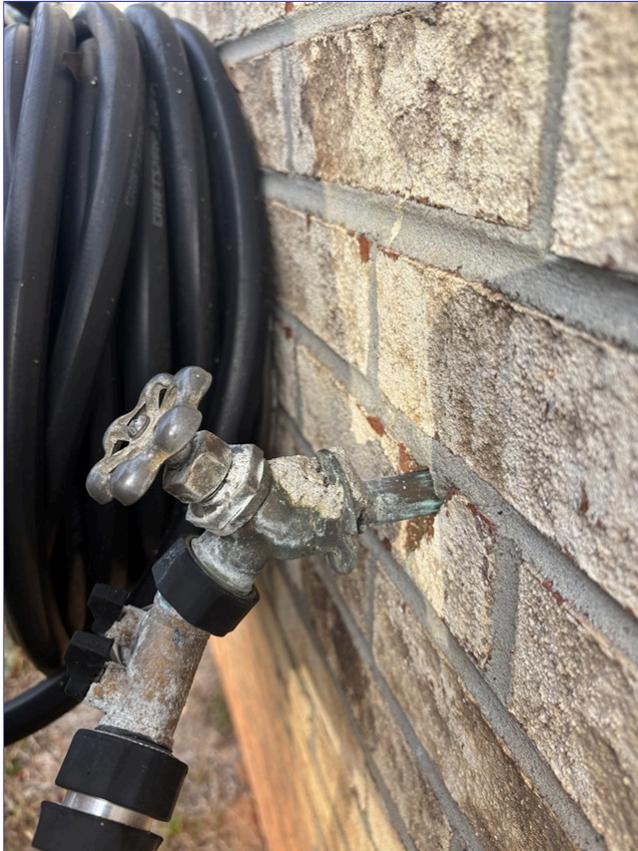
6.0 Item 1 (Picture)

(1) The water spigot at the rear of the home is loose in the wall, this can lead to leaks at the crawlspace. Recommend hard mounting the spigot to the wall to prevent damages, Repair or replace as needed..

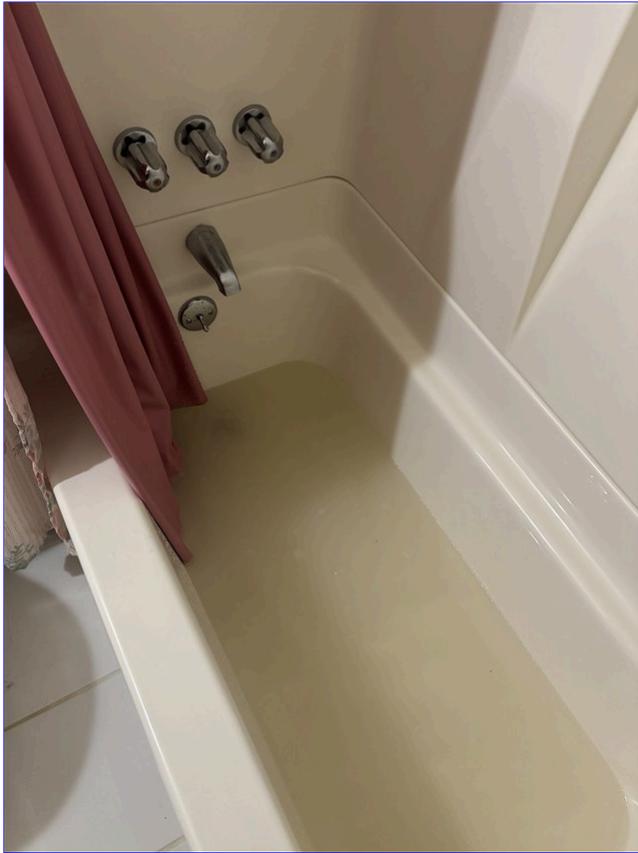
6.0 Item 2 (Picture)

(2) The water observed at multiple fixtures throughout the home appeared cloudy when operated at the time of inspection. Additionally, the water heater (manufactured in 2020) was not heating water, as the pilot light was found to be off. The cause of these conditions was not determined during the inspection. Recommend further evaluation and repair as needed by a qualified plumber or water heater technician.

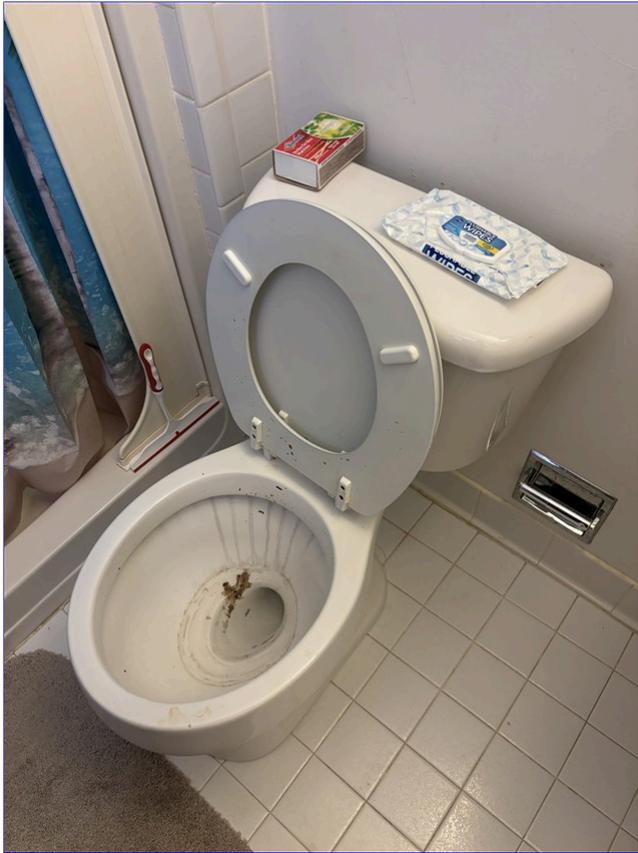
6.0 Item 3 (Picture)

(3) The toilet is loose at floor at the Master bath. Repairs may involve re-setting the toilet on a new wax seal. I recommend a qualified licensed plumber repair or correct as needed.

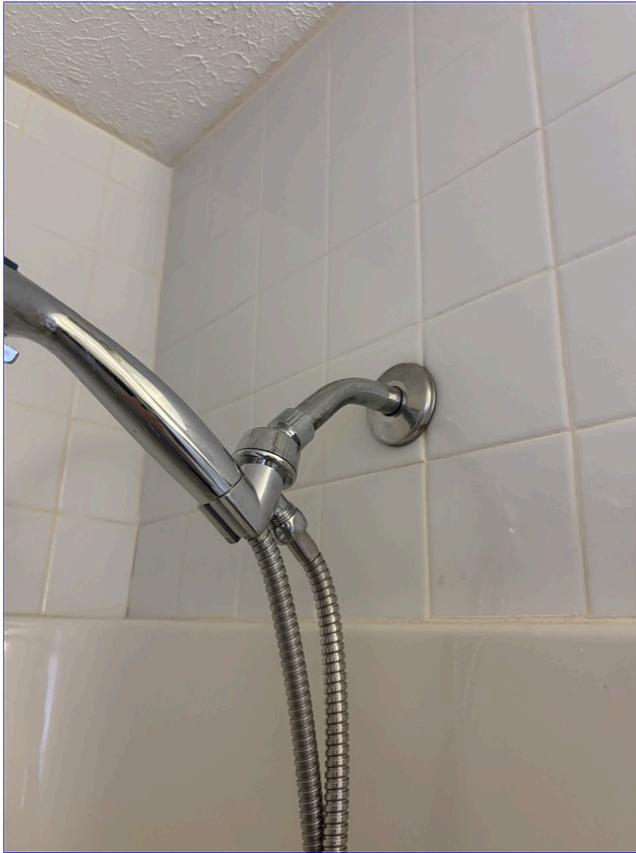
6.0 Item 4 (Picture)

(4) The shower head piping is loose in the wall and needs to be secured at the master bath. A qualified person should repair or replace.

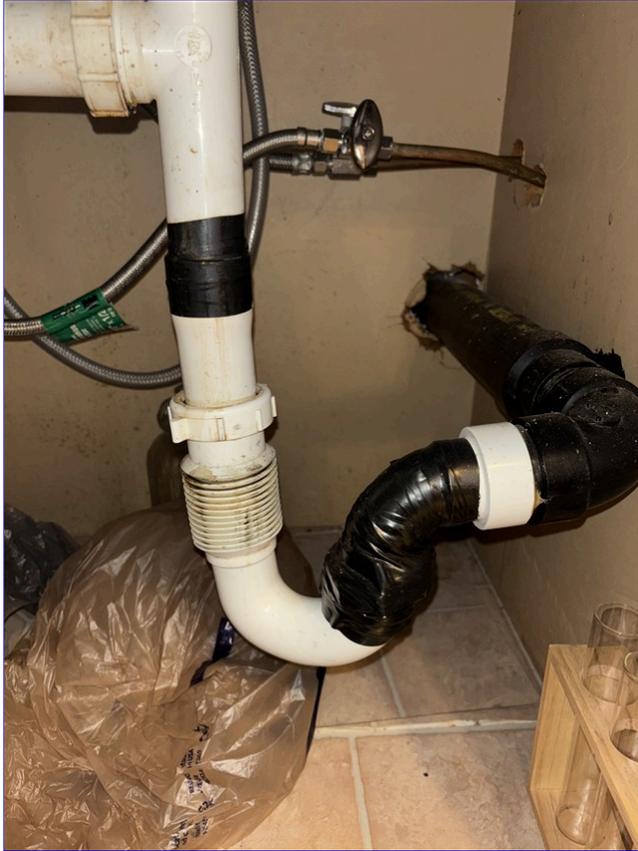
6.1 Item 1 (Picture)

(1) Plumbing drain under the kitchen sink is taped together, this could lead to leaks overtime causing further damage. Recommend repair or replace as needed by qualified contractor.

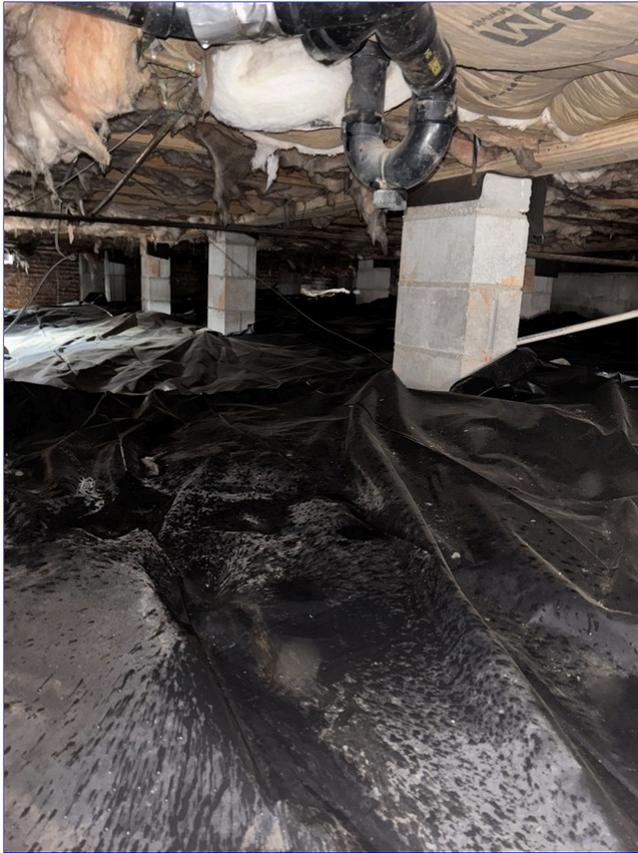
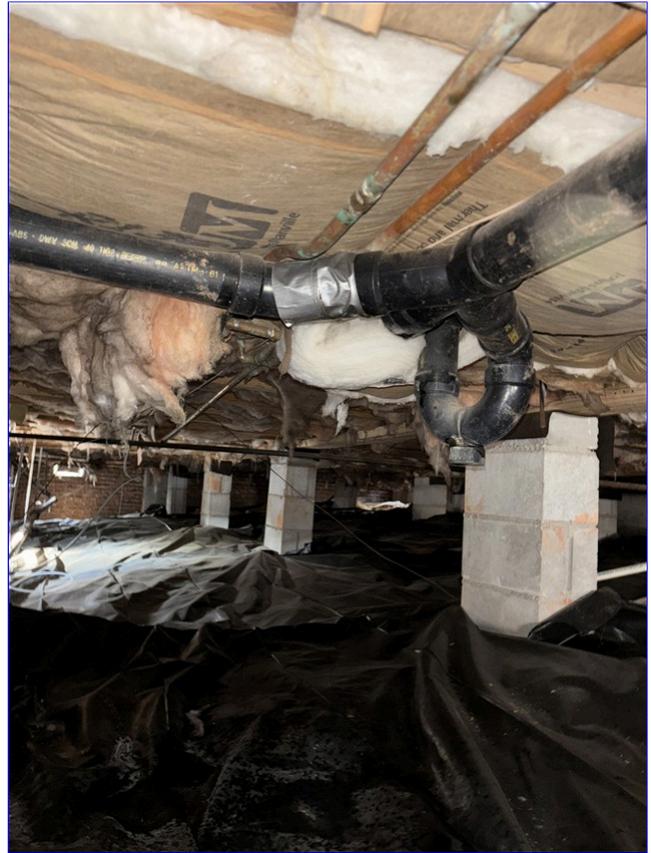
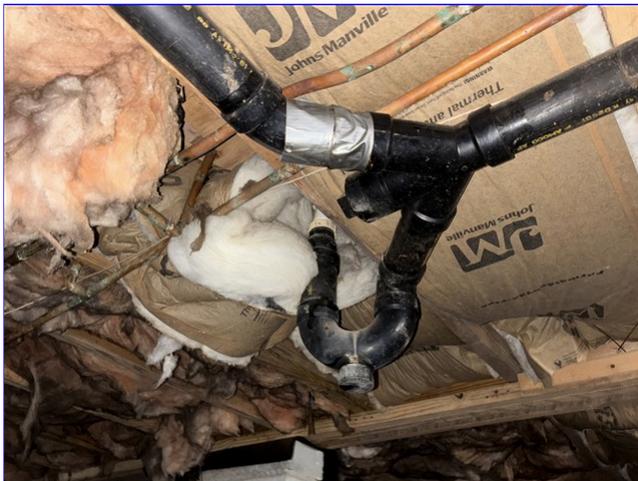
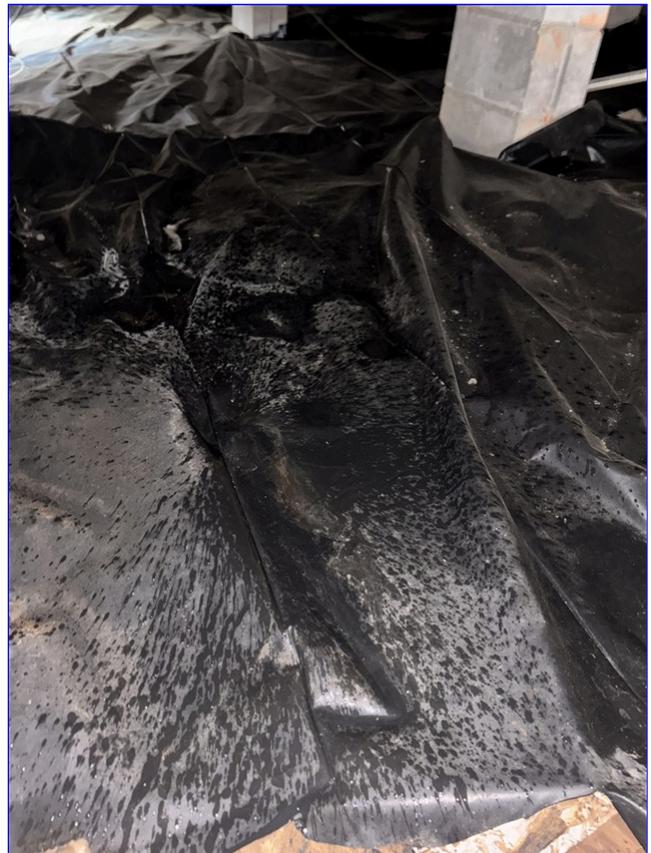
(2) Plumbing drain in the crawlspace has a large leak, the pipes are taped together with duct tape. This can lead to moisture intrusion in the crawlspace causing further damages. Recommend repair or replace as needed by qualified contractor.

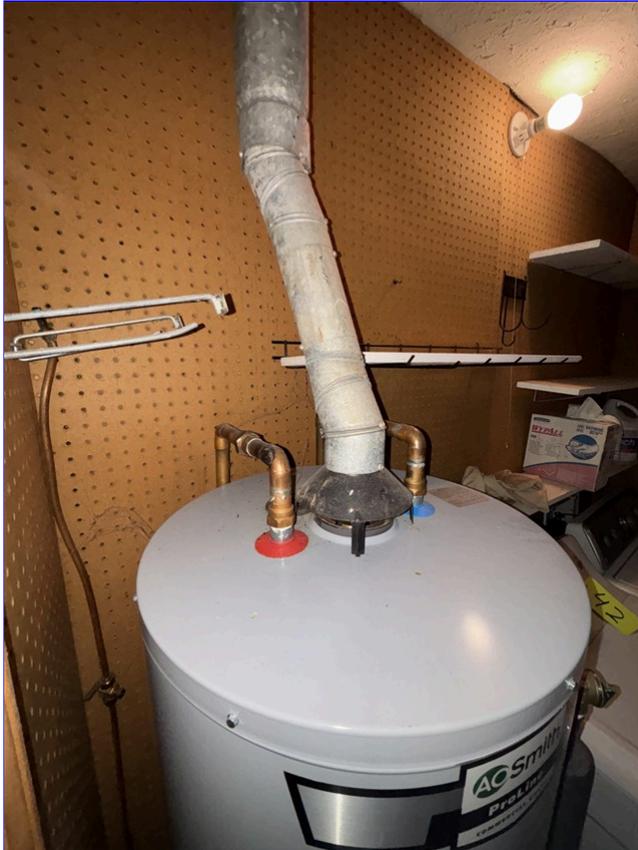
6.2 Item 3 (Picture)

(2) Your water heater does not have a "Thermal Expansion tank" installed to relieve tank pressure and prevent a possible leak at the T&P or "pop-off" valve. Recent changes in code in 2007 require one when a new water heater is installed. A licensed plumber should install an expansion tank.

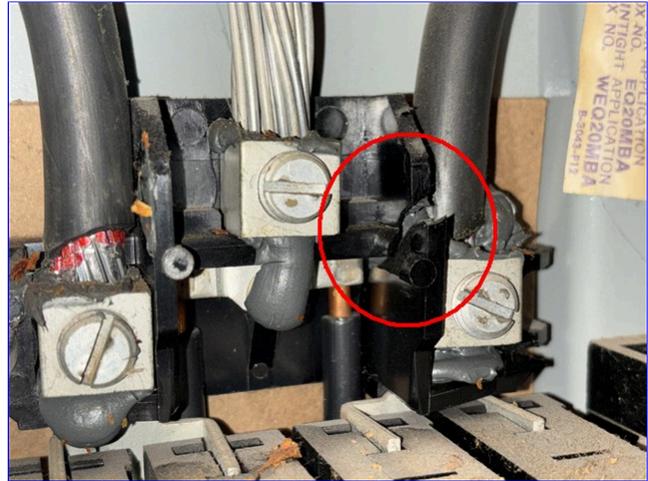
7.0 Item 2 (Picture)

The bracket securing the main service conductors inside the electrical panel was observed to have a small crack. Damage to this component could allow the service conductors to become loose, creating a significant safety hazard. Recommend evaluation and repair or replacement as needed by a qualified electrician.

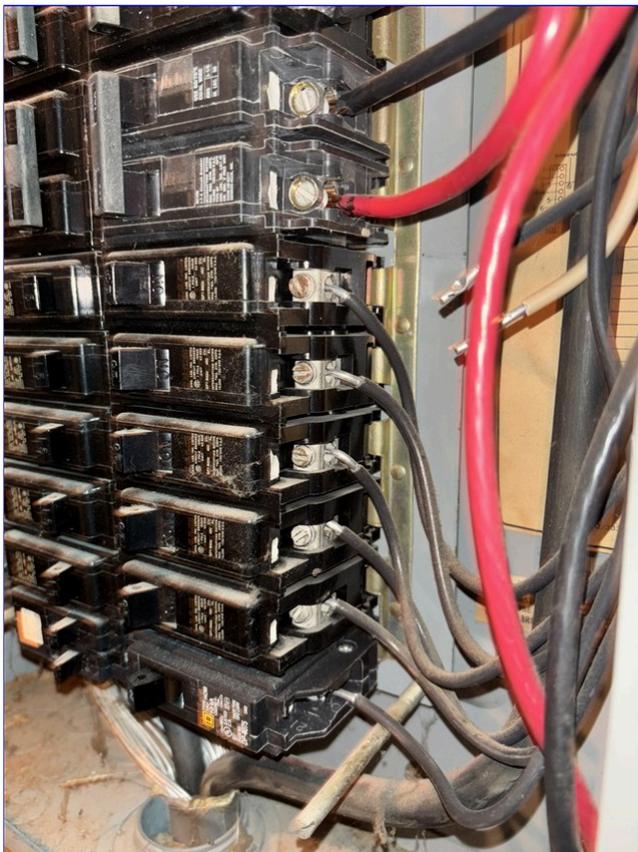
7.2 Item 1 (Picture)

(1) Aluminum wire is installed on 120 VAC branch electrical circuits in the subject house. These single strand, branch circuit aluminum wires were used widely in houses during the mid 1960s and 1970s. According to the U.S. Consumer Product Safety Commission, problems due to expansion can cause overheating at connections between the wire and devices (switches and outlets) or at splices, which has resulted in fires. For further information on aluminum wiring contact the U.S. Consumer Product Safety Commission via the Internet at <http://www.cpsc.gov/> . It is recommended that the electrical system be evaluated by a licensed electrical contractor.

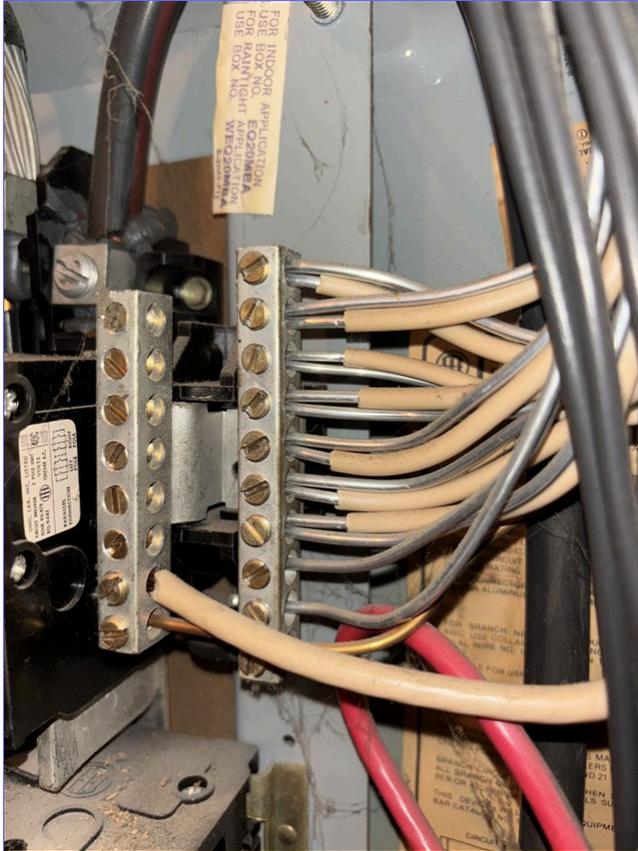
7.2 Item 3 (Picture)

(2) Multiple grounding conductors were observed terminated under a single lug (double-lugged). Most

terminals are designed to accept only one conductor, and this condition may result in a loose or improper connection. Recommend evaluation and correction as needed by a qualified electrician.

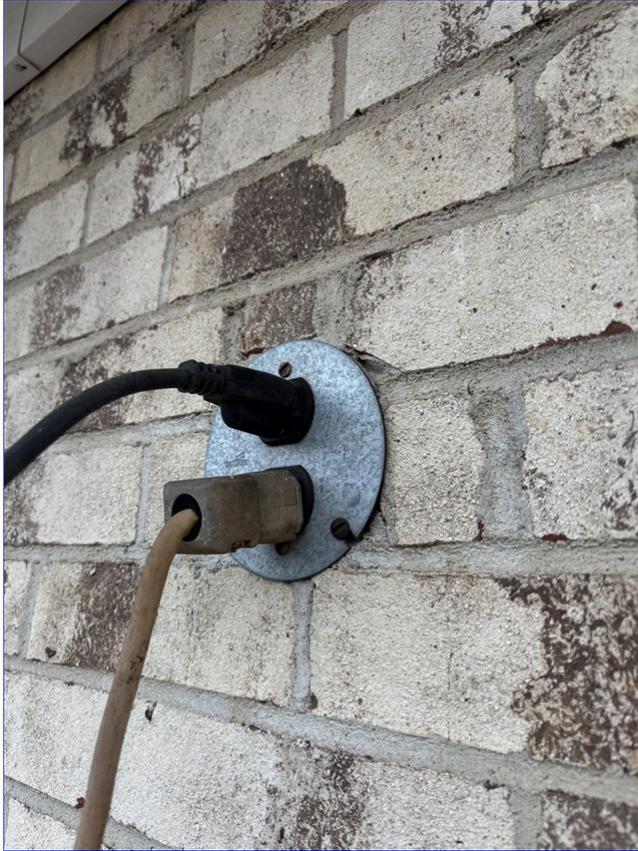
7.3 Item 1 (Picture)

(1) The exterior electrical outlet located at the right rear of the home is not properly covered and is not GFCI protected. This condition presents a potential safety hazard, especially in wet conditions. Recommend installation of a weather-resistant cover and GFCI protection by a qualified electrician to improve safety and meet current standards.

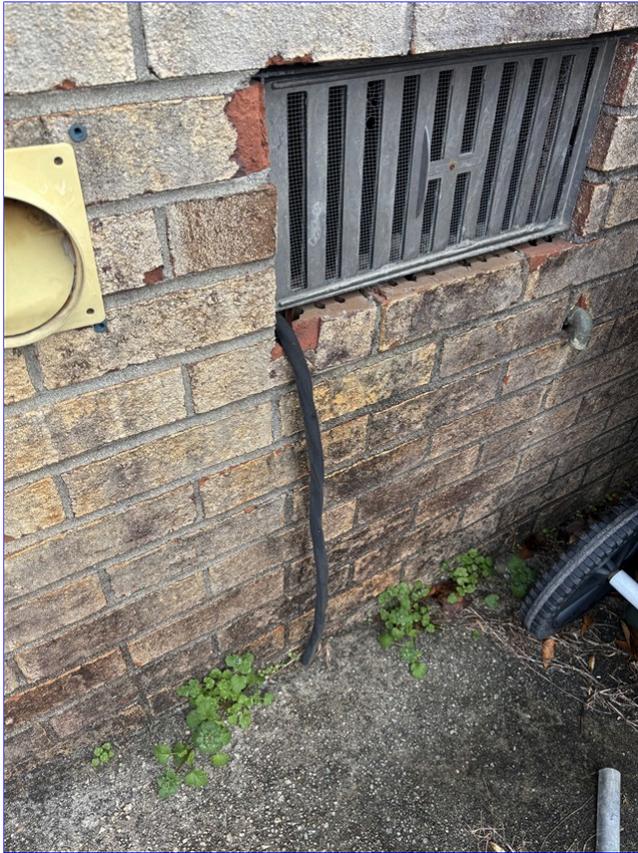
7.3 Item 2 (Picture)

(2) Exposed electrical wiring at the rear of the home, this is likely power leading to the detached garage, this leaves the wire exposed to sun damage or external damaging. Recommend installing a conduit for the wiring to run through for protection.

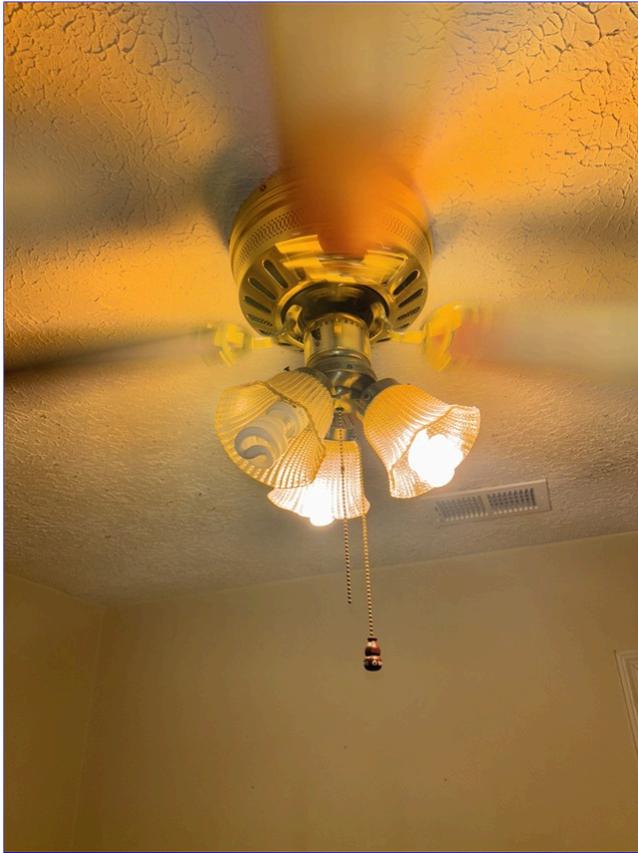
7.3 Item 3 (Picture)

(3) Light out at the guest bedroom, this can be a simple bulb replacement or possible electrical issue. Recommend repair or replace as needed.

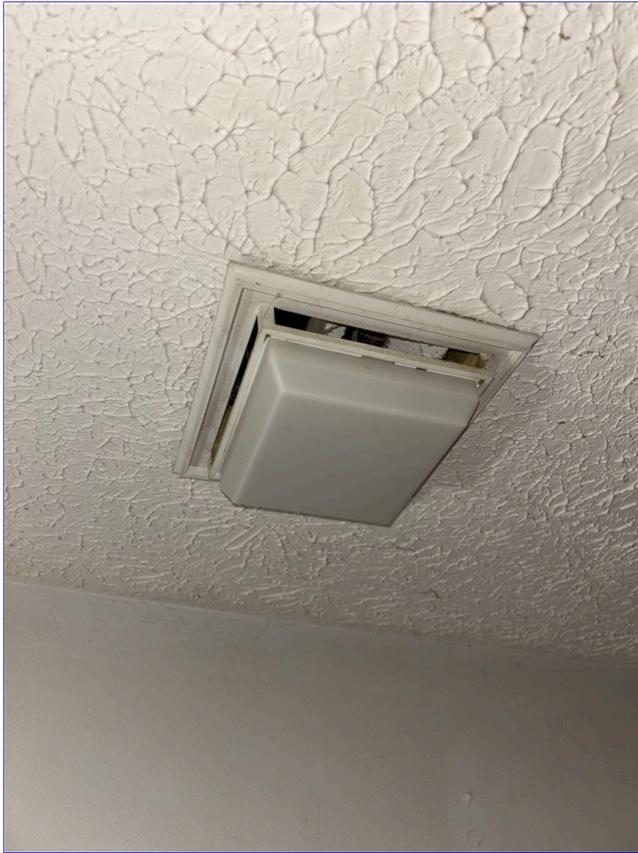
7.3 Item 4 (Picture)

(4) Light and fan at the guest bathroom did not work properly when tested. Recommend repair or replace as needed by qualified contractor.

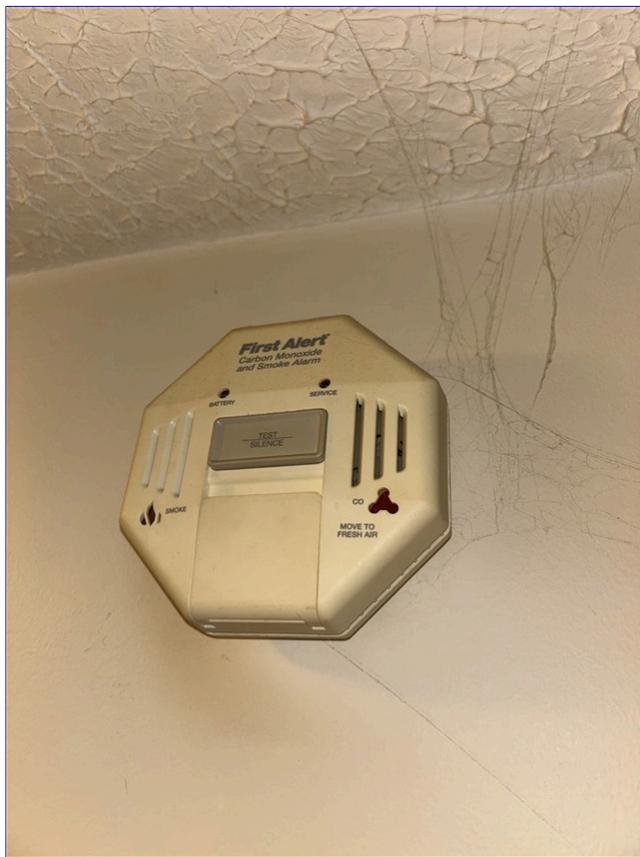
7.8 Item 1 (Picture)

(2) The smoke alarms in this home are over 10 years old and should be replaced. The National Fire Protection Association issued NFPA standard 72 that says all smoke alarms and carbon monoxide detectors should be replaced when they are 10 years old or sooner. A qualified person should replace all smoke alarms. for more info: <https://www.nachi.org/smoke-alarm-inspection.htm>
