# Inspection Report

**Property Address:**  
4696 Pine Valley Dr  
Macon GA 31210

<b>Date:</b> 1/23/2026	<b>Time:</b> 09:00 AM	<b>Report ID:</b> 20260123-4696-Pine-Valley-Dr
<b>Property:</b> 4696 Pine Valley Dr Macon GA 31210	<b>Customer:</b> Steve Slocumb	<b>Real Estate Professional:</b>

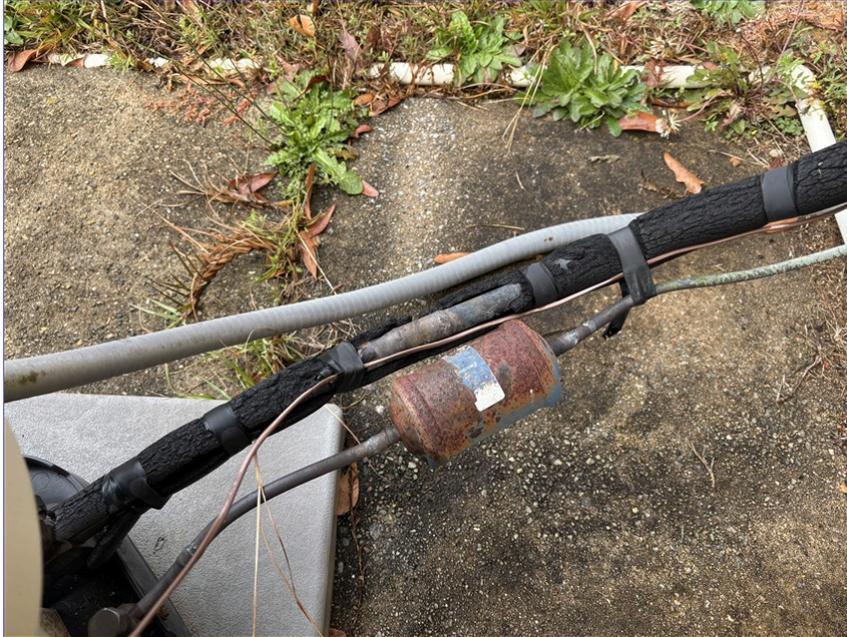
8.3 Item 4 (Picture)

(4) The insulation is deteriorated on the freon lines at the exterior condenser unit. This will degrade the efficiency of the unit. Replace the missing or deteriorated insulation as needed.

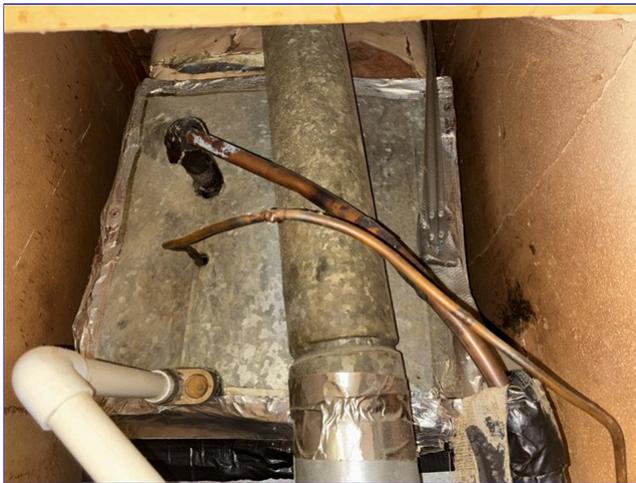
8.3 Item 5 (Picture)

(5) The refrigerant (Freon) lines at the furnace unit located in the closet were observed to be exposed and missing insulation. Lack of insulation can reduce system efficiency and may contribute to condensation issues. Recommend repair or installation of proper insulation as needed by a qualified HVAC contractor.

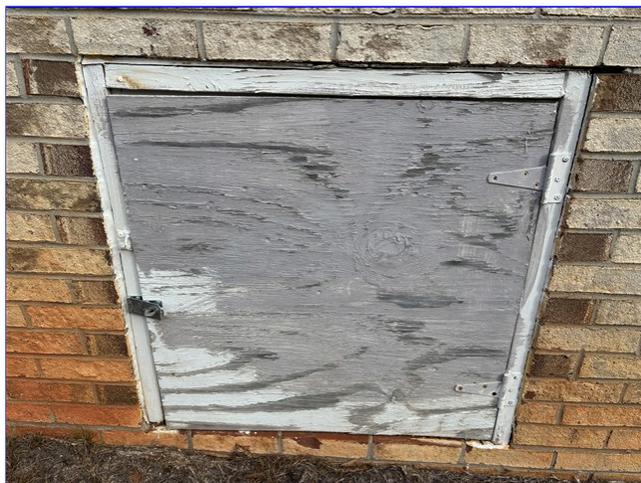
9.5 Item 1 (Picture)

(1) The crawlspace door shows signs of deterioration, and the paint is peeling. The door can be resurfaced and painted to prevent intrusion that could lead to further damaged. Recommend repair or replace as needed by qualified contractor.

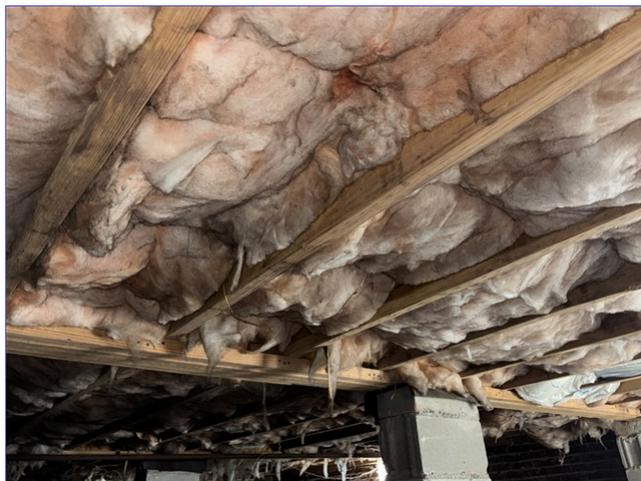
9.5 Item 9 (Picture)

(3) The insulation in the crawlspace was observed to be discolored, consistent with past or ongoing moisture intrusion. Moisture-damaged insulation may lose effectiveness and contribute to unfavorable conditions. Recommend further evaluation and repair or replacement as needed, along with addressing the source of moisture, by a qualified contractor.

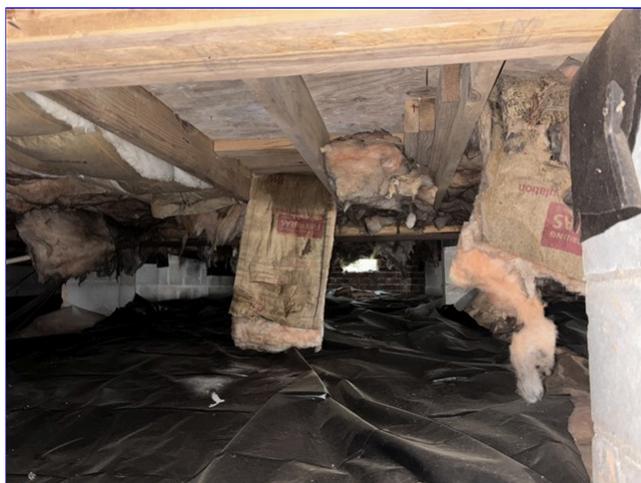
10.1 Item 1 (Picture)

The insulation is loose/fallen in the crawlspace. Insulation that has fallen to the ground or has become damp from the ground or from condensation usually needs to be replaced with new insulation. A qualified contractor should inspect and repair as needed.

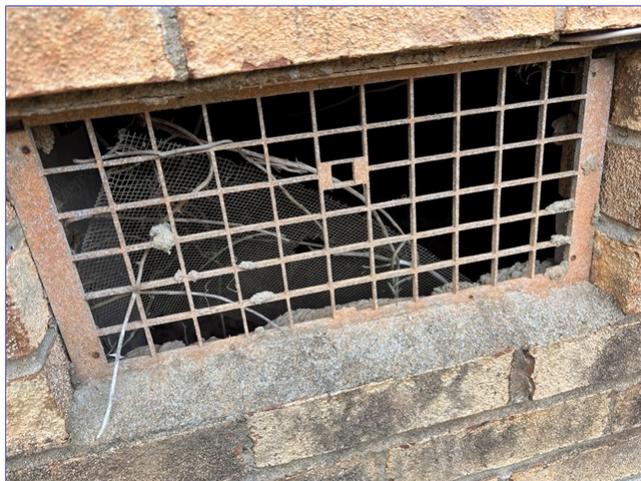
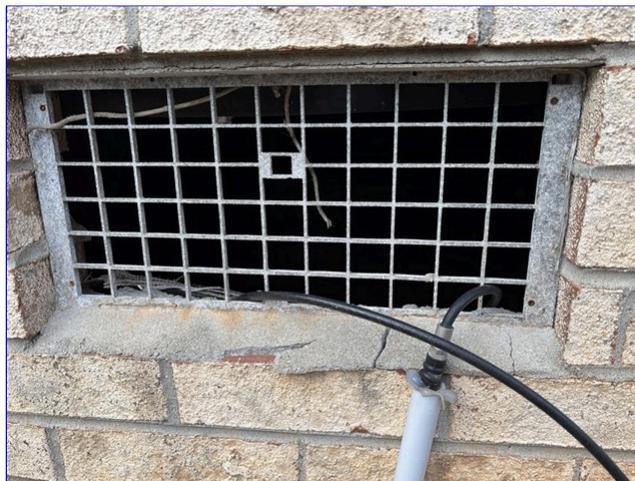
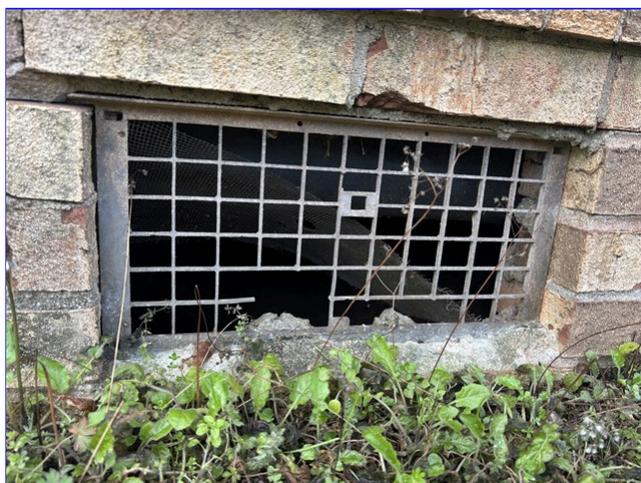
10.2 Item 1 (Picture)

The screens behind the crawlspace grates are loose and falling, this can allow for pest intrusion into the crawlspace that can cause further damage overtime. Recommend repair or replace as needed by qualified contractor.
