General Summary

Clear Pathways, Inc.

2800 Lewiston Road
Bumpass Virginia 23024

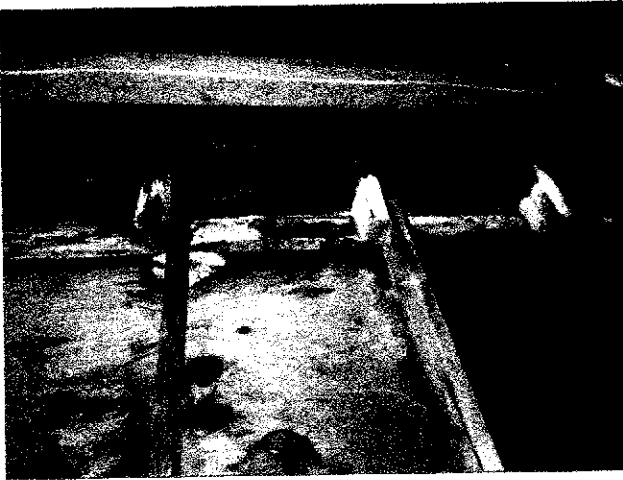
The metal roofing is in need of some attention. There is rust build up, active leaks and poorly installed in various areas. I recommend the entire roof be further evaluated and repaired or replaced as needed by a qualified licensed roofer. Please note, some of the leaks have caused moisture damage. Example areas pictured. This also includes the detached dwelling.

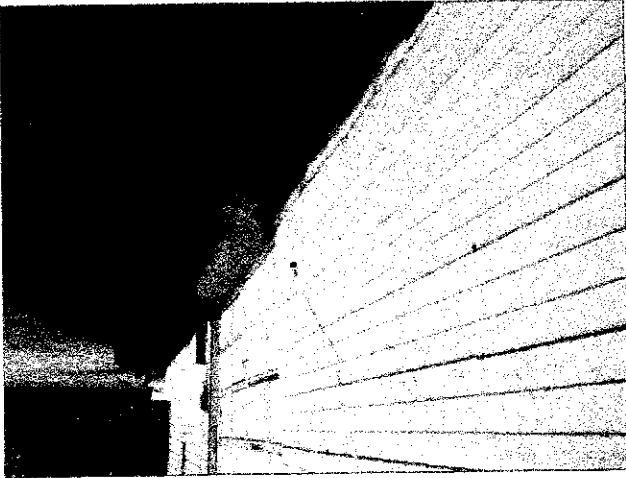
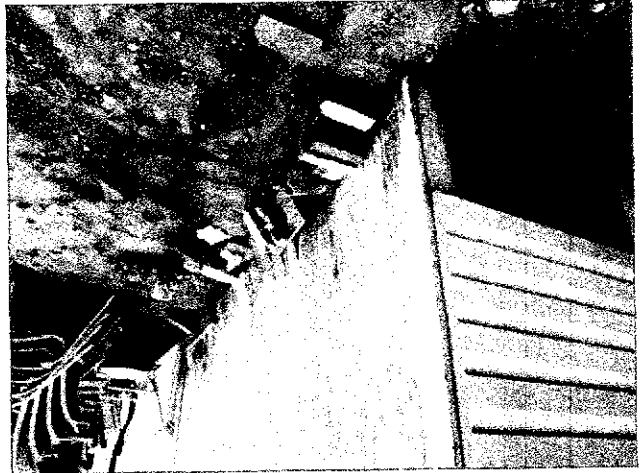
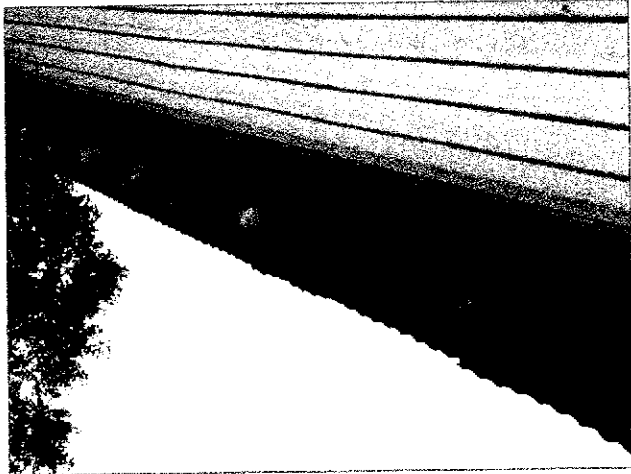
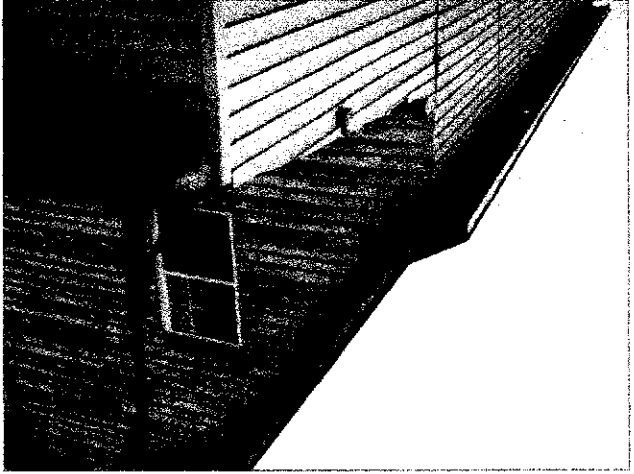
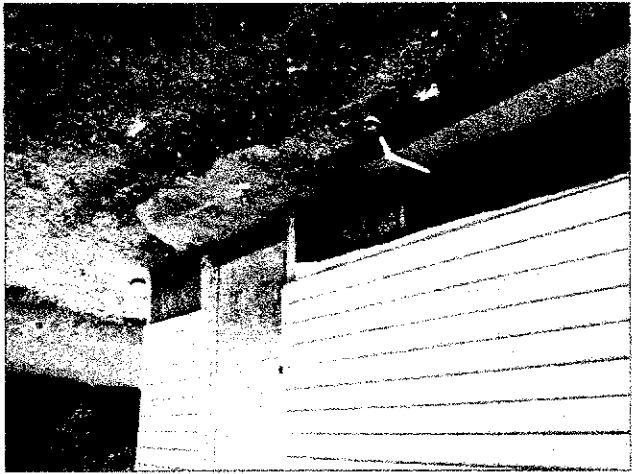
(1) There are several areas around the buildings with moisture damage to the trim and siding. Much of the trim and siding needs to be scraped, caulked, and painted to help prevent additional moisture damage. I recommend further evaluation and repairs/replacement as needed by a qualified licensed contractor. Example areas pictured.

(2) There are various areas around the buildings that need to be caulked/sealed to help prevent moisture damage. Example areas pictured.

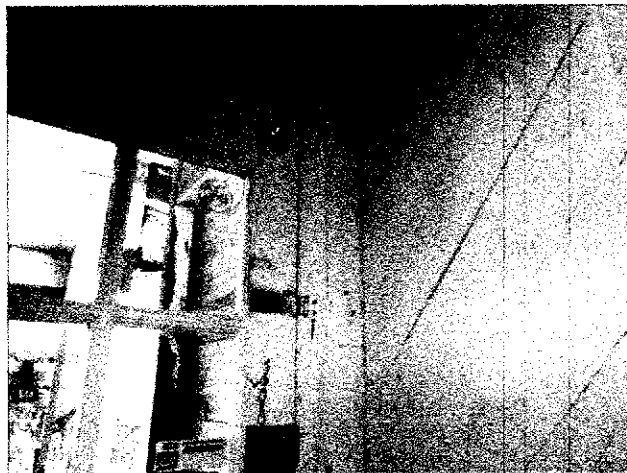
2.1 Item 1 (Picture)

(1) The pictured exterior door would not open. I recommend the door be in working order as needed. Also see 2.0 comment.

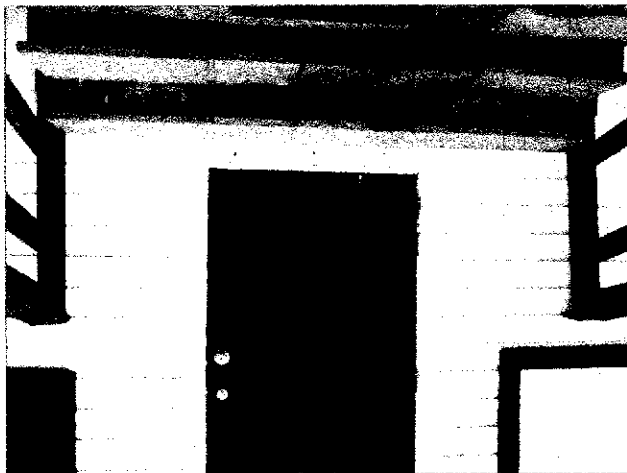
2.1 Item 2 (Picture)

(2) The pictured exterior door is weathered. I recommend repairs or replacement as needed.

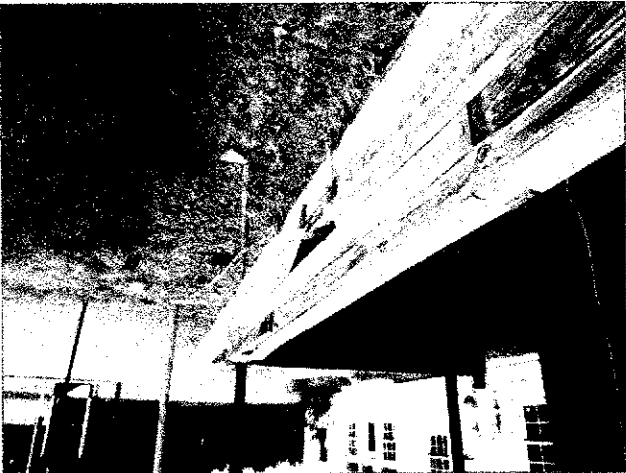
(1) The pictured covered area is weathered and is unsafe. Some of the supports are rotting, some supports are poorly supported and the retaining wall is damaged/weathered. I recommend further evaluation and repairs/replacement as needed by a qualified licensed contractor. Example areas pictured. Also see 1.0 & 2.0 comments.

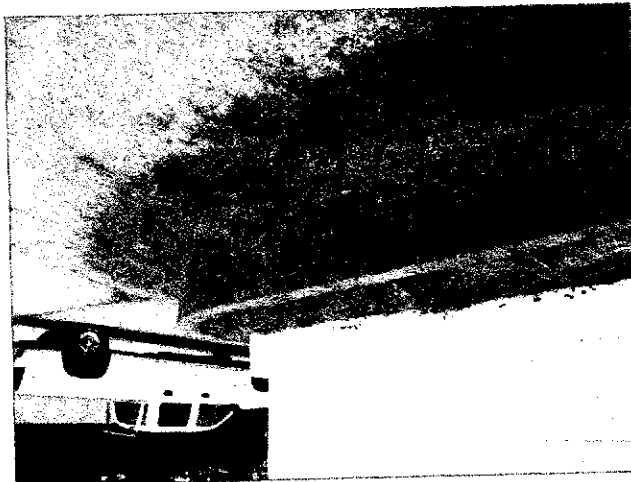
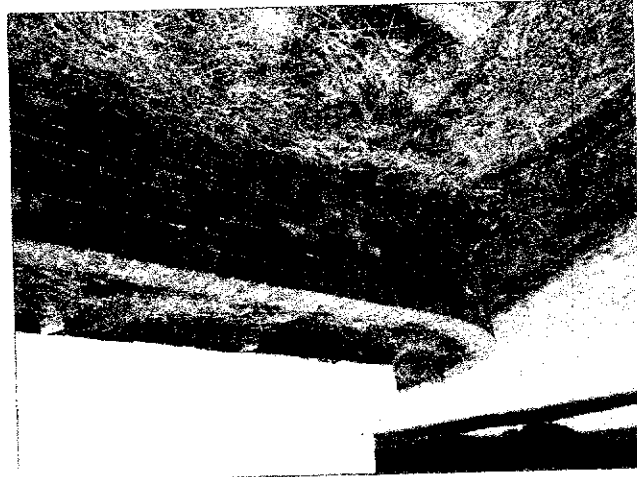
(2) The retaining wall around the detached building is cracked/damaged in various areas. I recommend repairs as needed. Example areas pictured.

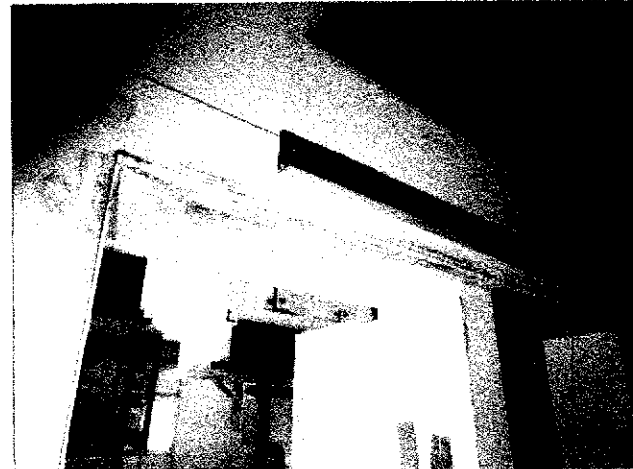
There is a suspicious substance present in several areas in the buildings. I recommend you contact a mold inspector or expert for investigation and correction as needed. Example areas pictured.

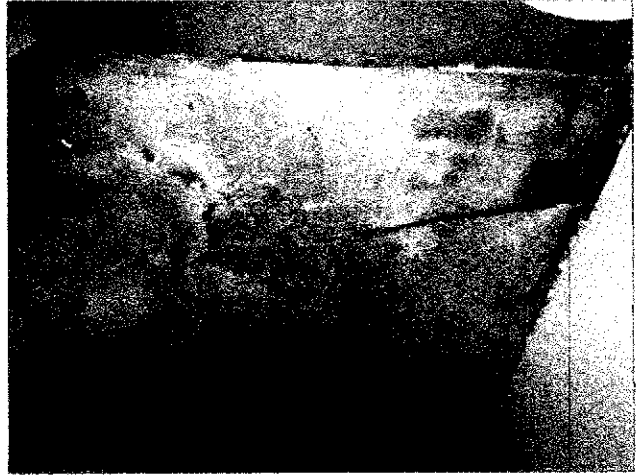
5.2 Item 1(Picture)

The slab floor is cracked in various areas. This appears to be from settling. I recommend repairs as needed. Example area pictured.

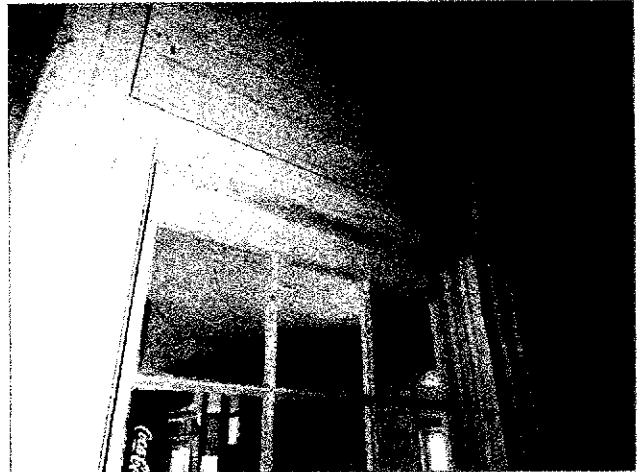
5.5 Item 1(Picture)

The glass is broken for some of the windows. In addition, several of the windows are aged/worn and some will not open. I recommend further evaluation and repairs or replacement as needed by a qualified licensed contractor. Example window pictured.

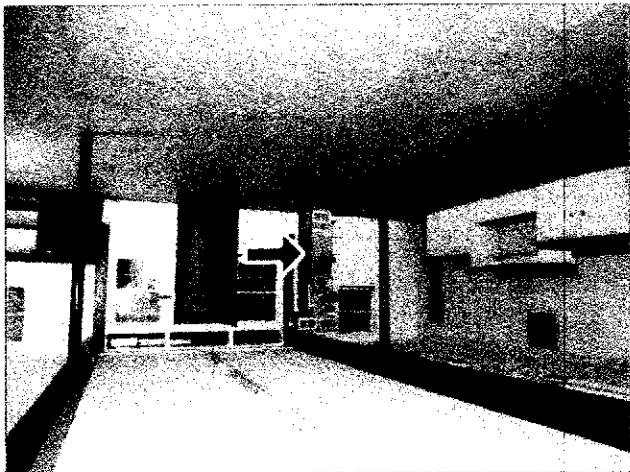
The heating and air conditioning systems do not appear to have been serviced within the last year. The air handlers/furnace and ductwork are very dirty. In addition, the pictured furnace would not come on. I recommend a complete system evaluation, cleaning, servicing and repairs or replacement as needed by a qualified licensed HVAC company.

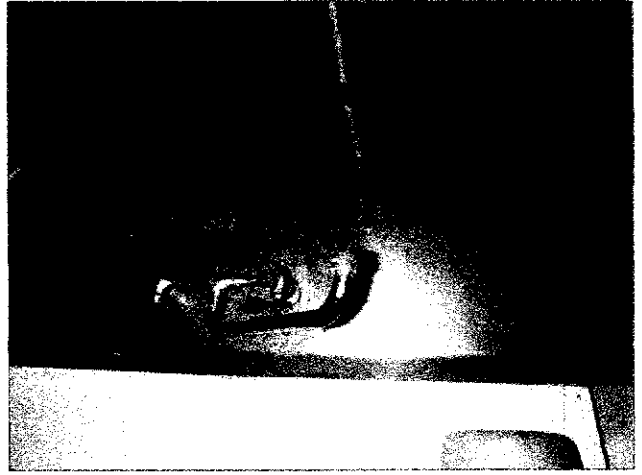
4.6 Item 1(Picture)

The kitchen sink faucet leaks when the water is off. I recommend repairs as needed.

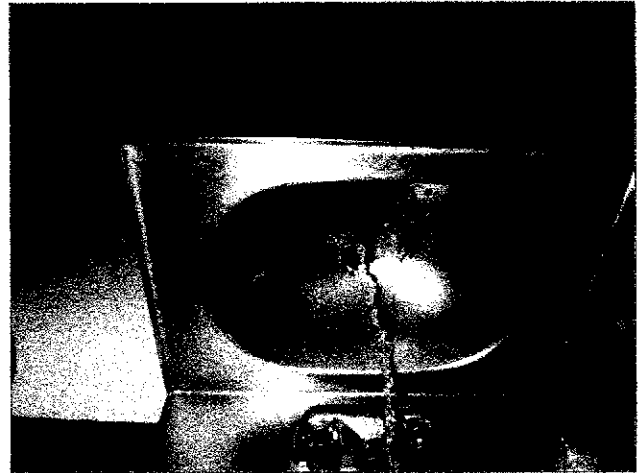
4.5 Item 1(Picture)

Some of the sinks drain slowly. I recommend the drains be unclogged or repaired as needed. Example drain pictured.

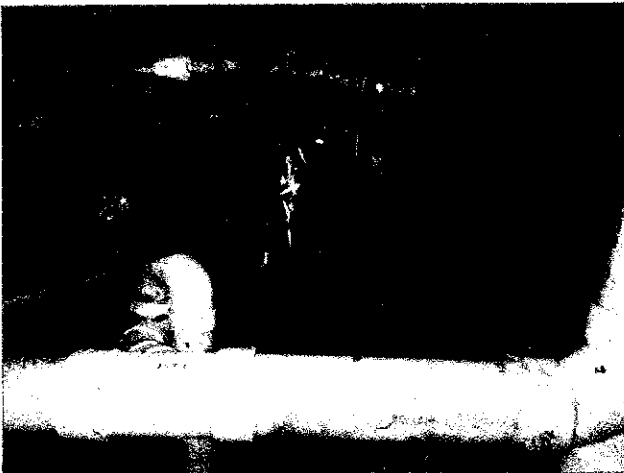
The shower drain screen is damaged. In addition, this drain leaks into the crawlspace. I recommend further evaluation and repairs as needed by a qualified licensed plumber.

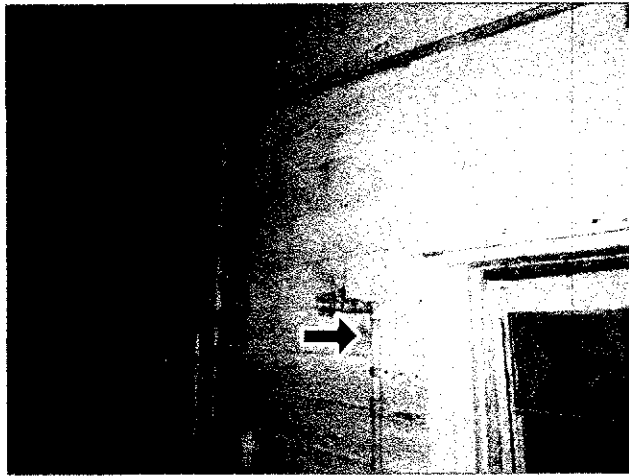
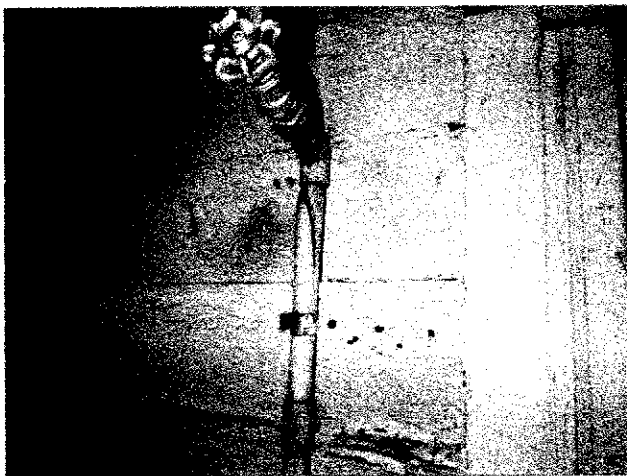
Plumbing Repair or Replace
There are few broken plumbing lines. In addition, some of the valves were off to some of the plumbing. I recommend a complete plumbing system evaluation and repairs as needed by a qualified licensed plumber. Example area pictured.

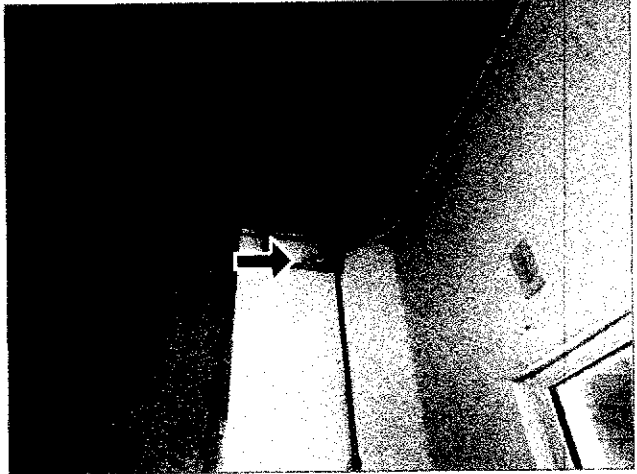
8.4 Item 1(Picture)

There are a few gas lines that are not capped. I recommend caps be installed on the gas lines as needed. Example area pictured.

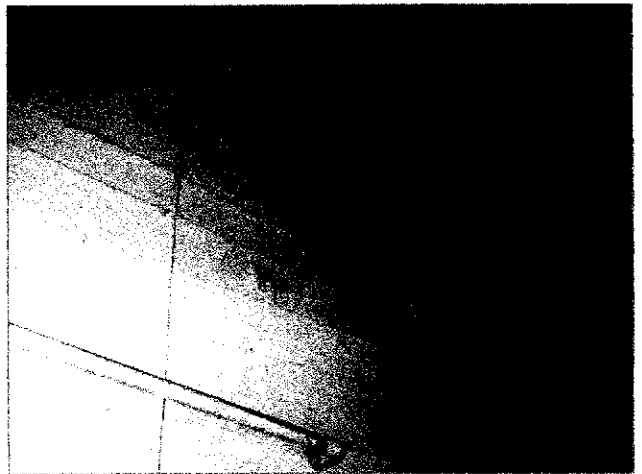
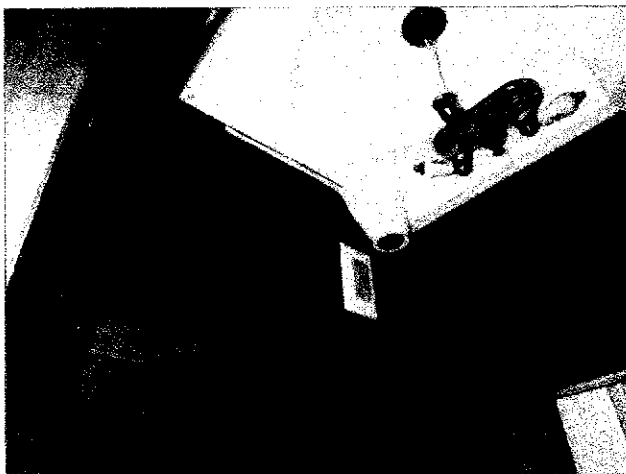
Some of the electrical outlets are damaged, some do not work and some are not grounded. In addition, the pictured GFCI outlet in the kitchen sparked when tested. I recommend a complete electrical system evaluation and repairs as needed by a qualified licensed electrician. Example outlets pictured.

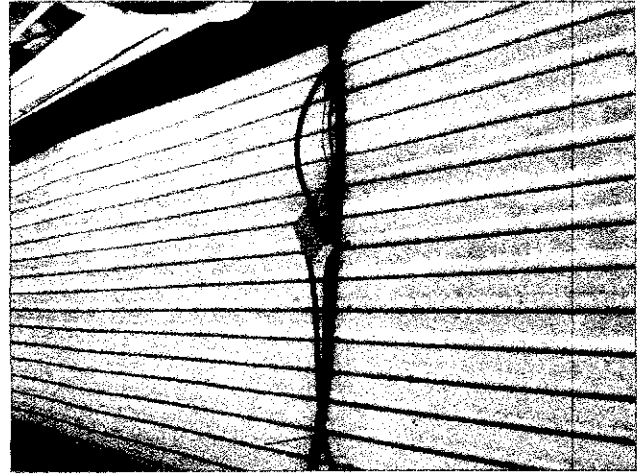
9.3 Item 2(Picture)

(2) The pictured electrical disconnect box is not secured. I recommend further evaluation and repairs as needed by a qualified licensed electrician.
