General Summary

Clear Pathways, Inc.

2800 Lewiston Road
Bumpass Virginia 23024

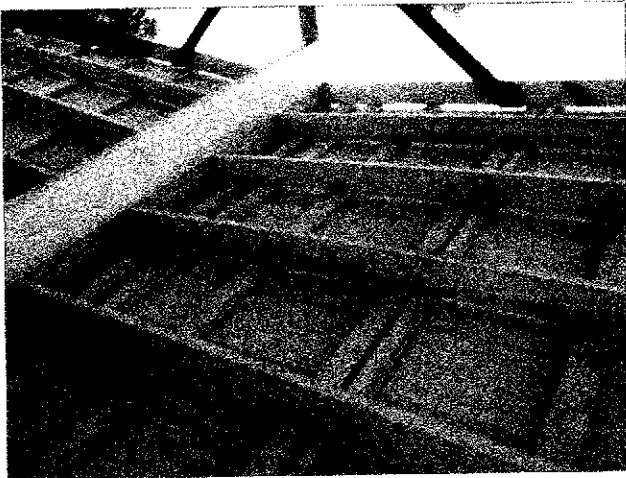
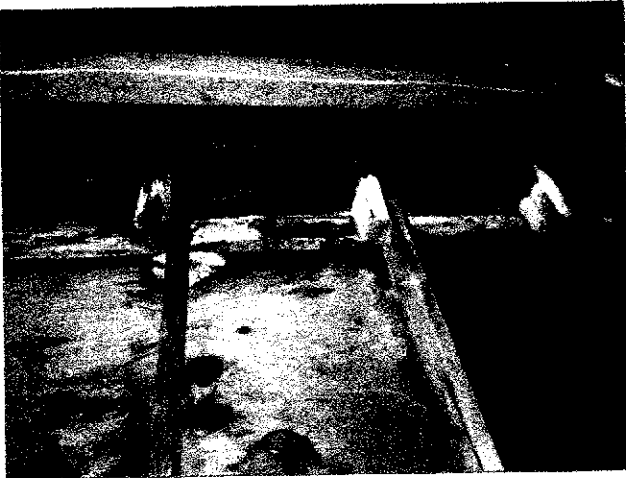
The metal roofing is in need of some attention. There is rust build up, active leaks and poorly installed in various areas. I recommend the entire roof be further evaluated and repaired or replaced as needed by a qualified licensed roofer. Please note, some of the leaks have caused moisture damage. Example areas pictured. This also includes the detached dwelling.

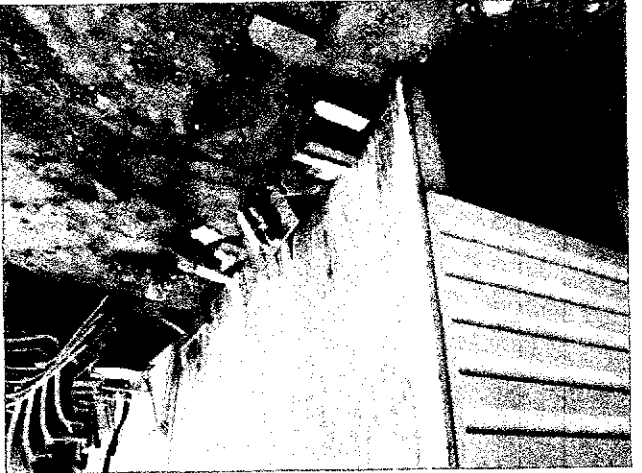
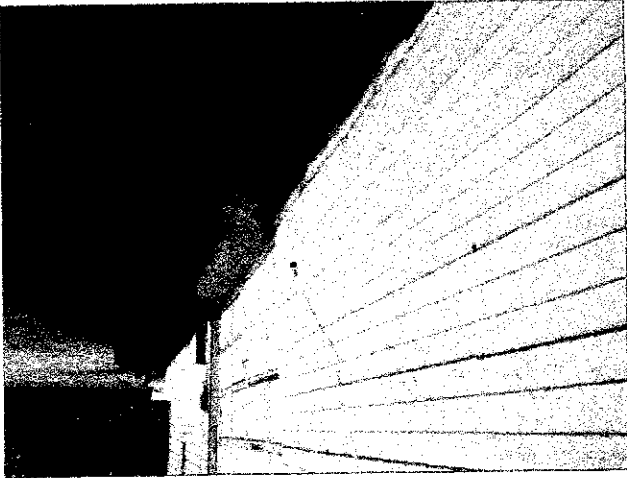
(1) There are several areas around the buildings with moisture damage to the trim and siding. Much of the trim and siding needs to be scraped, caulked, and painted to help prevent additional moisture damage. I recommend further evaluation and repairs/replacement as needed by a qualified licensed contractor. Example areas pictured.

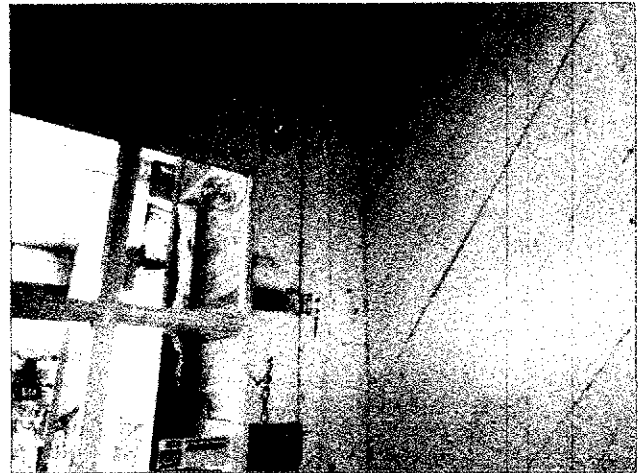
2.1 Item 1 (Picture)

(1) The pictured exterior door would not open. I recommend the door be in working order as needed. Also see 2.0 comment.

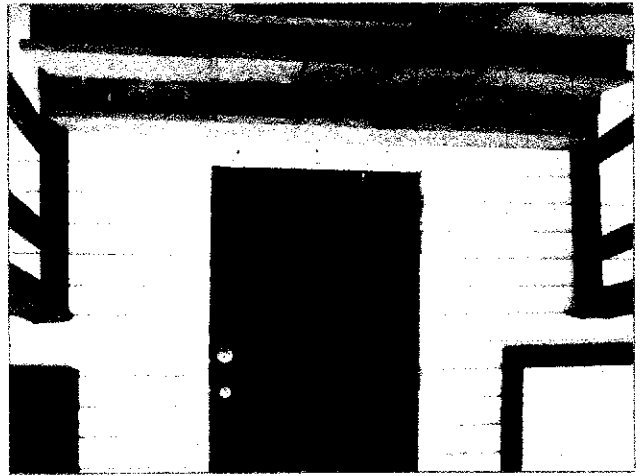
2.1 Item 2 (Picture)

(2) The pictured exterior door is weathered. I recommend repairs or replacement as needed.

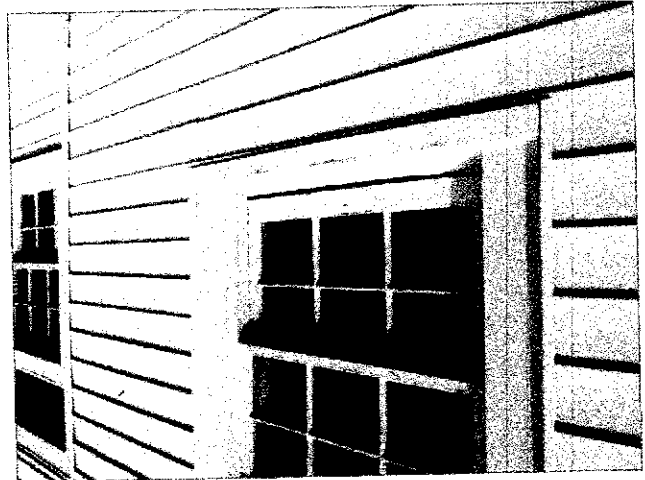
2.2 Item 1 (Picture)

The window glazing needs to be replaced on some of the windows to ensure air tightness. Proper window glazing will help minimize heat and cooling loss. Example window pictured. Also see 2.0 comment.

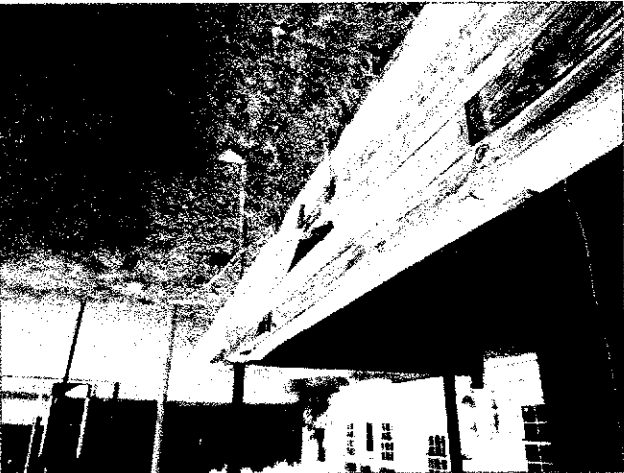
(1) The pictured covered area is weathered and is unsafe. Some of the supports are rotting, some supports are poorly supported and the retaining wall is damaged/weathered. I recommend further evaluation and repairs/replacement as needed by a qualified licensed contractor. Example areas pictured. Also see 1.0 & 2.0 comments.

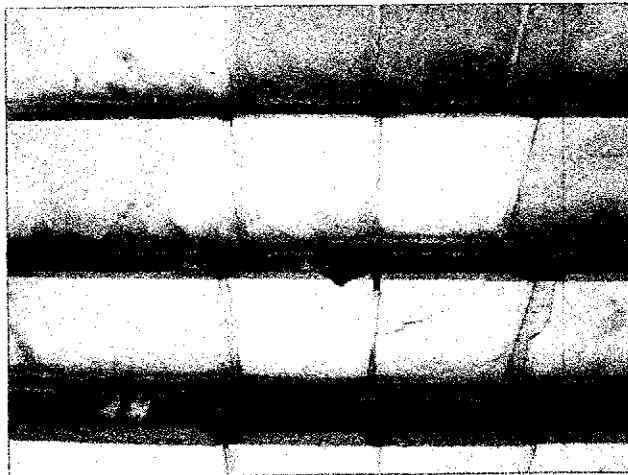
2.3 Item 5 (Picture)

(3) I recommend the deck boards be cleaned with a pressure washer and/or deck wash and treated with a waterproofing sealant. Example area pictured.

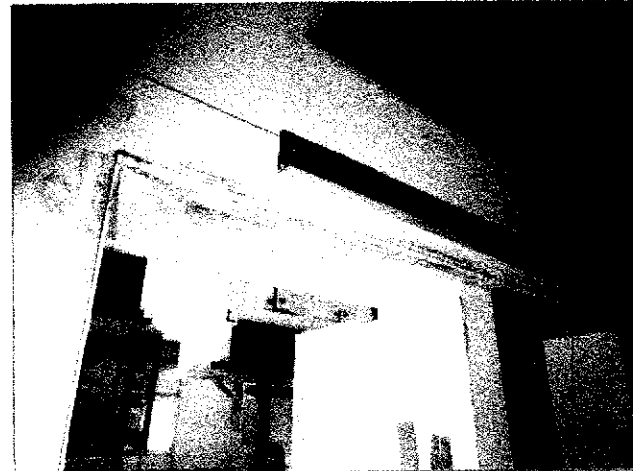
There is a suspicious substance present in several areas in the buildings. I recommend you contact a mold inspector or expert for investigation and correction as needed. Example areas pictured.

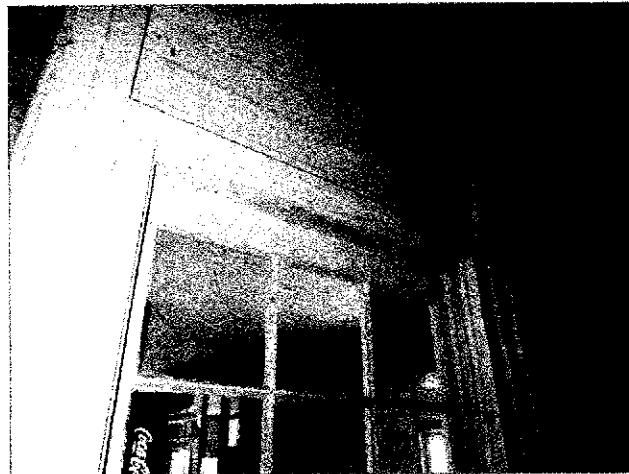
5.5 Item 1(Picture)

The glass is broken for some of the windows. In addition, several of the windows are aged/worn and some will not open. I recommend further evaluation and repairs or replacement as needed by a qualified licensed contractor. Example window pictured.

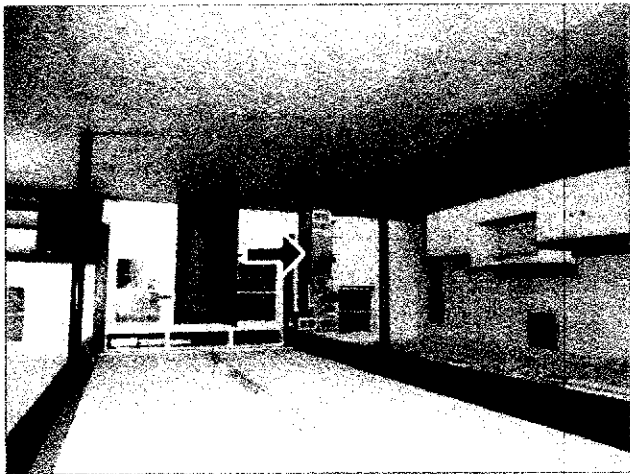
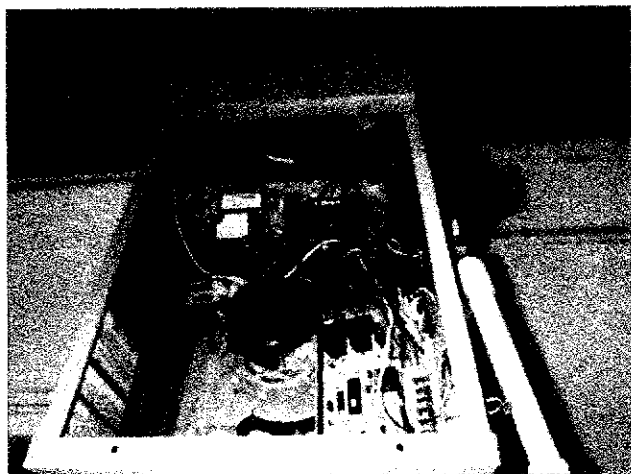
The heating and air conditioning systems do not appear to have been serviced within the last year. The air handlers/furnace and ductwork are very dirty. In addition, the pictured furnace would not come on. I recommend a complete system evaluation, cleaning, servicing and repairs or replacement as needed by a qualified licensed HVAC company.

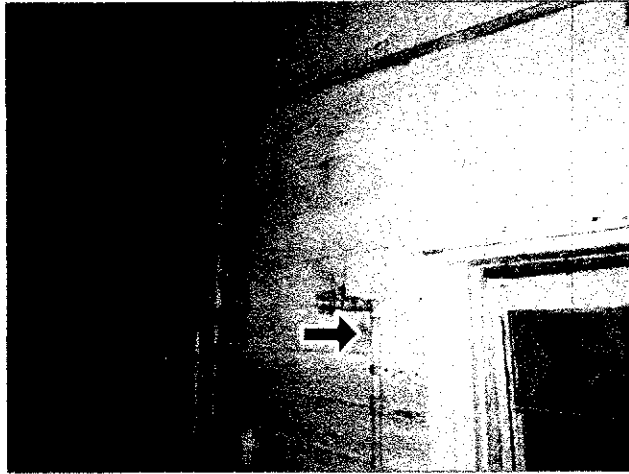
Plumbing Repair or Replace
There are few broken plumbing lines. In addition, some of the valves were off to some of the plumbing. I recommend a complete plumbing system evaluation and repairs as needed by a qualified licensed plumber. Example area pictured.
