## Inspection Report

### Blue Box Auctions

**Property Address:**  
225 Cheyenne Rd  
Virginia Beach VA 23462

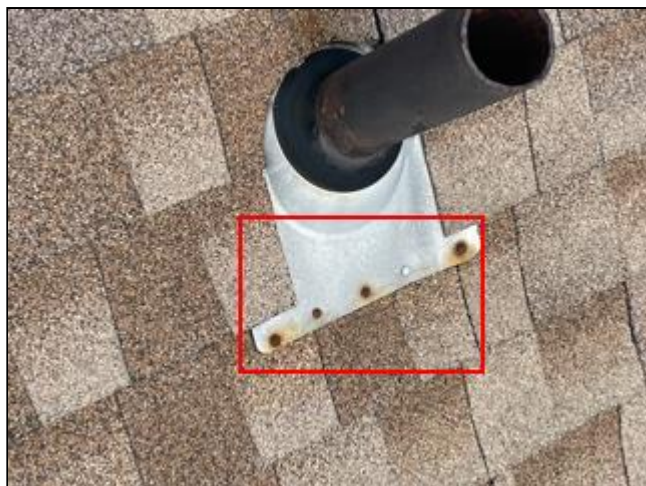
Item 1 - Item 1(Picture)

- 1 (1) Recommend having a qualified contractor caulk / seal exposed nail heads at roof penetrations.

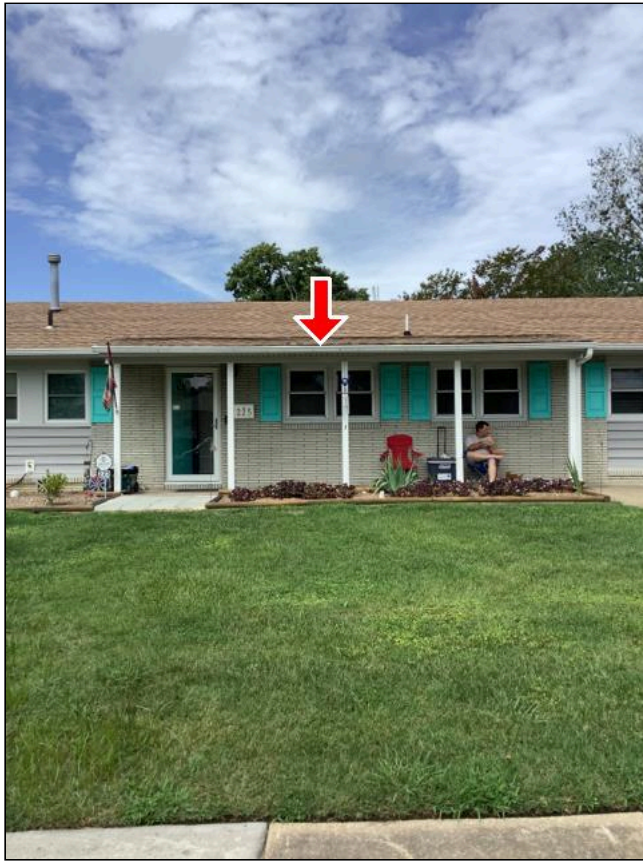
- 2 Properly secure loose gutters and slope towards downspouts to direct water away from structure.

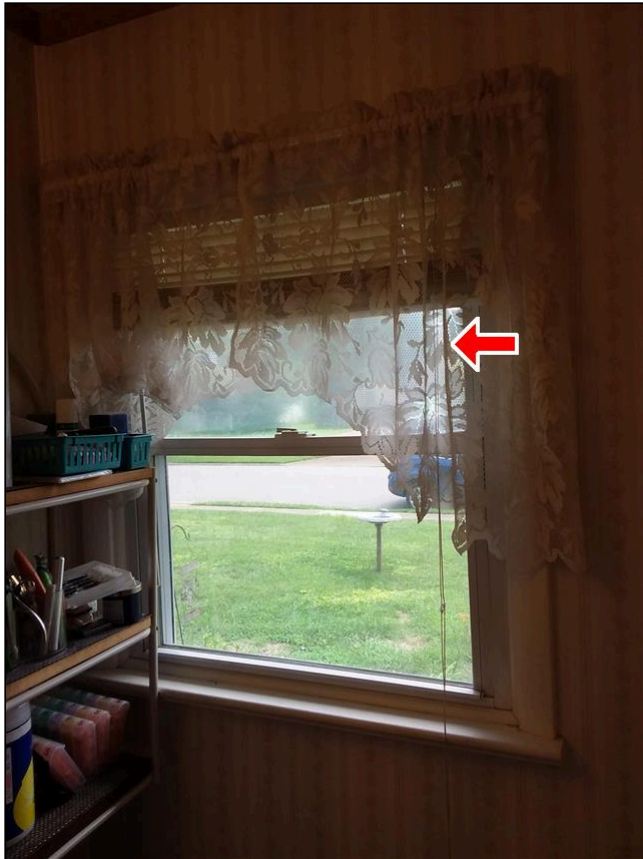
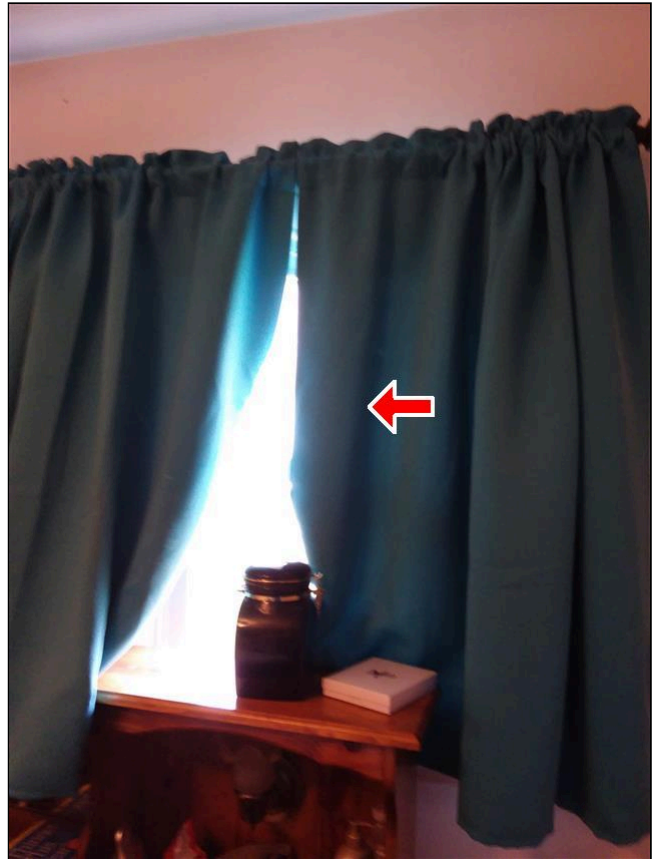
- 3 Failed seal between double panes of glass noted, but not limited to: see pictures . Windows have fogged. Have a qualified window contractor properly repair/ replace all damaged windows.

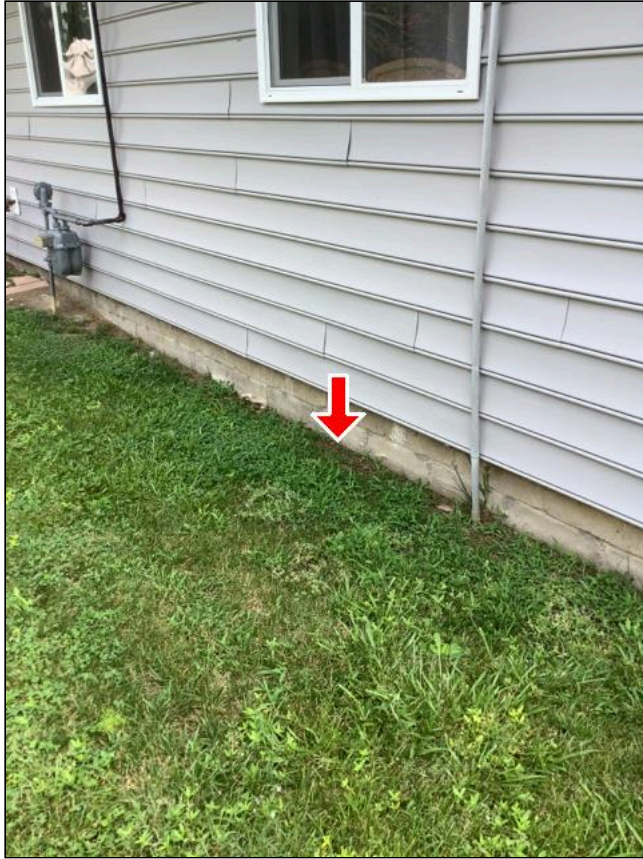
Item 4 - Item 1(Picture) Rear left

- 4 (1) There is a negative slope at the rear of home that can cause or contribute to water intrusion or deterioration. I recommend correcting landscape to drain water away from home.

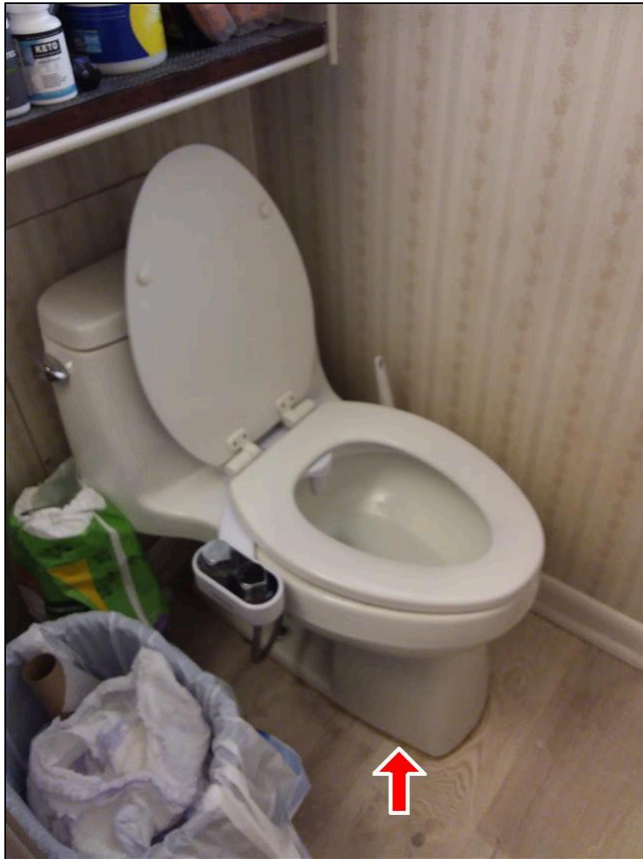
Item 5 - Item 1(Picture) Master

- 5 (1) The toilet is loose at the floor. Repairs may involve re-setting the toilet on a new wax seal. I recommend a qualified licensed plumber repair or correct as needed.

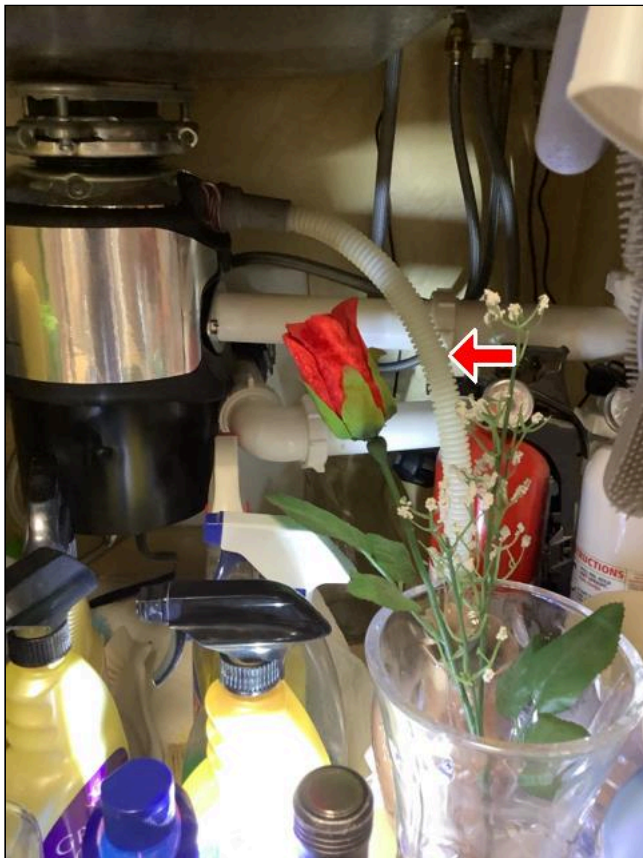
Item 6 - Item 1(Picture)

- 6 (2) Kitchen dishwasher drain should loop higher to properly function/ avoid backflow. Repair to normal function.

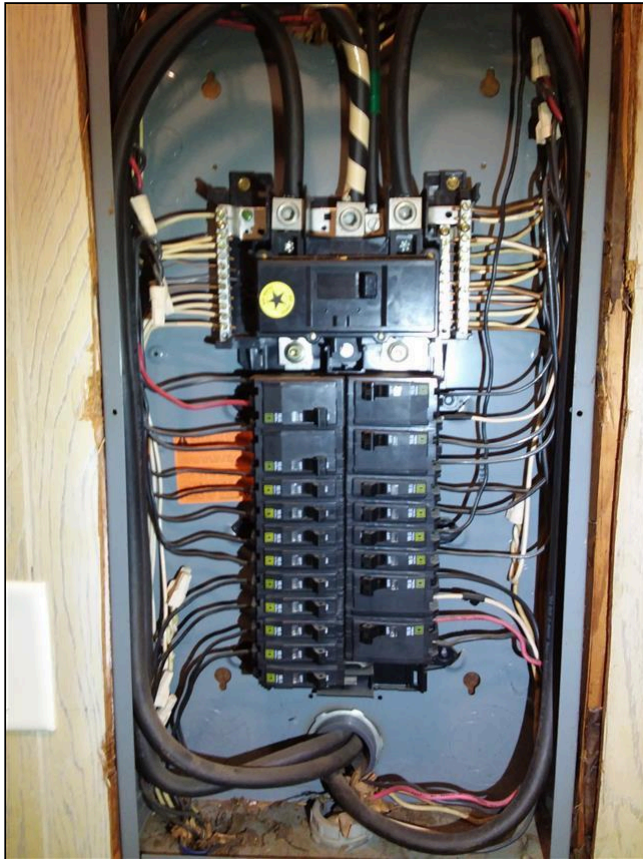
Item 7 - Item 1(Picture)

- 7 Interior view of distribution panel- Washer Dryer Room

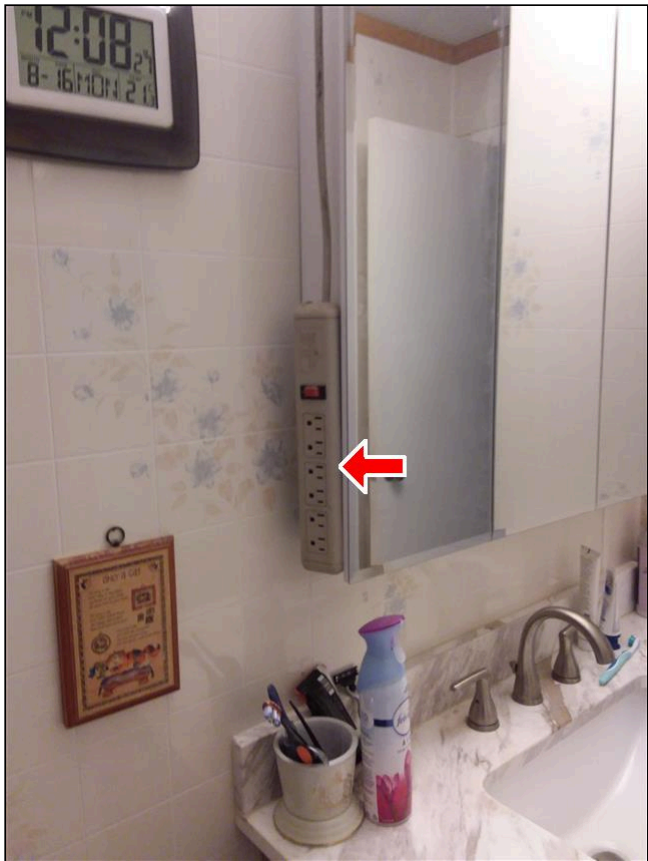
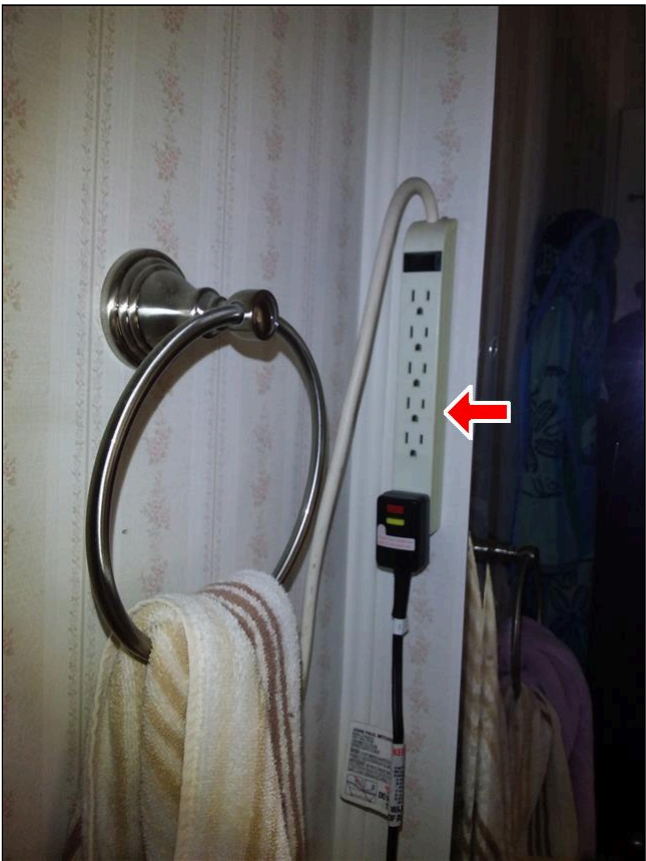
- 8 Install GFCI (shock) protection where missing at kitchen and bathroom outlets.

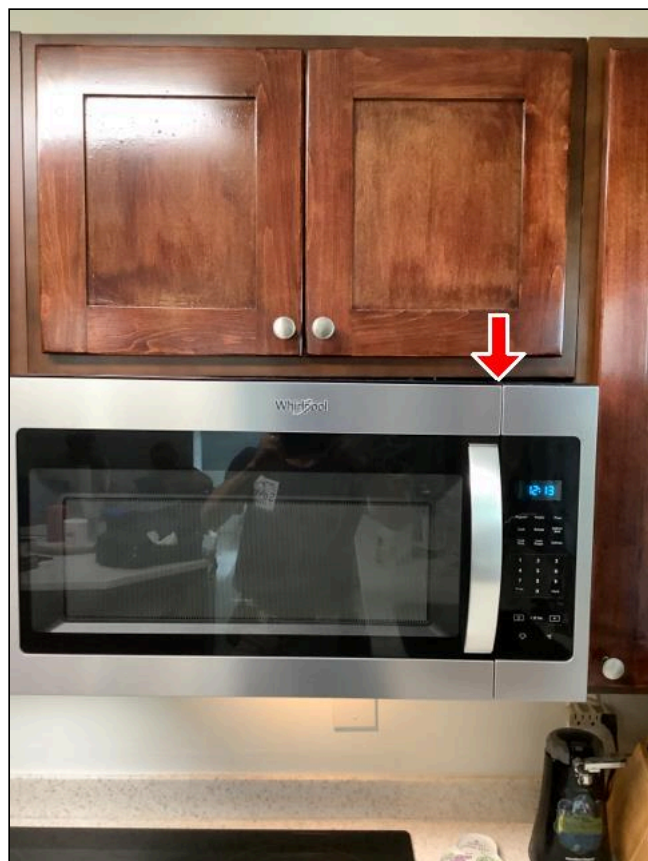
Item 13 - Item 1(Picture)

- 13 (2) Have a qualified contractor properly secure loose microwave oven.
