SoVa Inspection Group

Inspection Report

Property Address:
101 Canvas Back Circle
Franklin VA 23851

Date: 1/26/2022	Time: 10:00 AM	Report ID: 20220126-Joanna-BB-Auctions-Franklin-Va
Property: 101 Canvas Back Circle Franklin VA 23851	Customer: Blue Box Auctions	Real Estate Professional:

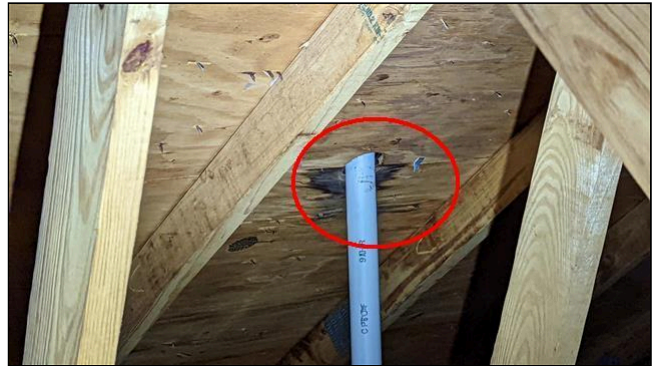
Item 2 - Item 1(Picture)

- 2 Loose collar flashing and stains beneath this area observed. Have a qualified roofing contractor properly fasten, caulk and seal all loose flashing to avoid further moisture intrusion and repair all associated damage as needed.

1.1 Loose collar flashing and stains beneath this area observed. Have a qualified roofing contractor properly fasten, caulk and seal all loose flashing to avoid further moisture intrusion and repair all associated damage as needed.

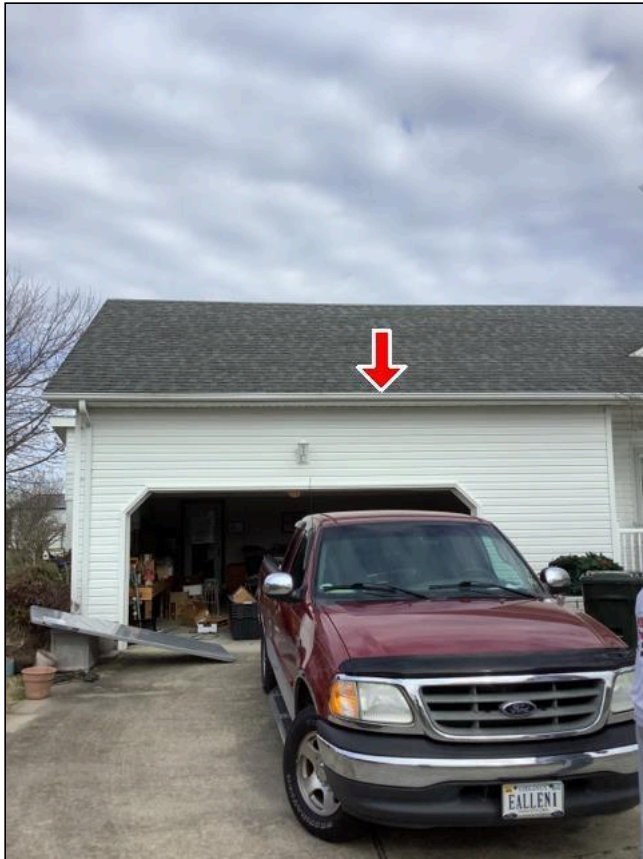
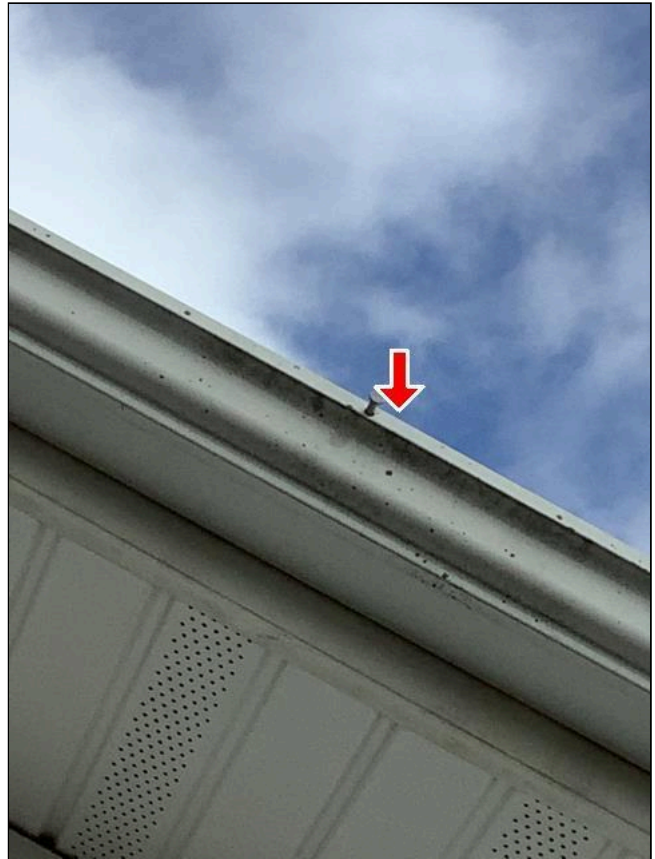
Item 3 - Item 1(Picture) Left rear

- 3 Properly secure loose gutters and slope towards downspouts to direct water away from structure.

1.3 Properly secure loose gutters and slope towards downspouts to direct water away from structure.

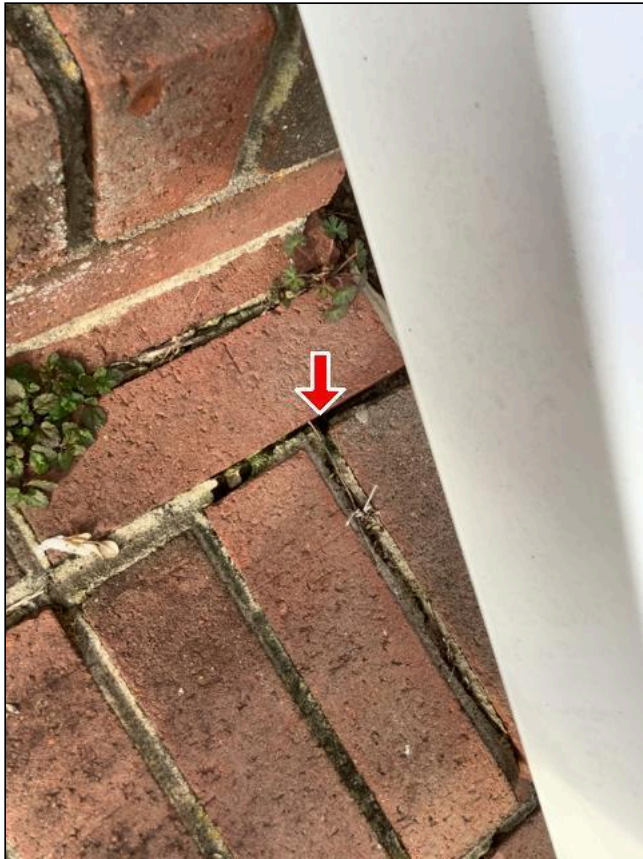
Item 4 - Item 1(Picture) Front steps

- 4 (1) Suggest having a qualified masonry contractor evaluate cracked, deteriorated mortar and repair/ re-point as necessary to avoid potential damages caused by moisture intrusion.

- 2.0 (1) Suggest having a qualified masonry contractor evaluate cracked, deteriorated mortar and repair/ re-point as necessary to avoid potential damages caused by moisture intrusion.

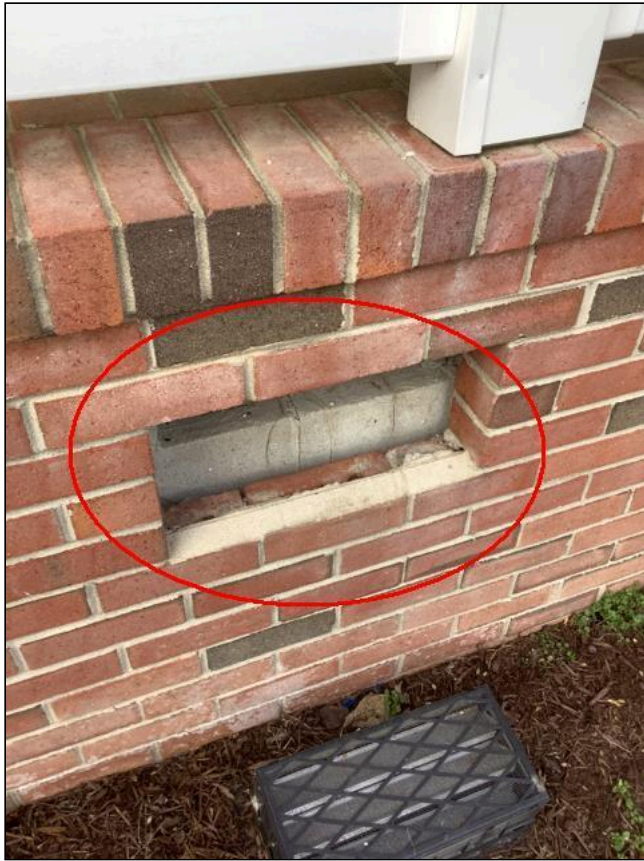
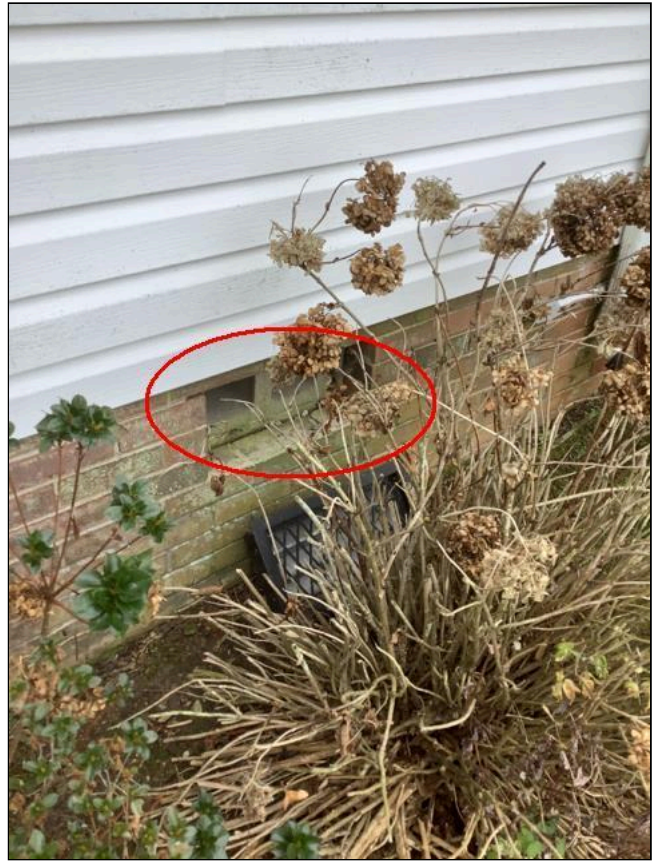
Item 5 - Item 1(Picture) Front right exterior

- 5 (2) Have a qualified contractor properly secure loose, detached foundation vents to avoid potential damage associated with rodent or insect intrusion.

- 2.0 (2) Have a qualified contractor properly secure loose, detached foundation vents to avoid potential damage associated with rodent or insect intrusion.

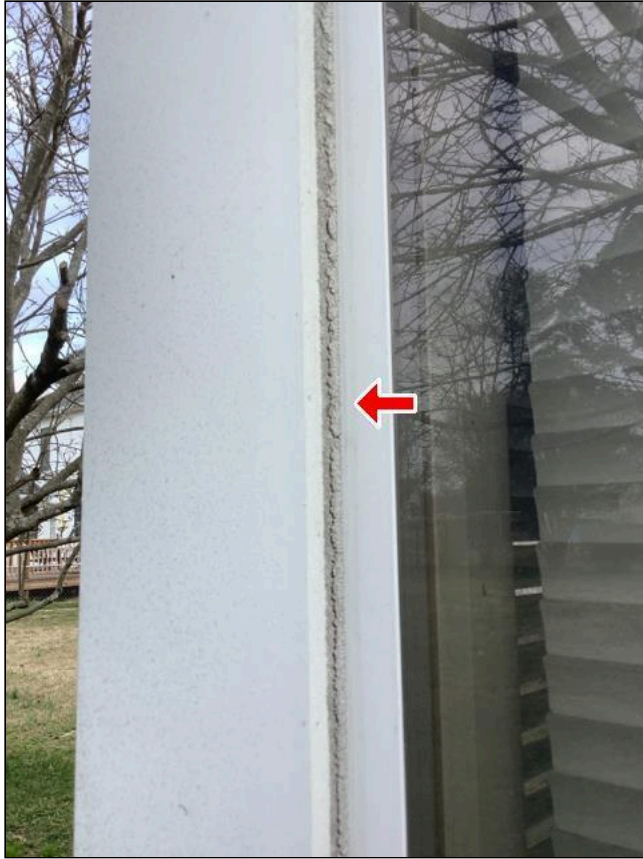
Item 8 - Item 1(Picture)

- 8 Recommend sealing any cracks and gaps around windows and doors to avoid issues related to moisture/ air penetration.

- 2.2 Recommend sealing any cracks and gaps around windows and doors to avoid issues related to moisture/ air penetration.
- 2.4 (1) Monitor trees in close proximity to structure as they may cause damage due to branch and root movement.

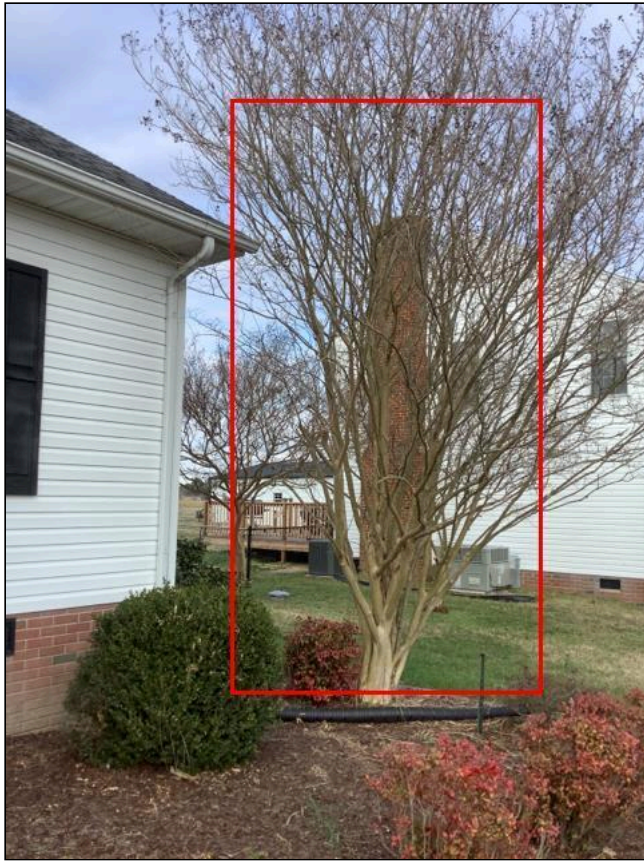
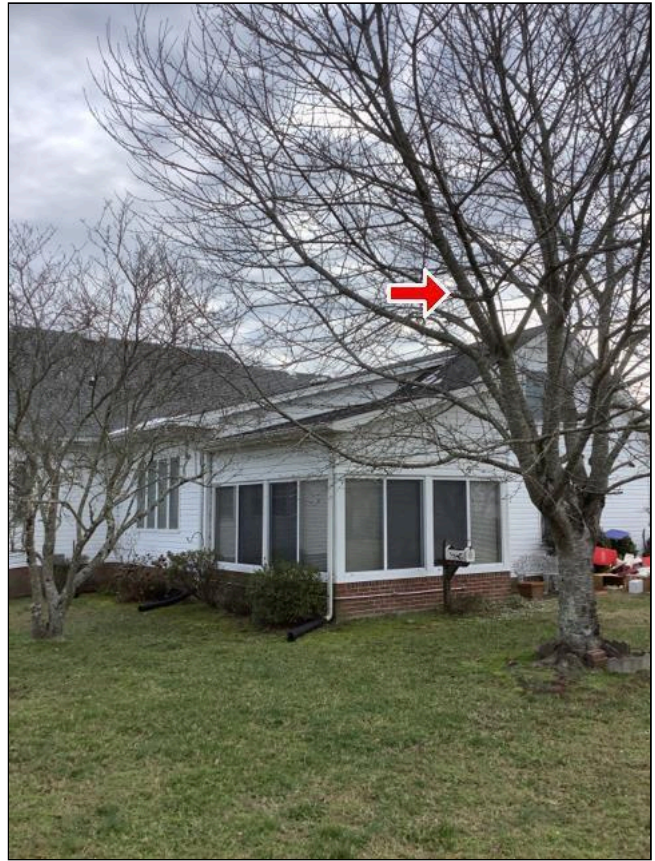
Item 9 - Item 1(Picture)

- 9** (1) Monitor trees in close proximity to structure as they may cause damage due to branch and root movement.

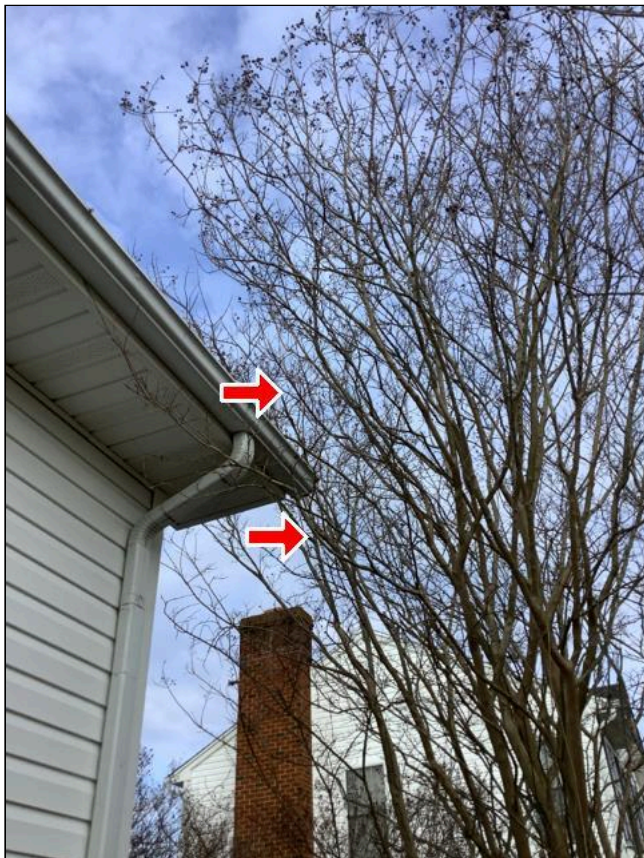
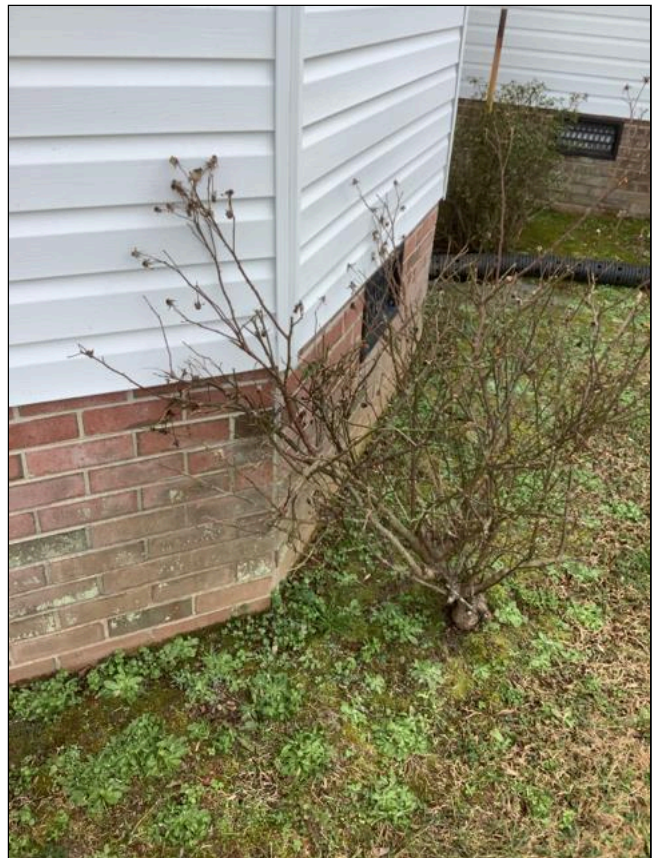
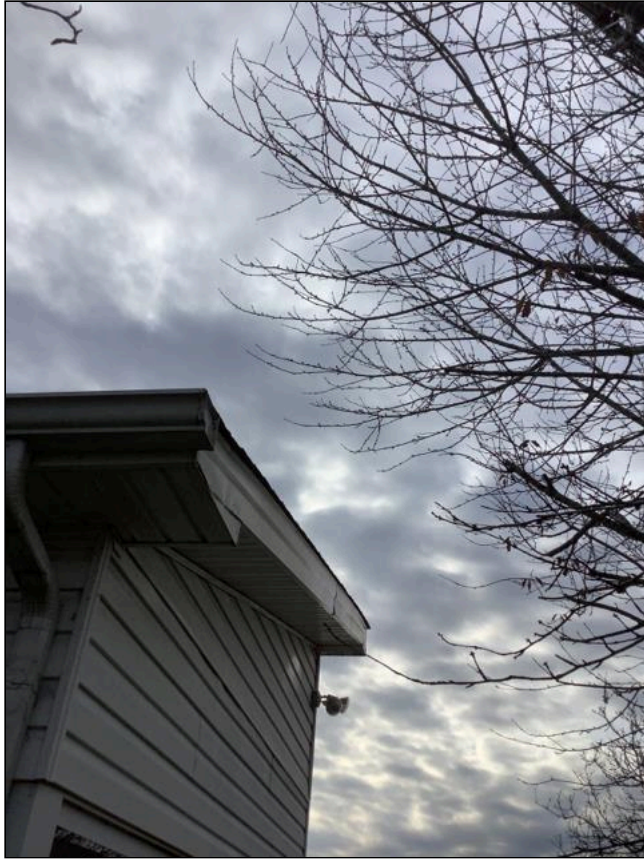
Item 10 - Item 1(Picture)

10 (2) Trim and maintain vegetation away from structure.

- 2.4 (2) Trim and maintain vegetation away from structure.
- 2.5 (1) Secure loose soffit vents to avoid rodent intrusion and subsequent damages.
- 2.5 (2) Paint is peeling at exterior claddings. Recommend repair/ repaint as needed.

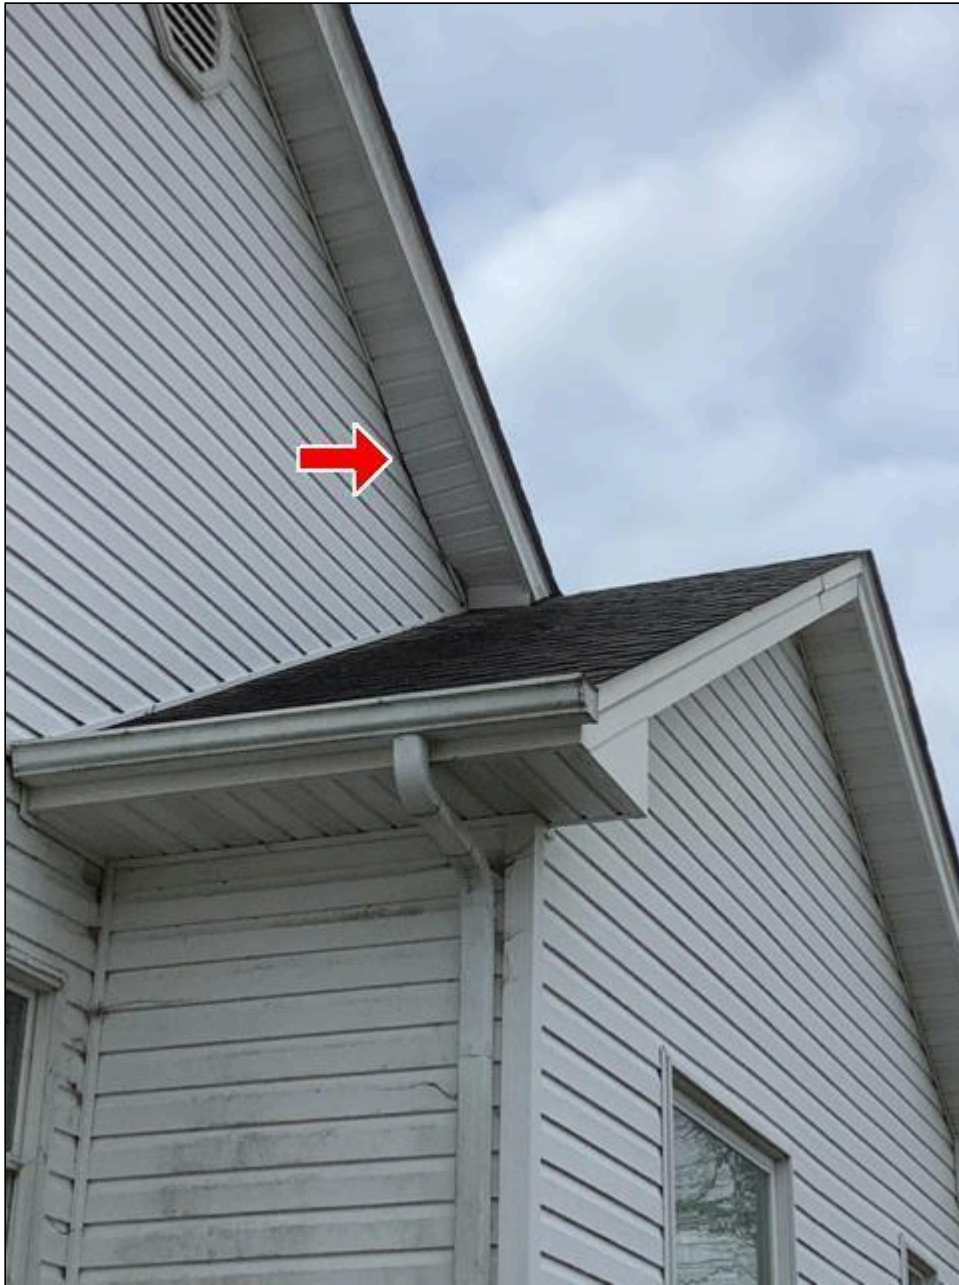
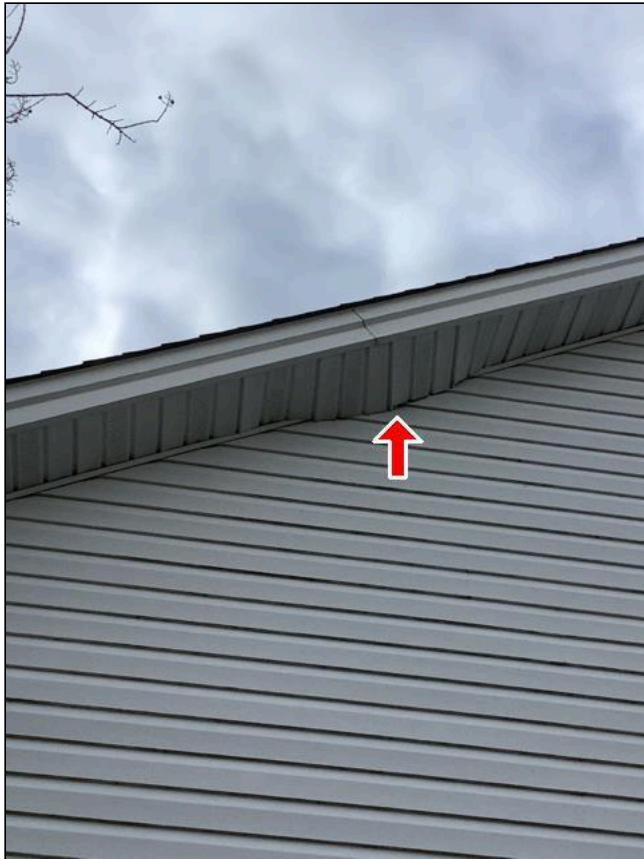
Item 11 - Item 1(Picture) Right exterior

- 11 (1) Secure loose soffit vents to avoid rodent intrusion and subsequent damages.

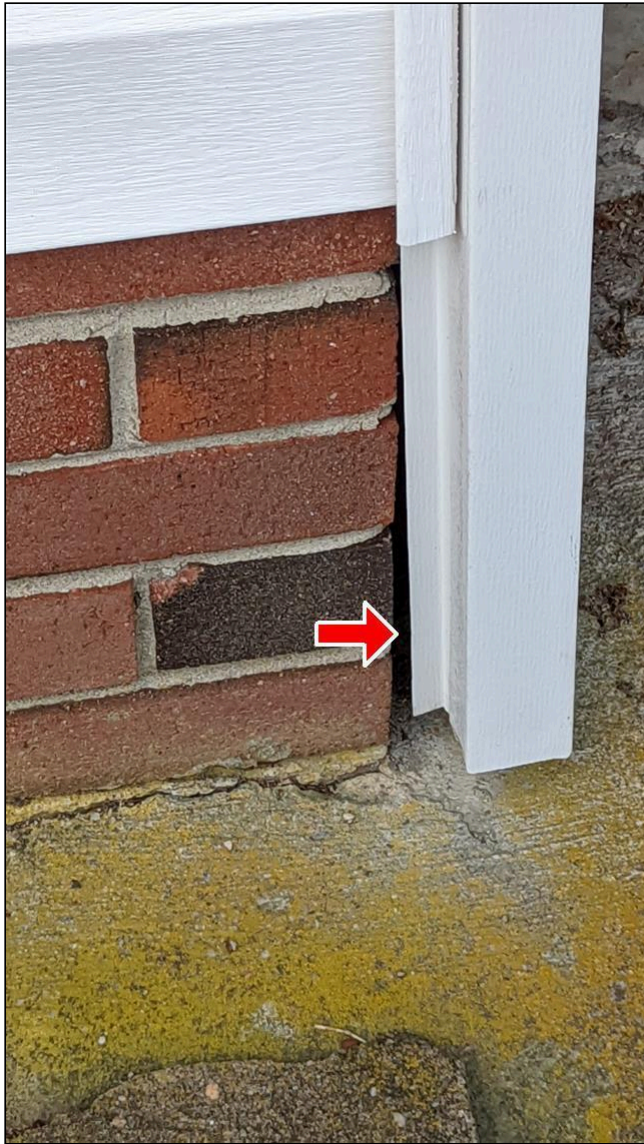
- 12** Concerns with the detached garage noted, but not limited to:
- Loose cladding
 - Vegetation on structure
 - Loose downspout
 - Damaged siding
 - Damaged, loose gutter with improper slope
 - Moss/ lichen growth on roof
 - Moisture damaged occupant door
 - No GFCI (shock protection)
 - Right roll up door operator not functioning at time of inspection
 - Securing hardware is damaged at left roll up door

Item 12 - Item 1(Picture) Loose cladding

Have a qualified contractor evaluate all concerns and repair/ replace as needed.

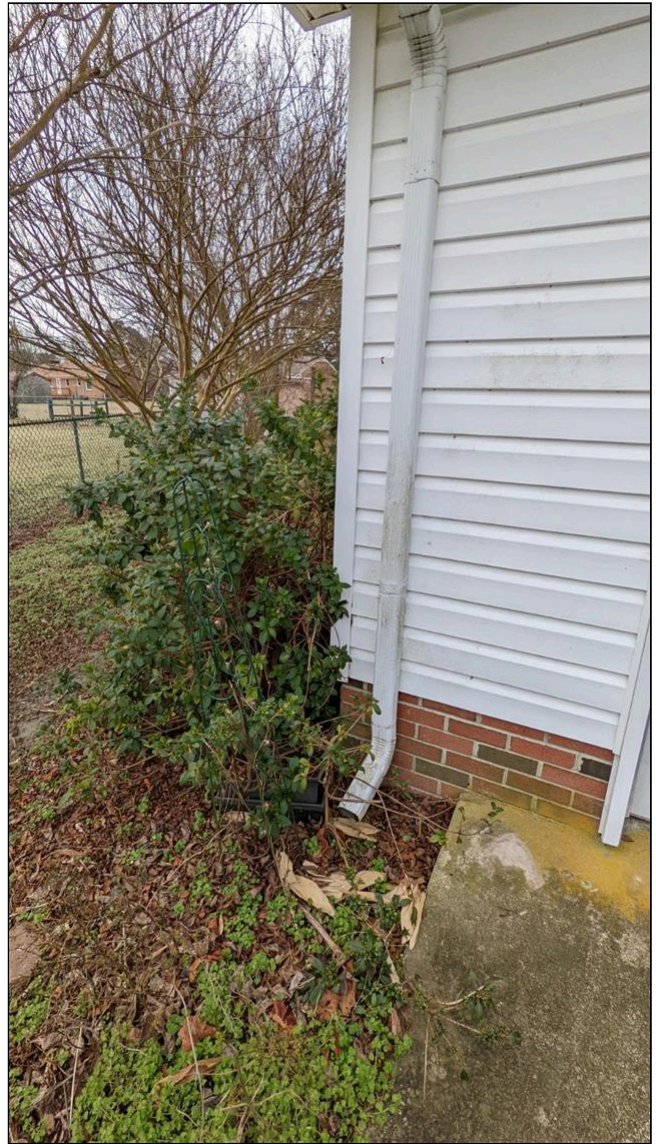
Item 12 - Item 2(Picture) loose downspout/ Vegetation

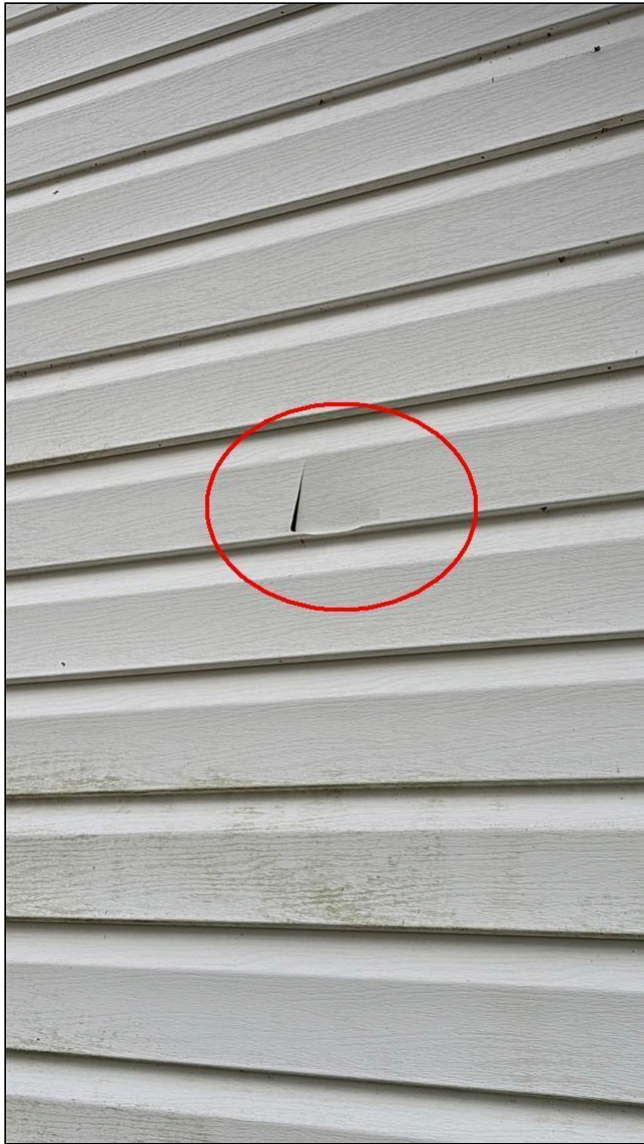
Item 12 - Item 3(Picture) Siding

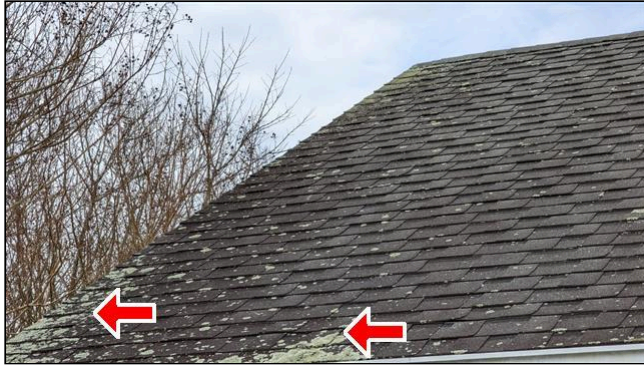
Item 12 - Item 5(Picture) Moss/ lichen

- Vegetation on structure
- Loose downspout
- Damaged siding
- Damaged, loose gutter with improper slope
- Moss/ lichen growth on roof
- Moisture damaged occupant door
- No GFCI (shock protection)
- Right roll up door operator not functioning at time of inspection
- Securing hardware is damaged at left roll up door

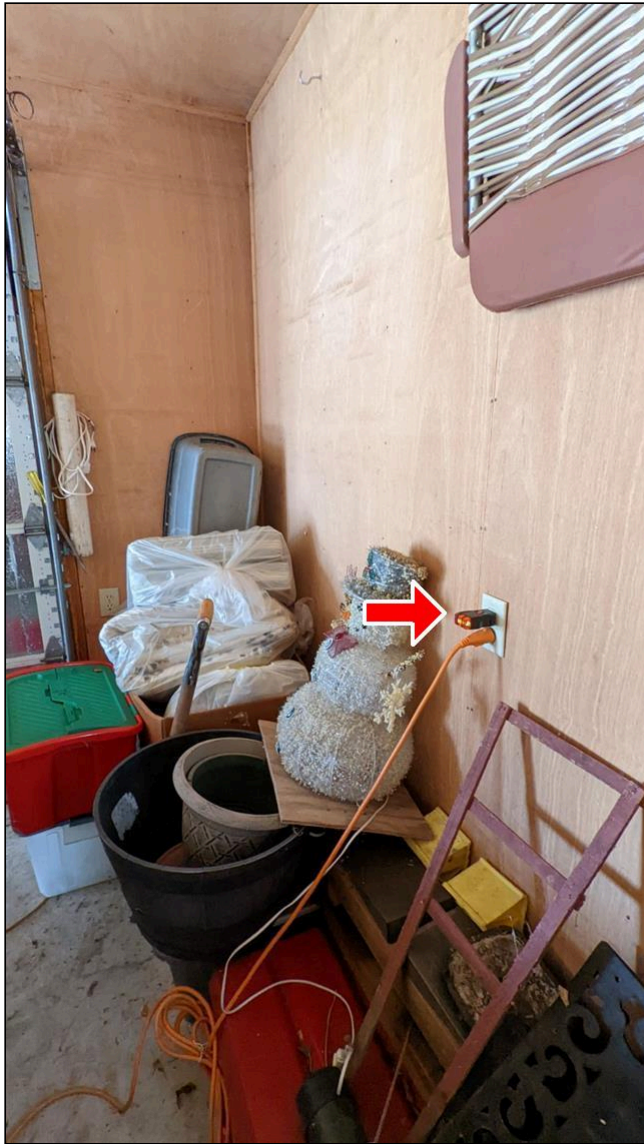
Item 12 - Item 7(Picture) GFCI

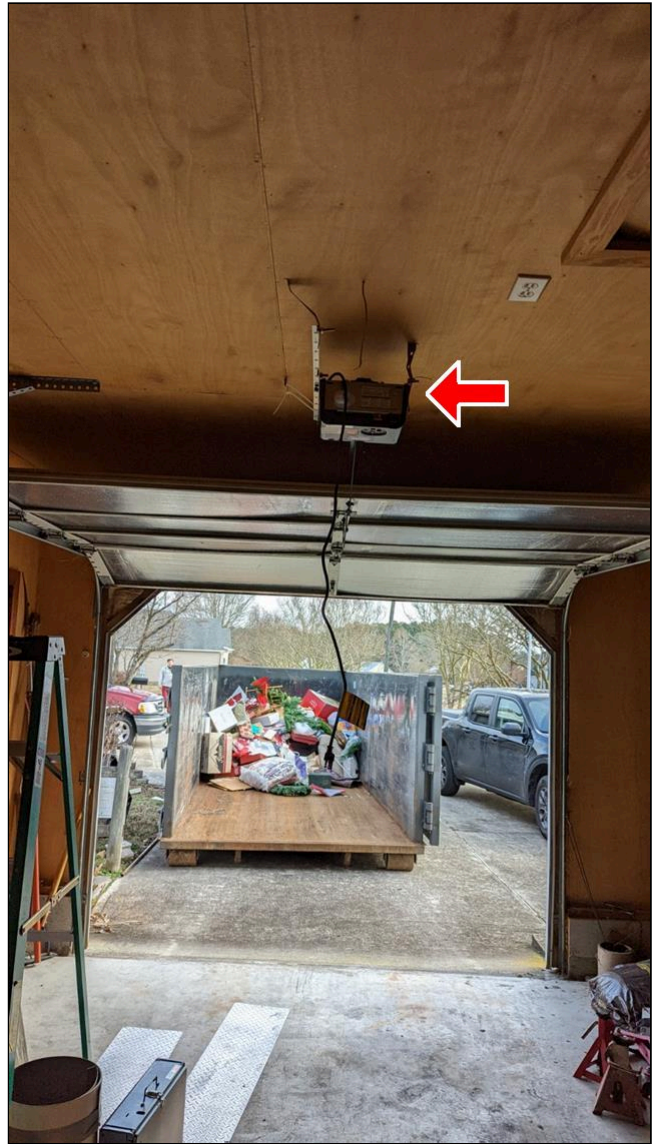
Item 12 - Item 8(Picture) Door operator

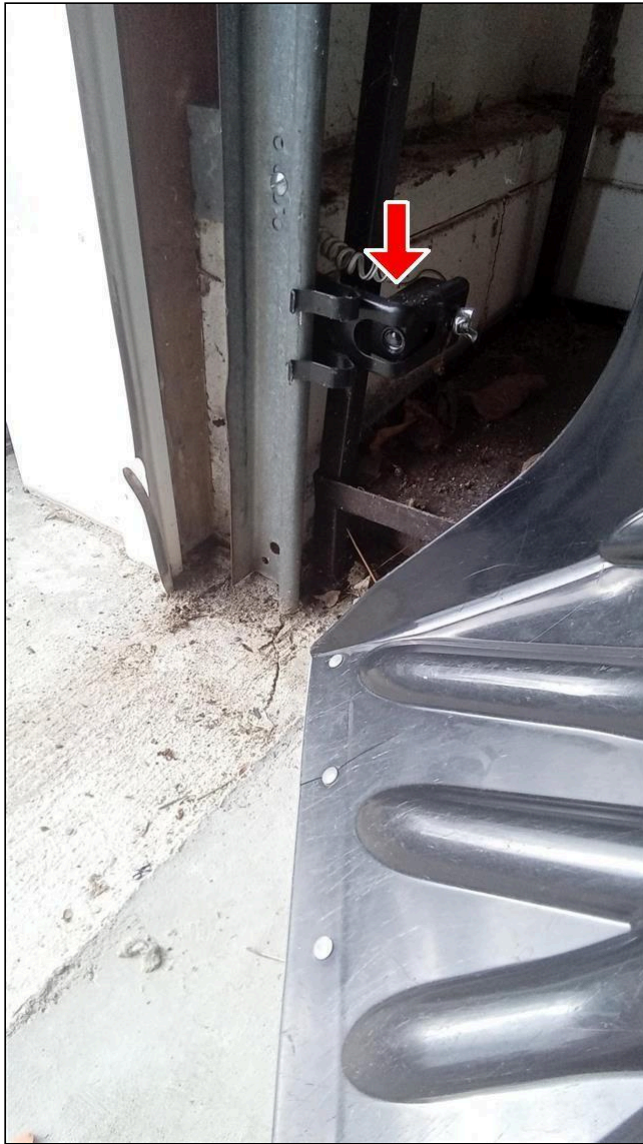
Item 13 - Item 1(Picture)

- 13 (1) Eye sensors are improperly installed. they should be installed per manufacturer specifications with the top of the sensors no higher than 4 to 6 inches off of the ground (currently approx 10"). I recommend having a qualified professional correct to safe function.

3.5 (1) Eye sensors are improperly installed. they should be installed per manufacturer specifications with the top of the sensors no higher than 4 to 6 inches off of the ground (currently approx 10"). I recommend having a qualified professional correct to safe function.

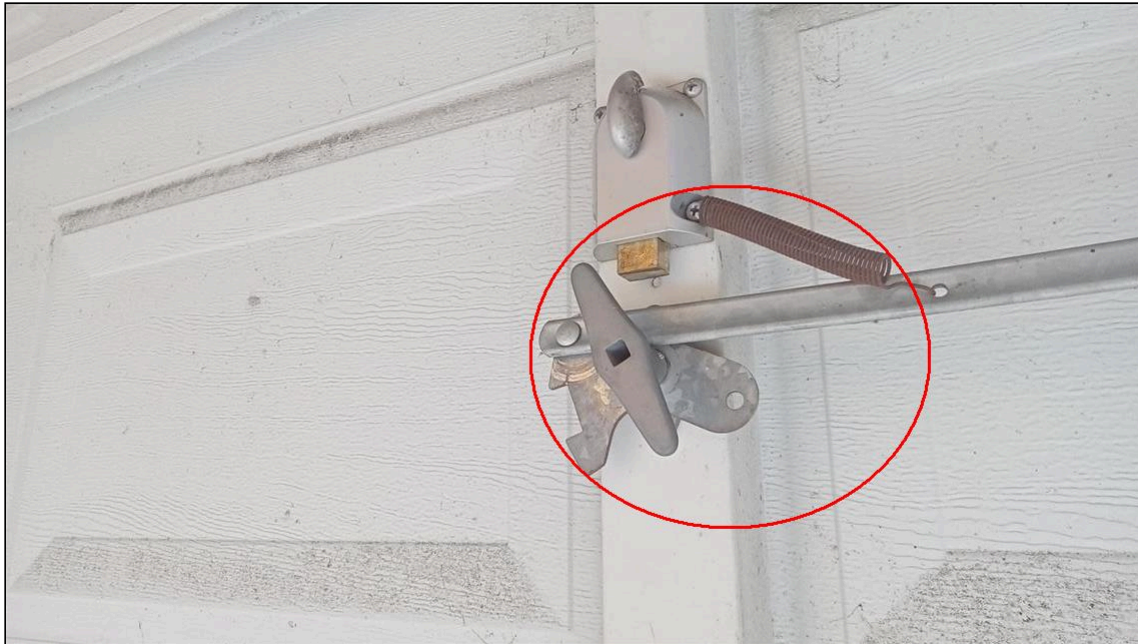
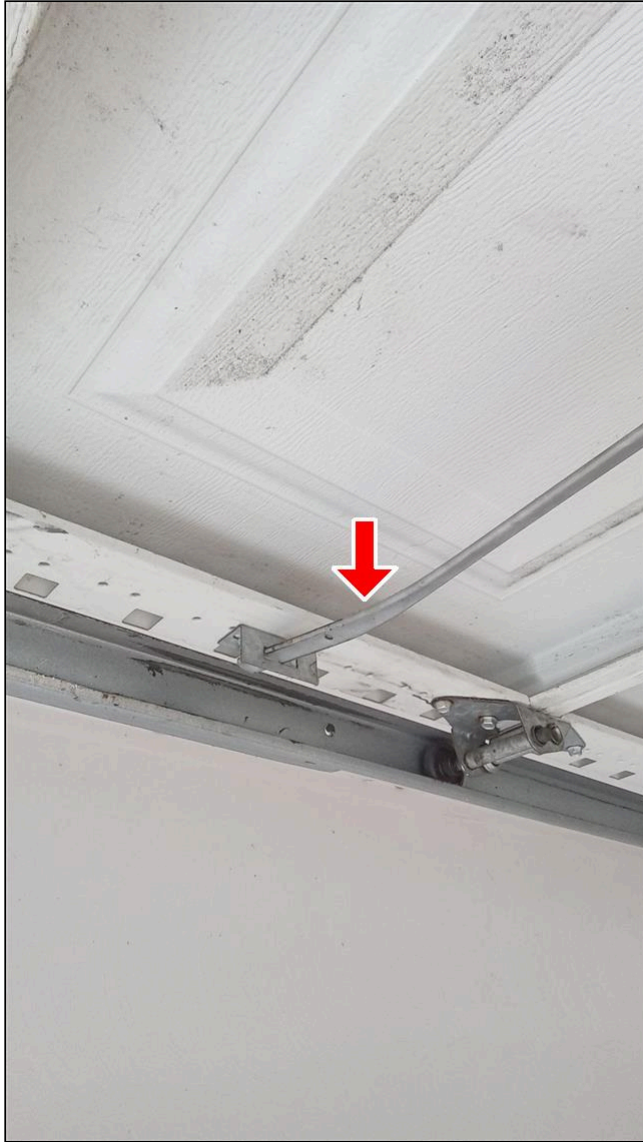
Item 14 - Item 1(Picture)

- 14 (2) Garage roll up door securing hardware is partially missing and damaged. Have a qualified contractor evaluate and repair/ replace as needed.

3.5 (2) Garage roll up door securing hardware is partially missing and damaged. Have a qualified contractor evaluate and repair/ replace as needed.

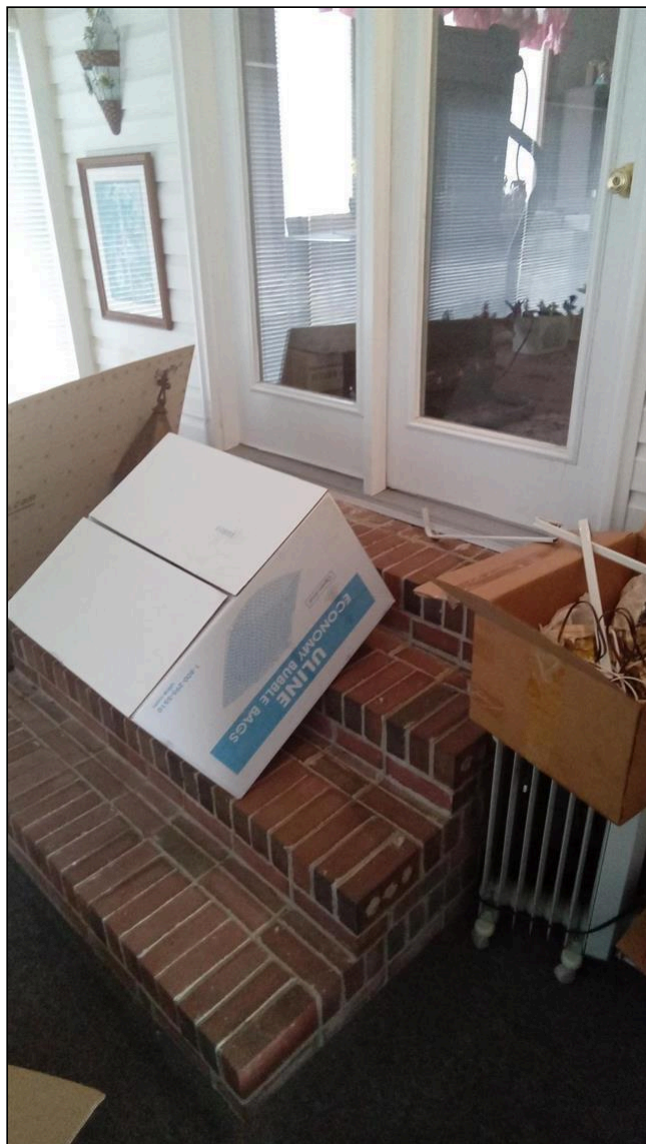
Item 17 - Item 1(Picture)

- 17 Suggest installing a graspable hand rail where missing at sunroom to avoid potential personal injury.

4.3 Suggest installing a graspable hand rail where missing at sunroom to avoid potential personal injury.

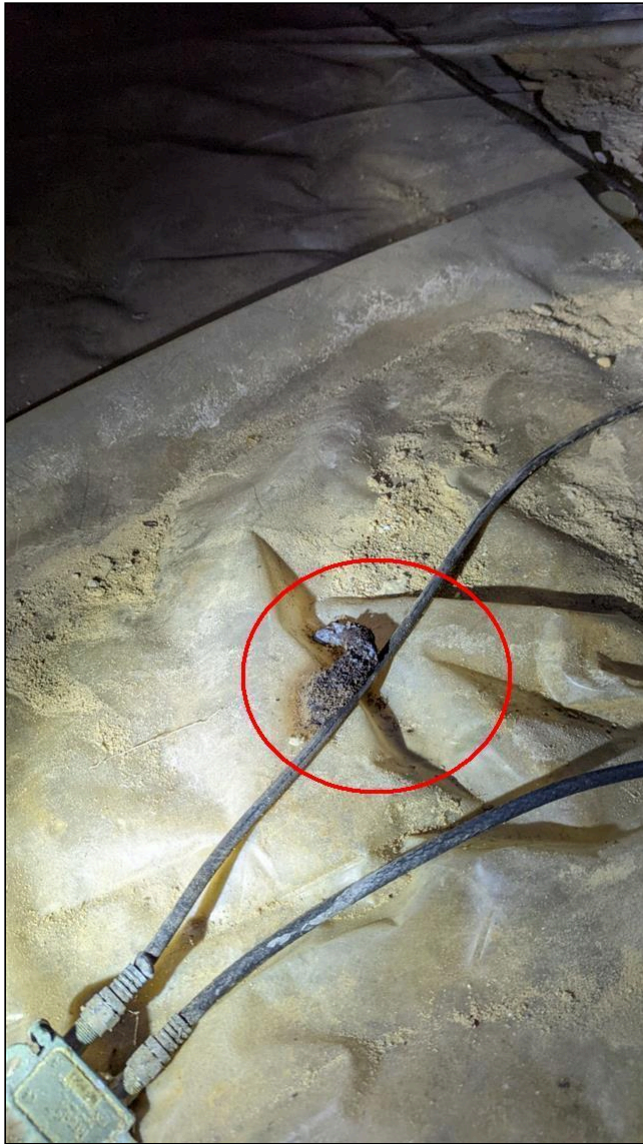
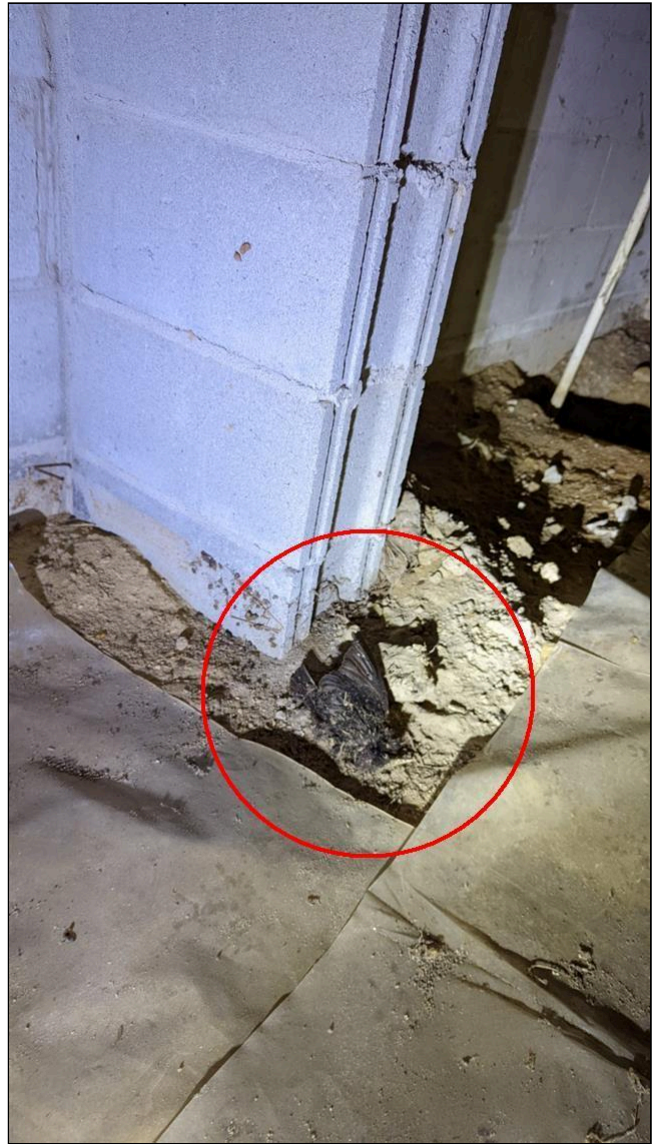
Item 18 - Item 1(Picture)

- 18 (1) Rodent activity and bird carcass noted in the crawl space. Have a qualified animal removal contractor evaluate, treat as required, seal access points of entry and replace damaged insulation/ vapor barrier.

- 5.0 (1)** Rodent activity and bird carcass noted in the crawl space. Have a qualified animal removal contractor evaluate, treat as required, seal access points of entry and replace damaged insulation/ vapor barrier.

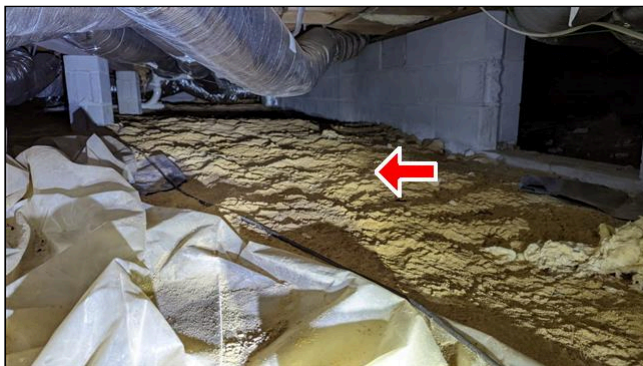
Item 19 - Item 1(Picture)

- 19 (2) Have a qualified contractor install vapor barrier where missing or damaged in the crawlspace.

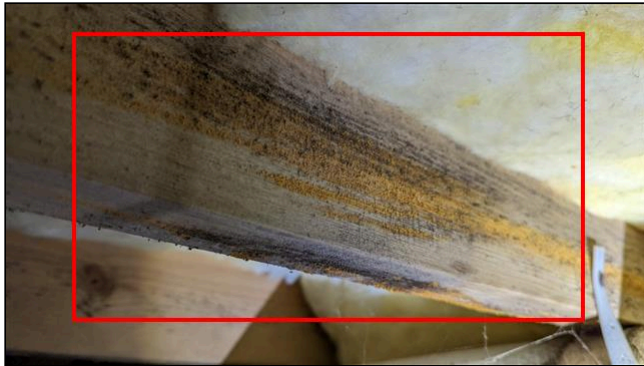
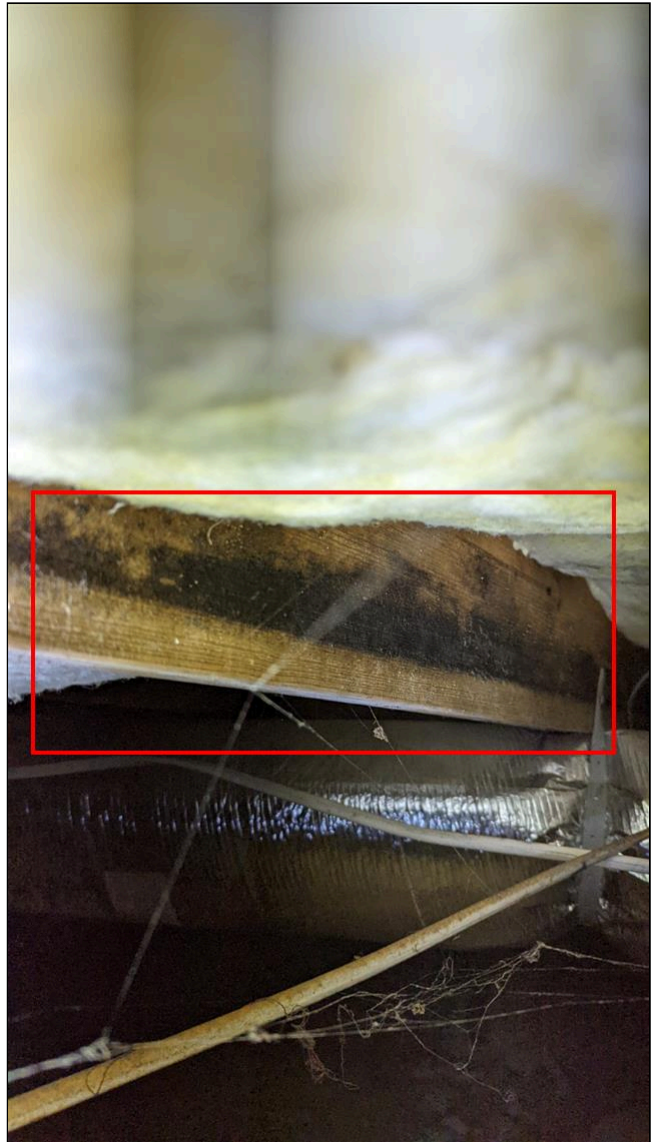
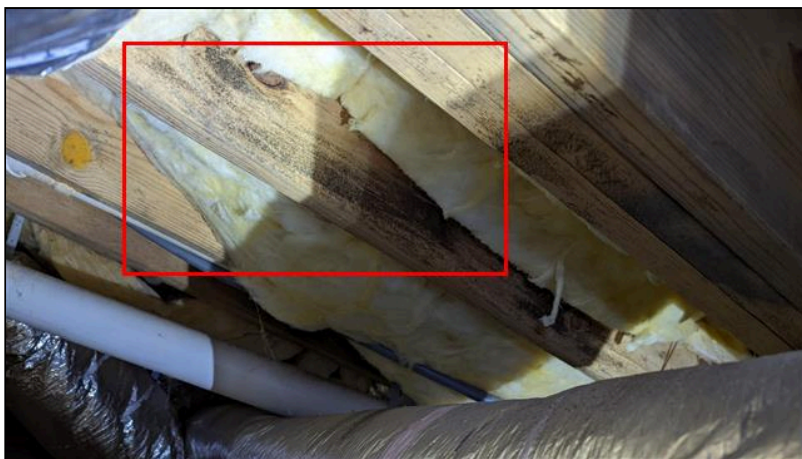
Item 20 - Item 1(Picture)

- 20 (3) WDO, wood destroying organisms noted (fungus), crawlspace may need to be treated; have a qualified moisture contractor evaluate for treatment. Repair any associated damage as recommended.

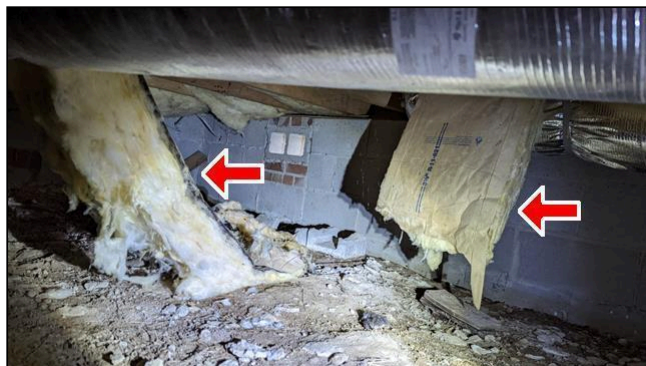
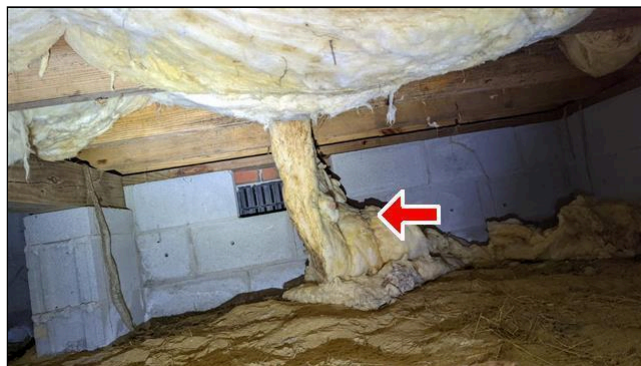
Item 21 - Item 1(Picture)

- 21 (4) Insulation has fallen in the crawl space. Replace damaged insulation, install where missing and properly secure with insulation stays.

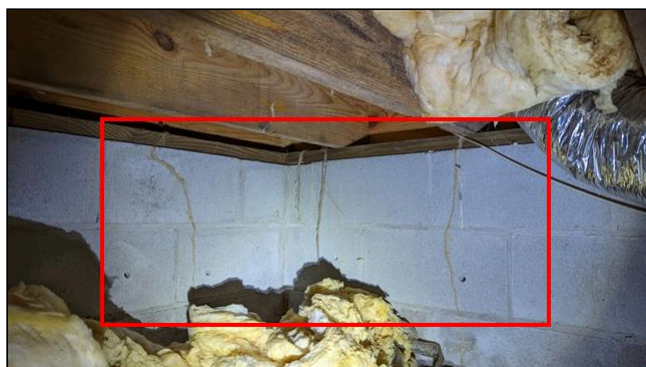
Item 22 - Item 1(Picture)

- 22 (5) Termite activity noted, but not limited to the crawl space. Have a qualified termite contractor evaluate, treat as required and repair any associated damage.

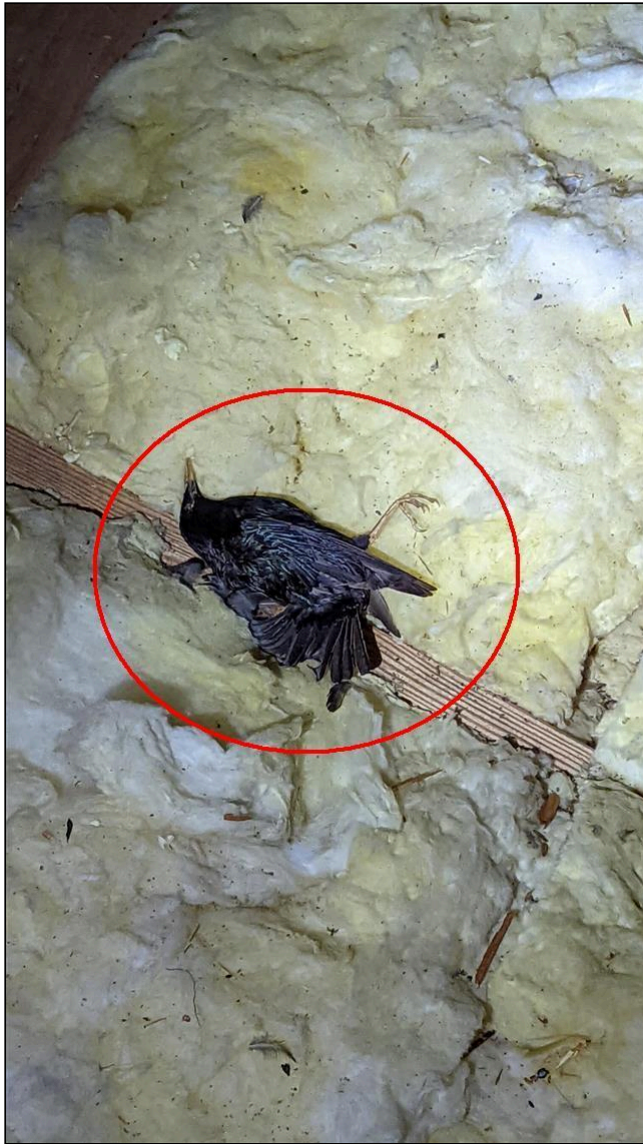
Item 23 - Item 1(Picture)

- 23 Observed dead birds in the attic. Have a qualified pest removal contractor remove carcasses, seal access points of entry, and replace damaged insulation.

- 5.5** Observed dead birds in the attic. Have a qualified pest removal contractor remove carcasses, seal access points of entry, and replace damaged insulation.

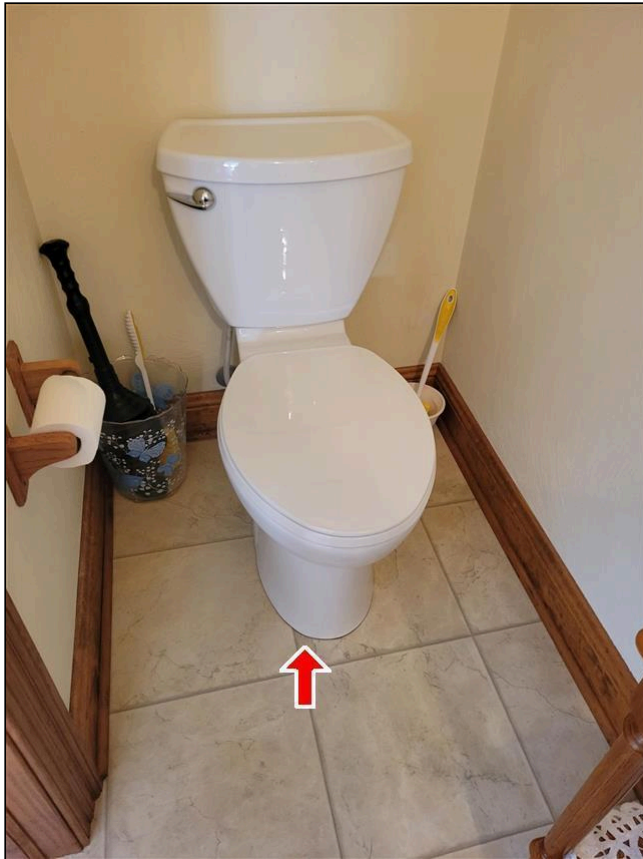
Item 24 - Item 1(Picture) Half bath

- 24 (1) The toilet is loose at the floor in the half bath. Repairs may involve re-setting the toilet on a new wax seal. I recommend a qualified licensed plumber repair or correct as needed.

6.0 (1) The toilet is loose at the floor in the half bath. Repairs may involve re-setting the toilet on a new wax seal. I recommend a qualified licensed plumber repair or correct as needed.

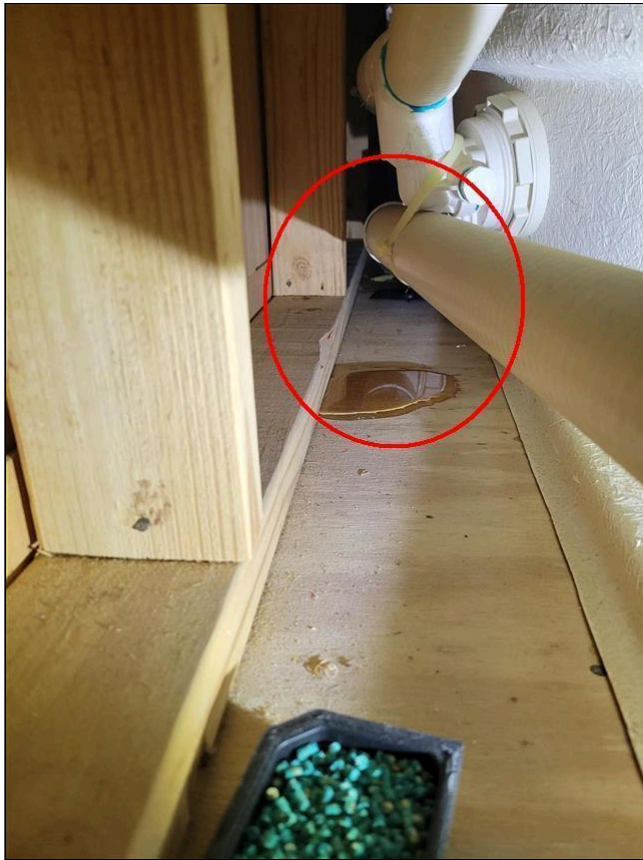
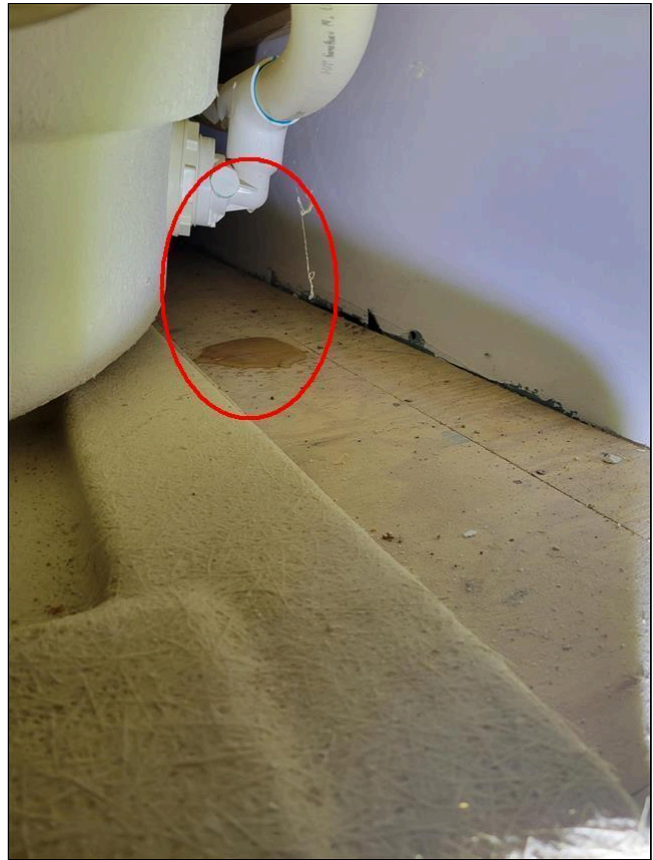
Item 26 - Item 1(Picture)

- 26 (1) Jetted tub actively leaks when in use. Have a qualified contractor repair/replace as needed.
