SoVa Inspection Group

Inspection Report

Property Address:
101 Canvas Back Circle
Franklin VA 23851

Date: 1/26/2022	Time: 10:00 AM	Report ID: 20220126-Joanna-BB-Auctions-Franklin-Va
Property: 101 Canvas Back Circle Franklin VA 23851	Customer: Blue Box Auctions	Real Estate Professional:

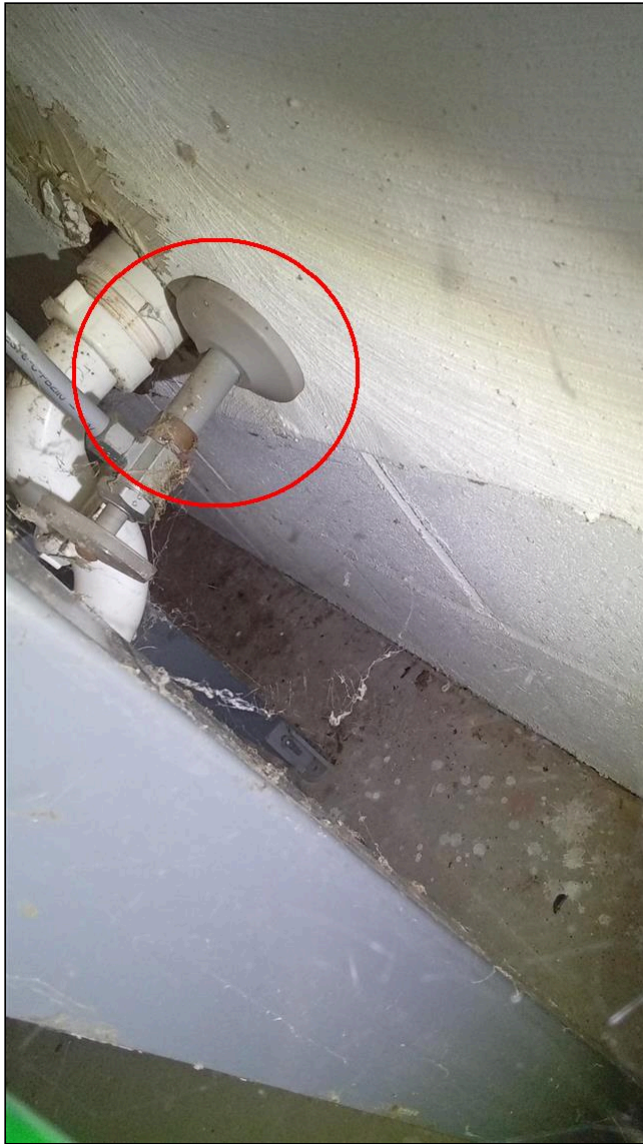
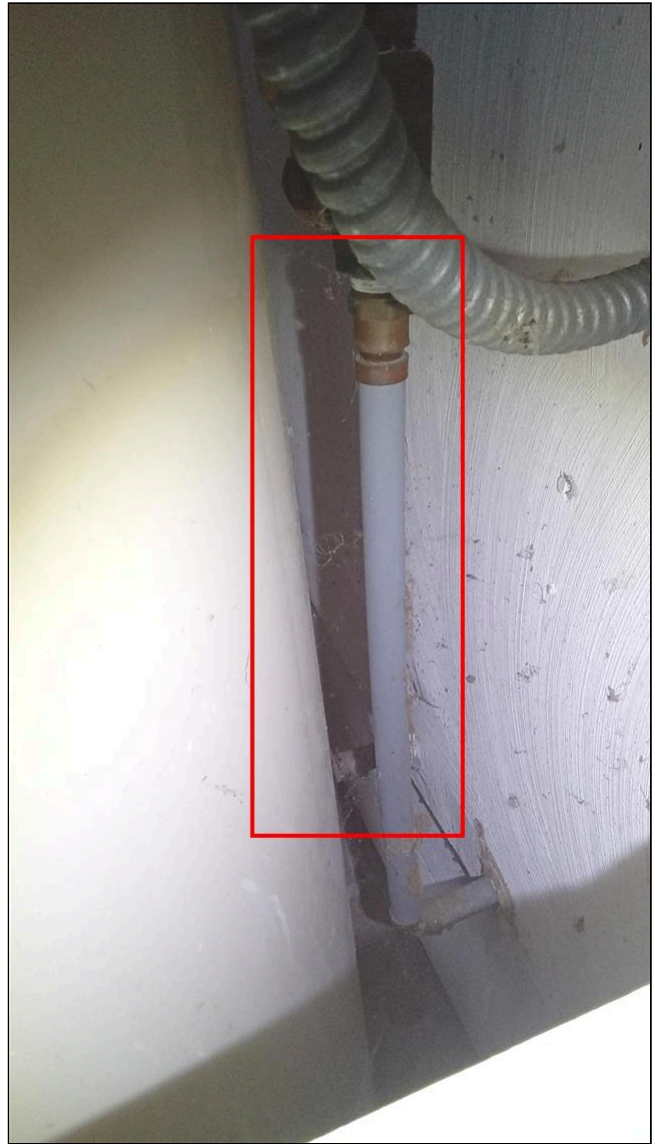
Item 27 - Item 1(Picture)

- 27 (2) Polybutylene plastic plumbing supply lines (PB) are installed in the subject house. Polybutylene has been used in this area for many years, but has had a higher than normal failure rate, and is no longer being widely used. Copper and Brass fittings used in later years have apparently reduced the failure rate. This subject house has copper fittings. For further details contact the Consumer Plumbing Recovery center at 1-800-392-7591 or the web at <http://www.pbpipes.com>

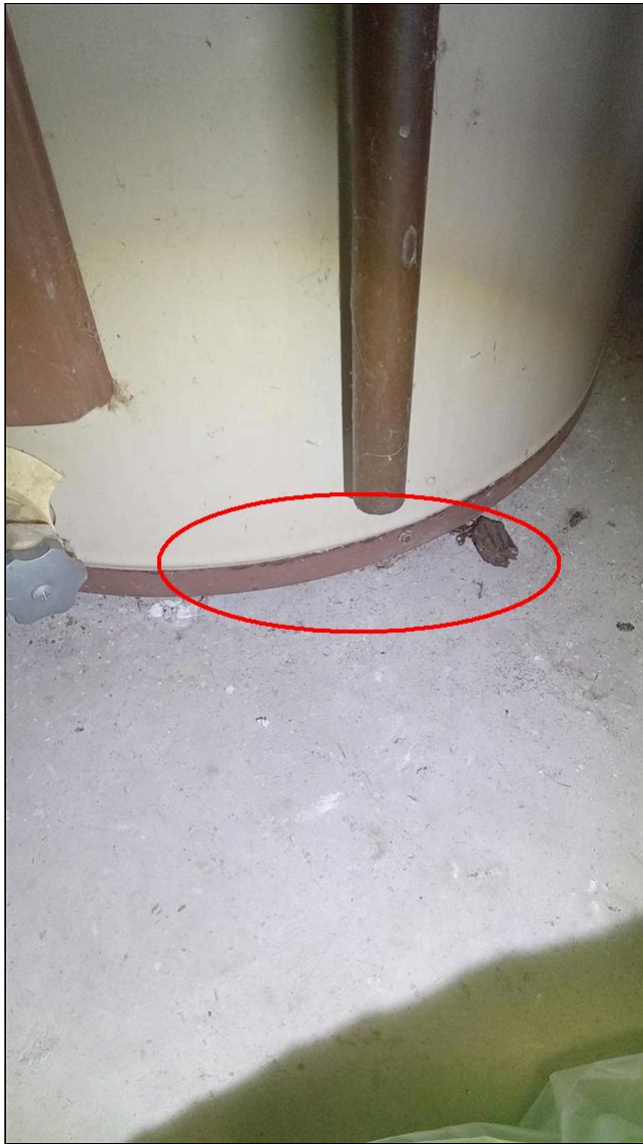
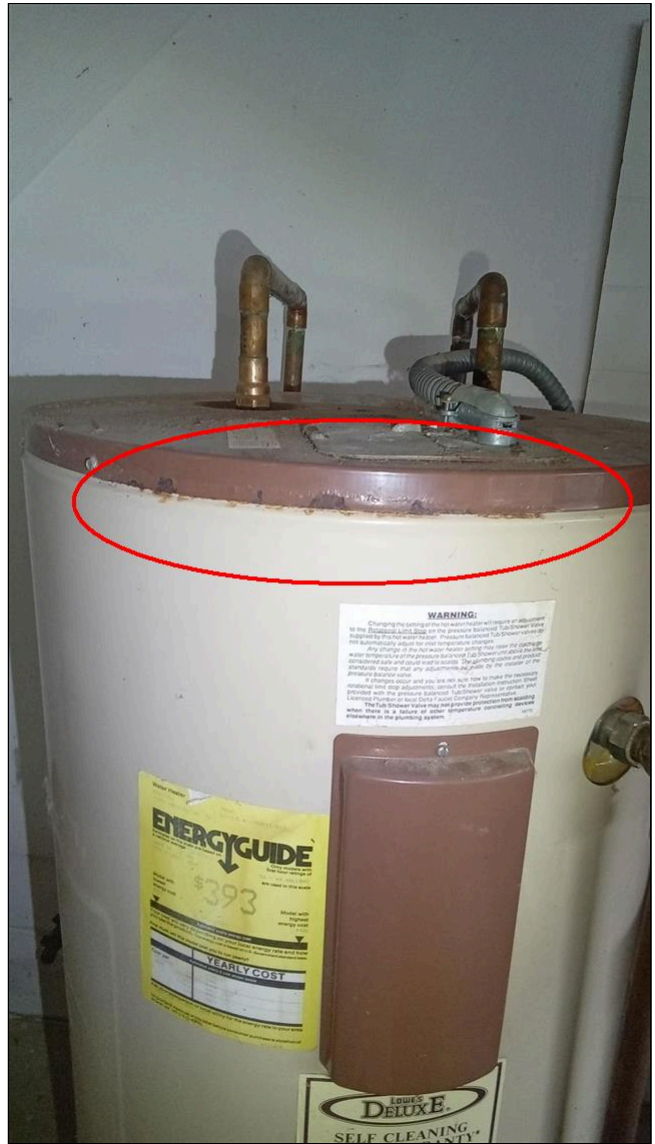
Item 28 - Item 1(Picture)

- 28 Water heater is 28 years old and has exceeded its typical life expectancy of 10-12 years. Corrosion noted at the base of the unit and at the top. Have a qualified plumbing contractor service and evaluate unit for repair vs

replacement. Repair/ replace as recommended.

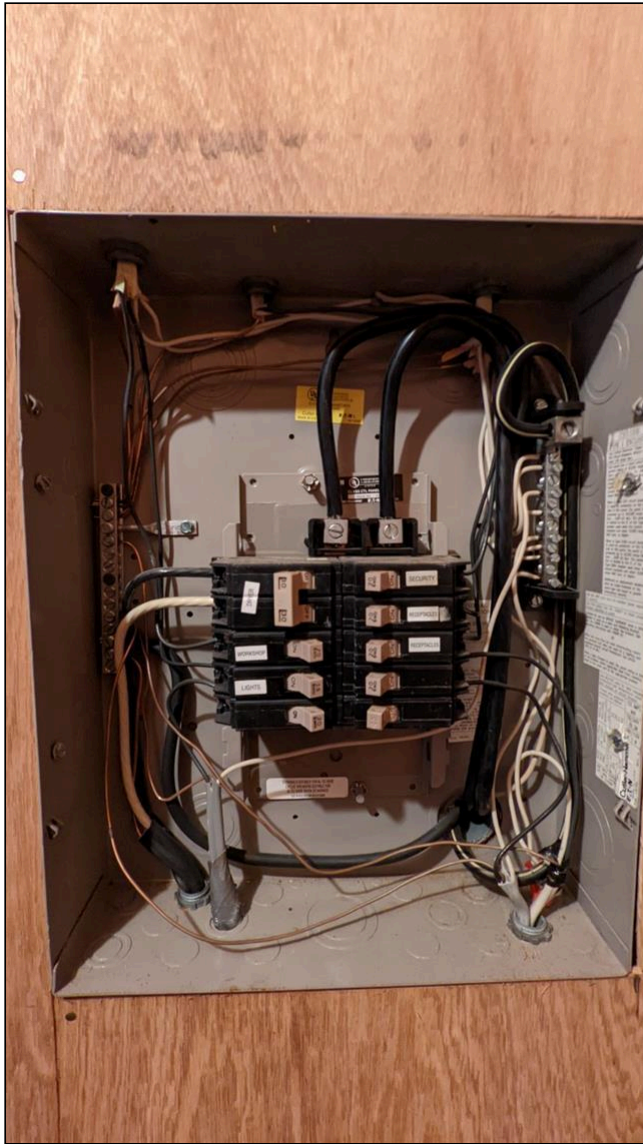
Item 29 - Item 1(Picture) Left, main garage

29 Interior view of distribution and sub panels- Garage and detached garage

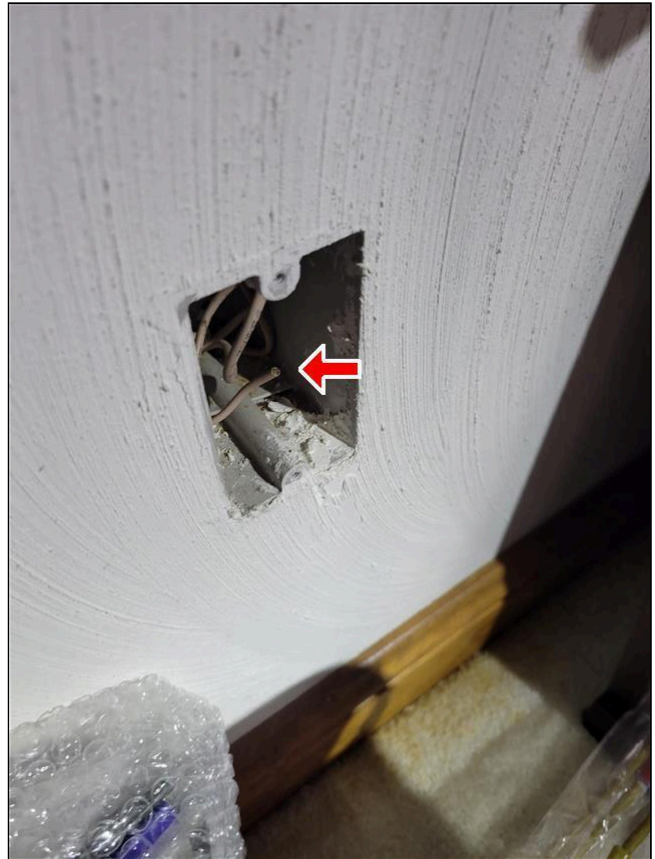
Item 30 - Item 1(Picture) Attic

- 30 Properly terminate, cover and secure loose, exposed wiring in the attic and front right bedroom.

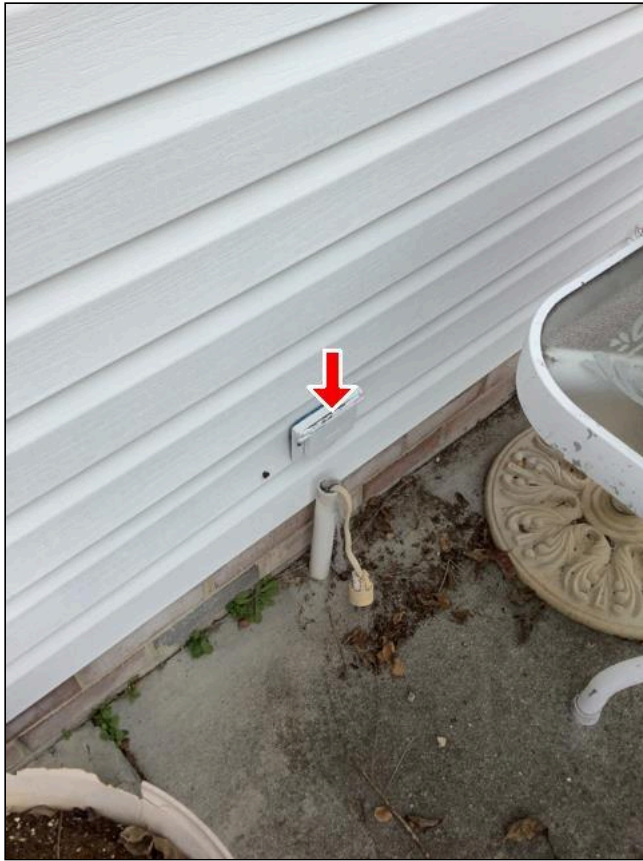
Item 32 - Item 1(Picture) Left exterior

- 32 (2) GFCI outlet at left exterior has no power and will not reset. Have a qualified contractor for the evaluate and repair or replace as needed to achieve normal, shock protected function.

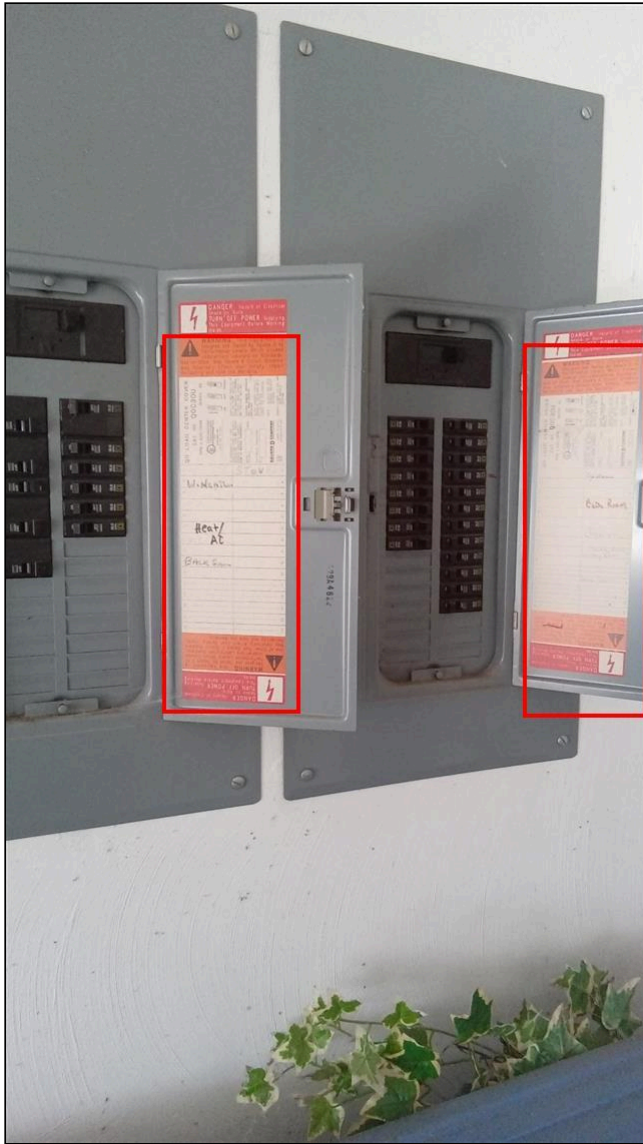
Item 33 - Item 1(Picture)

- 33** (1) Have a qualified contractor properly label circuits in panels for safe, efficient use.

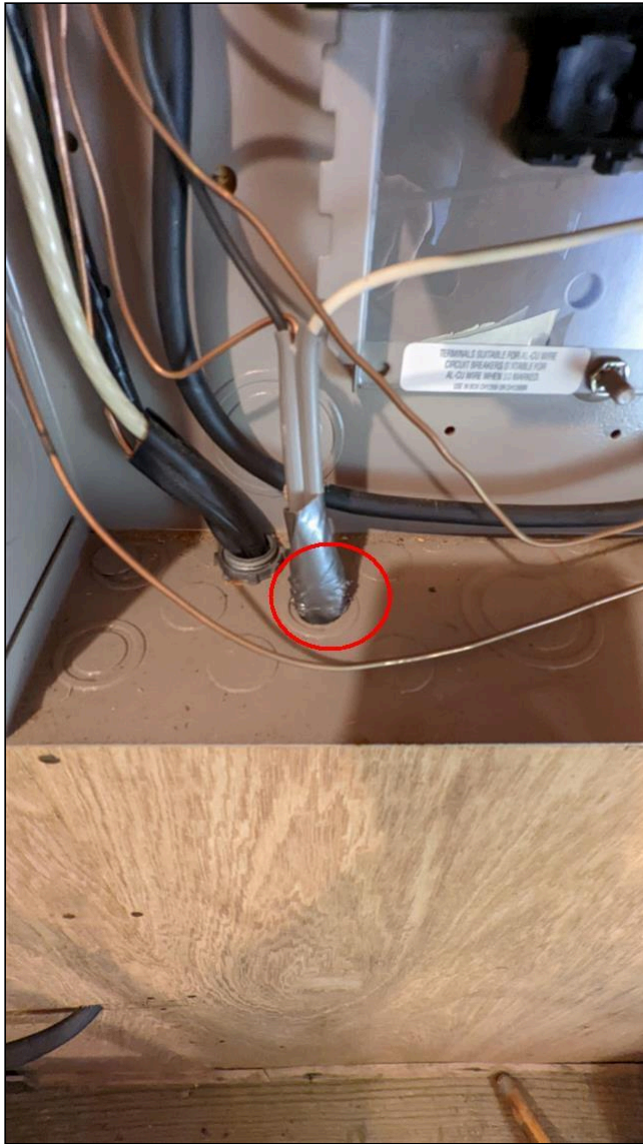
Item 34 - Item 1(Picture)

- 34 (2) Install terminal connectors where missing in the detached garage sub panel to prevent chafing of the wires.

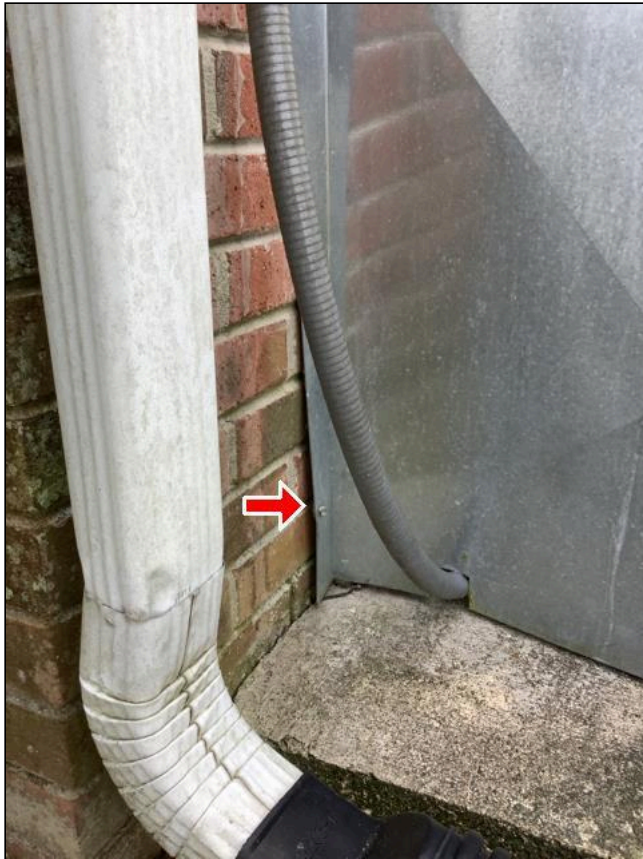
Item 36 - Item 1(Picture)

- 36** Have a qualified contractor properly sealed gaps around rear right exterior package unit plenum to avoid potential damage associated with rodent or insect intrusion.

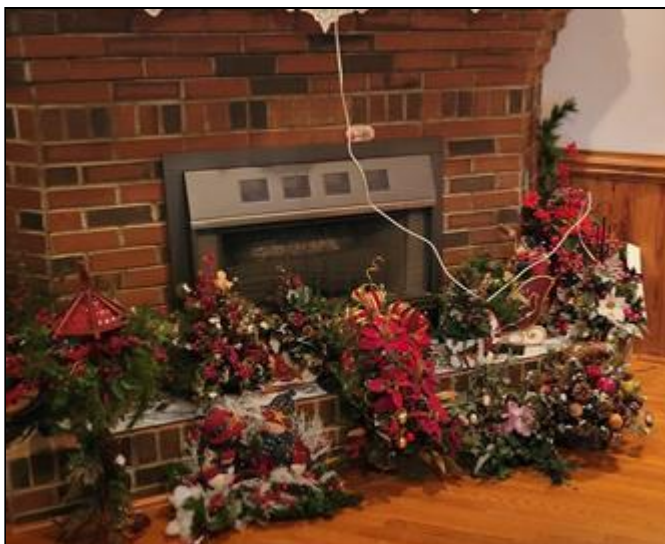
Item 37 - Item 1(Picture)

- 37 Fireplace not functioning at time of inspection. Have a qualified chimney sweep contractor evaluate and repair/replace as needed, ensure all safety features are properly functioning per manufacturer's specifications.

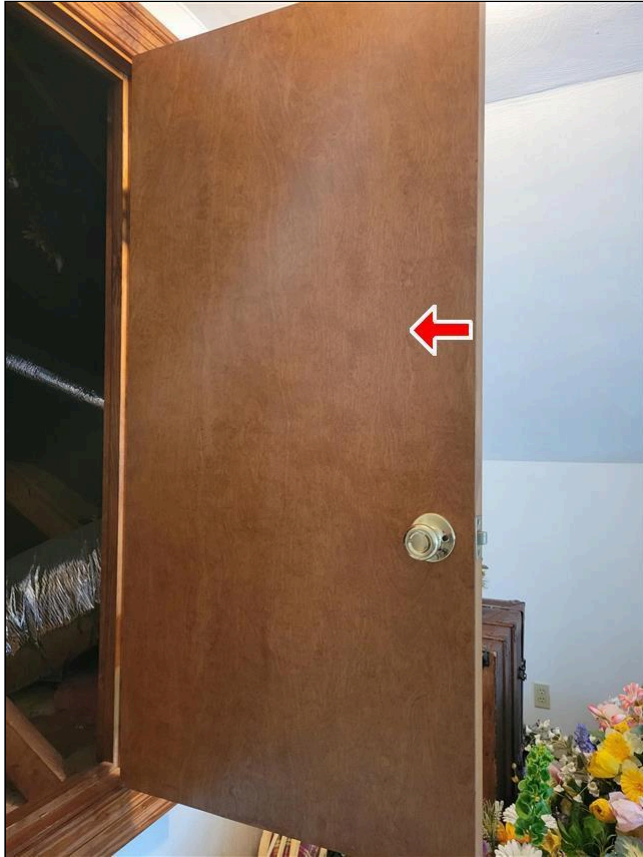
Item 38 - Item 1(Picture)

- 38 (1) Install insulation where missing at all attic doors.

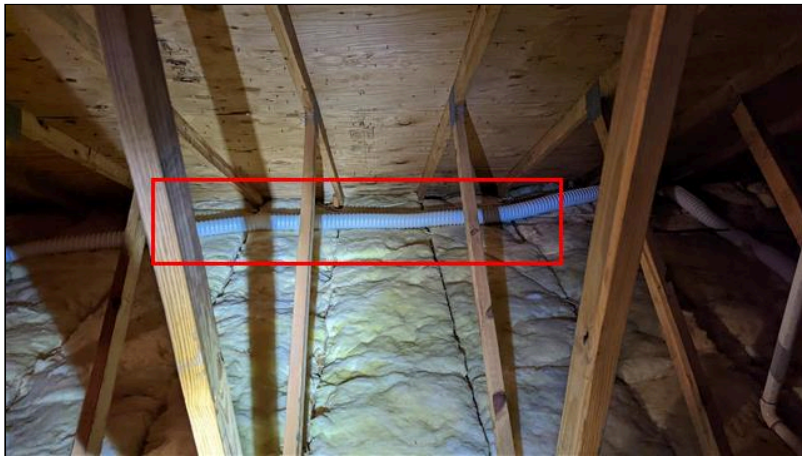
Item 39 - Item 1(Picture)

- 39 (2) Insulation in attic is blocking the soffits. Have a qualified contractor evaluate and correct to allow proper ventilation for attic, suggest installing baffles.

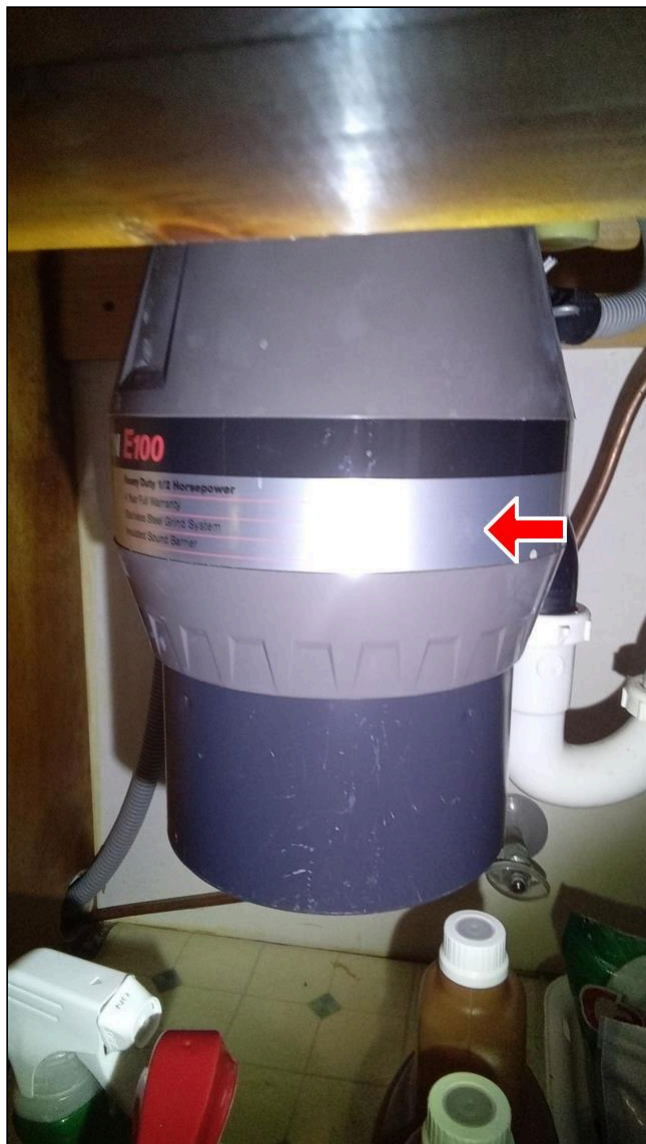
Item 40 - Item 1(Picture)

- 40 Kitchen food waste disposer binds at time of inspection. Have a qualified contractor evaluate and repair or replace as needed to achieve normal function.
