QAI RESIDENTIAL REPORT

203 Porter Ave
Hampton, VA 23669

Standard Residential Inspection

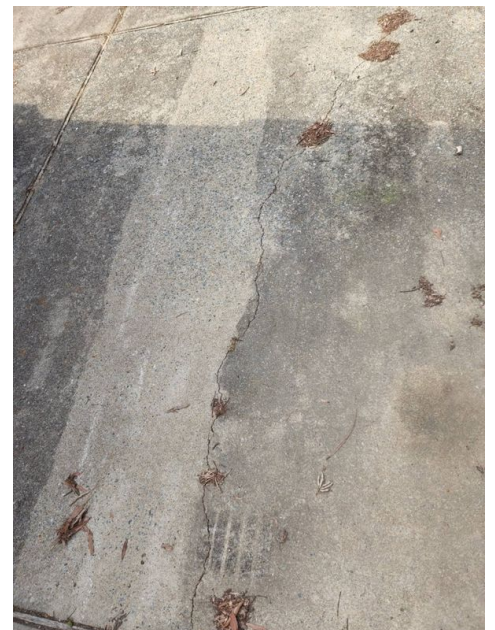
DRIVEWAY CRACKING - MINOR

Minor cosmetic cracks observed, which may indicate movement in the soil. Recommend monitor and/or have concrete contractor patch/seal.

Contact a qualified concrete contractor.

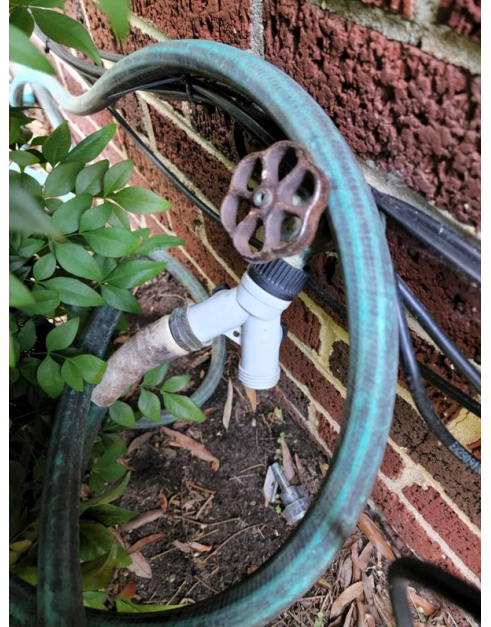
2.5.1 Hose Bibs

The hose bib is not equipped with an anti siphon device, possible cross connection can occur allowing non potable water into the house water supply system. Recommend installation. Although this is a safety concern this can be completed by homeowner for a small cost.

Contact a handyman or DIY project

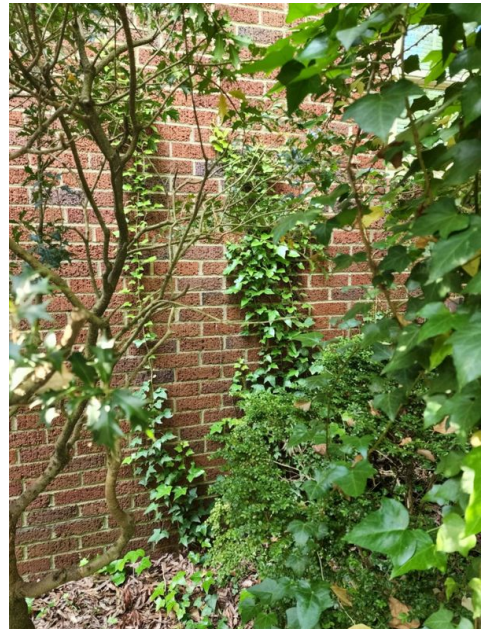
2.6.1 Landscaping affecting the foundation

There was vegetation in contact with the structure. Recommend trimming away from structure.

Contact a qualified landscaping contractor

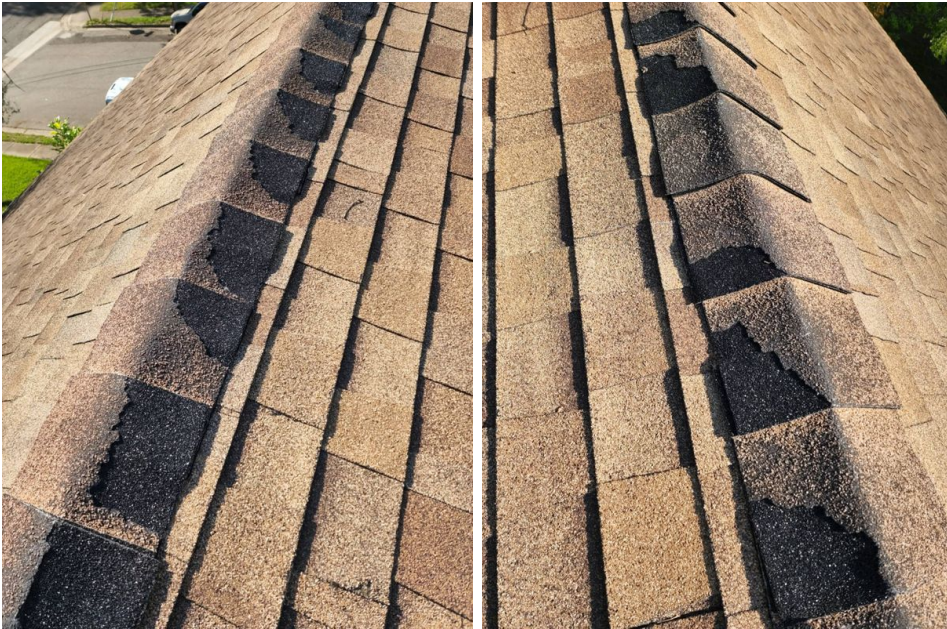
TILES CRACKED/BROKEN

Roof had cracked/broken tiles. Recommend a qualified roof contractor repair or replace to prevent moisture intrusion and/or mold.

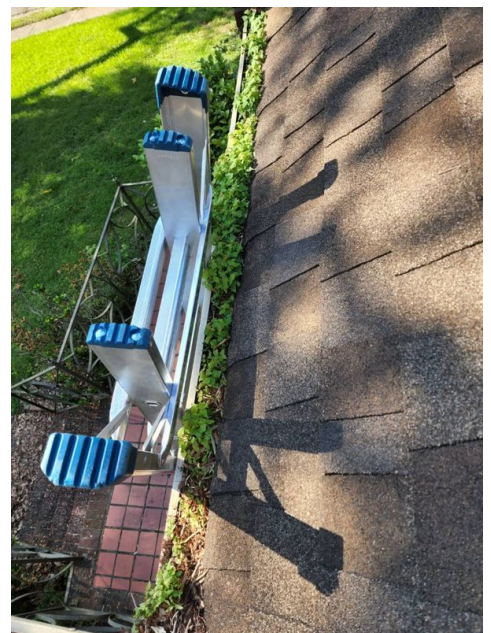
Debris has accumulated in the gutters. Recommend cleaning to facilitate water flow.

[Here is a DIY resource](#) for cleaning your gutters.

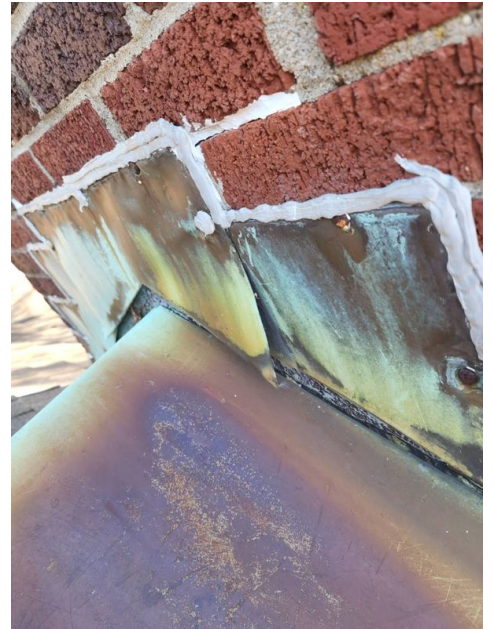
3.3.1 Flashings

Flashings observed to be loose or separated, which can lead to water intrusion and/or mold. Recommend a qualified roofing contractor repair.

Contact a qualified roofing professional.

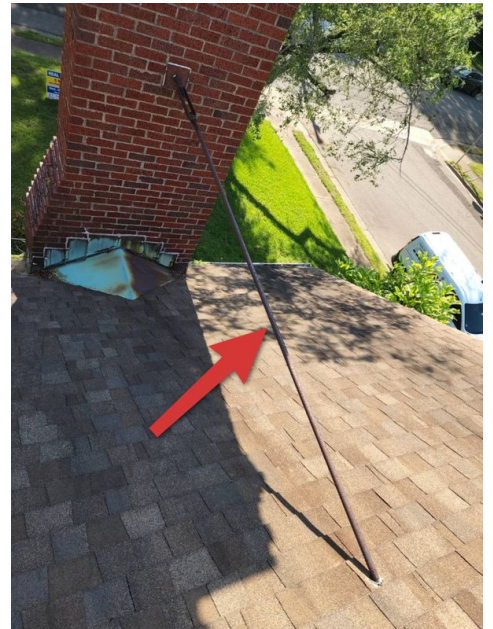
3.6.1 Chimneys

The Chimney shows signs of gaps at the joint against the home. The chimney appears to be pulling away from the home, recommend evaluation and repair by a qualified contractor.

Contact a qualified chimney contractor.

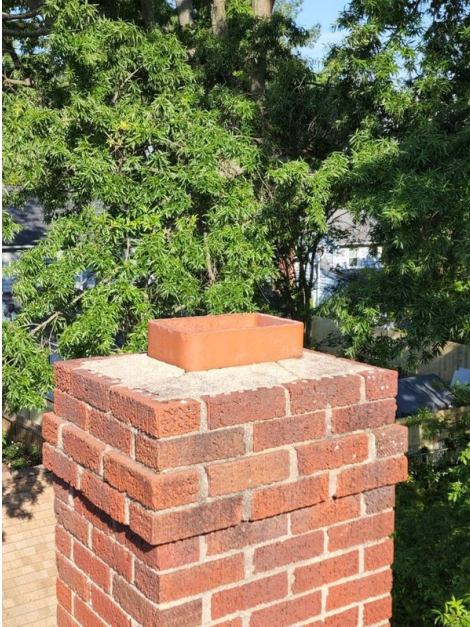
3.7.1 Chimneys 2

CHIMNEY RAIN CAP MISSING

No chimney rain cap was observed. This is important to protect from moisture intrusion and protect the chimney. Recommend a qualified contractor install.

Contact a qualified chimney contractor.

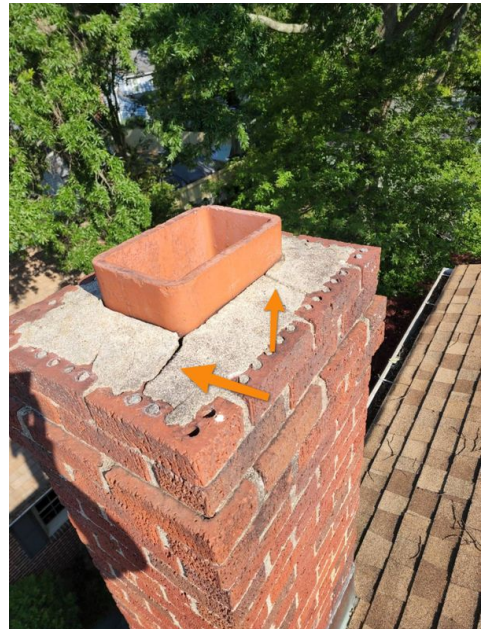
3.7.2 Chimneys 2

CHIMNEY CONCRETE CAP IS DAMAGED OR UNSEALED

The chimney concrete cap is damaged or unsealed. Recommend repair by a qualified contractor.

Contact a qualified chimney contractor.

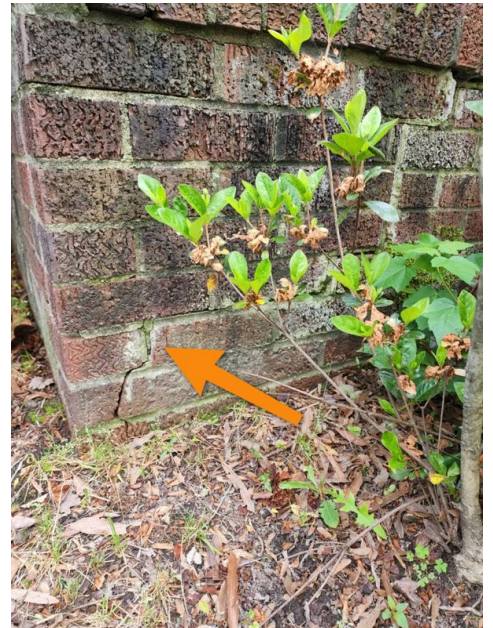
BRICK VENEER CRACKING / MINOR

Minor cracking noted on brick veneer. Recommend repair by a qualified contractor.

Contact a qualified masonry professional.

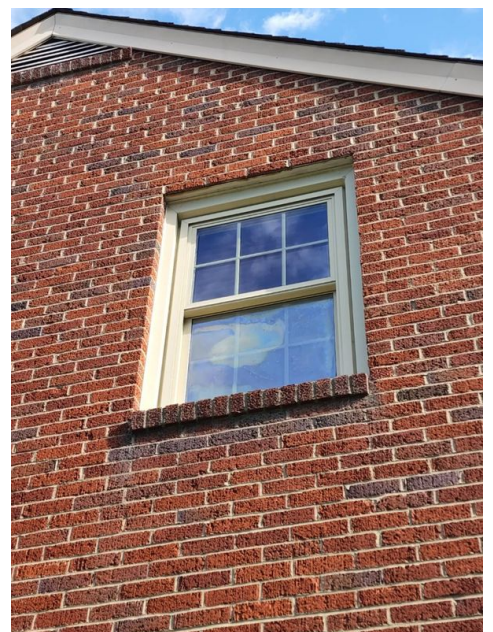
WINDOW HAS FAILED INSULATED SEAL, AND HAS LOST ITS THERMAL INTEGRITY

Window or windows has a failed insulated seal and has lost its thermal integrity. Recommend repair by a qualified professional.

Contact a qualified window repair/installation contractor.

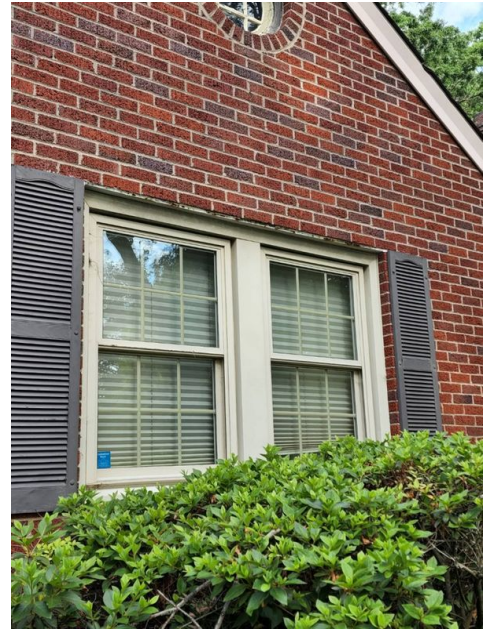
4.5.2 Window and Screens

SCREENS MISSING

Window or windows have missing screens. Recommend installing.

Contact a qualified professional.

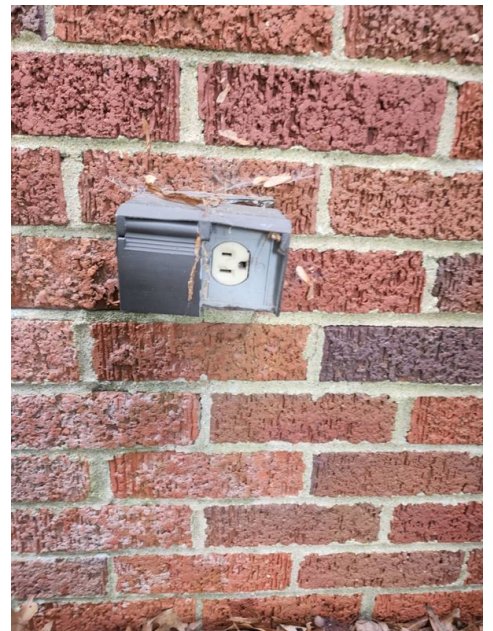
4.6.1 Electrical

DAMAGED/MISSING COVERS

Exterior electrical devices have damaged or missing covers. Recommend repair.

Contact a qualified electrical contractor.

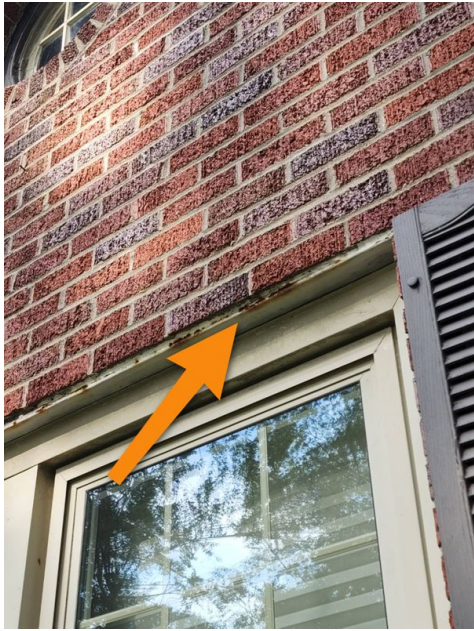
4.10.1 Lintels

LINTELS RUSTED / MINOR

Lintels above openings have minor rusting. Recommend repair by a qualified contractor.

Contact a qualified masonry professional.

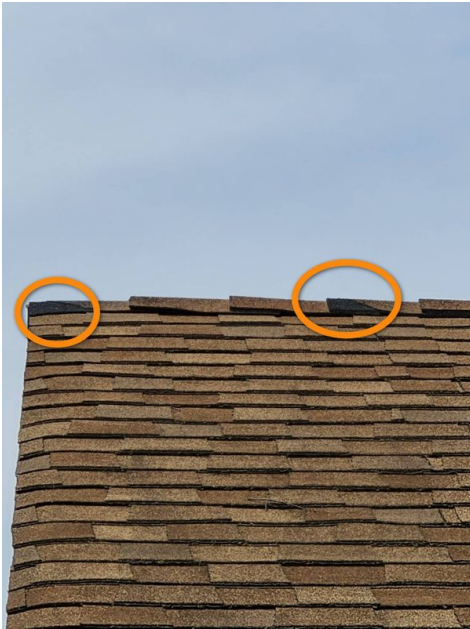
TILES CRACKED/BROKEN

Roof had cracked/broken tiles. Recommend a qualified roof contractor repair or replace to prevent moisture intrusion and/or mold.

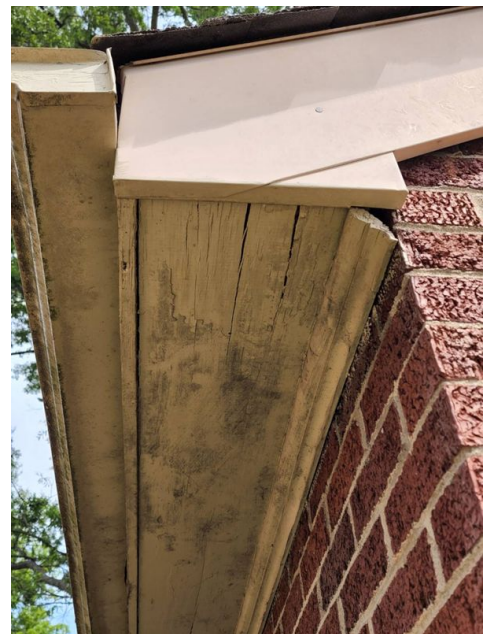
SOFFIT- DAMAGED

One or more sections of the soffit is damaged. Recommend evaluate & repair.

Contact a qualified roofing professional.

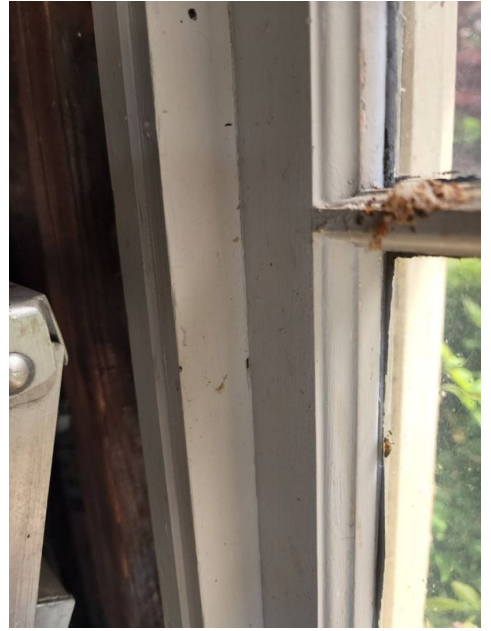
Some wooden windows are painted shut and will not open, this is an egress hazard. Recommend repair by a qualified professional.

Contact a qualified window repair/installation contractor.

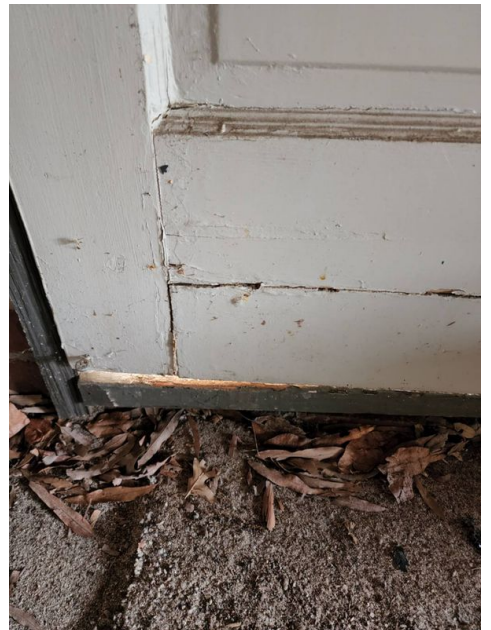
DOOR DAMAGED/ RUSTED

Garage service door damaged/ rusted, recommend repair/ replacement

Contact a qualified professional.

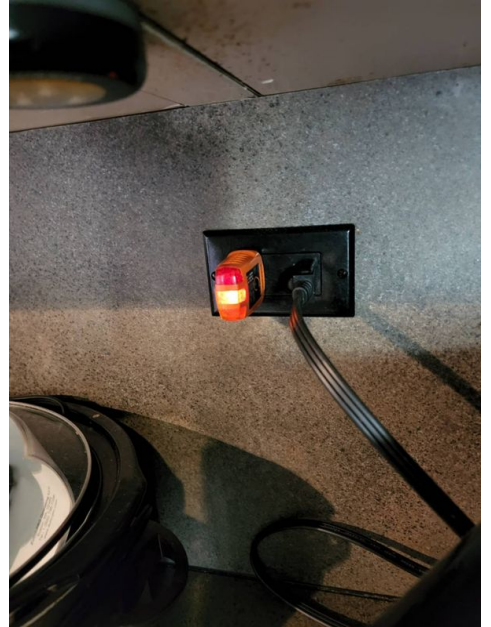
6.6.1 Electrical

Ungrounded receptacles observed in the kitchen. Recommend a qualified contractor repair.

Contact a qualified electrical contractor.

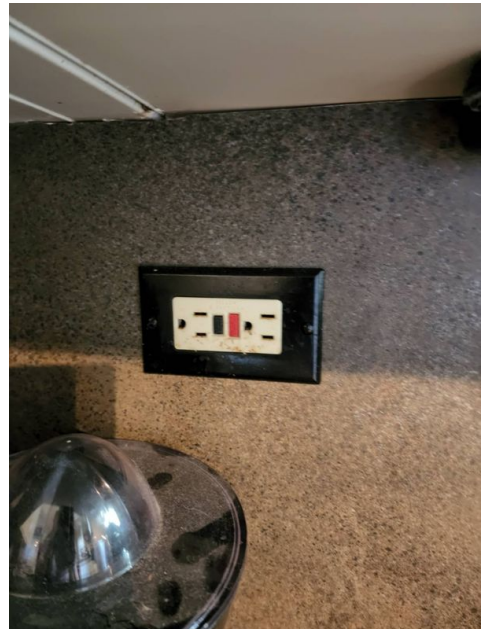
6.6.2 Electrical

GFCI FAILED TO RESET

The kitchen GFCI failed to reset after testing. Recommend repair by a qualified contractor.

Contact a qualified professional.

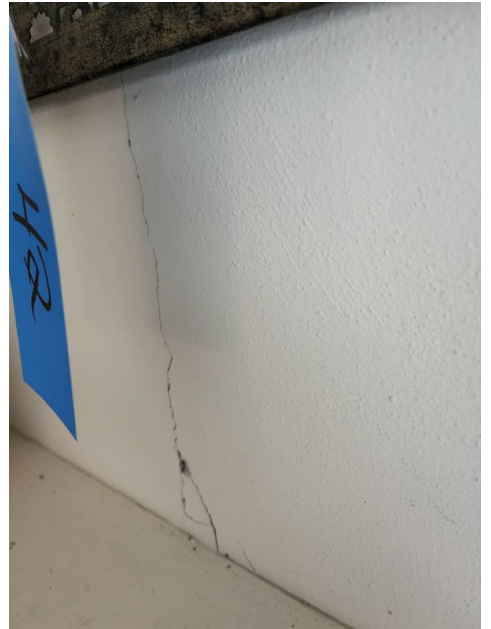
Living room walls and or ceilings were observed with typical cracks, patched damage and or other minor defects typical for the age of the home. No visible indications of differential movement or settlement noted. Recommend cosmetic repair if necessary and monitoring.

Recommendation
Recommend monitoring.

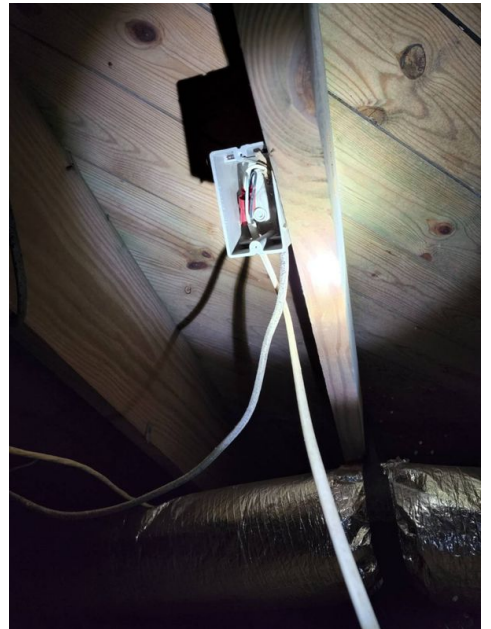
26.1.2 Distribution System

DAMAGED DUCTWORK

Contact a qualified professional.

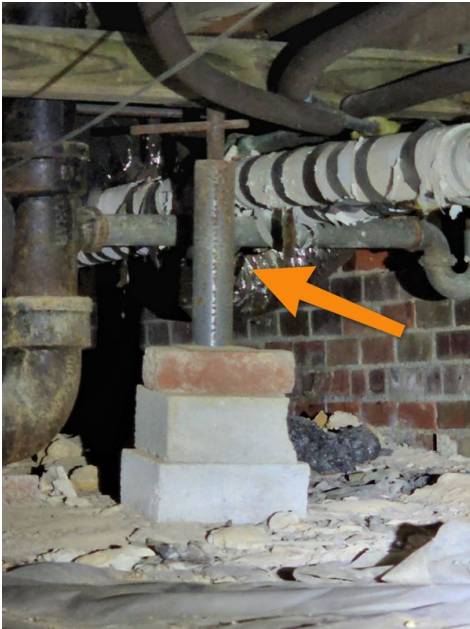
26.7.1 Girder / beams / columns

NON PROFESSIONAL FLOOR SUPPORT

Contact a qualified professional.

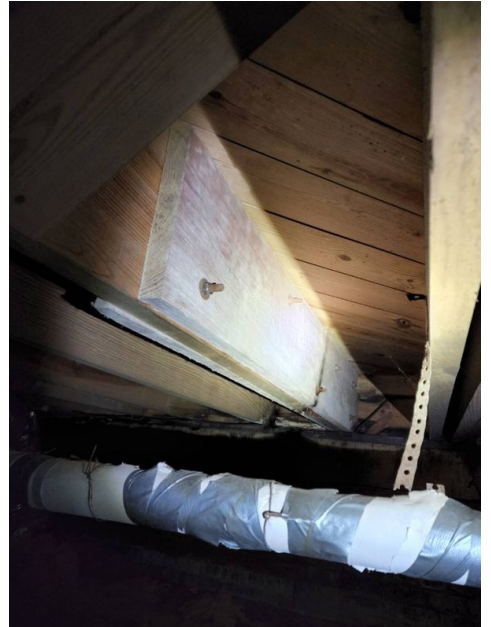
26.8.2 Joists

IMPROPER SISTERING OF JOIST

Contact a qualified professional.

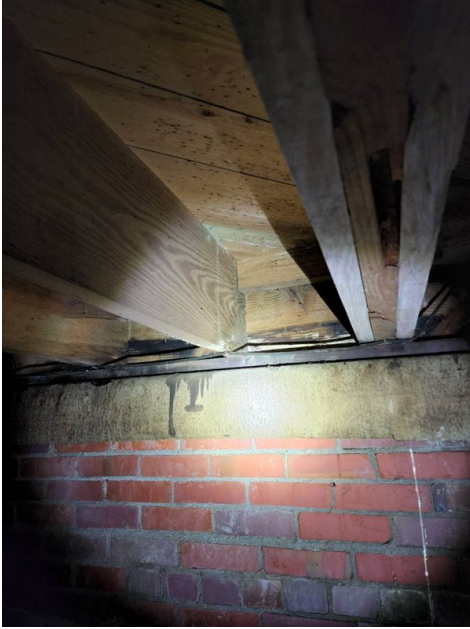
26.8.3 Joists

MOISTURE AND MICROBIAL GROWTH PRESENT IN CRAWL

Contact a qualified professional.
