1. No Title Report Furnished
2. Easements Not Shown May Exist
3. This Plat Is Based On A Field Survey Dated 3 August 2021
4. This Property Lies Inside The Area of Minimal Flood Hazard (Zone X)

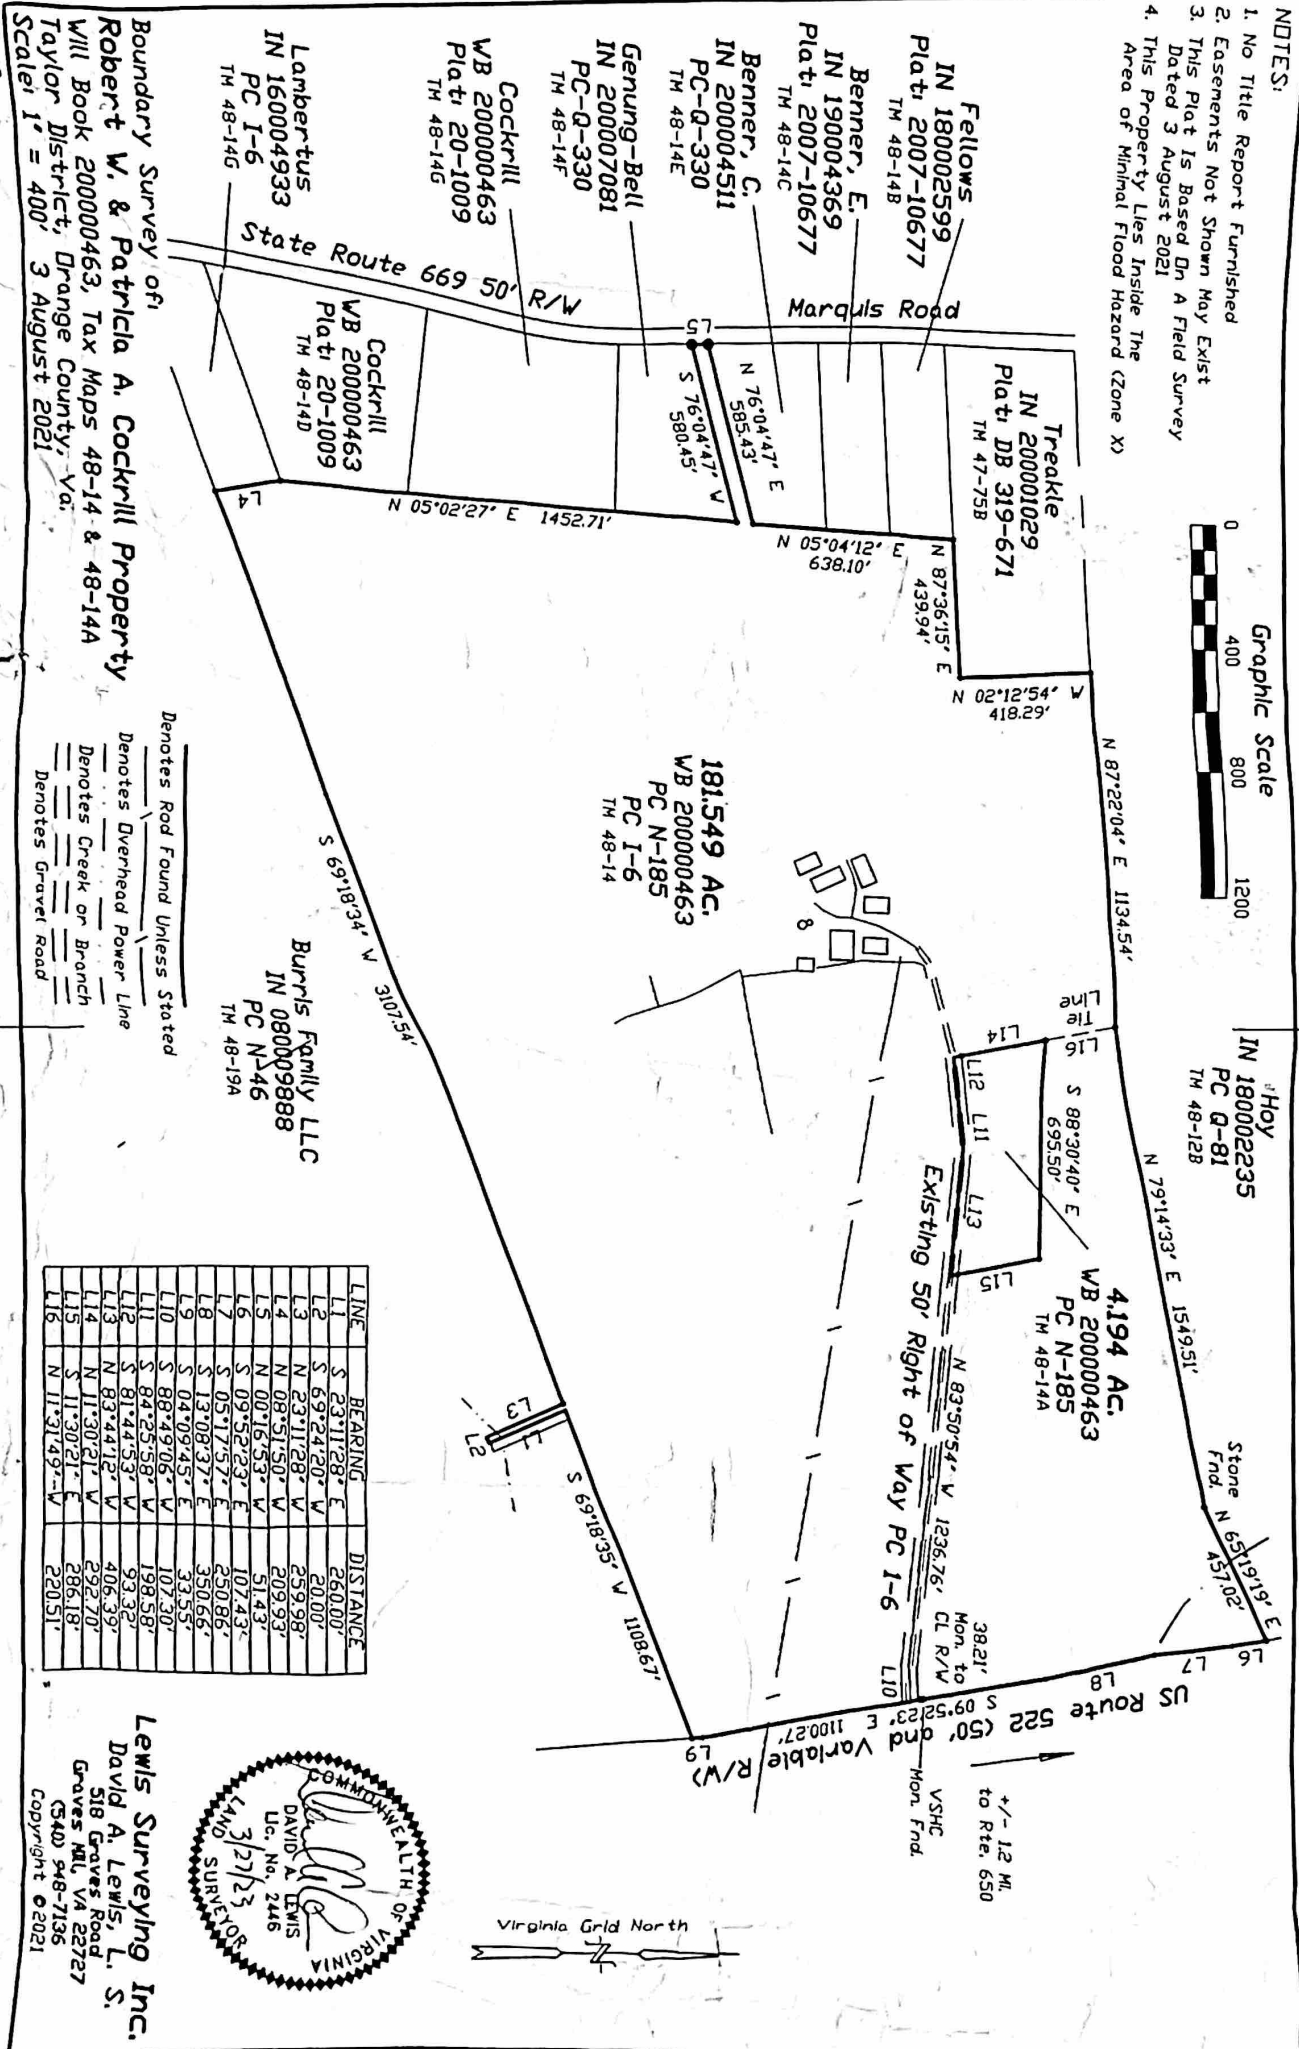
Denotes Rod Found Unless Stated
 Denotes Overhead Power Line
 Denotes Creek or Branch
 Denotes Gravel Road

LINE	BEARING	DISTANCE
L1	S 23°11'28" E	260.00'
L2	S 69°24'20" W	20.00'
L3	S 23°11'28" W	259.98'
L4	N 08°51'50" W	209.93'
L5	N 00°16'53" W	51.43'
L6	S 09°52'23" E	107.43'
L7	S 05°17'57" E	250.86'
L8	S 13°08'37" E	350.65'
L9	S 04°09'45" E	33.55'
L10	S 88°49'06" W	107.30'
L11	S 84°25'58" W	198.58'
L12	S 81°44'53" W	93.32'
L13	N 83°44'12" W	406.39'
L14	N 11°30'21" W	292.70'
L15	S 11°30'21" E	286.18'
L16	N 11°31'49" W	220.51'
