Condition Assessment Report

Oak View HOA

American Management of Virginia Oak view HOA

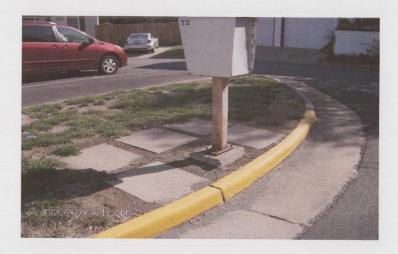
2. Repair Curb and Gutters: These repairs should be kept at a minimum but some of the more prominent damage should be addressed to prevent trip Hazards.

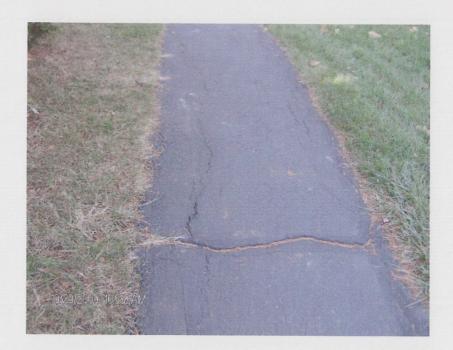
3. Asphalt Trail: Repairs at this time are not needed. However seal and crack fill should be performed since the traffic load on the trail is limited to pedestrian and bicycles. No damage should be expected from over load traffic. Roots and ground settlement are the only forces that may affect the area. Seal and crack fill should stop any water from penetrating the underlining of the trail and stop future damage.

Asphalt Trails: The property has a walking trail from the end of the court to the other side of the adjacent property that is 639 linear feet. Replacement is not necessary at this time but a seal should be considered to extend the life span of the path. Condition is good with some damaged sections that should be repaired with some crack fill and seal. Sometimes the shrinkage of asphalt, loss of flexibility, and the stress on the pavement leads to a series of cracks. The large cracks permit water to undermine the underlying soil, which will make it impossible for the paving to sustain ordinary loads. As the soil yields way the pavement begins to crack and deteriorate.

As time goes by, freeze-thaw cycles widen the cracks letting in even more water and the problem continues to worsen at an accelerated pace. Based on the condition, a crack filling will be necessary for some of the deeper cracks that have vegetation in them, and seal coating the entire path to extend the life of the asphalt is recommended. A preventive maintenance program will benefit the Oak View HOA by extending the life span of the path. Timely seal coating can extend the life of the path almost indefinitely. The program should be for every 10 years with yearly inspections for water damage, tree roots, and regular wear and tear.

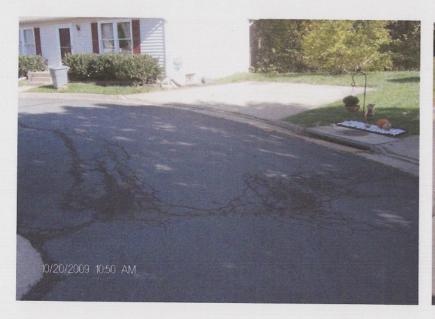
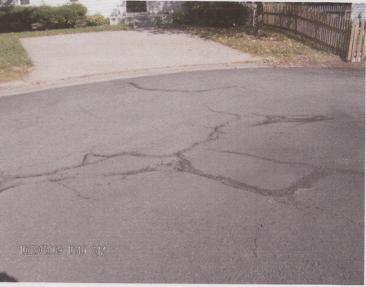
4. Paving Repairs: No serious damage was observed. Some alligator cracks and large cracks on some of the courts will require repairs in the near future.

1. Seal Courts: Crack fill and Seal should be completed on damaged courts. Large cracks should be repaired to stop water from undermining the surface. Oil spills should be cleaned before seal work.
