RECONNAISSANCE LEVEL SURVEY REPORT

DEPARTMENT OF HISTORIC RESOURCE
RECONNAISSANCE SURVEY FORM

DHR Identification Number: 253-0035-0644

PROPERTY NAMES	EXPLANATION
House, 208 North King Street	Current
House, 52 North King Street	Historic

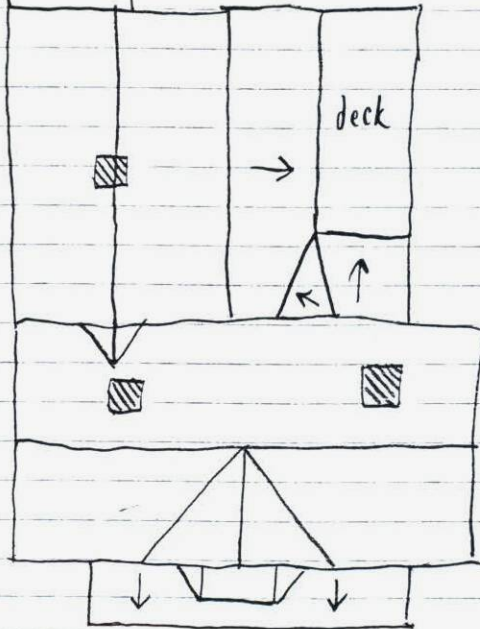
253-0035-0644
House, 208 N. King St.

The house was constructed in two distinct stages, with the original circa 1850 dwelling acting as a rear ell to the 1890 dwelling seen from the street. The original section of the house is two stories in height and three bays in width; it features brick construction laid in 7-course American bond and 6/6 windows with wood lintels and sills. The current facade features a center gable with a round-arched window above a canted bay at the second story. The centered entry of the five-bay wide house is framed by a three-light transom and two-light sidelights. Other details include cornice returns and square-cut balusters on the porch.

Condition: Fair

The alterations to the rear of the building include a 2-story bathroom addition with a shed roof and the addition of a wood deck. The porch of the original brick building has been enclosed with wood German siding and 1/1 windows.

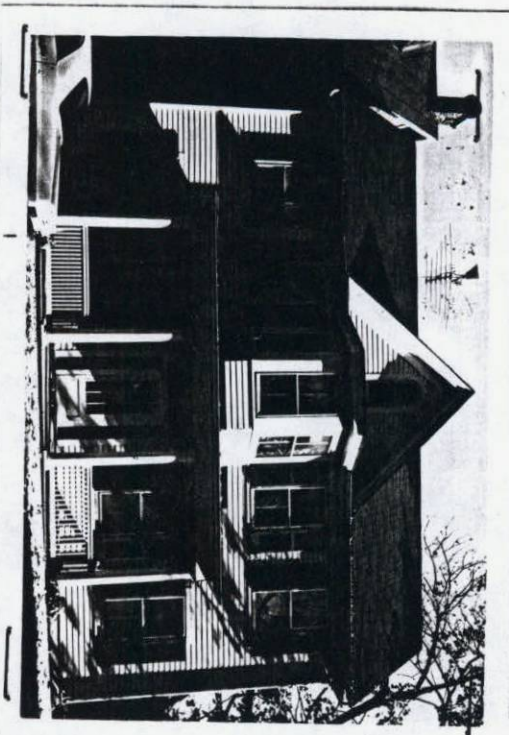
Photo: Roll# 13 Negative 13

Physical Description (materials): 5 bay form typical of the period covered in German siding. Three part bay window set under the cross gable. 2 over 2 glazing. Rear 2 story brick ell may be older section.

Exterior: Simple Colonial Revival Tuscan column porch. Circular-headed window set in cross gable. Plain, tripartite door frame.

Buildings: Type - board & batten shed. Concrete out bldg
 Condition - fair.
