LANCE HOME INSPECTION REPORT

7817 Ritter Dr
Charlotte, NC 28270

04/08/2026

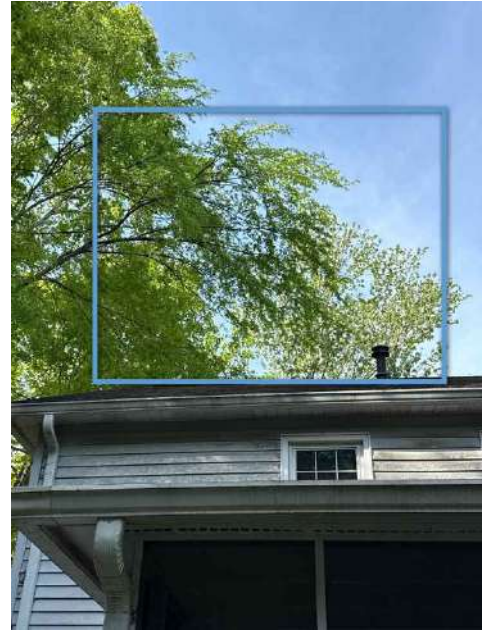
Right

Trees observed overhanging the roof. This can cause damage to the roof and prevent proper drainage and could cause damage to roof shingles over time. Recommend a qualified tree service trim to allow for proper drainage and prevent damage.

Contact a qualified tree service company.

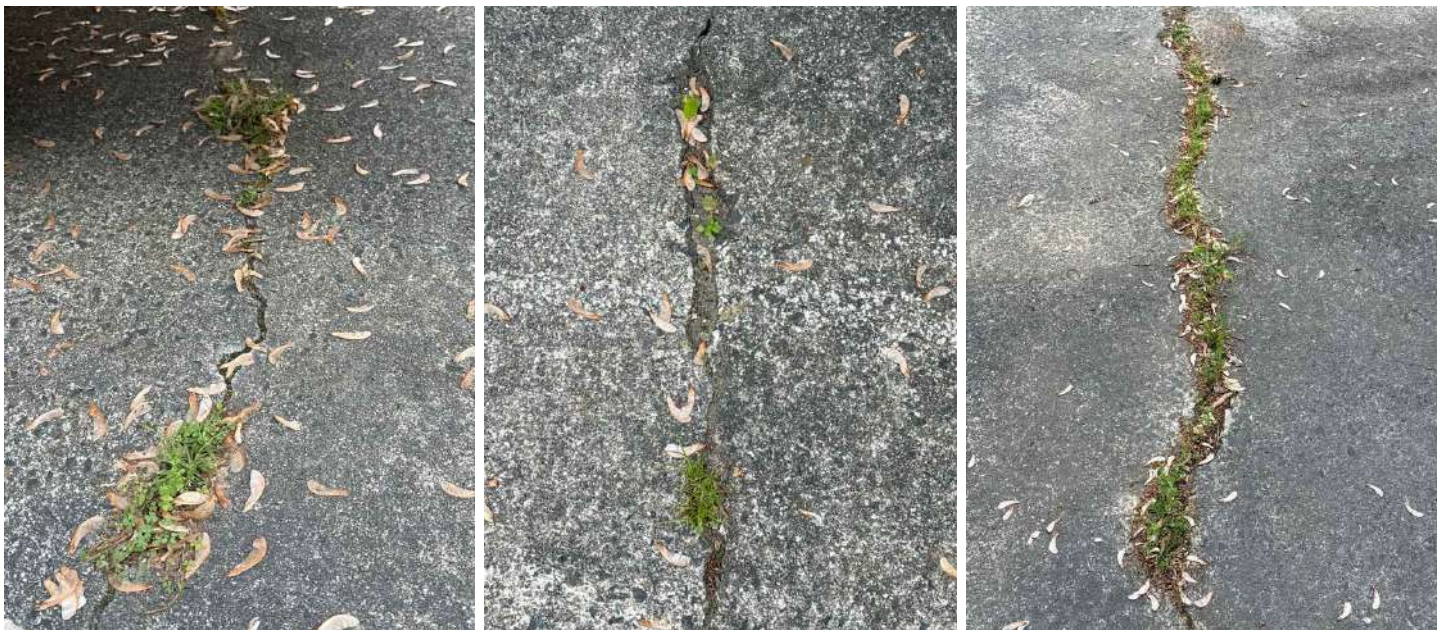
2.2.1 Driveways

DRIVEWAY OPEN CRACKS

Open cracking observed to the concrete driveway. This can allow for unwanted water intrusion below the surface of the driveway and could lead to possible erosion in affected areas. Recommend repair as needed by a qualified driveway contractor to prevent further damage.

Contact a qualified driveway contractor.

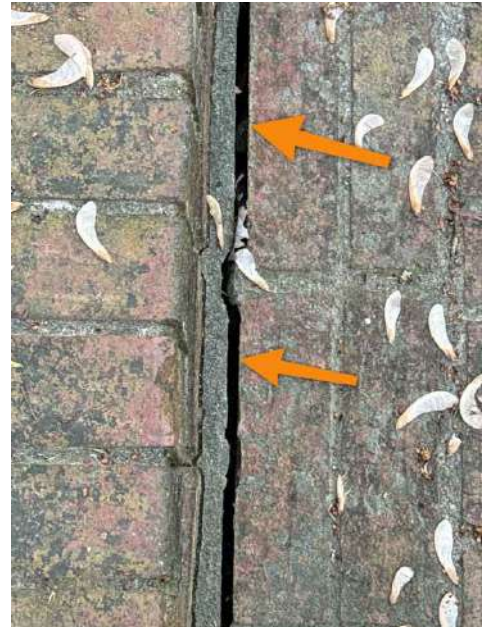
Front

Separation was observed between the brick steps and the front porch, indicating movement or settlement of the steps, which may create a tripping hazard and could allow water intrusion that may lead to further deterioration over time; recommend evaluation and repair by a qualified contractor to stabilize and properly secure the steps to the structure.

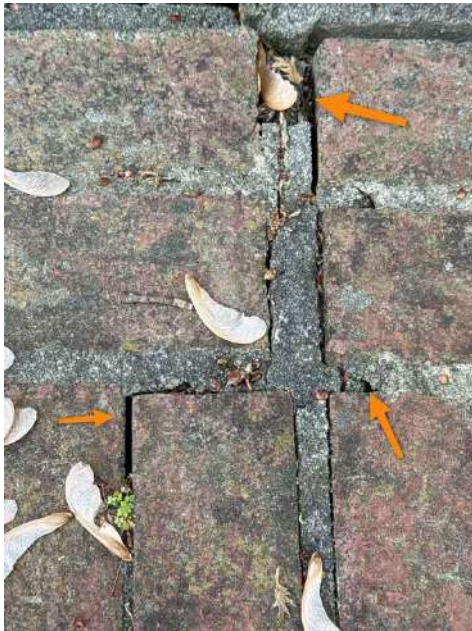
Front

MORTAR JOINT DETERIORATION

Deterioration of the mortar joints was observed at the front entry steps, including cracking and loss of material between the pavers, which may allow water intrusion, contribute to further displacement or movement of the bricks, and create a potential tripping hazard; recommend repair or re-pointing of the affected joints by a qualified contractor to restore stability and help prevent further deterioration.

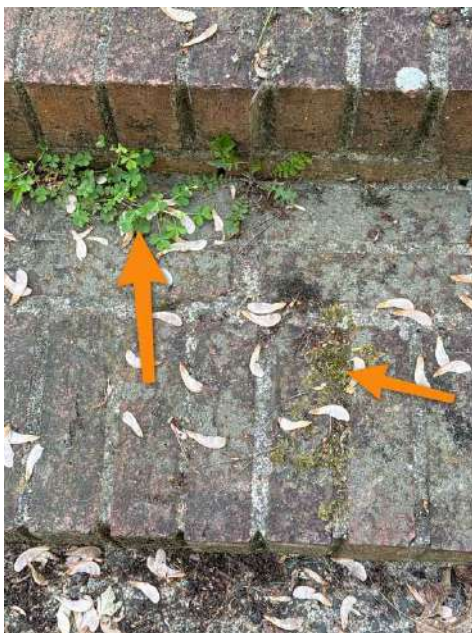
Front

Moss and vegetation growth was observed between the brick joints at the front entry steps, which is typically indicative of prolonged moisture retention and can contribute to deterioration of the mortar joints, displacement of the bricks, and a potential slipping hazard when wet; recommend removal of vegetation, cleaning of the affected areas, and sealing or repairing the joints as needed to help prevent further growth and deterioration.

Contact a qualified professional.

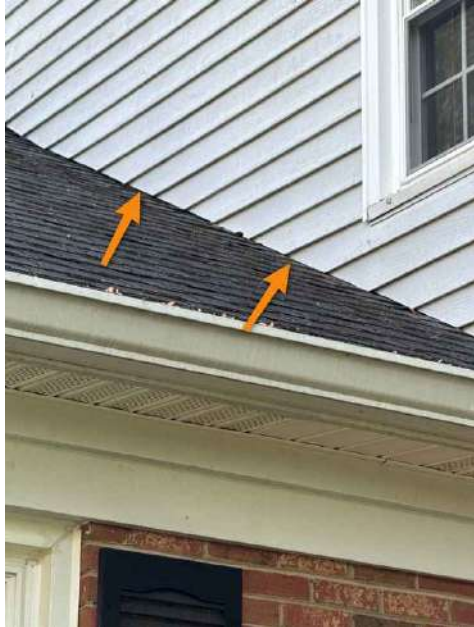
Front

Inspector observed insufficient Roof to sidewall flashing clearance at Sidewalls or Dormers (if applicable). A two inch clearance is desirable between roofing material and trim or siding to prevent water from being wicked up into the siding. Lack of this required clearance may result in water intrusion / wood rot. Interested Parties should consult with a qualified siding contractor to determine the significance of this concern and make corrections as needed.

Contact a qualified siding specialist.

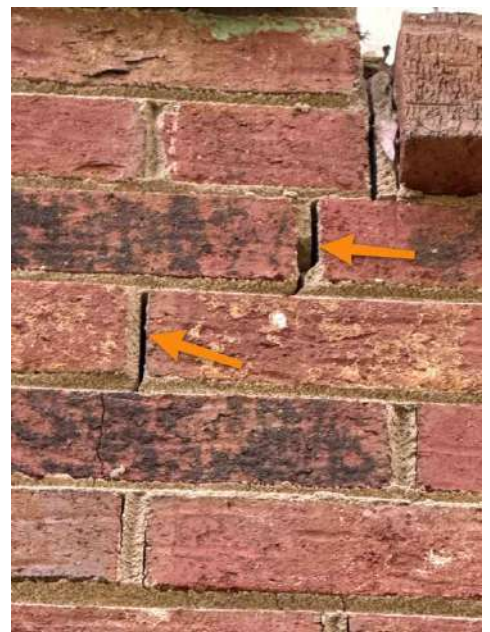
Front

BRICK VENEER - MINOR CRACK

Cracks noted in the brick veneer. It is recommended that only a cosmetic repair is needed to the brick veneer at this time. Following repair, the crack areas should be monitored and if a more significant crack (1/4 inch or more in width) forms or re-appears, further evaluation by a qualified and licensed general contractor or engineer would be recommended.

Contact a qualified masonry professional.

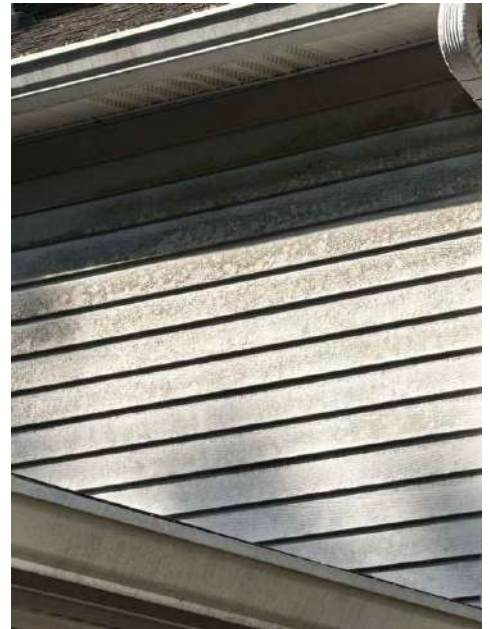
Inspector noted a buildup of mildew staining on the surface of the siding. This is primarily a cosmetic issue and we recommend the house be pressure washed.

Contact a handyman or DIY project

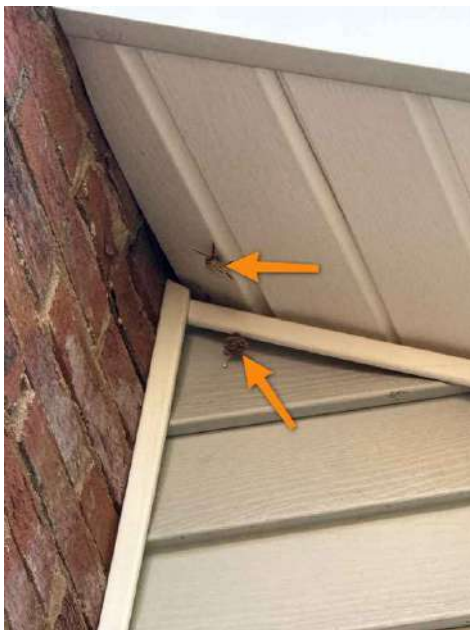
Left

Wasp nests were visible under the soffits. Recommend a qualified exterminator evaluate and remove.

Contact a qualified pest control specialist.

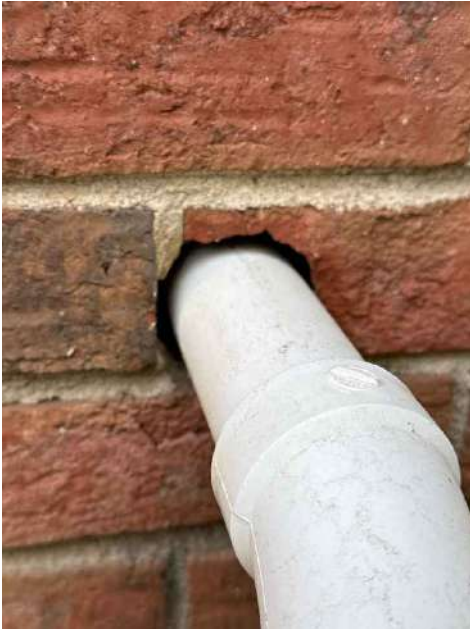
Front

MISSING SEALANT

Inspector noted exterior wall penetrations with open gaps in the exterior surface. This will allow moisture and pest intrusion and we recommend sealing all open gaps by a qualified handyman.

Contact a qualified handyman.

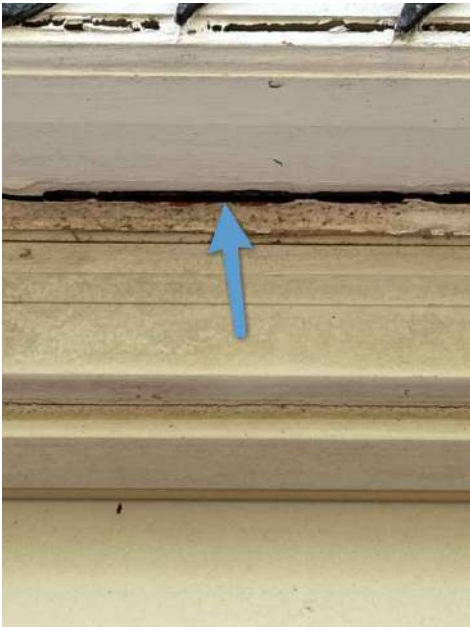
Front Door

CRACKED CAULKING

The caulking around components such as but not limited to windows, doors and exterior wall penetrations at various areas around the house need to be caulked/sealed, open voids and or missing cracked caulking observed.

Recommended DIY Project

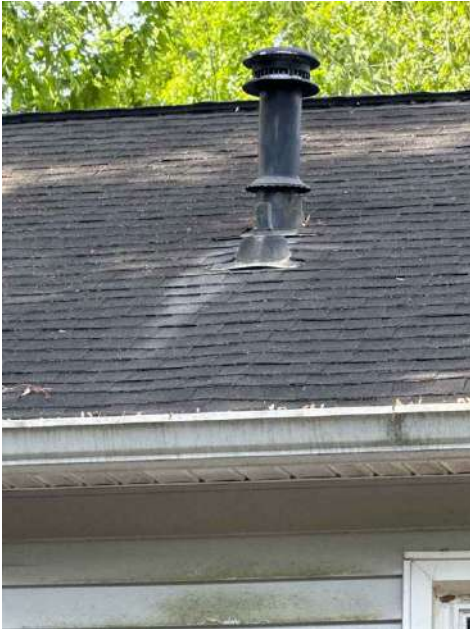
Rear Roof

Roof shingles were discolored, which can be caused by moisture, rust or soot. Recommend a qualified roofing contractor evaluate and remedy with a roof cleaning or repair.

Contact a qualified roofing professional.

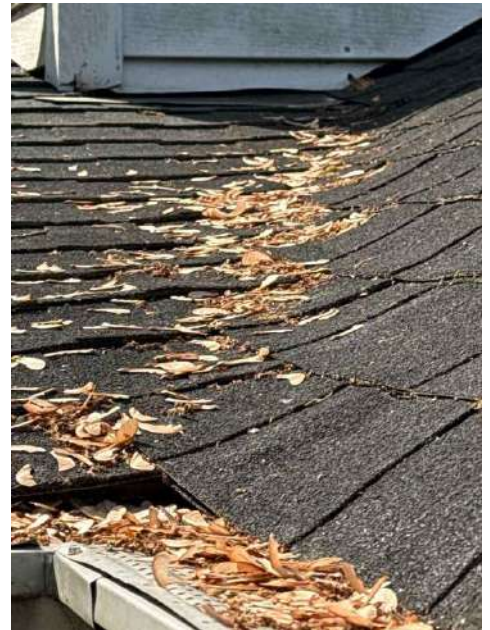
Rear Roof

Excessive organic debris noted on roof surface. During the winter season this could cause issues known as "ice damming". This can damage the roof construction and shingle covering significantly overtime. Recommend removal of all organic debris from roof surface.

Contact a qualified professional.

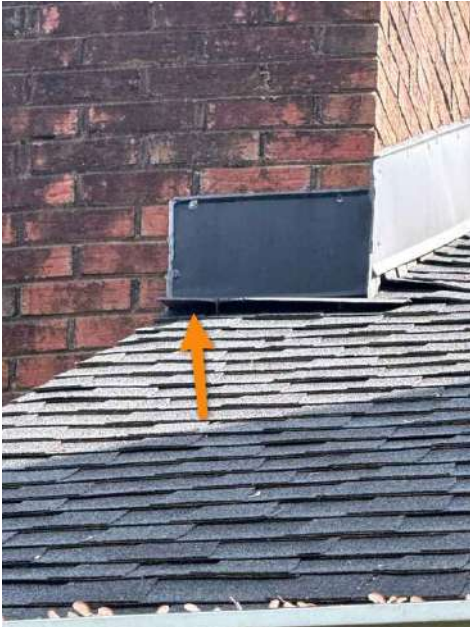
FLASHING LOOSE

Chimney flashing appears to be loose and or pulling away from the chimney and or roof decking and may be leaking to the interior of home. We recommend further evaluation by a professional contractor and repair or replace as deemed necessary by that contractor.

Contact a qualified roofing professional.

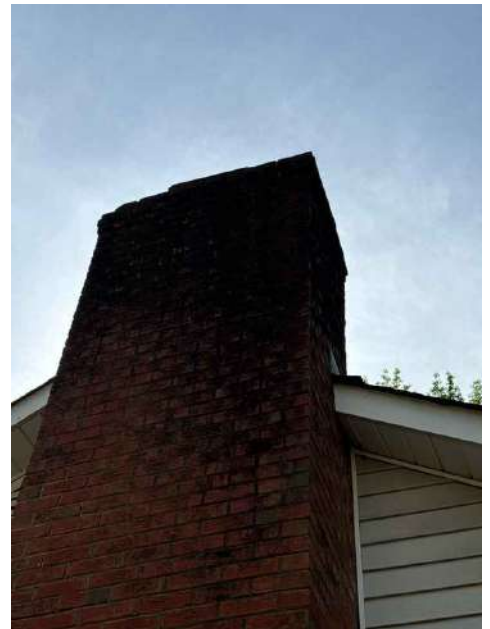
HEAVY SOOT

Heavy soot staining was observed on the exterior of the chimney, which is not typical and may indicate improper drafting, incomplete combustion, or issues with the fireplace or flue system; this condition may contribute to reduced performance and potential safety concerns, and recommend evaluation and cleaning by a qualified chimney professional prior to continued use.

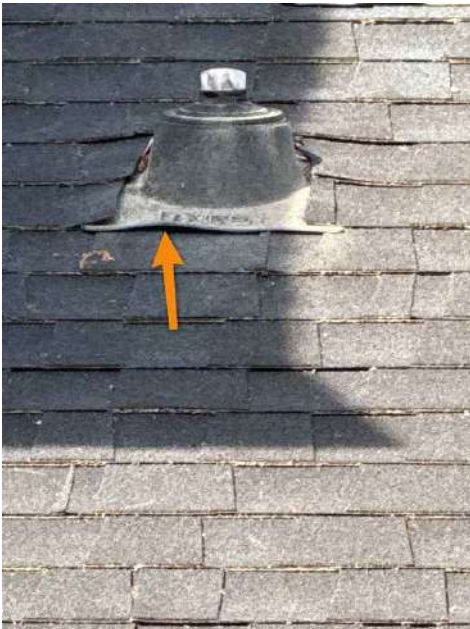
Rear Roof

LIFTING EDGES

Inspector observed some of the roof flashing has raised bottom edges. At some locations the nails may have backed out of the flashing. This can result in damage to the flashing and / or water intrusion around the unprotected roof area. Recommend flashing be secured flat to the roof and sealed to prevent possible water intrusion or damage in high winds.

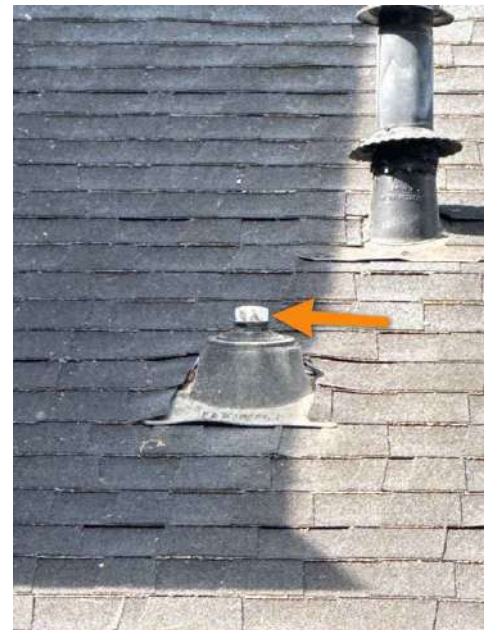
Rear Roof

A plumbing vent on the rear roof plane was observed to be cut off and terminating at a low height, which may not allow for proper venting of the plumbing system and can increase the potential for sewer gas odors or moisture intrusion at the roof penetration; recommend evaluation and correction by a qualified plumbing contractor to ensure the vent is properly extended and sealed in accordance with current standards.

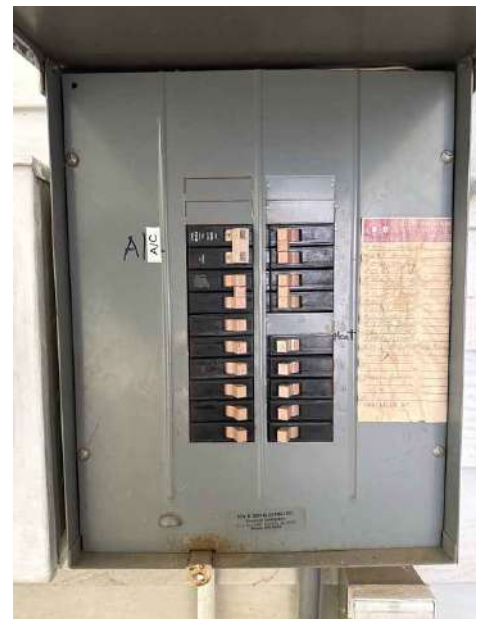
Service and Grounding Equipment, Main Overcurrent Device, Main and Distribution Panels: Required Photos - Panel cover on(1) and removed(1)

Service and Grounding Equipment, Main Overcurrent Device, Main and Distribution Panels: Main Panel Capacity

Unknown

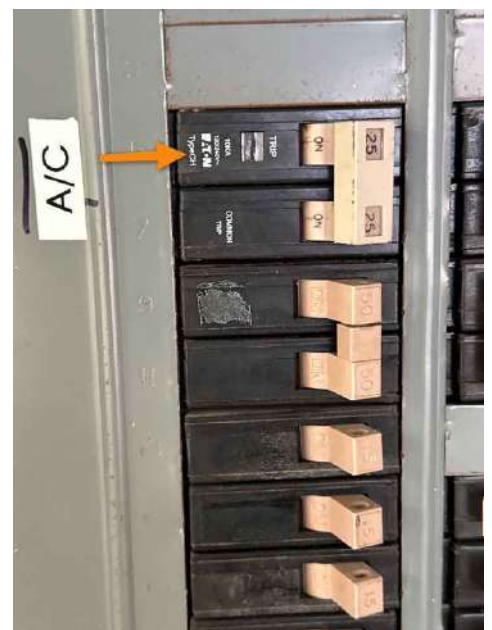
The exterior electrical panel exhibited signs of interior rust/corrosion and contained at least one breaker that may not be compatible with the panel, which can affect proper operation and safety; additionally, proper grounding and bonding could not be confirmed, and recommend further evaluation and any necessary repairs by a licensed electrician.

Several breakers in the main electrical panel have been added or replaced. The new breakers are of a different brand from the panel enclosure and are not listed on the label of the panel. Breakers must be UL listed and certified for each panel to ensure proper operation. The compatibility of the breakers to the panel needs further evaluation by a licensed professional electrician to ensure safe and proper operation of the overcurrent protection systems.

Contact a qualified electrical contractor.

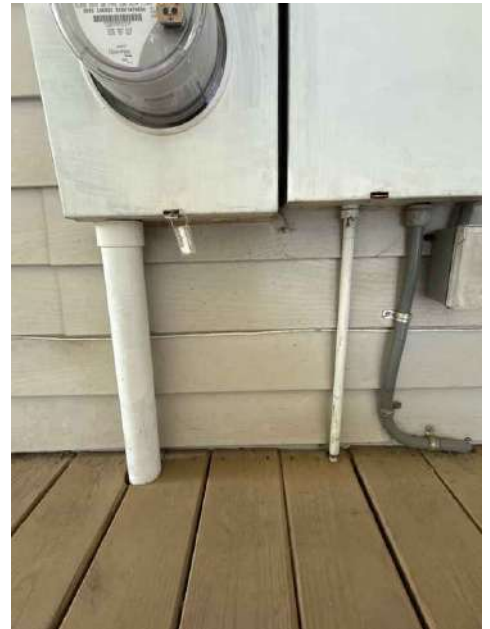
Proper ground could not be found at the time of inspection. The ground may not be present or could be hidden from view or buried. This is a safety hazard and it is recommended that a licensed electrician verify or install proper ground.

Contact a qualified electrical contractor.

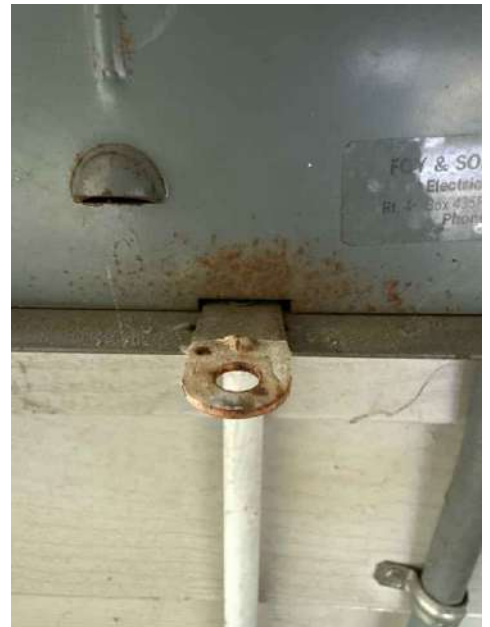
EXCESSIVE RUST

Contact a qualified electrical contractor.

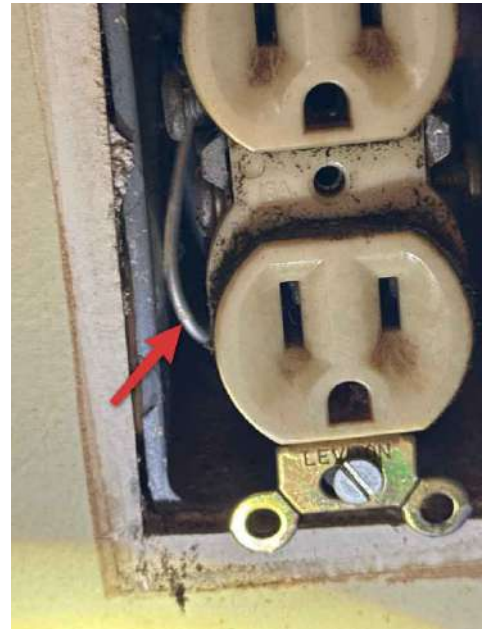
Single strand aluminum wire is present on 120 volt branch circuits in this house. This single strand, branch circuit aluminum wire was used widely during the 1960s and 1970s. According to reports published by the U.S. Consumer Product Safety Commission (CPSC), problems due to overheating at the connections between the wire and devices such as switches, outlets, and light fixtures may have been responsible for house fires. It is recommended that the circuits using single strand aluminum wiring be evaluated and modified as may be deemed necessary by a licensed electrical contractor who is familiar with the problems inherent in this type of wiring. For more information on aluminum household wiring, refer to the National Electrical Code and the C.P.S.C. booklet "Repairing Aluminum Wiring." The toll-free hotline number for obtaining this booklet is 1-800-638-2772, or you can visit: [Aluminum Wiring Repair](#)

Contact a qualified electrical contractor.

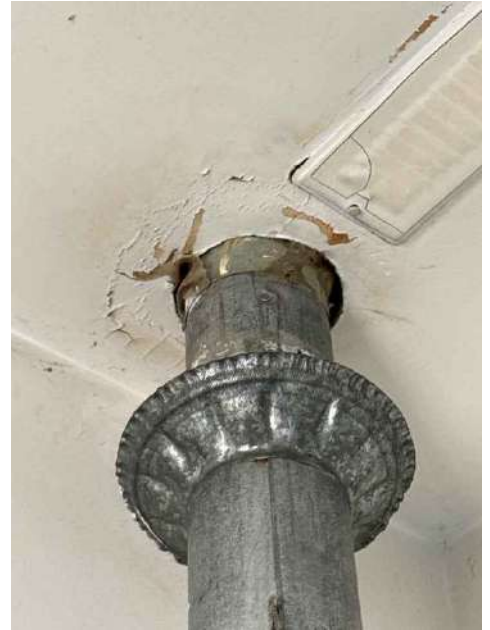
Laundry Room

IMPROPER FLUE CLEARANCE

Contact a qualified professional.

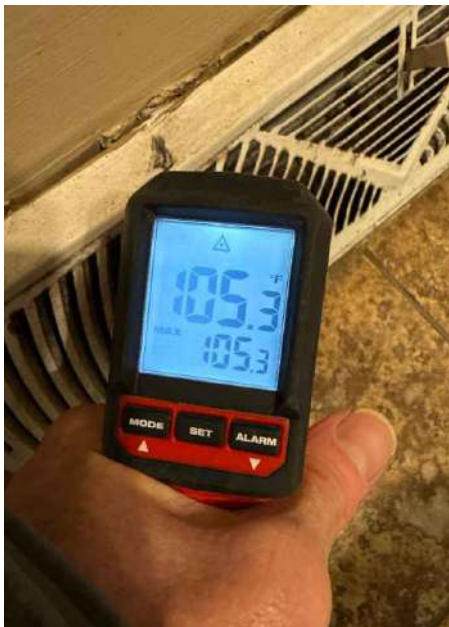
Picture of Supply Temperature, Picture of Return Temperature

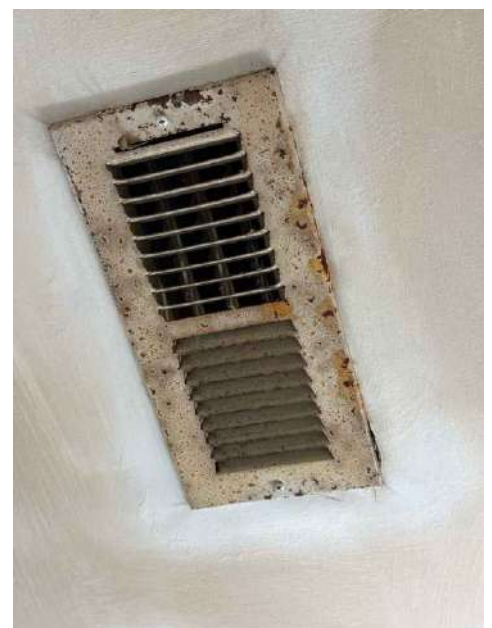
2nd Floor Main Bathroom

RUSTED SUPPLY REGISTER

Heavy rust and corrosion were observed on the supply register in the second-floor primary bathroom, which is typically indicative of prolonged moisture exposure and may lead to deterioration of the component and reduced air distribution efficiency; recommend replacement of the affected register and evaluation of the area for excessive humidity or ventilation issues to help prevent recurrence.

Contact a qualified professional.

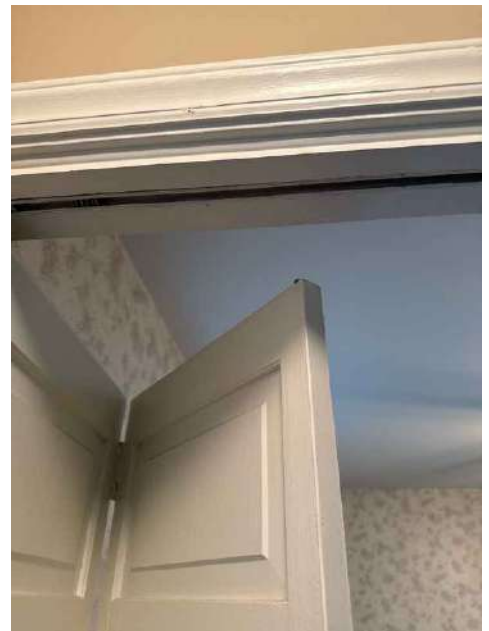
1st Floor Dining Room

MISSING HARDWARE

Contact a qualified professional.

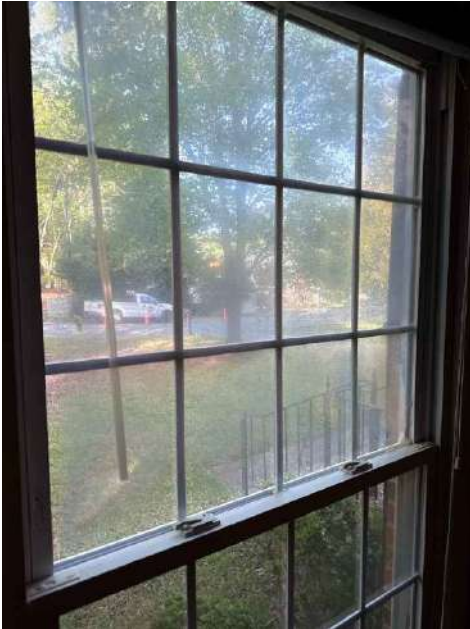
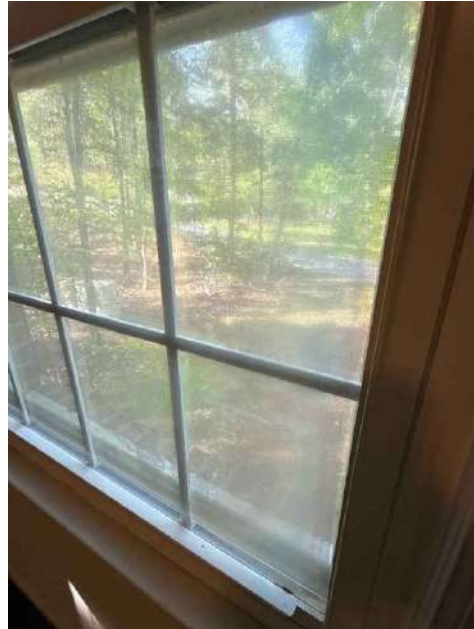
10.9.1 Windows

FAILED THERMAL SEAL

Observed condensation or fogging between some of the window panes, which indicates a failed thermal seal. This could reduce the thermal efficiency of the window system. Recommend qualified window contractor evaluate & replace.

Contact a qualified window repair/installation contractor.

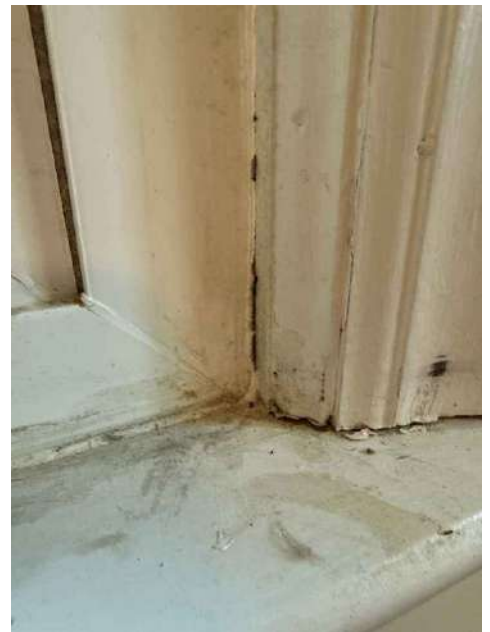
Multiple Windows

10.9.2 Windows

CRACKED CAULKING

The caulking around some of the windows at various areas around the house need to be caulked/sealed, open voids and or missing cracked caulking observed.

Recommended DIY Project

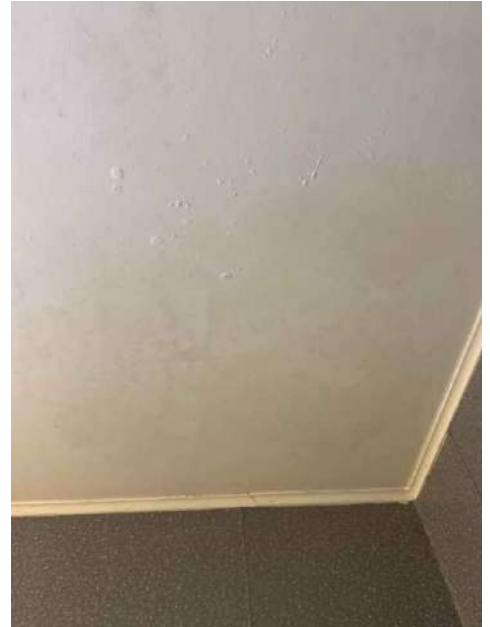
2nd Floor Hallway Bathroom

LEAK STAINS - INACTIVE

Stains on the ceilings indicate a history of a leak. Using a moisture meter provides additional evidence that the leak is not active as there is NO elevated moisture when tested. Further Investigation by a repair specialist and / or Painter and owner disclosure is recommended.

Contact a qualified painting contractor.

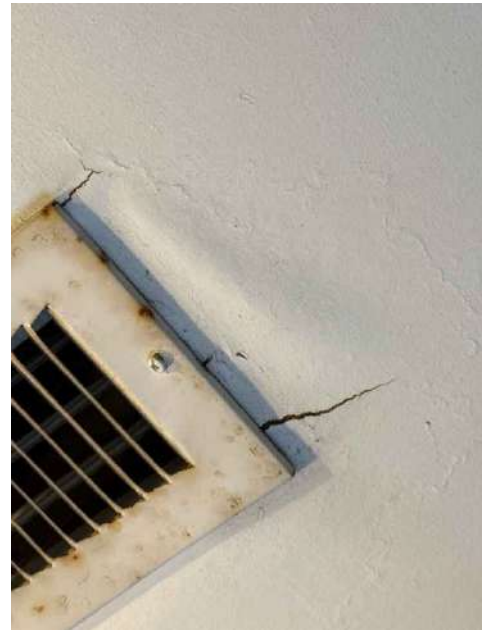
2nd Floor Hallway Bathroom

11.3.2 Ceilings

PAINT CRACKING

Paint was noted to be cracking at one or more locations, recommend repair by a qualified painter.

Contact a qualified painting contractor.

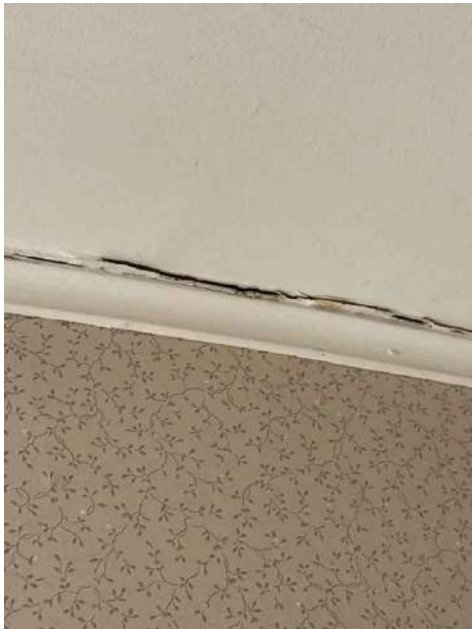
1st Floor Half Bathroom

11.3.3 Ceilings

CRACKS

Inspector noted one or more cracks in ceilings. No additional evidence to suggest structural issues. Recommend repair by a qualified contractor.

Contact a qualified general contractor.

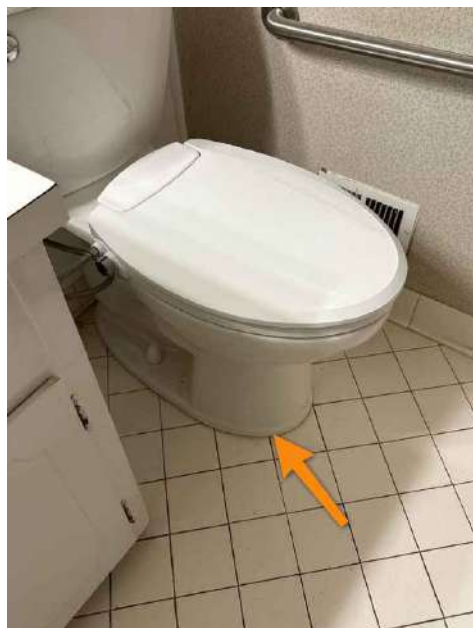
1st Floor Half Bathroom

TOILET LOOSE - NO LEAK

The toilet is loose at the floor and needs to be secured properly. As the toilet loosens the seal that is formed from the toilet loosens and the seal is not as tight as it once was. This may result in a leak allowing waste water or sewage gases into the home from a deformed wax ring. At time of Inspection, no active leak noted however further evaluation by a licensed plumbing contractor is recommended to determine IF a new wax seal is needed and secure toilet.

Contact a qualified plumbing contractor.

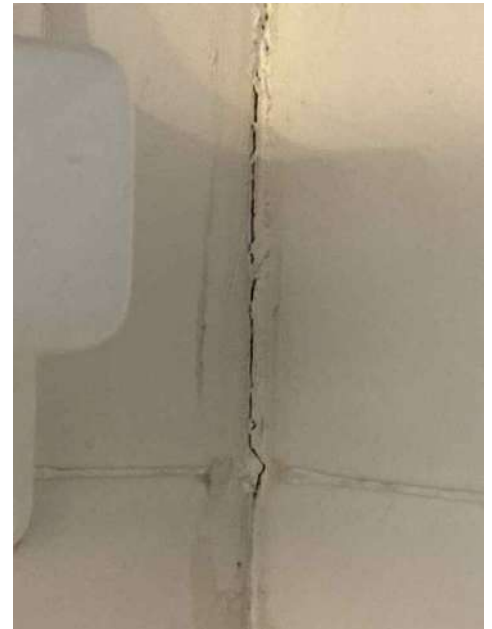
2nd Floor Hallway Bathroom

11.8.1 Shower / Tub

GROUT MISSING OR CRACKED

Inspector noted gaps in the grout between tiles at the shower surround. This will allow water intrusion and possibly moisture related issues. Recommend repair by a qualified tile contractor.

Contact a qualified tile contractor

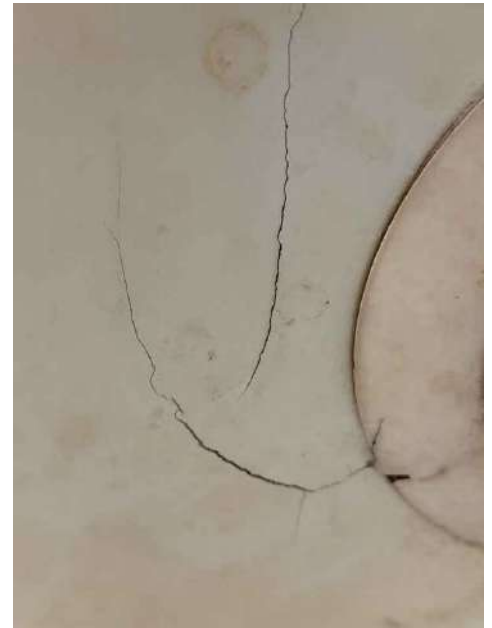
2nd Floor Main Bathroom

11.8.2 Shower / Tub

CRACKS IN SHOWER ENCLOSURE

Cracking was observed in the ceiling surface of the shower enclosure in the second-floor primary bathroom, which may allow moisture intrusion into the ceiling assembly and lead to deterioration, mold growth, or concealed damage over time; recommend sealing and repairing the affected area and further evaluation by a qualified contractor to determine the extent of damage and prevent moisture penetration.

Contact a qualified professional.

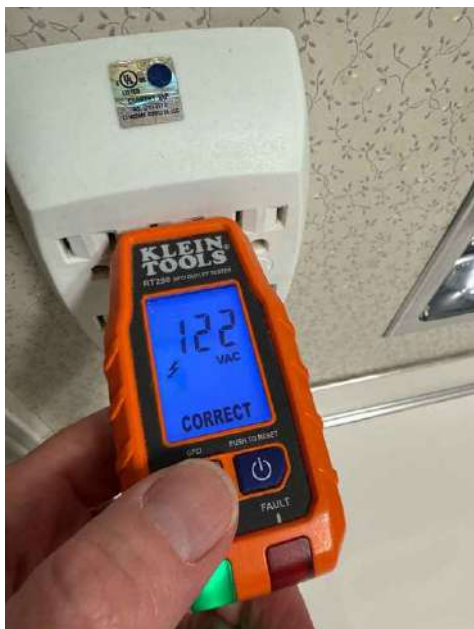
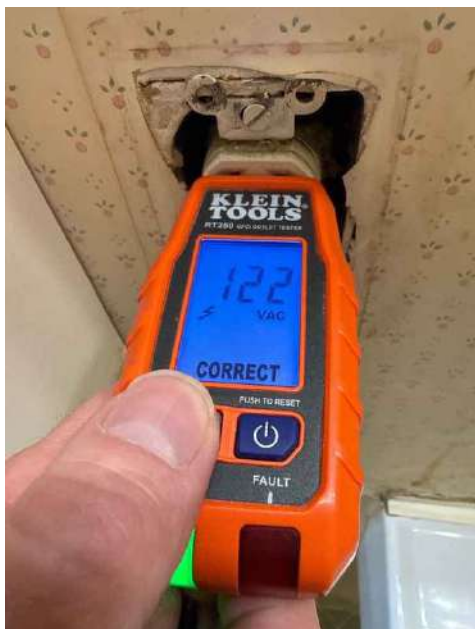
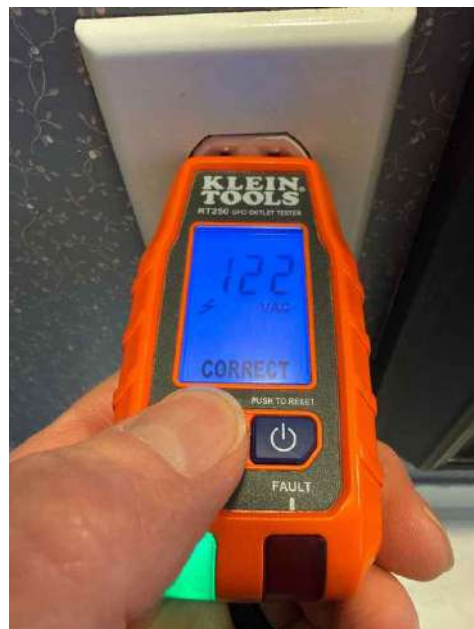
11.10.1 GFCI

Inspector noted one or more electrical outlets are not GFCI protected. A GFCI (ground fault circuit interrupter) outlet is a device that adds a greater level of safety by reducing the risk of electric shock. GFCI outlets have been required as follows:

Recommend a licensed electrician repair or upgrade by installing ground fault receptacles in all required locations.

Contact a qualified electrical contractor.

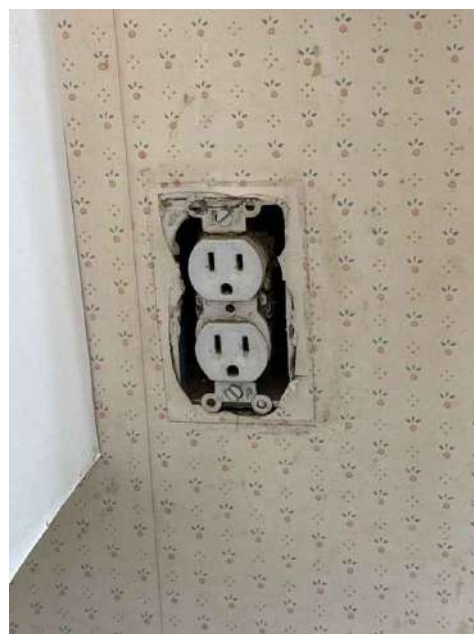
2nd Floor Main Bathroom

11.11.1 Lighting Fixtures, Switches & Receptacles

COVER PLATES MISSING

One or more receptacles / light switches are missing a cover plate. This creates a shock risk and is a safety hazard. Recommend installation of plates for safety.

Recommended DIY Project

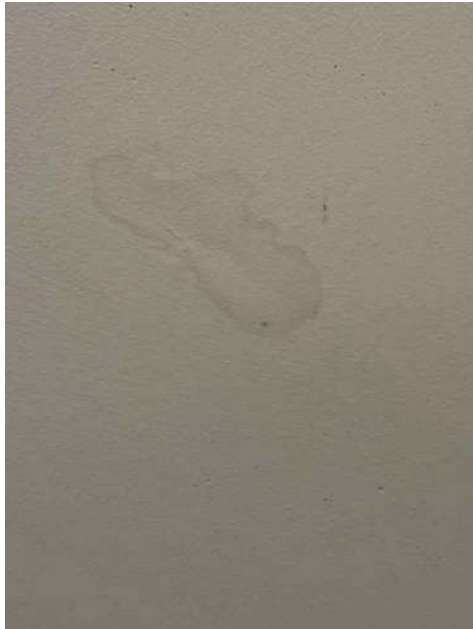
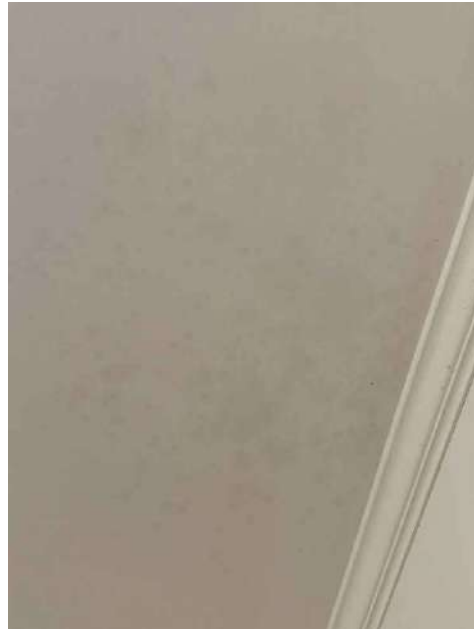
**LEAK STAINS - INACTIVE**

Stains on the ceilings indicate a history of a leak. Using a moisture meter provides additional evidence that the leak is not active as there is NO elevated moisture when tested. Further Investigation by a repair specialist and / or Painter and owner disclosure is recommended.

Contact a qualified painting contractor.

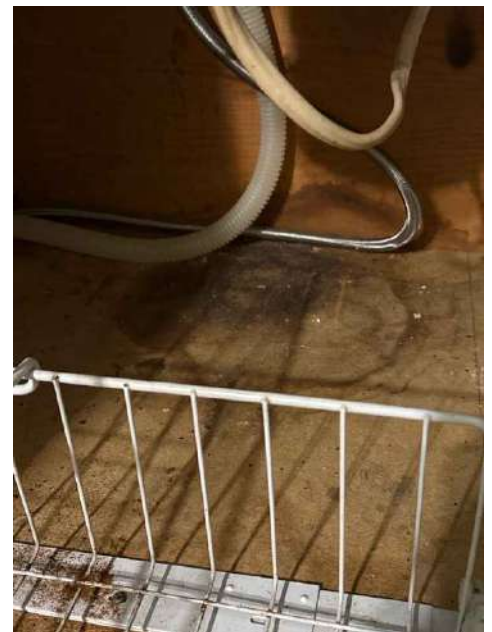
Kitchen

12.5.1 Sink

**STAINS UNDER SINK**

Stains under the sink indicate a history of a leak. At the time of the inspection it was not possible to determine if the condition was due to an active or past occurrence. Further Investigation by a repair specialist and owner disclosure is recommended.

Contact a qualified handyman.

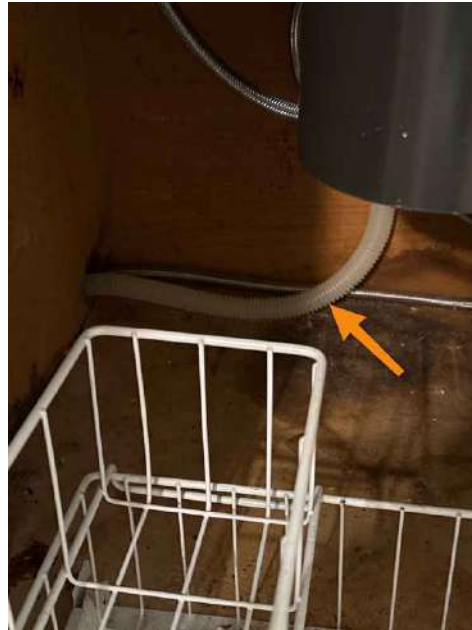
Kitchen

P154
No Drain Loop Pic

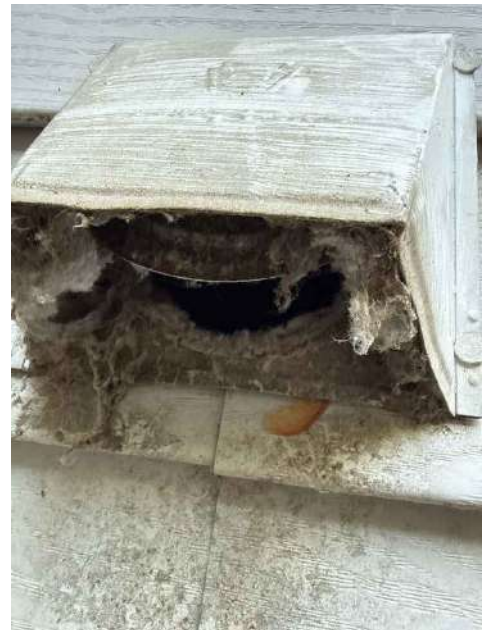
Excessive lint buildup was observed at the exterior dryer exhaust vent, which can restrict airflow and create a potential fire hazard due to the highly combustible nature of lint, as well as reduce the efficiency and performance of the dryer; recommend cleaning the vent and exhaust duct system and having it further evaluated and serviced as needed by a qualified contractor to ensure proper and safe operation.

Contact a qualified professional.

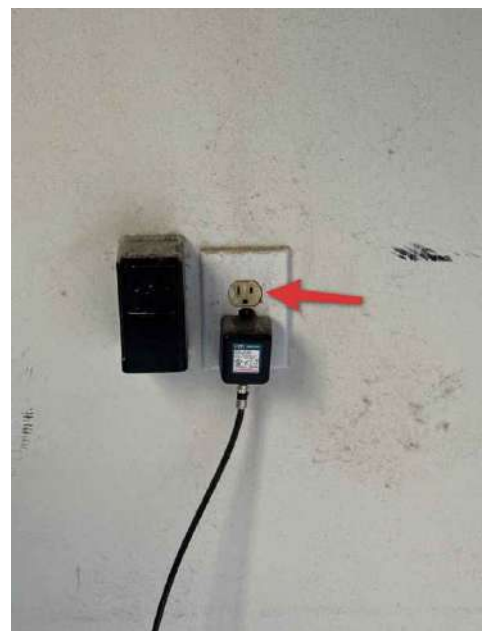
Laundry Room

Residential laundry areas require GFCI protection for all 15 and 20 amp receptacles in laundry rooms regardless of whether there is a sink in the laundry area. The laundry room receptacle is not GFCI protected in this home. Recommend installation of a GFCI receptacle in the laundry room by a licensed professional electrician.

Contact your builder.

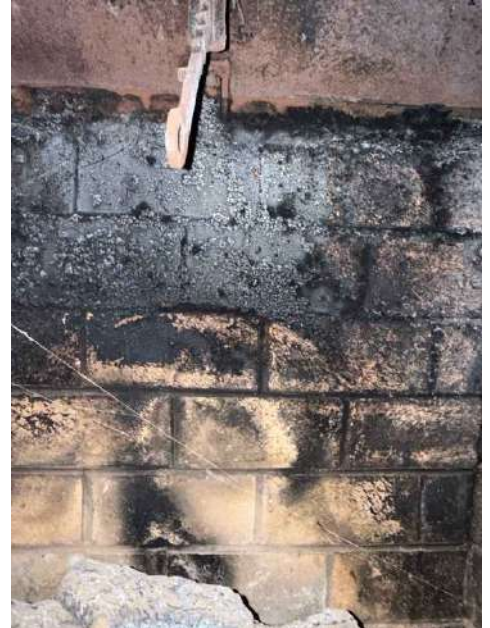
Living Room

Heavy soot and creosote-like buildup was observed within the firebox of the gas log fireplace, which is not typical for properly functioning gas appliances and may indicate incomplete combustion, improper fuel-to-air mixture, or venting issues; this condition can lead to reduced efficiency and potential safety concerns including carbon monoxide production, and recommend evaluation, cleaning, and servicing by a qualified fireplace or HVAC technician prior to continued use.

Contact a qualified professional.

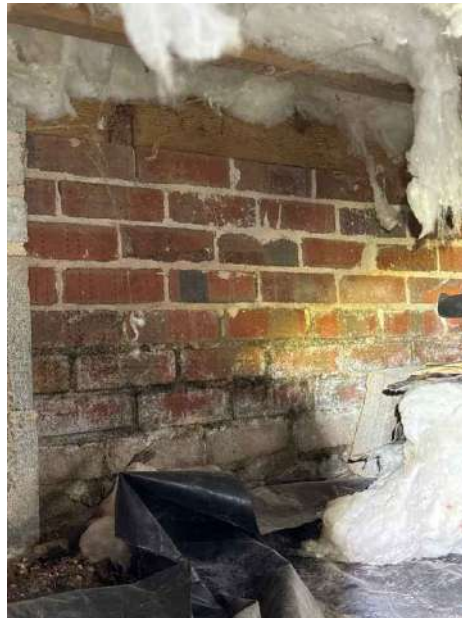
Foundation Wall Structure:

Material

Brick

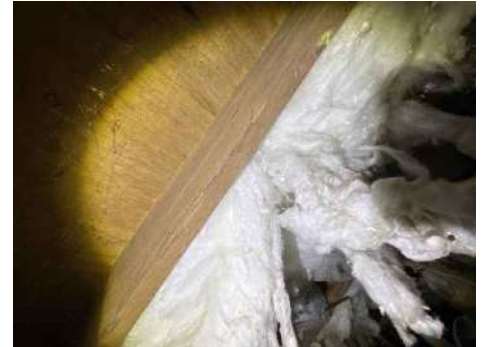
Sub Floor Structure: Material

Wood Joist, Concrete Block Piers

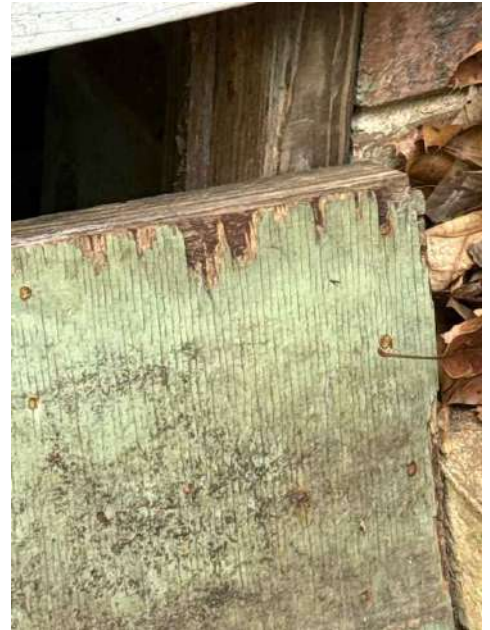
WOOD ROT CRAWL SPACE DOOR

Contact a qualified professional.

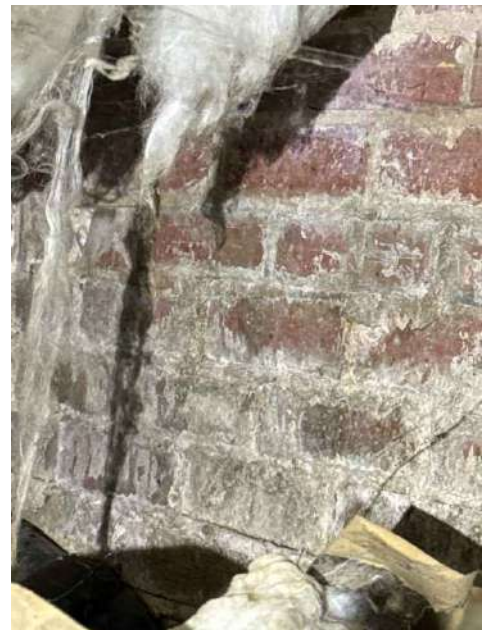
EFFLORESCENCE ON WALLS

Contact a qualified professional.

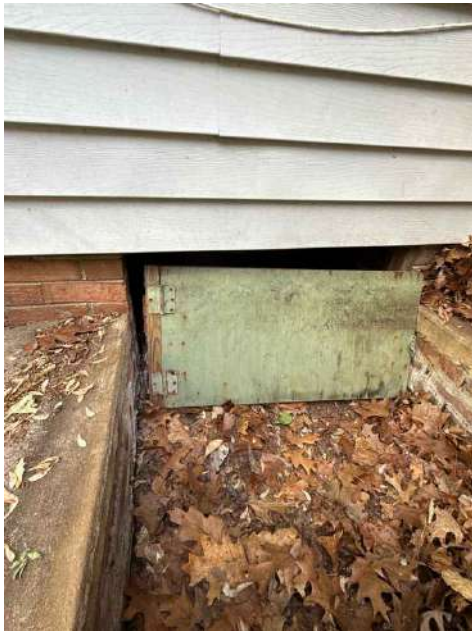
DAMAGED ACCESS DOOR

Contact a qualified professional.

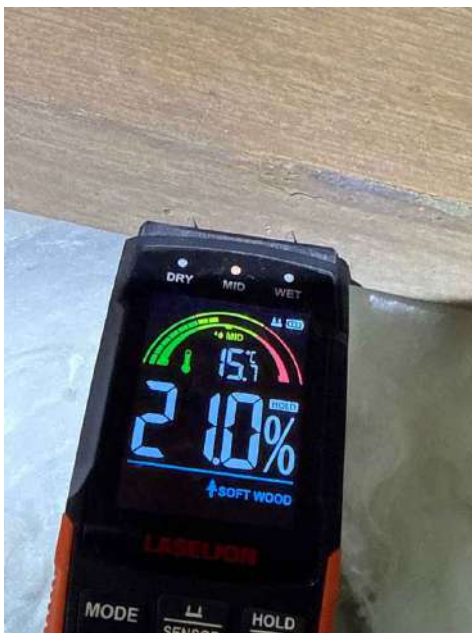
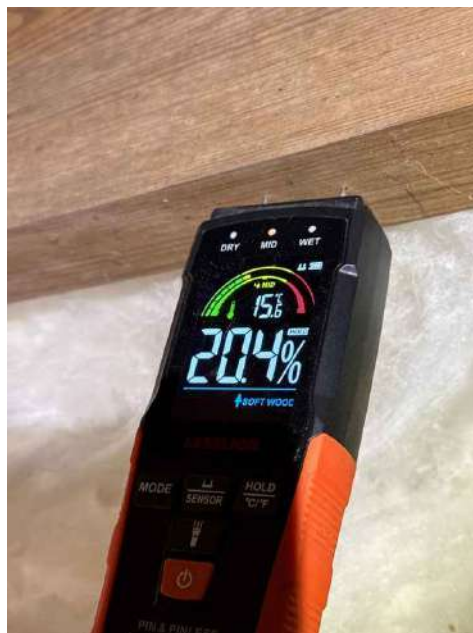
ELEVATED MOISTURE LEVELS (>20%)

Contact a qualified waterproofing contractor

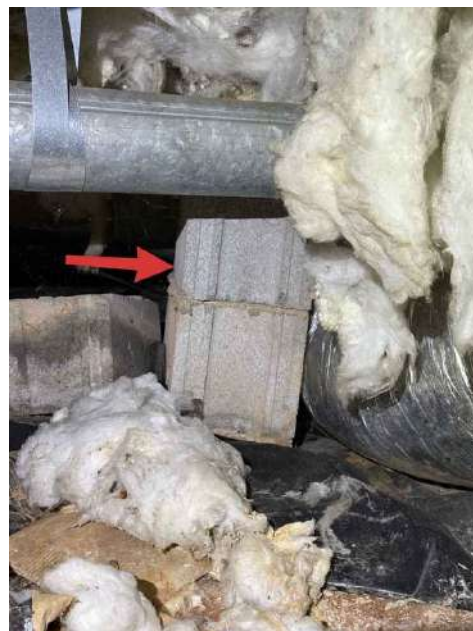
Crawl Space

Urgent or Safety Concern

Contact a qualified professional.
