Inspection Report

Property Address:
181 HP Cook rd.
Cairo Ga 39828

South Georgia Home Inspections

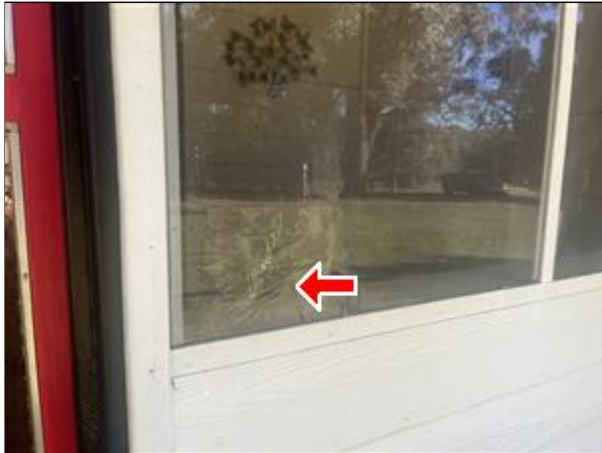
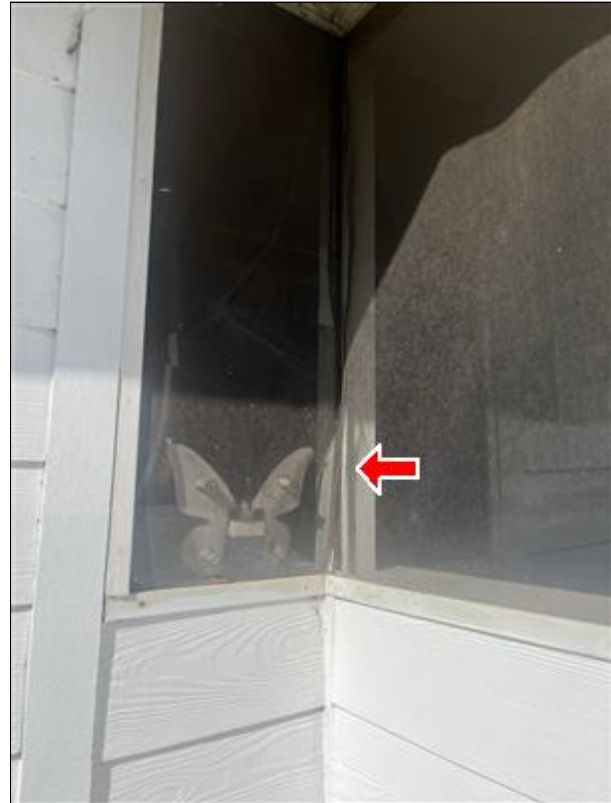
2.3 Picture 1

2.3 There is one area where the screen is damaged at the screened in porch at side of the home, this is for information, replace as desired.

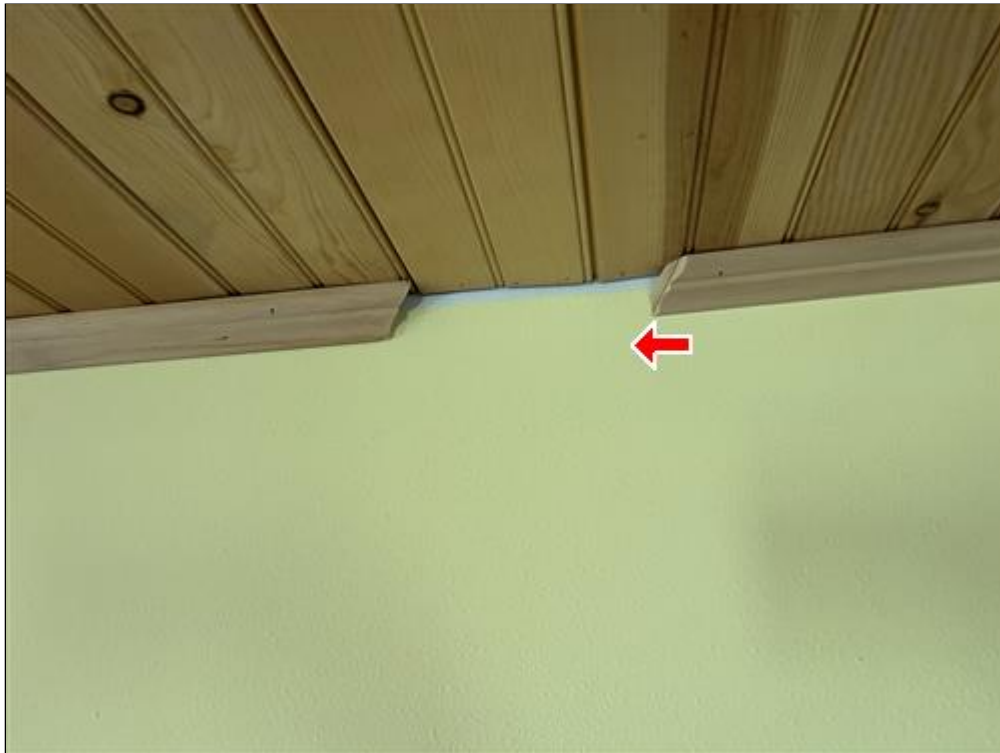
4.0 Picture 1

4.0 The wood crown molding on the ceiling is missing piece at the Living Room. This is a small repair issue for your information. .

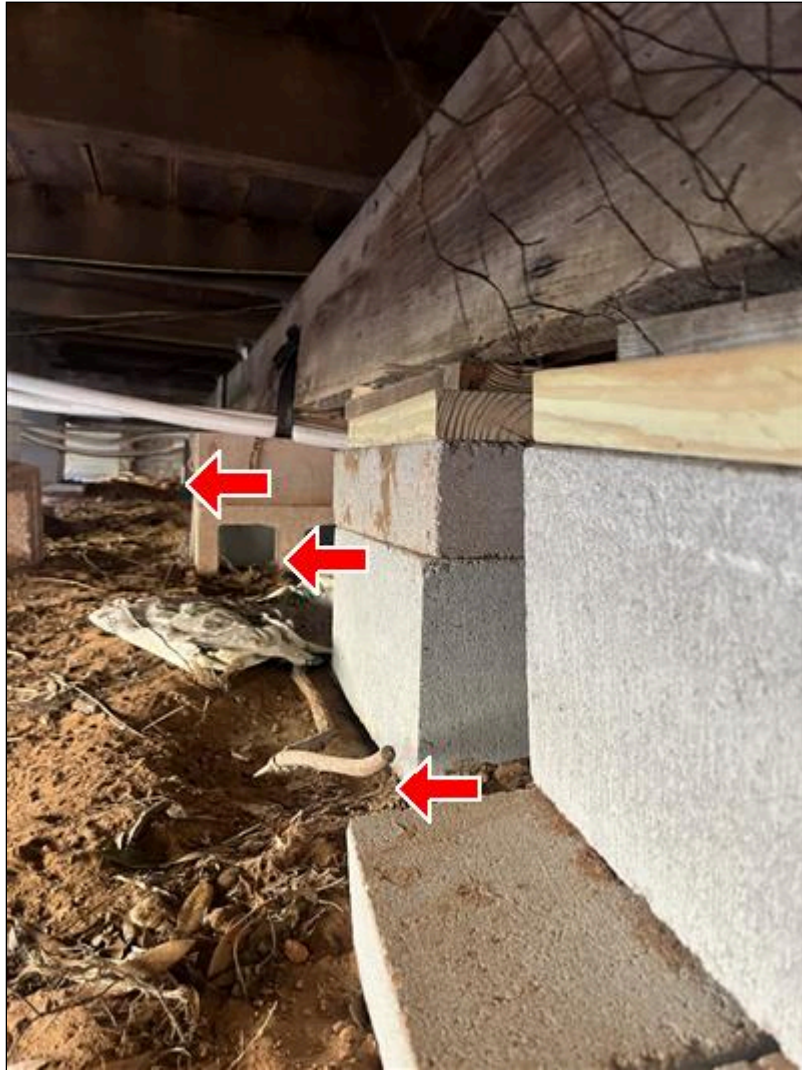
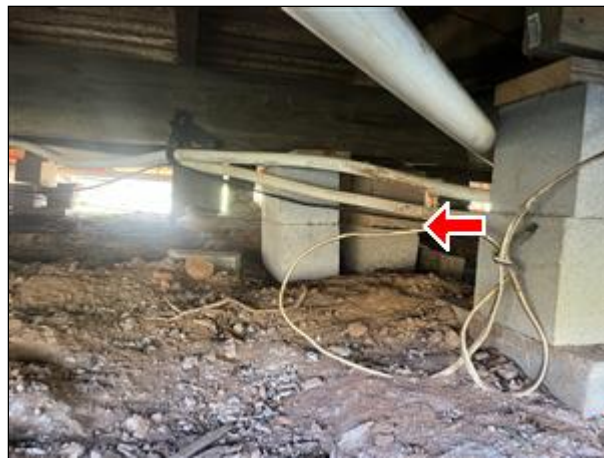
5.2 Picture 1

5.2 The concrete piers does not sit on a proper concrete footing under the kitchen along the Girder Beam. . While this repair will work, most tradesmen will recognize it as sub-standard.

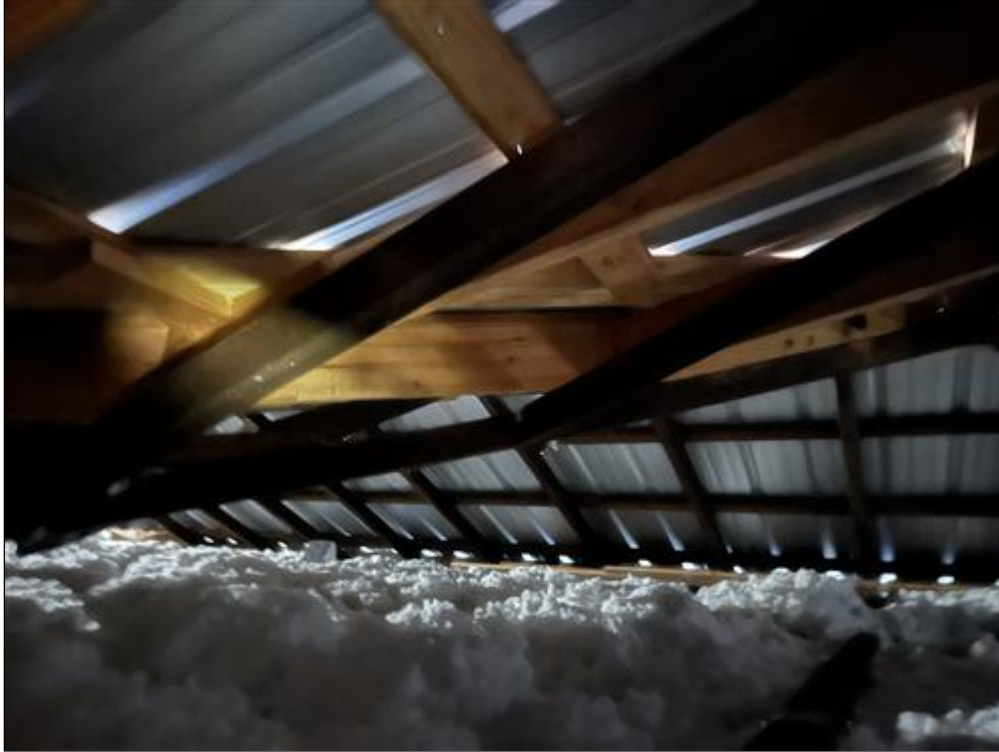
5.5 Picture 1

5.5 There is no plywood sheathing at the roof structure. This is common with some houses and most barns. This is for your information

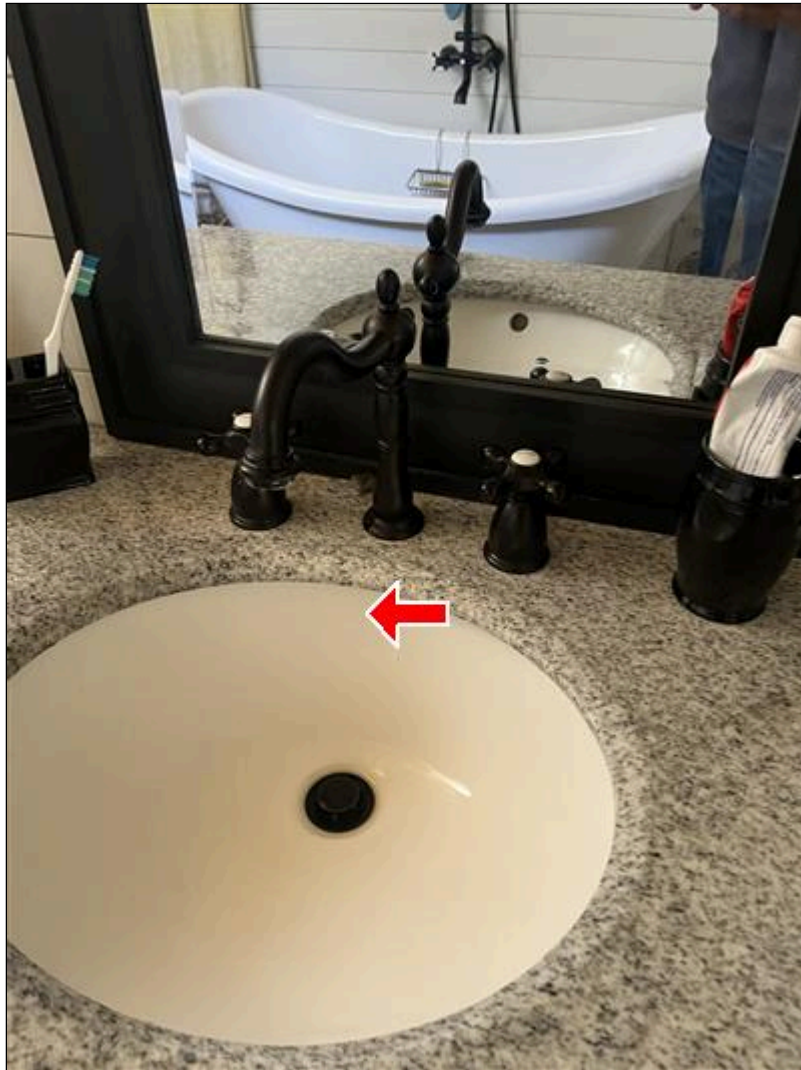
6.1 Picture 1

6.1 The vanity sink at the master bathroom has a small continuous drip, this is a small repair and for your information.

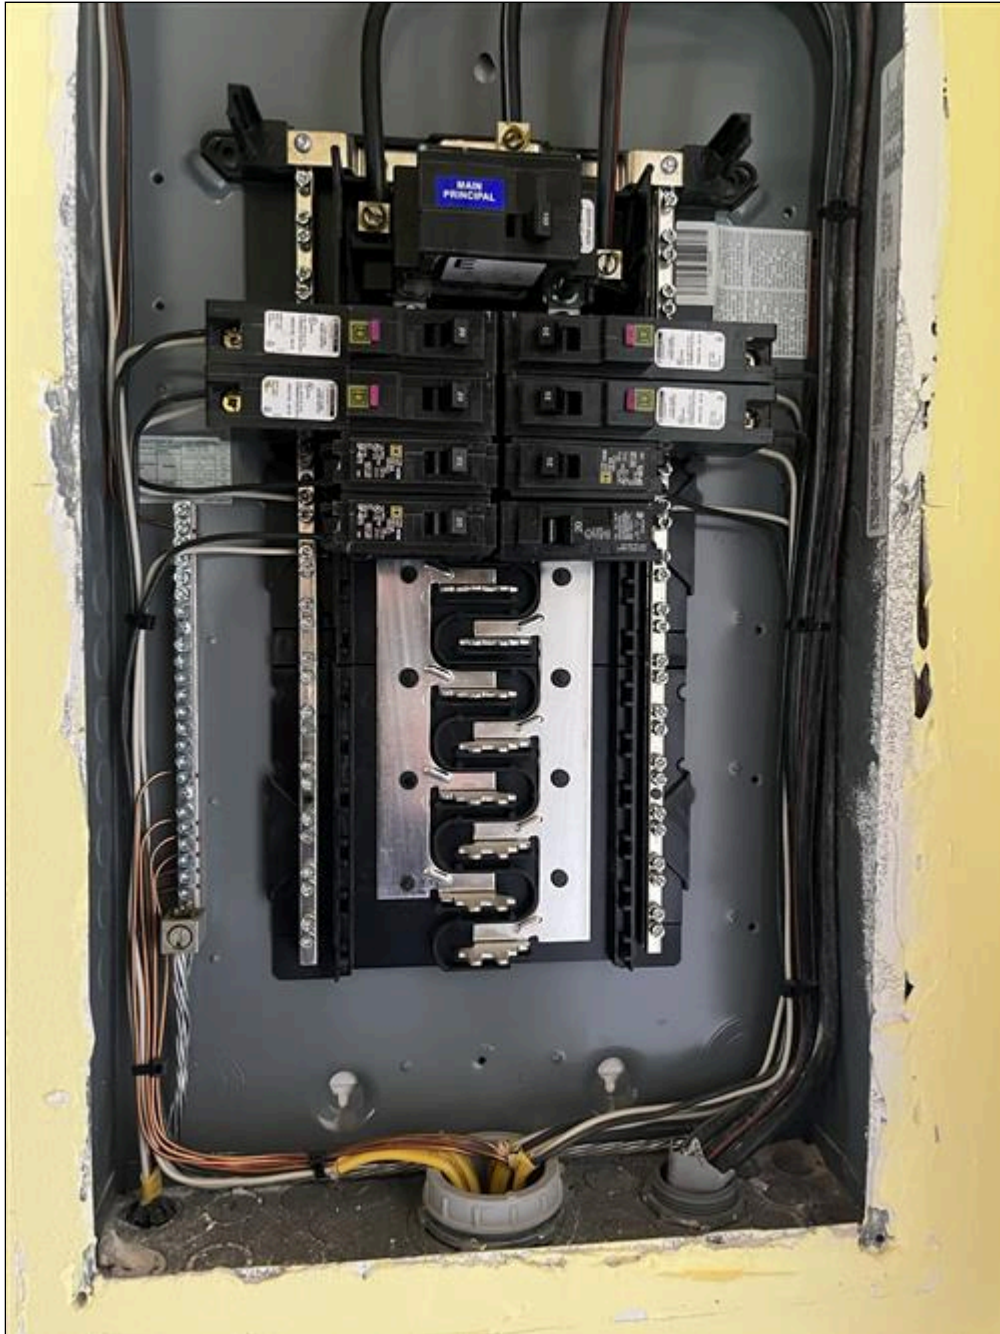
7.6 Picture 1

7.6 This is just a picture of both panel boxes for the original part of the home and the newer addition. No repairs are needed.

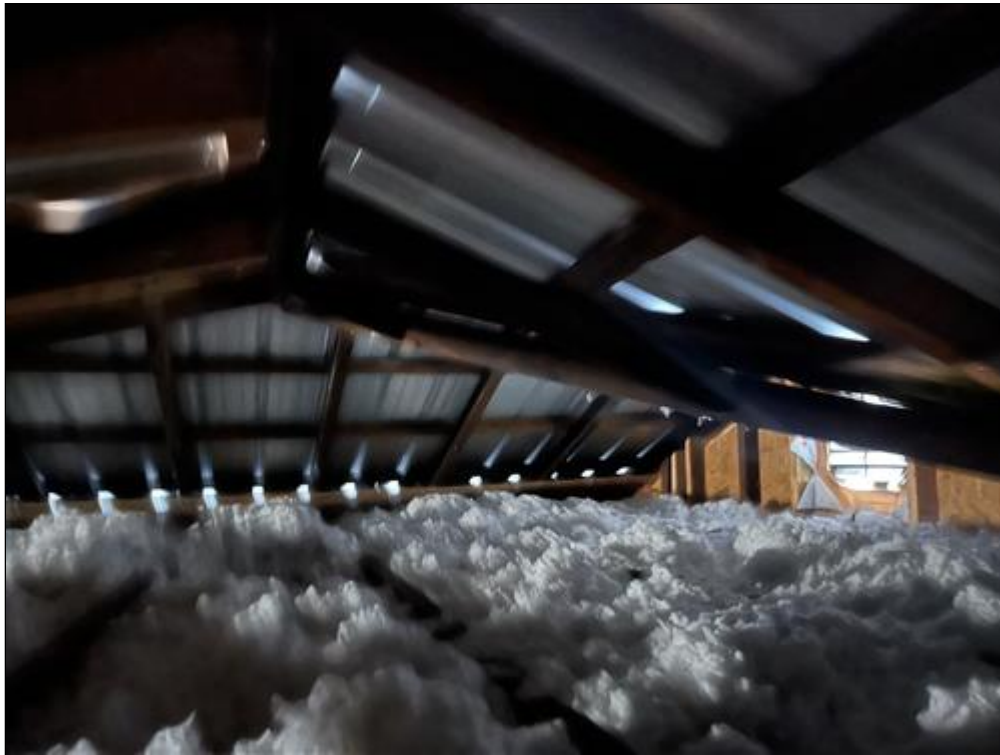
9.0 Picture 1

9.0 insulation thickness is about nine inches thick or just under 33 R-Value.

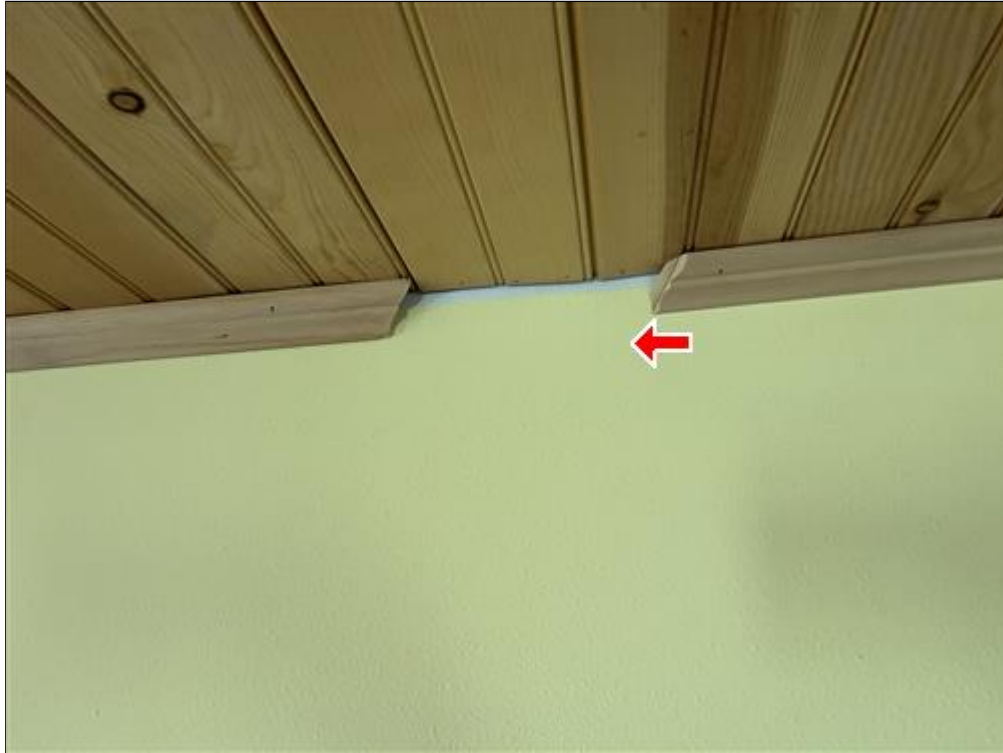
4.0 Picture 1

The wood crown molding on the ceiling is missing piece at the Living Room. This is a small repair issue for your information. .
