Inspection Report

Property Address:
730 Summerhill Rd.
Thomasville Ga 31792

E House' Home Inspections

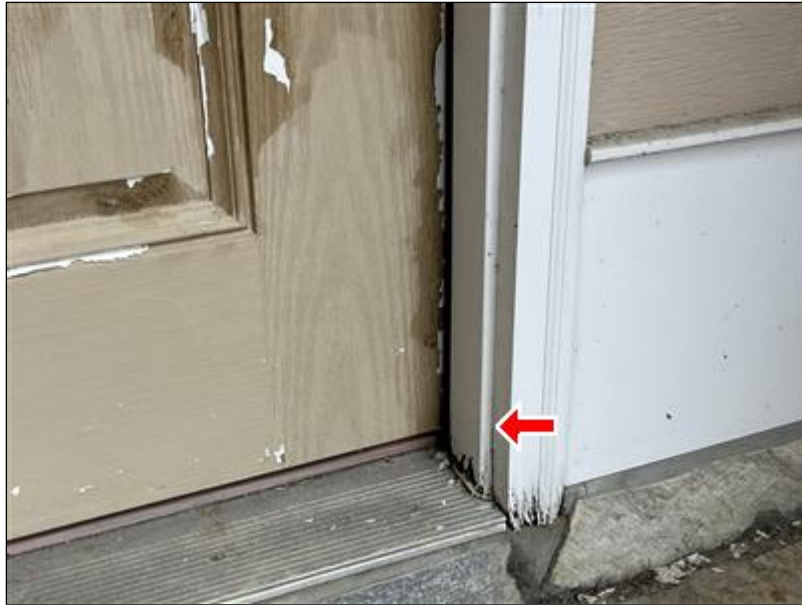
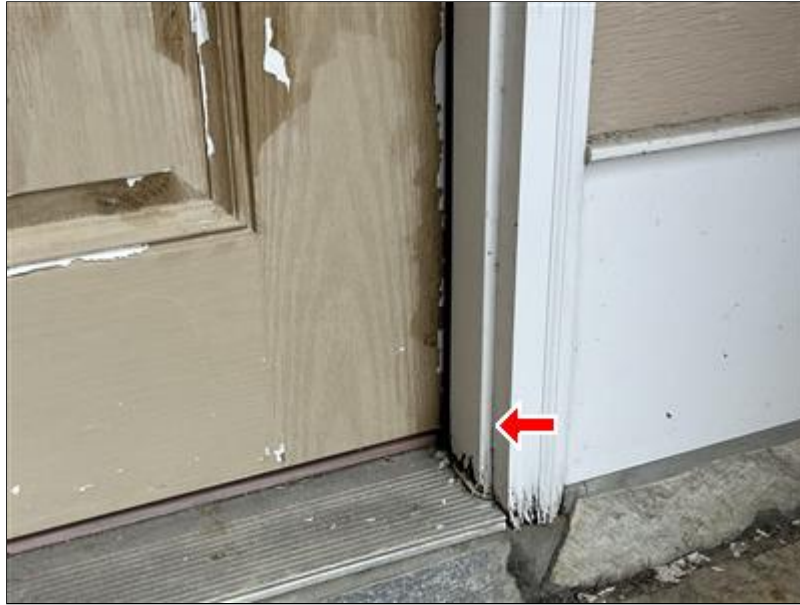
2.1 Picture 2

(2) The entry door rear of home has deteriorated at brick-mold or trim (exterior). . A qualified person should repair or replace as needed.

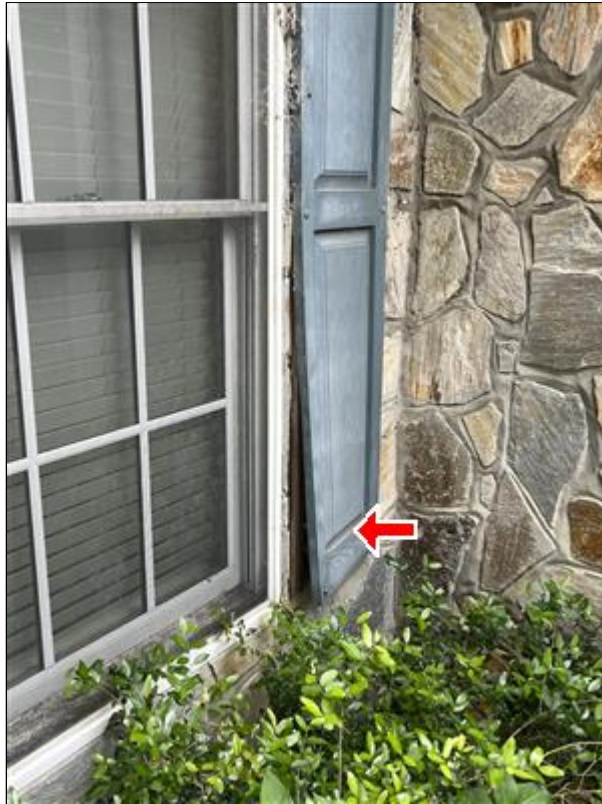
2.2 Picture 1

2.2 There are two vinyl window shutters that are loose at the front of the home. This is a small repair for your information.

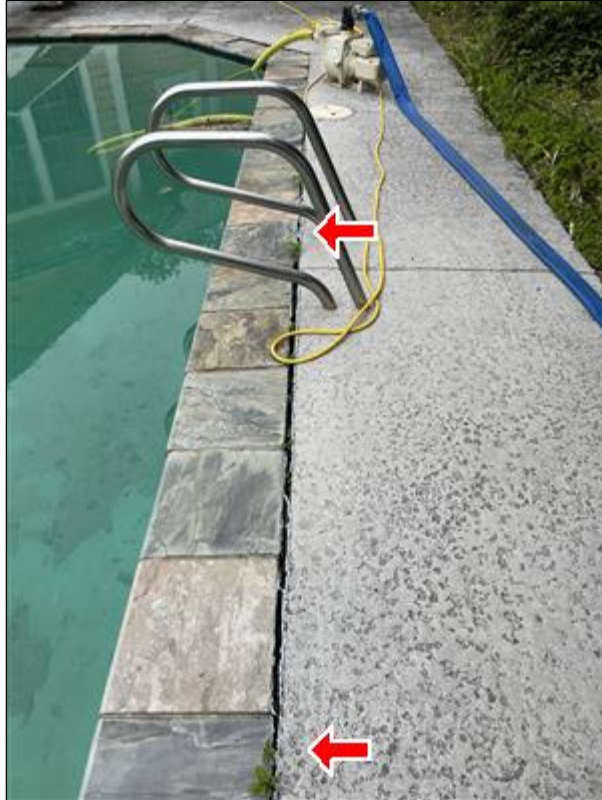
2.3 Picture 1

2.3 The concrete tiles at the pool deck area appear to be starting separate apart from the concrete walkway, I recommend monitoring this area and repair as needed.

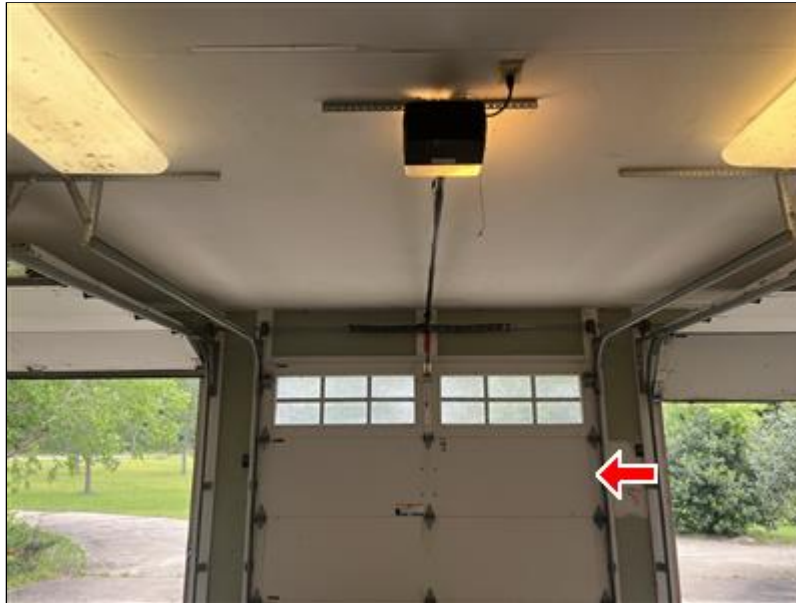
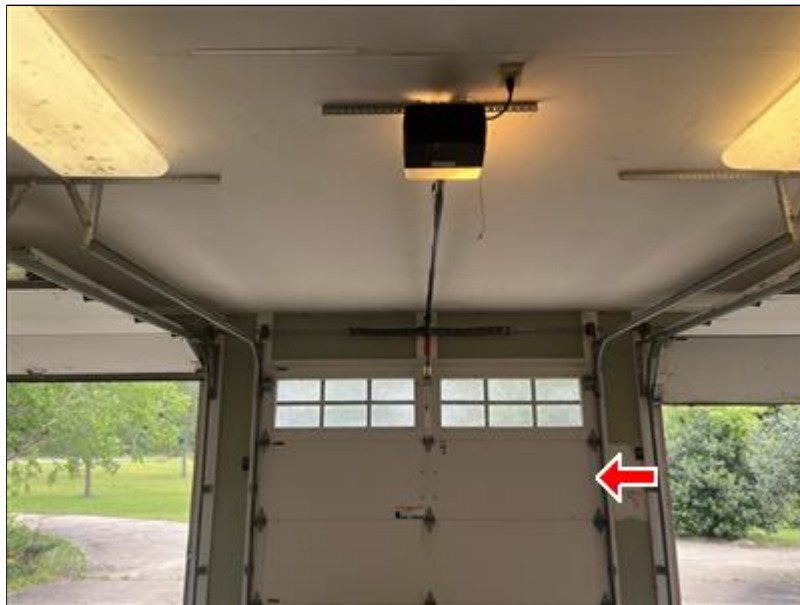
3.3 Picture 1

3.3 The middle garage door did not operate correctly at the time of the inspection. This is maintenance issue for your information.

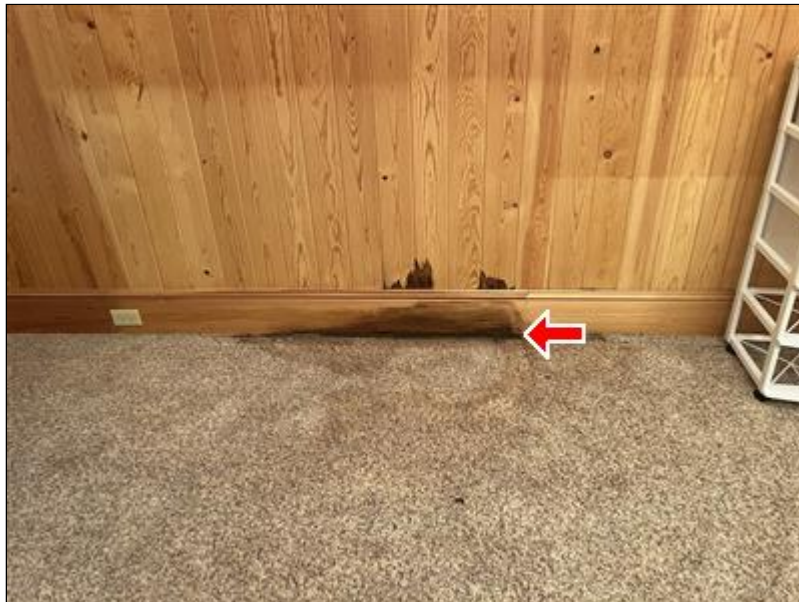
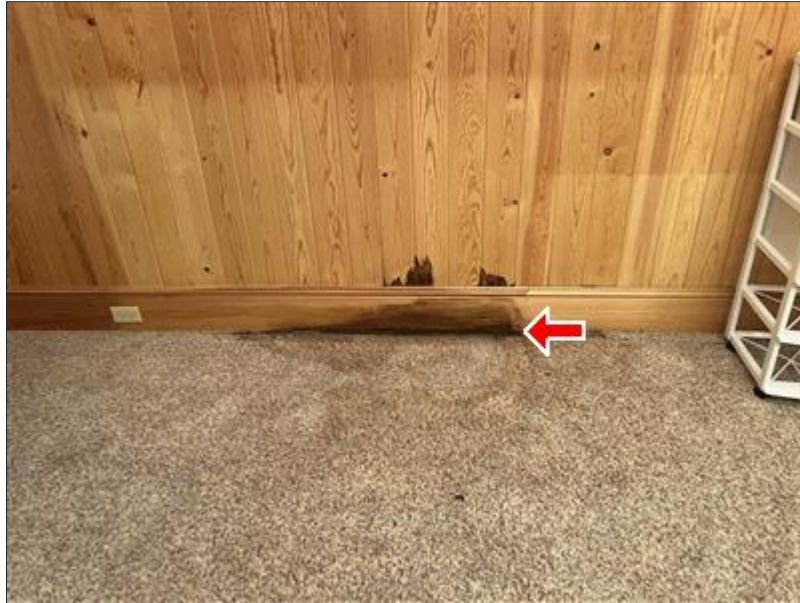
4.1 Picture 1

4.1 The wood panels in the living room area have wet stains indicating a leak in the master bathroom. Repairs are needed in this area.

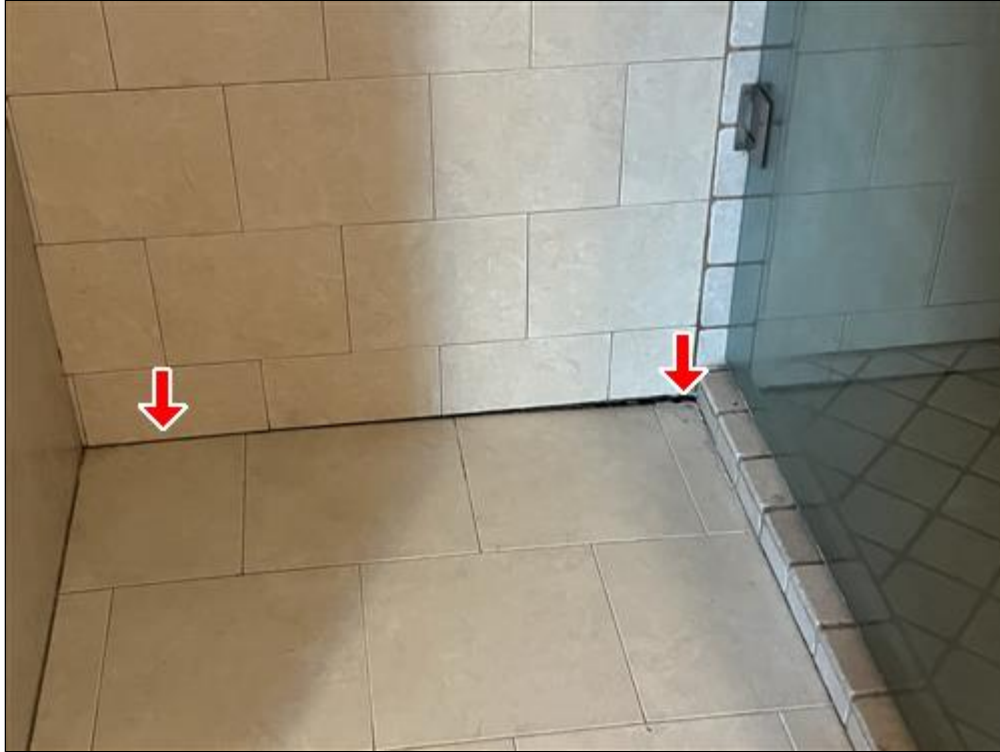
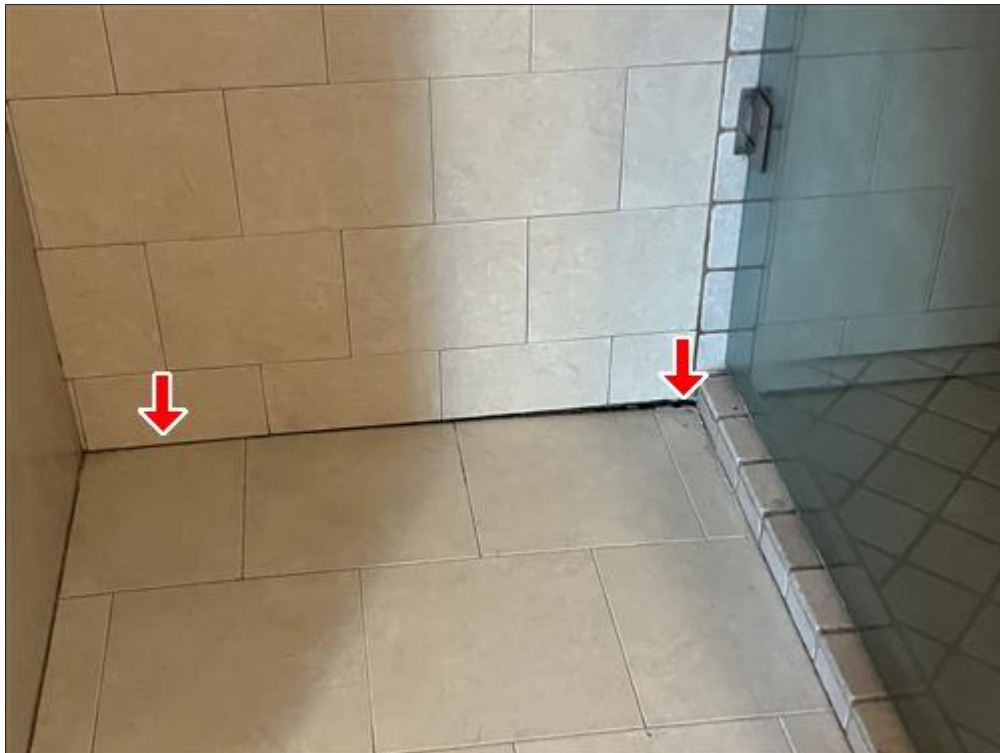
4.2 Picture 1

4.2 The floor tile in the master bathroom has settled due to the active leak in the master bathroom, this is for your information.

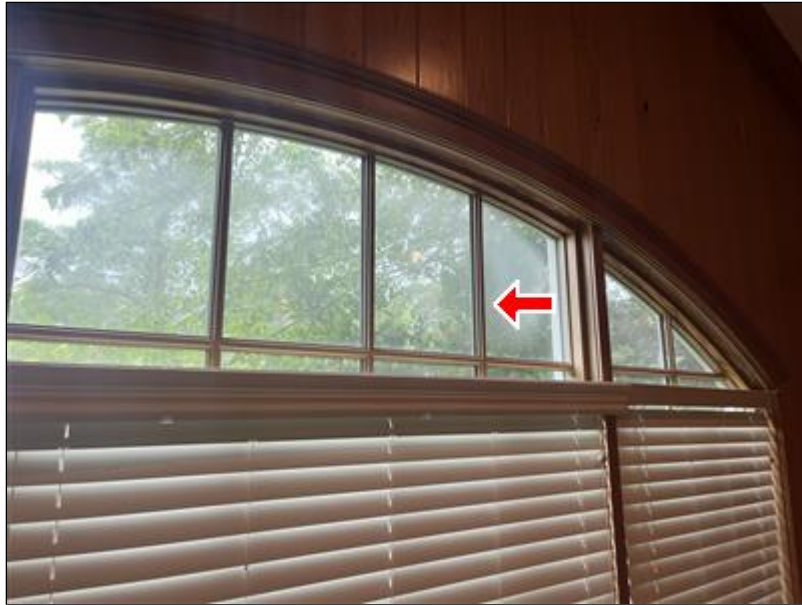
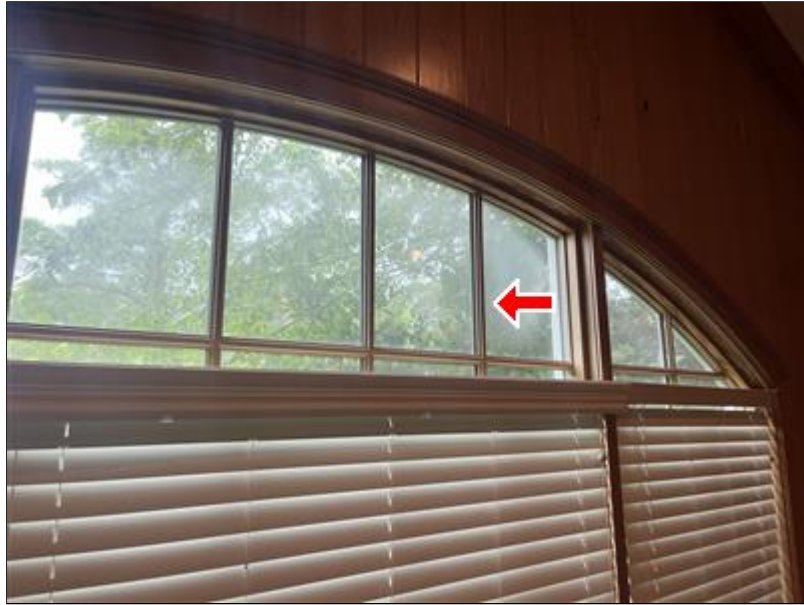
4.6 Picture 1

4.6 Three windows cloudy (lost seal) at the home. In order to correct the cloudy appearance of glass, a replacement of glass pane or the unit will be necessary. A qualified person should repair or replace as needed.

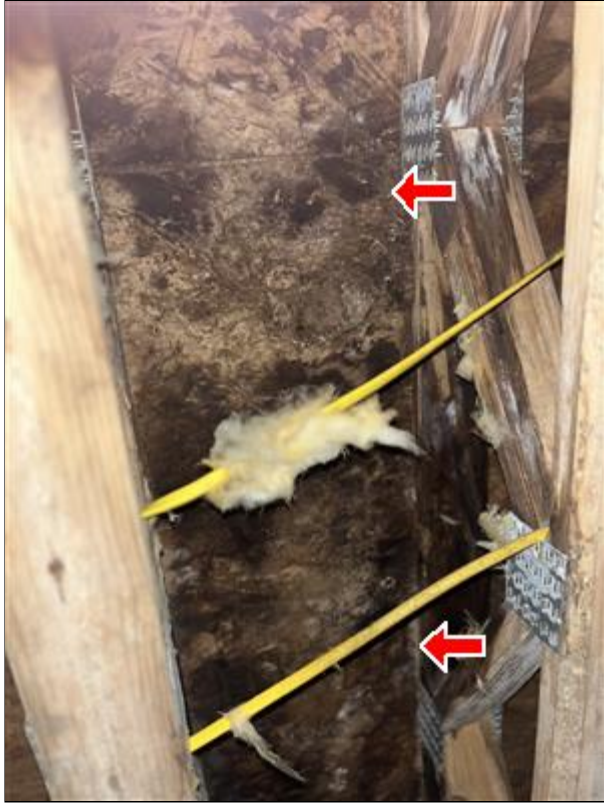
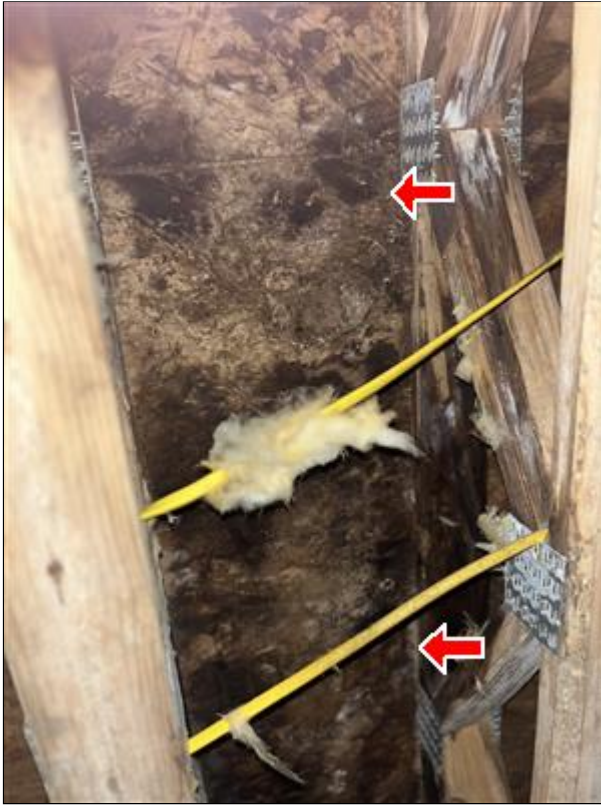
5.3 Picture 1

5.3 At least Three floor joist(s) and Sub-flooring are deteriorated from a leak under the Master bath and Private (possibly shower pans). Repairs are needed by a qualified person.

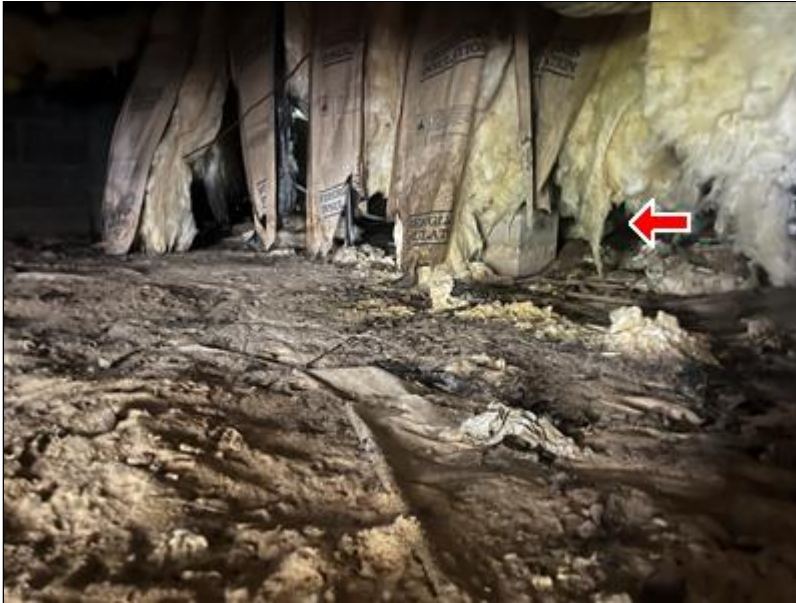
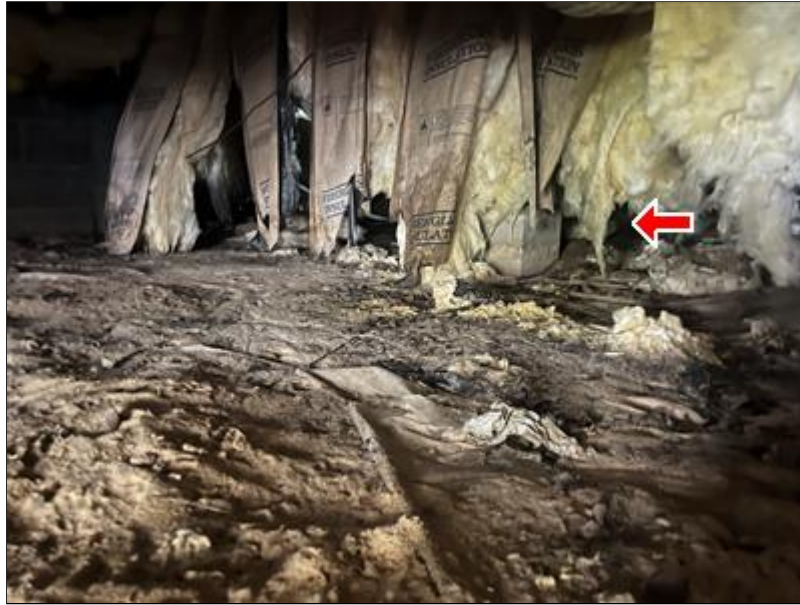
9.1 Picture 1

9.1 The insulation is loose/fallen in the crawlspace. Insulation that has fallen to the ground or has become damp from the ground or from condensation usually needs to be replaced with new insulation. A qualified person should repair or replace as needed.
